WATER LICENCE INSPECTION FORM

Licensee		Licensee Representative	
City of Iqaluit		M Karveli and P MacMunn	
Licence No. / Expiry		Representative's Title	
3AM-IQA1626		NA	
Land / Other Authorizations		Land / Other Authorizations	
NA			
Date of Inspection		Inspector	
June 4, 2018		Jonathan Mesher	
Activities Inspected			
<input type="checkbox"/> Camp	<input type="checkbox"/> Drilling	<input type="checkbox"/> Mining	<input type="checkbox"/> Construction
<input type="checkbox"/> Roads/Hauling	<input checked="" type="checkbox"/> Other: Municipal		<input type="checkbox"/> Reclamation
			<input type="checkbox"/> Fuel Storage
			<input type="checkbox"/> Other:

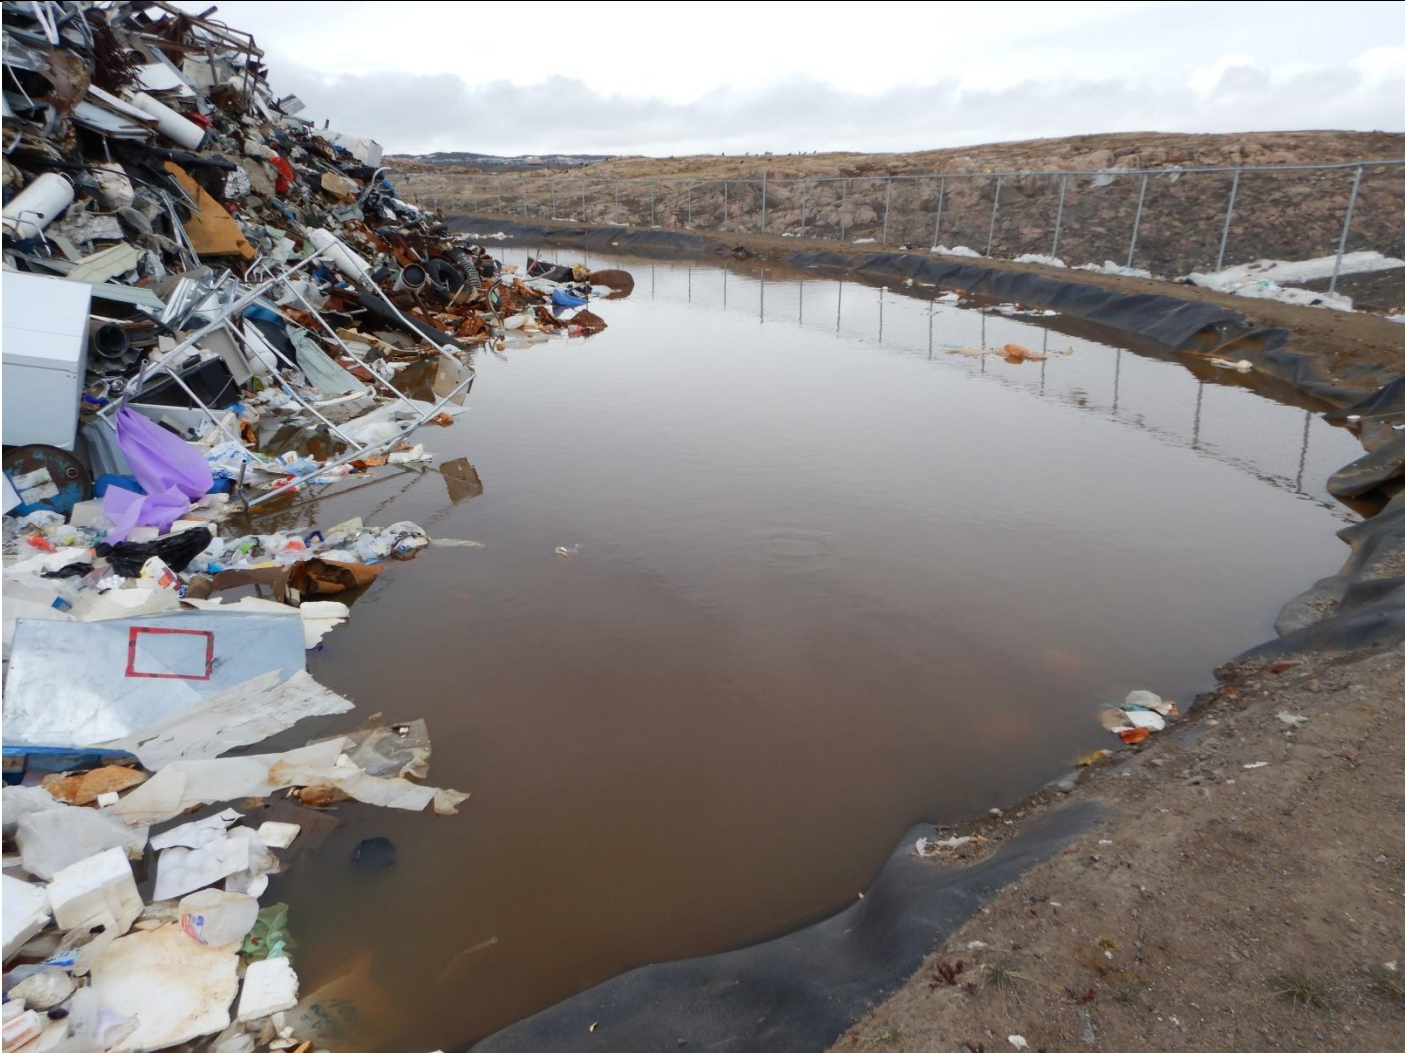
Photo 1

11. During the inspection at the West 40 Landfill southeast containment ponds, there were signs of tears, rips and signs of a high water mark leading the inspector to believe that this facilities ability to contain leachate is jeopardized. Due to the poor condition of the containment ponds the inspector is requesting that the licensee conduct a study to ensure that the containment ponds are operating as intended, If the containment ponds are found to be jeopardized the licensee is to follow the conditions in PART G: Conditions Applying to Modifications.

Description: West 40 Landfill containment pond.

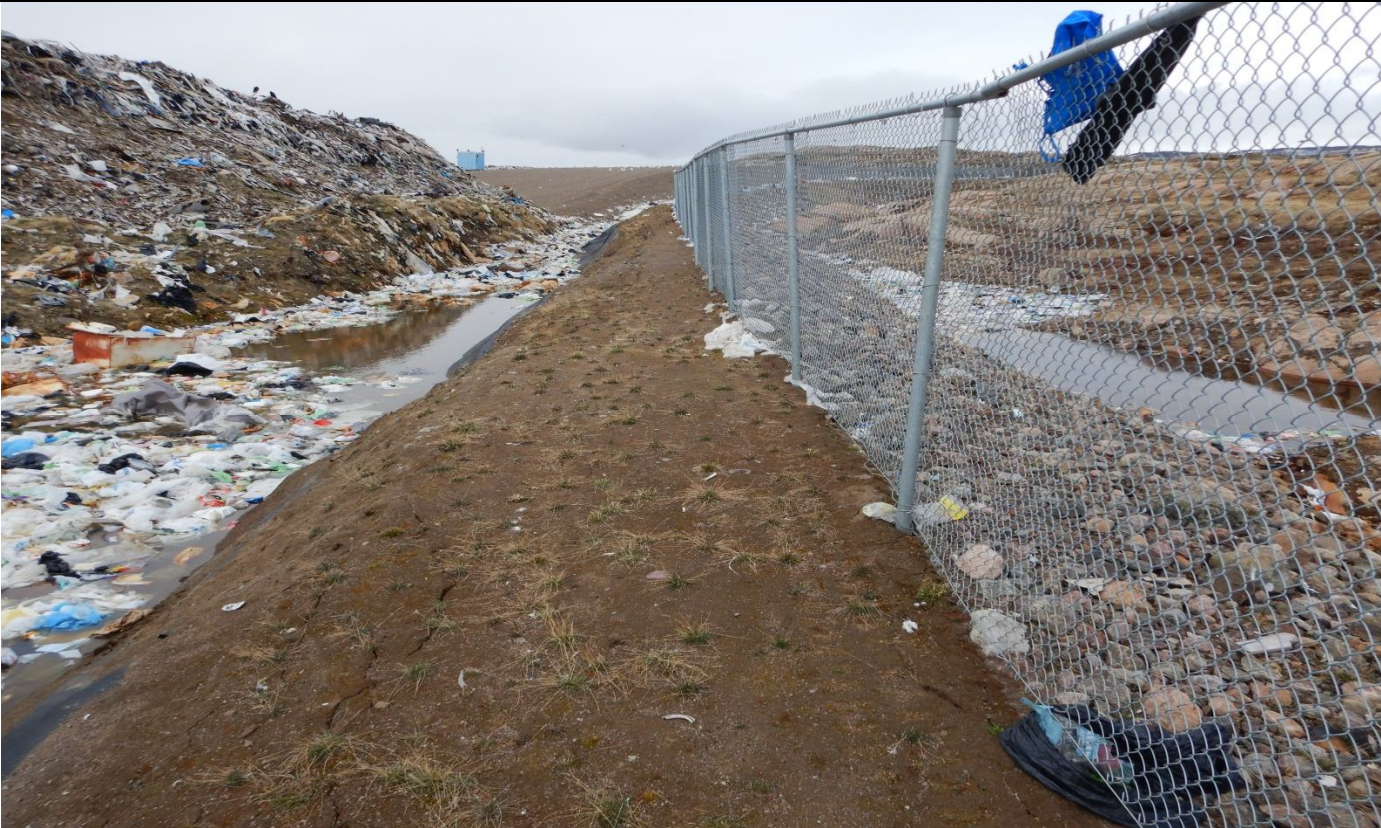
Photo Log #	Location City of Iqaluit
Photo 2

Description: West 40 Landfill containment pond.

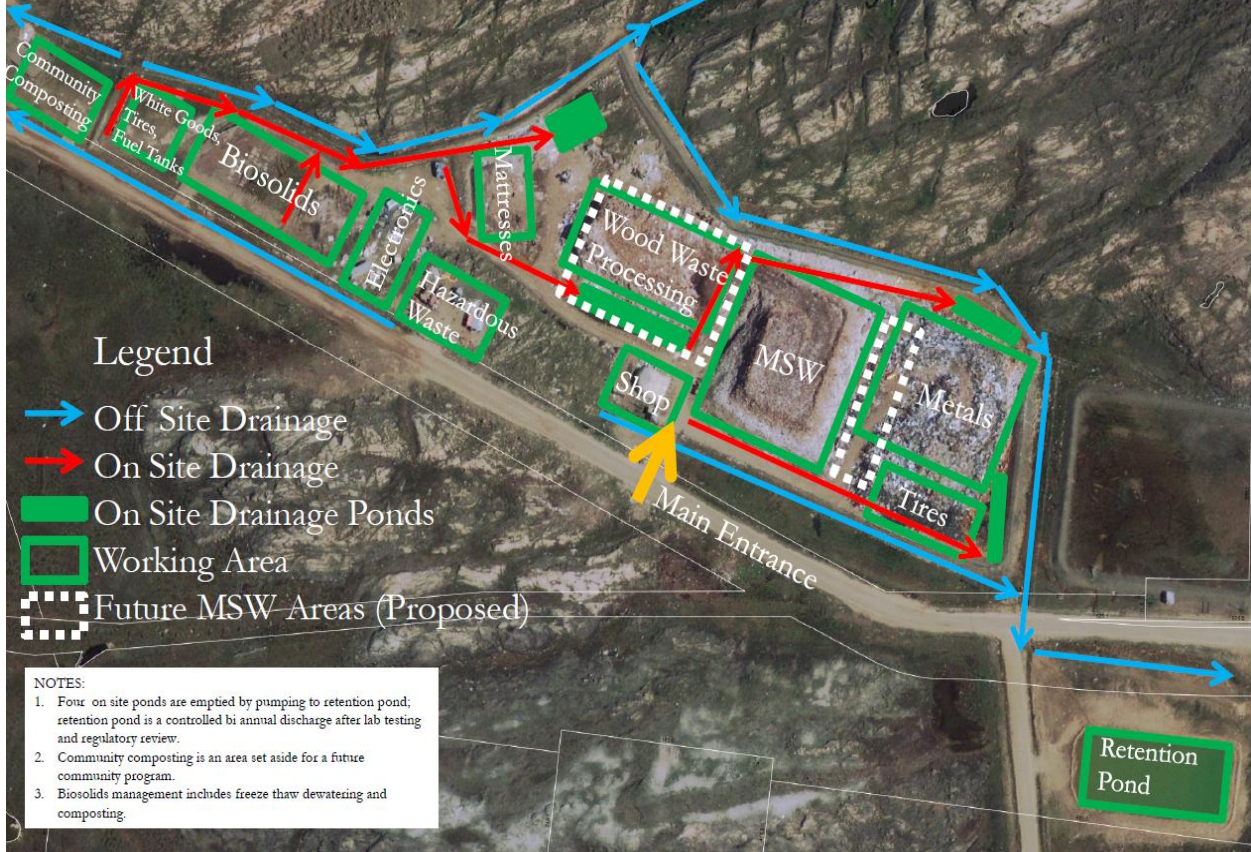
Photo Log #	Location: City of Iqaluit
Photo 4	N W

8. In the document “The City of Iqaluit City of Iqaluit Landfill Operations and Maintenance Manual, Date: January 2014”, Appendix E - 2006 Drainage Improvements. It identifies a containment pond on the east side on the facility and one in the center these structures were not in use or visible at the time of the inspection. See photo 4 for the missing ponds.

- I. Please provide the approval provided to remove or modify these waste management structures.
9. In the document, “The City of Iqaluit City of Iqaluit Landfill Operations and Maintenance Manual, Date: January 2014”, Appendix E - 2006 Drainage Improvements, it shows that the surface drainage on the north side of the facility is intended to flow East towards ditches and two containment ponds within the facility. The North end of this facility now slopes west towards an area where no containment ditches are present and flows directly in the surrounding environment. See photo 6 for the landfill sloping to the environment and photo 4 for the intended slope of the landfill.

Description: Landfill operation configuration.

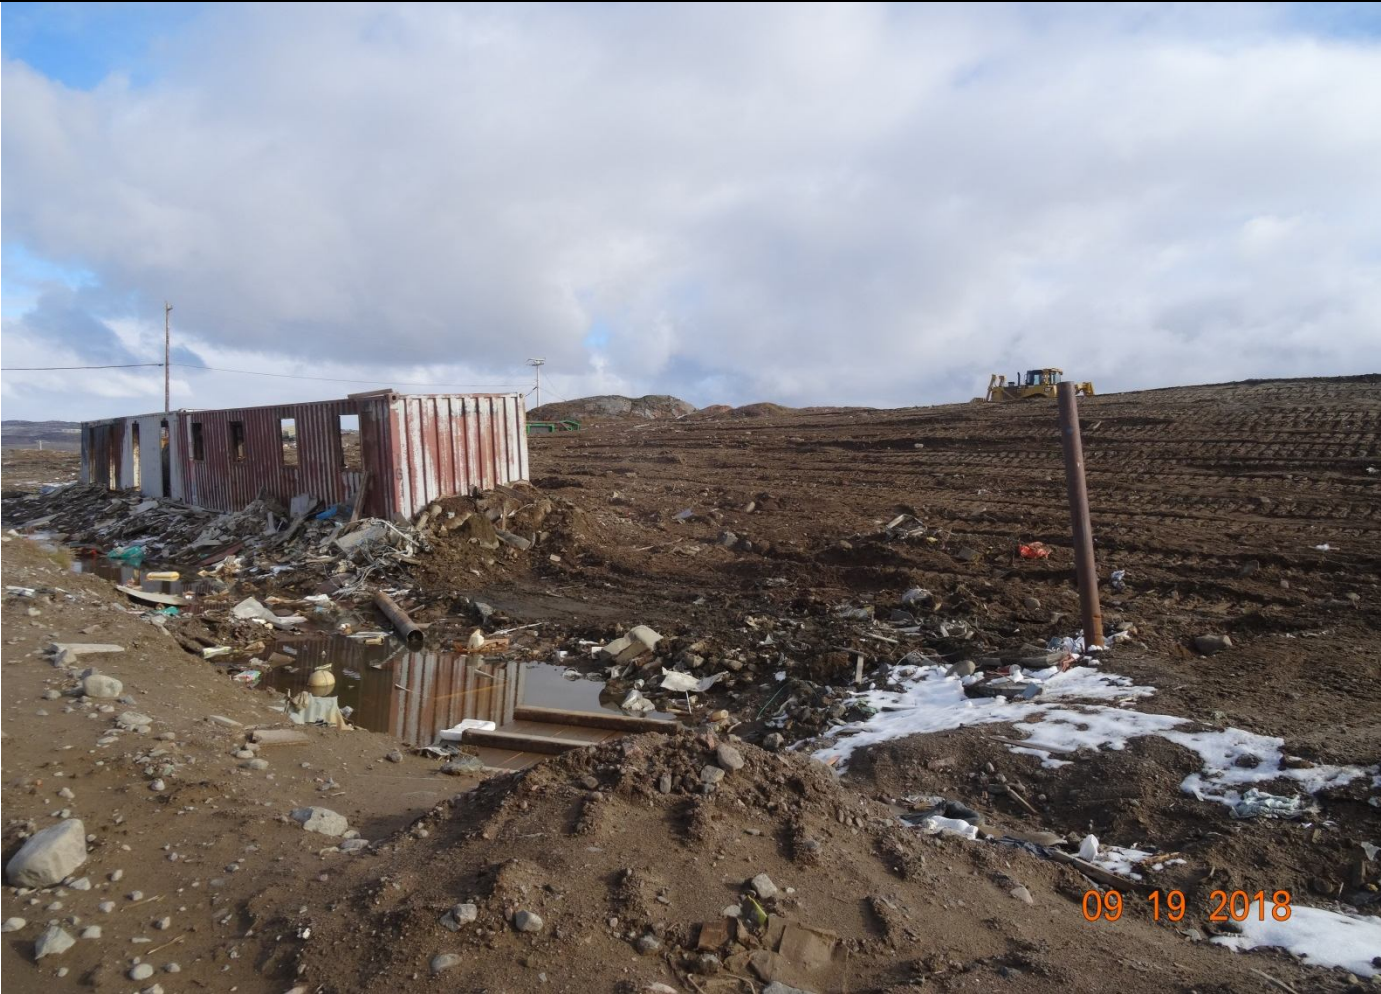
Photo 6

- I. This facility is not maintained to the satisfaction to the inspector as required in Part E, Item 17 of the licence 3AM-IQA which states, “The Licensee shall maintain the Licensed Facilities to the satisfaction of an Inspector.”

- II. This observation is in contradiction of Part E, item 13 of the licence 3AM-IQA1626, which states, “The Licensee shall collect and contain all leachate generated by the West 40 Landfill within the Landfill.”

Description: slope of the landfill leading into the environment.

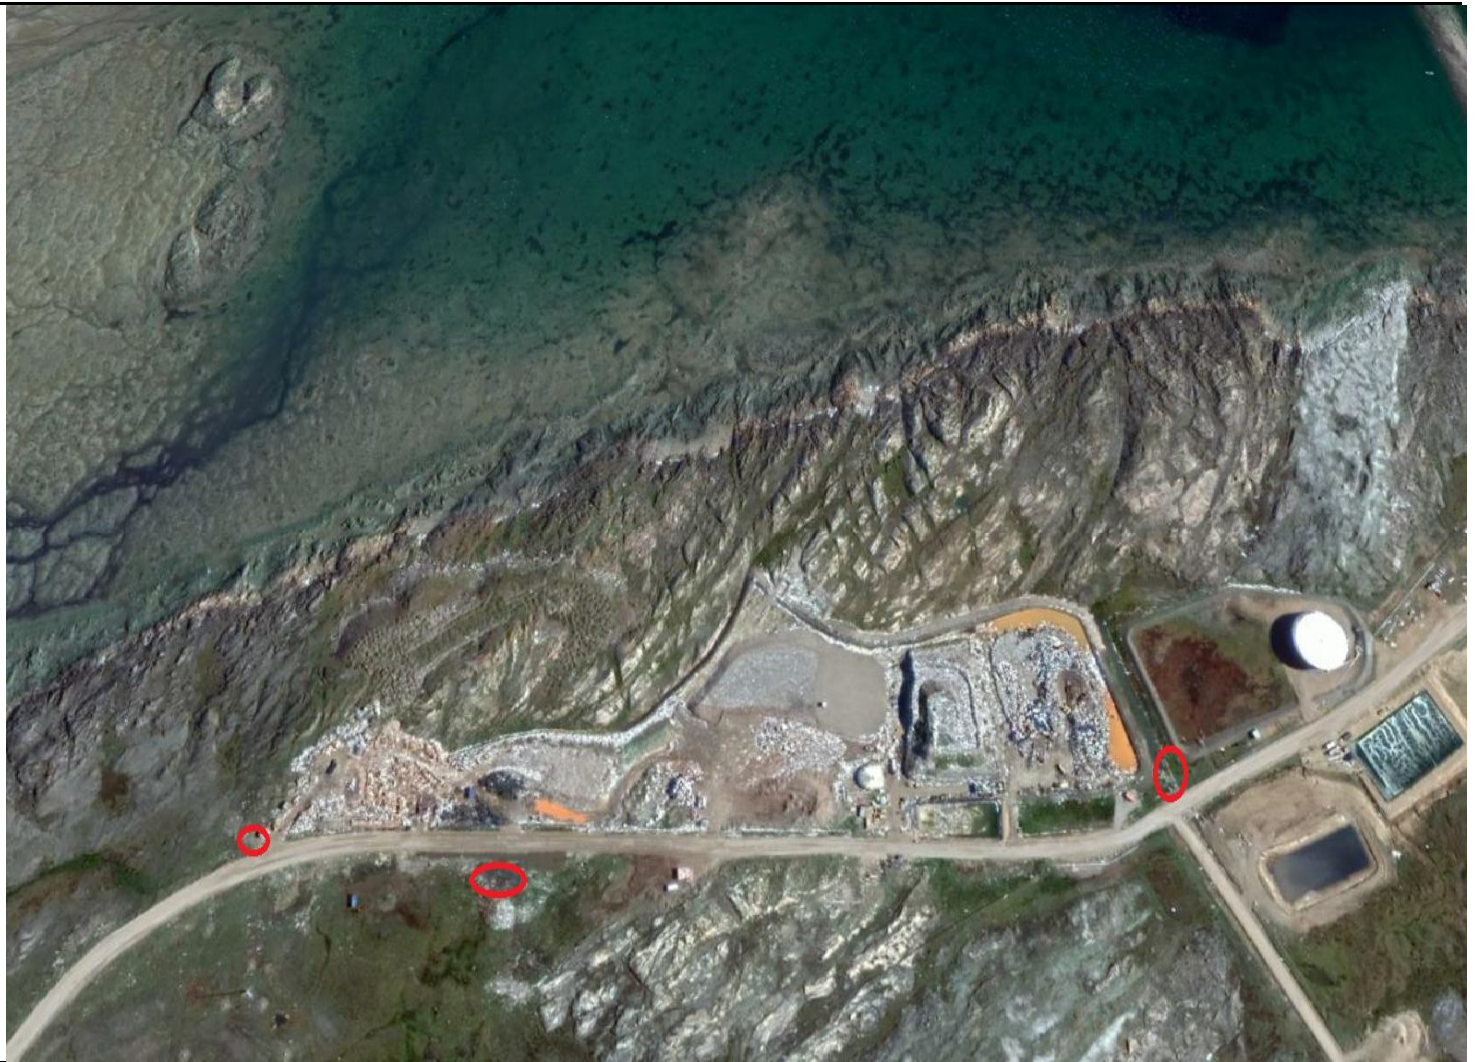
Photo Log #		Location City of Iqaluit		
Photo 8

12. Due to the poor condition of the landfill the Inspector has requested that monitoring be conducted in three (3) locations surrounding the facility(see photo 8), the ability to request monitoring stems from, PART I, Item 11 of the water licence 3AM-IQA1626. The result showed that the city is above the allowed levels of Total Suspended Solids (TSS), the pH results were almost below the acceptable limit and Zinc is almost above acceptable levels. The sampling results were then analyzed by David Zhong, A Regulatory and Science Advisor with CIRNAC. The following comments were made by David;

- I. TSS values of the two samples collected at location C (i.e., samples 013991-05 and 013991-06) are extremely high (i.e., 822 mg/L and 2,400 mg/L, respectively) and would exceed any applicable water or wastewater standard;

- II. Zinc concentrations of the two samples collected at location C (i.e., samples 013991-05 and 013991-06) are elevated (i.e., 0.406 mg/L and 0.397 mg/L, respectively). For reference, MMER limit for zinc is 0.500 mg/L and MDMER limit for zinc is 0.400 mg/L;

- III. Field-measured pH shows that water at sample location A is weakly acidic (i.e., pH at 6.18);
  - IV. There is a systematic discrepancy between lab and field measured pH values: lab results show higher pH values than field measurements (i.e., between 0.3 and 1.2 pH unit difference), indicating chemical reactivity of the samples.

Description: Location of samples requested at the west 40 Lanffill.
