INSPECTION FORM

Licensee	Licensee Representative
City of Iqaluit	NA
Licence No. / Expiry	Representative's Title
3AM-IQA1626	
Land / Other Authorizations	Land / Other Authorizations
Date of Inspection	Inspector
August 20, 2019	Jonathan MESHER
Activities Inspected	
<input type="checkbox"/> Camp	<input type="checkbox"/> Drilling
<input checked="" type="checkbox"/> Roads/Hauling	<input type="checkbox"/> Mining
	<input checked="" type="checkbox"/> Construction
	<input type="checkbox"/> Reclamation
	<input checked="" type="checkbox"/> Fuel Storage
	<input checked="" type="checkbox"/> Other: Municipality

On August 20, 2019, an inspection was conducted by WRO Jonathan MESHER of the road leading to “Unnamed Lake”, the pipe line from Niaqunguk river to Lake Geraldine. The inspection was to ensure that the City remains in compliance with the Nunavut Waters and Nunavut Surface Rights Tribunal Act and their current license.

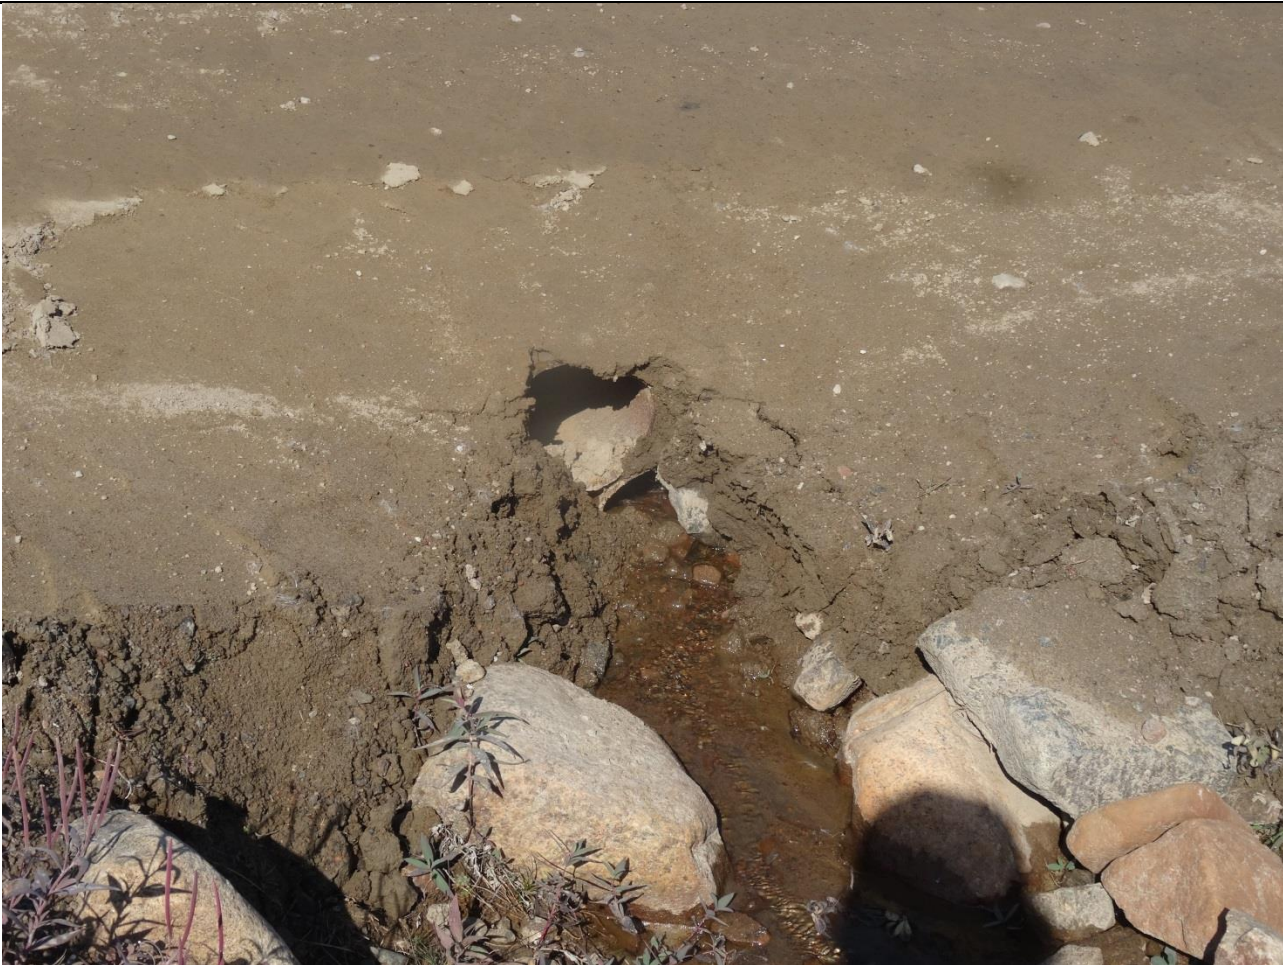
Date	Camera	Inspector	Authorization
	Sony Cyber-shot	J.Mesher	3AM-IQA1626
Photo Log		Location Iqaluit	
Photo 3

At approximately N63.760569 W68.460616 there are 3 small pipes buried in the road, when questioned about the usage of the pipes Matthew Follett of Stantec informed the inspector that this it is outside the scope of the work. The water in this area normally flowed down an ATV trail and pooled next to the previous road. At some point during the construction an excavator had dug a ditch to divert this water away from where it normally pools to the pipes. These pipes are to be replaced by an appropriate sized culvert (See photo # 2 and 3).

Description: Three pipes being used as a culvert

2. The licensee shall implement measures to prevent or mitigate erosion and/or the release of sediment into Water as required in Part F, Item 8. Therefore the inspector is requesting that culverts be considered at approximately N63.760569 W68.460616, near survey post 0 +200, or any other location that may be affected.
