WATER LICENCE INSPECTION FORM

| City of Iqaluit | Joe Brown |
| 3AM-IQA1626 | |
| May 15, 2020 | Jonathan MESHER |

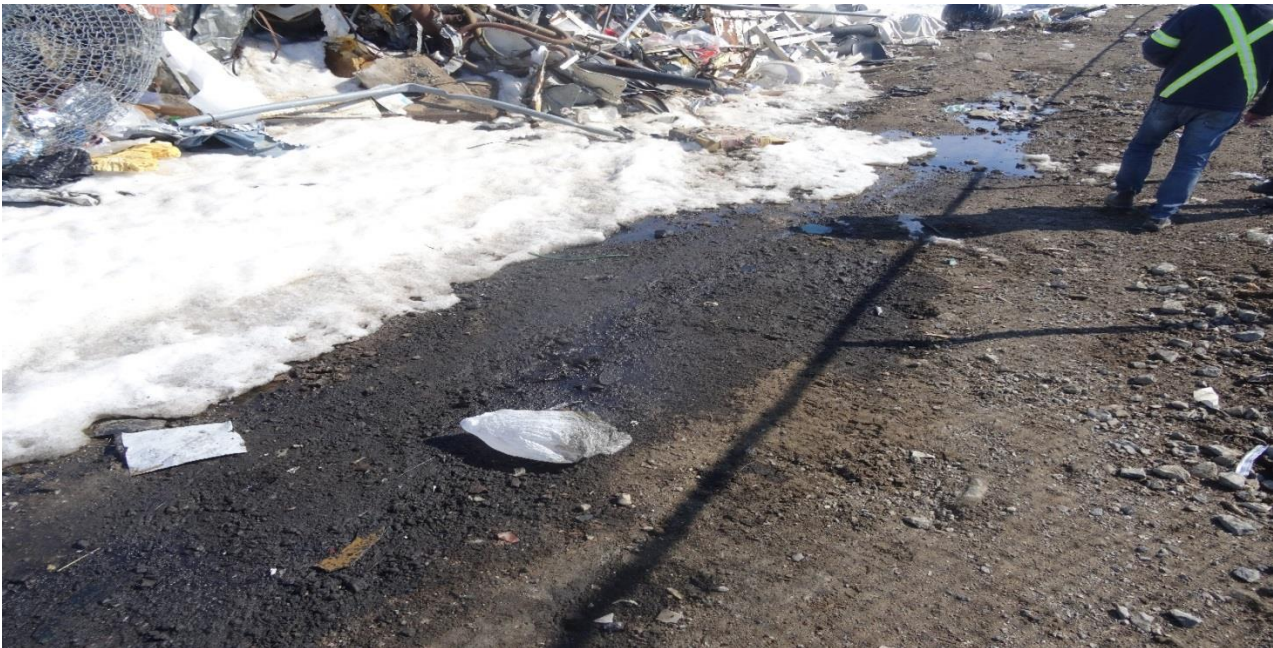
The inspector identified a spill at the South West corner of the facility, the inspector requested that the licensee representatives remediate the spill identified at the time of the inspection. See photo 1.

Photo 1; spill identified at time of inspection.

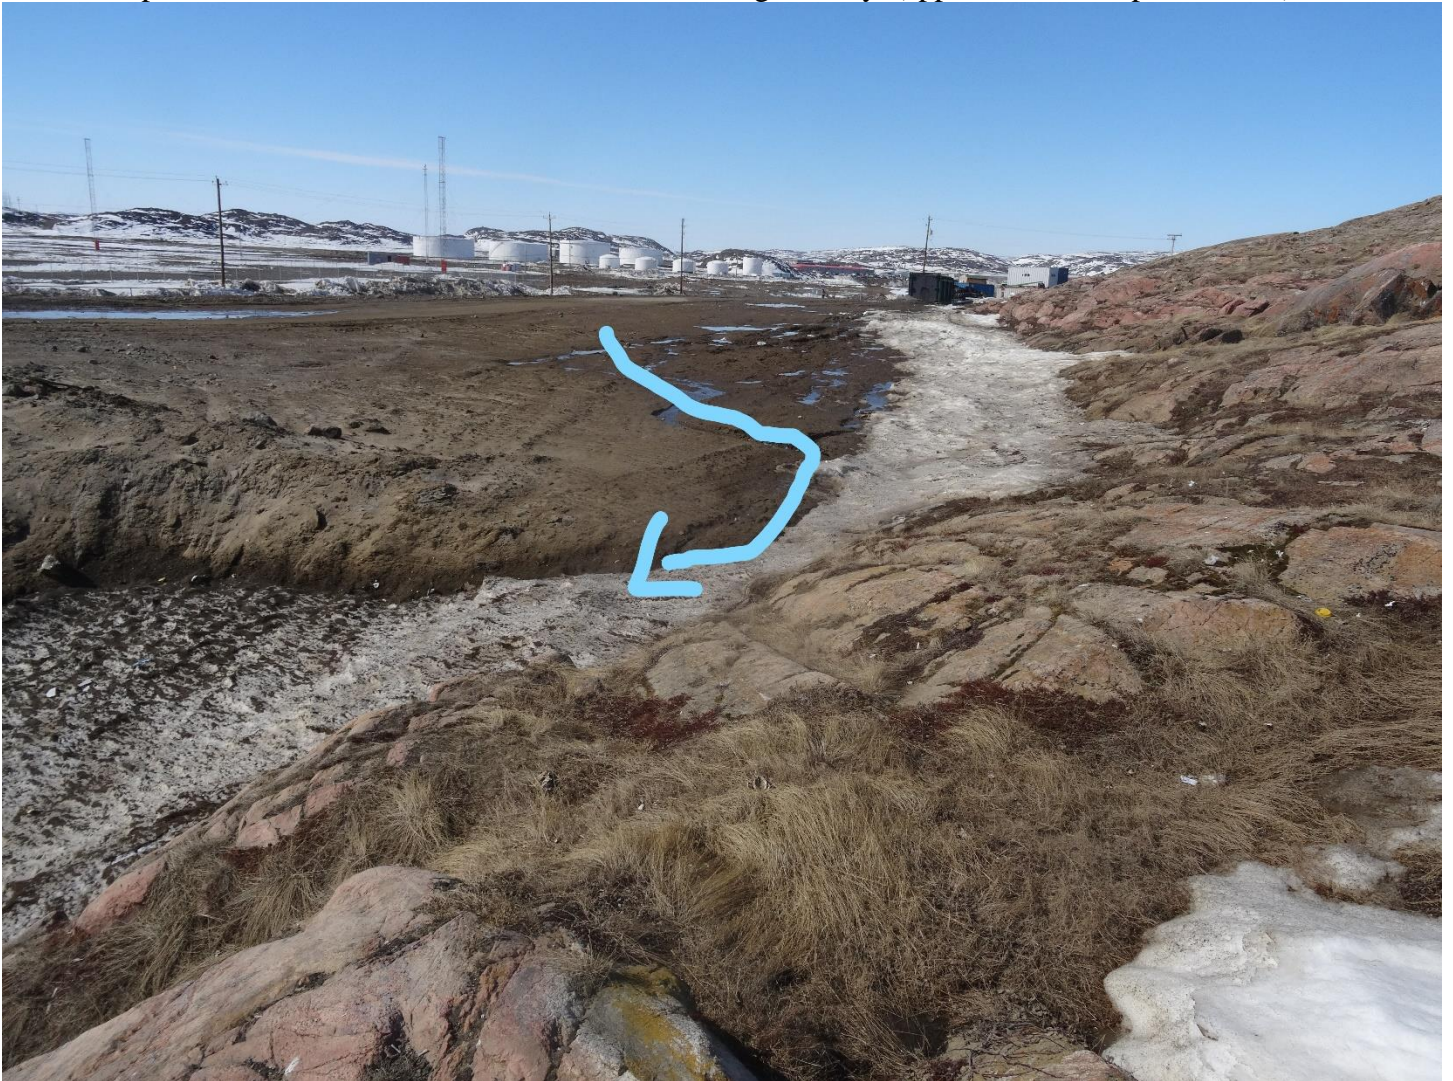
The inspector noted leachate leaving the facility on the North East side and the North west side of the landfill. PART E, ITEM 13, states that; “The Licensee shall collect and contain all leachate generated by the West 40 Landfill within the Landfill.” Therefore this leachate leaving the facility is in contradiction of Part E, ITEM 13, The inspector is requesting that the licensee provide a plan to construct the appropriate waste management structures to discontinue this act of non-compliance at the locations identified in figure__ and all other locations where leachate may be leaving this facility. This plan and all structures that come as a result of this request shall comply with PART F and PART G of the licence which give guidance on modifications and the construction of waste and water management structures.

Photo 2: up stream of South East corner of leachate leaving facililty. (approximate flowpath in blue)

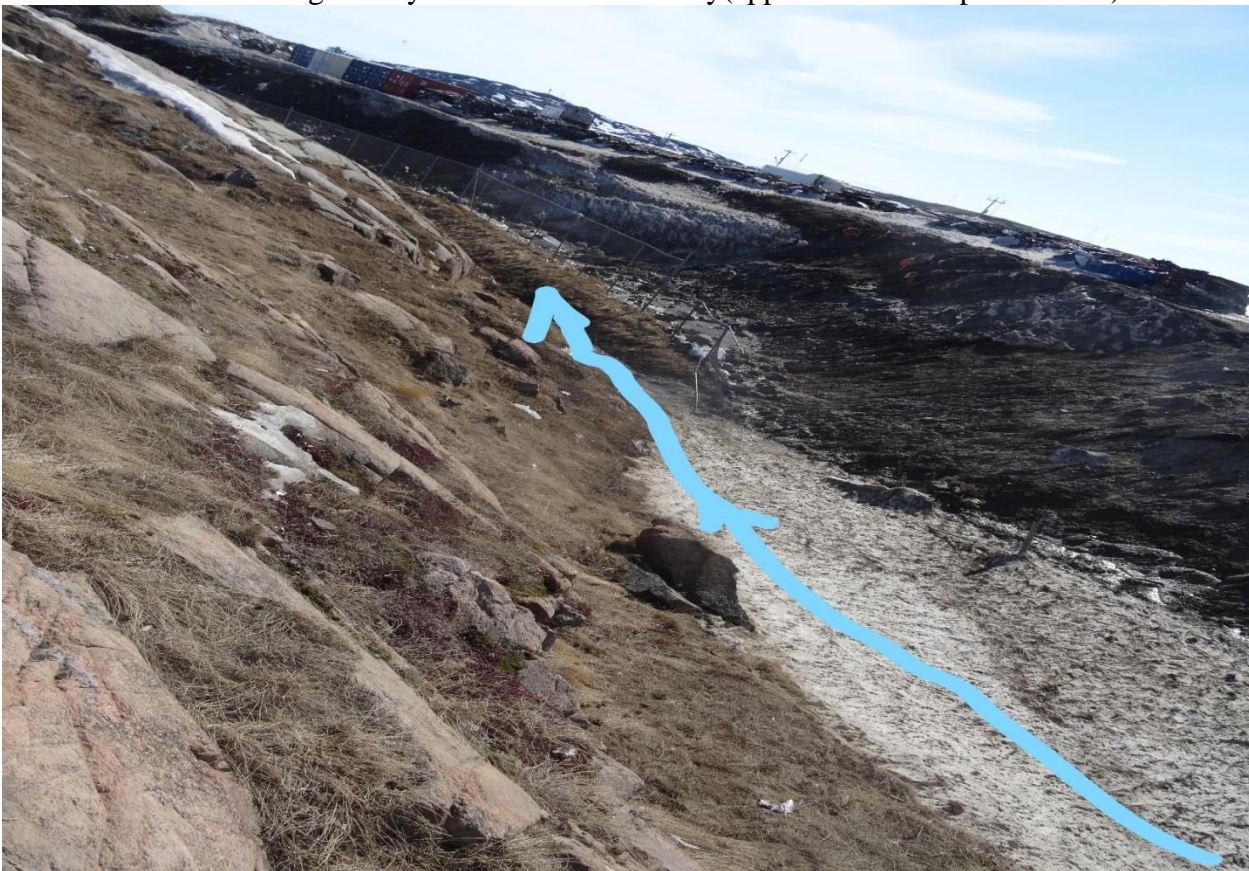
Photo 4: leachate leaving facility at SE corner of facility(approximate flowpath in blue)

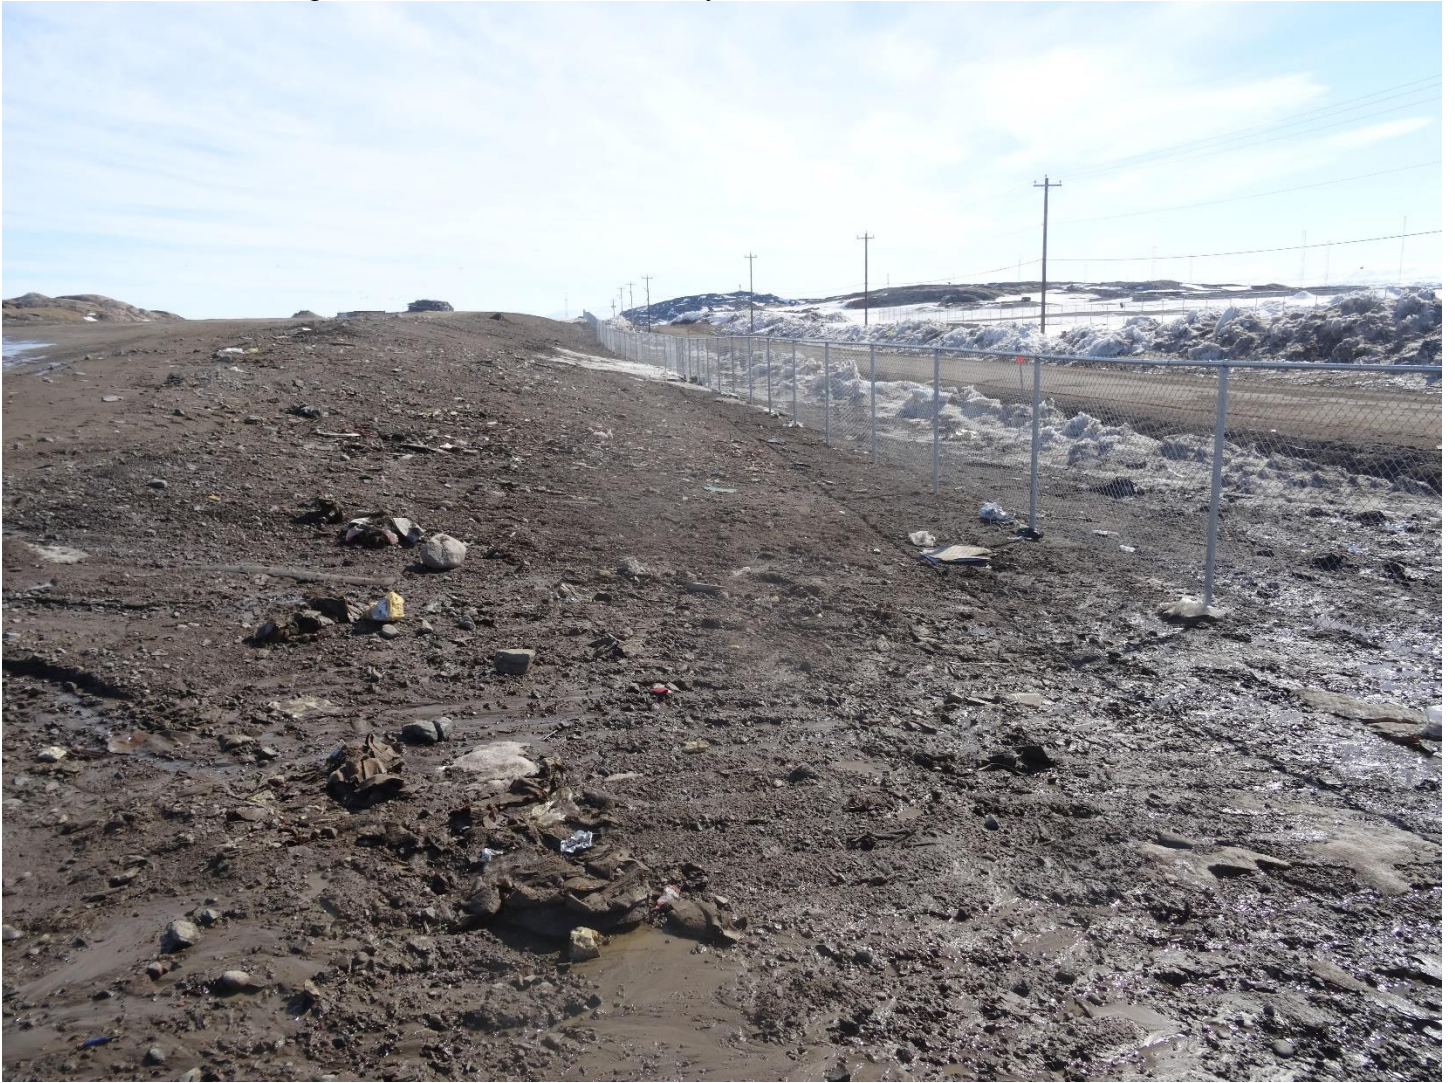
Photo 5: leachate leaving the South West side of facility.
