WATER LICENCE INSPECTION FORM

| City of Iqaluit | Joe Brown |
| 3AM-IQA1626 | NA |
| 6/10/2021 | Jonathan MESHER |

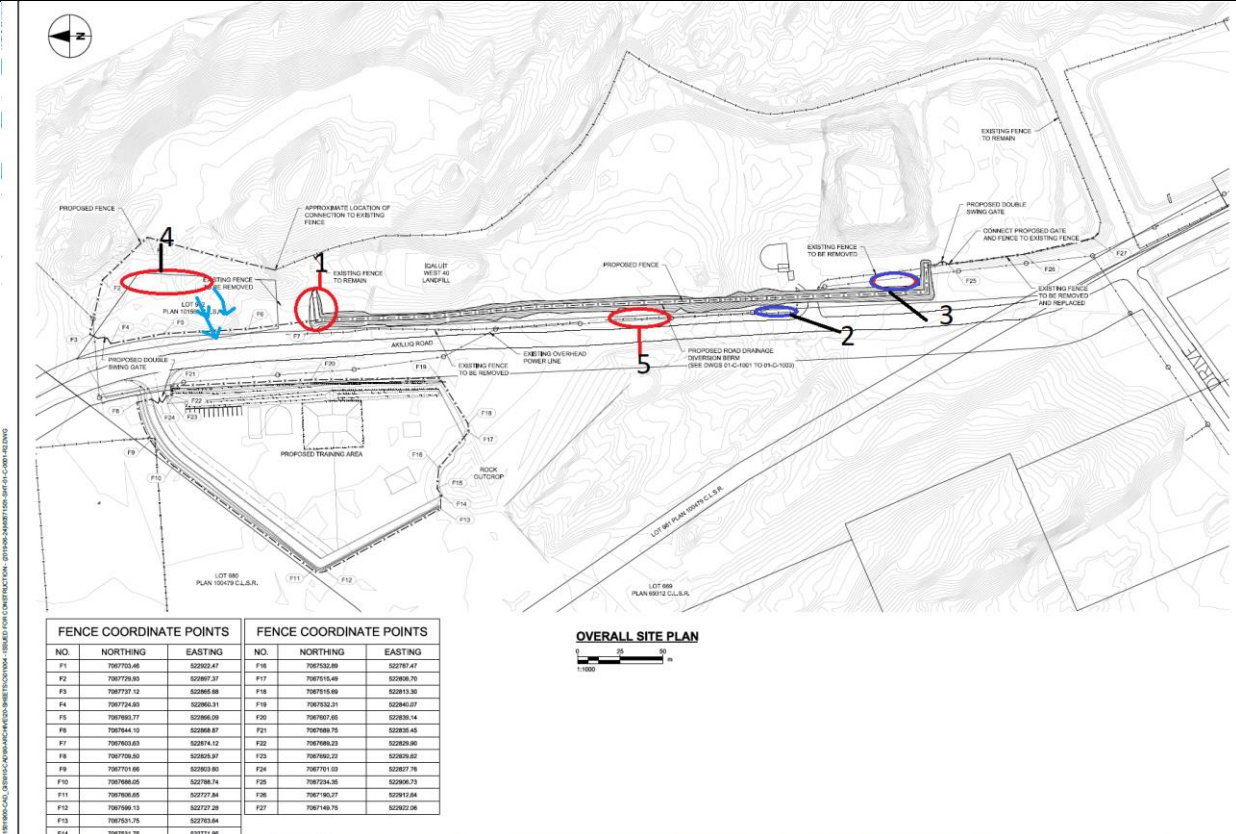
C. The North side of the berm is missing a section of the berm identified in Photo 1, item, leachate from the Northwest side of the facility is diverted north along the berm to a area with no containment, this leachate appears to be able to flow freely into the receiving environment.

D. In photo 1, item 3, the city has constructed a low lying area where water is pooling, in the 2011

6. In the 2011 drainage plan the City indicates that the non contact water/offsite drainage will flow past the shop to the south, the licensee has blocked this flow path and the water is currently creating a pond north of the entrance, this is shown in Photo 1 item 2 and in photo 3.

Description: IFC of the recently installed berm and concerns noted while on site

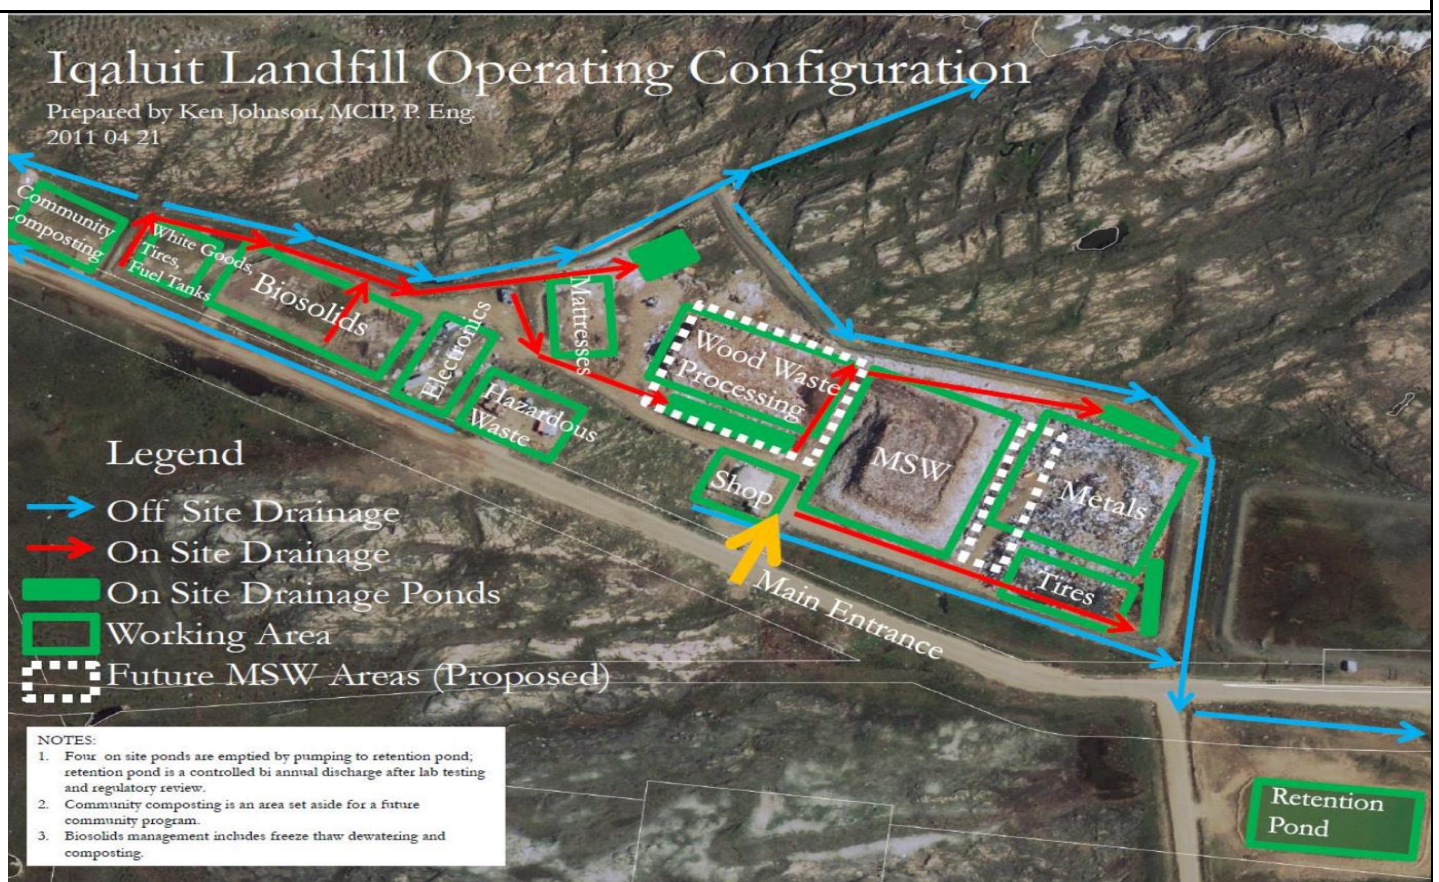
Photo 2

drainage plan it shows onsite drainage to flow from the southwest side of the facility into the containment pond at the south side of the facility. There are no drainage ditches to allow this drainage to occur nor is the facility appropriately graded to promote this flow of leachate to its containment pond. The 2011 Site drainage plan needs to be updated as the municipal refuse is not contain by berms or ditches that promote the flow of leachate to its containment ponds.

Description: out dated drainage plan.

| SECTION 2 | <input type="checkbox"/> Comments | <input checked="" type="checkbox"/> Non-Compliance with Act or Licence | <input checked="" type="checkbox"/> Action Required |
|---|---|---|---|
| 2) The licensee is to update information in the City of Iqaluit Landfill Operations and Maintenance Manual related to drainage, waste storage areas and all other outdated information as required in Part B, item 10 which states; “The Licensee shall review the Plans referred to in this Licence as required by changes in operation and/or technology and modify the Plans accordingly. Revisions to any Plan shall be submitted in the form of an addendum to be included within the Annual Report required under Part B, Item 1, complete with the lists of revisions detailing where significant content changes are made.” | | | |

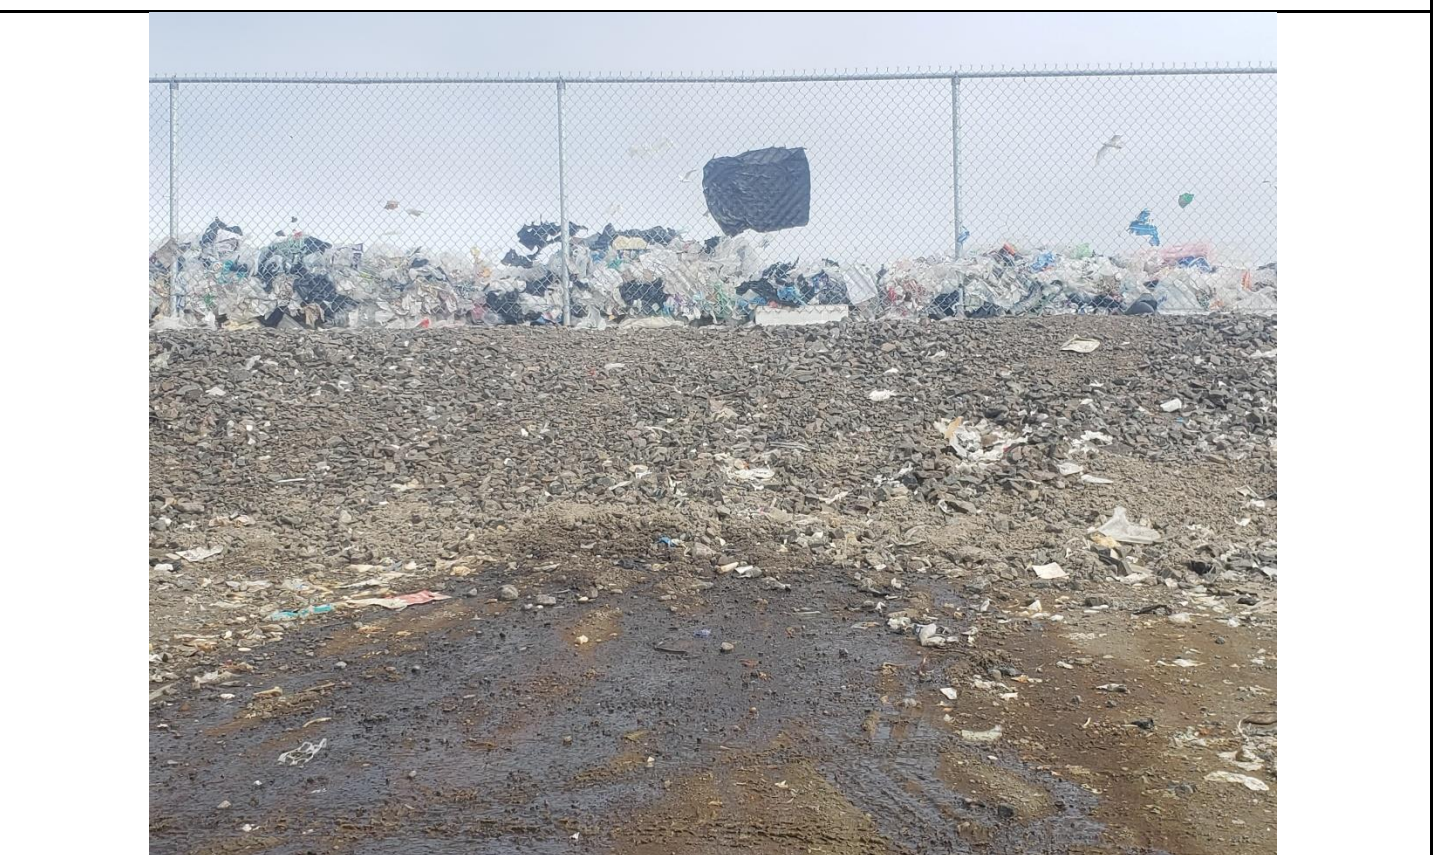
Photo 3

- E. At the approximate location N63.7344 W68.5365 there is pooing water inside the landfill, on the outside of the Landfill adjacent to the location there appears to be water seeping through the berm. Please ensure this waste water is removed and the area is properly graded to stop the leachate from leaving the Landfill. See photo 3 below for the seepage.

**Description:** seepage from pooling water within the landfill.

- 4) The licensee is to remove the pooling water from within the landfill and ensure the grade of the facility promotes flow to the containment ponds to minimize animal, insect infestation and seepage from the unlined berms.
- 5) To prevent the mixing of paints and other hazardous wastes with water the inspector is recommending that the licensee keep sea cans used for storage of hazardous waste closed when not in use.

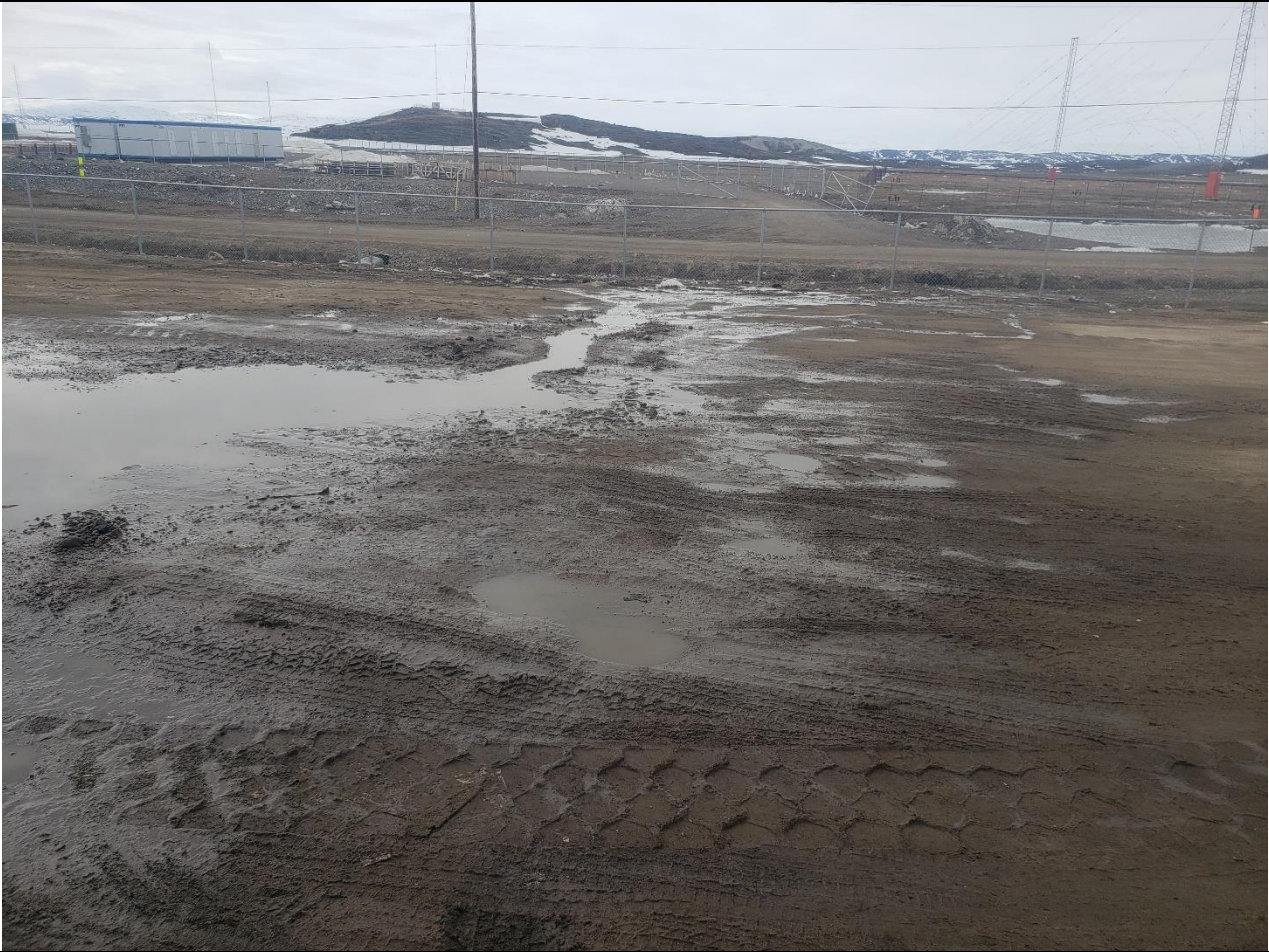
| Date | Camera | Inspector | 3am |
|---|---|---|---|
| Photo 4 | | | |

2. Hazardous Waste; while on site there was leachate flowing from the Hazardous waste storage area to the ditches outside of the facility, this is a failure to comply with PART E, Item 13 which states; “The Licensee shall collect and contain all leachate generated by the West 40 Landfill within the Landfill.” See photo 4 for picture of the leachate flowing from the hazardous waste storage area.

3. In section 8.3 of the City of Iqaluit Landfill Operations and Maintenance Manual The licensee states; “The hazardous waste storage area has sea lift containers for storage of wastes. This area is surrounded by fence and has a separate gated entrance from the main road.” This is information is incorrect and needs to be updates, this area is not surrounded by fence nor does it have a separate gated entrance. See photo 1 item 4 for the location of the leachate flow path and photo 4 for a picture of the uncontained leachate.

| Date | Camera | Inspector | 3am |
|---|---|---|---|
| Description:uncontained leachate flowing from the Hazardous waste storage. | | | |

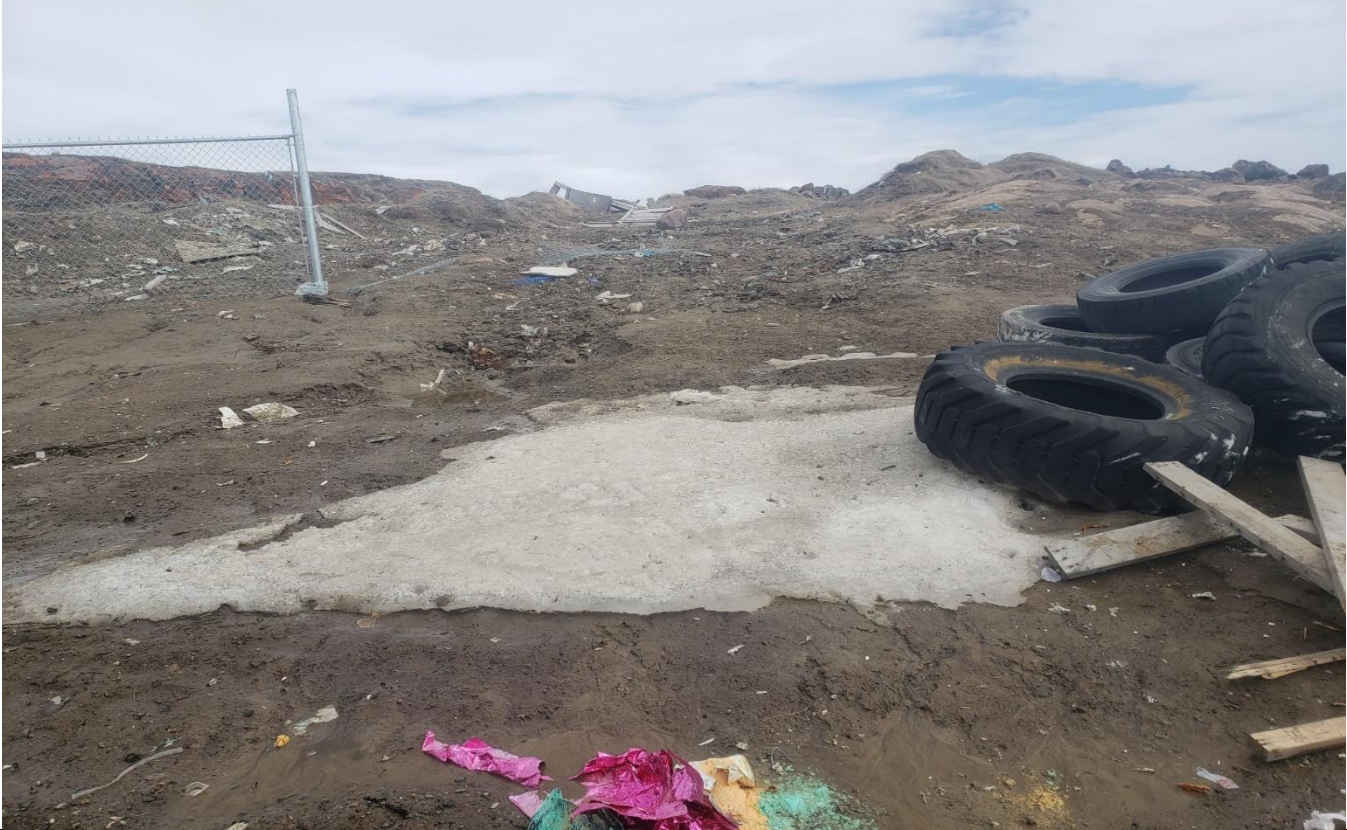
| Date | Camera | Inspector | 3am |
|---|---|---|---|
| Photo 5 | | | |

4. Behind the Hazardous waste storage there are no ditches to separate contact water and non contact water, at the time of the inspection there was signs of erosion from water flowing into the facility. See photo 5 for a photo of this erosion.

| Date | Camera | Inspector | 3am |
|---|---|---|---|
| Description: Erosion from water flowing into the Landfill and coming in contact with uncontained paint. | | | |
