## Water Licence Inspection Report

| City of Iqaluit | Tamilore Adeleke |
| 3AM-IQA1626 | Project Officer of Engineering and Capital Projects |

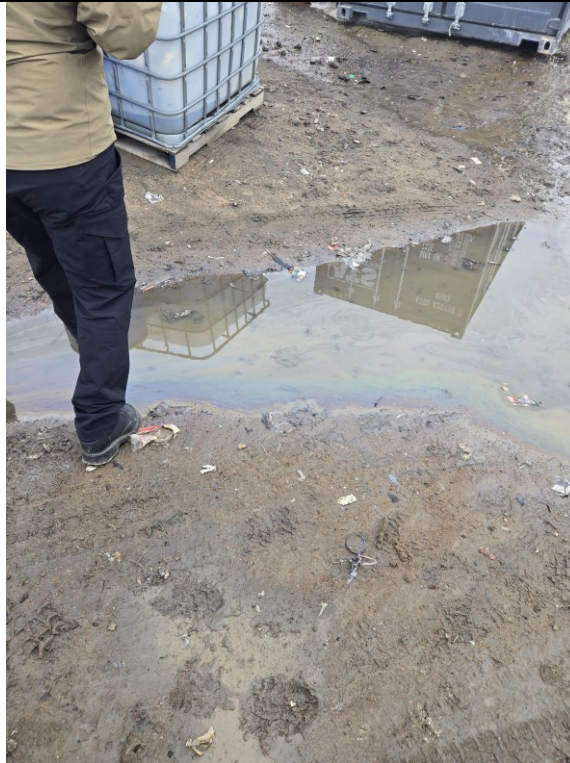
**Photo No. 1** Lat/Long (DD.MM.SS.SS, NAD83)

Visible sheen close to the entrance of the Landfill.

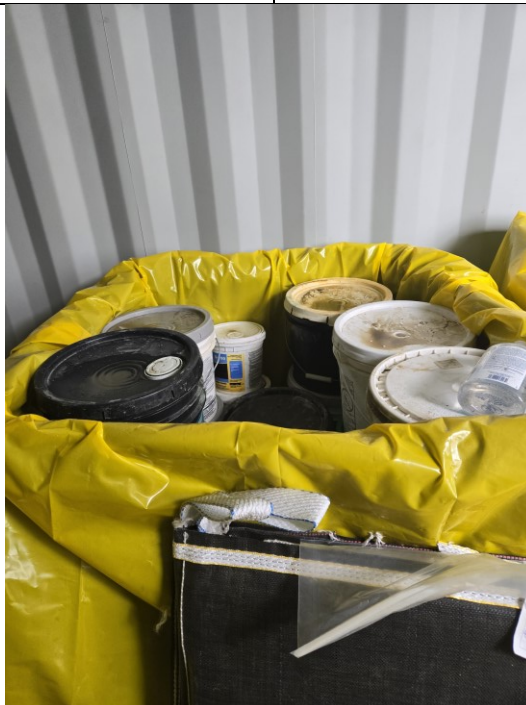
**Photo No. 2**

Hazardous Waste stored within secondary containment, which is a requirement under this License.

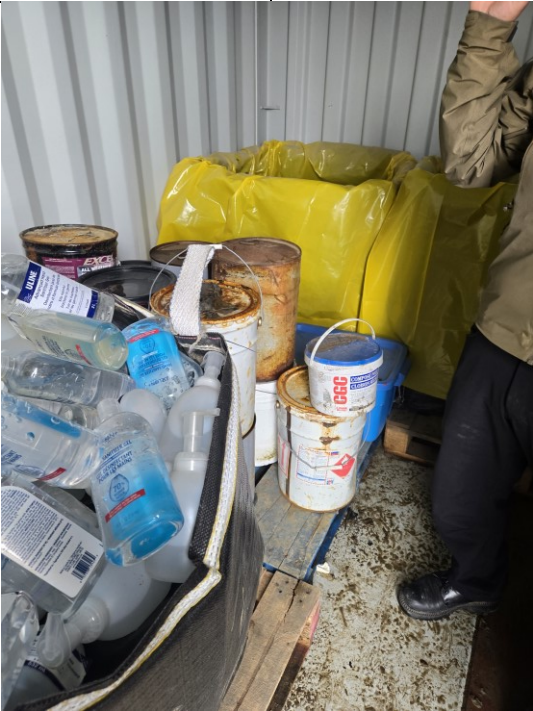
| Photo No. 3 | | Lat/Long (DD.MM.SS.SS, NAD83) |

1. During the inspection, the Inspectors discovered that a large section of the fencing surrounding the Landfill was not installed. This is non-compliant with Part E; Section 17 of the Water License.
2. Hazardous waste was identified in a sea can that was not placed within secondary containment.

| Photo No. 3 | | Lat/Long (DD.MM.SS.SS, NAD83) |
|---|--|---|
| <b>Description:</b><br>Hazardous waste not situated within secondary containment. This photo was taken inside the sea can used for hazardous waste storage. | | |

1. Fencing must be installed in the area that does not have any fencing currently in place. Fencing must be installed within (60) days. If the licensee cannot have the fencing installed before then, a detailed plan for fence installation must be provided to CIRNAC within (30) days.
2. Hazardous waste must be situated within secondary containment. This includes all batteries, oil, aerosols, etc.

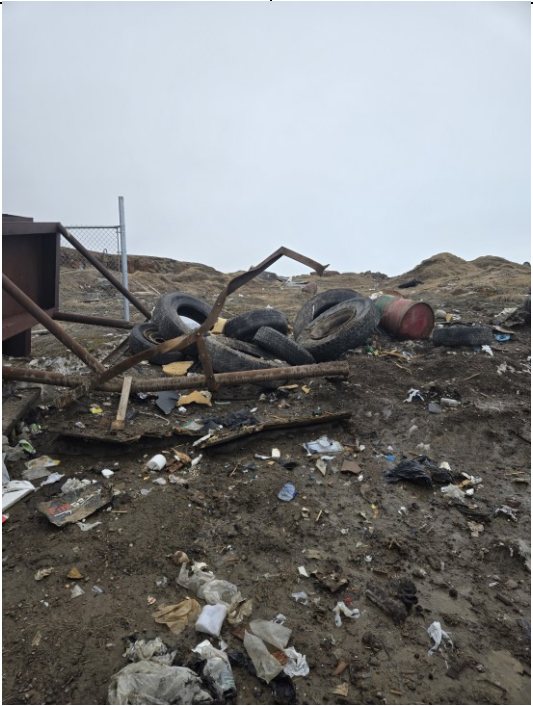
| Photo No. 4 | | Lat/Long (DD.MM.SS.SS, NAD83) |

| Photo No. 4 | | Lat/Long (DD.MM.SS.SS, NAD83) |
|---|--|---|
| <b>Description:</b><br>A section of the Landfill did not have any fencing installed which is a environmental and safety risk. This photo is facing the Northeast side of the Landfill. | | |

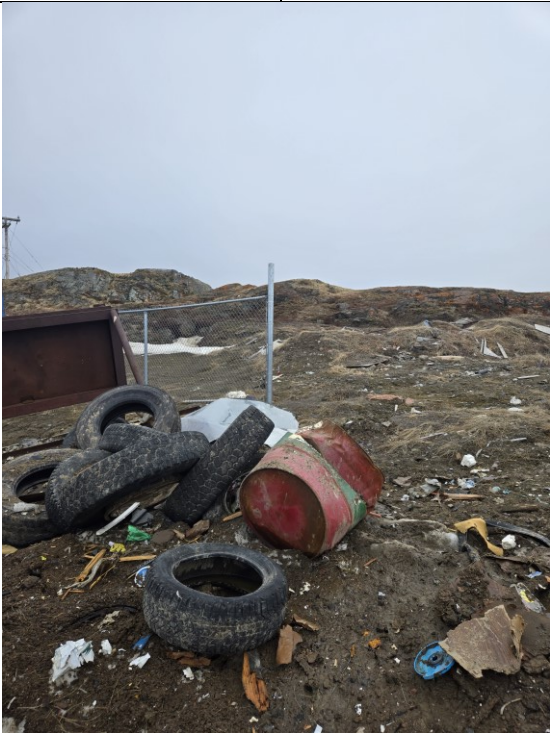
| Photo No. 5 | Lat/Long (DD.MM.SS.SS, NAD83) |

| Photo No. 5 | Lat/Long (DD.MM.SS.SS, NAD83) |
|---|---|
| <b>Description:</b><br>Another photo showing the end of the fence. This section of missing fence continues for at least 200 meters. | |

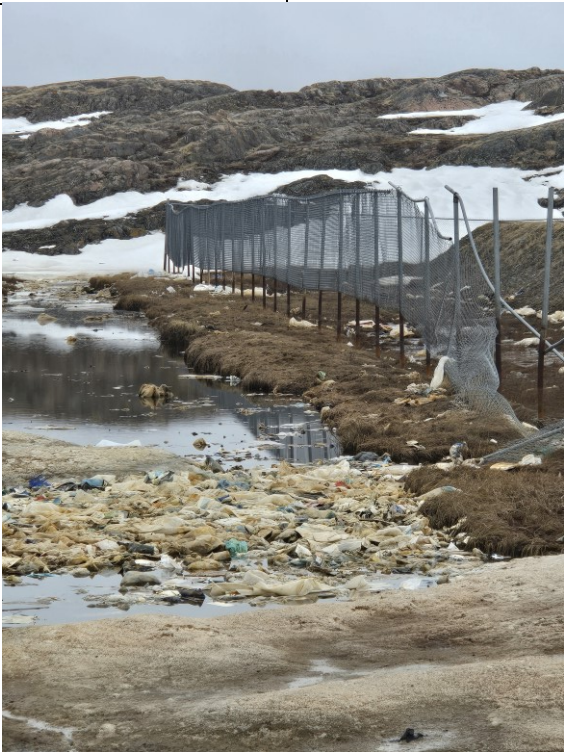
| Photo No. 6 | Lat/Long (DD.MM.SS.SS, NAD83) |

| Photo No. 6 | Lat/Long (DD.MM.SS.SS, NAD83) |
|---|---|
| <b>Description:</b><br>This section of fencing along the Southeast side of the landfill was damaged and is not working as its intended purpose. | |

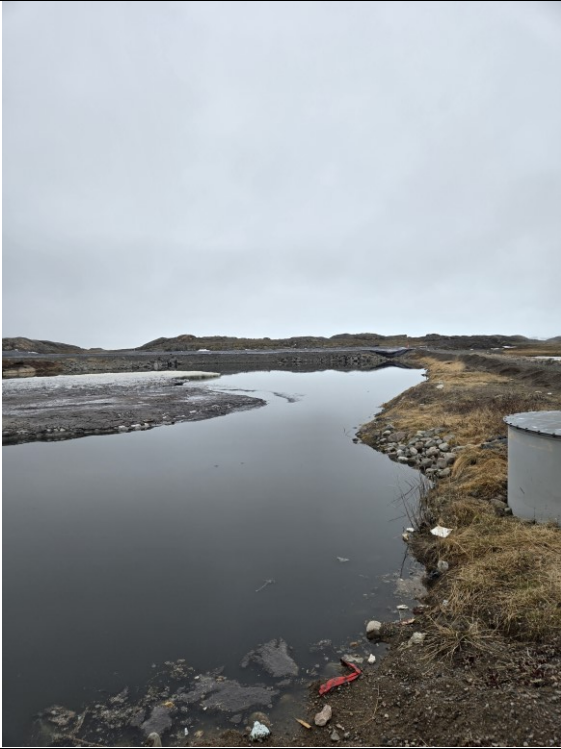
| Photo No. 7 | Lat/Long (DD.MM.SS.SS, NAD83) |

| Photo of the Sewage Lagoon facing South. No issues were observed. | |

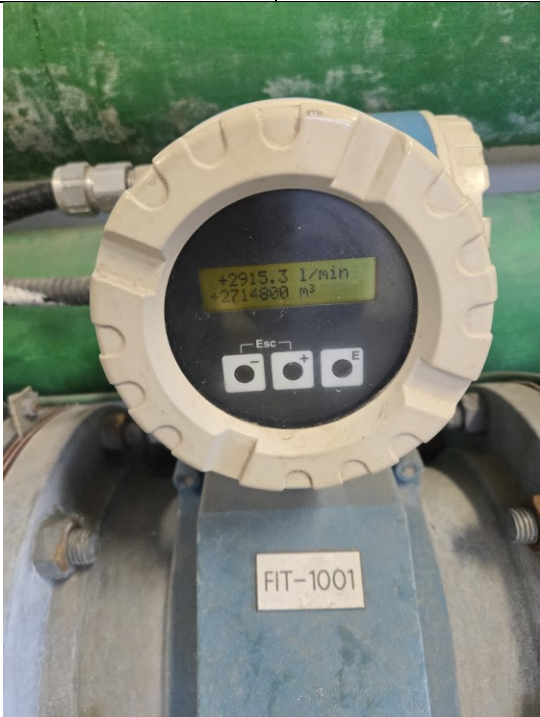
| Photo No. 8 | Lat/Long (DD.MM.SS.SS, NAD83) |

| Raw water intake meter at the Water Treatment Plant. | |

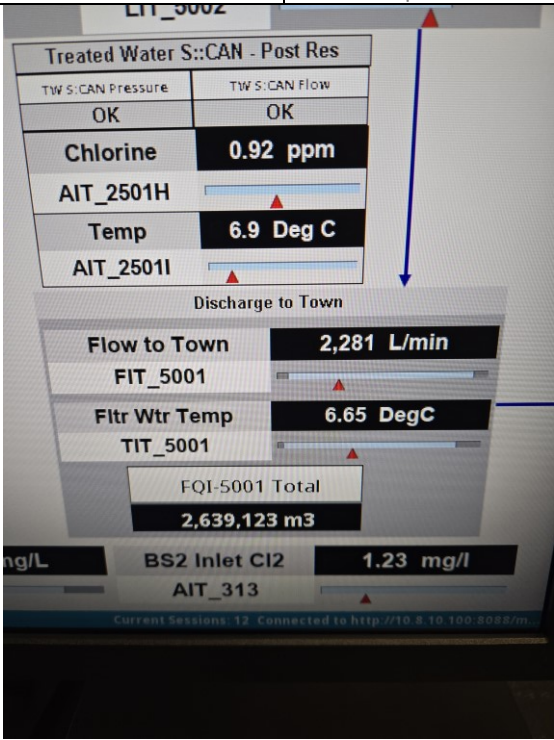
| City of Iqaluit computer program with flow meter and water intake data. | | |
