WATER LICENCE INSPECTION FORM

Licensee	Licensee Representative
City of Iqaluit	NA
Licence No. / Expiry	Representative's Title
3AM-IQA1626	NA
Land / Other Authorizations	Land / Other Authorizations
	--
Date of Inspection	Inspector
5/20/2021	Jonathan MESHER
Activities Inspected	
<input type="checkbox"/> Camp	<input type="checkbox"/> Drilling
<input type="checkbox"/> Roads/Hauling	<input checked="" type="checkbox"/> Other: Landfill
<input type="checkbox"/> Mining	<input type="checkbox"/> Construction
	<input type="checkbox"/> Other:
<input type="checkbox"/> Reclamation	<input type="checkbox"/> Fuel Storage

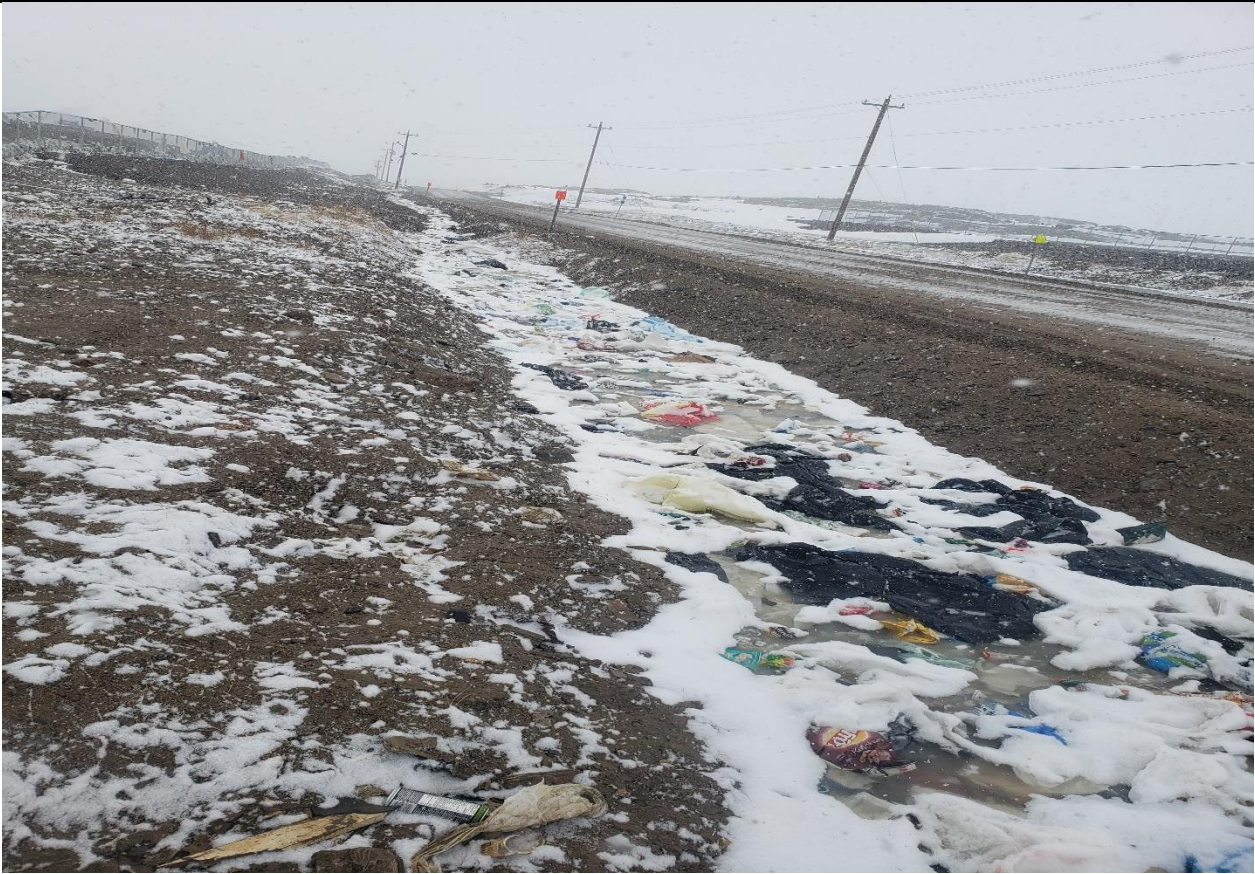
Photo 1

3. During the inspection there was significant waste in the drainage ditches within the landfill and outside the facility. To prevent to the waste from flowing into the surrounding water bodies, allow the water/waste water to flow through the ditches as intended and to prevent damage to the liner within the facility, the licensee is to clear the solid waste from the ditches within and surrounding the landfill.

Description: wind blown litter outside of the landfill in a water management structure.

- 1) The Licensee is to recover the waste from the surrounding lands, water management structures and waterbodies outside the West 40 landfill as required in part E, item 11 which states; “The Licensee shall dispose of and contain all municipal solid waste generated by the City at the West 40 Landfill as associated site(s) authorized under this licence or as otherwise approved by the Board in writing.” A follow up inspection will be conducted 3 weeks after the submission of this report to ensure the ditches surrounding the facility are free of municipal refuse.

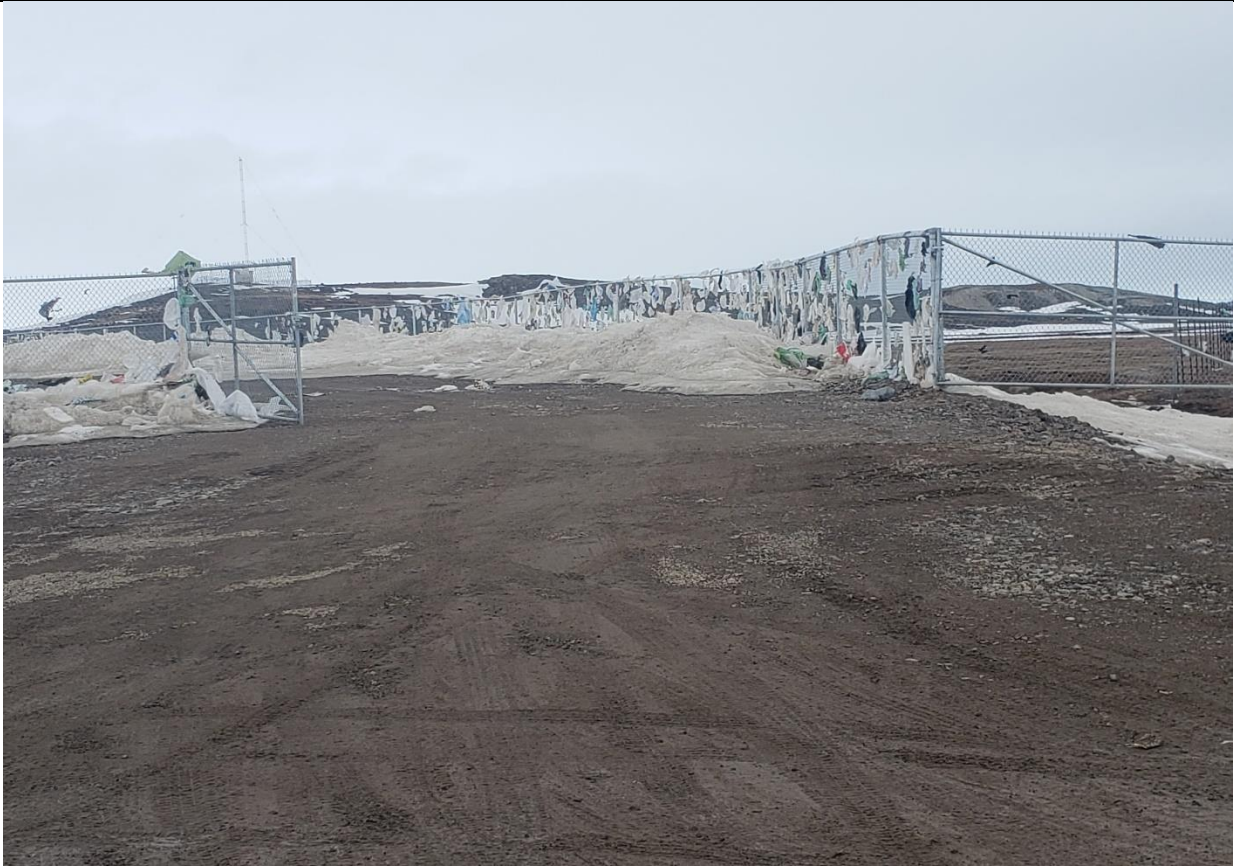
Photo 2

along the property, the waste load should be inspected for any identifying wastes (i.e. addressed envelopes, utility bills, etc.) and the City of Iqaluit Municipal Enforcement Officer should be contacted. This waste must be cleaned up immediately to comply with operating and approval requirements.

Description: wind blown litter across the street of the landfill.

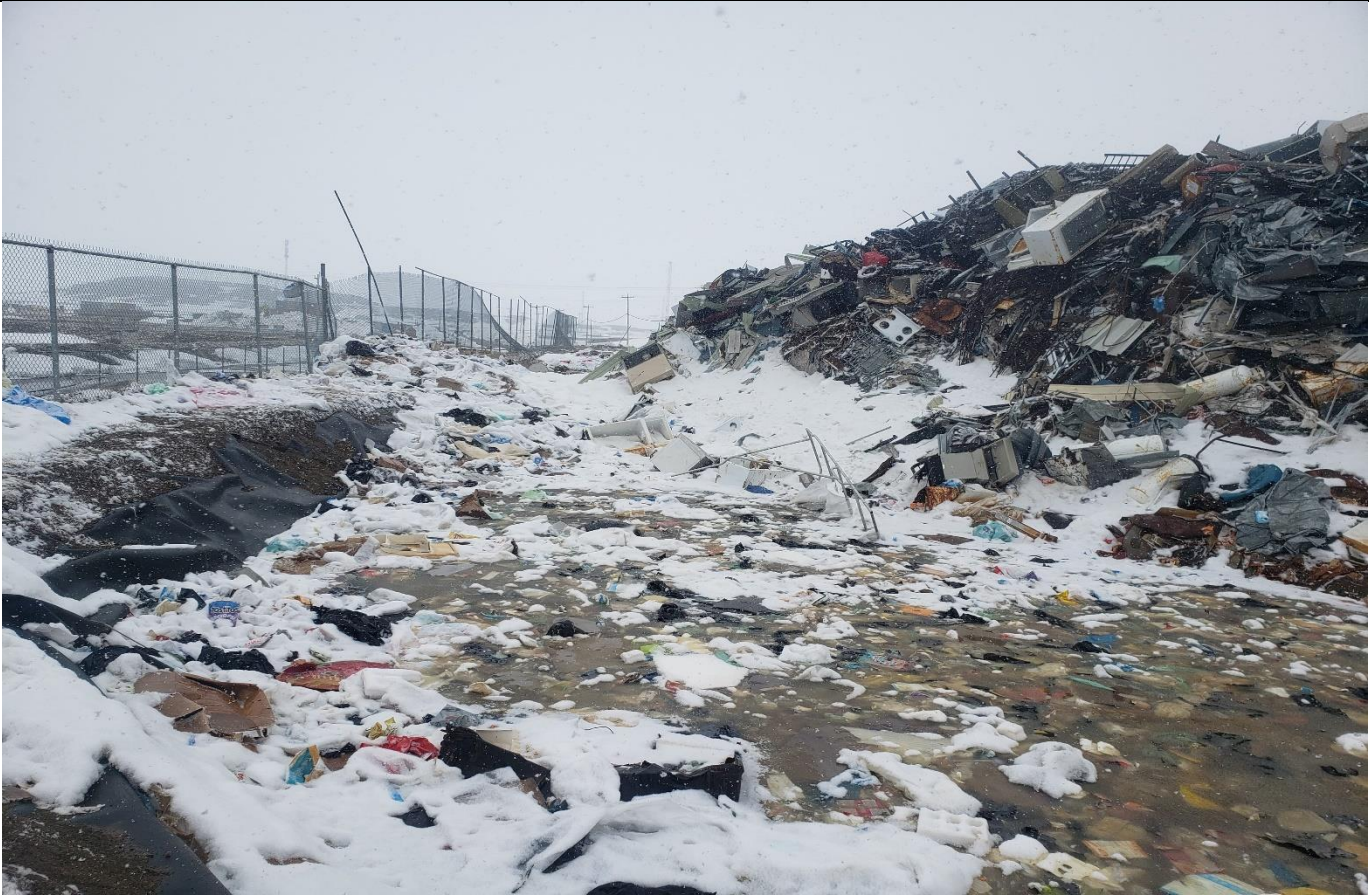
Description: West side of landfill of landfill leachate containment pond

- 3) The licensee is to provide a plan by September 1, 2021 to remove the waste within the leachate ponds to prevent damage to the liner and a potential leak. Please ensure this plan is submitted in accordance with guidance provided in Part B of the water licence 3AM-IQA1626.

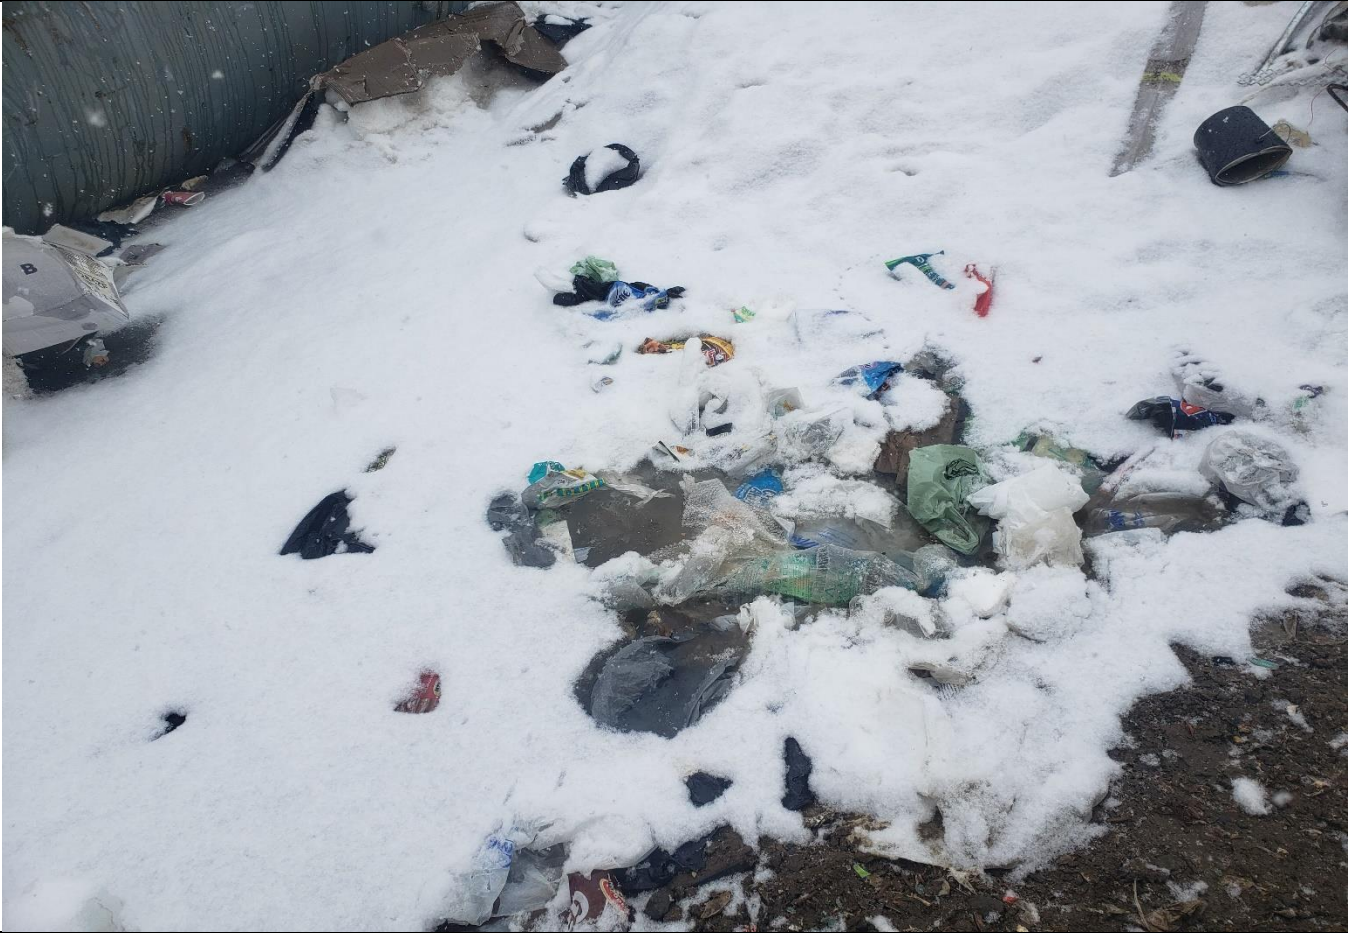
4. During the inspection there was pooling within the landfill, one pond near the center of the landfill and one in the metal waste area, both area do not appear to be able to flow to any containment ponds. Section 10.6, of the City of Iqaluit Landfill Operations and Maintenance Manual states the following; “Following are “best management” approaches to minimizing the potential of an animal and insect infestation: • Eliminate areas of ponded water other than designated retention ponds (insects and animals require water”. CIRNAC is recommending that the licensee follow the Operations and Maintenance manual and remove the ponded water.

Description: pooling water within metal side of landfill.

- 4) The licensee is to remove the pooling water from within the landfill and ensure the grade of the facility promotes flow to the containment ponds to minimize animal and insect infestation.
- 5) To prevent the mixing of paints and other hazardous wastes with water the inspector is recommending that the licensee keep sea cans used for storage of hazardous waste closed when not in use.

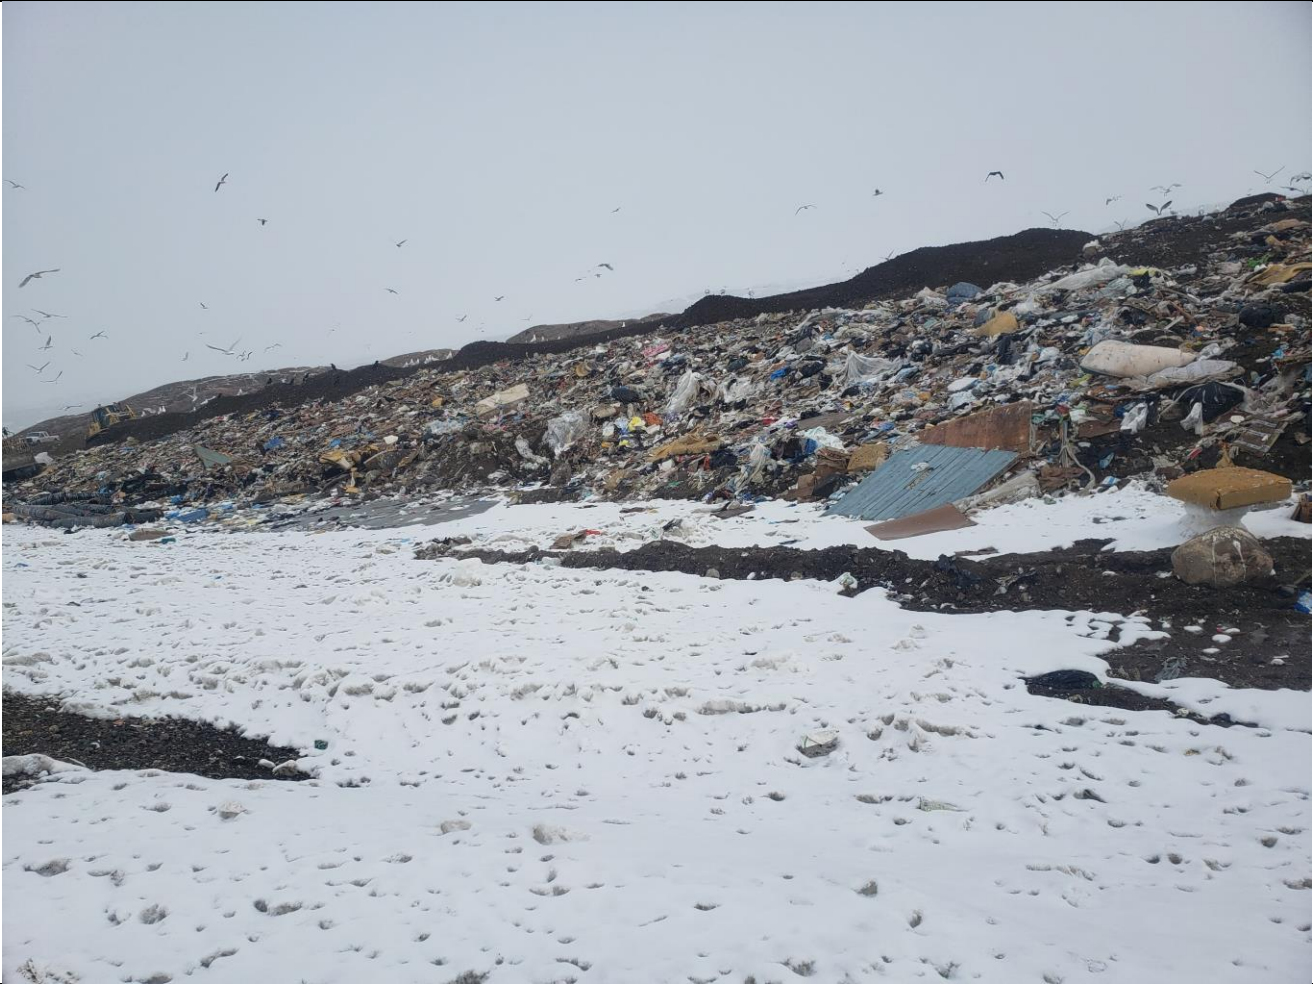
Description: pooling water with no apparent ability to drain to the containment ponds.

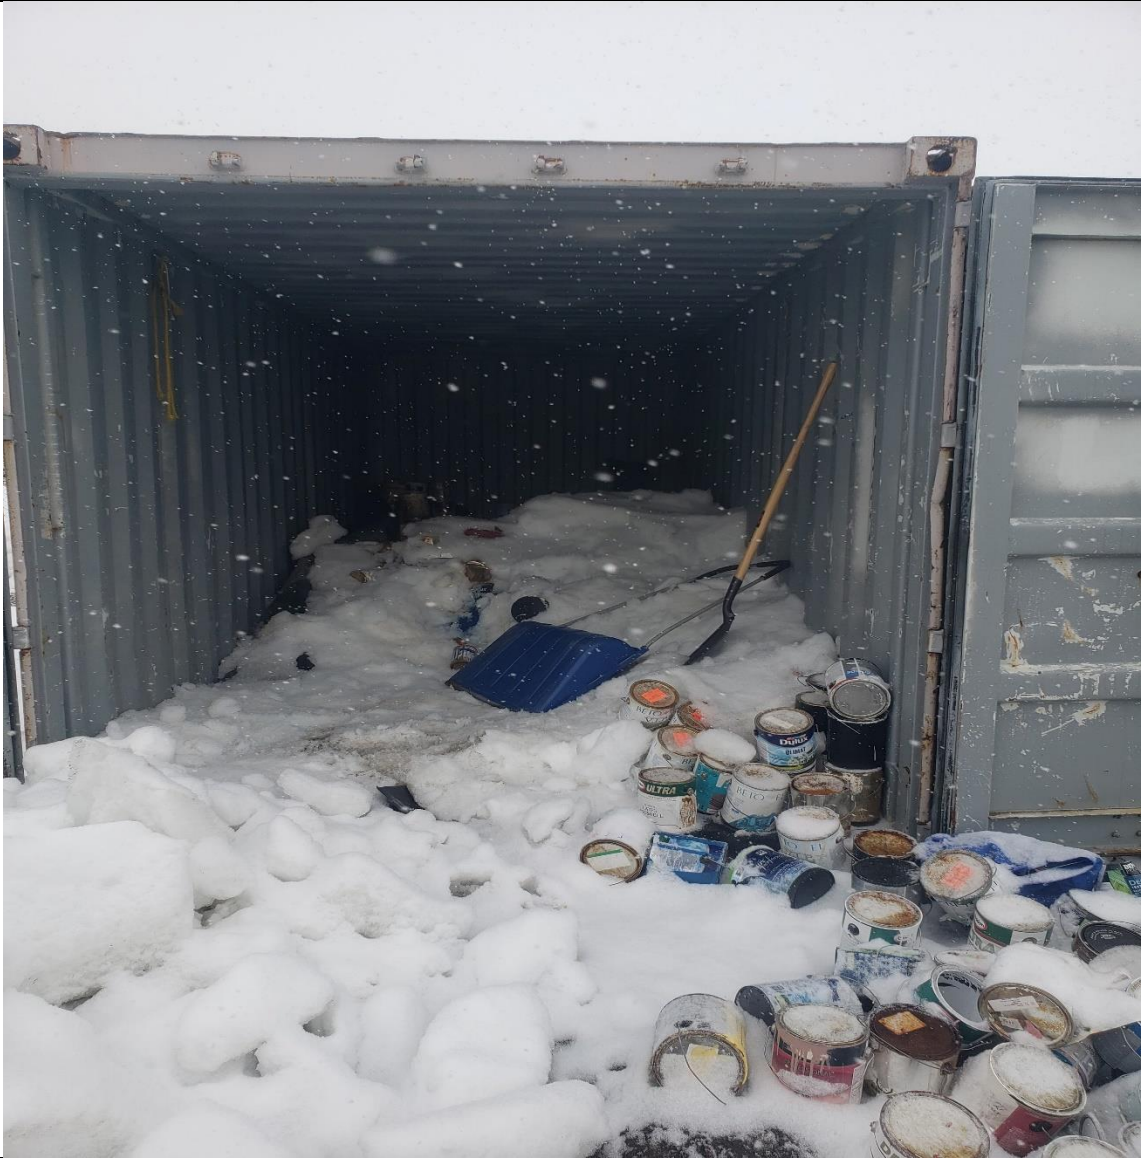
5. During the inspection the waste paint was stored in in a sea can, the sea can was full of water (snow). the inspector is requesting that the licensee keep the sea cans closed when not in use. See photo

Description: used paint storage.
