Water License Annual Report - Executive Summary

Water License No. 3AM-IQA0611
2009 Annual Report
City of Iqaluit

**Lake Geraldine Dam
Iqaluit, Nunavut
Dam Safety Inspection**

**City of Iqaluit Sewage Lagoon
Iqaluit, Nunavut
Dam Safety Inspection**

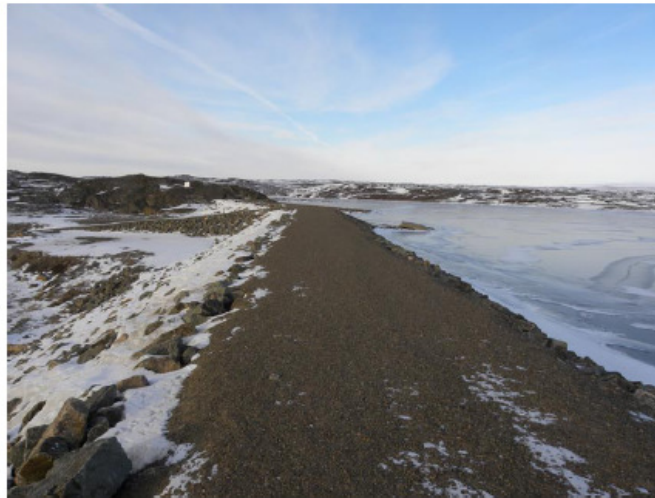
Photograph 1
Overview of North berm.

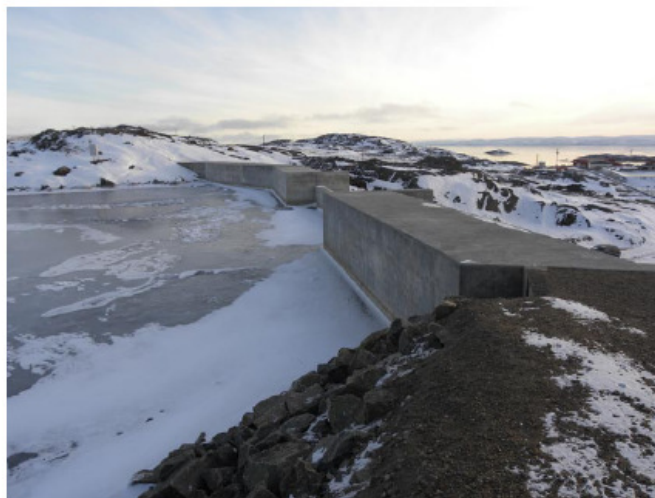
Photograph 2
Overview of upstream face of concrete structure.

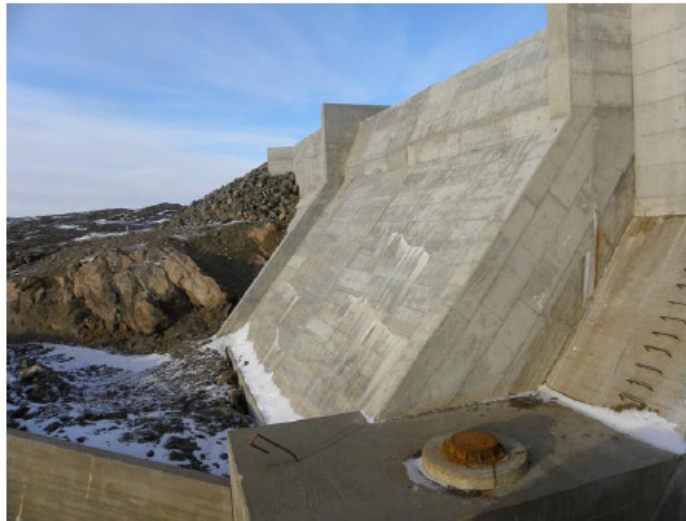
Photograph 3
Overview of spillway section, downstream face.

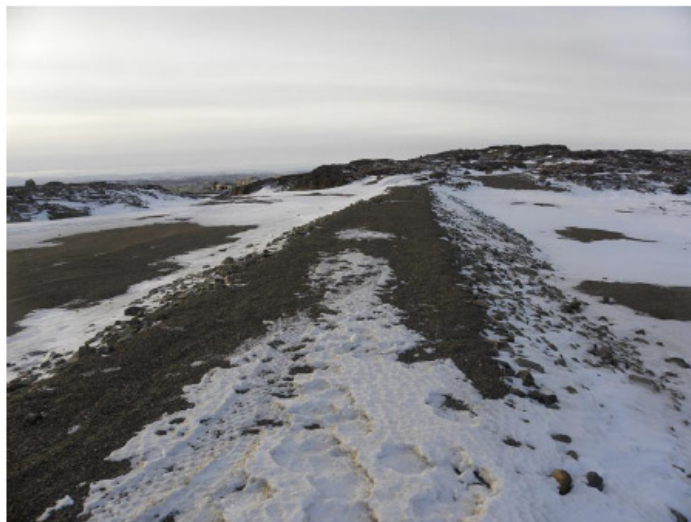
Photograph 4
Overview of South berm.

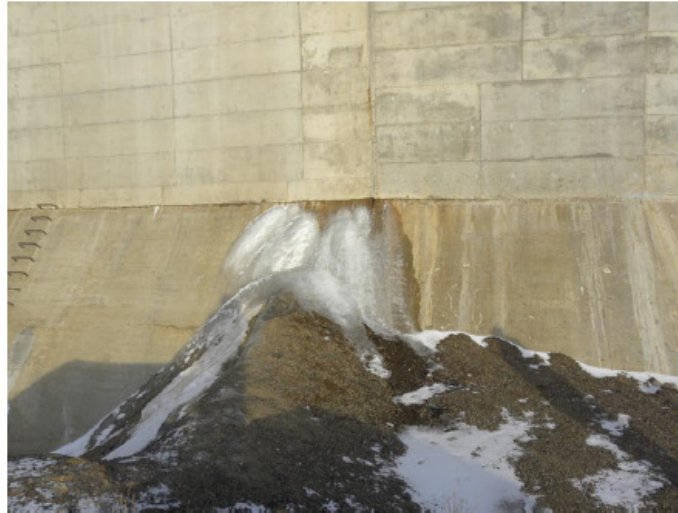
- A significant leak has developed in the concrete dam structure south of the spillway section.
- Upwelling along the south concrete wing wall appears to have increased moderately since originally identified in 1997.

Photograph 5
New leak South of spillway section.

1. A grouting program should be designed for implementation in 2010 to address the observed leakage. The grouting program should include injection of the vertical and transverse joints in the vicinity of the above grade leak in the concrete section south of the spillway.
A grouting program should also target the upwelling source. It is possible that the underwater survey (recommended below) will assist in assessing the source and developing a repair strategy.

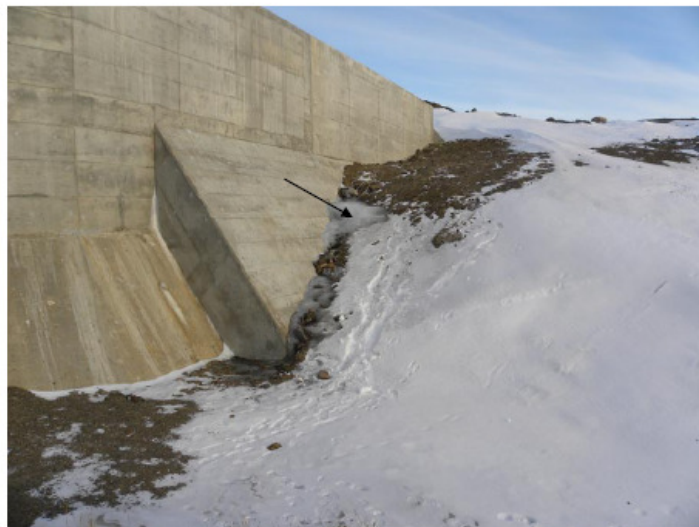
Photograph 6
Upwelling area previously identified in 1997.

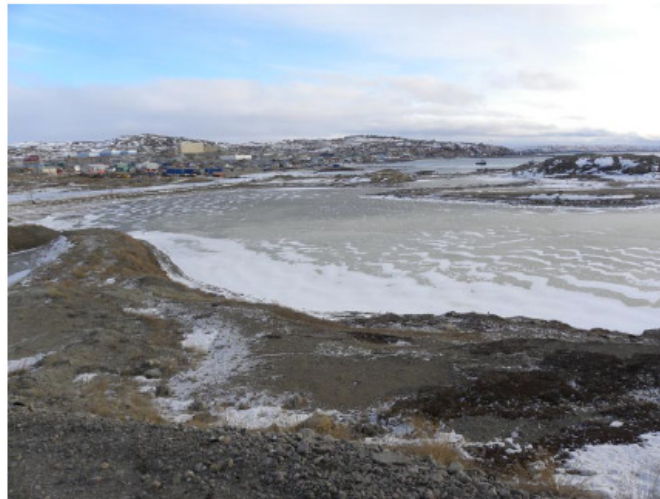
Photograph 1
Overview looking East.

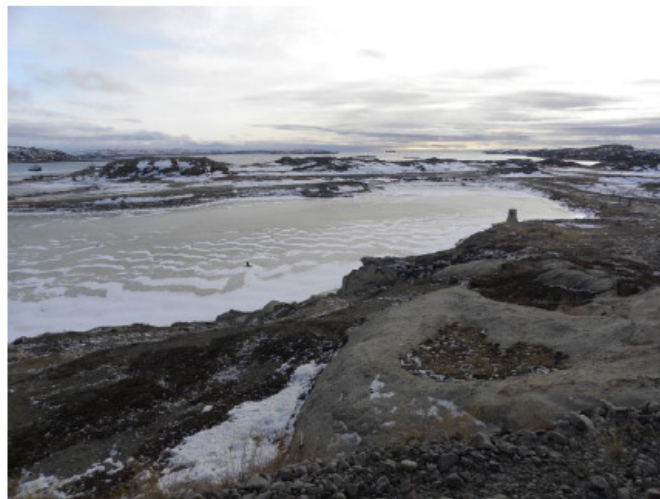
Photograph 2
Overview looking West

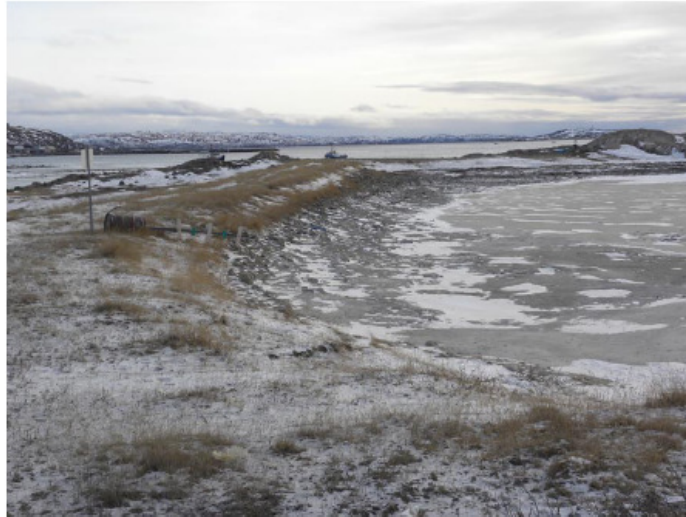
Photograph 3
East Berm, North segment; no change since 2006

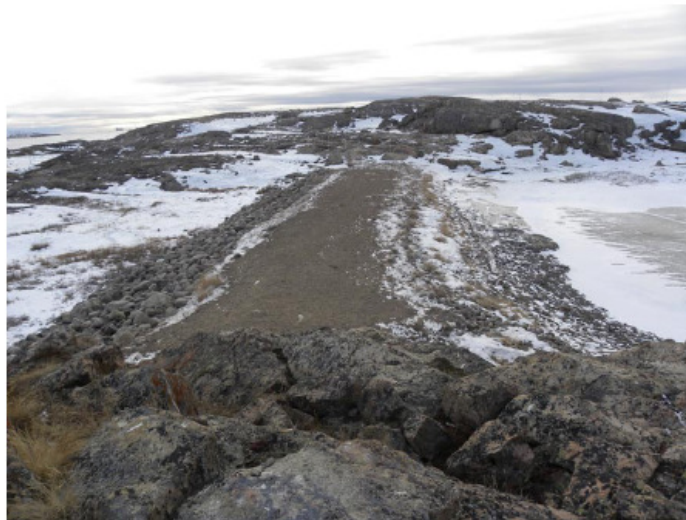
Photograph 4
East Berm, South segment; no change since 2006

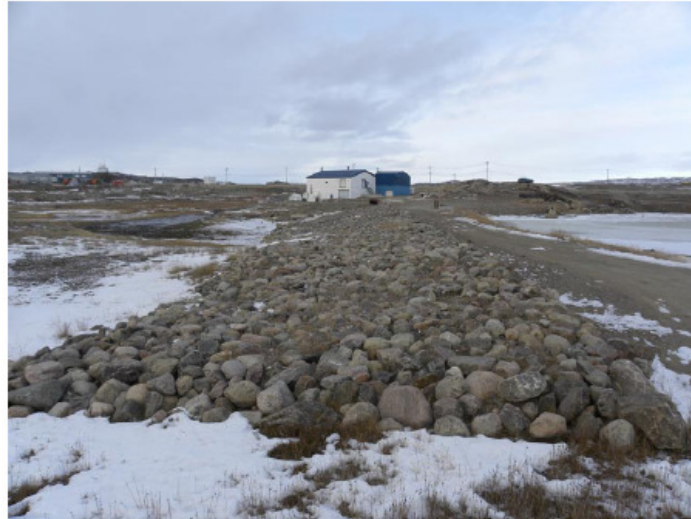
Photograph 5
West Berm, no change since 2006

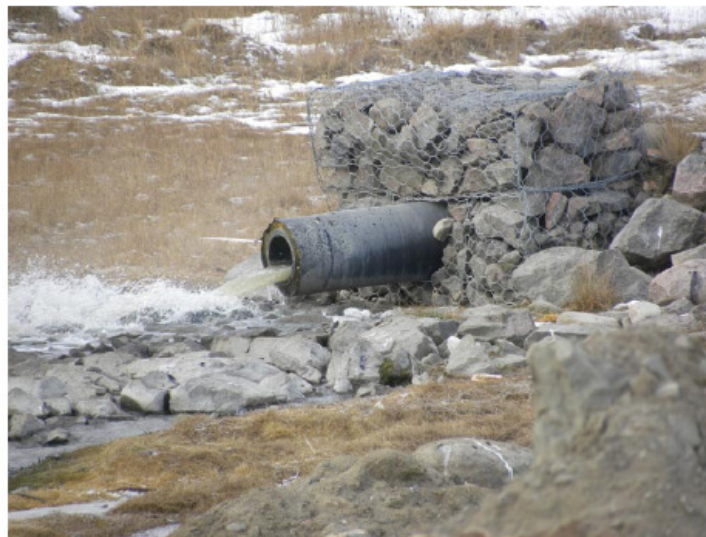
Photograph 6
Discharge from Sewage Treatment Plant
