Water License Annual Report - Executive Summary

Water License No. 3AM-IQA0611
2010 Annual Report
City of Iqaluit

**Lake Geraldine Dam
Iqaluit, Nunavut
Dam Safety Inspection**

*November 23, 2010
REPORT*

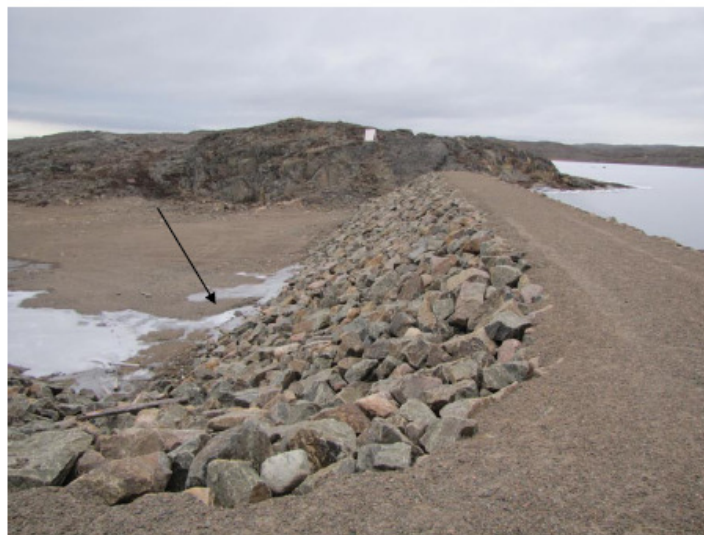
Through leakage in the north berm was observed on both the north and south sides of the vehicular access ramp.

Photograph 2
Overview of North Berm, Downstream Face. Note leakage just north of ramp access.

3. The through leakage in the north berm at the vehicular access ramp requires investigation and repair in 2011. An investigative program will be prepared if requested by the City.

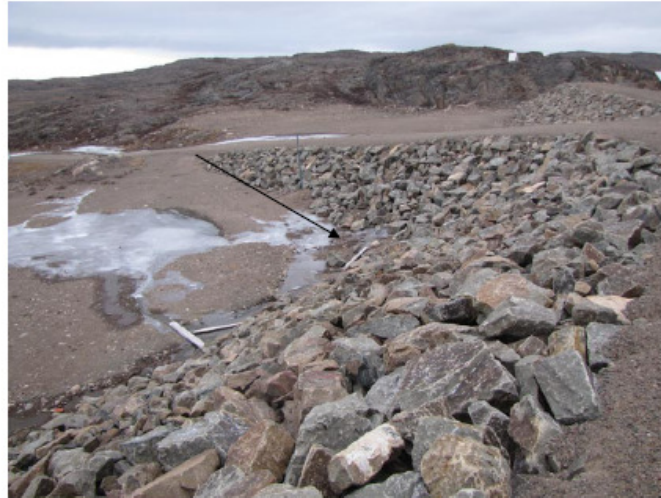
Photograph 3
North Berm at South side of ramp access; note leakage.

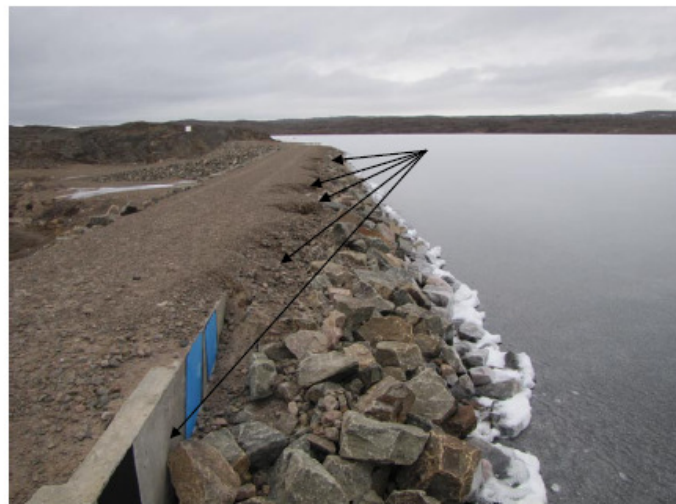
Wave action as a result of high winds caused the erosion of granular material and the exposure of the concrete cutoff wall within the north berm.

Photograph 4
Southern portion of North Berm, upstream face; note localized washouts due to wave action.

2. The localized wash outs from the wind events of 2010 require repair. As a short term interim measure all areas of erosion should be filled with rock of similar size to the existing rock fill. In the longer term, the upstream berm should be filled with rock up to and slightly above the top of the cutoff wall, and thus eliminate a 1.2 metre width of the vehicular roadbed.

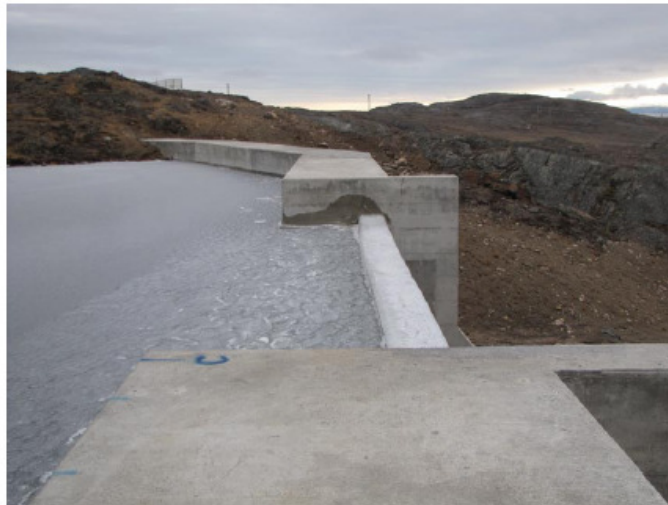
Photograph 5

- The visible concrete portions of the dam structure are in general unchanged from that observed for the 2009 DSI.
- The level of the Lake Geraldine reservoir has increased at least 0.6 metres since October 2009. The water level was within approximately 0.2m of the spillway crest at the time of our recent inspection; i.e. close to capacity.

Overview of spillway; note water level near capacity; approx. 0.6m higher than October 2009.

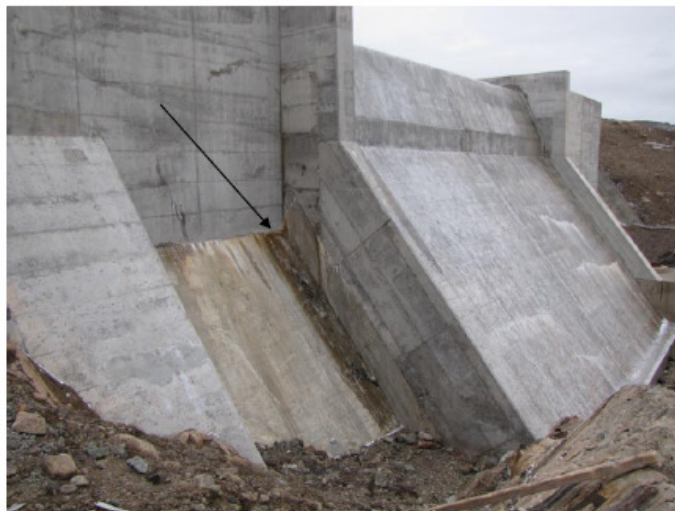
Photograph 6

Leakage at North end of Spillway, similar to 2009 DSL

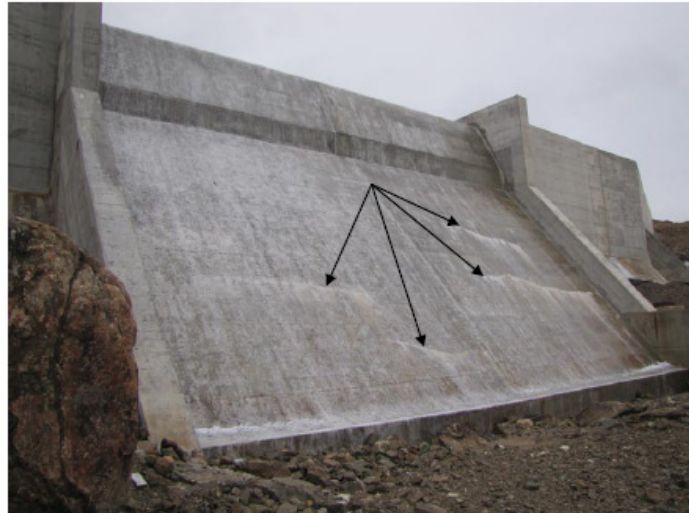
Photograph 7
Leaching cracks in Spillway face; Similar to 2009 DSL.

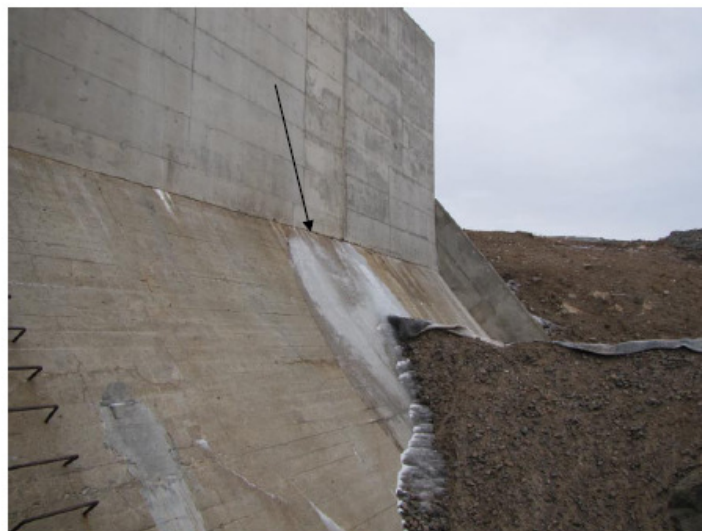
- The leak in the concrete dam structure south of the spillway section that was identified in the 2009 DSI has not changed significantly.
- Upwelling along the south concrete wing wall appears has not changed significantly since the 2009 DSI.

Photograph 8
Leakage at South Gravity section; Similar to 2009 DSL.

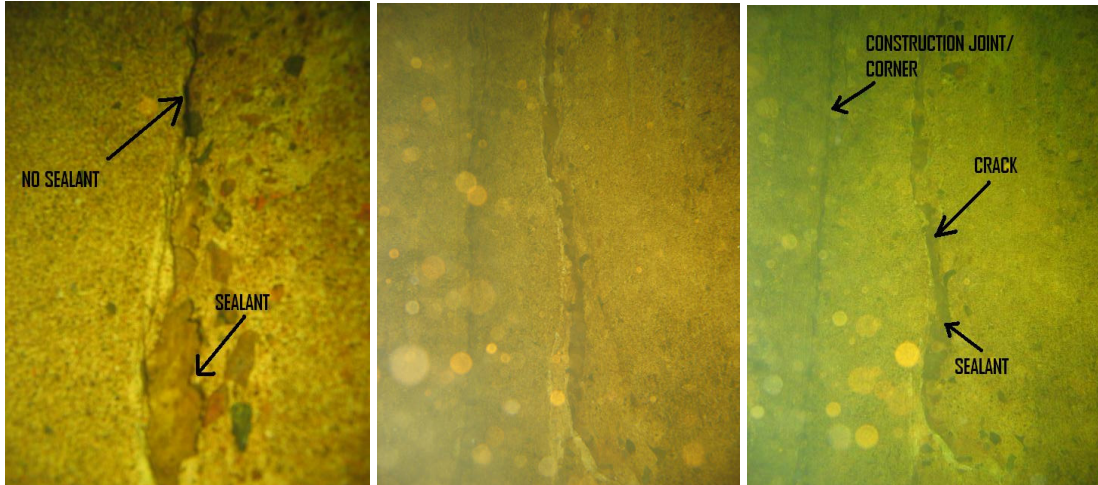
These photos were taken of the crack found about +8050mm from line D, very close to line E, and between elevation 2 and 3 on the drawing.

The crack seems to have had some type of sealant injected into it, and is also in line with one of the leaks found on the downstream side.

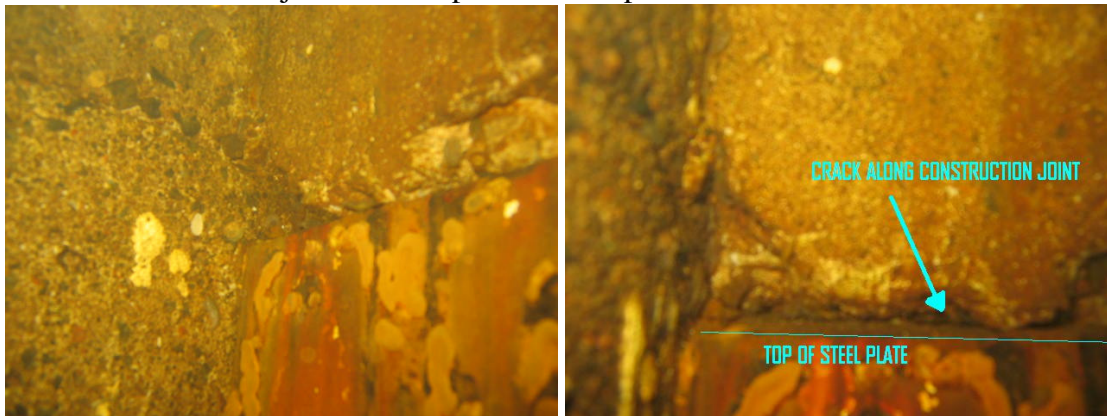
The top of the crack starts at the construction joint between the old concrete and the newer addition. It runs almost parallel with the construction joint in the corner down to the next construction joint at the top of the steel plate.

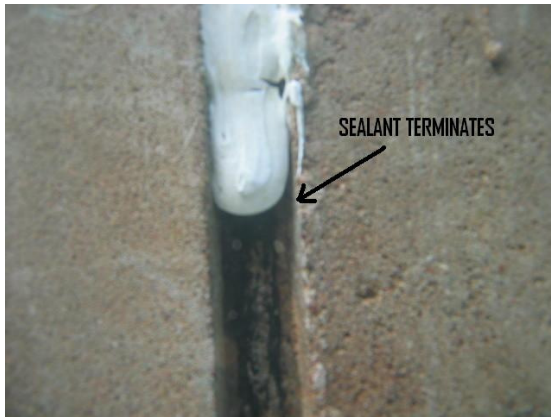
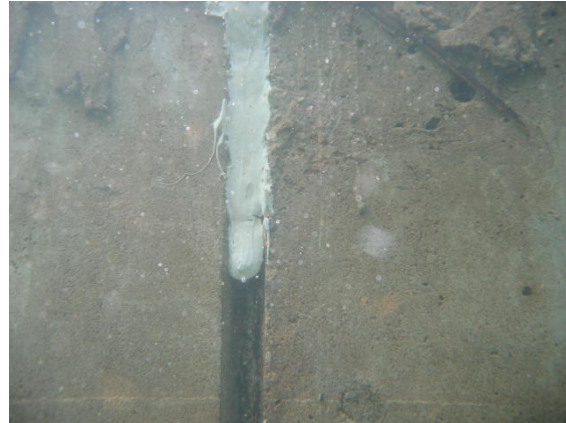
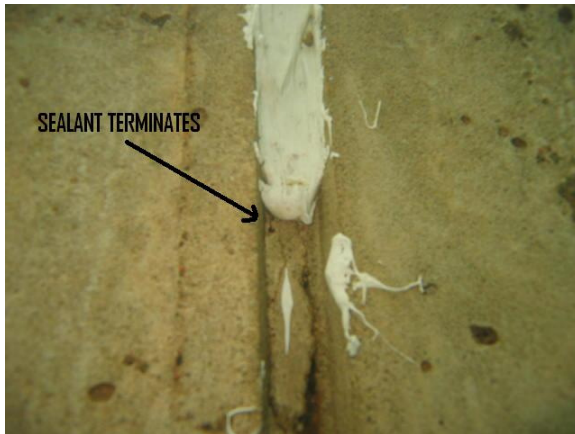
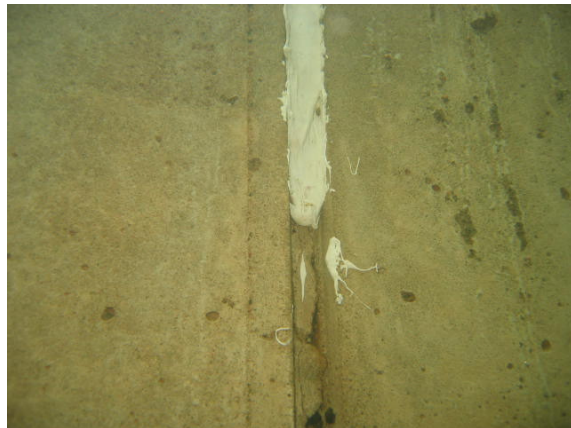
The photos below show the sealant in the expansion joints. This sealant does not go beyond the new concrete. The photos clearly show that there was no sealant in the joint previous to the placement of the sealant shown. All of the expansion joints look like this. More visual evidence can be seen in the video that was produced.
