**CITY OF IQALUIT  
DAM SAFETY INSPECTION  
LAKE GERALDINE DAM  
IQALUIT, NUNAVUT**

**CITY OF IQALUIT**

**CONCENTRIC ASSOCIATES INTERNATIONAL INCORPORATED**

**JULY 11, 2012**

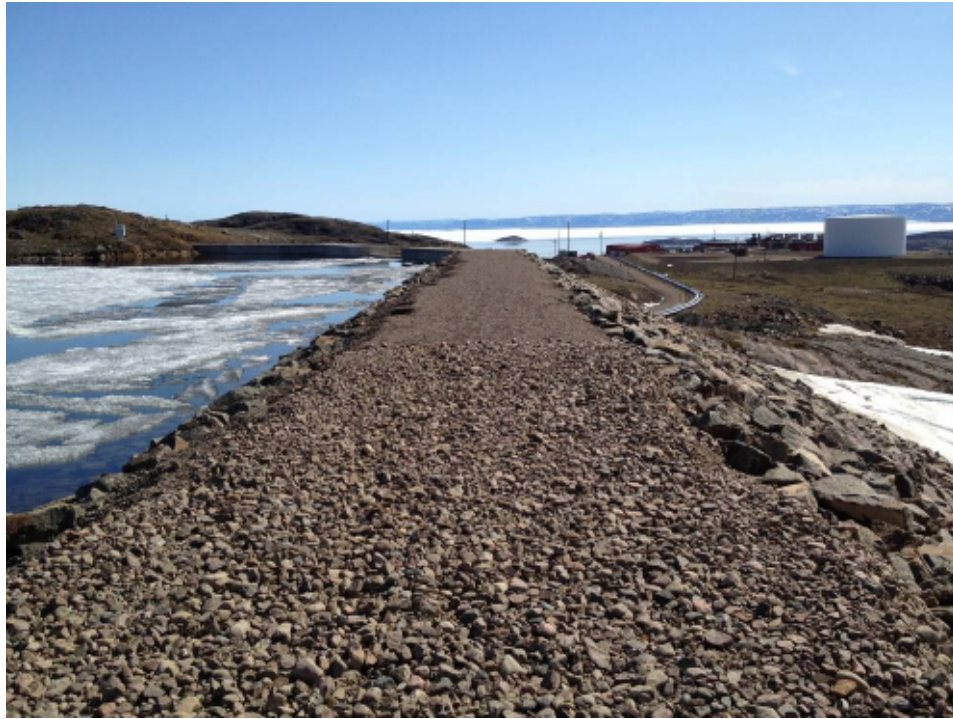
Photograph 1  
Overview of north berm looking south.

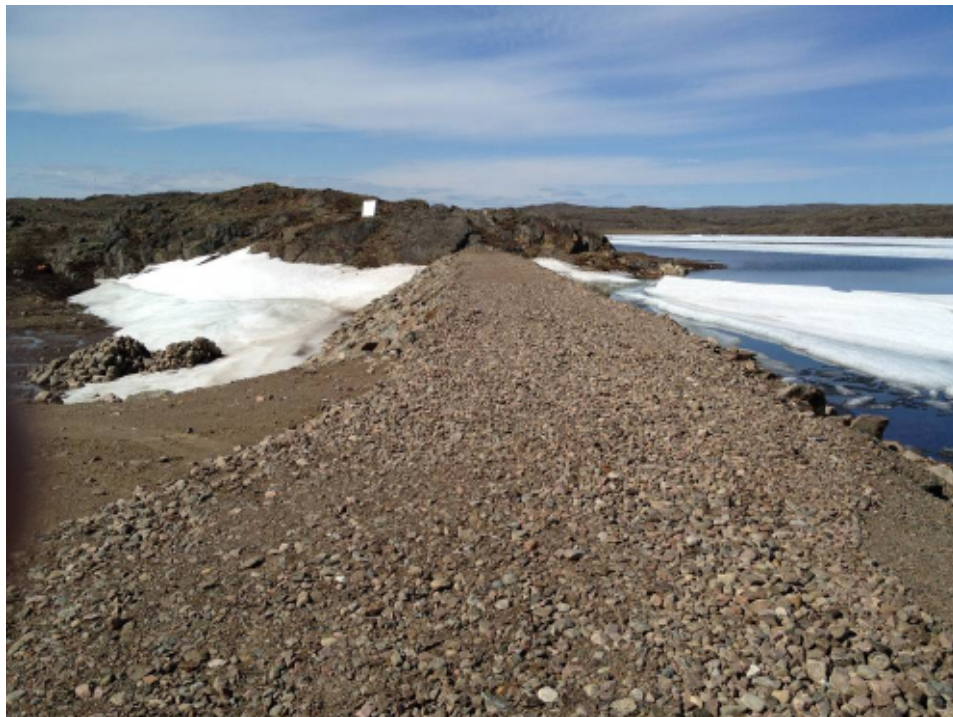
Photograph 2  
Overview of north berm looking north.

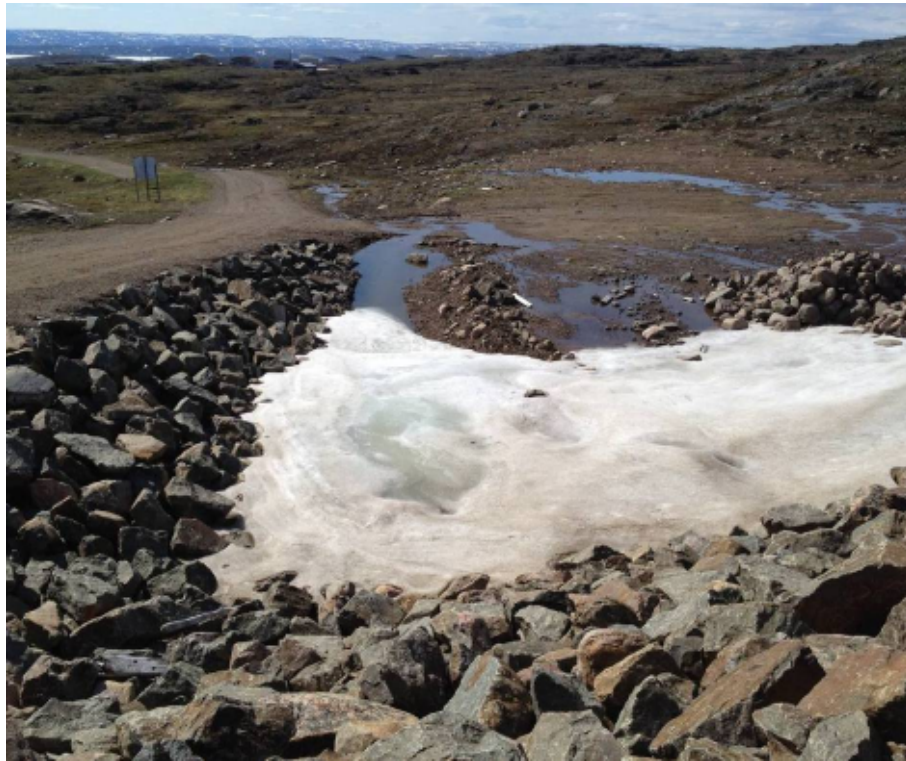
Photograph 3  
Meltwater and potential minor leakage at north side of access road / north berm.

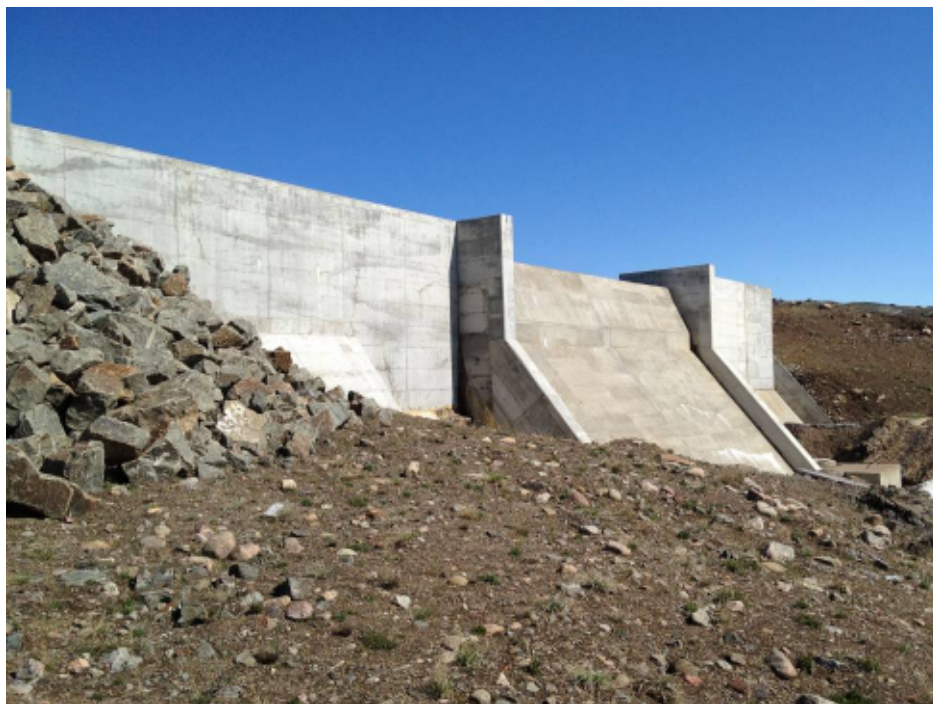
Photograph 4  
Overview of concrete structures from the northwest.

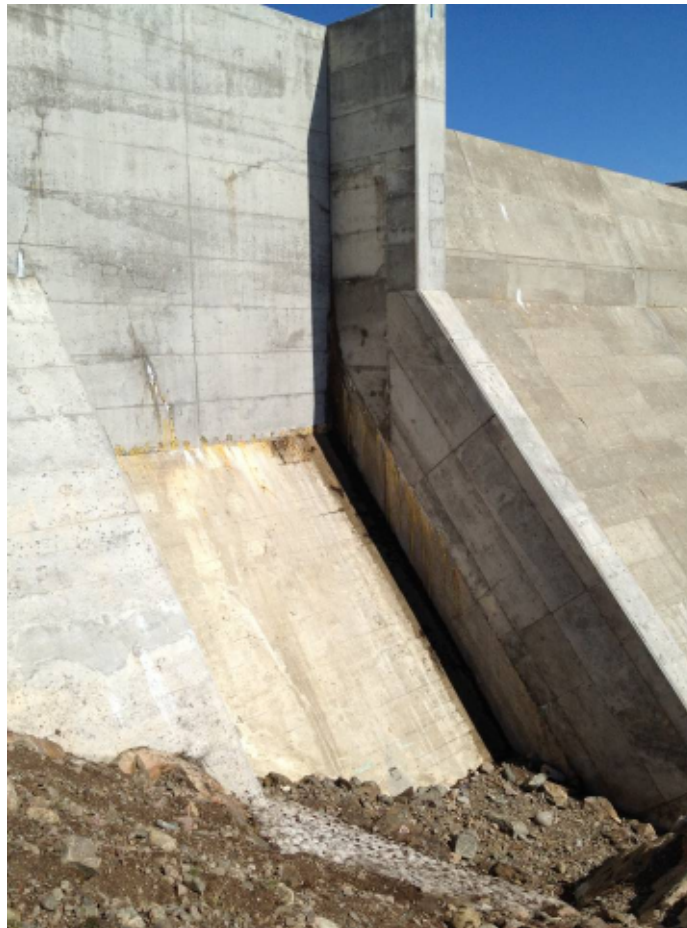
Photograph 5  
Minor leakage at north transition of spillway at previous injection repair.

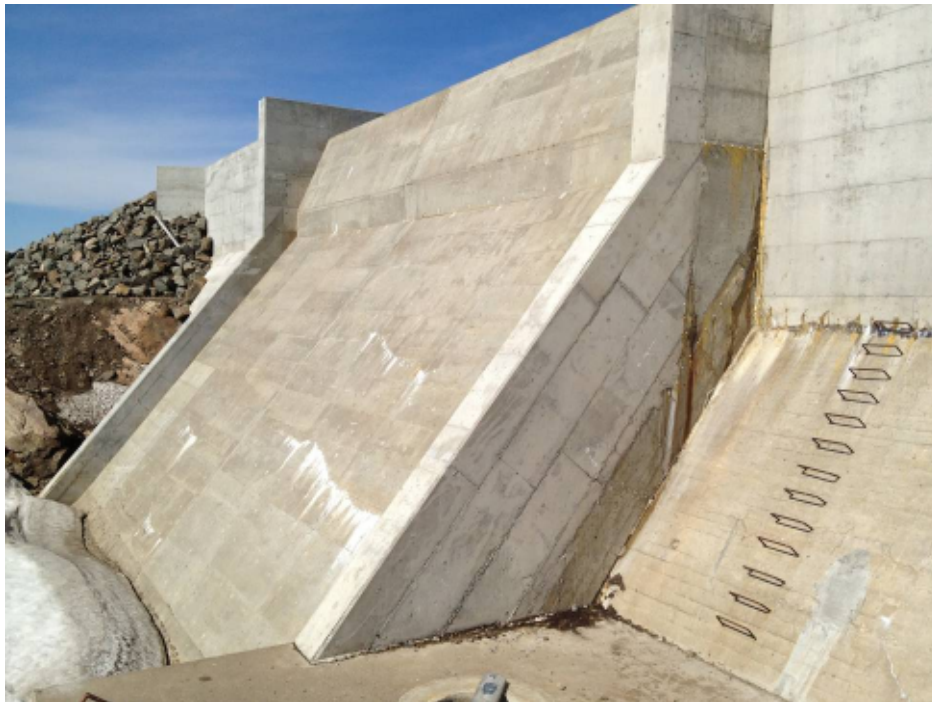
Photograph 6  
Overview of spillway from the southwest. Note minor leakage at previous injection repair.

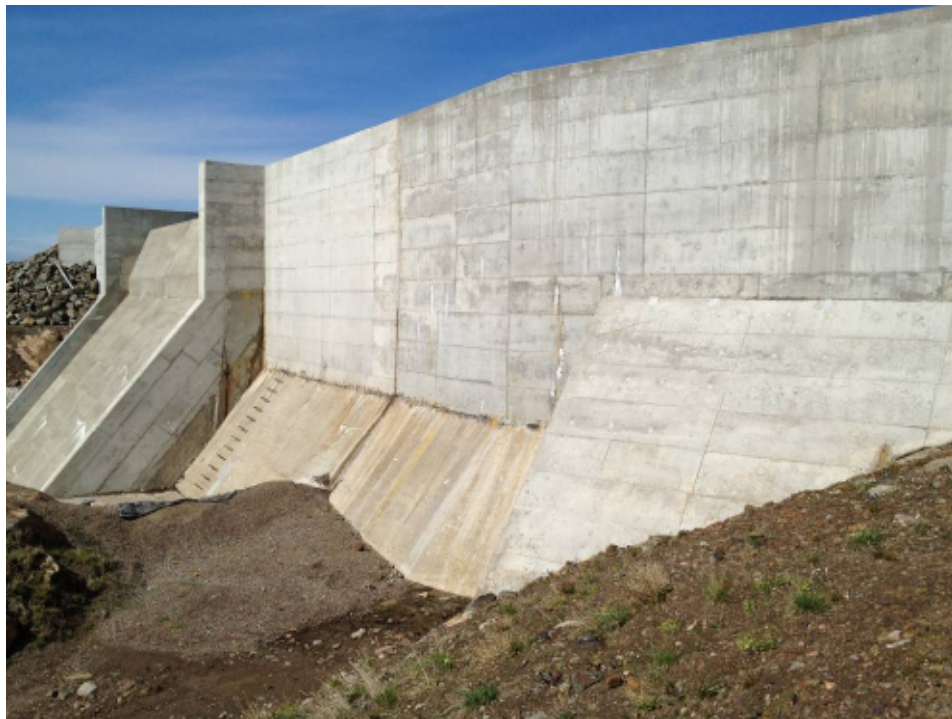
Photograph 7  
Overview of south concrete structures from the southwest.

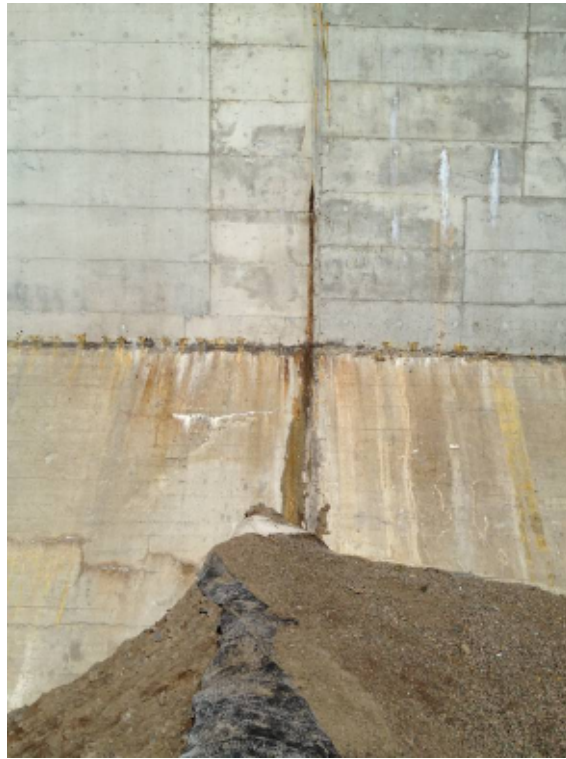
Photograph 8  
South structure control joint showing minor leak at previous injection repair.

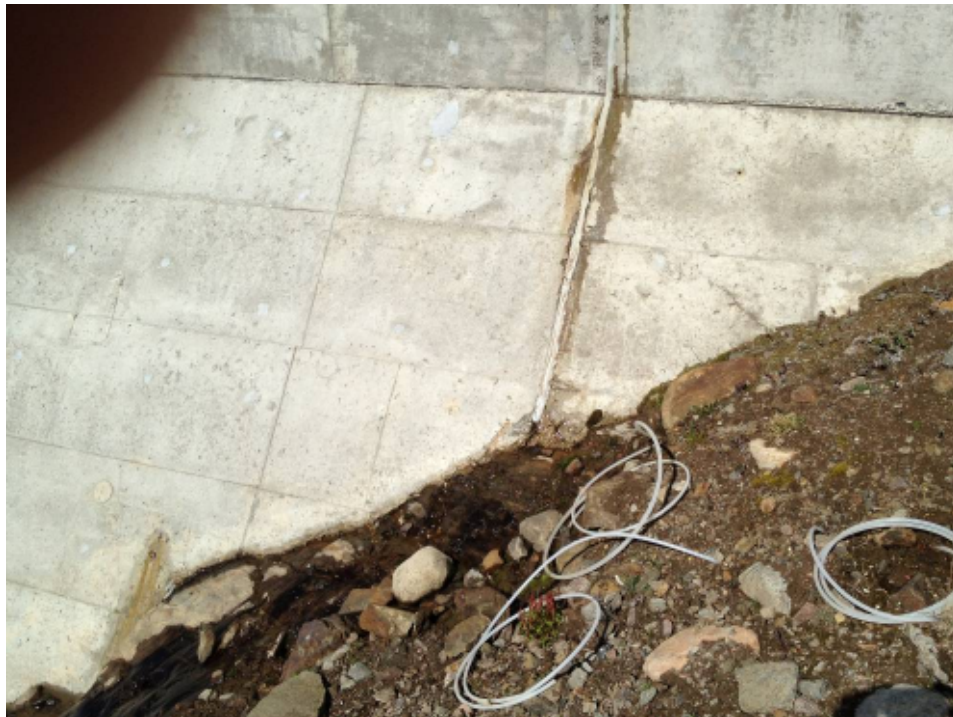
Photograph 9  
Minor leak at another control joint on south structure.

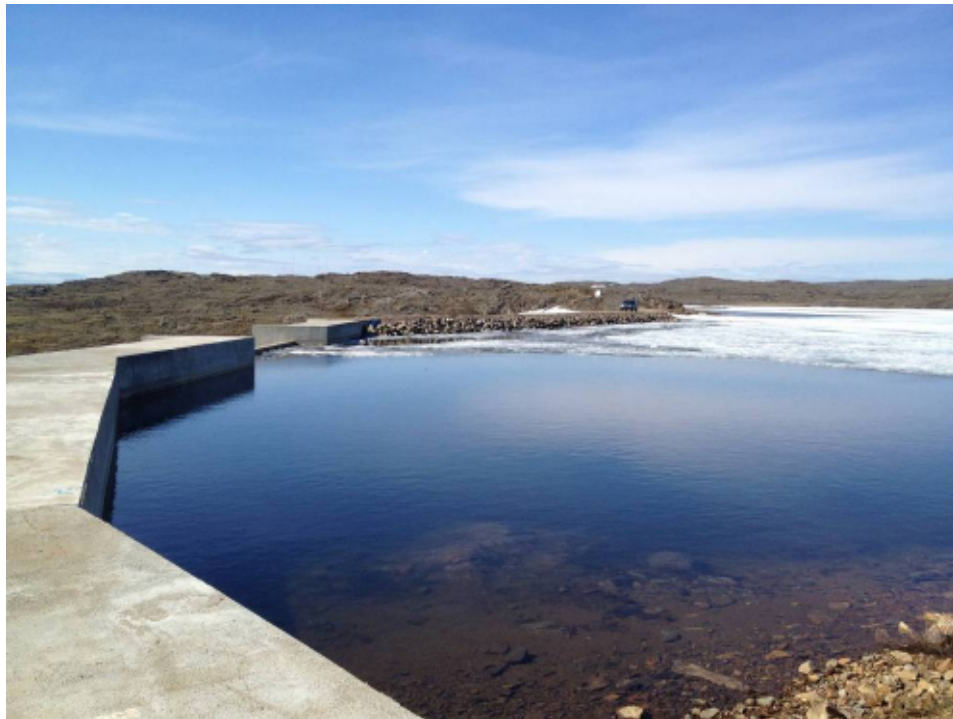
Photograph 10  
Overview of upstream face.

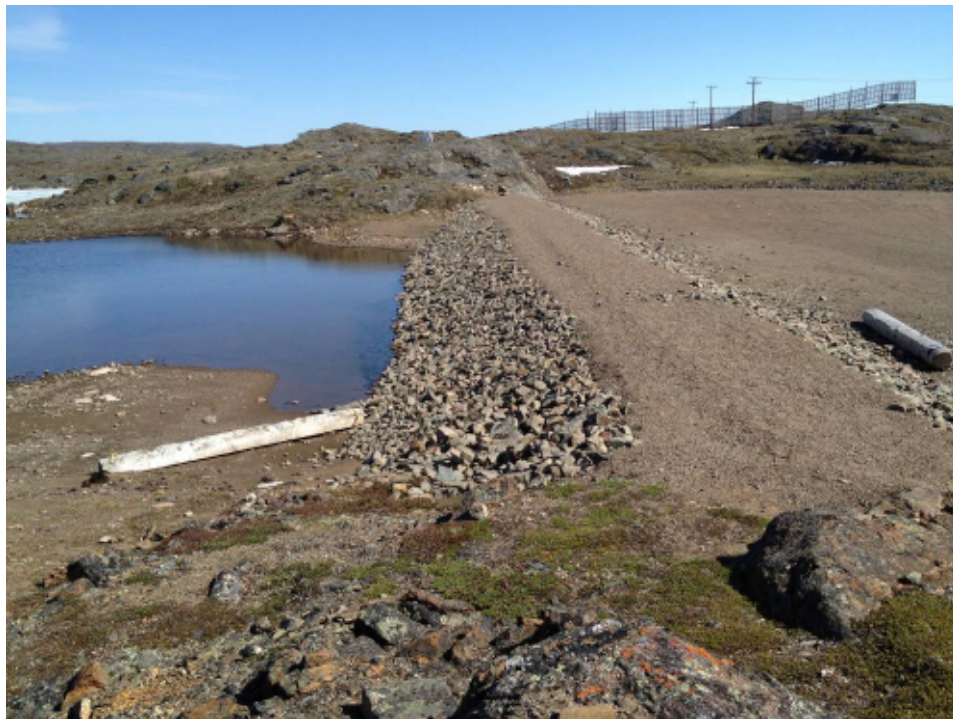
Photograph 11  
Overview of south berm.
