**LAKE GERALDINE DAM  
SAFETY REVIEW  
Iqaluit, Nunavut  
Final Report**

PREPARED FOR:  
**THE CITY OF IQALUIT**

PREPARED BY:  
**CONCENTRIC ASSOCIATES INTERNATIONAL INCORPORATED**

DATE:  
**March 27, 2014**

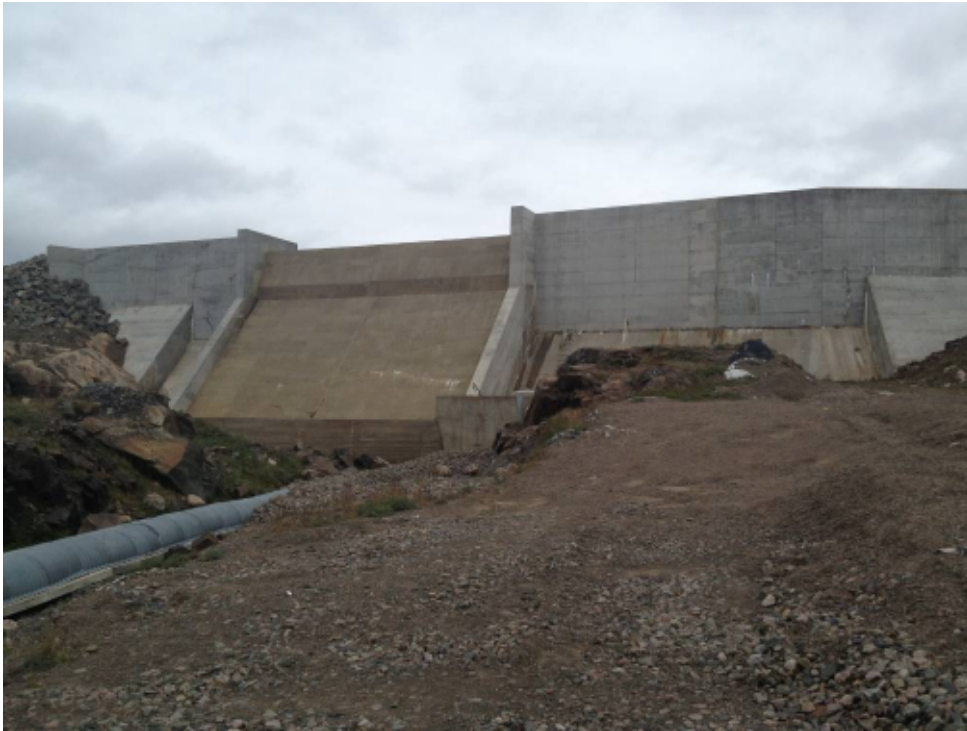
**Photo 1:** Overview of Dam Spillway and Wingwalls.

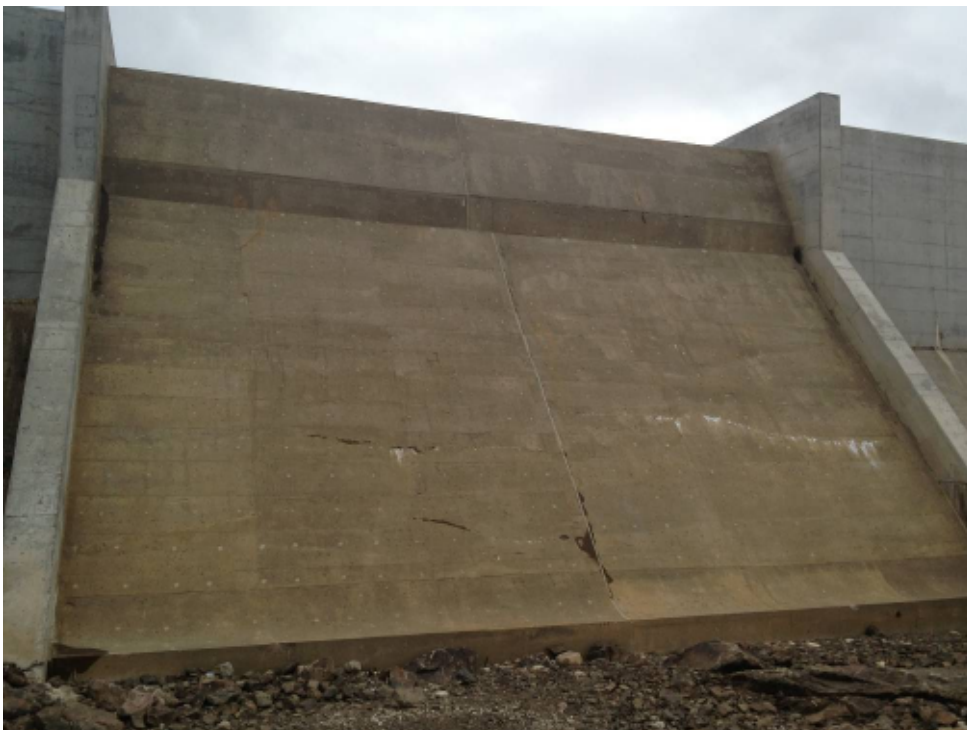
- The reservoir level has reached the south berm.
- No significant changes were noted in the general condition of the concrete and earthworks portions of the dam. Seepage/leakage was observed to be occurring at the same locations as previously identified. Overall the magnitude of seepage/leakage was observed to be slightly reduced.
- Additional ballast/rip-rap is recommended at the south end of the north berm.
- The north berm in the vicinity of the ramp access did not exhibit visible leakage.

**Photo 2:** Spillway – Note minimal leakage.

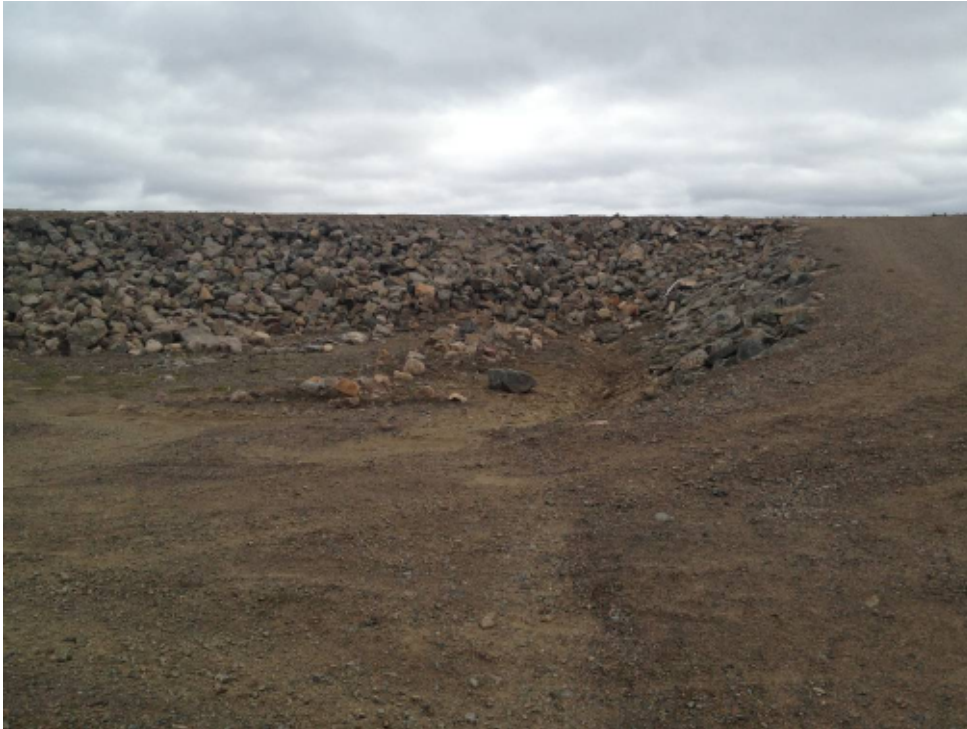
**Photo 3:** North Side of Ramp Access – Note no leakage.

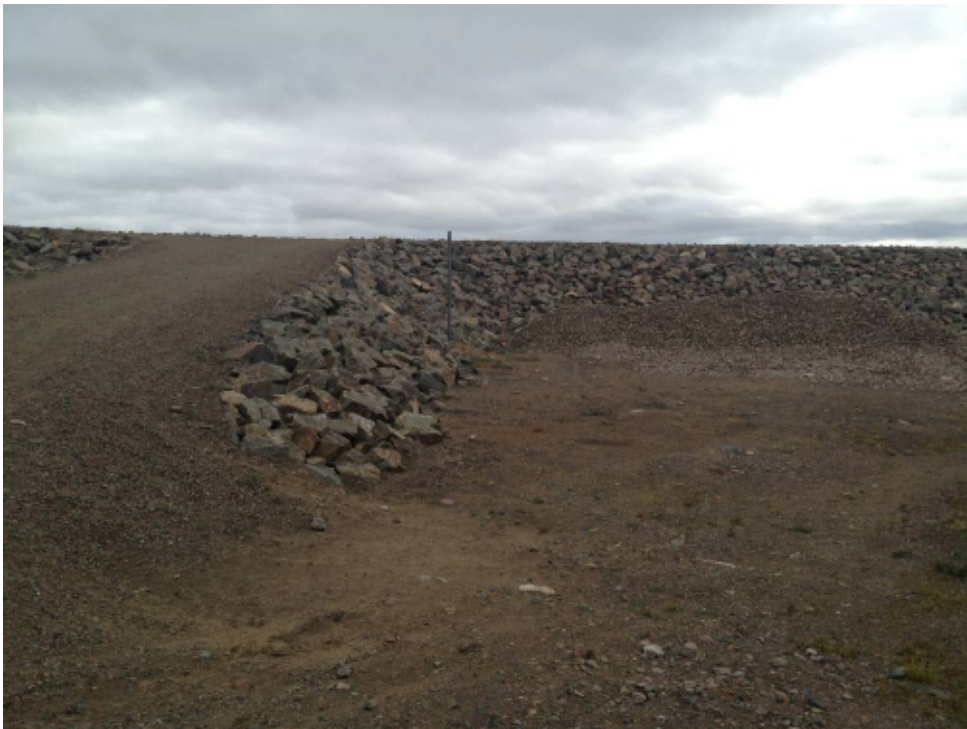
**Photo 4:** South Side of Ramp Access – Note no leakage.

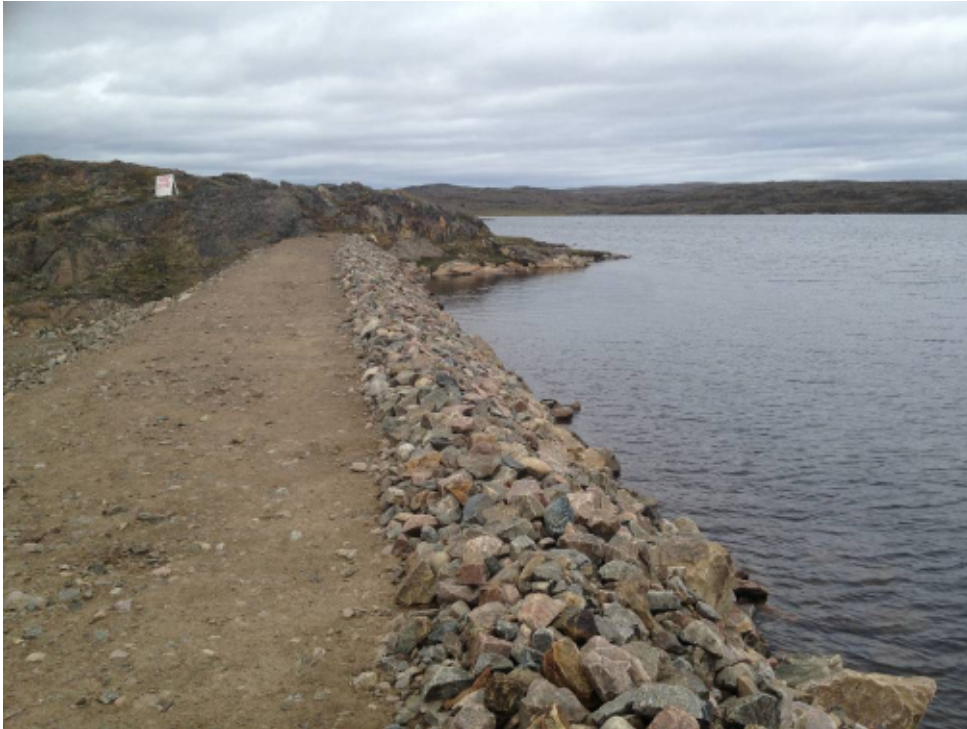
**Photo 5:** Overview – North Berm – Looking north.

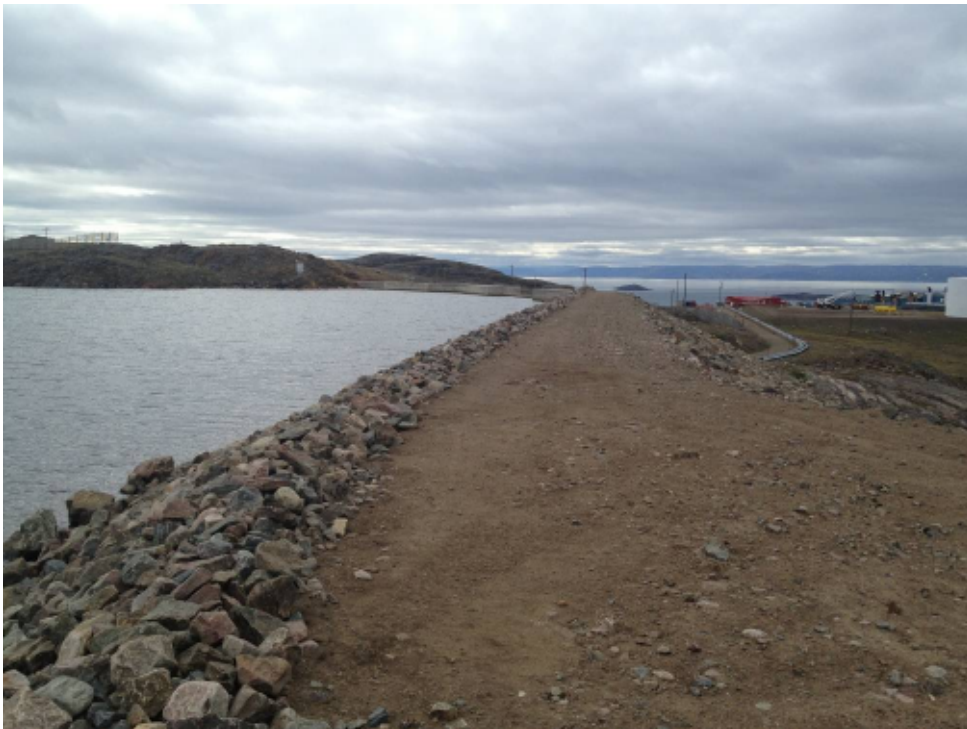
**Photo 6:** Overview – North Berm – Looking south.

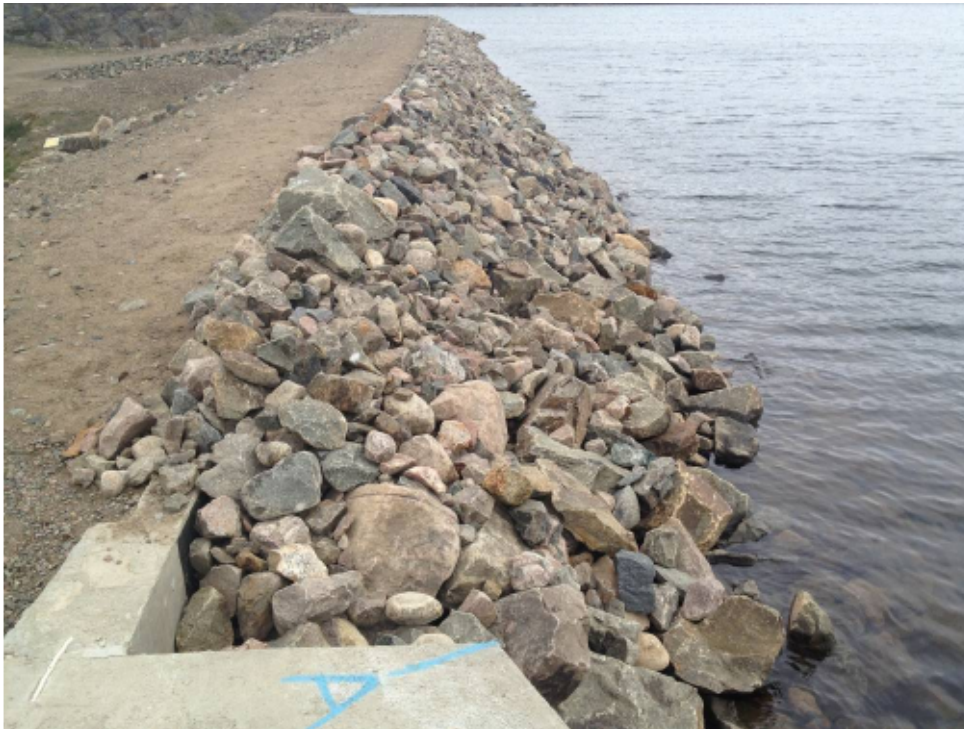
**Photo 7:** North Berm at Wingwall – Supplementary ballast and riprap required.

9. A Seismic Hazard Assessment (SHA) is recommended prior to the next DSR in 2018.
10. An underwater survey is recommended for 2014.
11. It is recommended that ballast and rip-rap be supplemented at the south end of the north berm (where the berm abuts the concrete dam structure).

11. It is recommended that supplementary ballast and rip-rap be installed at the south end of the north berm.
12. Insufficient data exists on the berm construction. In conjunction with Item 8., above, invasive/material testing and independent analysis should be conducted leading up to the 2018 DSR.

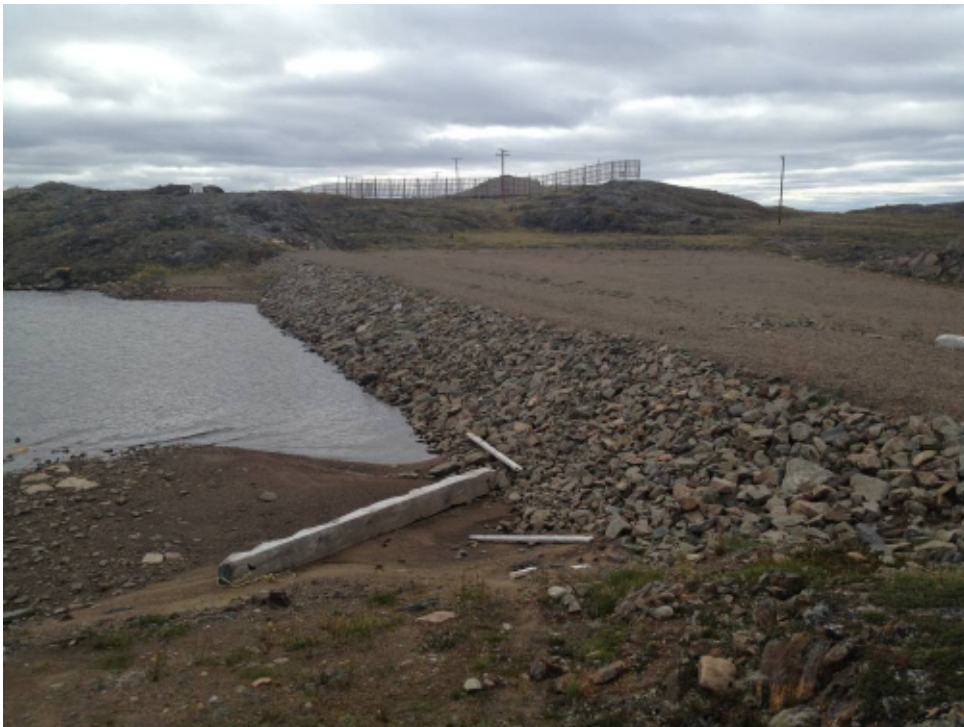
**Photo 8:** Overview – South Berm.
