**SEWAGE LAGOON
DAM SAFETY INSPECTION
Iqaluit, Nunavut**

PREPARED FOR:
THE CITY OF IQALUIT

PREPARED BY:
CONCENTRIC ASSOCIATES INTERNATIONAL INCORPORATED

DATE:
September 9, 2013

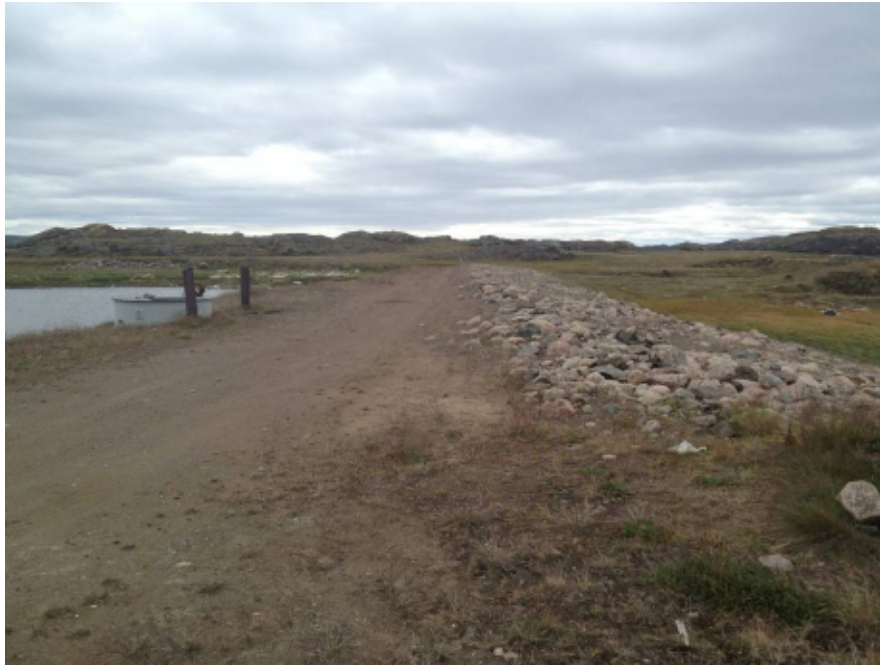
Photo 1: Overview of west berm.

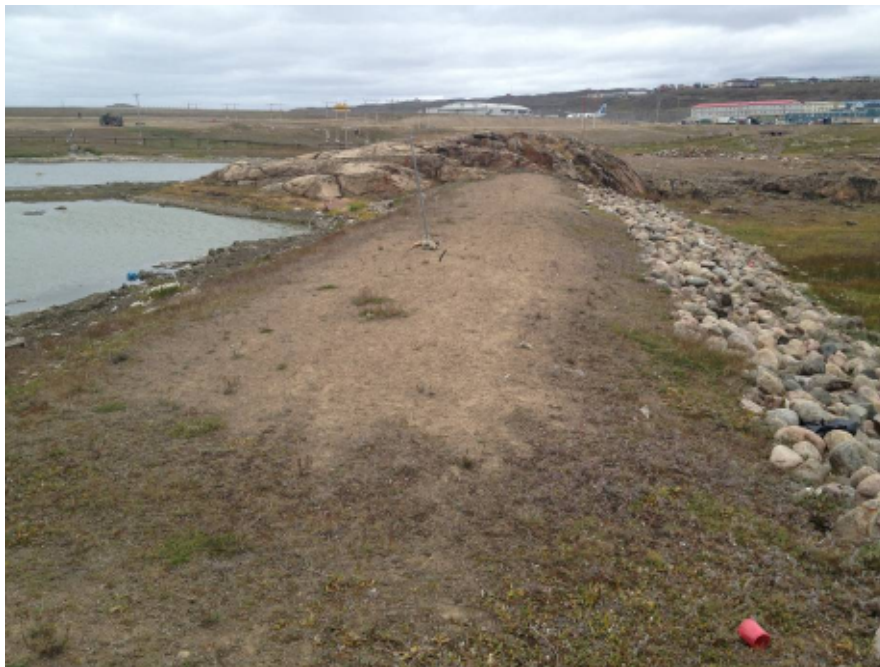
Photo 2: Overview of south berm.

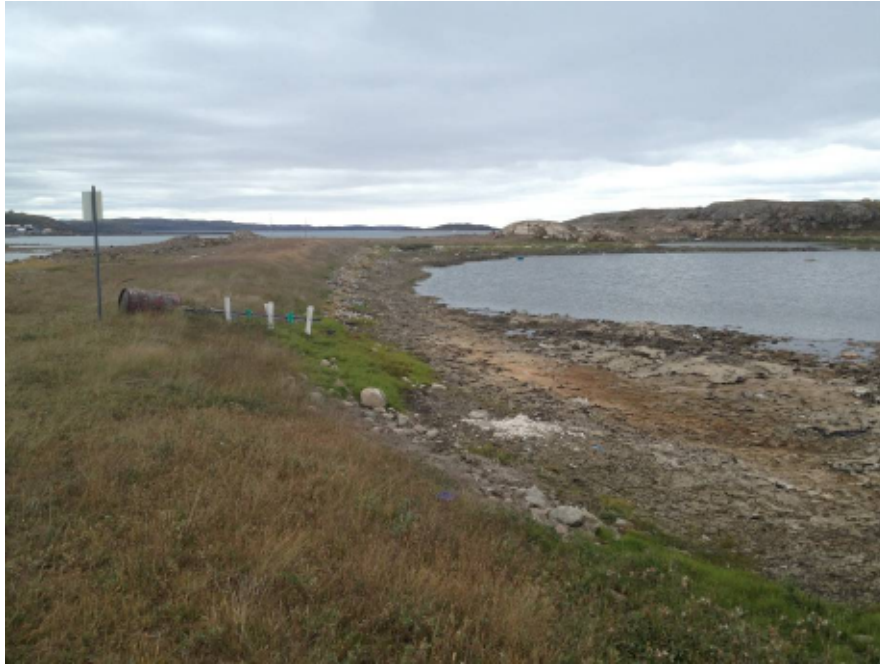
Photo 3: Overview of east berm.
