DAM SAFETY INSPECTION REPORT

CITY OF IQALUIT

Lake Geraldine Dam Safety Inspection

October 2014

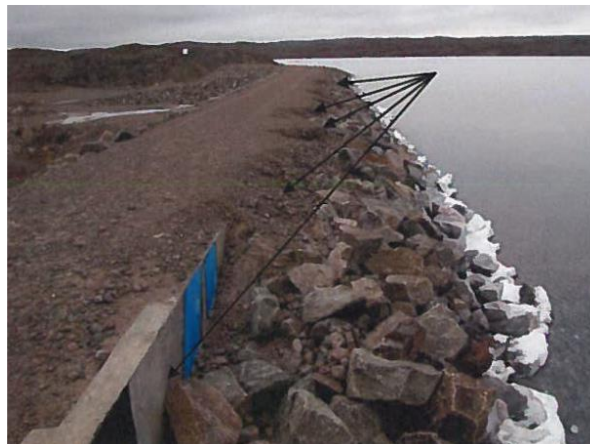
Wave action in 2010 damaged the North and Central Berm to the point of eroding and overtopping the berm during a storm (Figure 2-1 below). No detailed records of the pool elevation during the storm, estimates of wave run-up or damage or repair were available for review during the site visit. The crest was repaired and armored in 2012. The wave damage event occurred with the reservoir at full pool (reportedly) with approximately 1 m of freeboard.

Figure 2-1: Photograph of wave erosion on upstream side of Central Berm in 2010.

Based condition of the armor on the upstream side of the North and Central Berms and the damage that was caused in 2010 when the reservoir was a normal pool, it is likely that without additional armor, future storms including the IDF will cause similar or worse damage. Under the IDF there is less than 50 cm of freeboard during the 2010 storm there was approximately 1 m of freeboard.

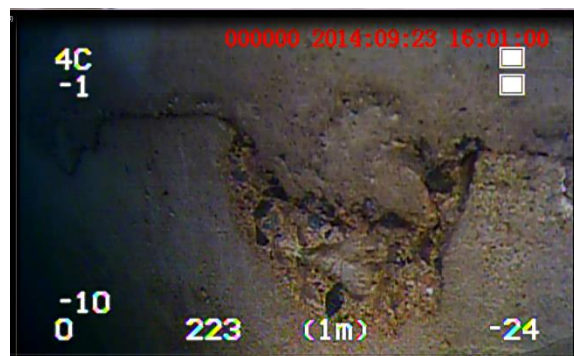
Concrete spalling was noted along the contact between the 2006 lift and the earlier 1995 crest. The linear nature of the staining, coincident with the 2006 lift line and the geometry of the spalls or pop-outs, suggests the spalling is related to 2006 construction products, such as the water stop, or the execution of the work. Joint filler is missing in some of the lower section of the 2006 construction and is completely absent from the older concrete.

Figure 3-5: Spalling 2 m below crest, 7 m east of blue A.

- Repair concrete spalling and fill joints on upstream faces of concrete structures by **autumn 2016**.
- Complete this work sooner if there are changes to site conditions such as seepage that are linked to concrete condition. If conditions deteriorate, repairs should be initiated as soon as practical.
- Record and document all repairs for inclusion in the project file.
- Inspect the upstream faces of the concrete structures during the **5-year DSRs** and time the inspection to gain as much visual inspection of the upstream face as possible. Document findings in the DSRs.
- Provide descriptions of observations that allow for repeatability.

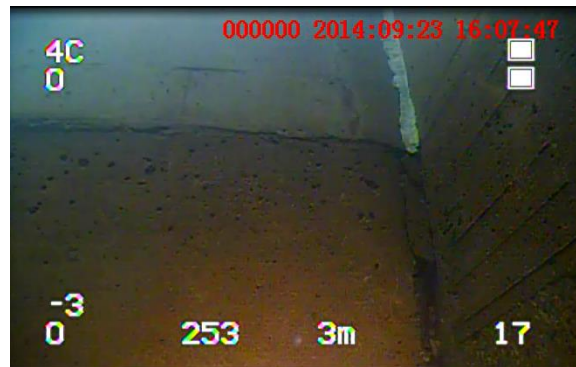
Figure 3-6: Joint filler of J1 terminates at 2 m below the crest at the 1995 and 2006 construction contact. ROV camera directed upward.

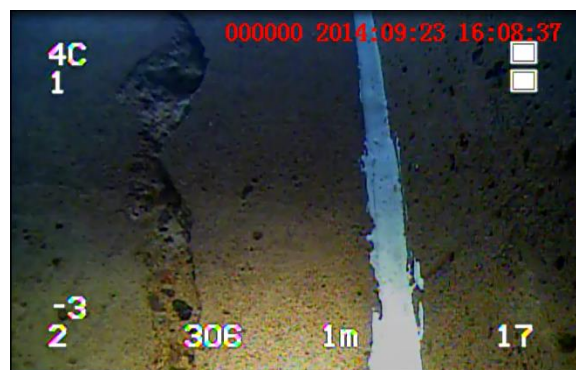
Figure 3-7: Spalling a metre or so below spillway crest to left of J1.

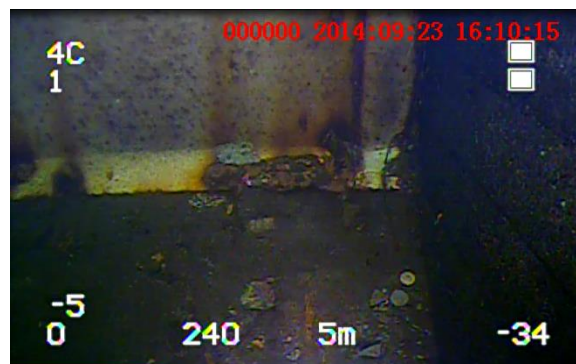
Figure 3-8: Corrosion of steel plate along spillway at El 106.7 m, corner junction at J1 (refer to Section A-A dwg S2, 2006).

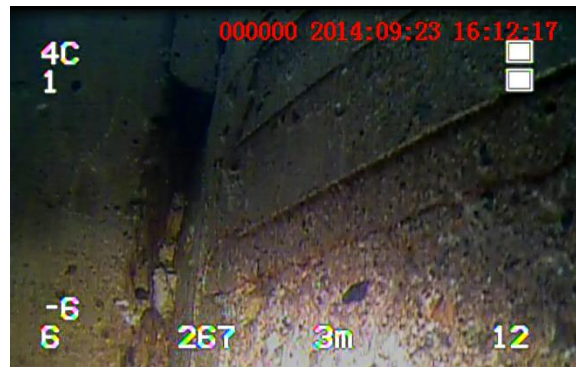
Figure 3-9: Spalling in 1995 concrete joint J1.

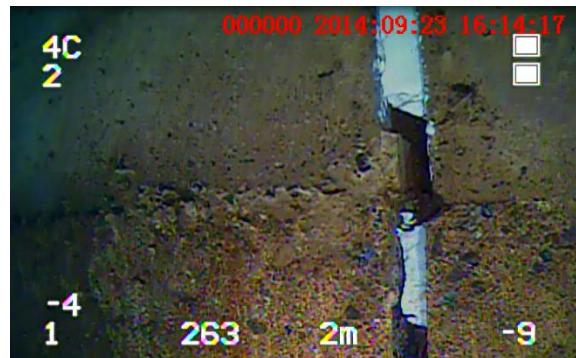
Figure 3-10: Joint filler termination at 2 m below crest on J2.

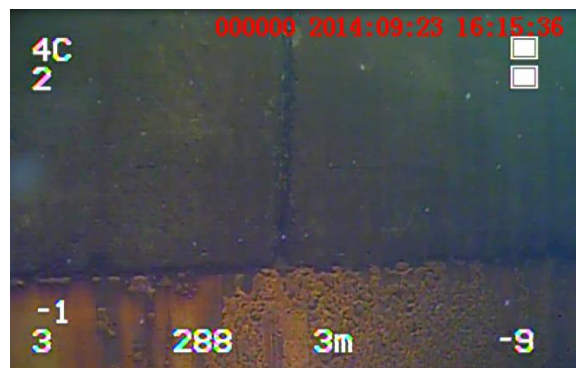
Figure 3-11: Joint filler missing from J2, photograph of contact with steel plate El 106.7 m.

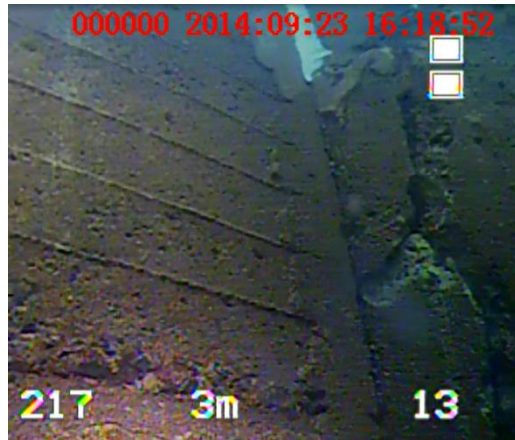
Figure 3-12: Spalling at J3 on the eastern edge of the spillway, from 2-m depth to underlying contact with steel plate.

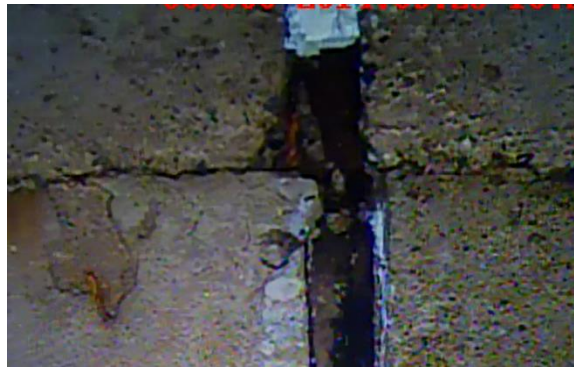
Figure 3-13: Spalling and absence of joint filler J4 on South Dam (left abutment).

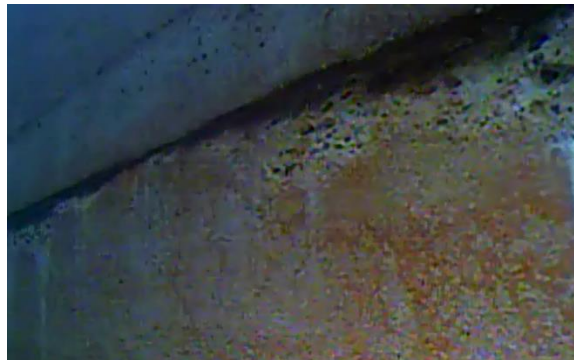
Figure 3-14: Spalling ~2 m east of J4, 2 m below crest.

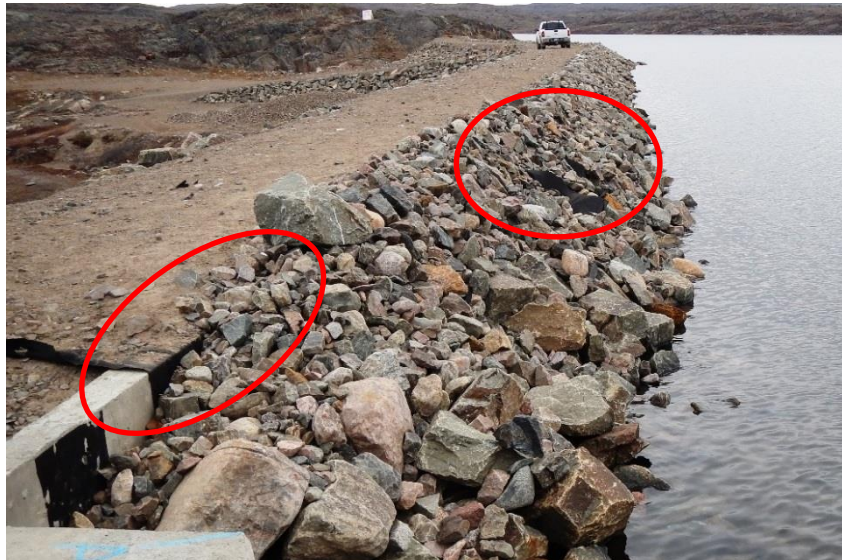
Rock armor and cover have been lost due to wave action exposing smaller rip-rap and road fabric on the upstream side of the Central Berm Station 1+35 and 1+28 (Figure 3-15 below).

Figure 3-15: Evidence of wave action acting on Central Berm upstream armor.

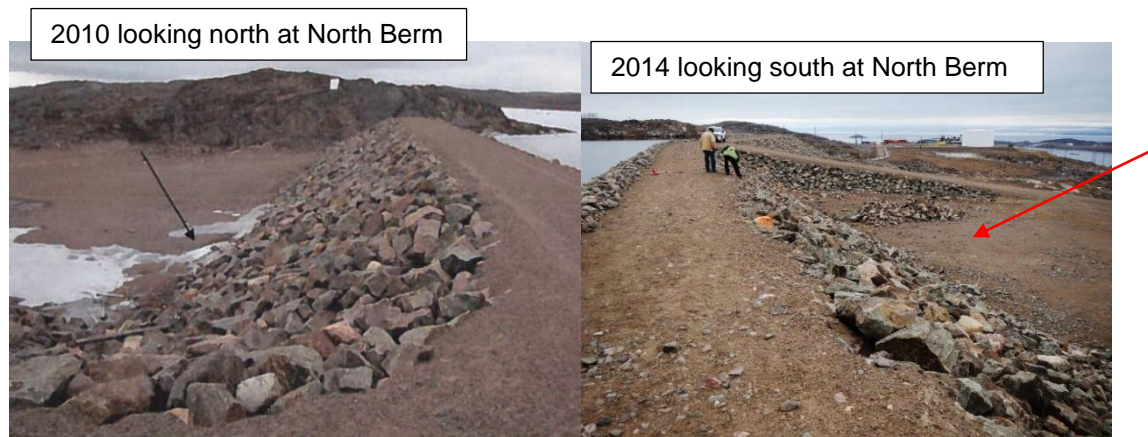
Seepage was not observed on the north side of the access road at the toe of the North Berm during the 2014 inspection, although it was noted in 2010.

Figure 3-16: Photograph of seepage in 2010 on the downstream face of the North Berm. Seepage was not evident at this location in 2014 (right photograph).

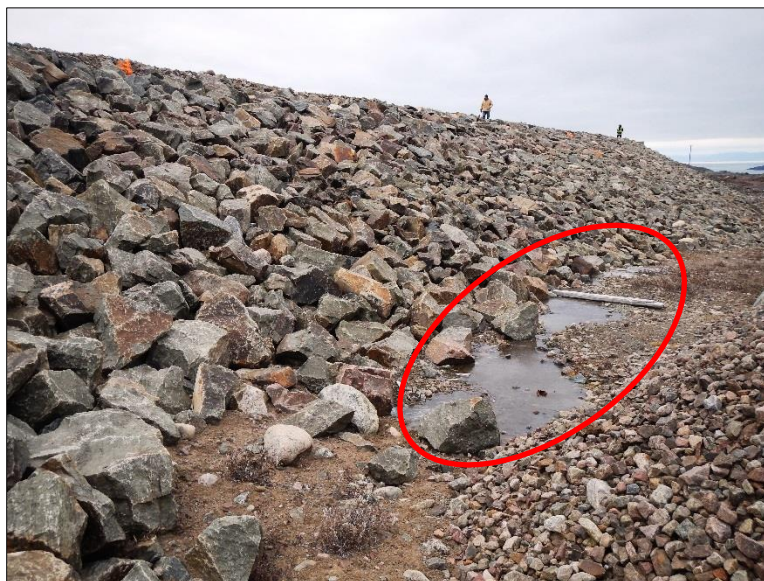
Partially frozen, clear, standing water from minor seepage was noted at the toe of the Central Berm. Figure 3-17 below shows the ponded water observed near Station 0+70. This seepage was observed in earlier inspections and is relatively unchanged.

Figure 3-17: Photograph of ponding due to seepage at Station 0+70.

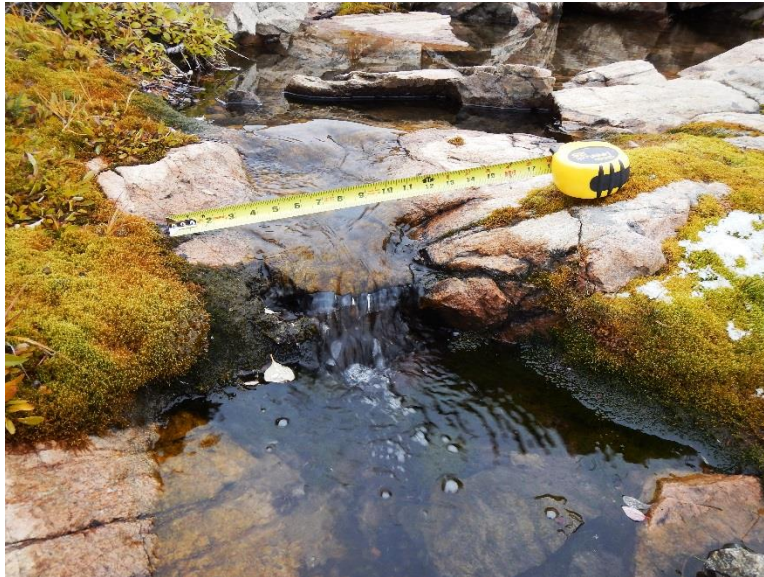
Clear seepage in the range of 10 litre/minute was observed at the Central Berm toe near the termination of the rock armor (photographs shown in Figures 3-18 and 3-19). Ponding from the seepage is directly below Station 1+10 and coincides with a natural draw in the bedrock topography (Figure 3-20), suggesting that the reservoir seepage may be traveling along the contact between the dam and the bedrock. Based on a review of earlier reports, there has been no change in seepage rate.

Figure 3-18: Photograph of seepage at Station 1+10.

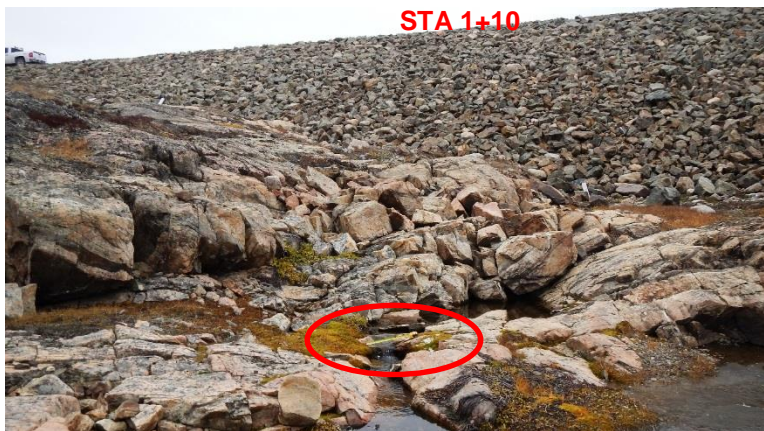
Figure 3-19: Photograph of seepage measure location circled red below Station 1+10.

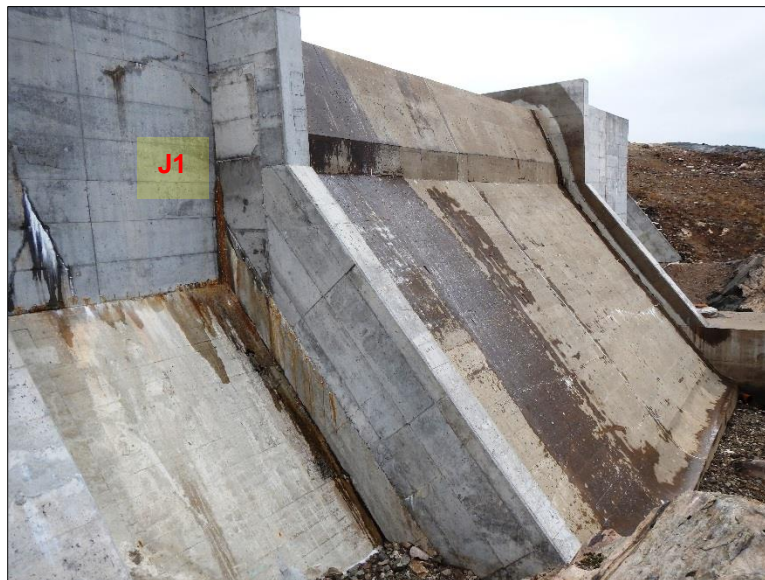
Clear seepage too small to measure and staining were observed at J1, J2, and J3 on the downstream face of the dam (photographs from inspection in Figures 3-21 through 3-25 below). Based on the information available, this seepage and staining is relatively unchanged from earlier inspections.

Figure 3-21: Seepage and staining at J1 and along 2006 construction lift contact.

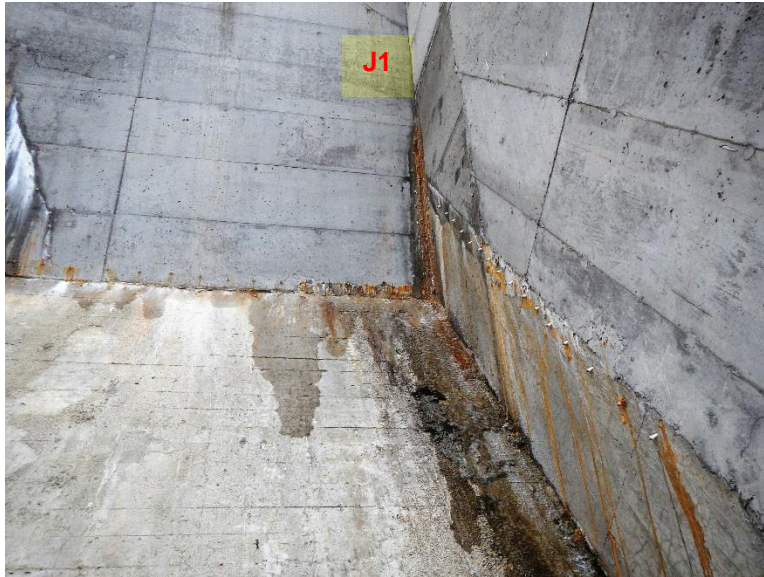
Figure 3-22: Close-up photograph of seepage and staining at J1.

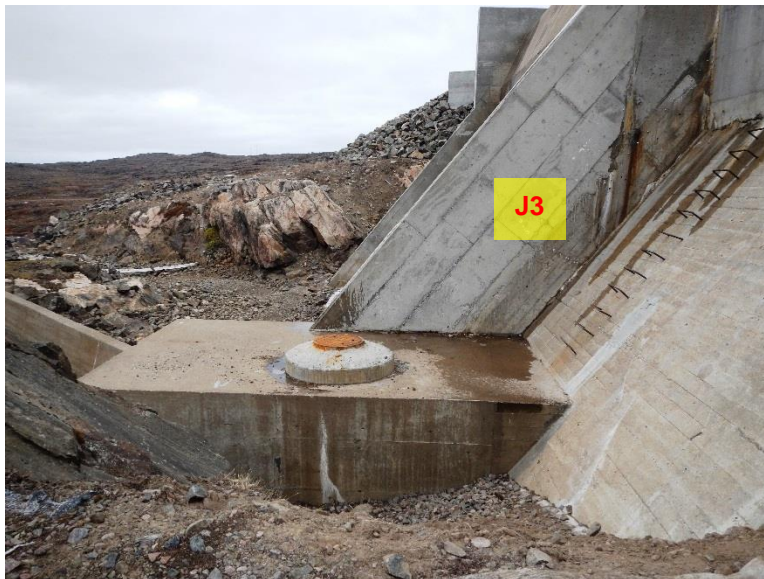
Figure 3-23: Seepage and staining at J3 and along 2006 construction lift contact.

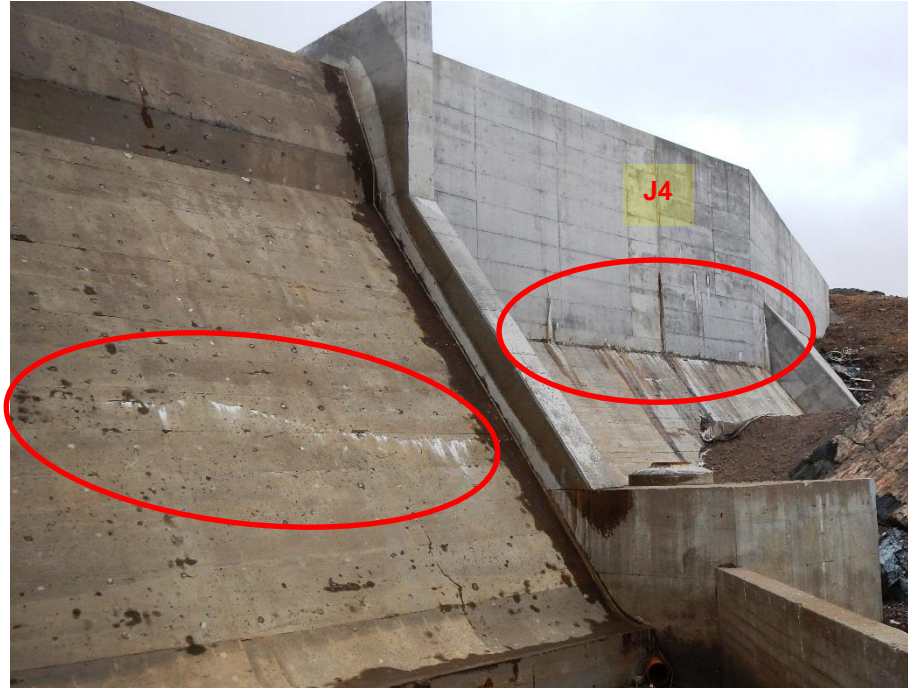
Figure 3-24: Downstream dam face showing efflorescence associated with seepage through spillway crack. Seepage and staining also noted at 2006 concrete lift contact.

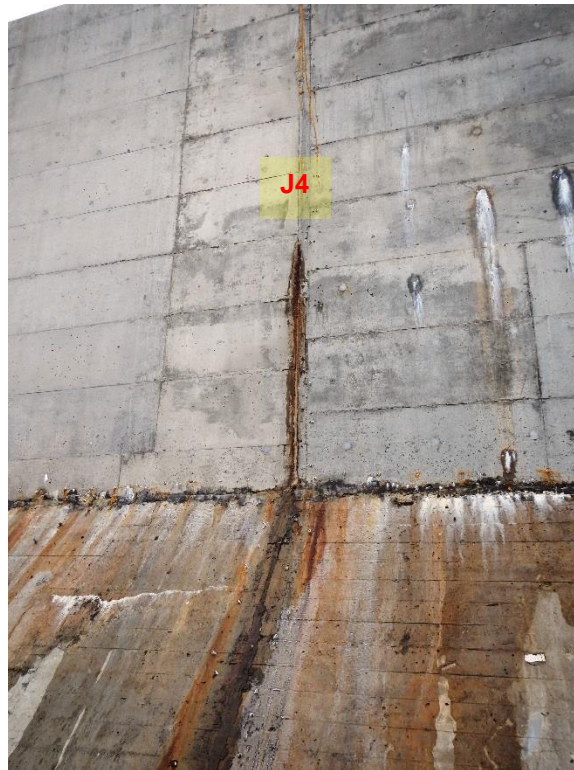
Figure 3-25: Seepage and staining at J4 and along 2006 construction lift contact.

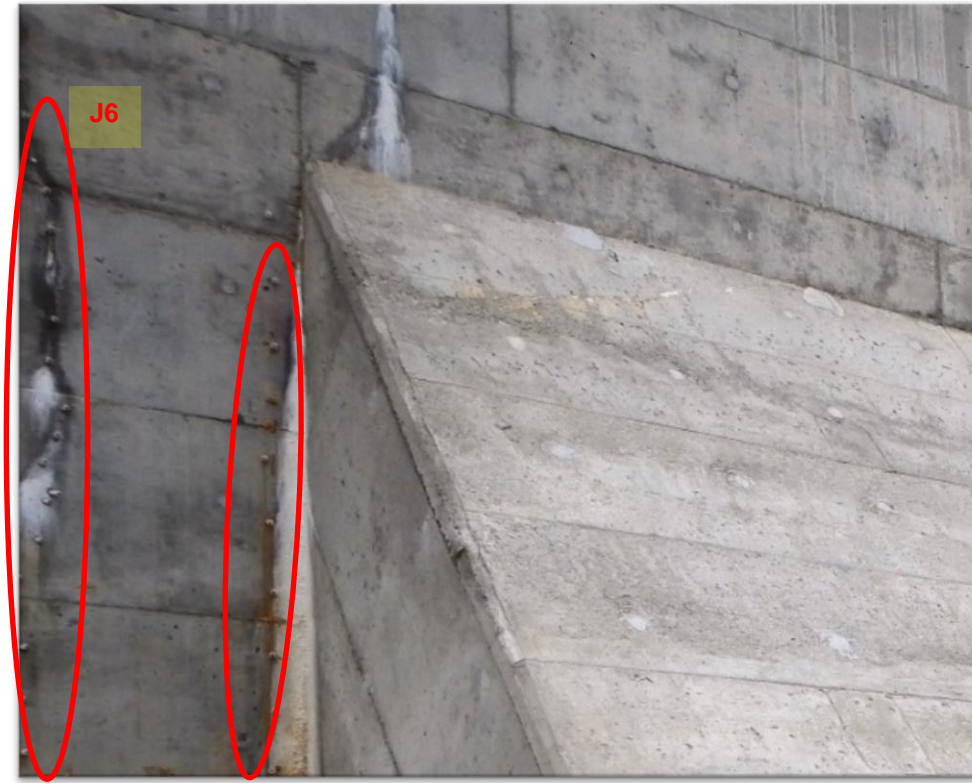
The seepage repair and efflorescence were observed at J6 (left abutment), Figure 3-26 below.

Figure 3-26: Efflorescence and staining at J6, left abutment. Injection ports from seepage repair shown.

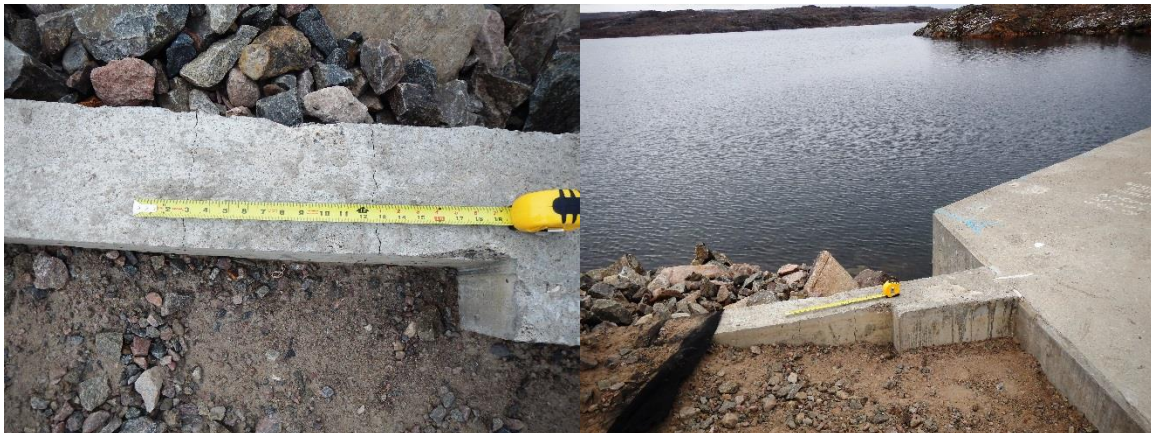
Concrete crack repairs on the downstream face of the dam and spillway are performing adequately. Seepage from cracks appears unchanged from earlier inspections. Minor surface shrinkage cracks were noted on the right abutment wingwall (Figure 3-27 below), Station 1+35.

Figure 3-27: Shrinkage cracks on wingwall right abutment Station 1+35.

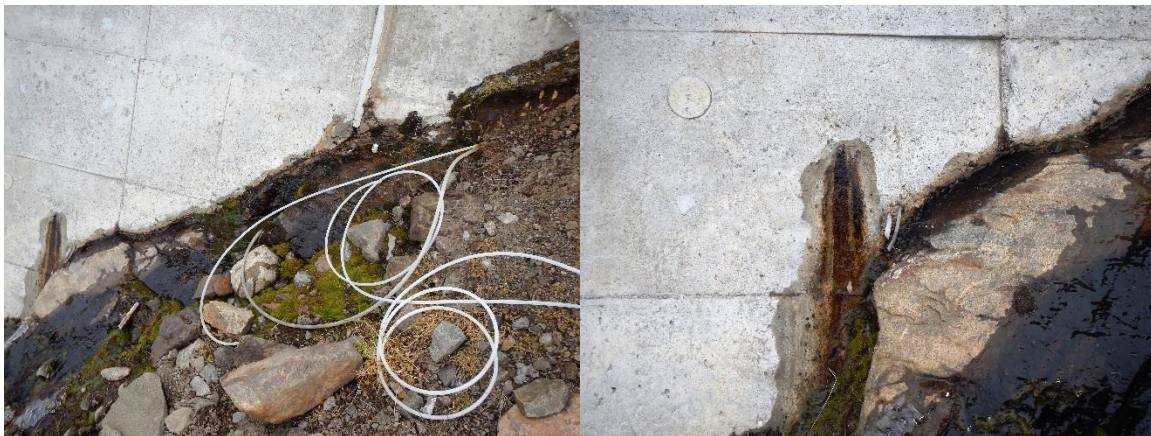
No measurement of uplift pressures is made. The design and the installation of the plastic tube drains at the 2006 left buttress are unavailable and no information is available regarding the discharge requirements to meet design uplift relief needs. The flow from the drains is less than a litre per minute (Figure 3-28 below).

Figure 3-28: Pressure relief tubing at left abutment buttress.

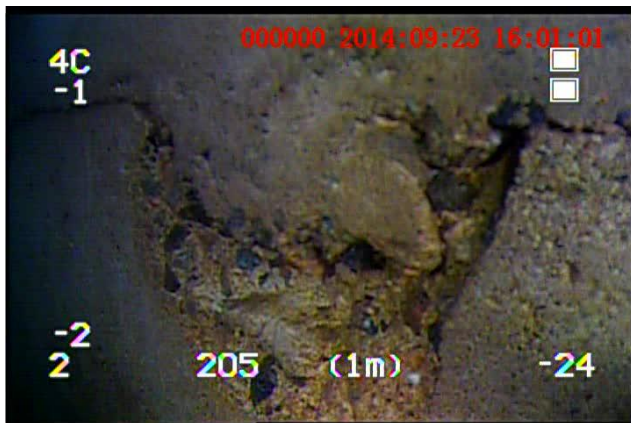
Spalling along horizontal joint prior to J1

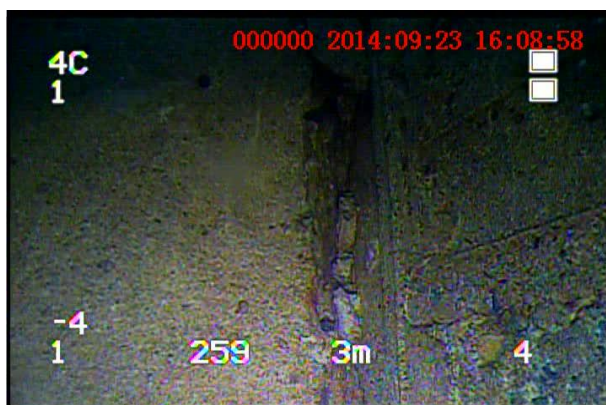
Joint J1 spalling in concrete

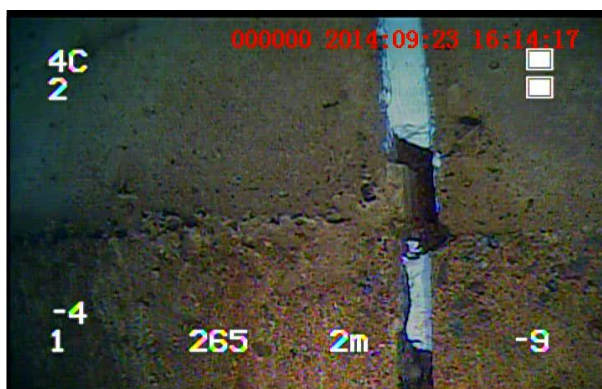
Joint J2 start of gap, and missing material

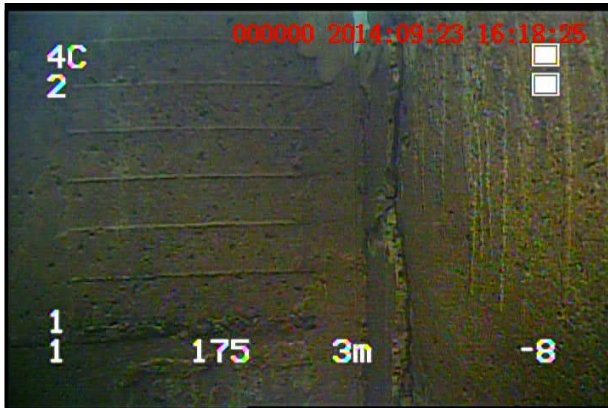
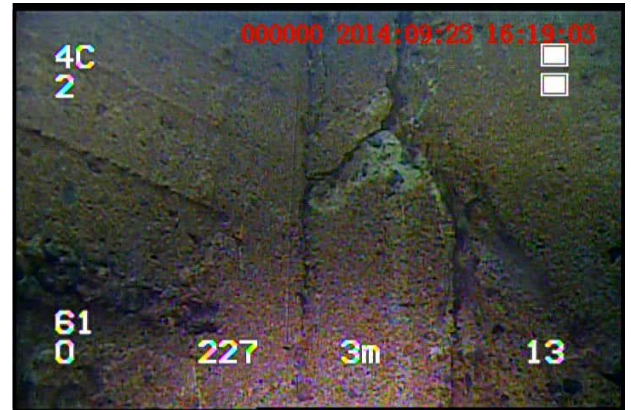
J3 just below caulking, crack in concrete extending down and out.

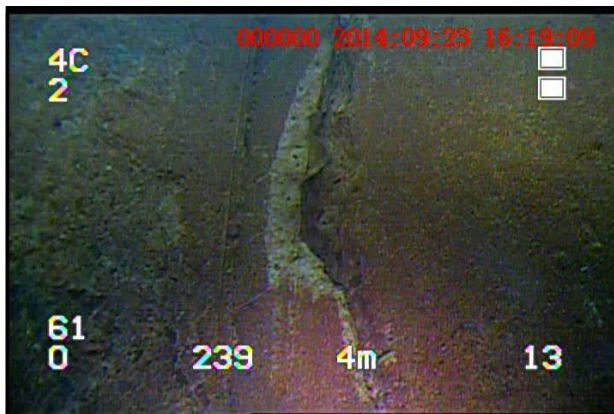
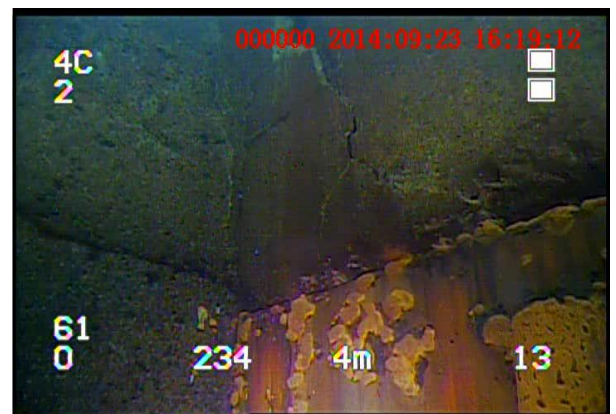
J3 continuing down showing crack until it reaches top of old structure.

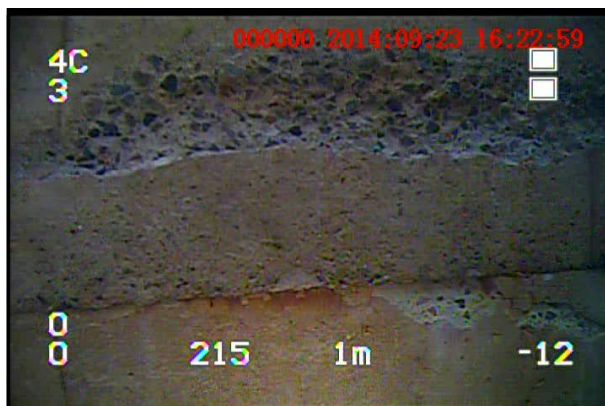
Spalling in horizontal Joint between J3 & J4

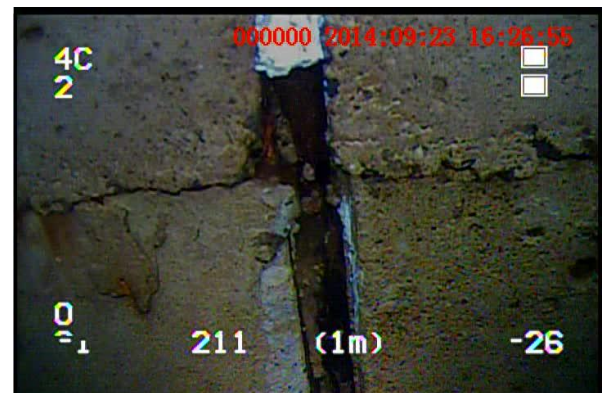
J4 showing gap in joint starting just below white caulking

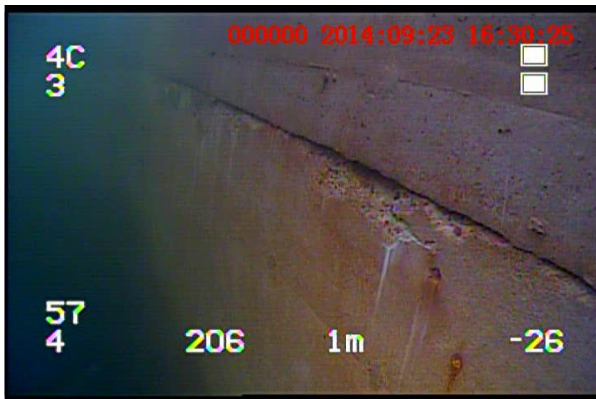
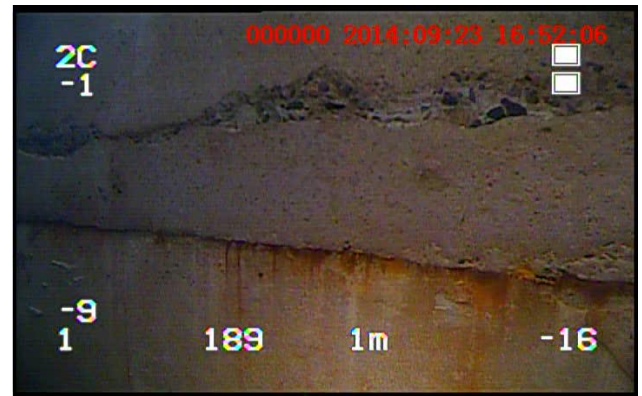
Spalling in concrete, horizontal joint between J4 & J5

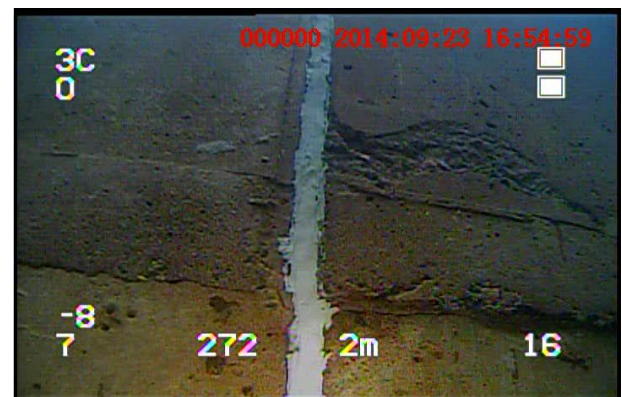
Spalling in concrete along vertical joint J5
