**LAKE GERALDINE DAM
SAFETY INSPECTION
IQALUIT, NUNAVUT
Final Report**

PRODUCED FOR: THE CITY OF IQALUIT
PRODUCED BY: CONCENTRIC ASSOCIATES INTERNATIONAL INCORPORATED
CONCENTRIC REFERENCE NUMBER: 15-6279-B
DATE: NOVEMBER 05, 2015

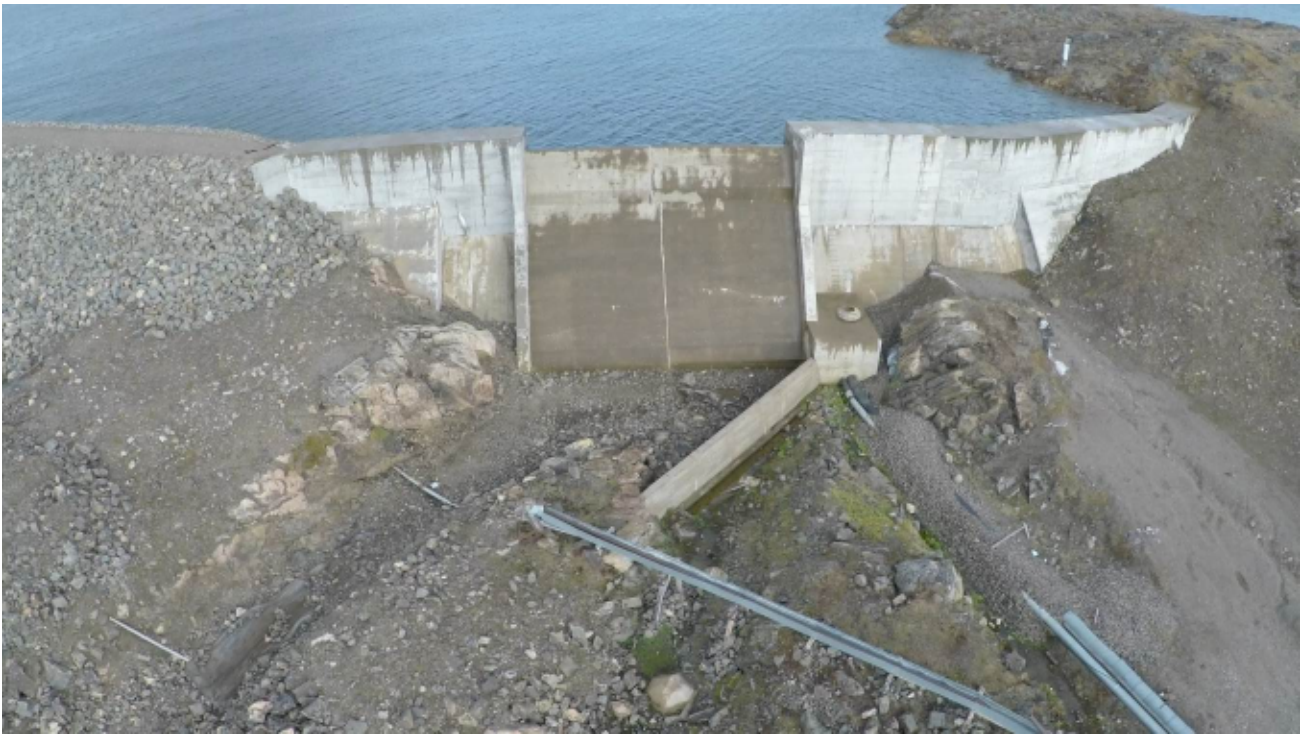
Photo 1: Main dam structure

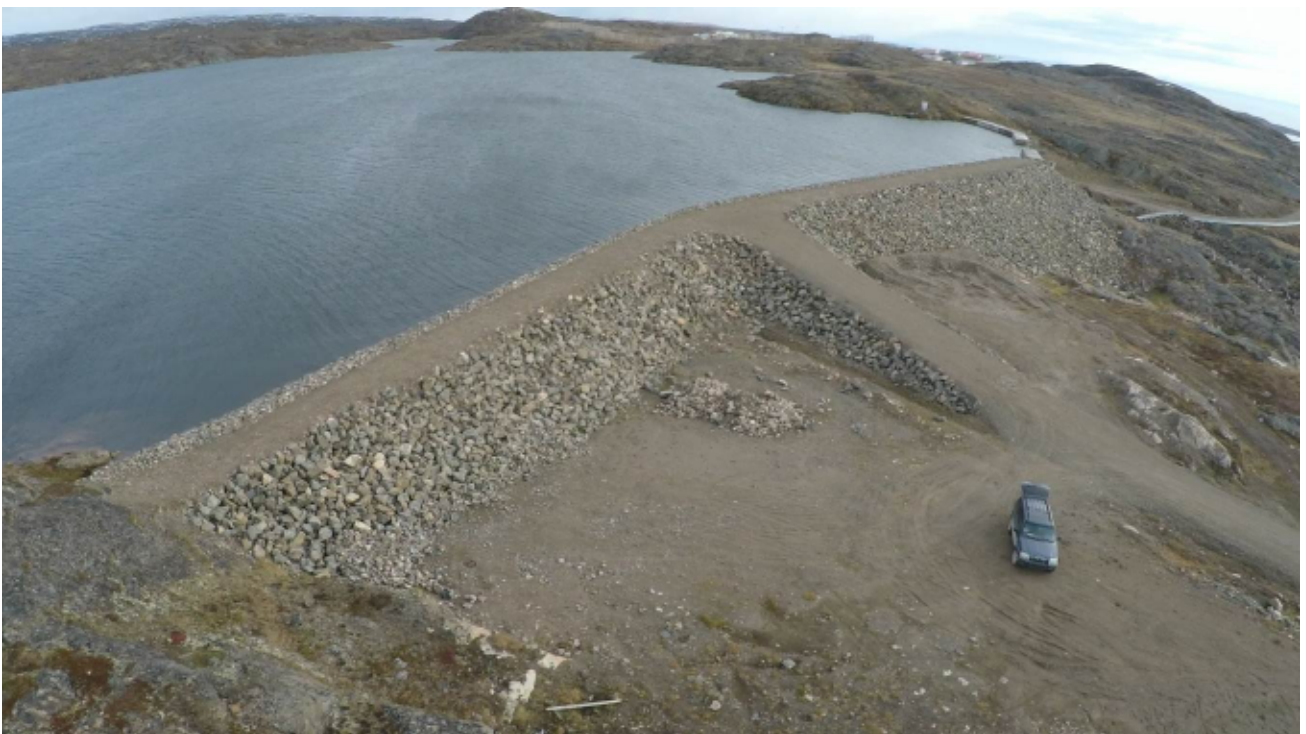
Photo 2: West elevation of the north and center berms.

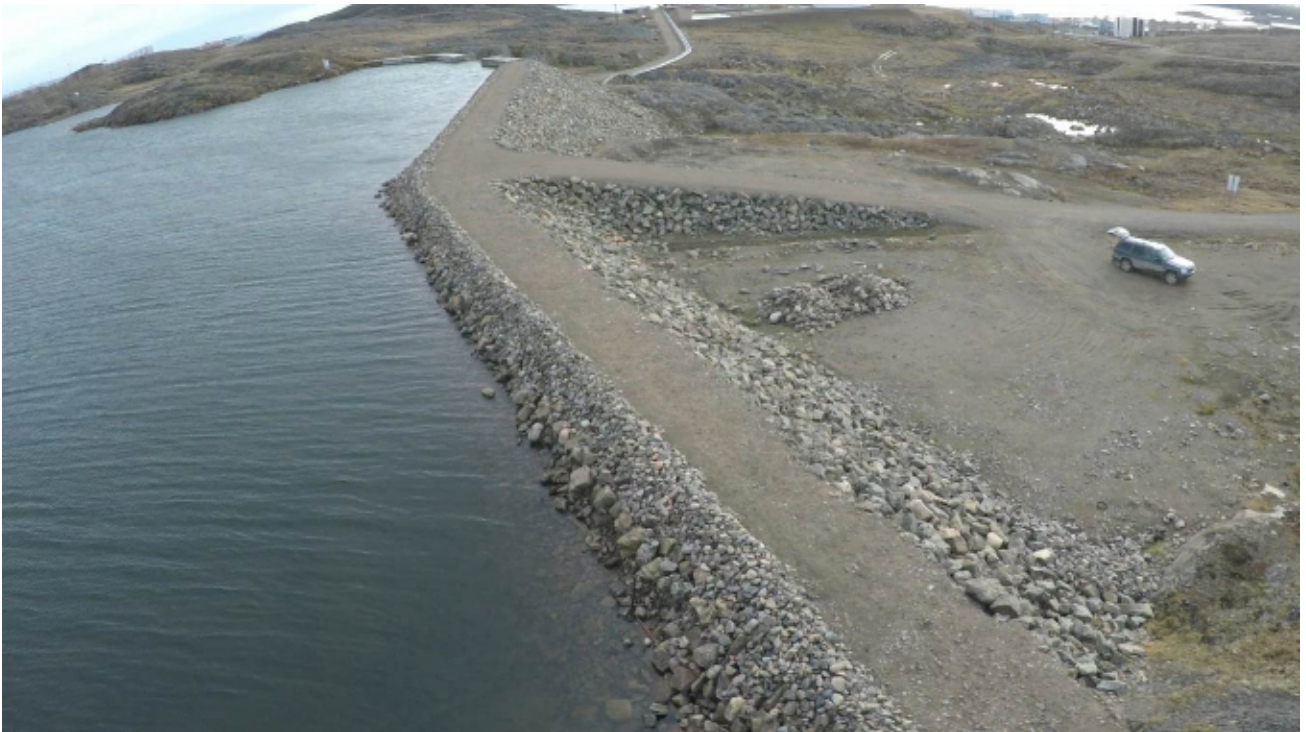
Photo 3: East elevation of the north berm.

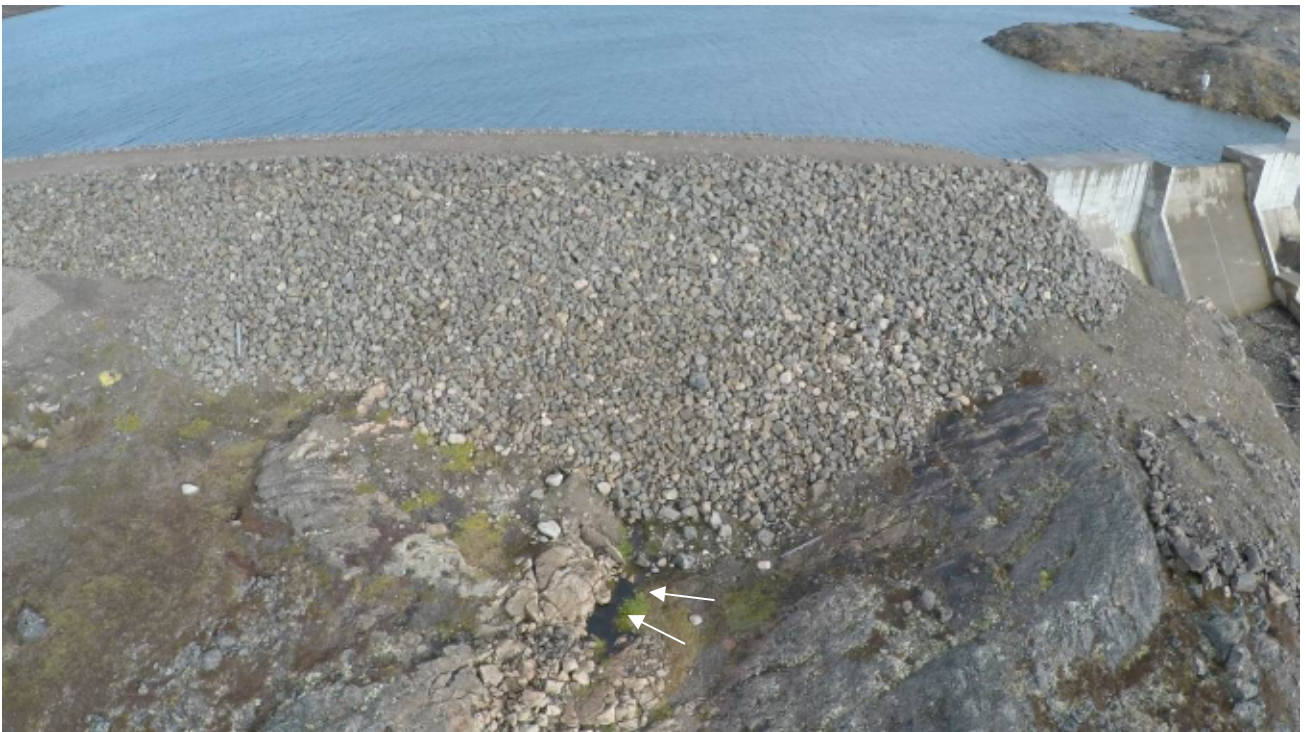
- Areas of active seepage/leakage were observed to be occurring at locations identified in previous DSI's.
- The visible portions of the concrete structures are generally in good condition. There was no evidence of distress or overstressing of any portion of the visible concrete structures.

Photo 4: West elevation of the center berm, note the seepage at the base of the berm.

8. It is recommended that a Seismic Hazard Assessment (SHA) be conducted prior to the next DSR (2018).
9. It is recommended that the monthly berm monitoring program be implemented to monitor the observed active leakage identified in previous DSI's.

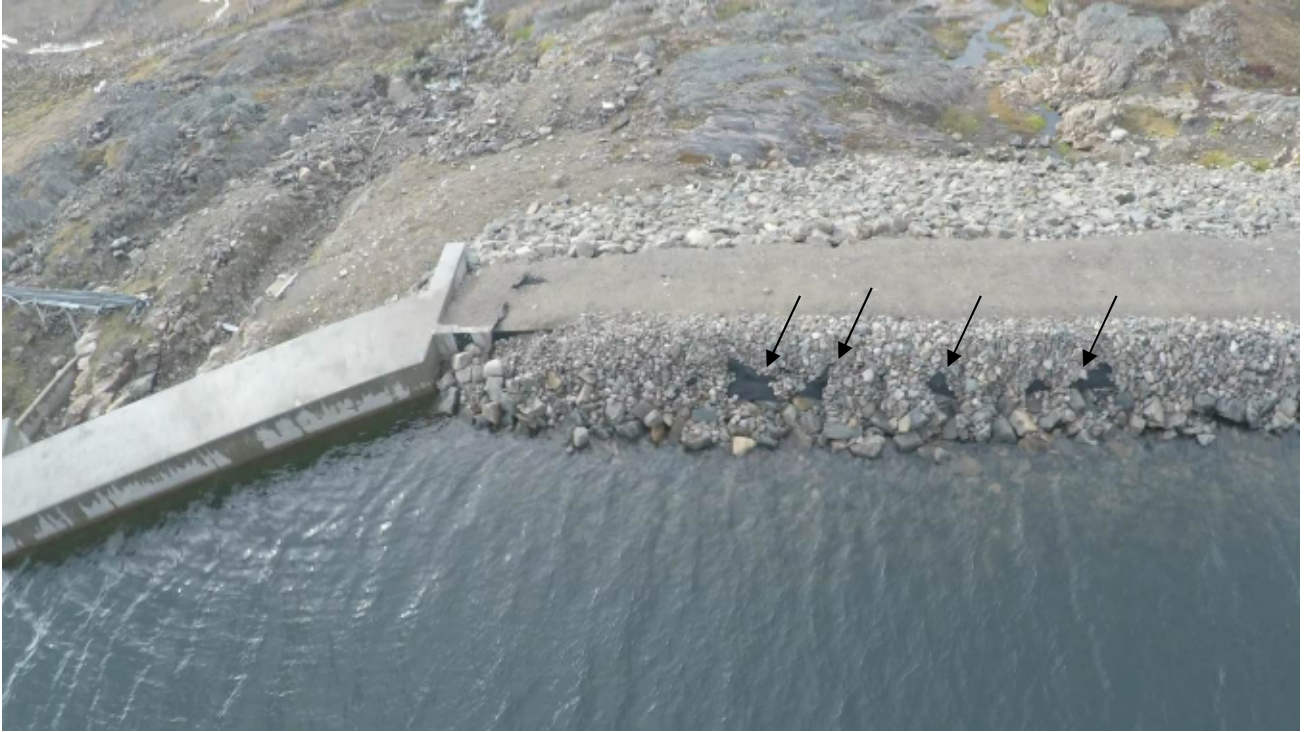
- Minor erosion of the top of the berm was observed at the interface between the north abutment and south-end of the central berm.
- Displacement and erosion of the granular fill and exposure of the geotextile fabric was observed along the east elevation (upstream) at south end of the central berm.

Photo 5: East elevation of the center berm, note the exposed geotextile membrane.

10. Maintenance and repairs to the north access road is recommended.
11. Additional ballast/rip-rap is recommended at the:
 - South end of the central berm.

- East elevation of the central berm. (upstream elevation).
 - Within the downstream drainage channel at the base of the spillway.
12. Exercising and testing of the valves within the valve chamber are recommended prior to the next maintenance cycle.

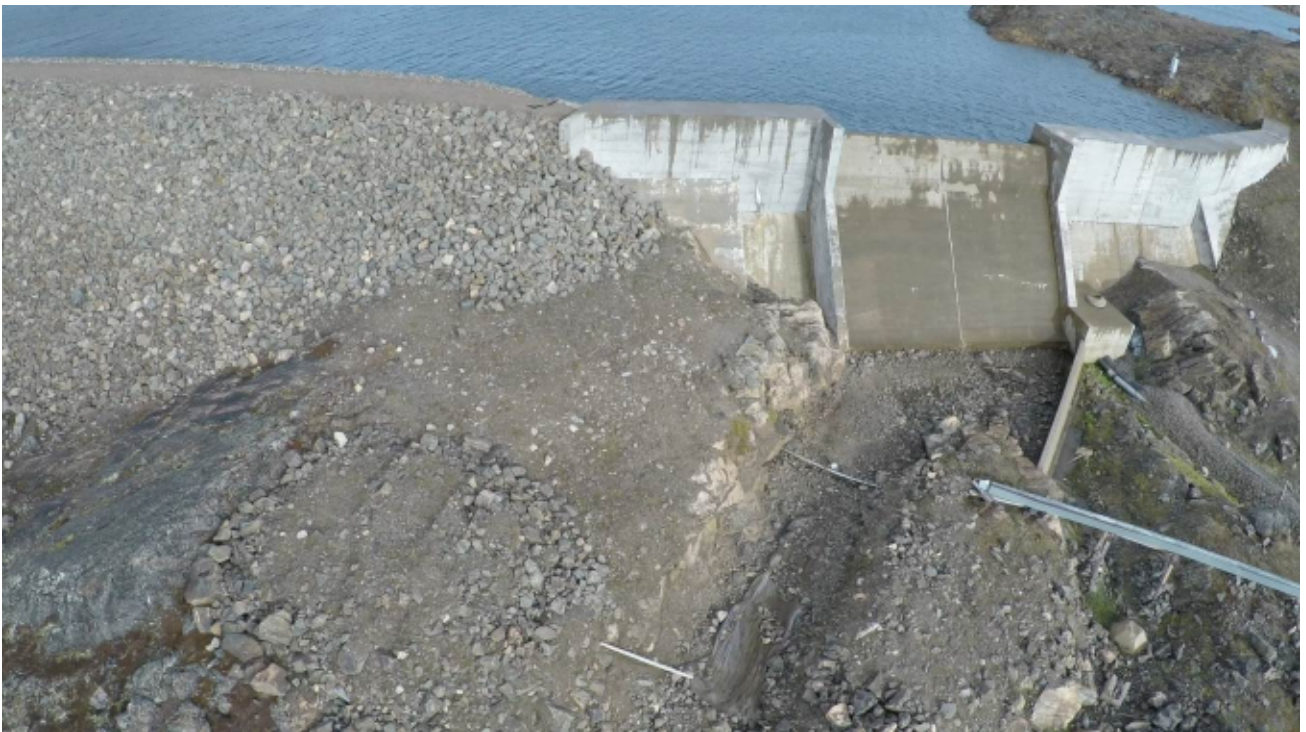
- Displacement of the rock fill and exposure of the geotextile fabric was observed within the downstream drainage channel at the base of the concrete spillway.

Photo 6: West elevation of the center berm and dam, note the exposed geotextile membrane within the spillway channel.
