**SEWAGE LAGOON
DAM SAFETY INSPECTION
IQUALUIT, NUNAVUT
FINAL REPORT**

PRODUCED FOR: THE CITY OF IQUALUIT
PRODUCED BY: CONCENTRIC ASSOCIATES INTERNATIONAL INCORPORATED
CONCENTRIC REFERENCE NUMBER: 15-6279-B
DATE: NOVEMBER 11, 2015

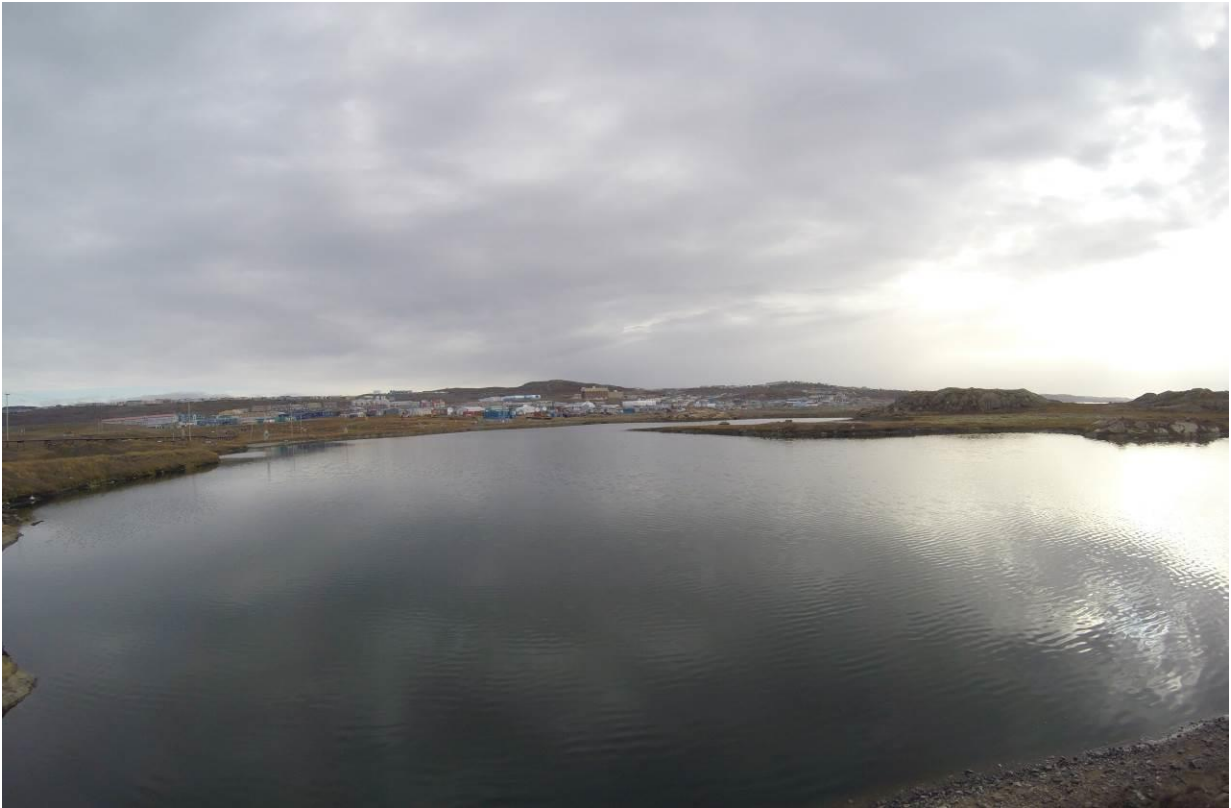
Photo 1: View of the east side of the sewage lagoon.

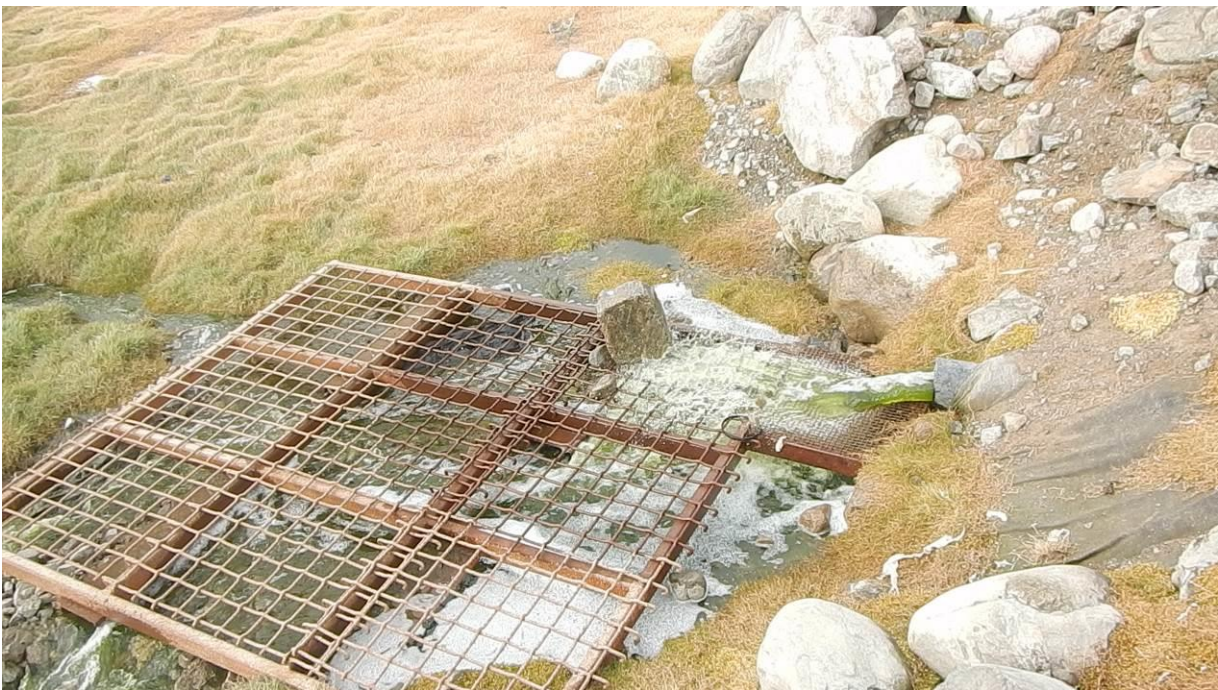
- No recent seepage was reported by the lagoon operator.
- Active decanting/drainage of the lagoon into the Frobisher bay was being completed during our review. Decanting/drainage of the lagoon is undertaken yearly in the spring and fall of the year as part of the lagoon maintenance program.

Photo 2: Active decanting of the sewage lagoon, west berm.

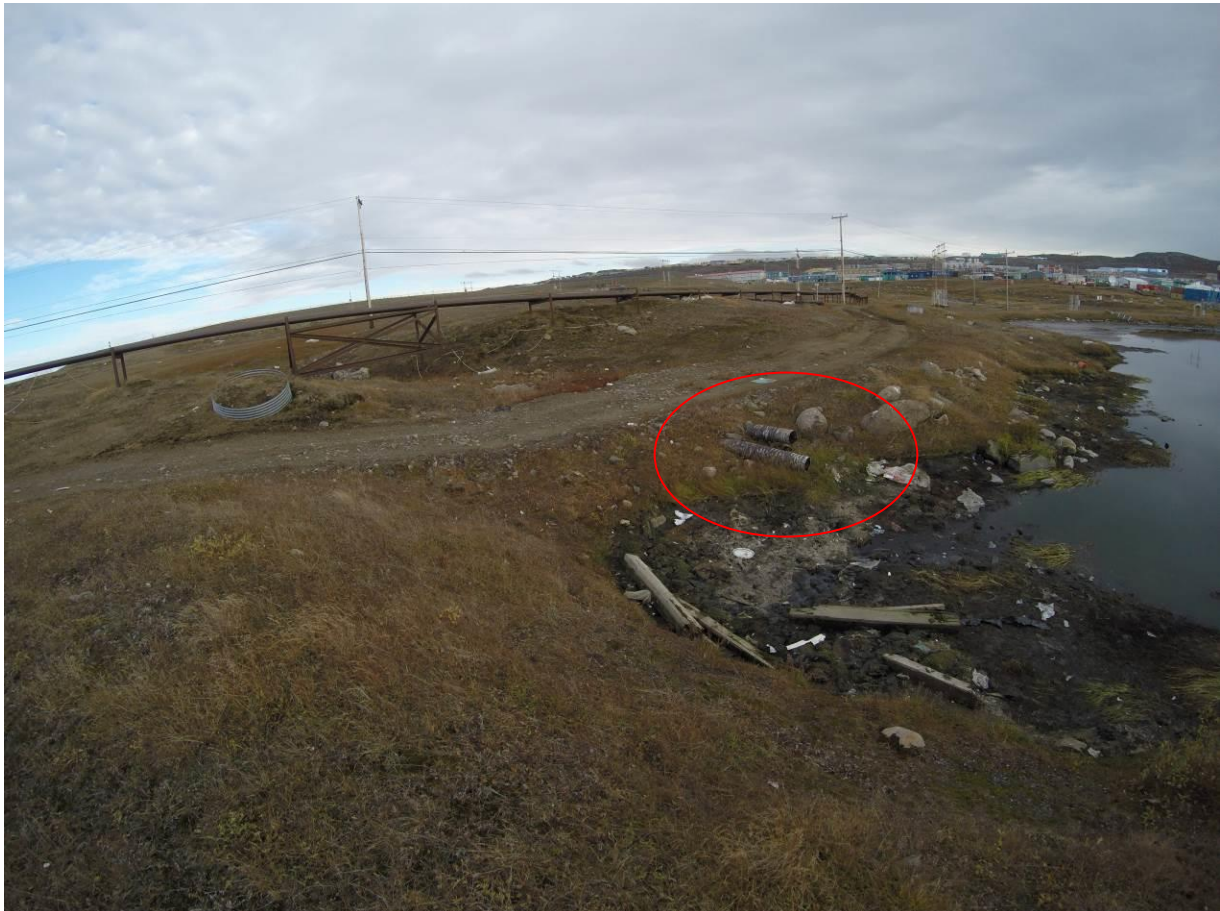
- The Permanent Record File requires updating.
- Three small (10" +/-) galvanized, corrugated steel pipes were observed within the embankment on the north elevation of the lagoon. There was no active drainage through these pipes into the lagoon at the time of our review. A cursory review of the area immediately to the north of the pipe outlets did not reveal the source of these pipes. Discussions with the lagoon operator and City of Nunavut Public Works Department staff did not reveal the intended use for these pipe outlets.

Photo 3: Galvanized steel pipes (3) located on the north side of the sewage lagoon.

4. A Dam Safety Inspection (DSI) is required prior to October 2017.
5. The purpose of the three small (10” +/-) galvanized, corrugated steel pipes observed within the embankment on the north elevation of the lagoon should be confirmed.
6. Garbage removal around the perimeter of the sewage lagoon should be completed in the spring and fall of each year.
7. New signage in all official languages and in compliance with the dam safety guide should be installed around and at entry access points to the sewage plant and lagoon.
8. Areas of (minor) erosion should be repaired in the spring of 2016.
