**Re: Crown-Indigenous Relations and Northern Affairs Canada (CIRNAC) Reply to
City of Iqaluit Responses to CIRNAC Review Comments on City of Iqaluit
2018 Annual Report for Water Licence No. 3AM-IQA1626**

Replies to Responses to Review Comments

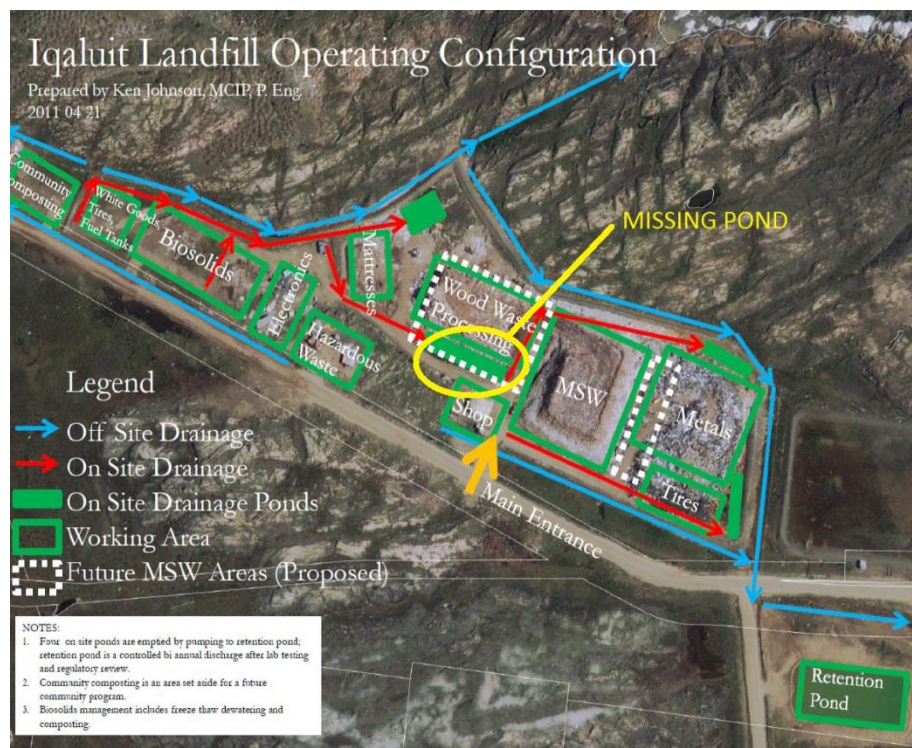
CIRNAC Fields Operations noticed that an on-site drainage pond identified in *Appendix E - 2006 Drainage Improvements* within the West 40 Operation and Maintenance

Manual was not visible. A site plan from the Operation and Maintenance Manual is attached for reference as Figure 1 in Section C. The City has replied that no changes were made to this pond. CIRNAC considers item e) unresolved and seeks further information to explain this discrepancy.

Figure 1: Site Map from City of Iqaluit Operation and Maintenance Manual for the West 40 Landfill with an added arrow in yellow indicating the pond that was not visible during the June 4, 2018 inspection

- provide a report outlining what work recommended in the 2015 DSI has been completed;
- provide justification for the discrepancy between the site map in the Operation and Maintenance Manual for the West 40 Landfill and the observations made by the CIRNAC Field Operations Inspector during the June 4, 2018 Inspection;
- continue to seek resolution with CIRNAC Field Operations Inspectors outside of the 2018 Annual Report Review to confirm the agency with responsibility for the deposit of waste at the end of Federal Road; and
- follow up with the Nunavut Water Board regarding the submission of required documents.
