# DEVELOPMENT OF A MASTER DRAINAGE PLAN – FINAL SUBMISSION

City of Iqaluit

Nunami Stantec Ltd.  
1088C Noble House, PO Box 1779,  
Iqaluit NU X0A 0H0

144902610  
May 3, 2019

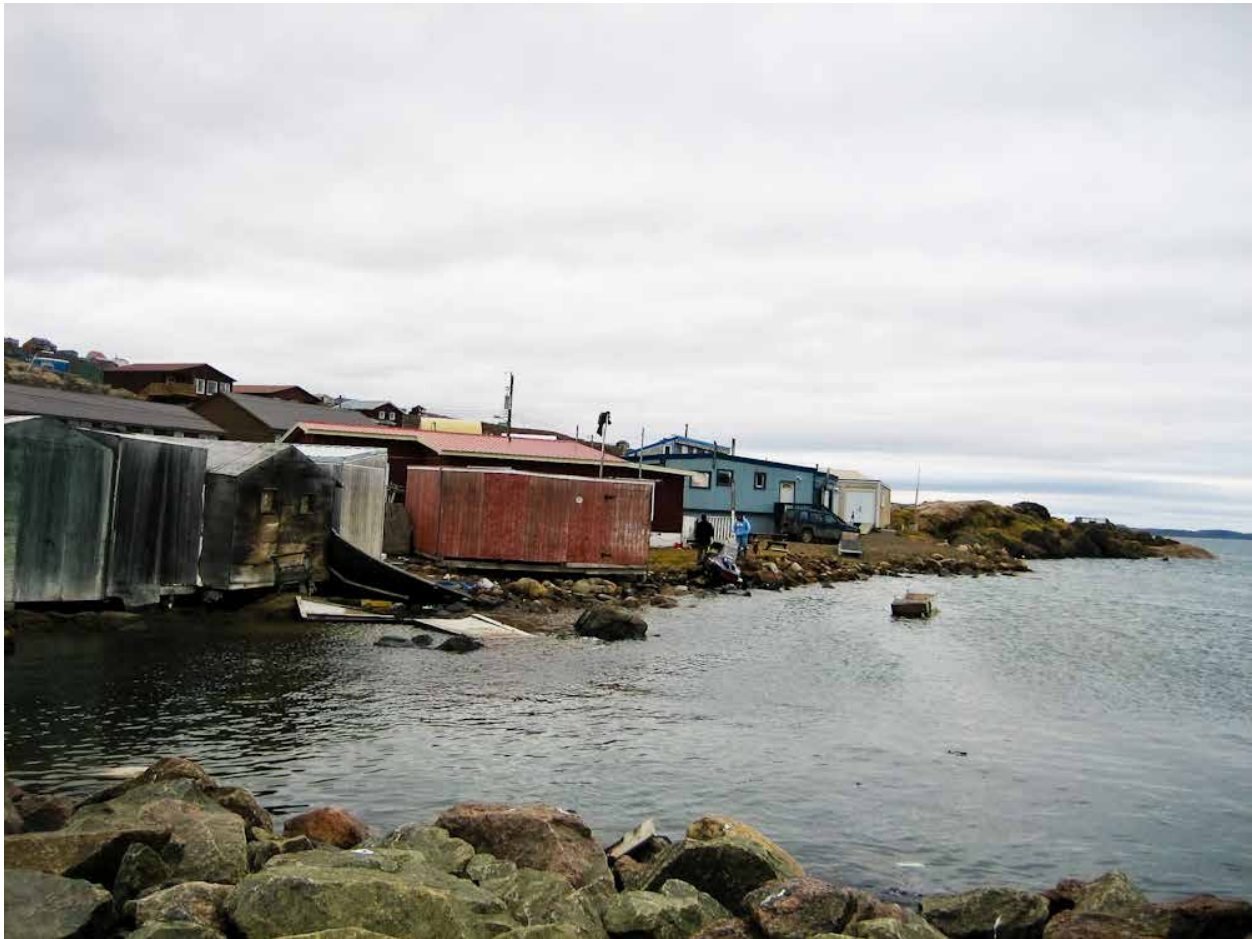
**Figure 3-8: Flooding that occurred in October 2003. Photo courtesy of Rick Armstrong. The winds were light and offshore (northwest). The high-water level was not associated with a storm, so was likely the result of an anomalously high tide. This photo was taken roughly 50 m from the base of the main breakwater, facing east.**

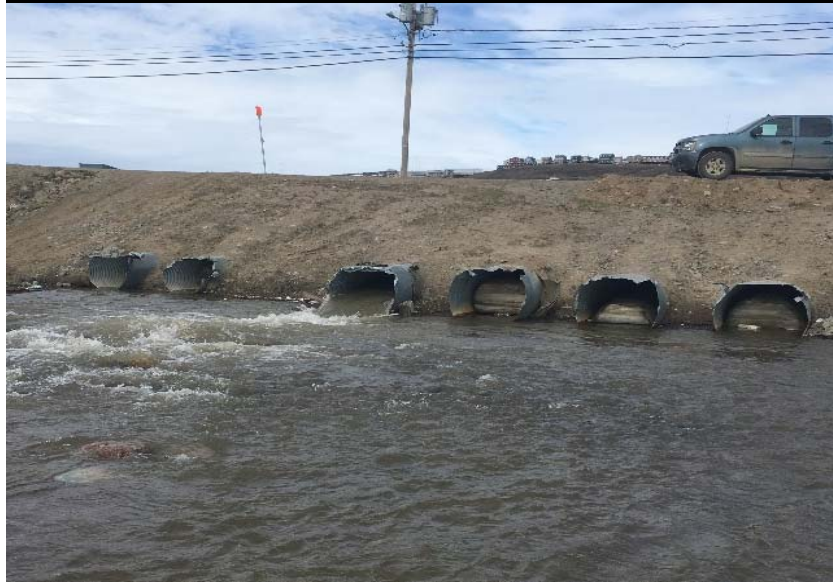
South of Crossing 3 (4 x 1200 mm dia. and 2 x 1000 mm dia.) - Damaged Ends

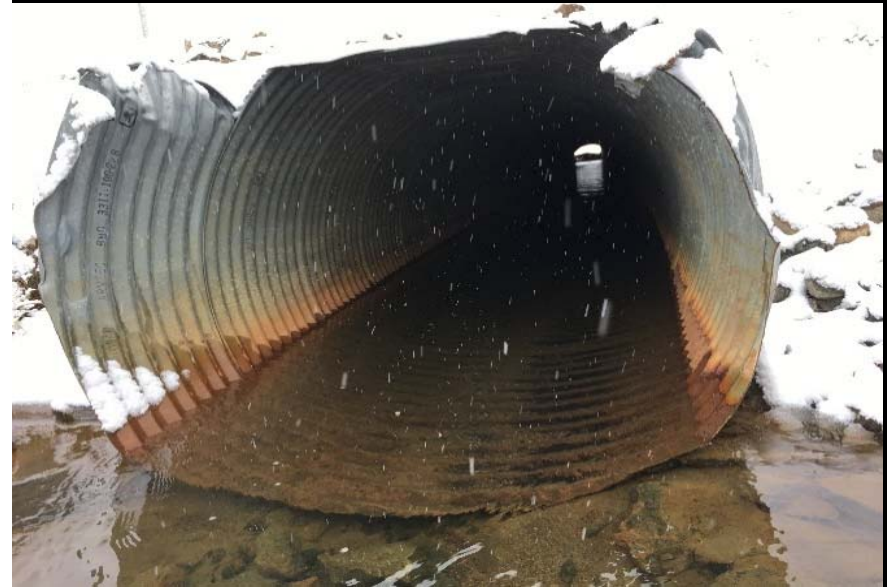
North of Crossing 3 - damaged ends

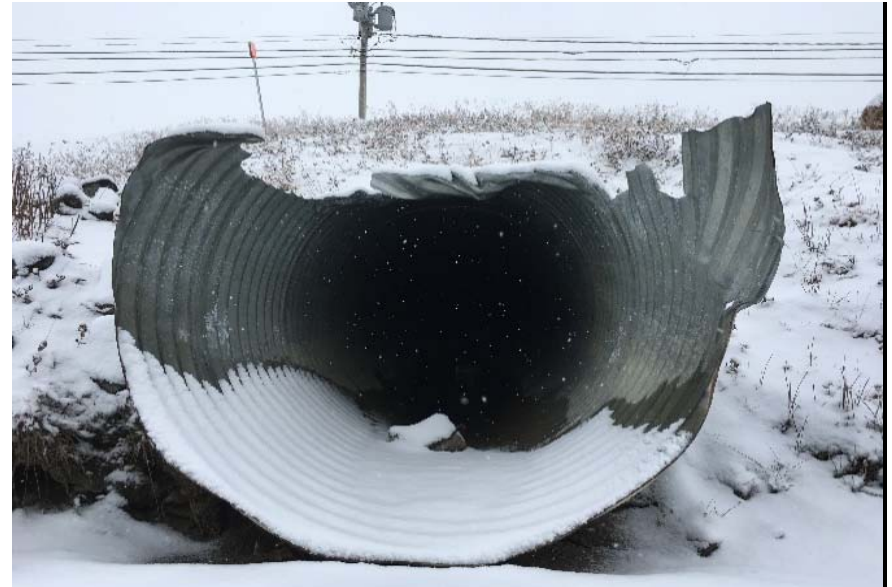
North of Crossing 3 - Broken End

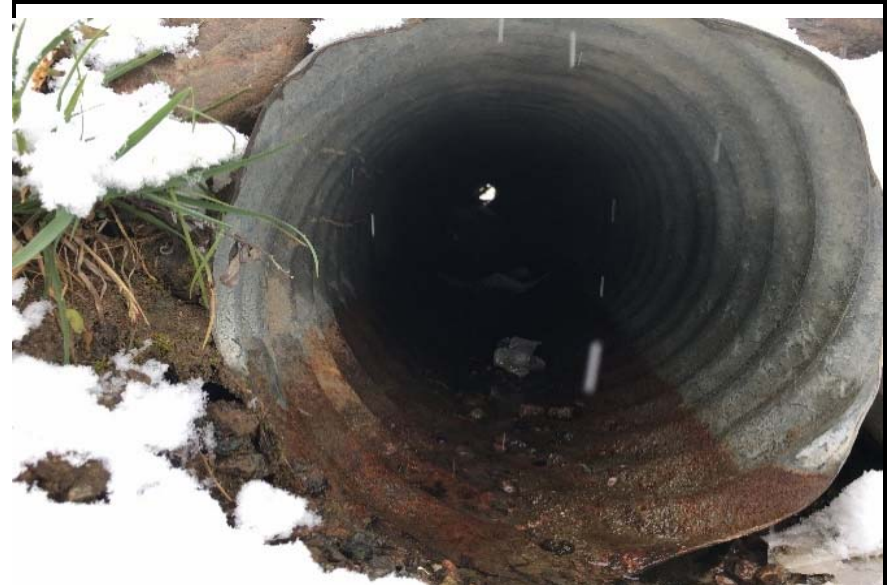
North of Crossing 5 (300 mm dia. ) looking  
Upstream - Corroded pipe exposed after the  
removal of garbage

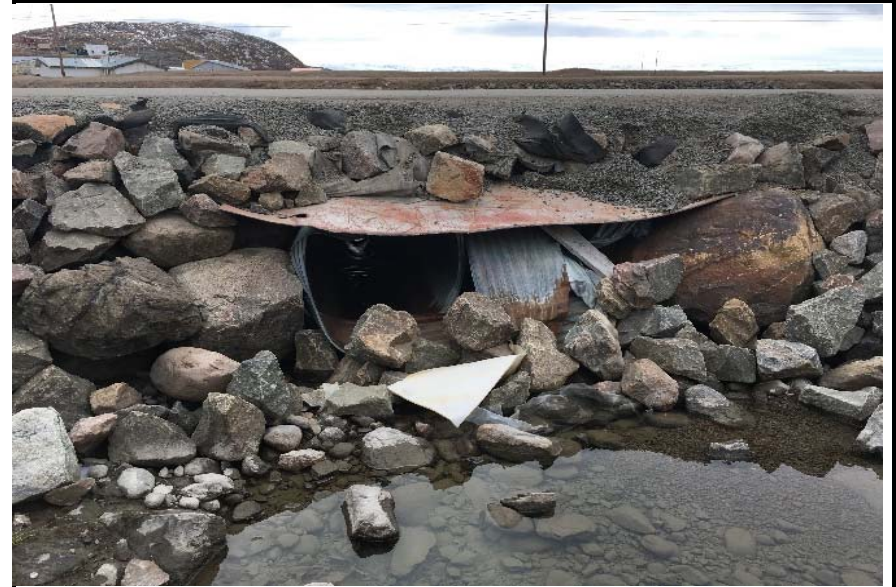
Cluster 1 of 4 Culverts (4 x 9400 mm dia.) on north  
side of road - Garbage and broken pieces in front of  
pipe

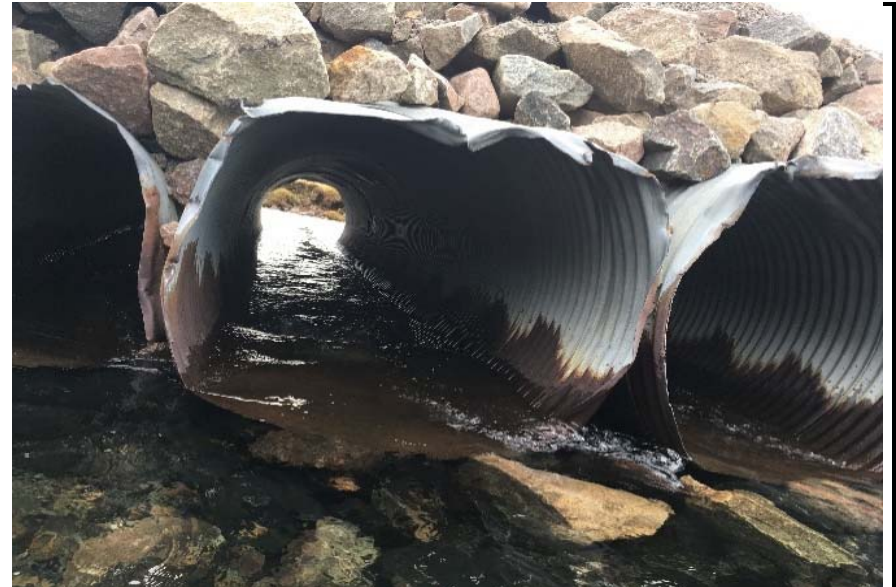
Cluster 2 (3 x 1100 mm dia.) taken from South side of road - Damaged Ends

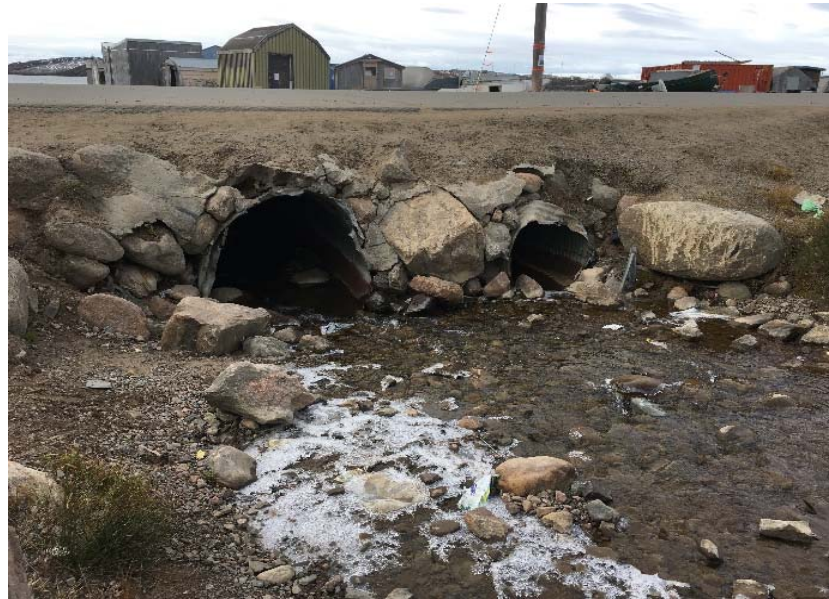
Upstream of Crossing 1 ( 2 x 700 mm dia.) -  
Damaged Ends

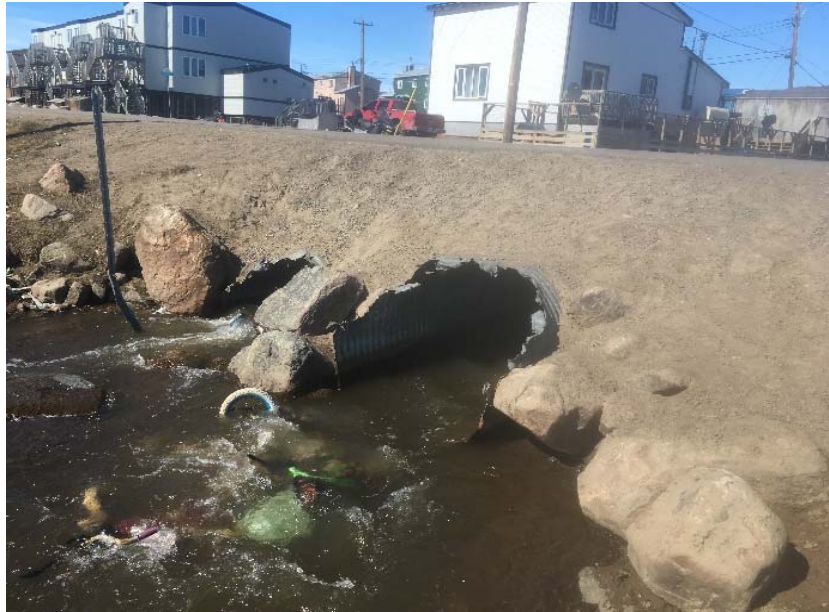
South of Crossing 1 ( 2 x 700 mm dia.) - Bike and Garbage in the stream

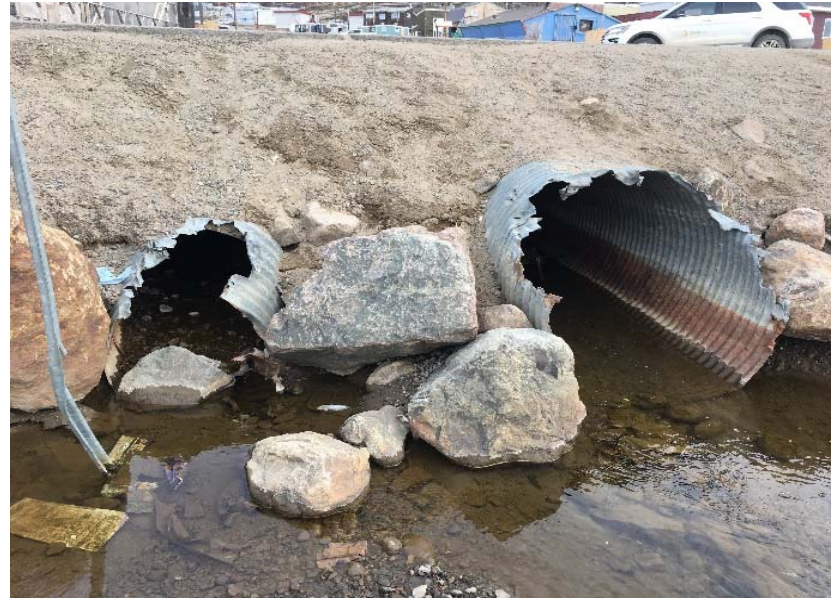
Downstream of Crossing 1 ( 2 x 700 mm dia.) - Damaged and broken pieces

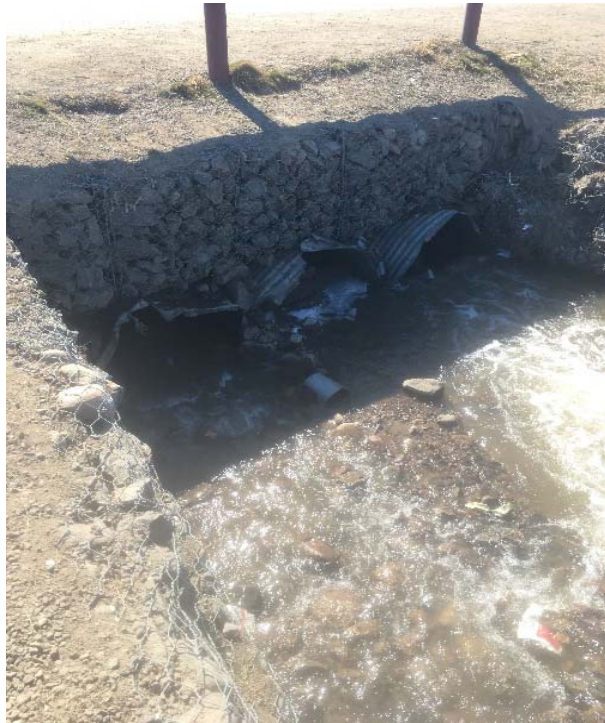
North of  
Crossing 2 (3  
x 1200 mm  
dia.) -  
Garbage

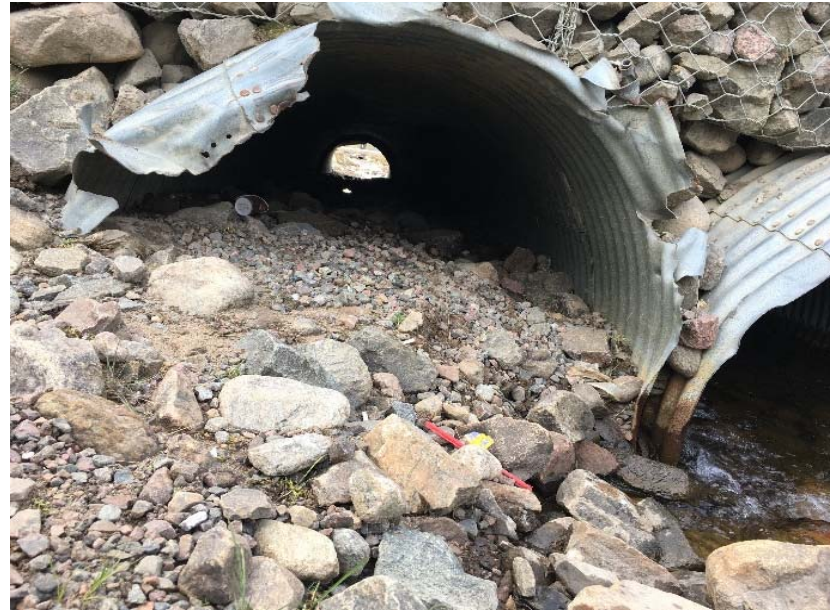
Upstream of Crossing 2 (3 x 1200 mm dia.) - Broken End

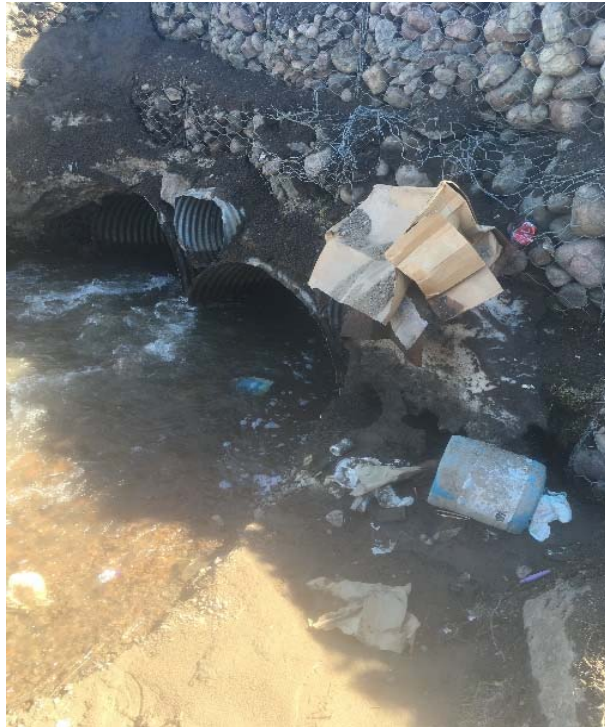
North of  
Crossing 3 (3  
x 1500 mm  
dia. and 2 x  
620 mm dia.)  
- Garbage  
right beside  
the pipe

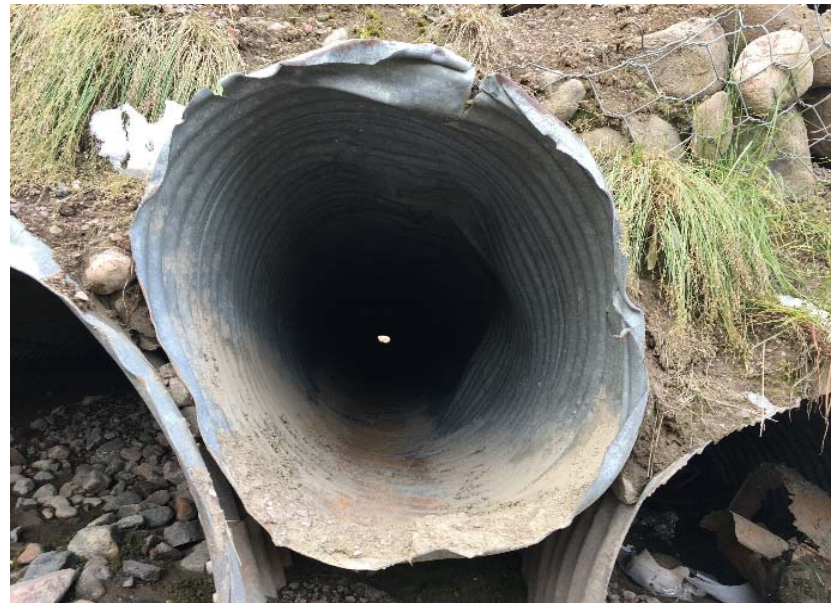
Upstream of Crossing 3 (2 x 1500 mm dia. and 1 x  
620 mm dia.) - Deflected Pipe with damaged ends

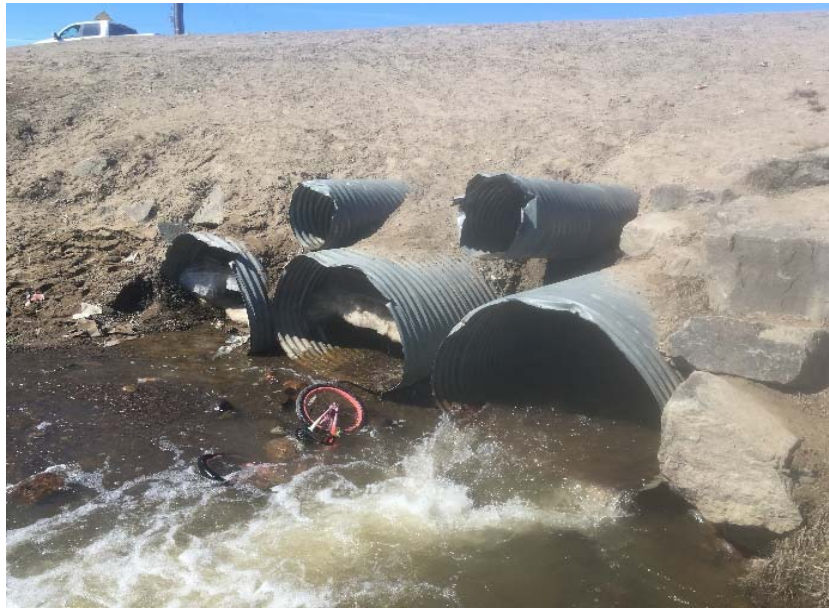
South of Crossing 3 (3 x 1500 mm dia. and 2 x 620 mm dia.) - Bike in the stream

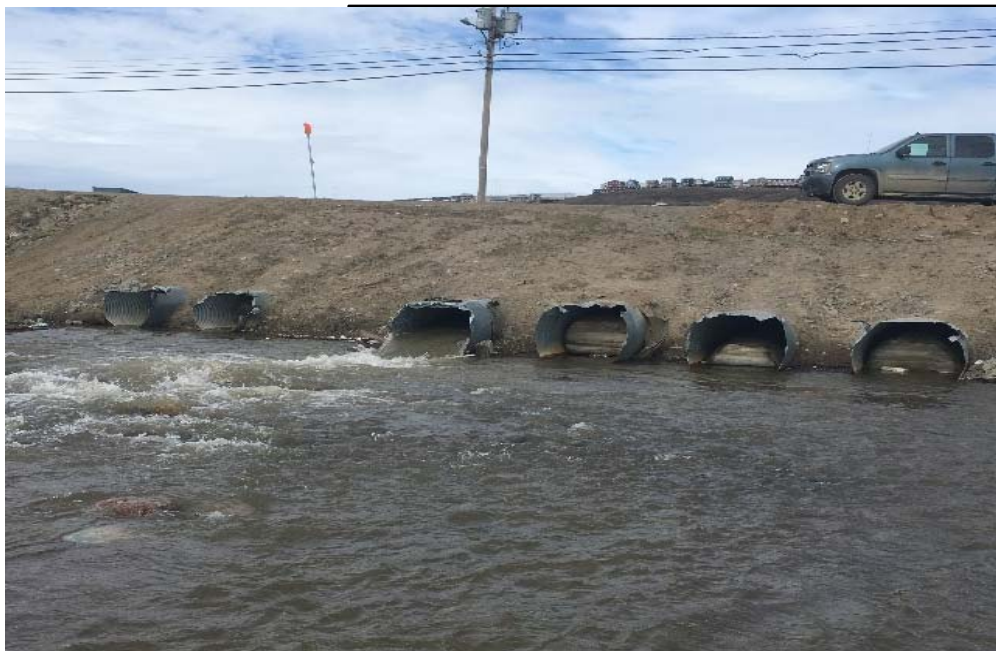
South of Crossing 3 (4 x 1200 mm dia. and 2 x 1000 mm dia.) - Damaged Ends

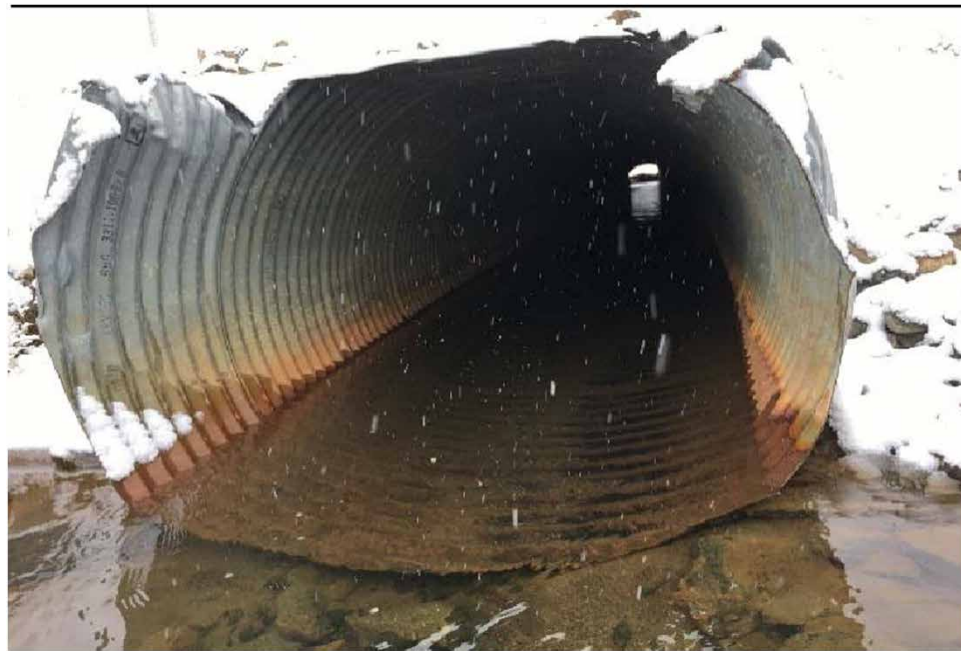
North of Crossing 3 - damaged ends

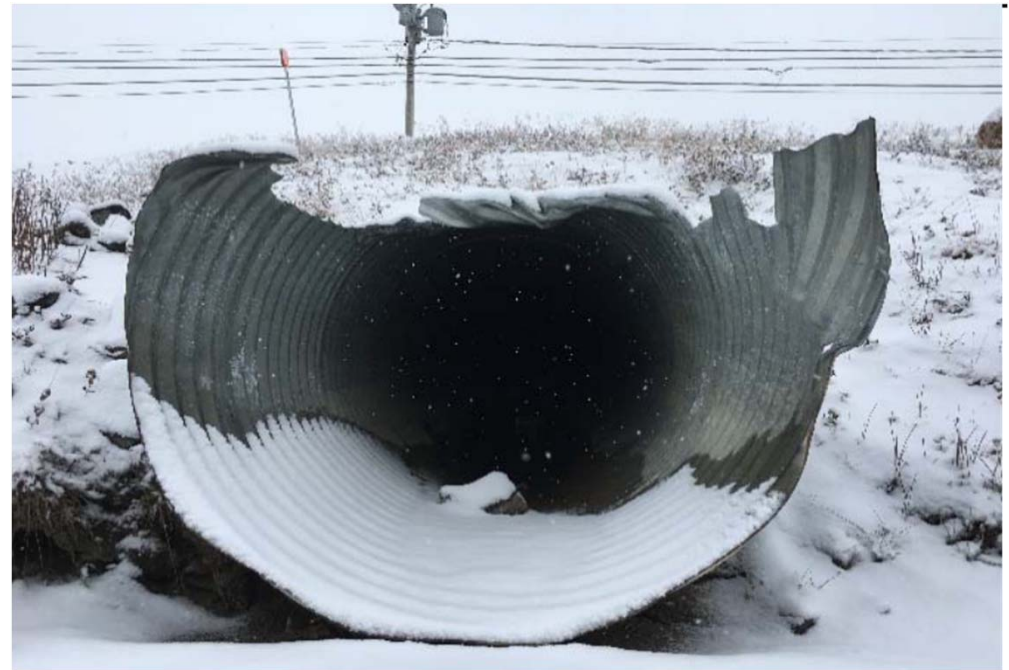
North of Crossing 3 - Broken End

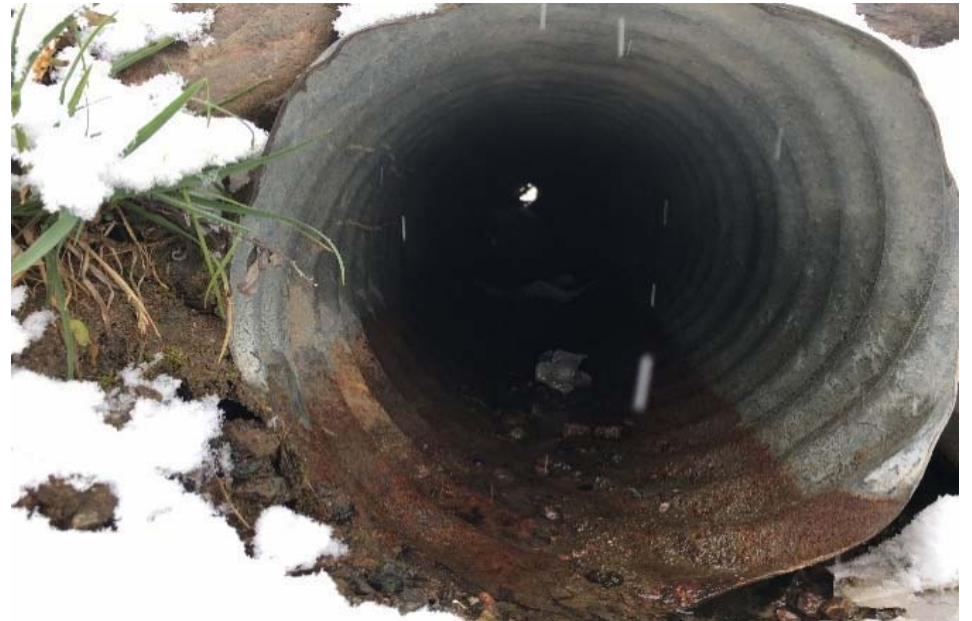
North of Crossing 5 (300 mm dia. ) looking Upstream -Corroded  
pipe exposed after the removal of garbage

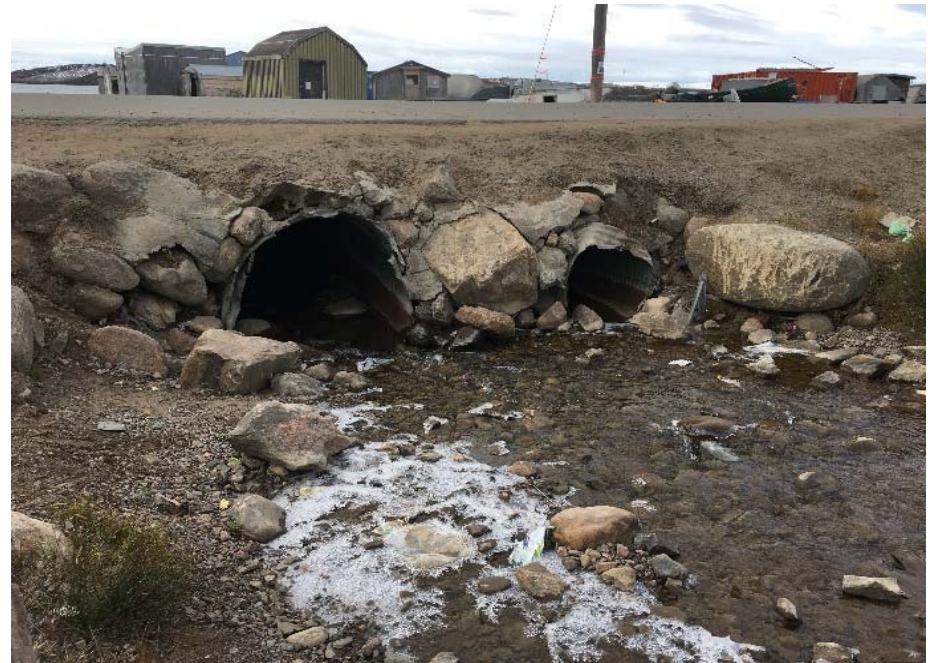
Upstream of Crossing 1 (2 x 700 mm dia.) -  
Damaged Ends

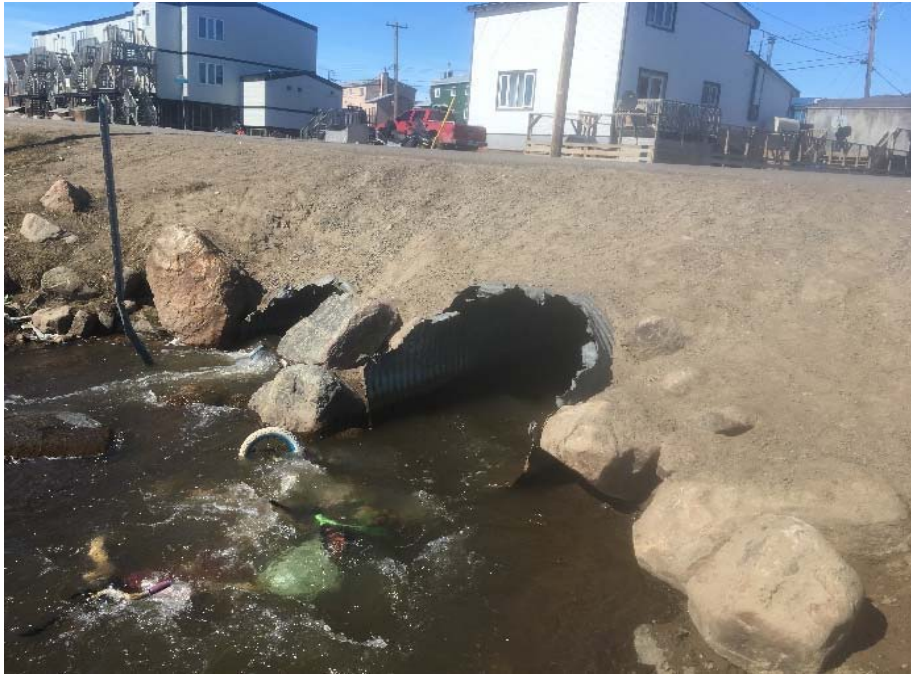
South of Crossing 1 ( 2 x 700 mm dia.) - Bike and Garbage in the stream

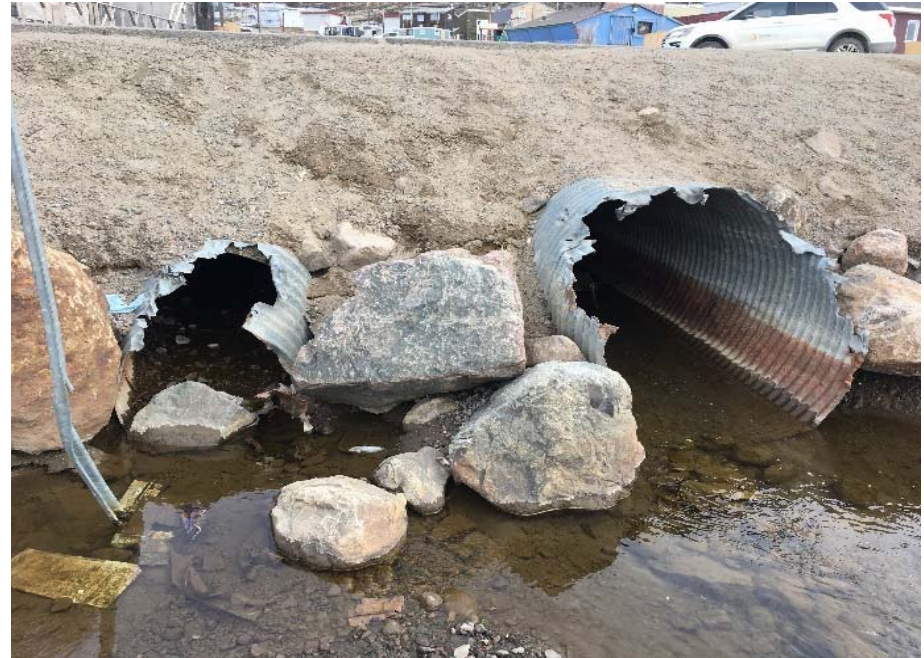
Downstream of Crossing 1 ( 2 x 700 mm dia.) -  
Damaged and broken pieces

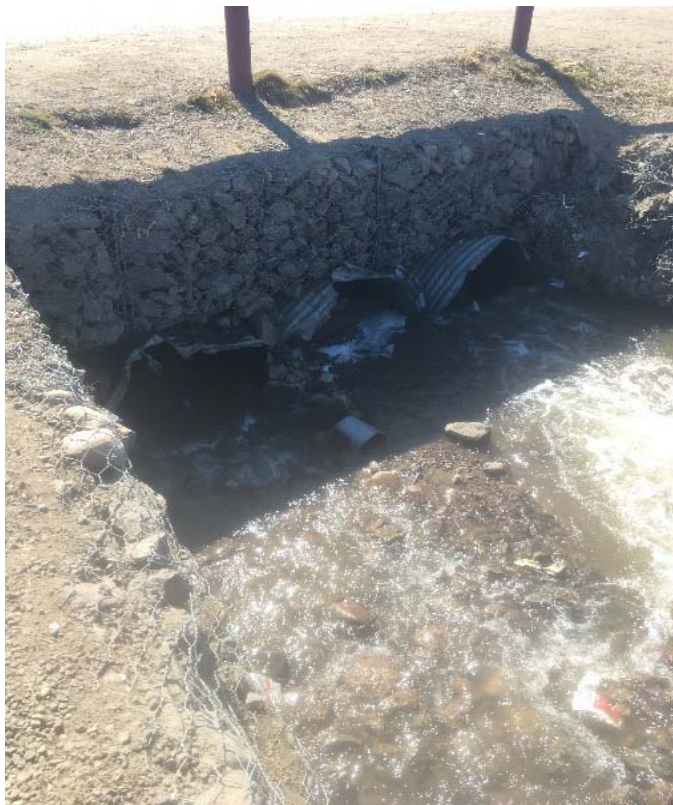
North of Crossing 2  
(3  
x 1200 mm dia.) -  
Garbage

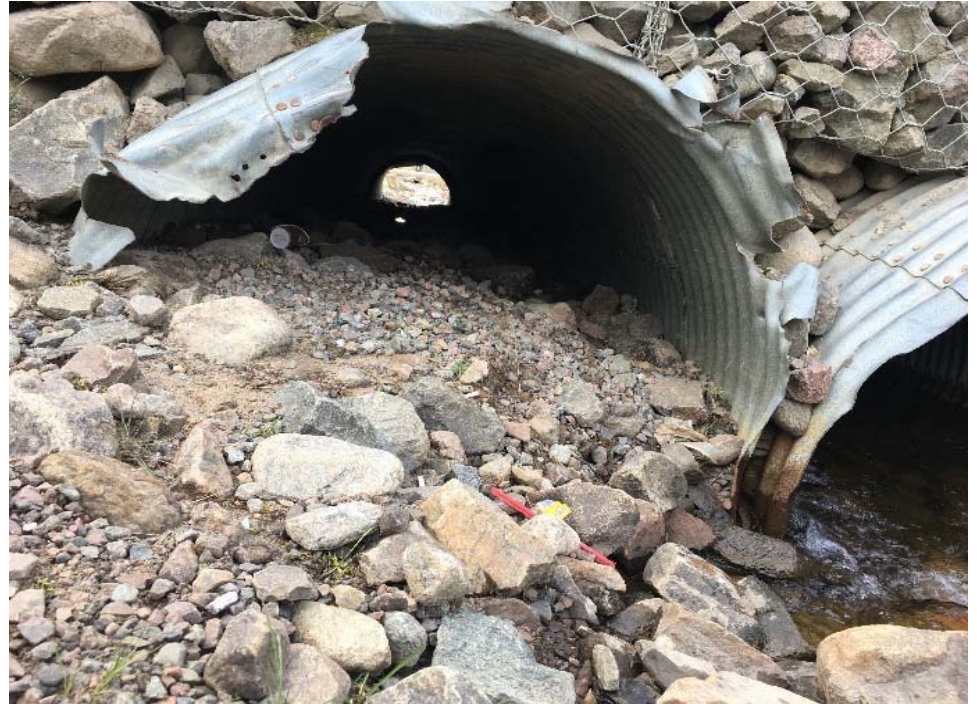
Upstream of Crossing 2 (3 x 1200 mm dia.) - Broken End

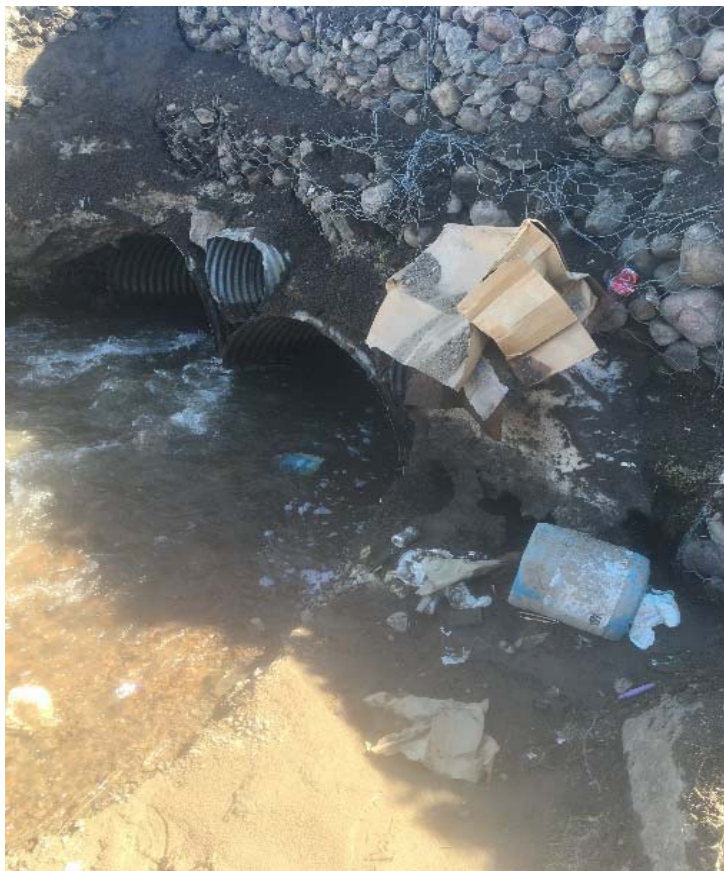
North of  
Crossing 3 (3  
x 1500 mm  
dia. and 2 x  
620 mm dia.)  
-Garbage  
right beside  
the pipe

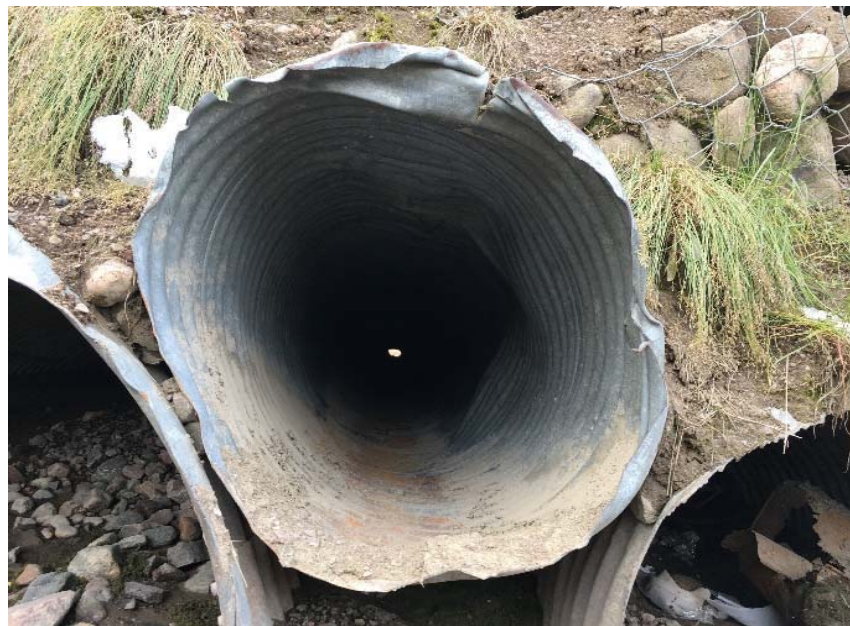
Upstream of Crossing 3 (2 x 1500 mm dia. and 1 x  
620 mm dia.) -Deflected Pipe with damaged ends

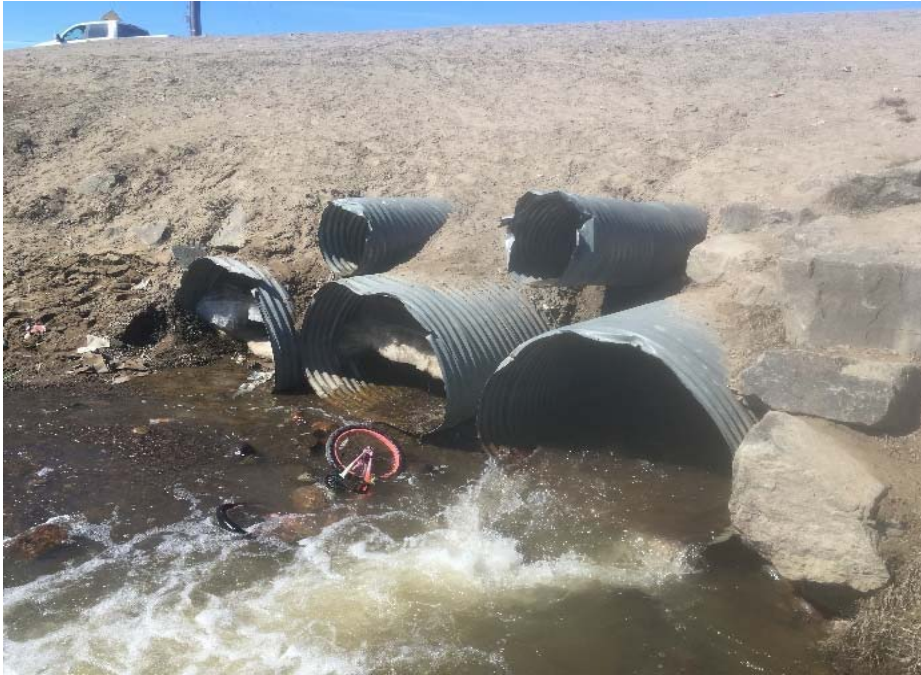
South of Crossing 3 (3 x 1500 mm dia. and 2 x 620 mm dia.) -Bike in the stream

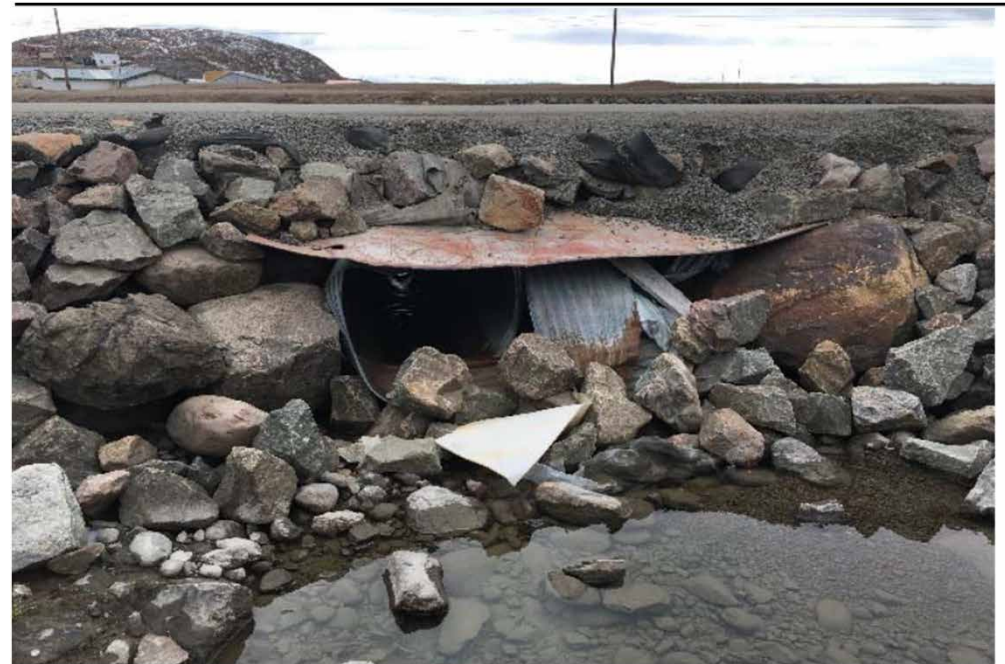
Cluster 1 of 4 Culverts (4 x 9400 mm dia.) on north  
side of road - Garbage and broken pieces in front of  
pipe

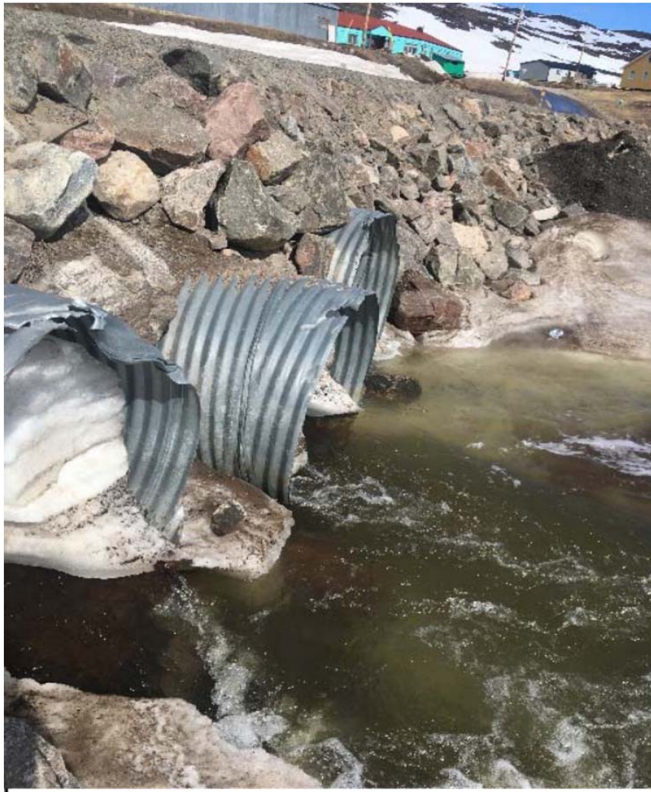
Cluster 2 of 3  
Culverts (3 x  
1100 mm  
dia.) on south  
side of road -  
Blocked due  
to snow

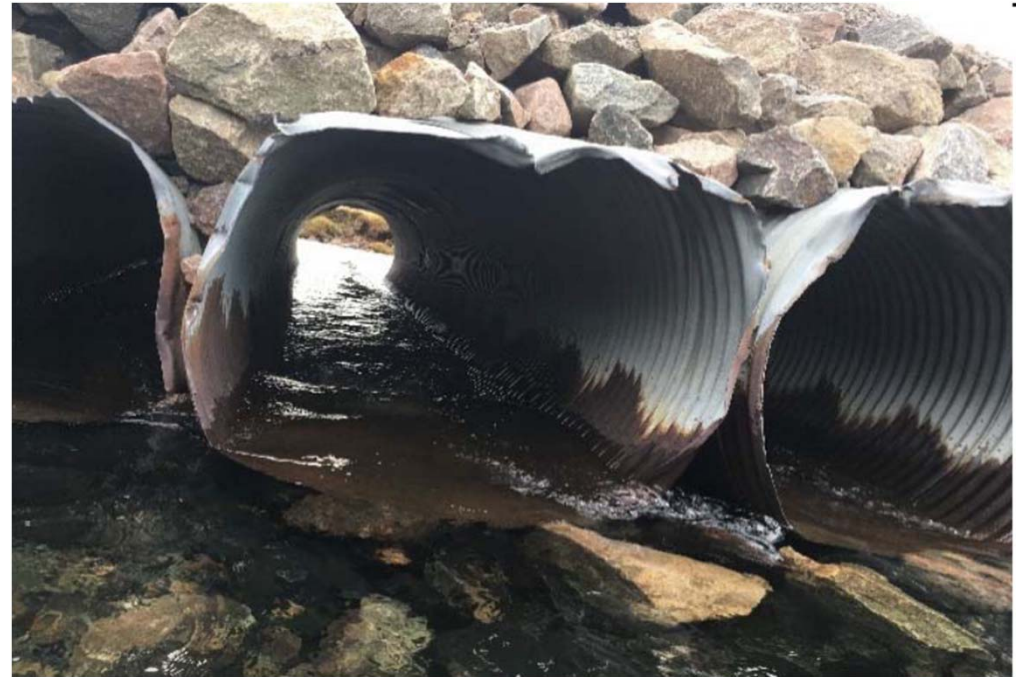
Cluster 2 (3 x 1100 mm dia.) taken from South side of road - Damaged Ends

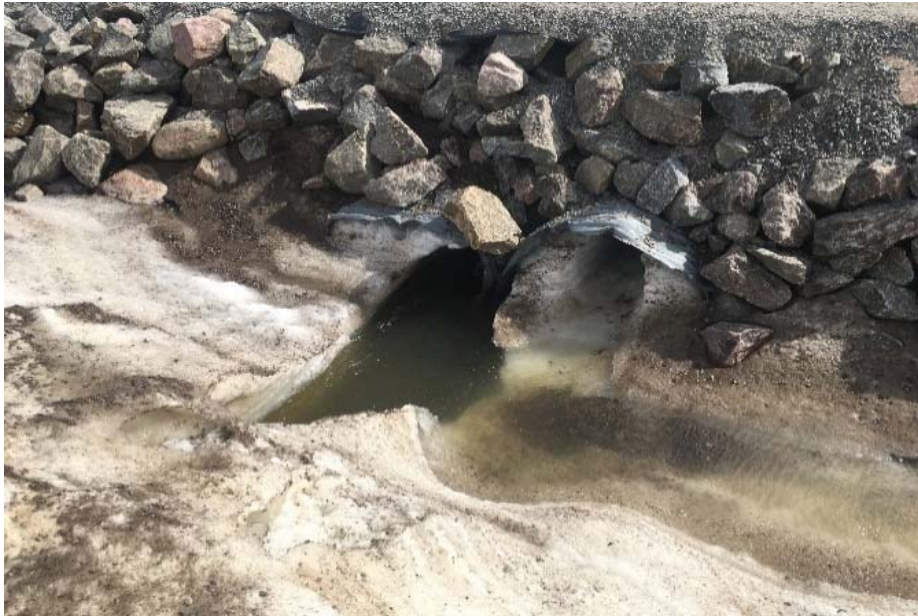
Cluster 1 (4 x 9400 mm dia.) taken from north side of road - Blocked due to snow
