CITY OF IQALUIT WATER LICENCE 3AM-IQA1626 2021 ANNUAL WATER LICENCE REPORT

JUNE 24, 2022

LAKE GERALDINE DAM
DAM SAFETY INSPECTION 2021 #1
IQALUIT, NUNAVUT

LAKE GERALDINE DAM
2021 DAM SAFETY REVIEW
IQALUIT, NUNAVUT

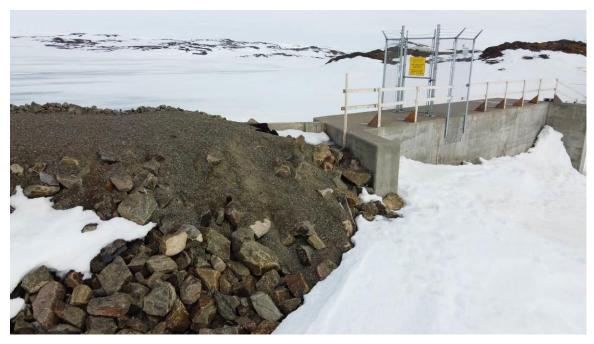
- The aggregate stock piles located near the north berm have been exhausted and only a minimal amount of aggregate material remains.
- Moderate erosion of the stone and gravel was noted at the interface between the north end of the concrete structures and the south end of the center berm (see photograph 5).

Photograph 4 – Moderate erosion of the earthen berm at the north end of the concrete dam – south end of the center berm.

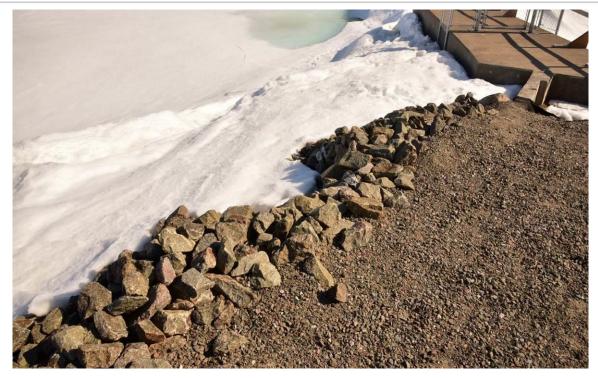
Photograph 7 – Area where the rip-rap on the upstream face of the dam has been eroded by wave action. South end of the center berm.

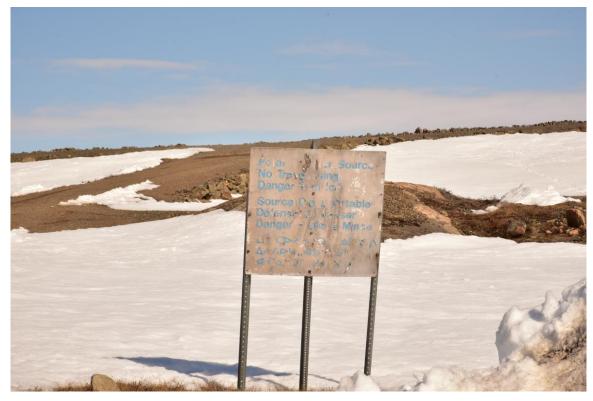
- The warning signs at the base of the access ramp to the north/center berm is missing and the remaining signage is faded (see photograph 8).
- Temperature sensor strings (thermistors) have been installed and abandoned at various locations on all berms (see photograph 9).

Photograph 8 – Typical signage condition.

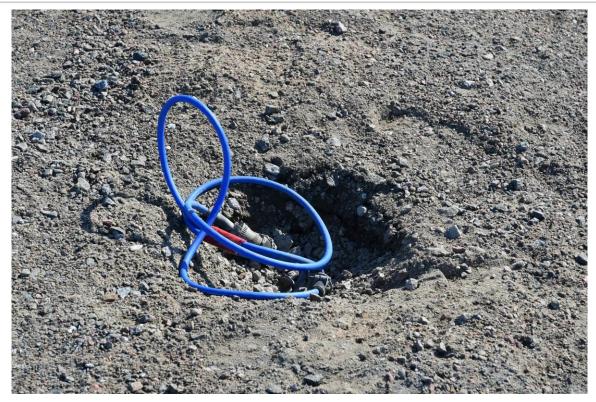
Photograph 9 – Typical temperature sensor string installation (center berm).

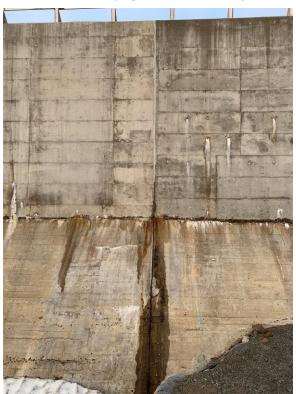
Photograph 4 – Water leakage at J4 joint, and horizontal joint, south of spillway.

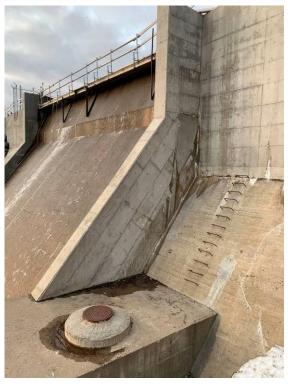
Photograph 5 – Water leakage at J3 corner, south of spillway.

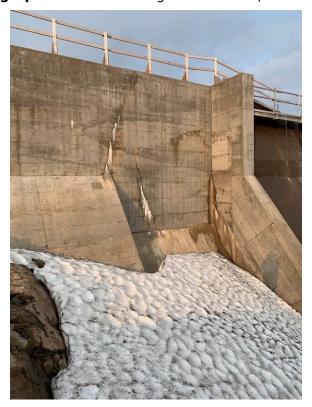
Photograph 6 – Water leakage between J0 and J1, north of spillway.

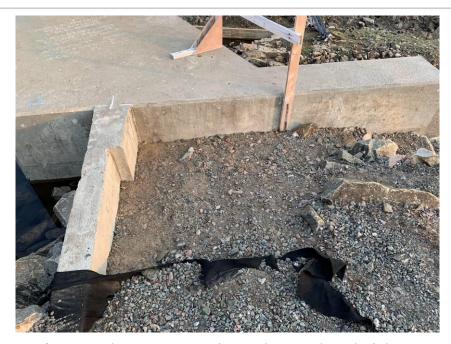
Photograph 7 – Moderate erosion of granular, south end of the center berm (adjacent to J0)

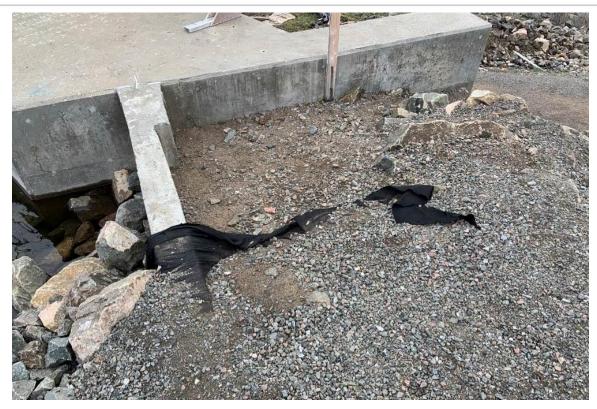
Photograph 3 – Moderate erosion of the earthen berm at the north end of the concrete dam – south end of the center berm.

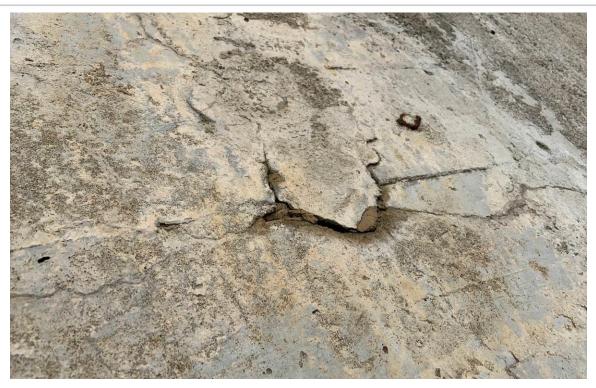
Photograph 5 – Area of minor concrete spalling. North end, downstream face of the concrete dam.

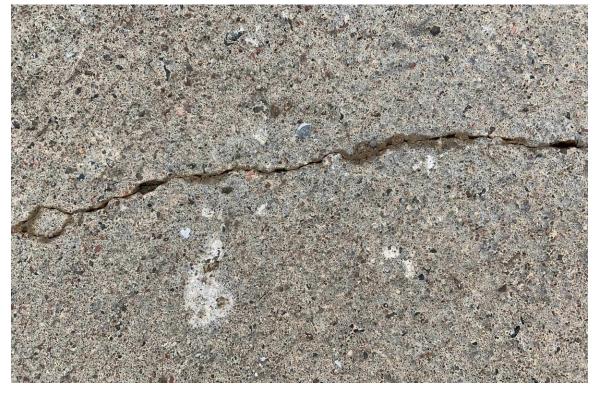
Photograph 6 – Hairline crack in the top face of the concrete dam at the north end.

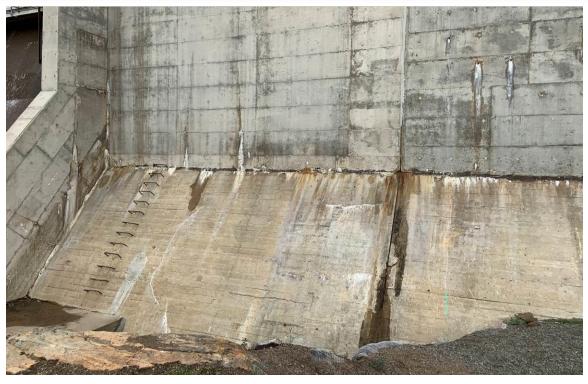
Photograph 7 – Typical seepage, downstream face of the concrete dam at the south end.

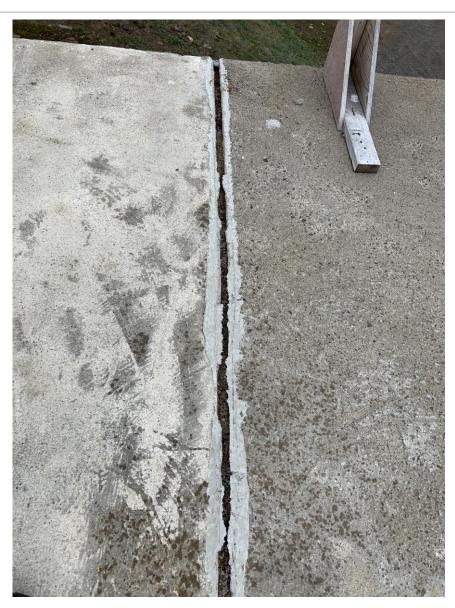
Photograph 9 – Deteriorated sealant joint on the top surface of the dam along an expansion joint in the south half of dam.

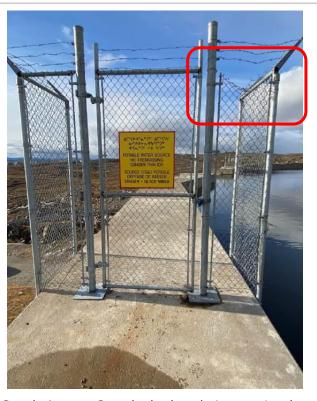
Photograph 5 – South Access Gate locked and signage in place, damaged fence wire.

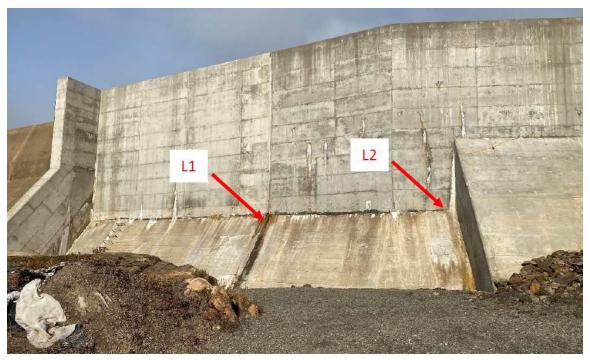
Photograph 6 – Two area of minor seepage. Downstream (west) face of the concrete dam.

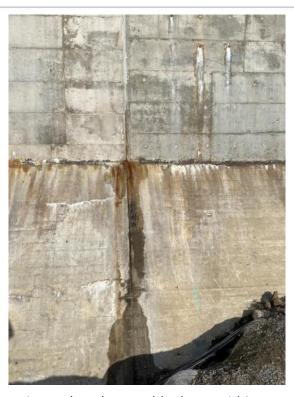
Photograph 7 – Deteriorated sealant and leakage within concrete dam structure, leakage location L1.

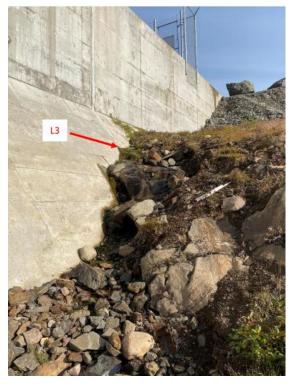
Photograph 8 – Partial elevation at south end of concrete structure, leakage location at arrow.

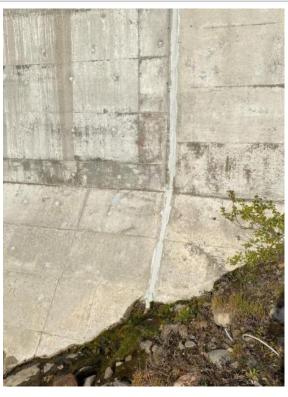
Photograph 9 – Partial elevation at south end of concrete structure, leakage location at arrow.

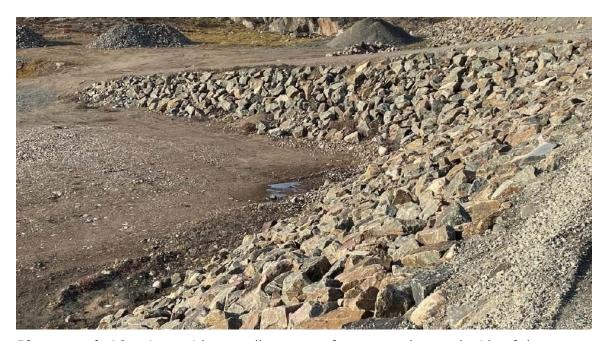
Photograph 10 – Area with a small amount of water on the south side of the access ramp, base of center berm.
