APPENDIX A

DAM SAFETY INSPECTION REPORTS

**LAKE GERALDINE DAM
DAM SAFETY INSPECTION 2022 #1
IQUALUIT, NUNAVUT**

DATE: JUNE 30, 2022

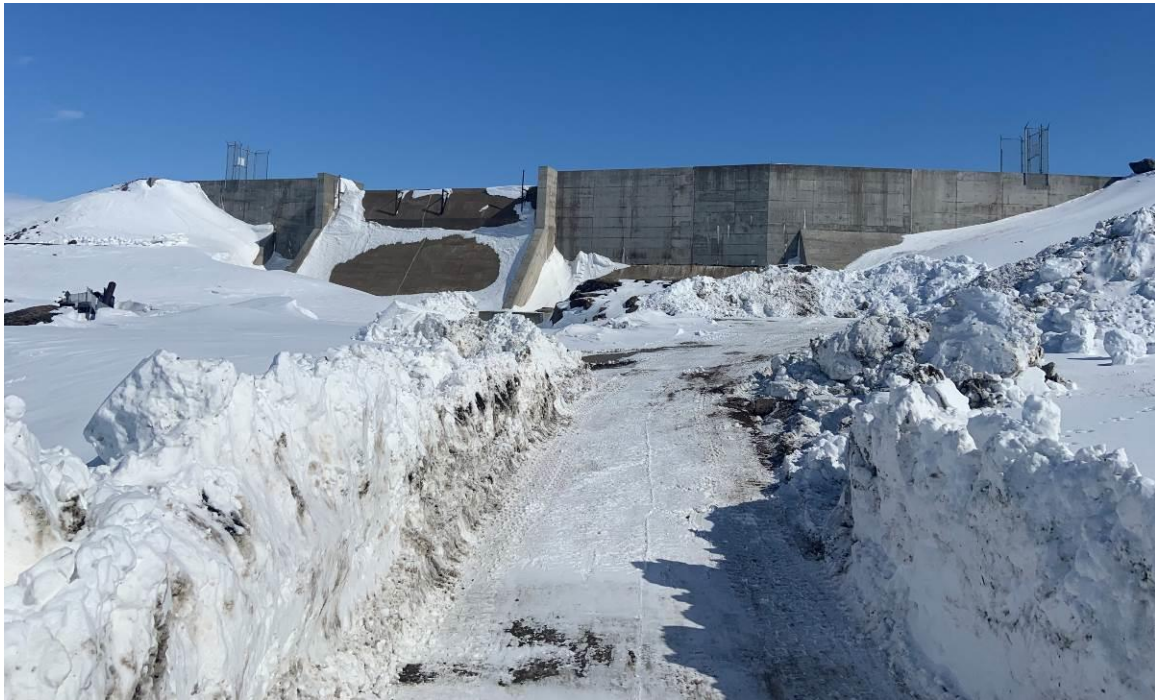
Photograph 1 – Overview of concrete structure, center berm and north berm.

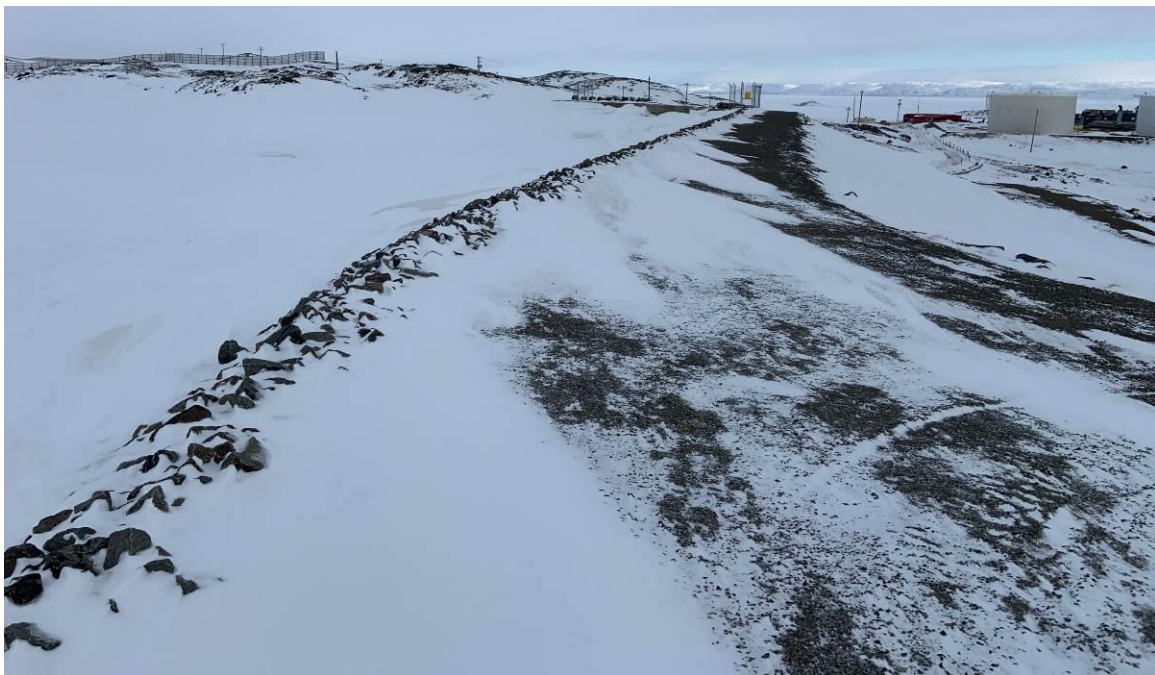
Photograph 2 – Typical center berm condition at the time of our review.

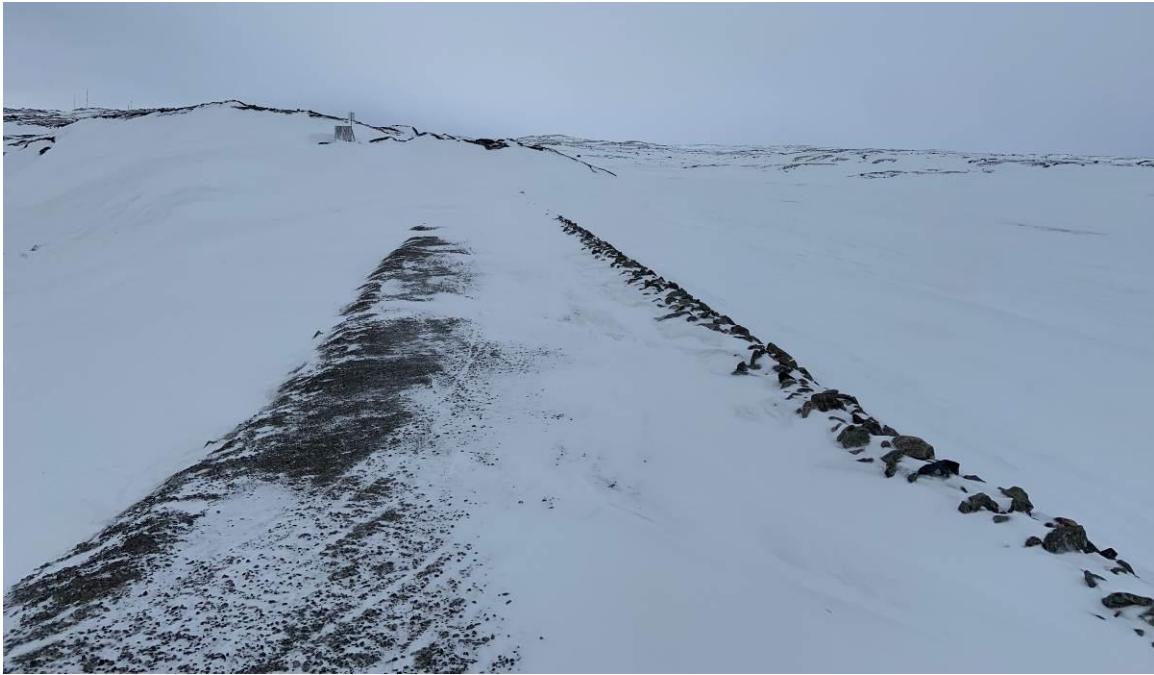
Photograph 3 – Typical north berm condition at the time of our review.

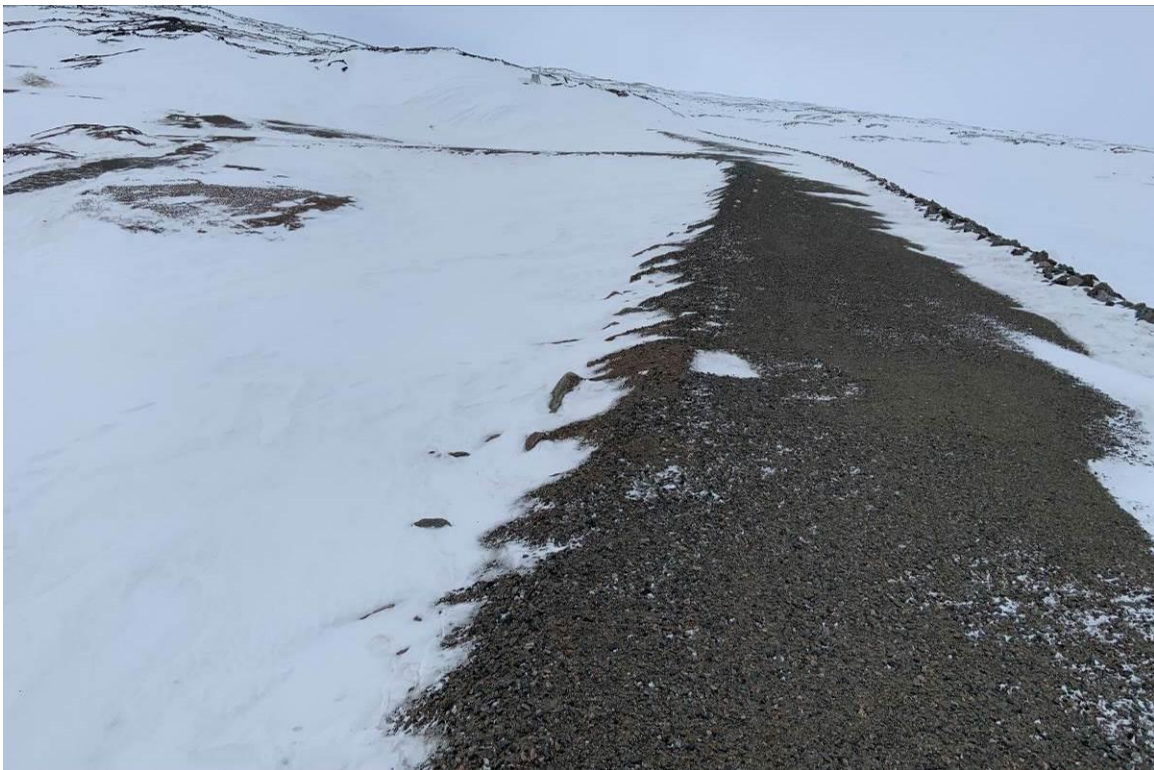
Photograph 4 – Typical snow and ice accumulation on the downstream face of the north and center berms.

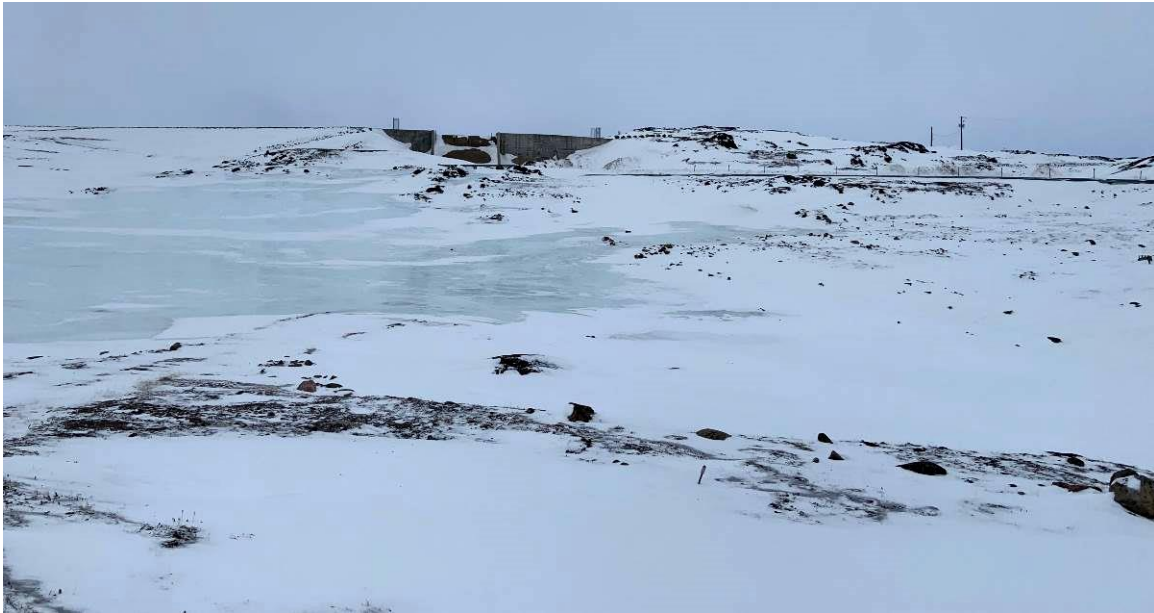
Photograph 5 – Snow and ice accumulation within the valley downstream of the concrete dam and earthen berms.

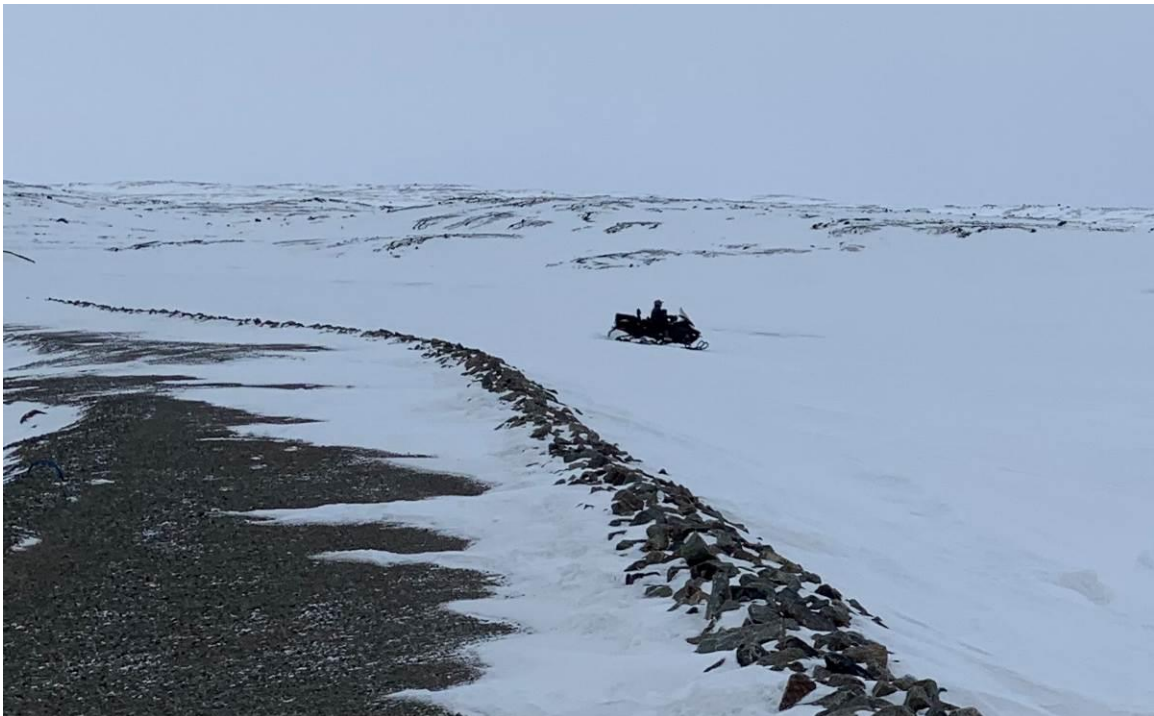
- Members of the public continue to access the Dam, and Lake Geraldine (when iced over). Approximately 8 – 12 people were observed traveling across the lake during our site review (see photograph 6). There appears to be a trail that has been established that originates at the gap in the snow/wind fencing to the south of the south berm and continues across the lake.

Photograph 6 – Typical public access atop and over the dam and onto the reservoir.

- c) ATV and skidoos should not be traveling atop the berms and across Lake Geraldine.
 5. Implementation of a monitoring program to record data from the installed network of piezometers and thermistors used to monitor hydrogeologic and thermal environments within the backfill and foundations. This work is tentatively scheduled for implementation in summer of 2022.

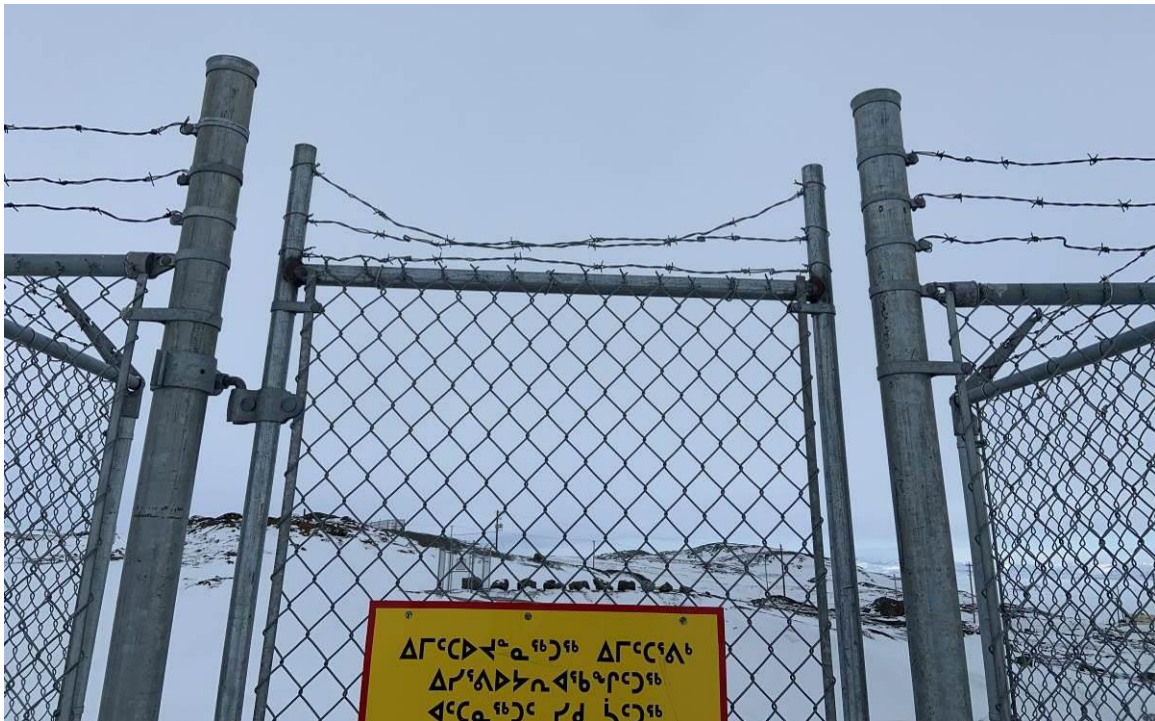
Photograph 7 – Typical damage to the fencing atop the dam.

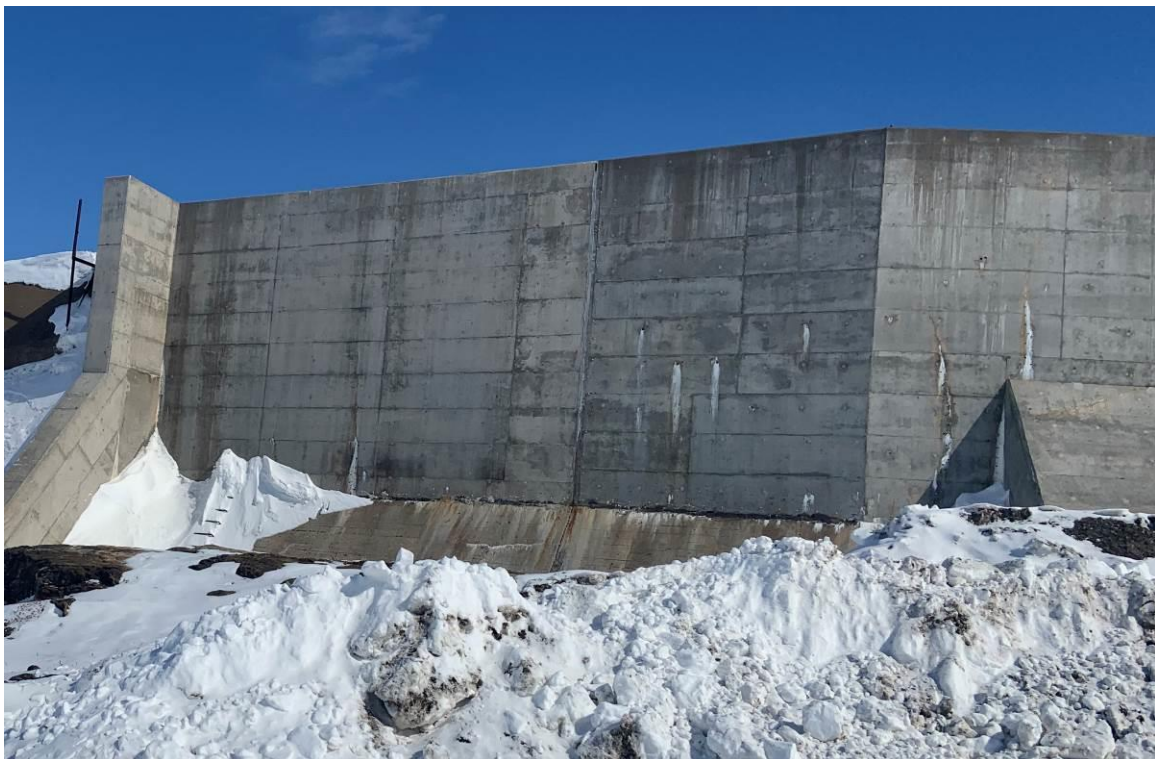
Photograph 8 – Typical concrete condition, south of the spillway.

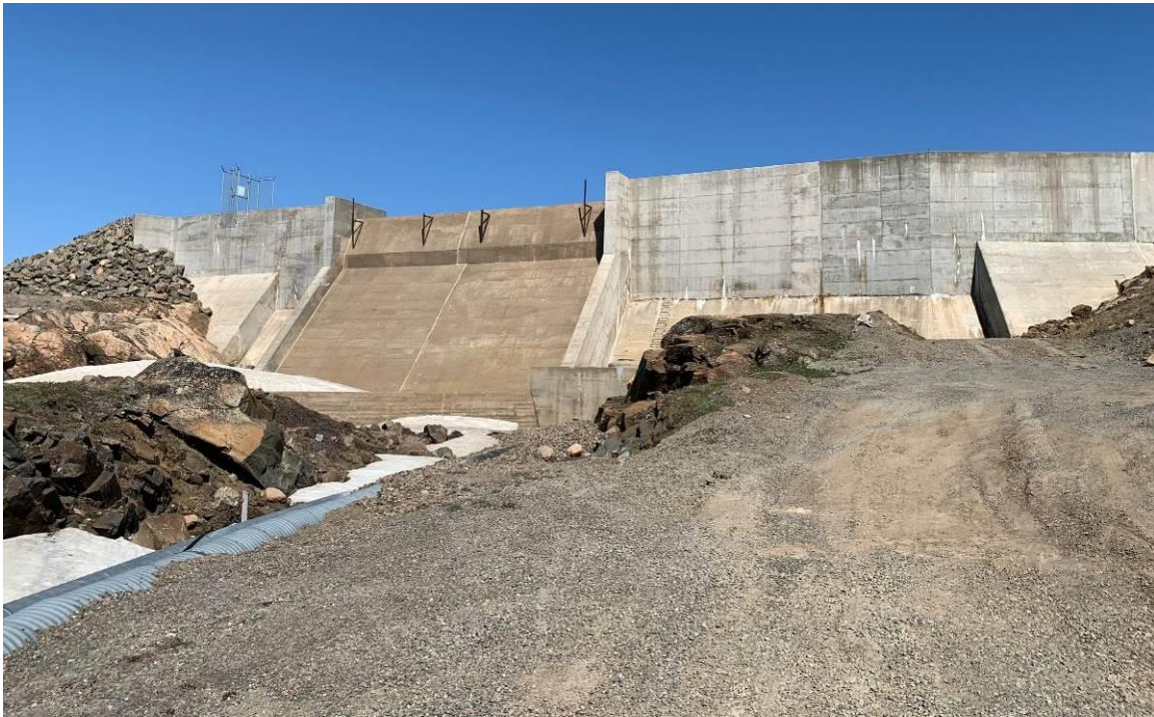
Photograph 1 – Overview of concrete structure.

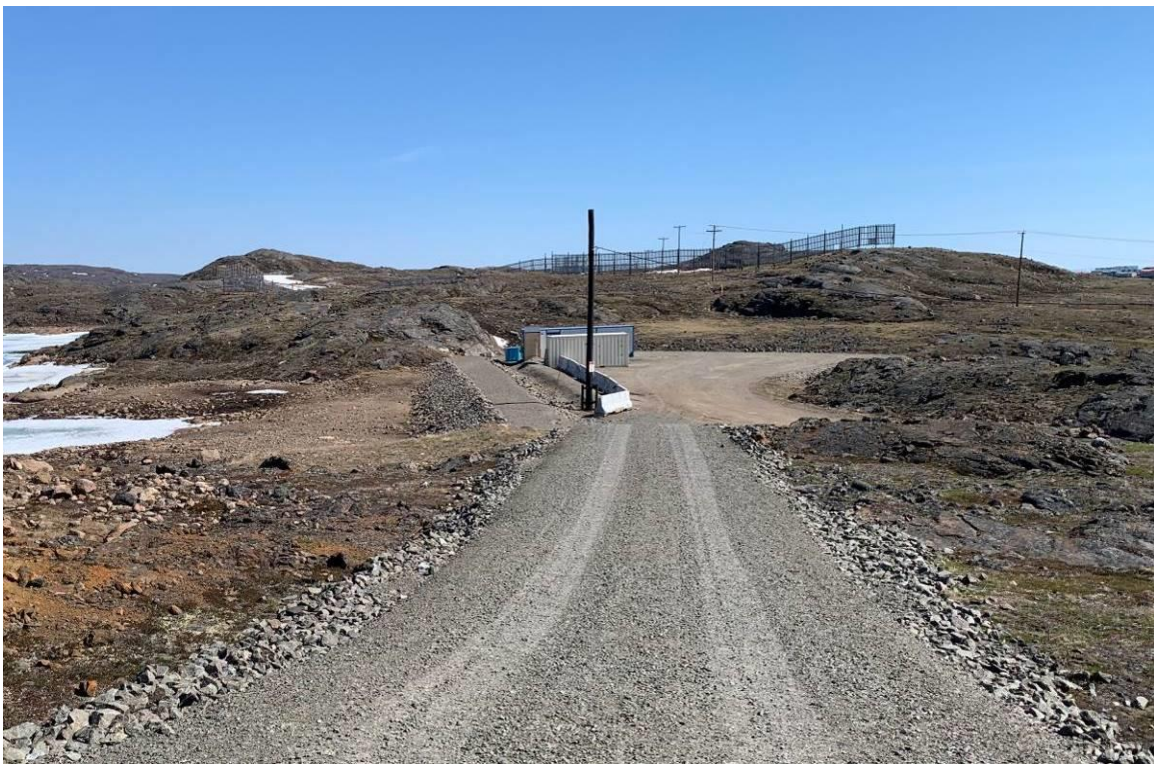
Photograph 2 – Typical south berm condition at the time of our review.

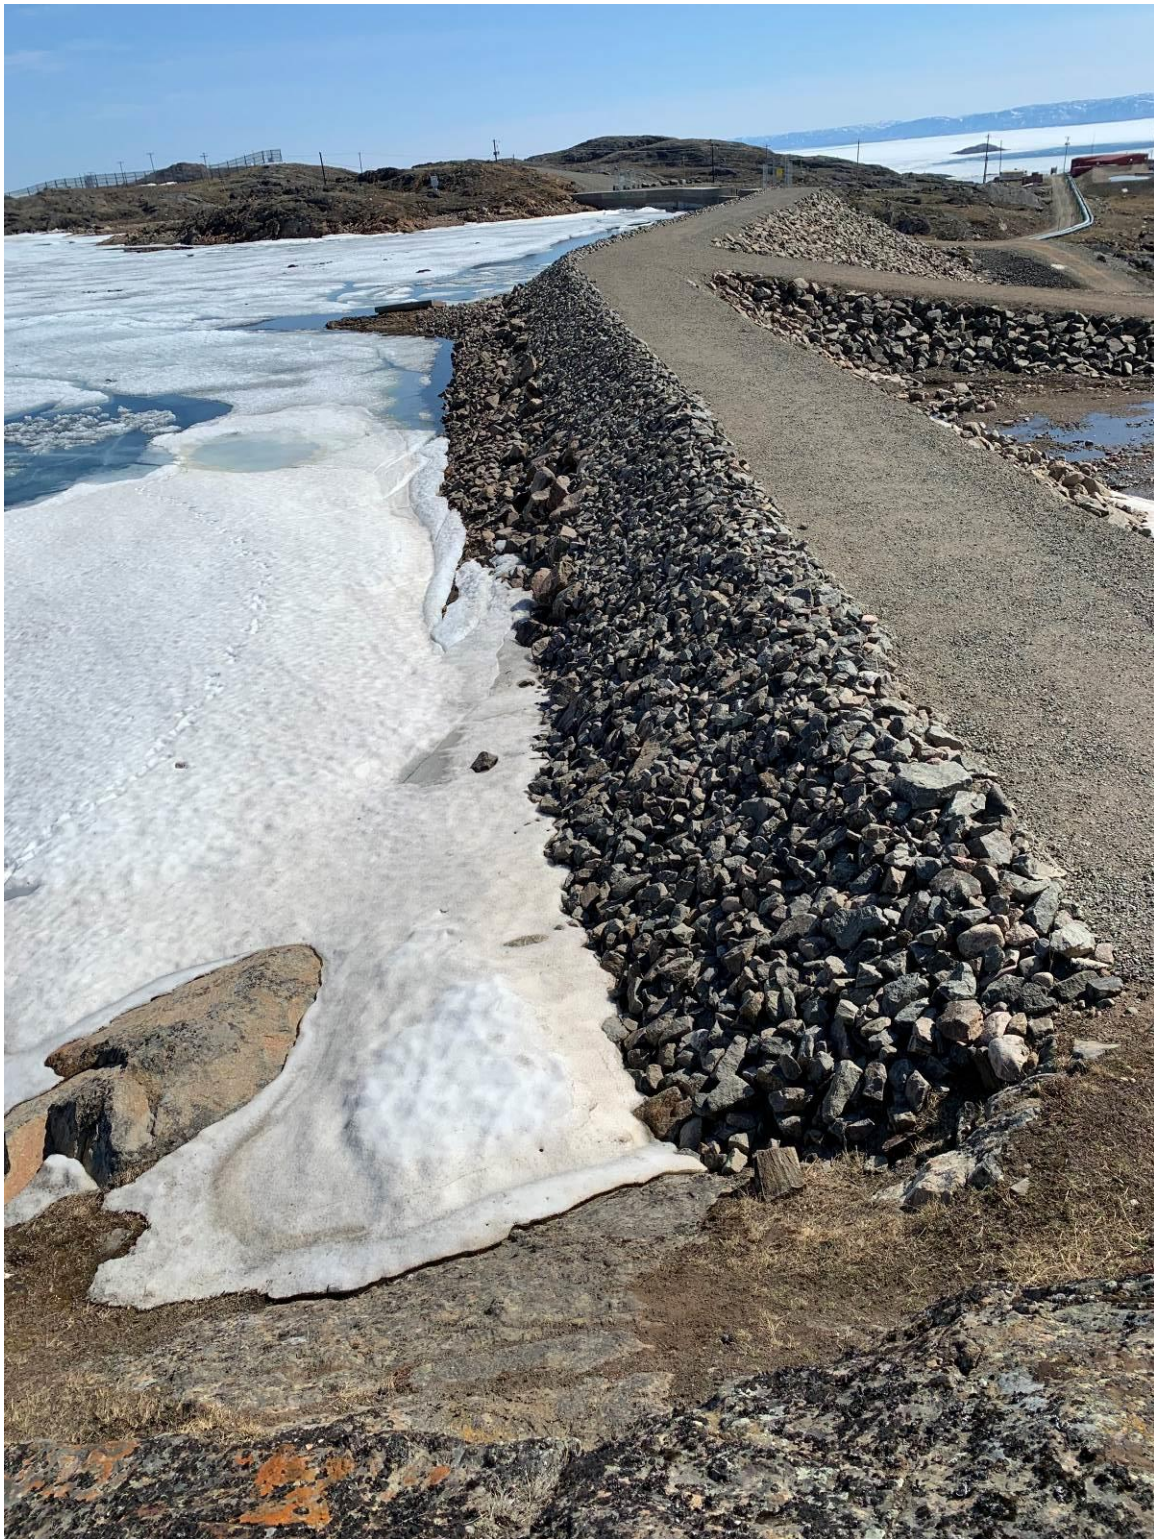
Photograph 3 – Typical north and center berm condition at the time of our review.

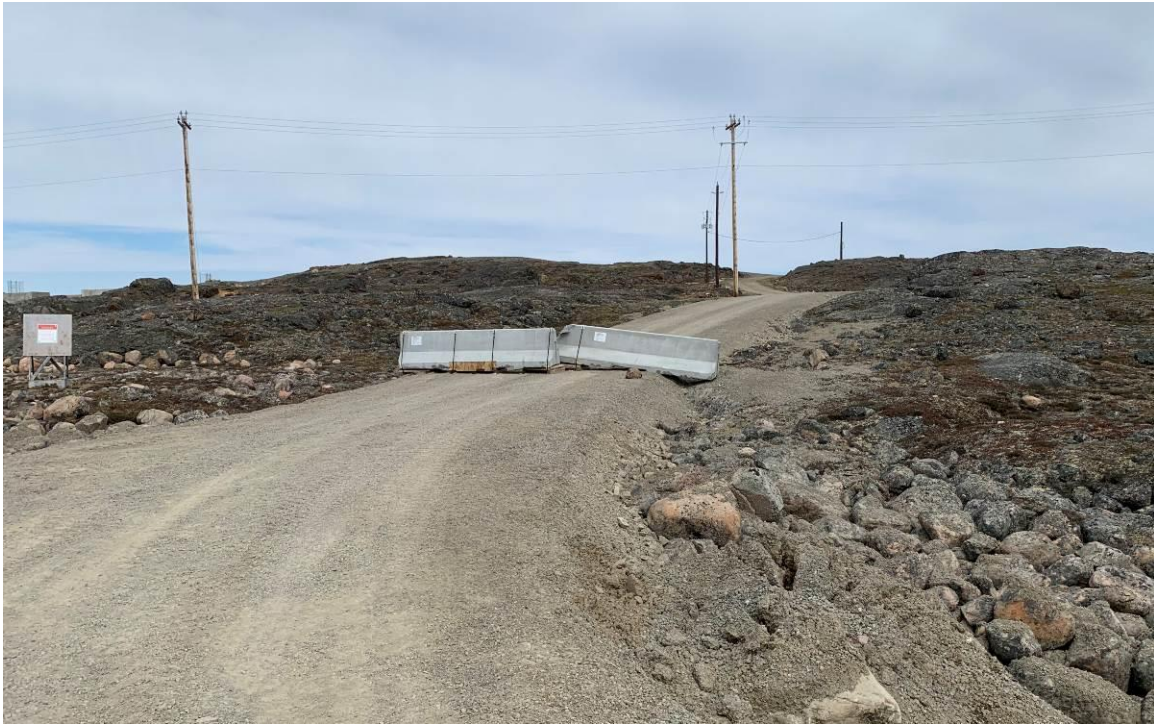
Photograph 4 – The temporary road to south berm has been blocked with a concrete barrier to limit public access to the dam and reservoir.

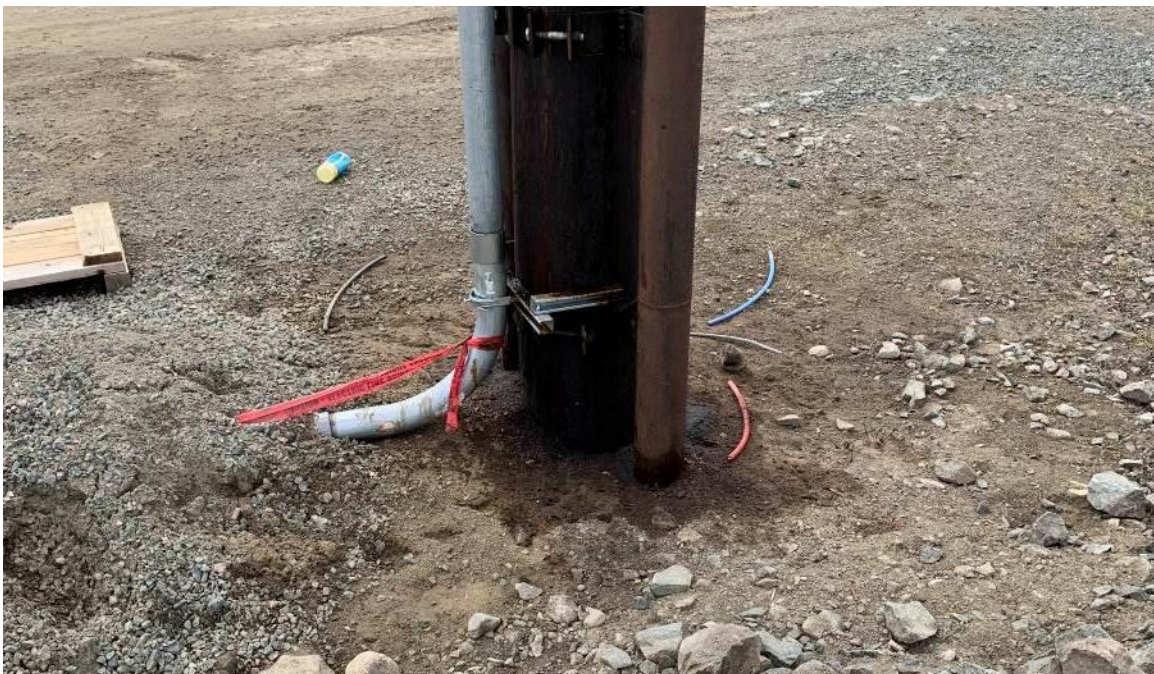
Photograph 5 – Oil residue on the ground around the base of the hydro pole, south berm.

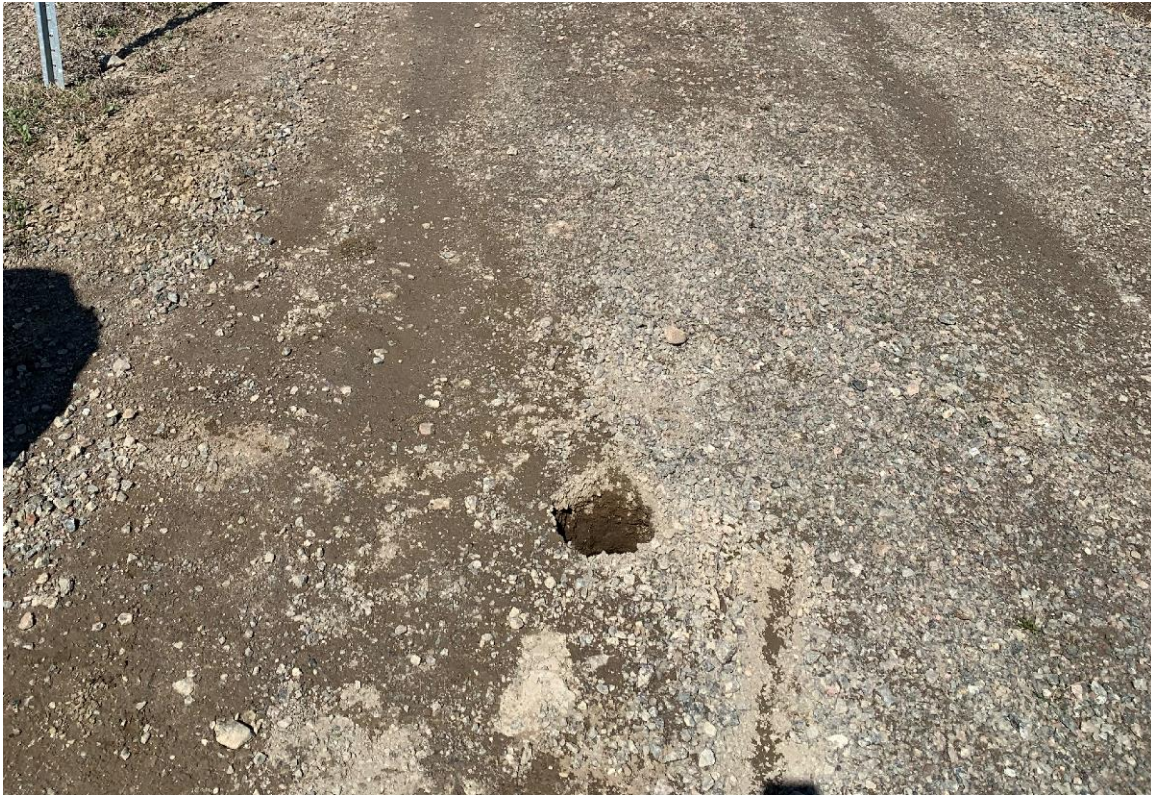
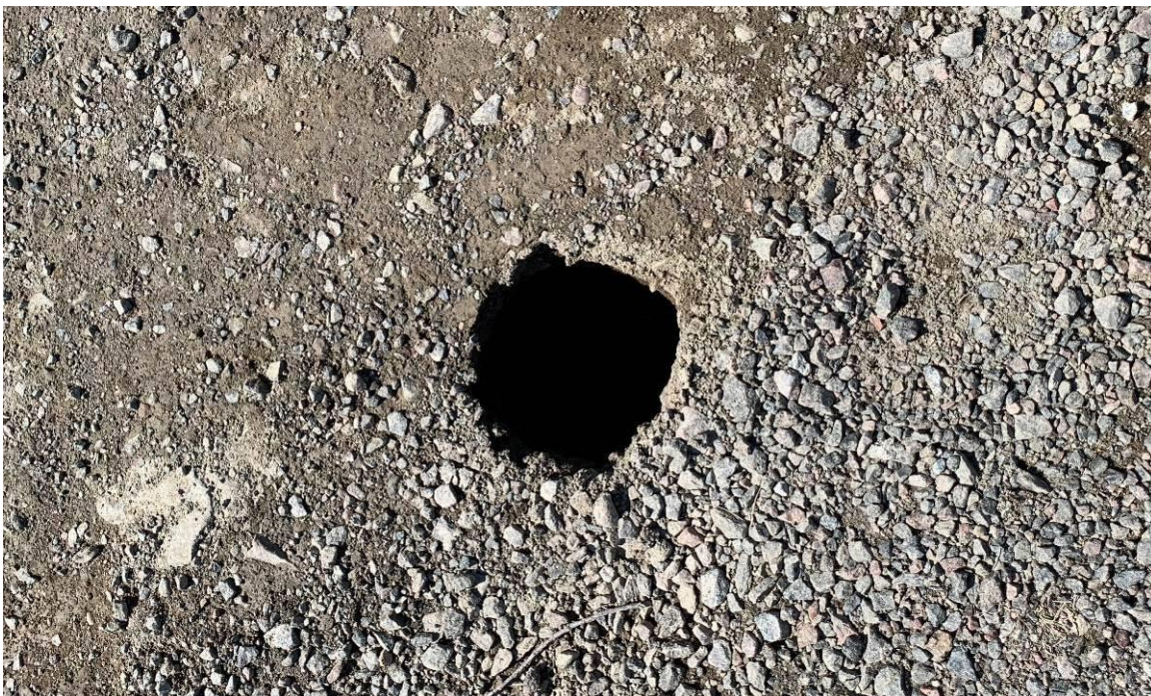
- A sink hole was found within the south access road, approximately 40' south of the access control gate. See Photographs 6 & 7.
- No significant changes were noted in the general condition of the concrete structures. Seepage was observed at two locations within the visible portions of the concrete structures. See Photograph 8.

Photograph 6 –Sink hole within the south access road, approximately 40' south of the access gate.

Photograph 7 –Sink hole within the south access road, approximately 40' south of the access gate.

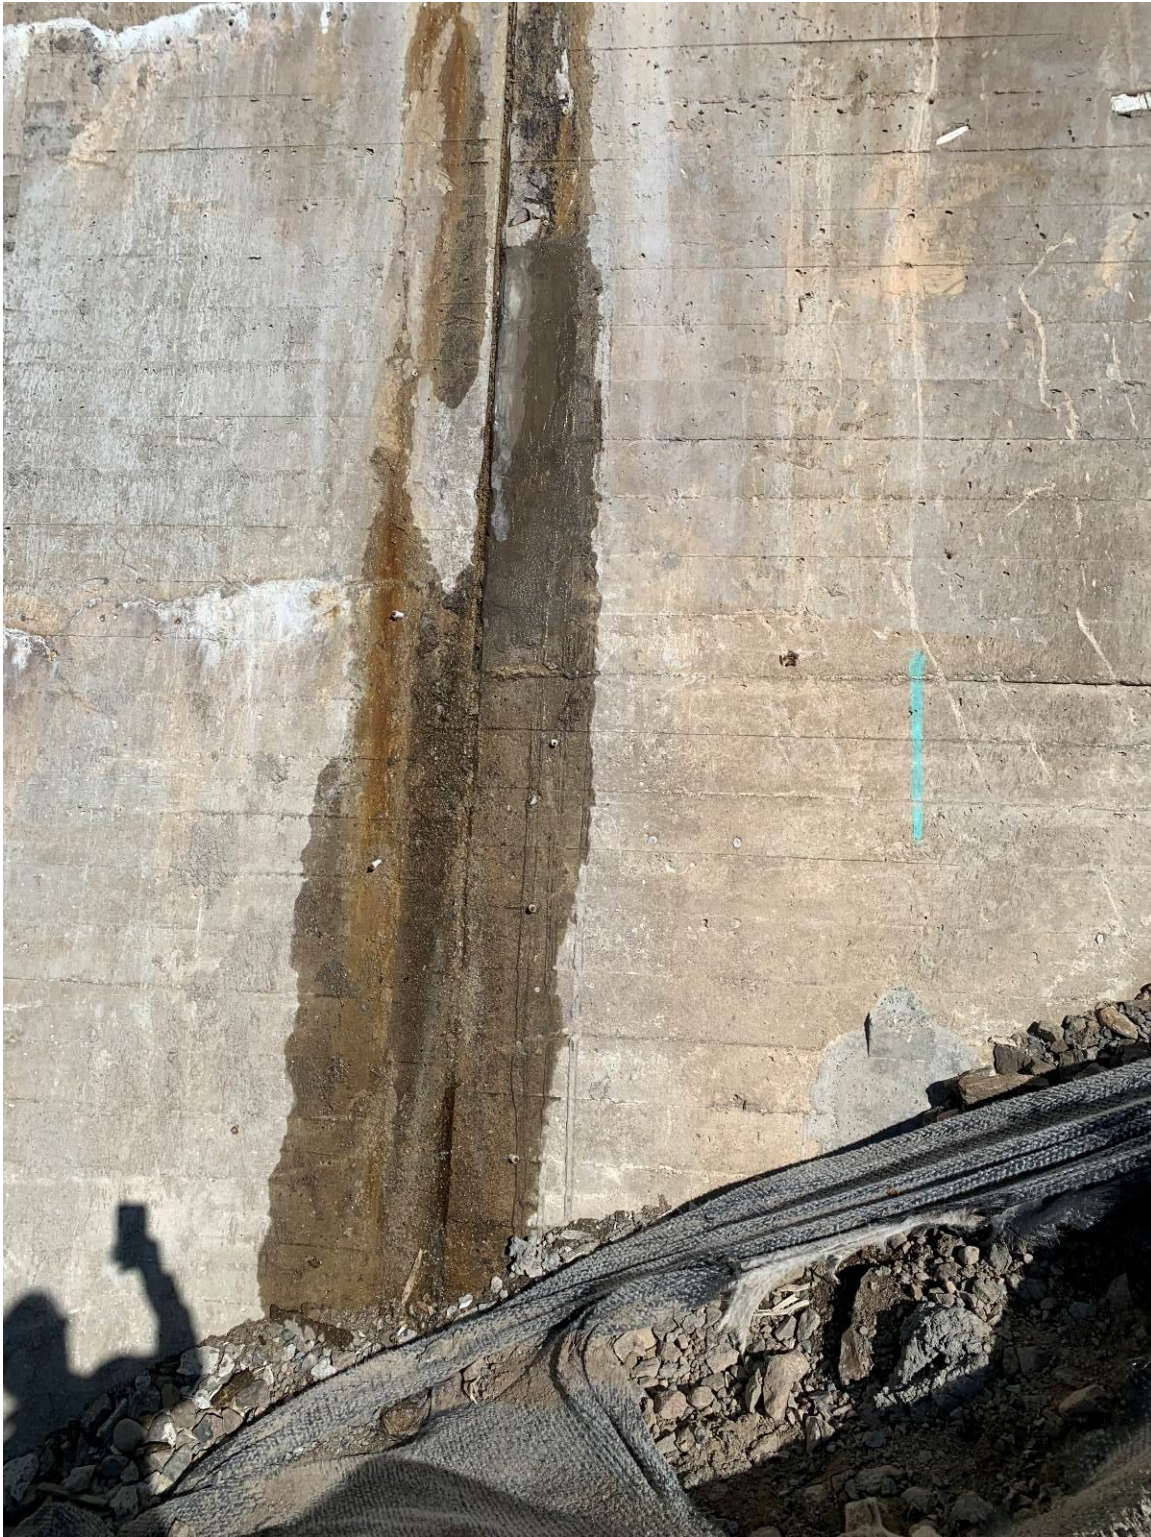
Photograph 8 – Typical expansion joint seepage (concrete dam).

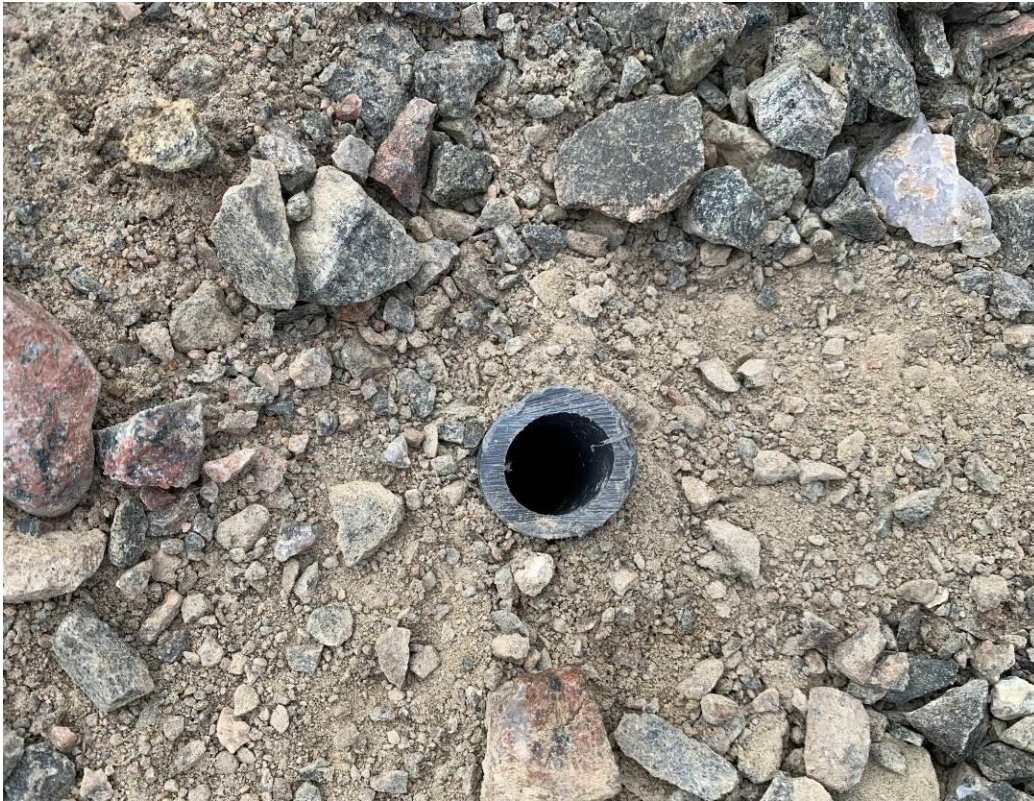
Photograph 9 – Borehole tube for piezometer (open).

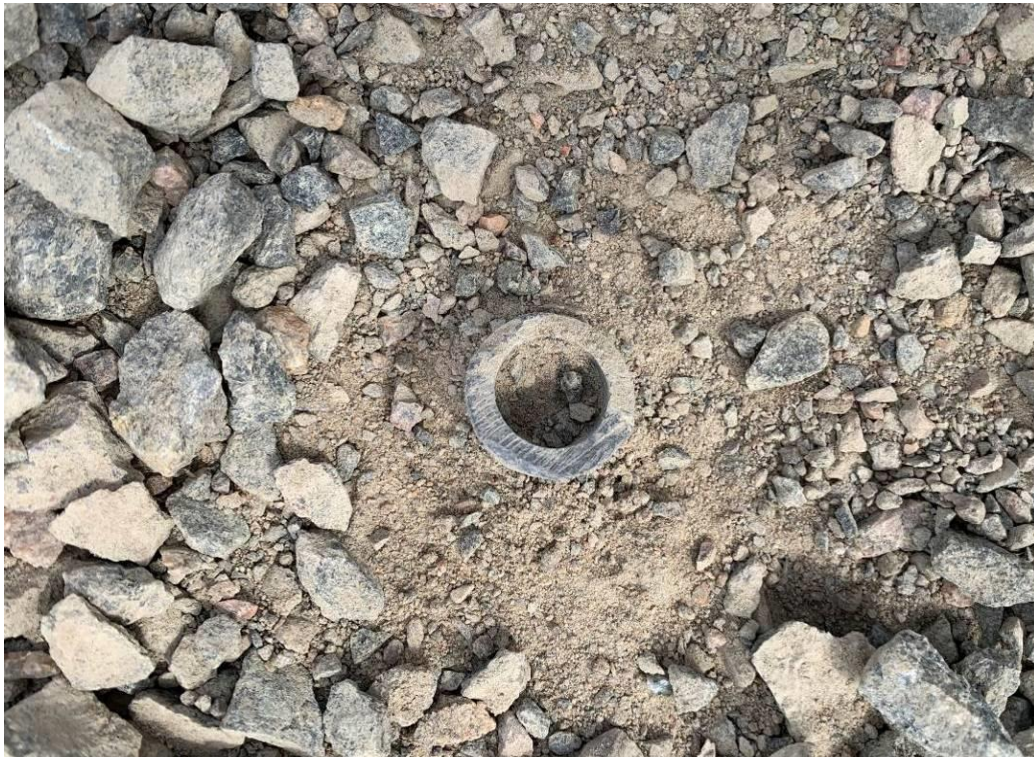
Photograph 10 – Borehole tube for piezometer blocked with aggregate material.

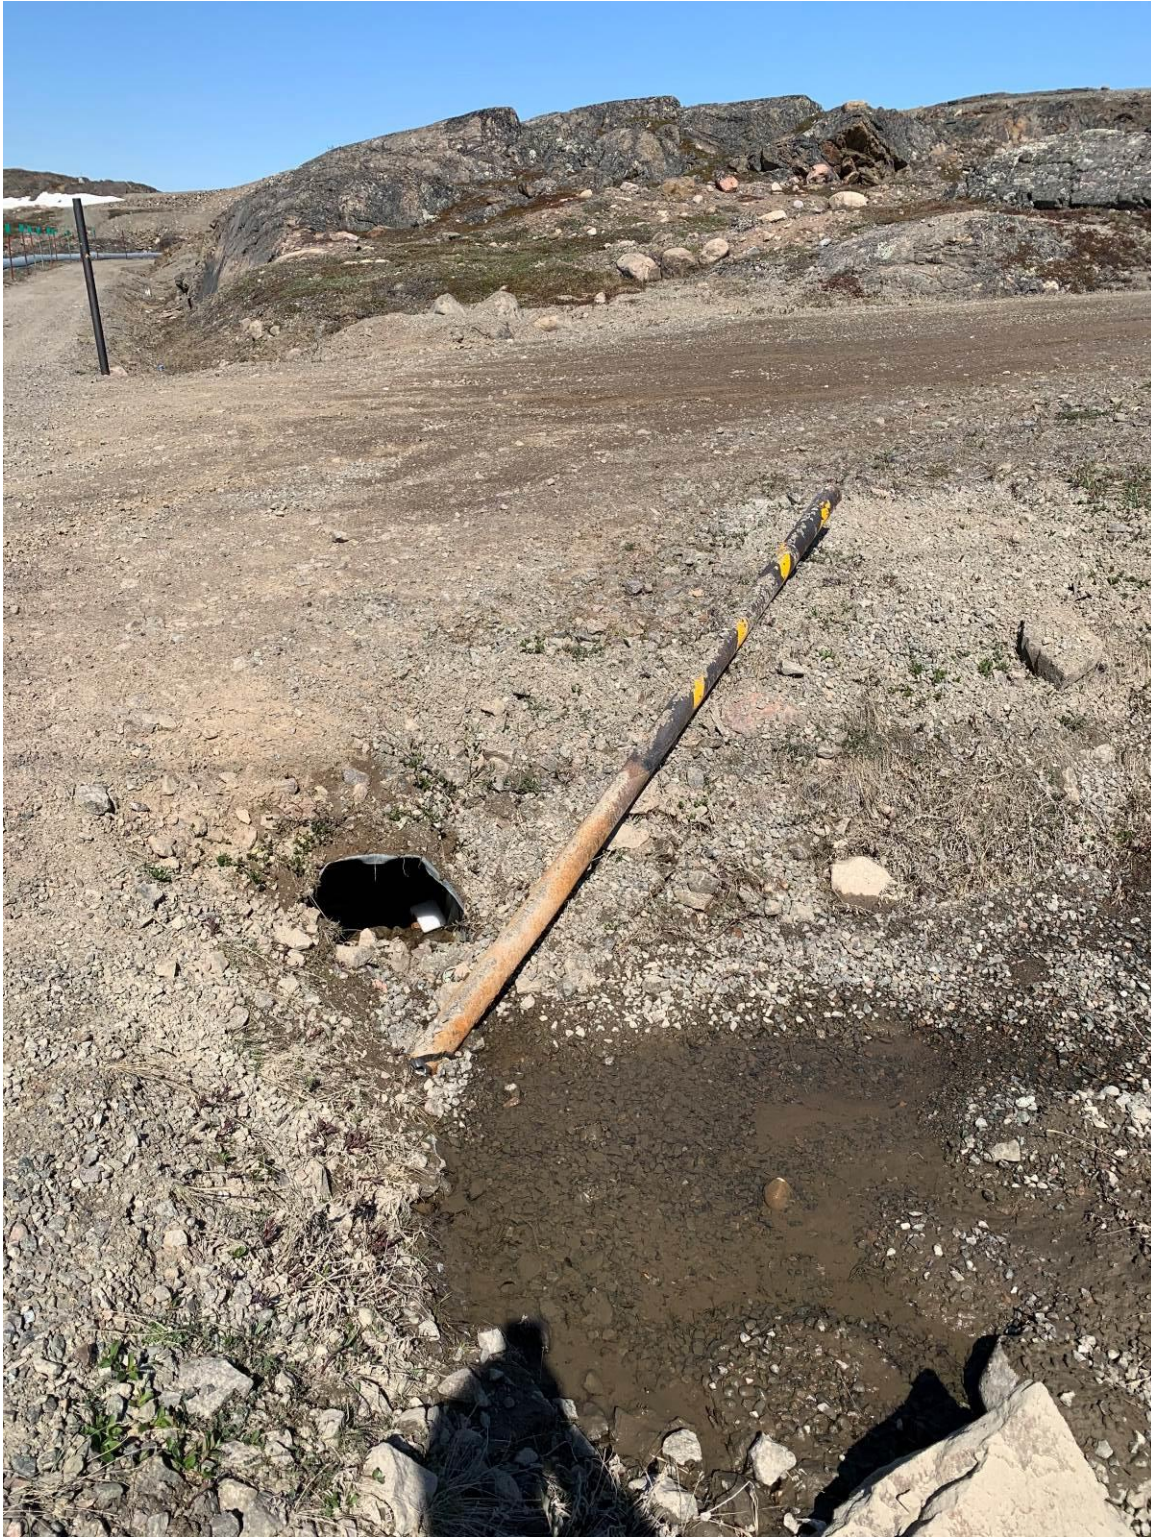
Photograph 11 – Corner marker at the junction of the south access road and the road to the south berm has been knocked over.

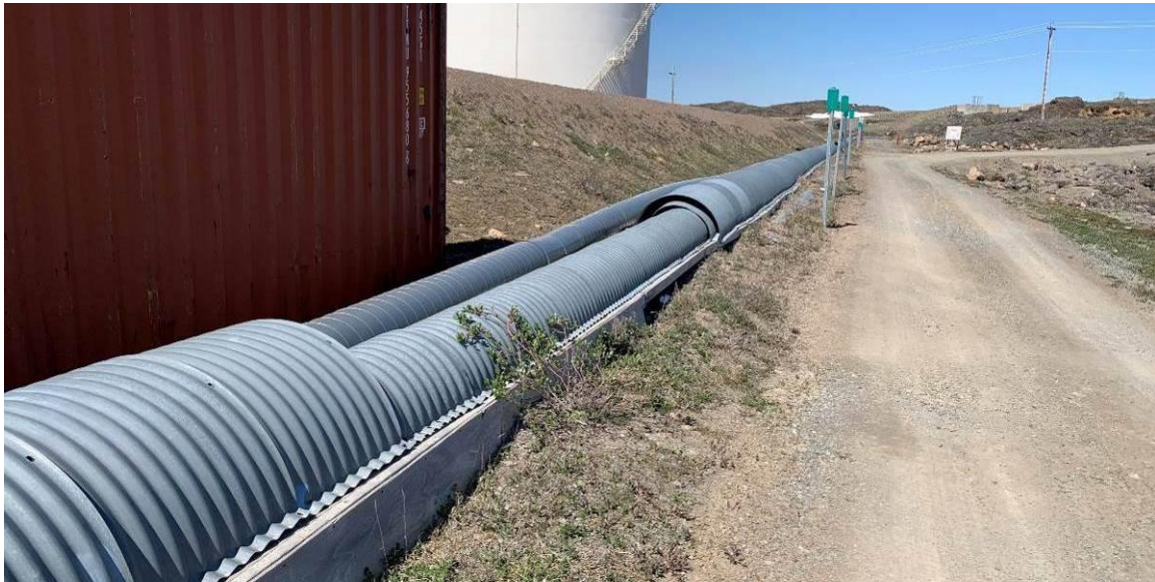
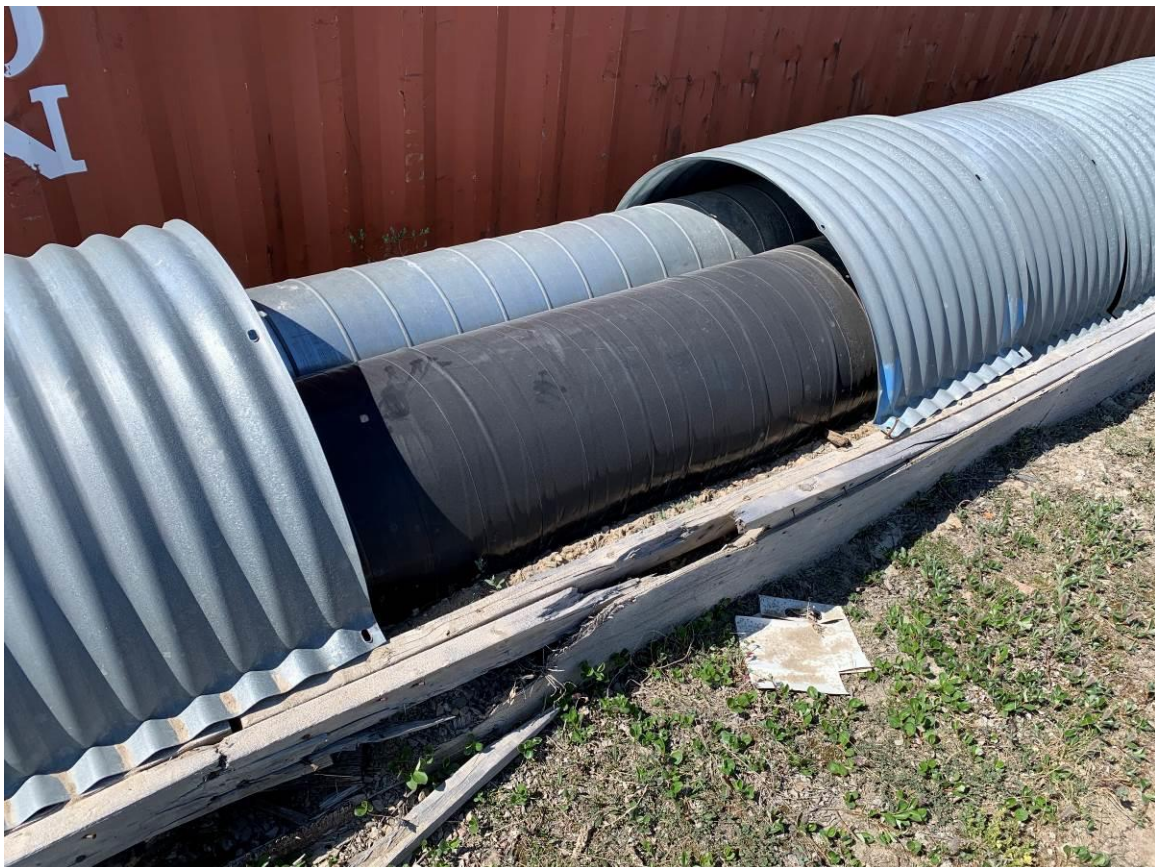
Photograph 12 – Section of the supply pipe from the dam with the corrugates metal enclosure removed.

Photograph 13 – Section of the supply pipe from the dam with the corrugates metal enclosure removed.

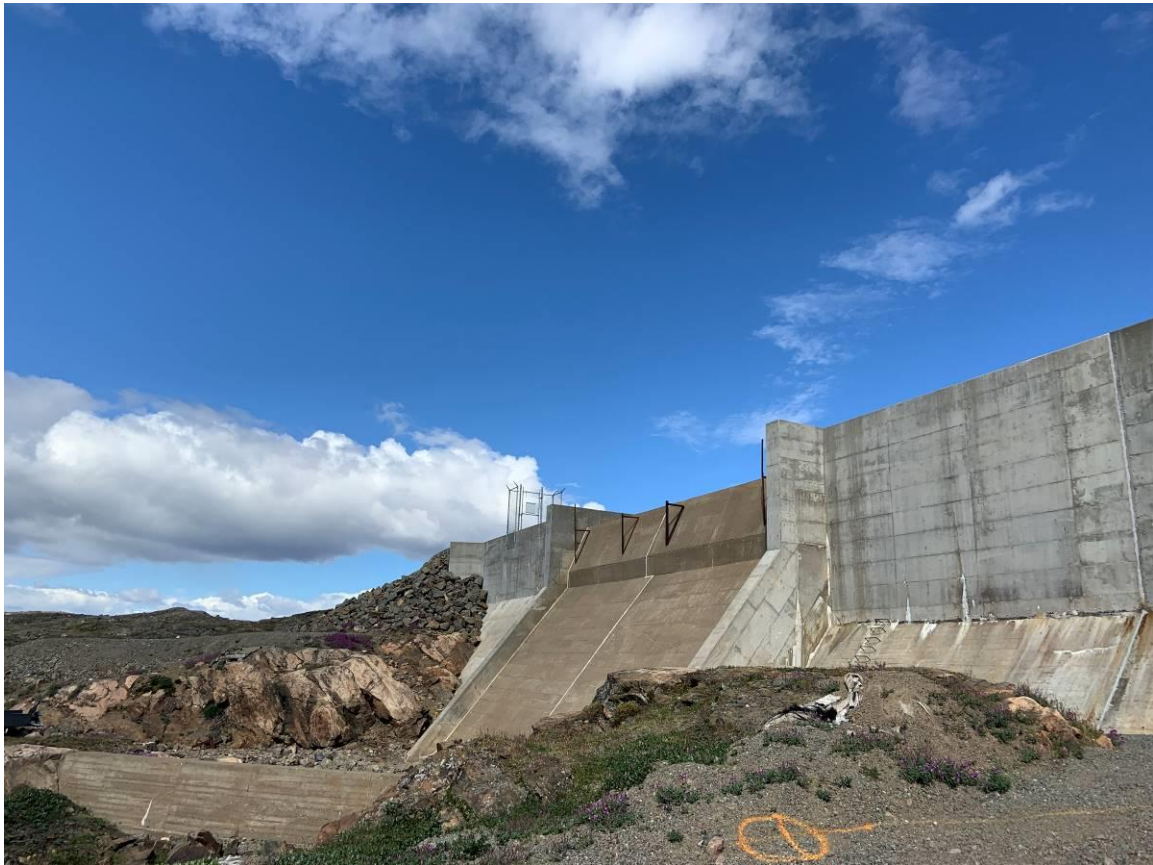
Photograph 1 – Overview of concrete structure.

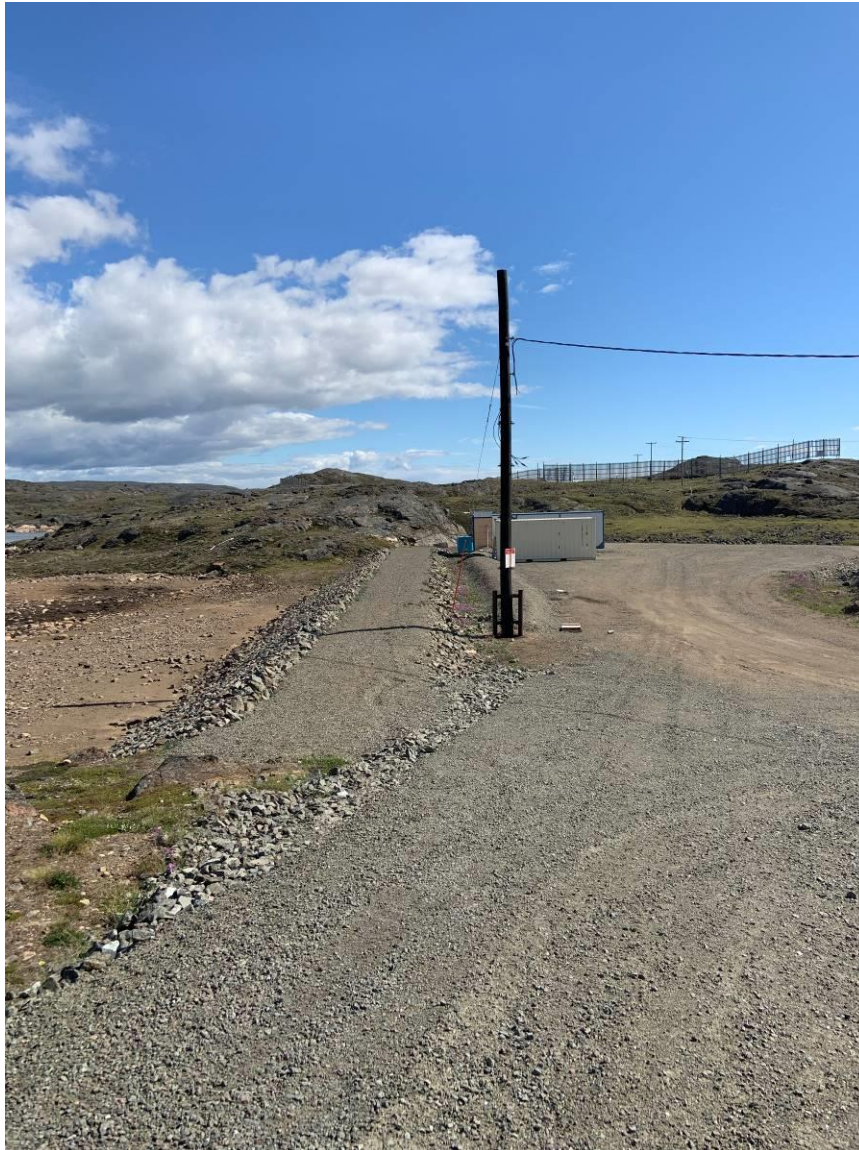
Photograph 2 – Typical south berm condition at the time of our review.
