APPENDIX A

DAM SAFETY INSPECTION REPORTS

**LAKE GERALDINE DAM
DAM SAFETY INSPECTION 2022 #1
IQUALUIT, NUNAVUT**

DATE: JUNE 30, 2022

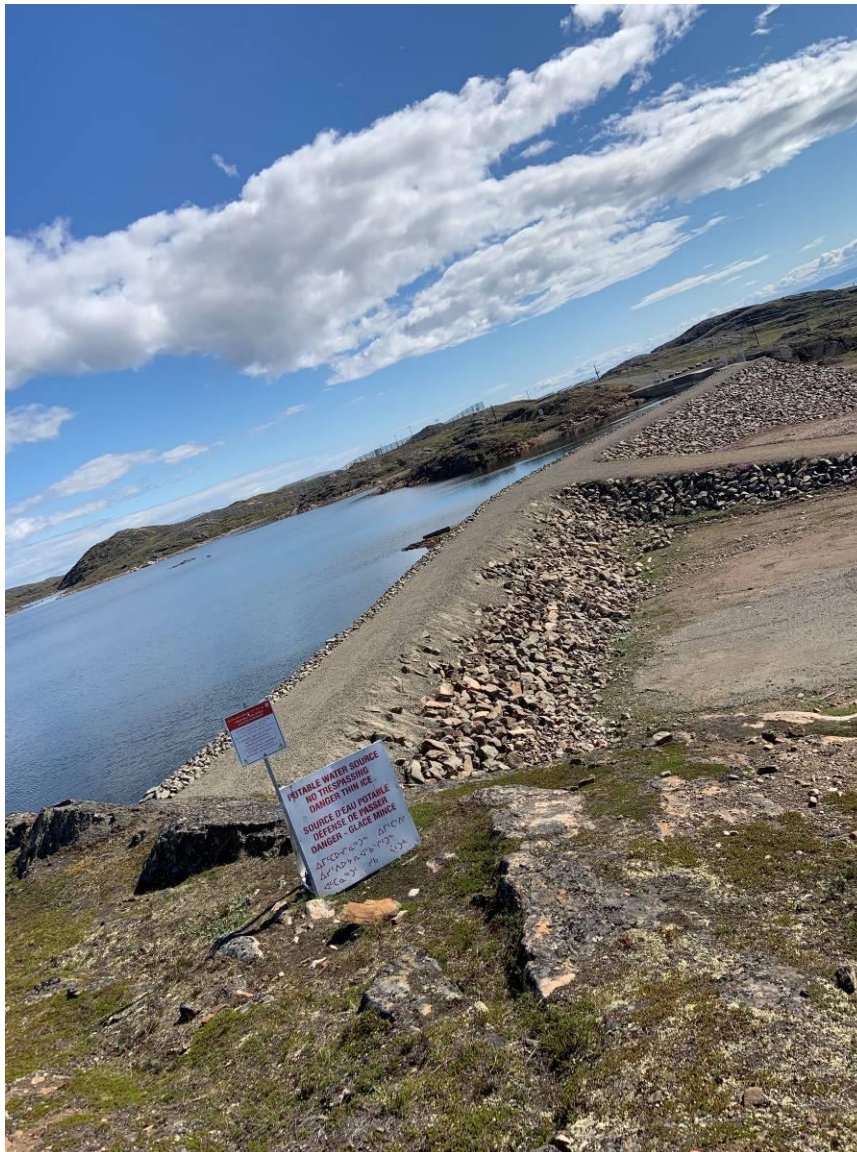
Photograph 3 – Typical north and center berm condition at the time of our review.

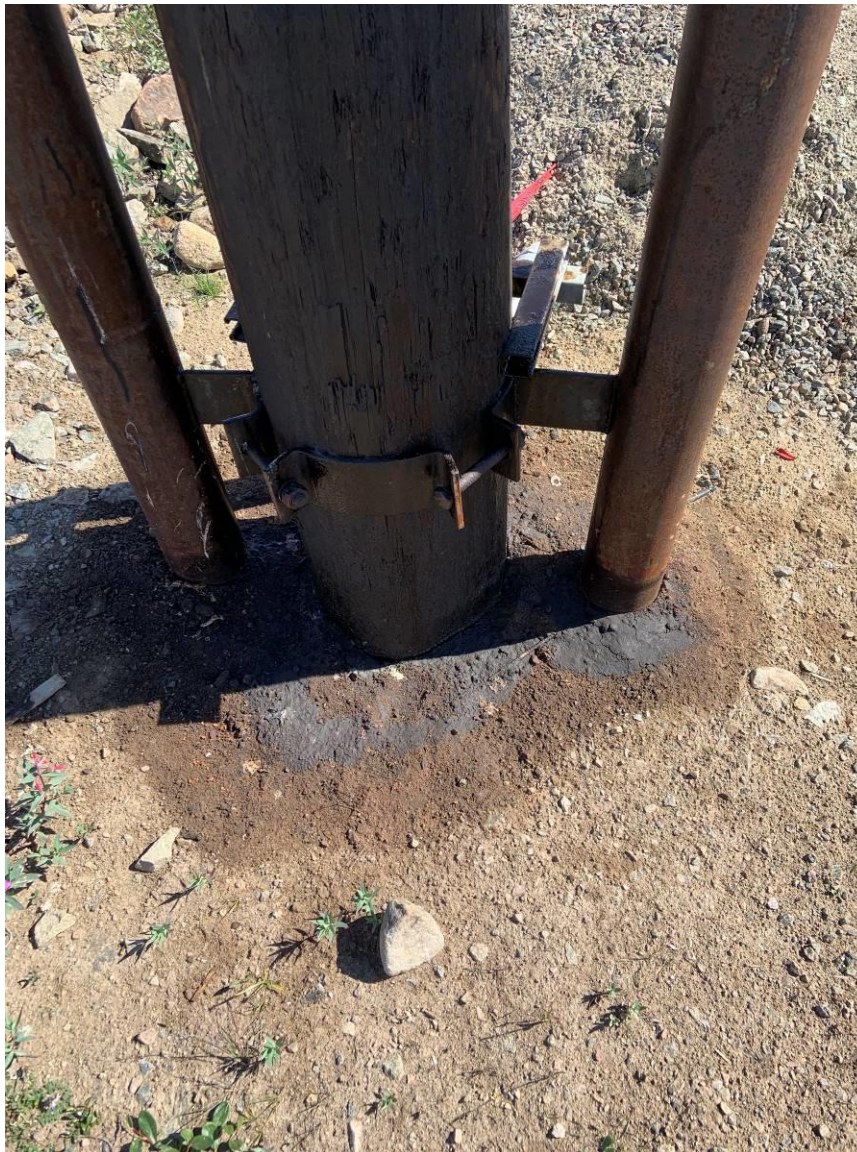
Photograph 4 – Oil residue on the ground around the base of the hydro pole, south berm.

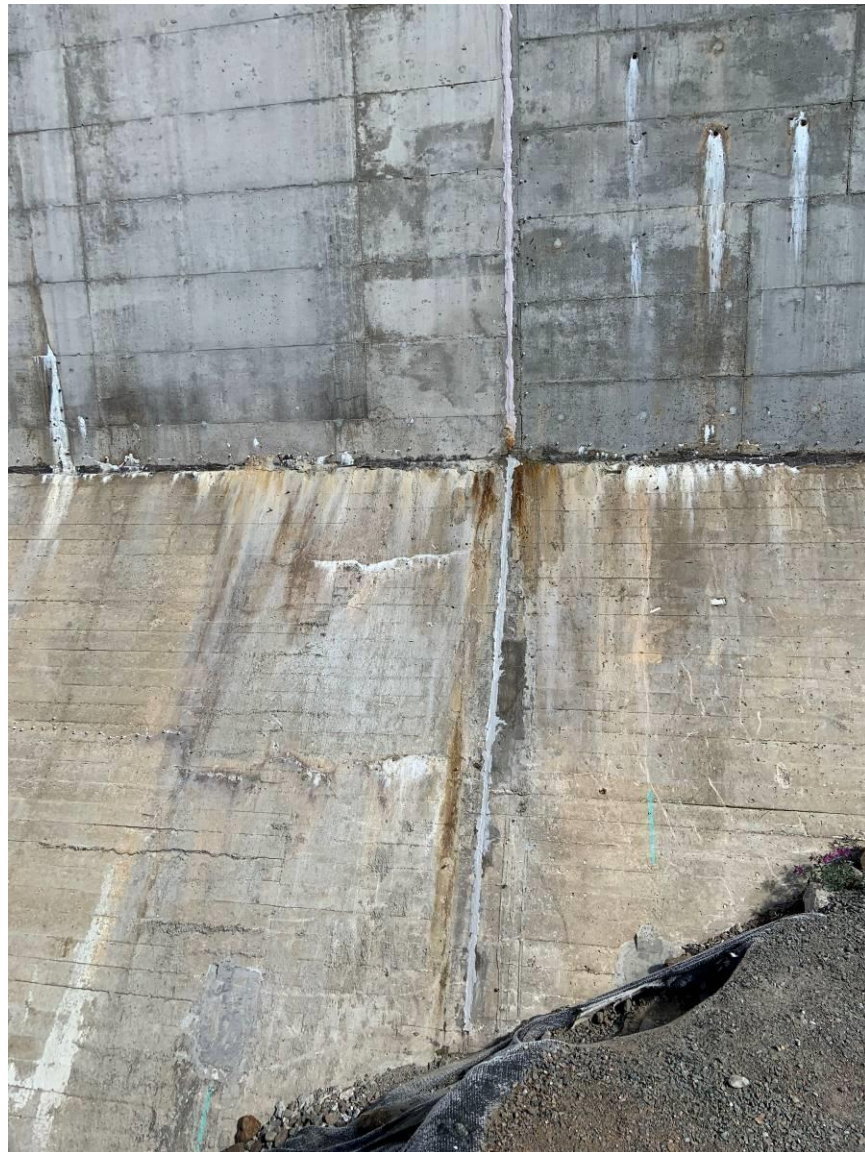
Photograph 5 – Typical expansion joint (concrete dam).

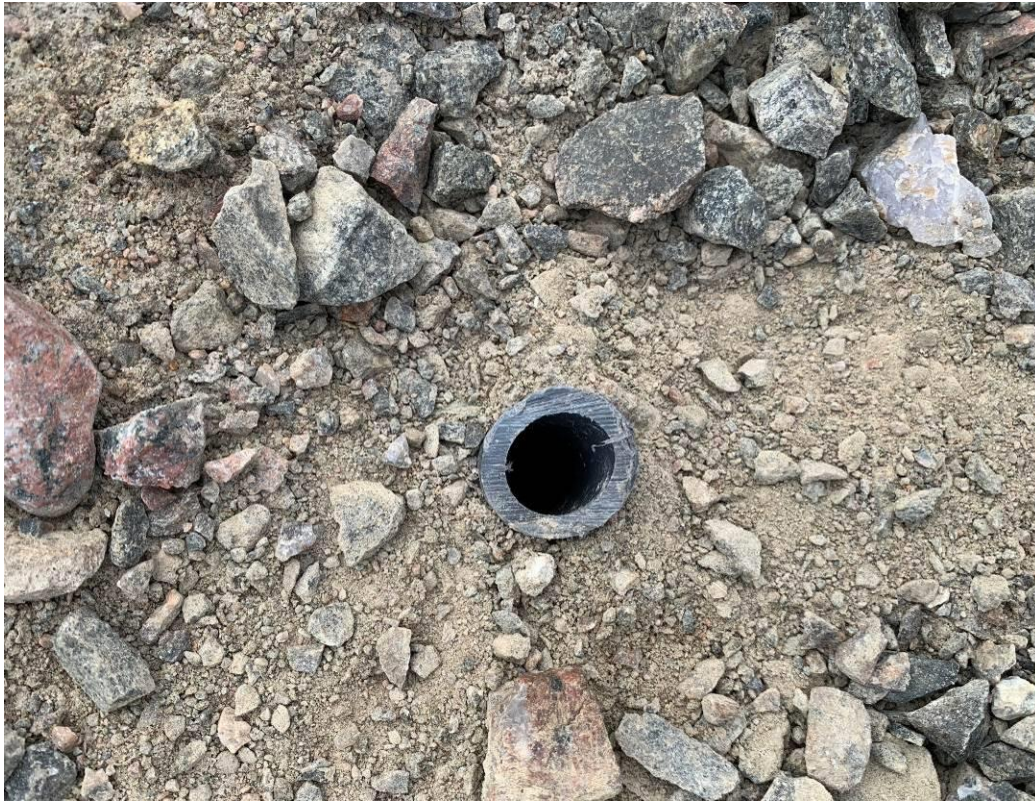
Photograph 6 – Borehole tube for piezometer (open).

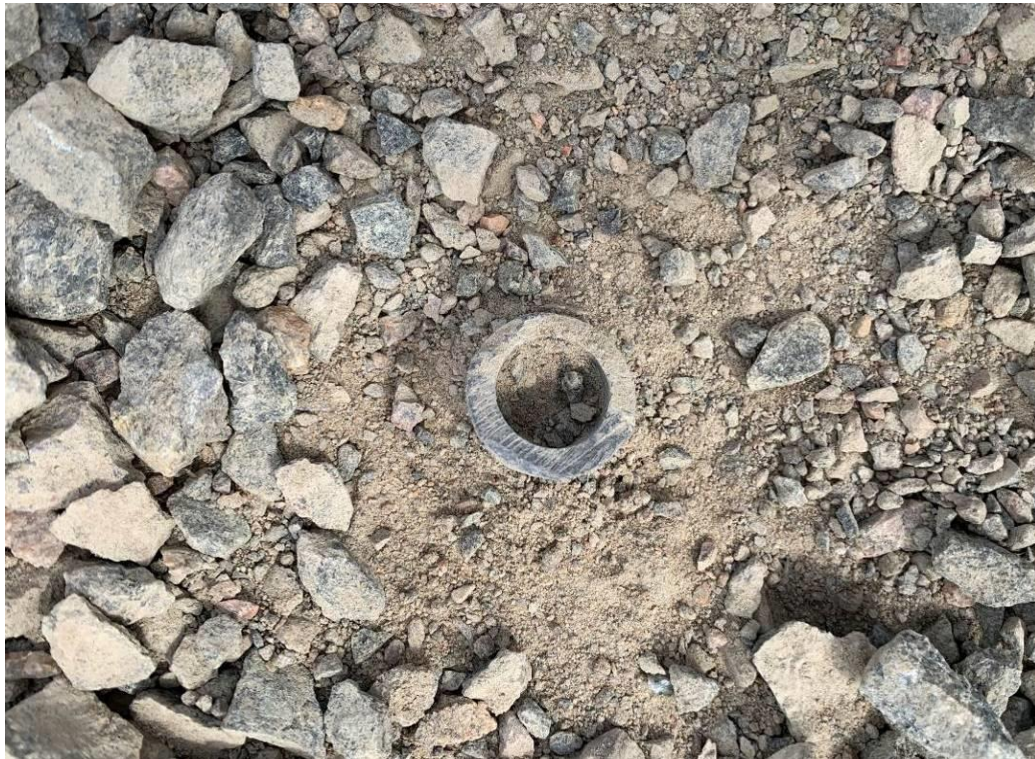
Photograph 7 – Borehole tube for piezometer blocked with aggregate material.

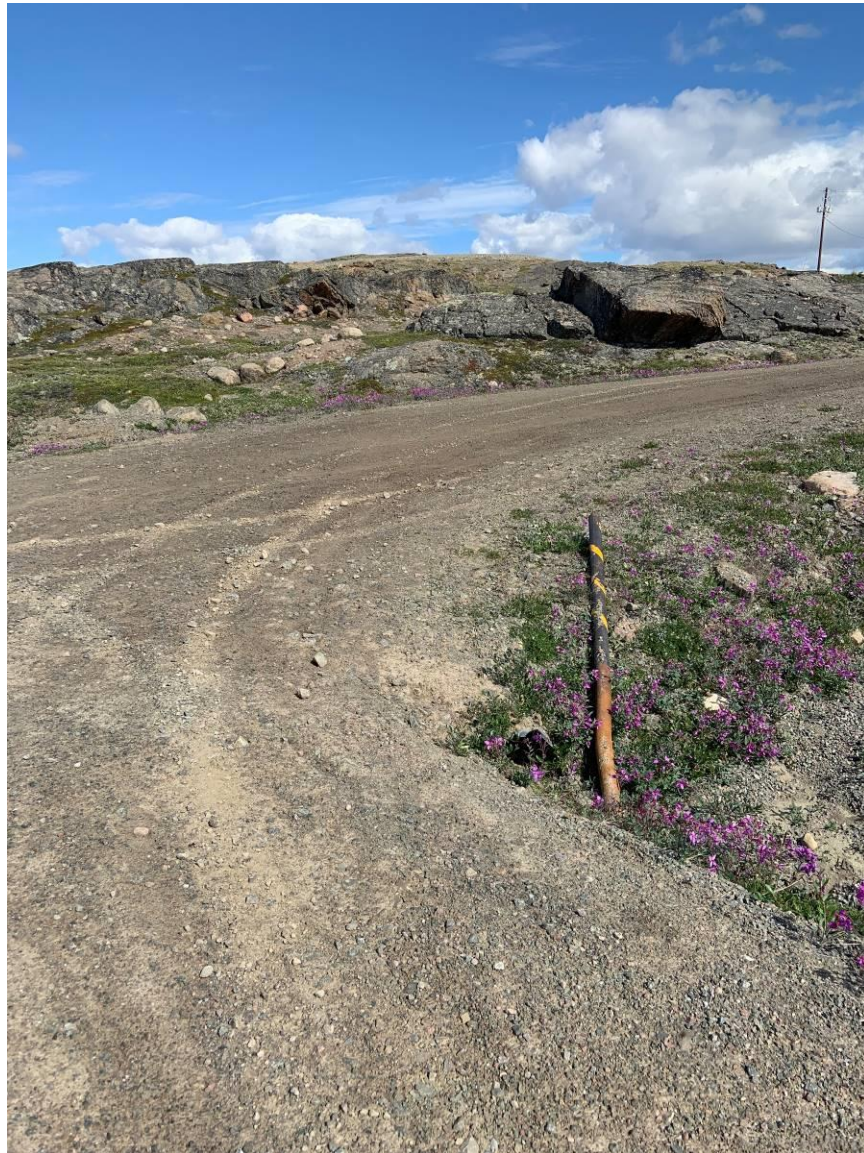
Photograph 8 – Corner marker at the junction of the south access road and the road to the south berm has been knocked over.

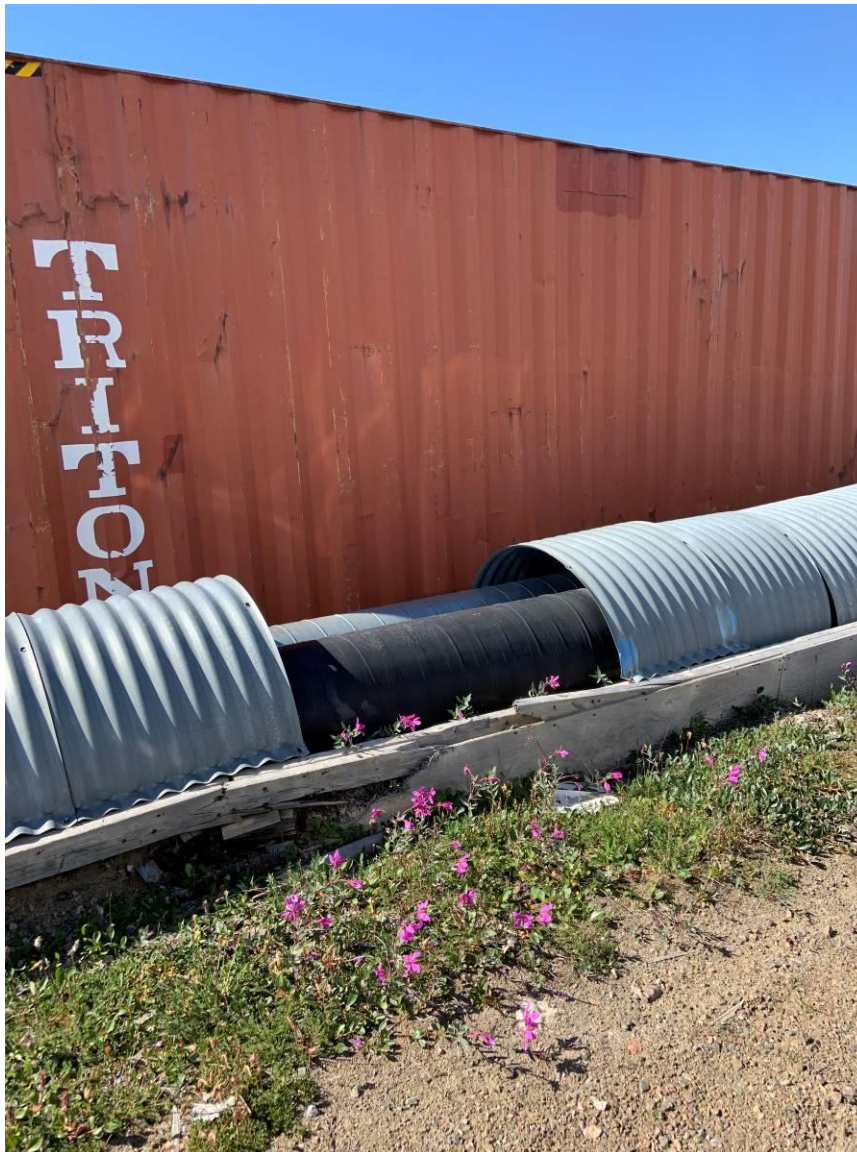
Photograph 9 – Section of the supply pipe from the dam with the corrugates metal enclosure removed.

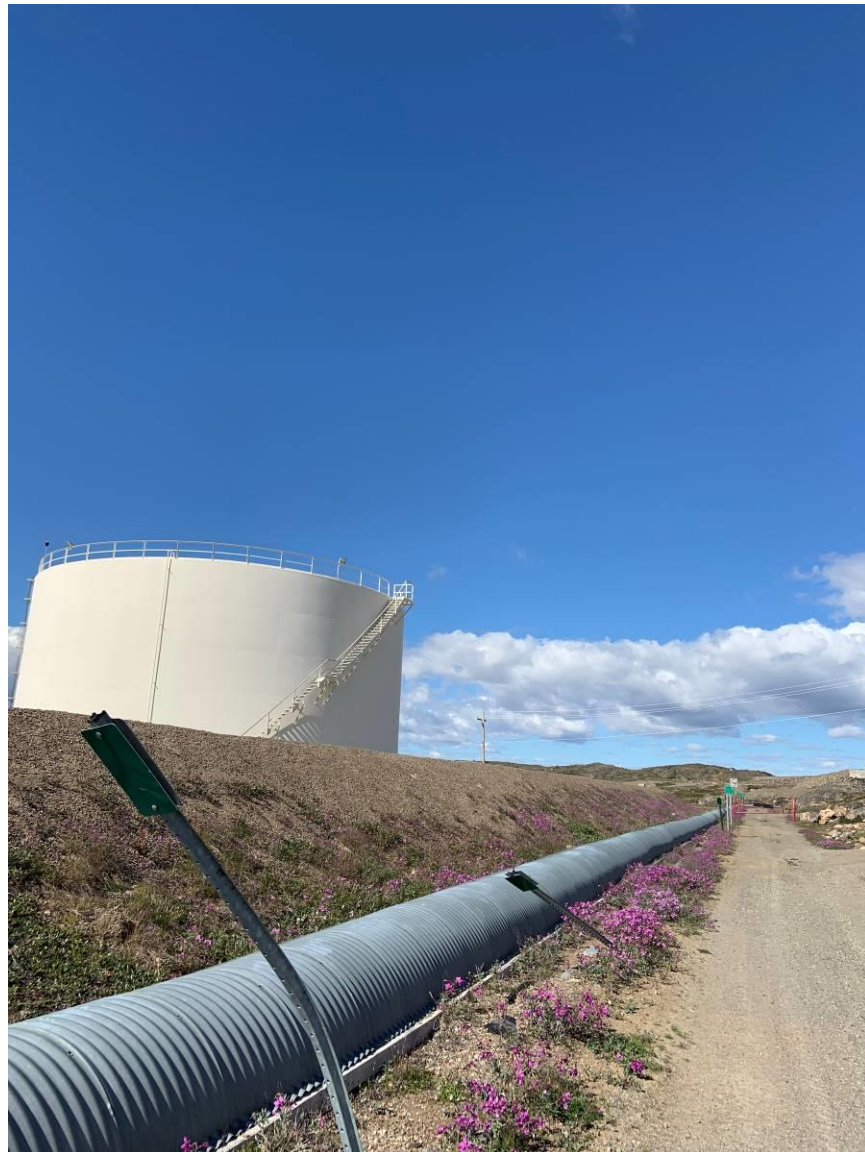
Photograph 10 – Blizzard markers knocked over

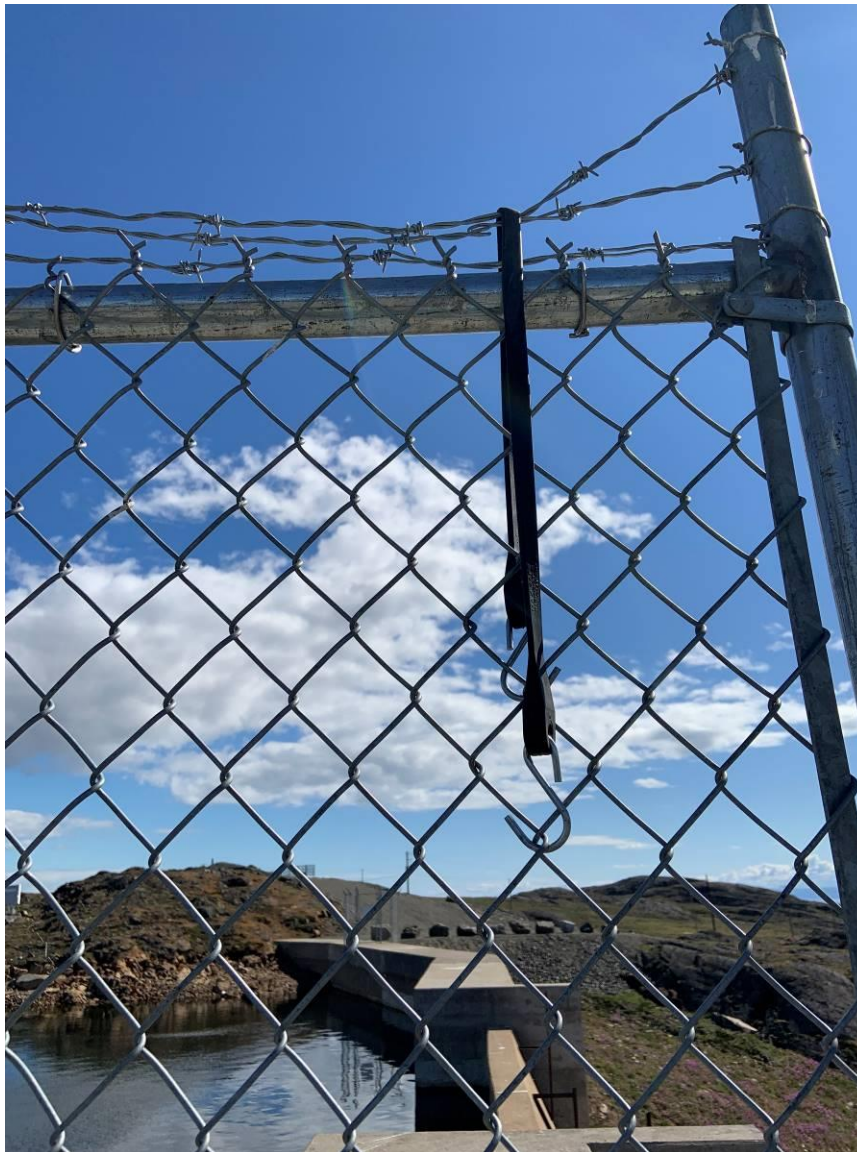
Photograph 11 – Bungee cord suppressing barbed wire

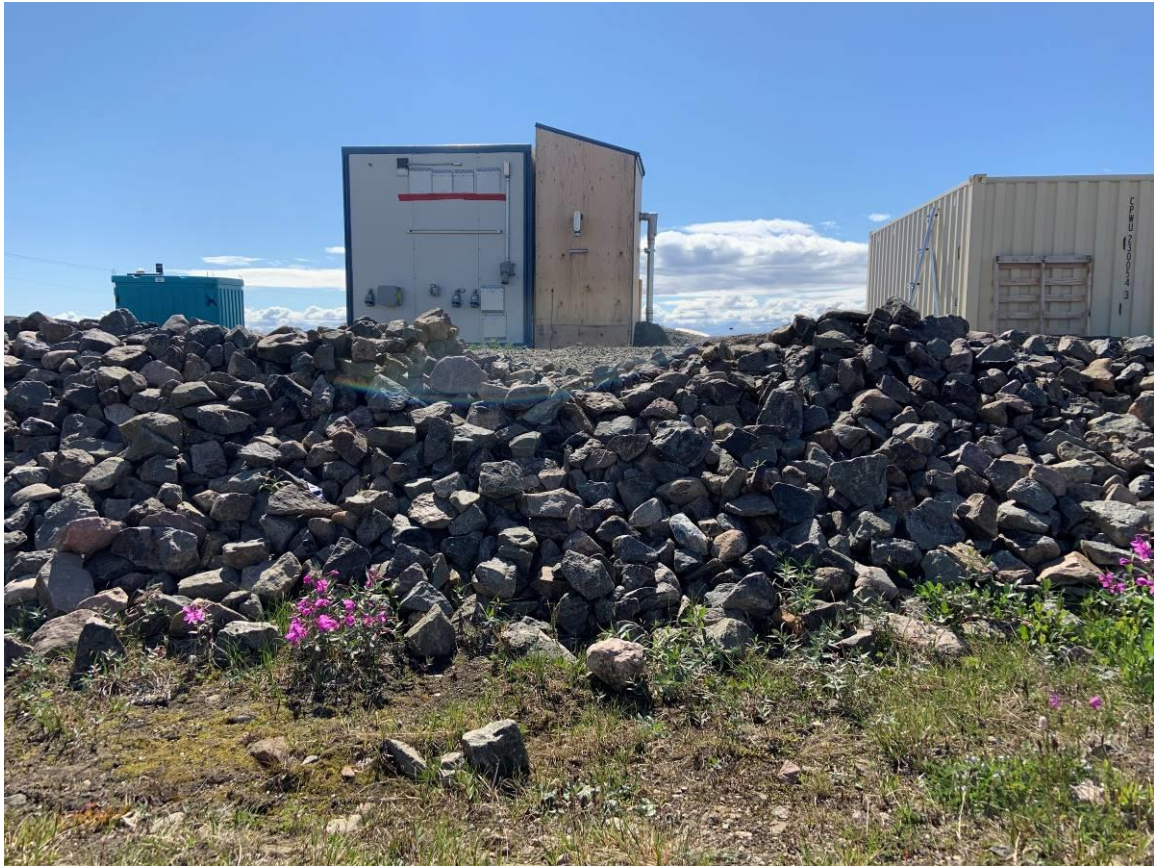
Photograph 12 – Displaced rip rap in South Berm

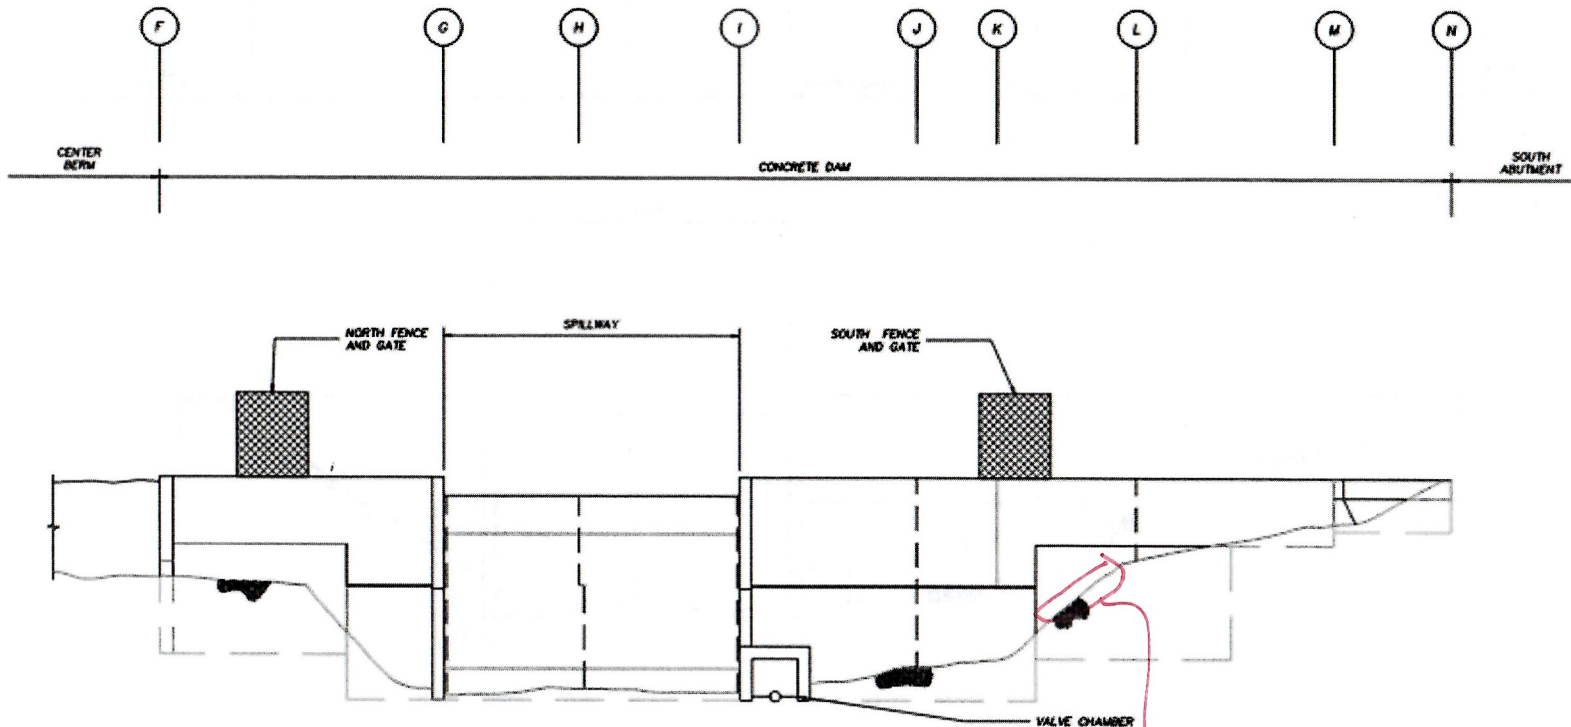
Elevation – Downstream Face, Concrete Dam and Spillway

Leakage in
this location

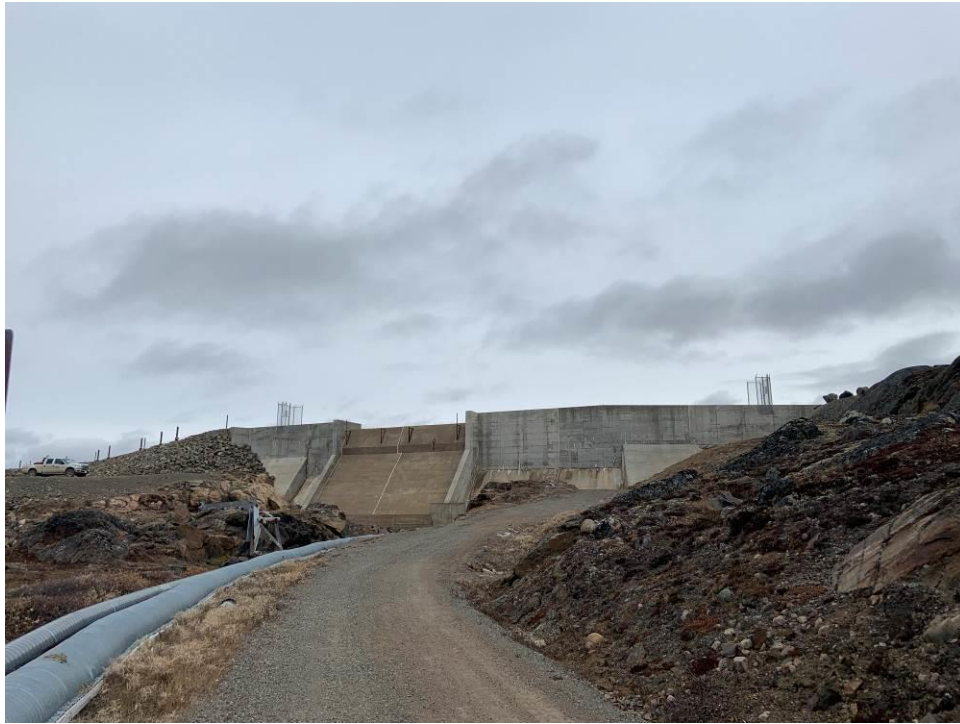
Photograph 1 – Overview of concrete structure.

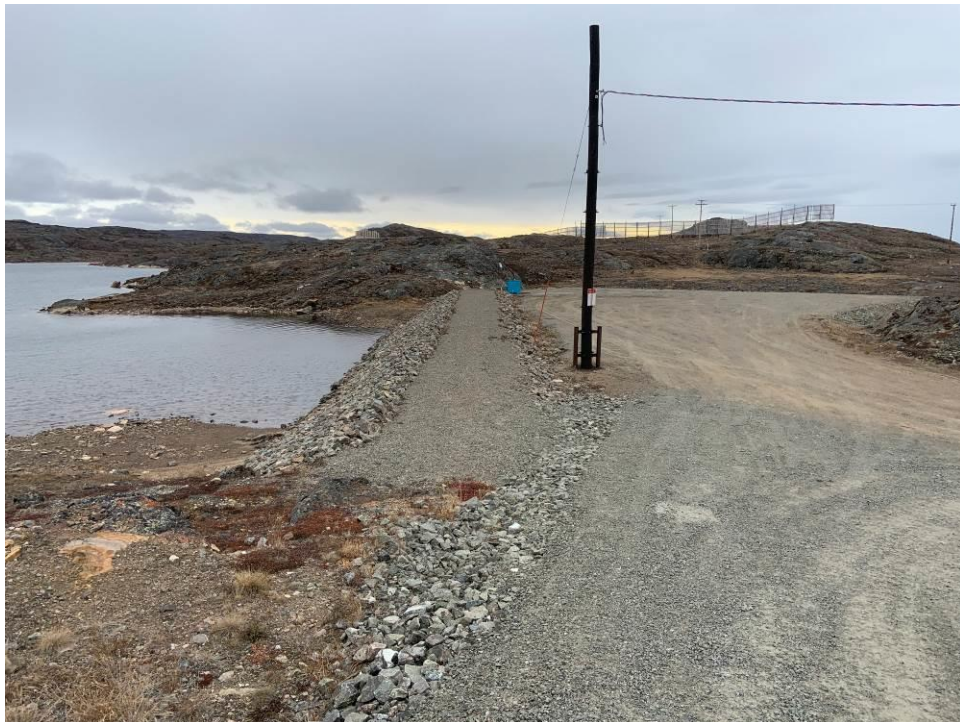
Photograph 2 – Typical south berm condition at the time of our review.

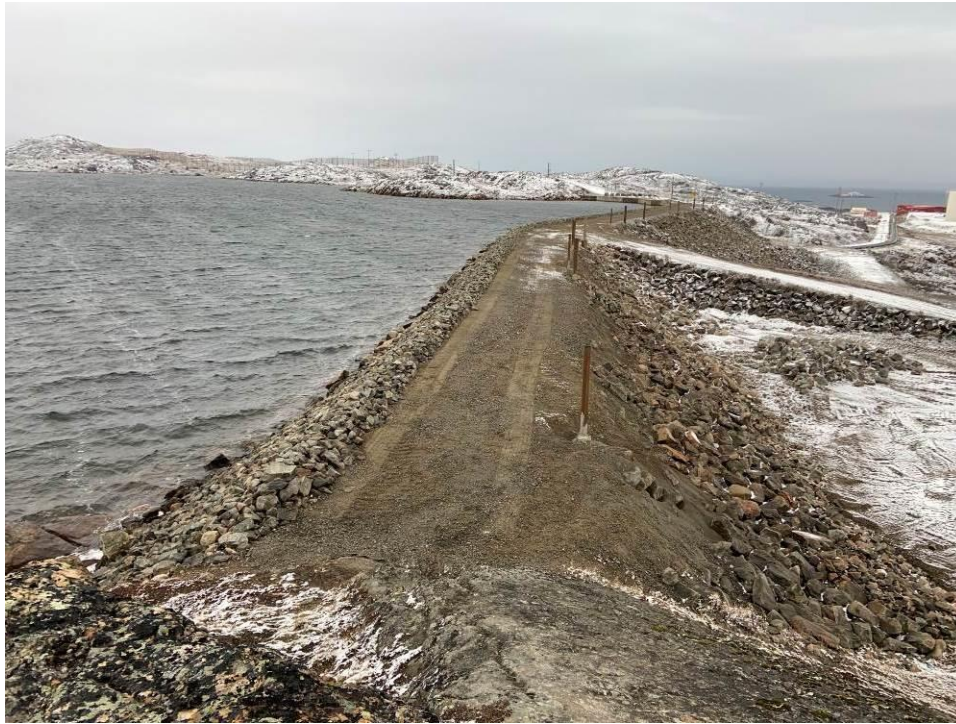
Photograph 3 – Typical north and center berm condition at the time of our review. New monitoring stations installed.

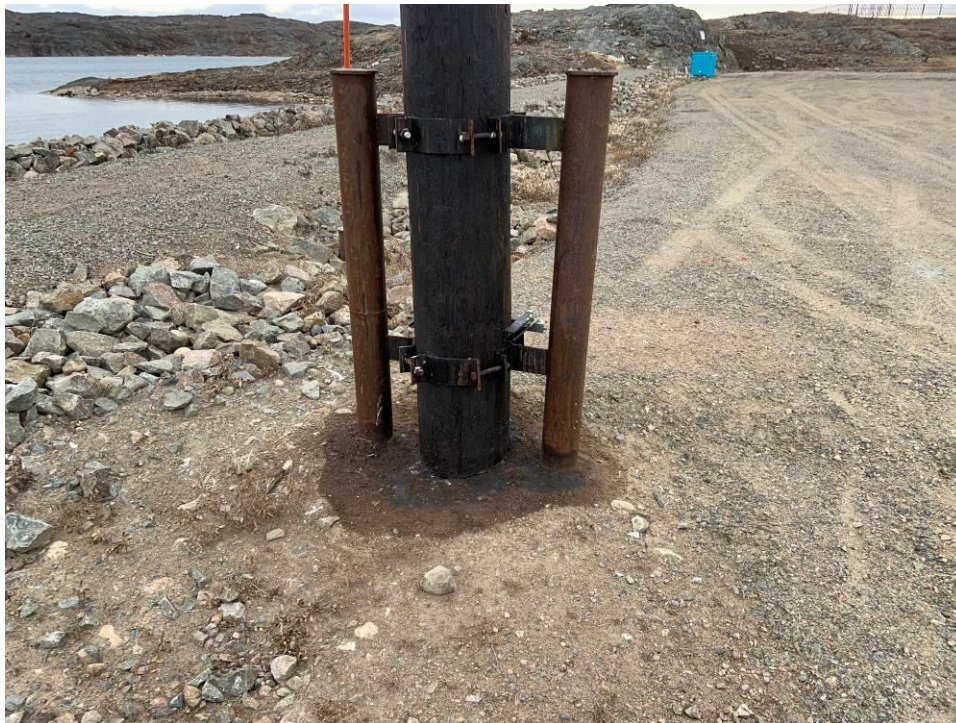
Photograph 4 – Oil residue on the ground around the base of the hydro pole, south berm.

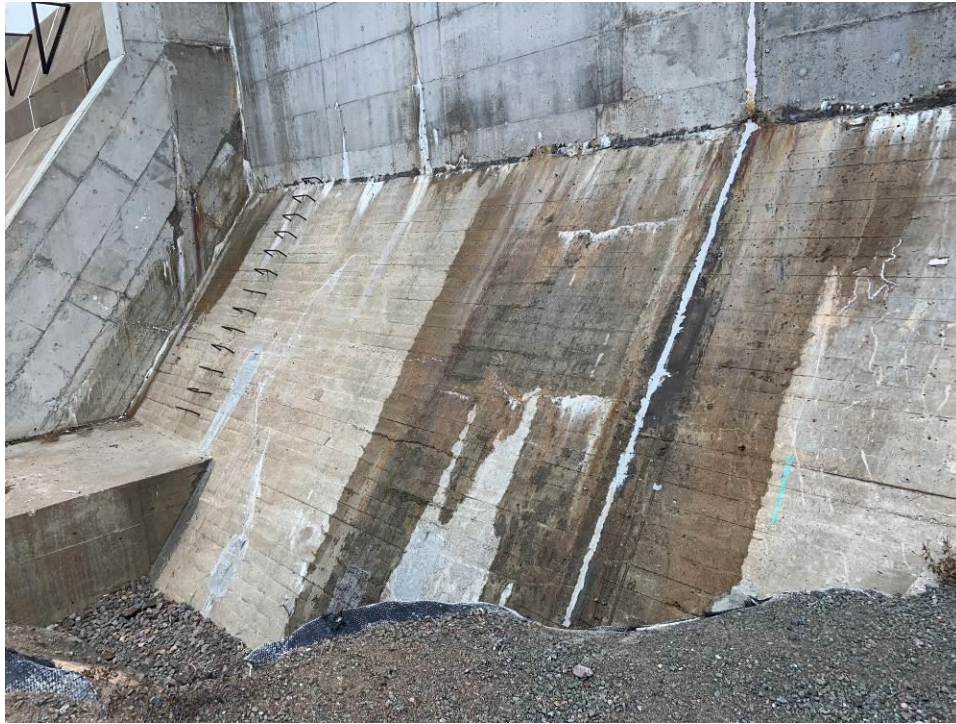
Photograph 5 – Typical expansion joint (concrete dam).

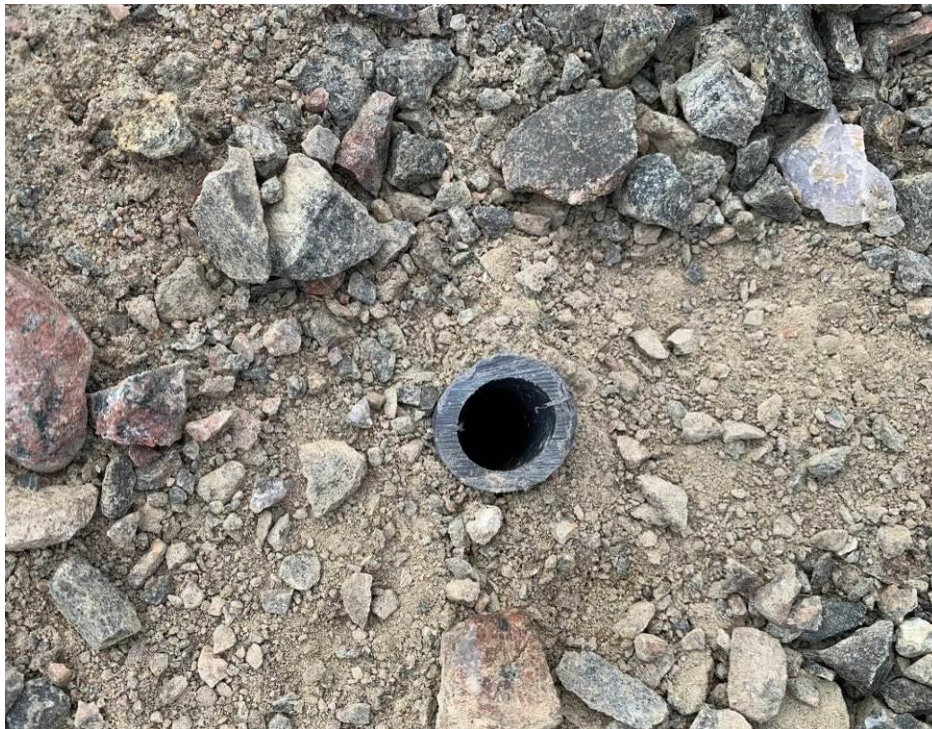
Photograph 6 – Borehole tube for piezometer (open).

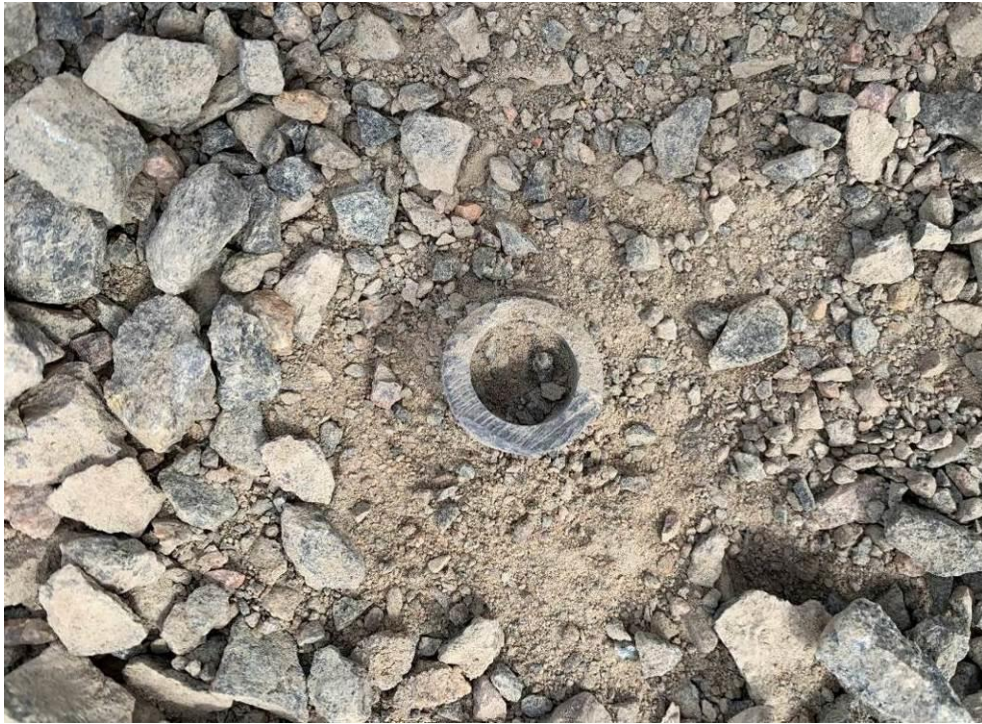
Photograph 7 – Borehole tube for piezometer blocked with aggregate material.

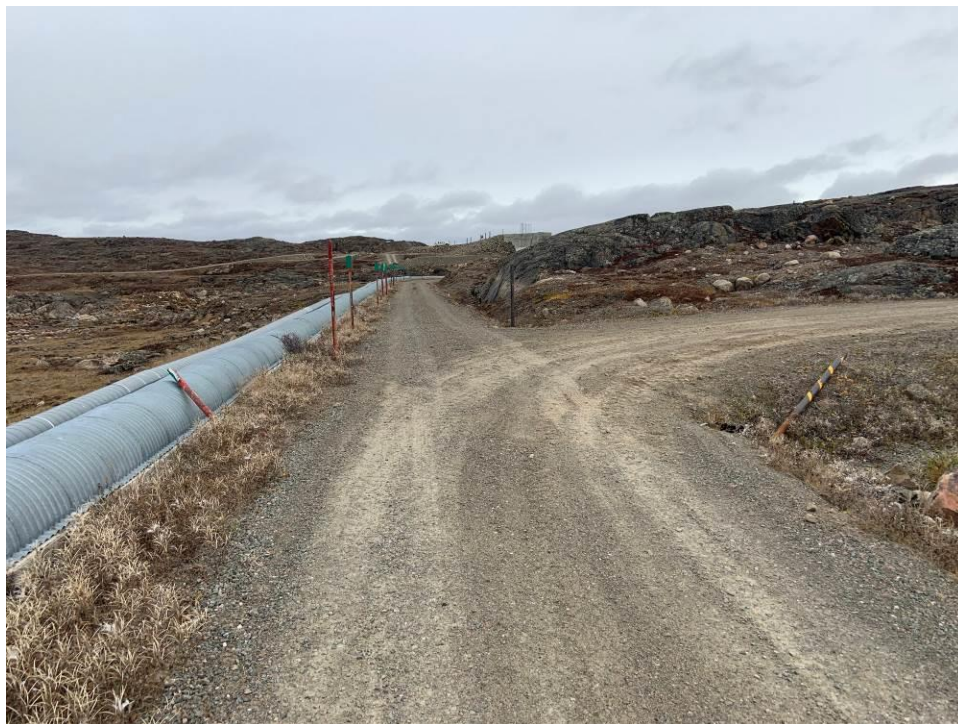
Photograph 8 – Corner marker at the junction of the south access road and the road to the south berm has been knocked over.

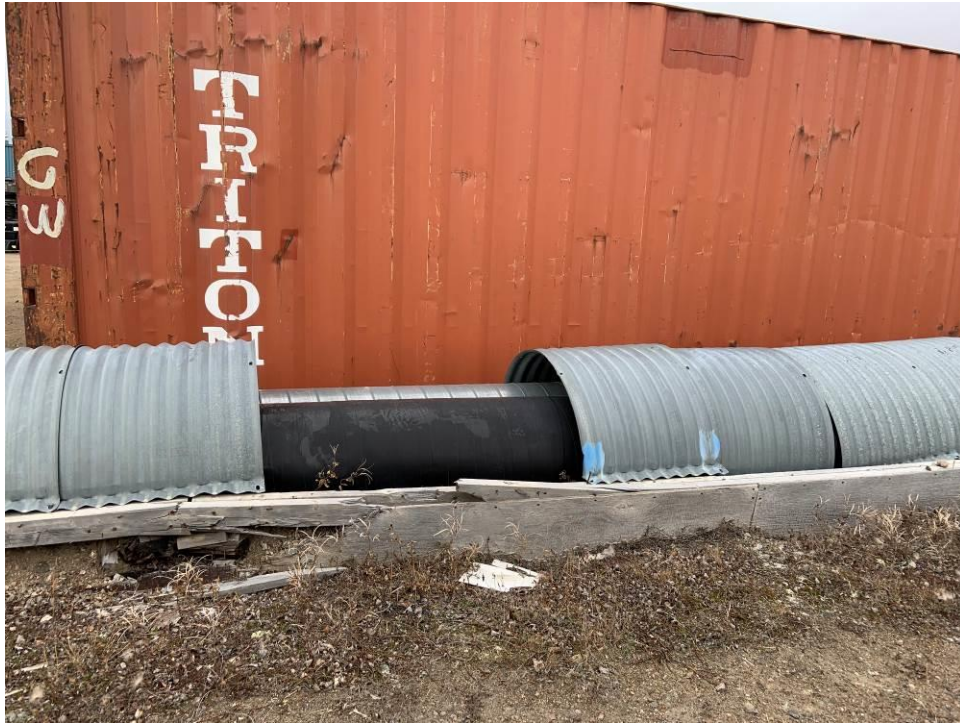
Photograph 9 – Section of the supply pipe from the dam with the corrugates metal enclosure removed.

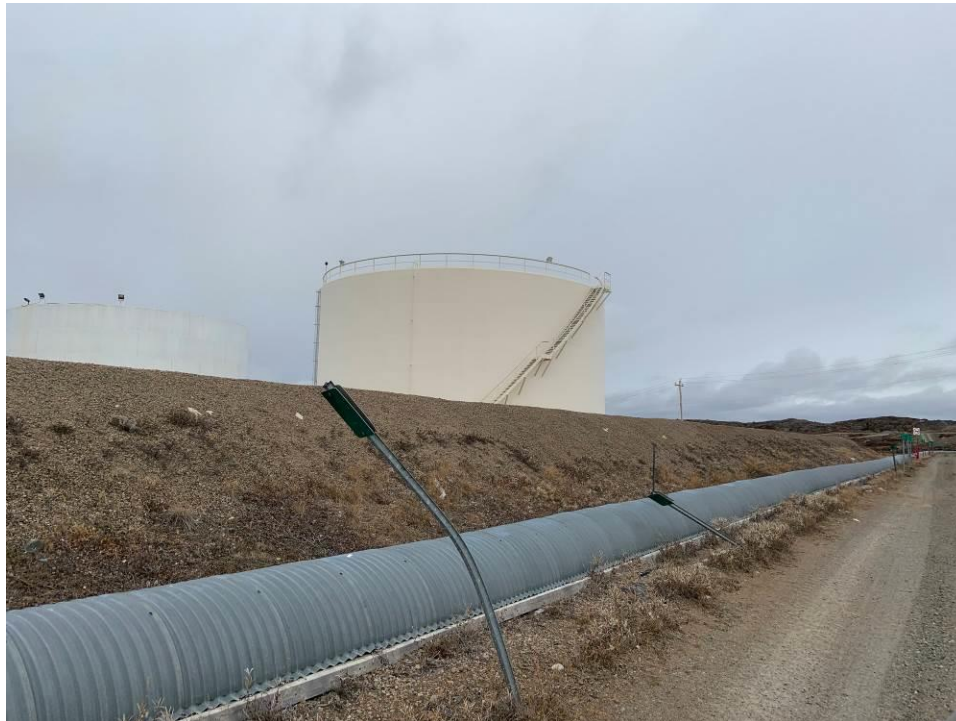
Photograph 10 – Blizzard markers knocked over.

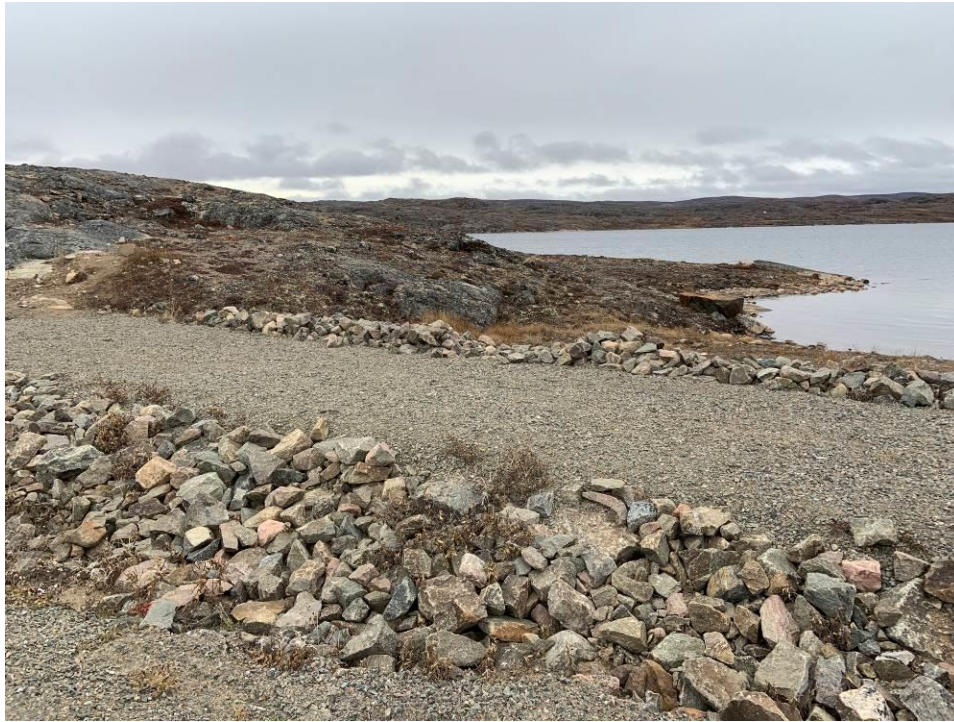
Photograph 12 – Displaced rip rap in South Berm.

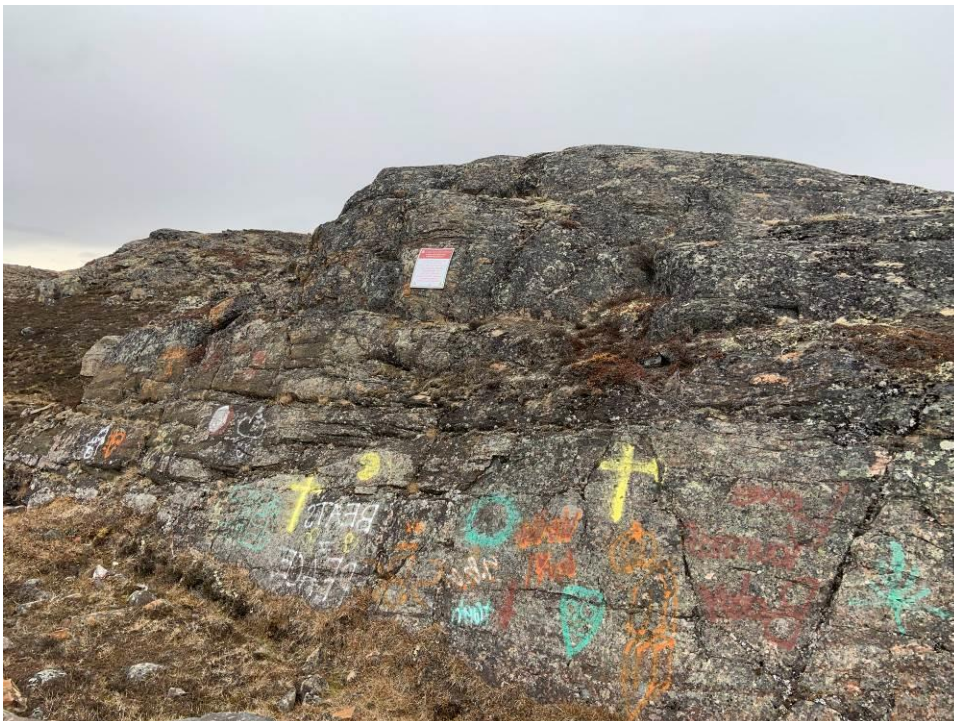
Photograph 13 – Warning signage installed in the wrong location at the South end of the South Berm.
