**LAKE GERALDINE DAM
DAM SAFETY INSPECTION 2023 #1 REV 1
IQUALUIT, NUNAVUT**

PRODUCED FOR: THE CITY OF IQUALUIT
C/O COLLIERS PROJECT LEADERS

PRODUCED BY: CONCENTRIC ASSOCIATES INTERNATIONAL INCORPORATED

DATE: JUNE 8TH, 2023

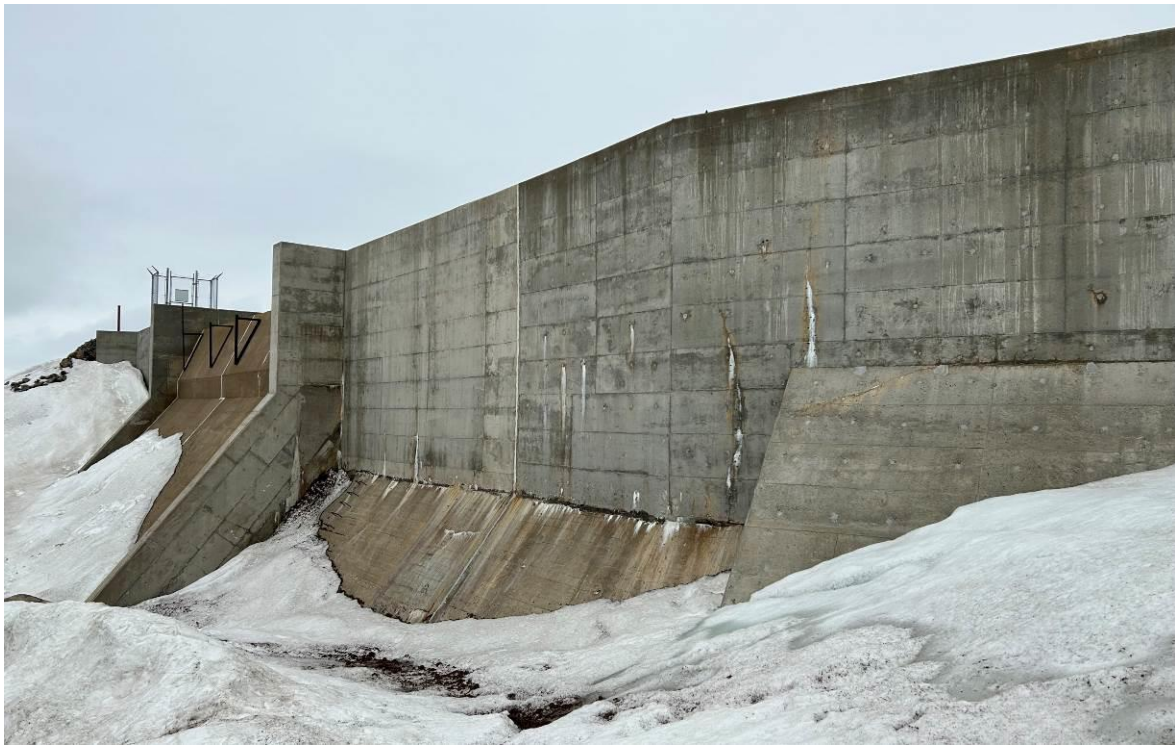
Photograph 1 – Overview of concrete dam structure.

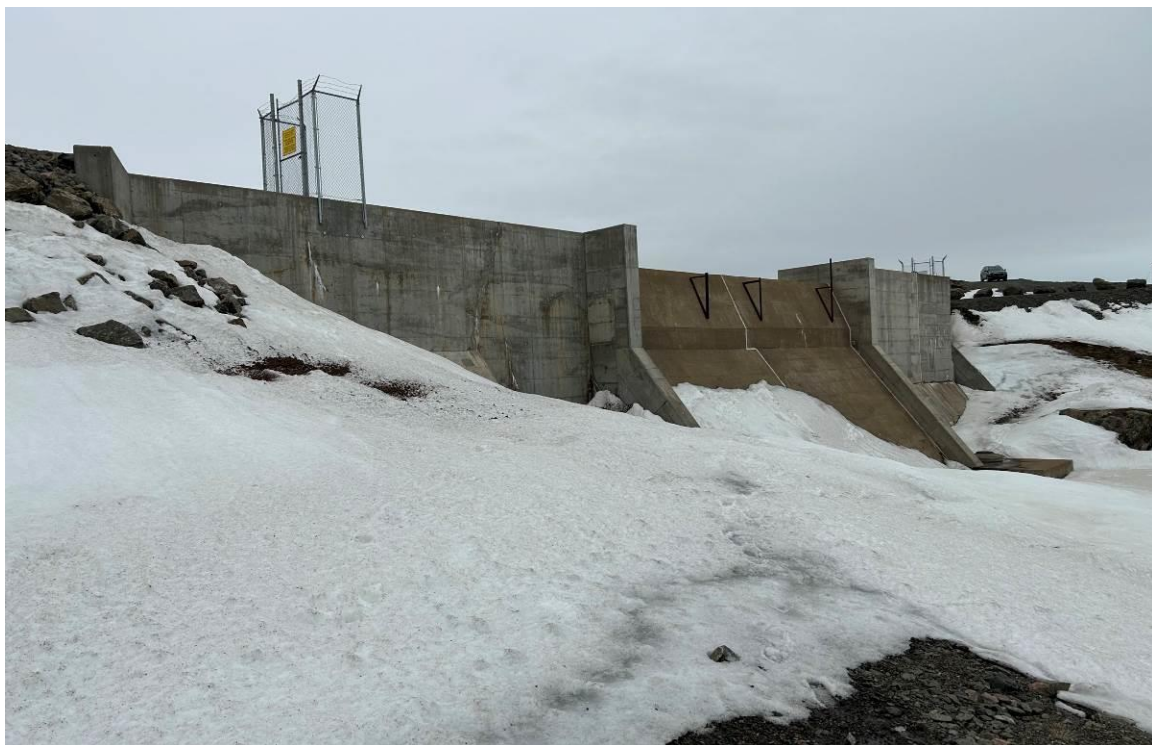
Photograph 2 – Overview of concrete dam structure.

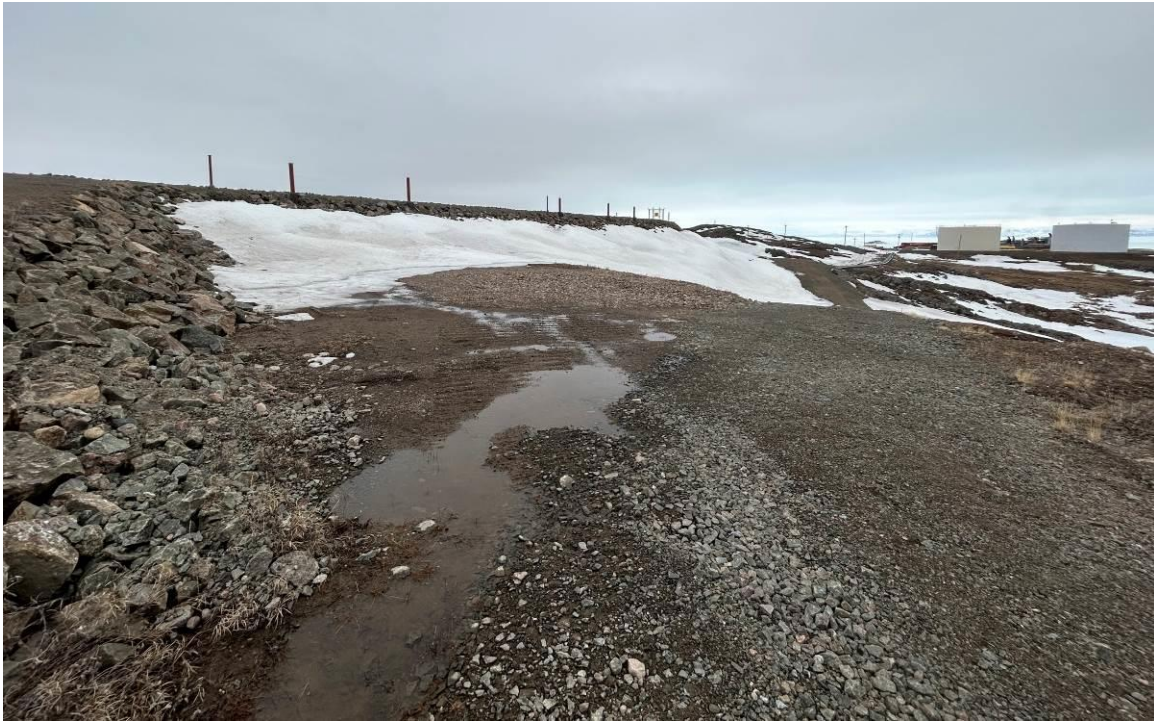
Photograph 3 – Downstream face of the center berm.

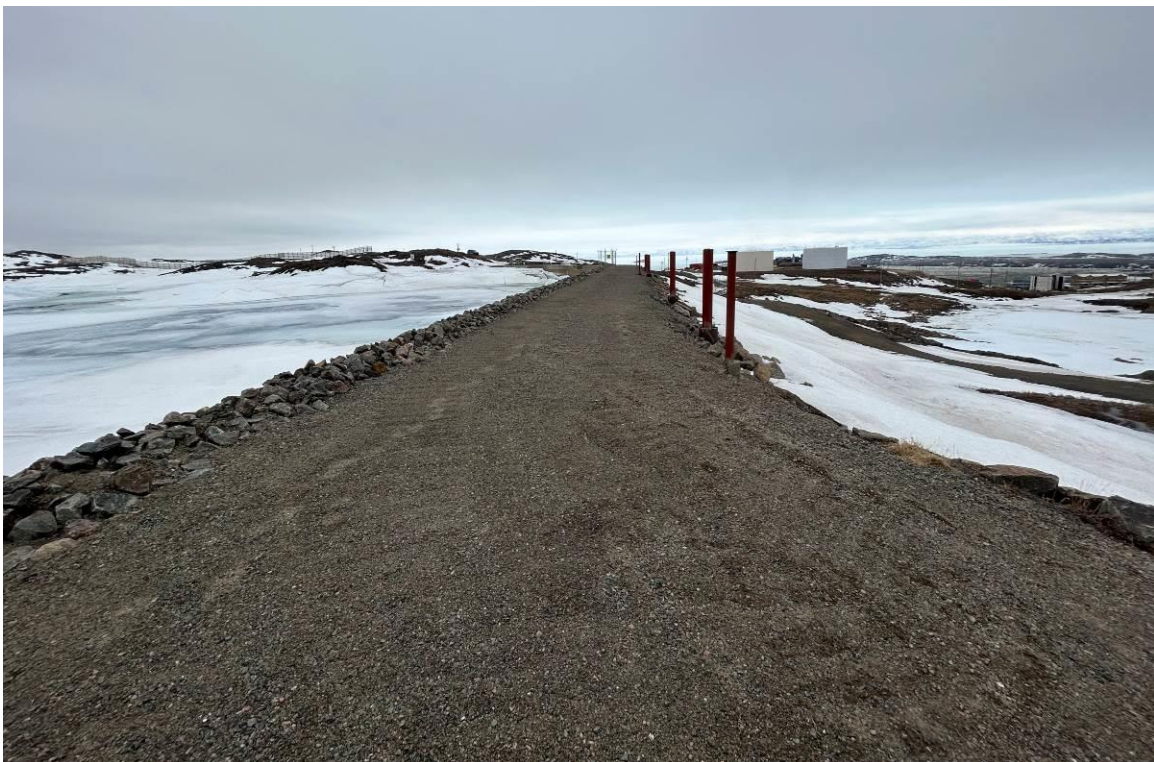
Photograph 4 – Top of the center berm.

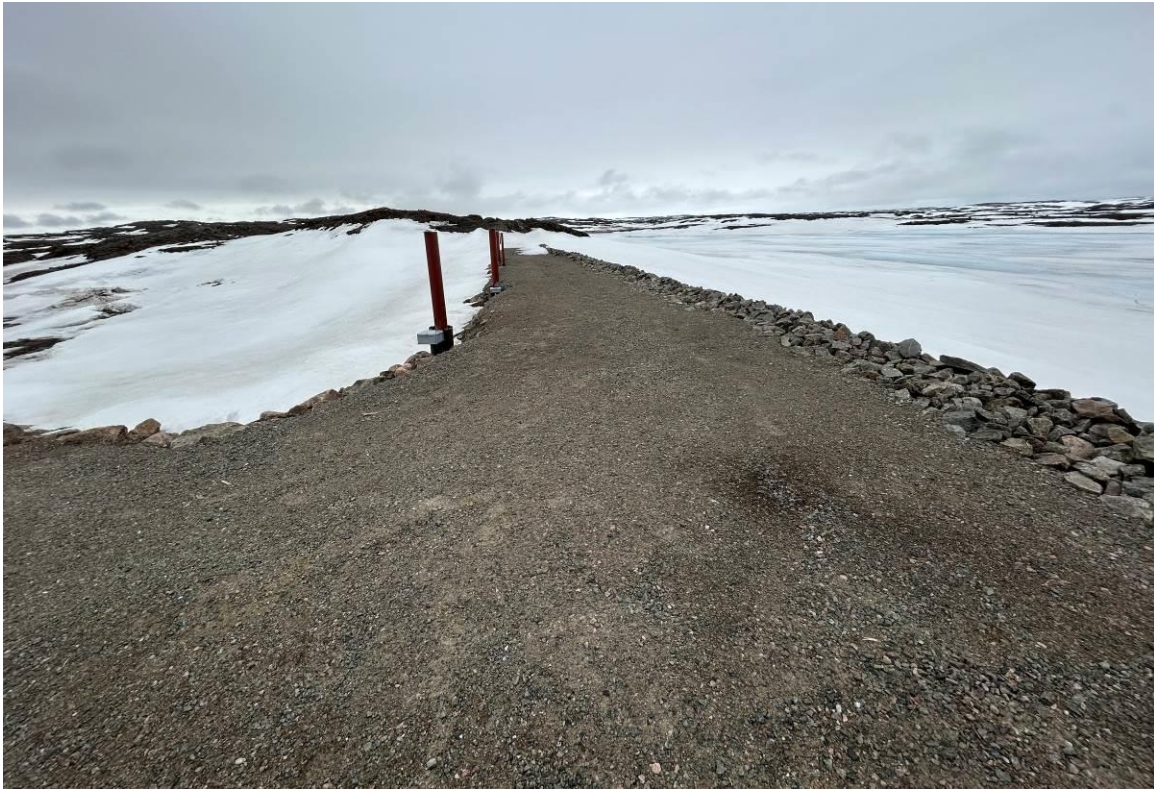
Photograph 5 – Top of north berm.

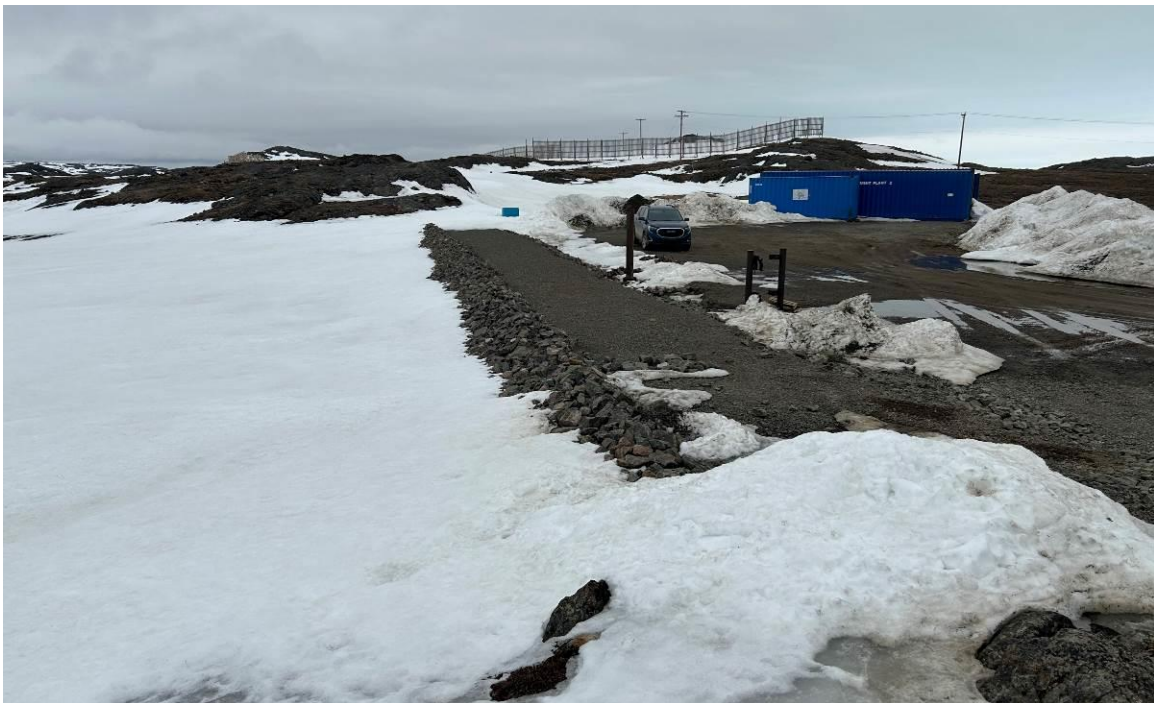
- The power pole that had previously supplied power to the temporary water treatment facility at the south berm has been removed. It is unclear if the VOC contaminated soil observed at the base of the pole and noted in DSI no. 4, dated September 29, 2022 had been removed from site (due to snow and ice). This item will be verified on our next visit to the site.

Photograph 6 – South berm, note the electrical pole adjacent to the berm has been removed.

1. Items deemed to be of an immediate need include:
 - a. Removal of the contaminated soil around the base of the hydro pole adjacent to the south berm.

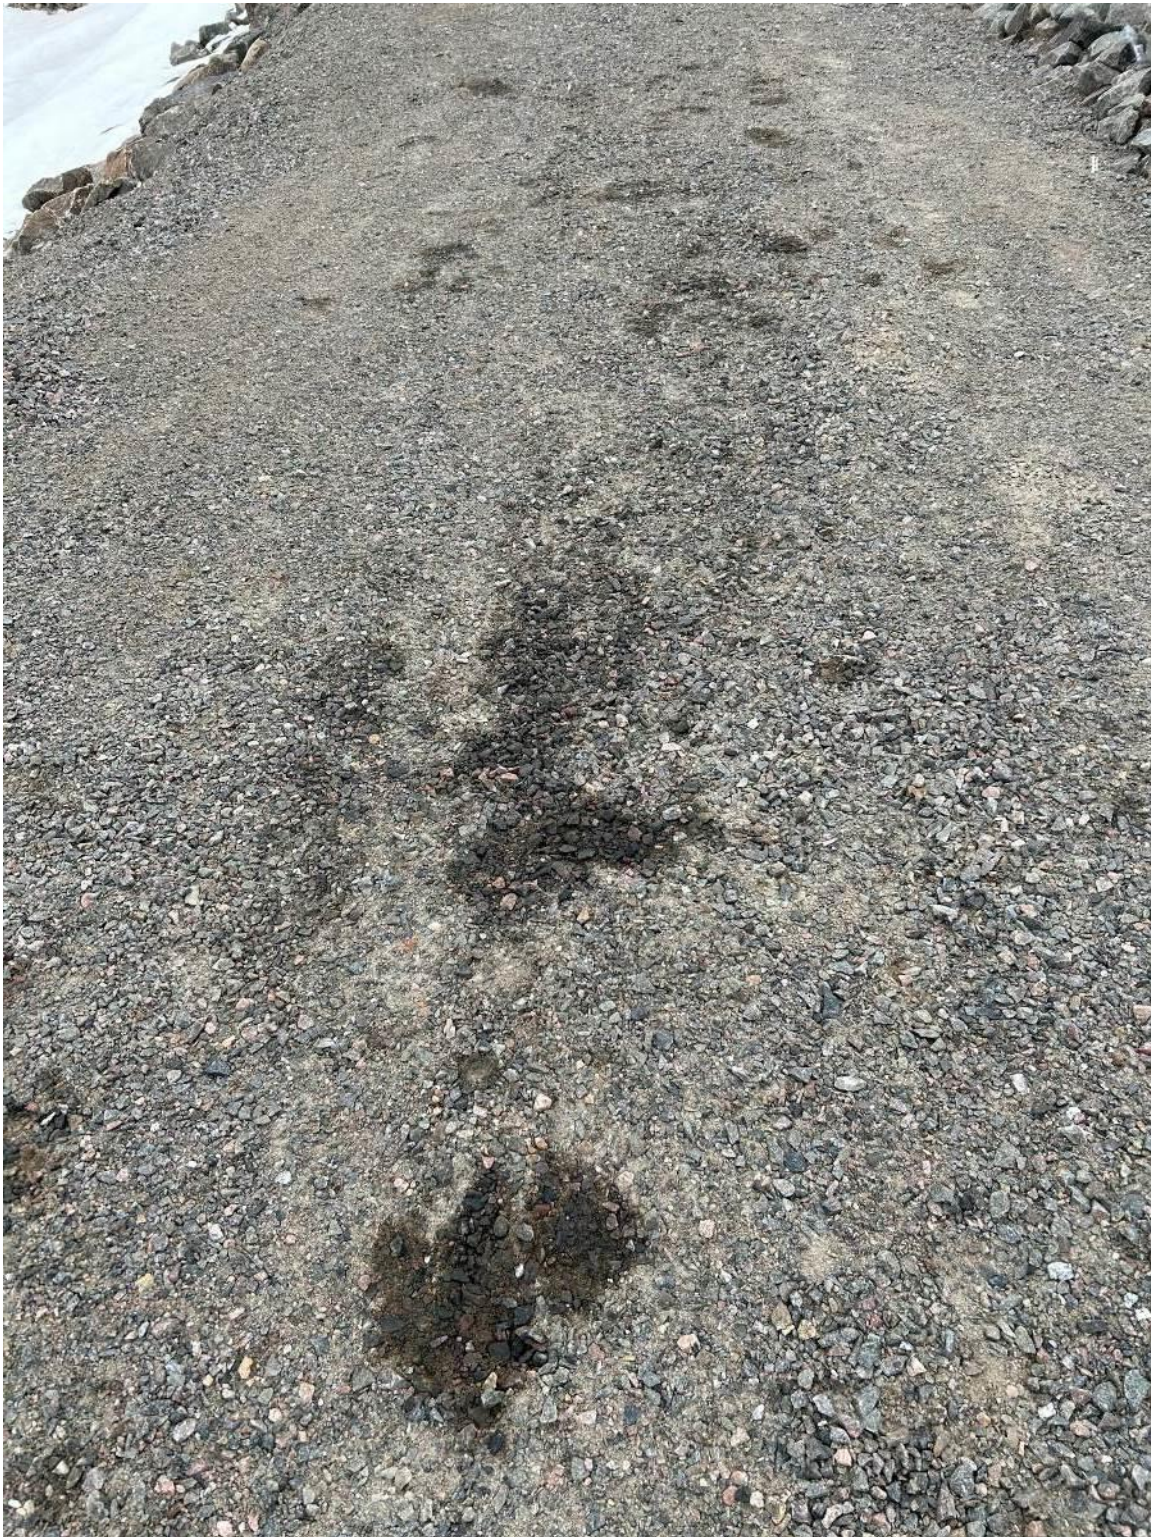
- The aggregate stockpiles located on the downstream side of the north berm could not be verified due to the snow and ice present.
- The drilling contractor has spilled/leaked hydraulic fluid atop the center and north berms, this material should be removed from atop the berms and new material installed. The Contractor has been advised to correct this item by Concentric.

Photograph 7 – Oil residue (hydraulic fluid) atop the center berm from drill rig.

Oil contamination was noted on top of the berm, this appears to be residue from the installation of the piles in the fall of 2022. The contractor has been advised to correct this item on site. See DSI report dated 8 June 2023 for additional details.

- b. Removal and replacement of the contaminated soil atop the center and north berms. The contractor undertaking the 2022 dam repairs has been directed to complete this work.

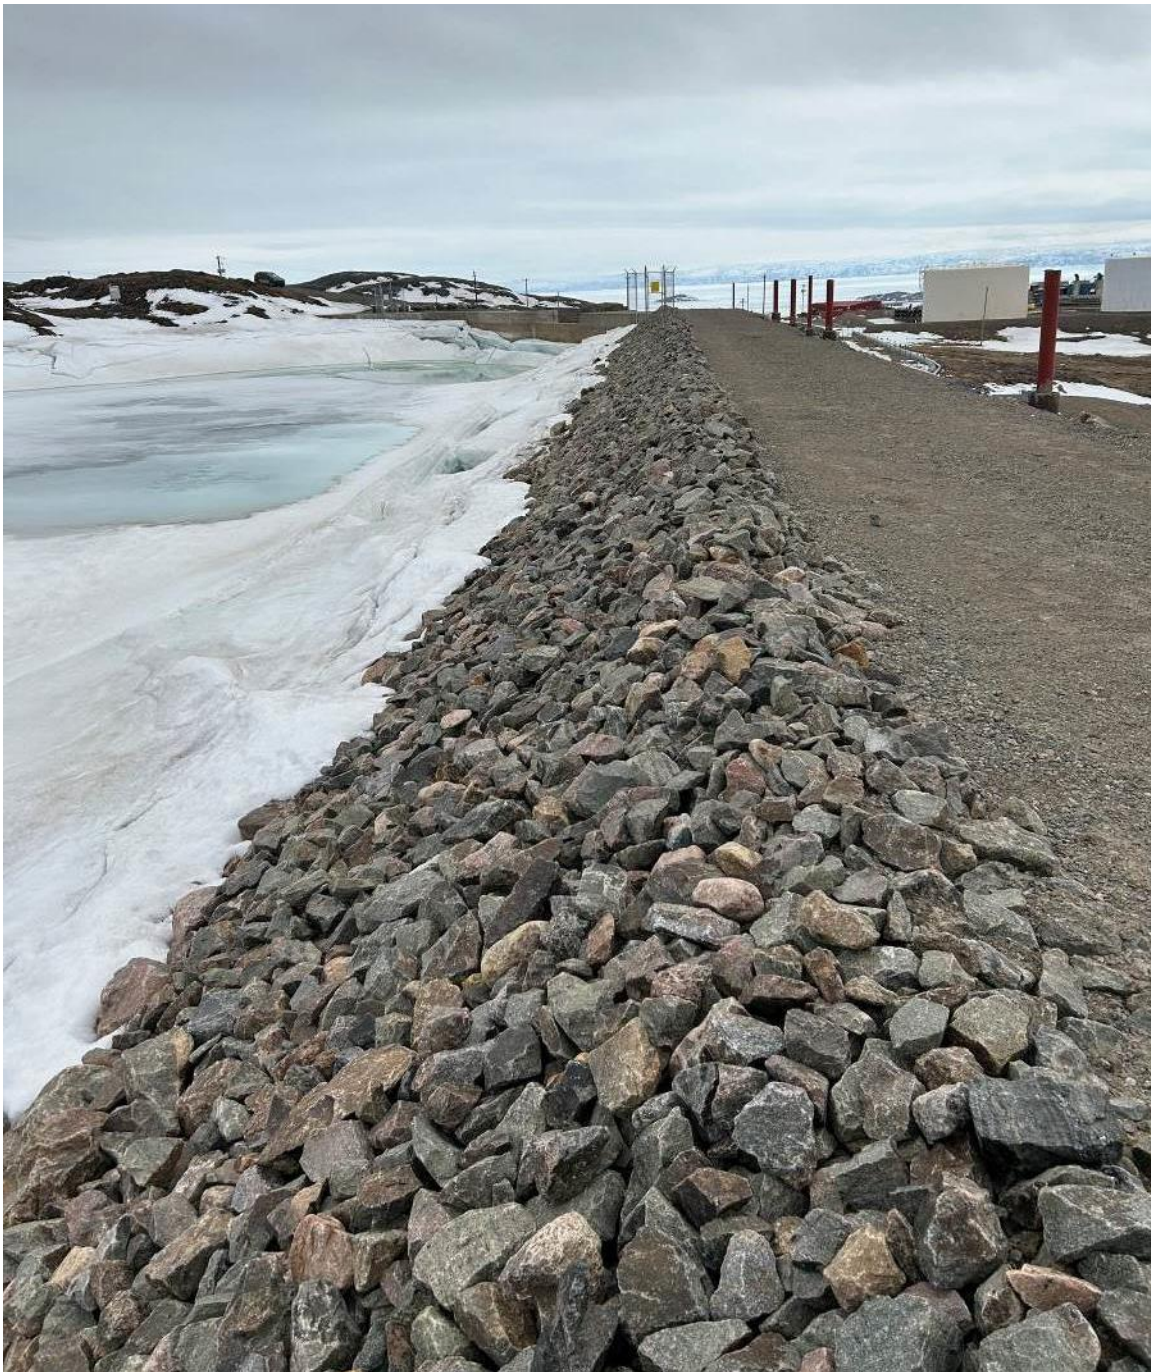
- Members of the public continue to access the Dam structures and Lake Geraldine.
- Several depressions within the upstream face of the dam were noted when the water level was low in June 2022, these depressions should be corrected in the spring – summer of 2023 when the water level is low in the dam.

Photograph 8 – Typical condition of the rip-rap on the upstream face of the center berm.

- c. Installation of new rip-rap material should be installed within the upstream face of the north and center berms prior to the reservoir being re-filled.

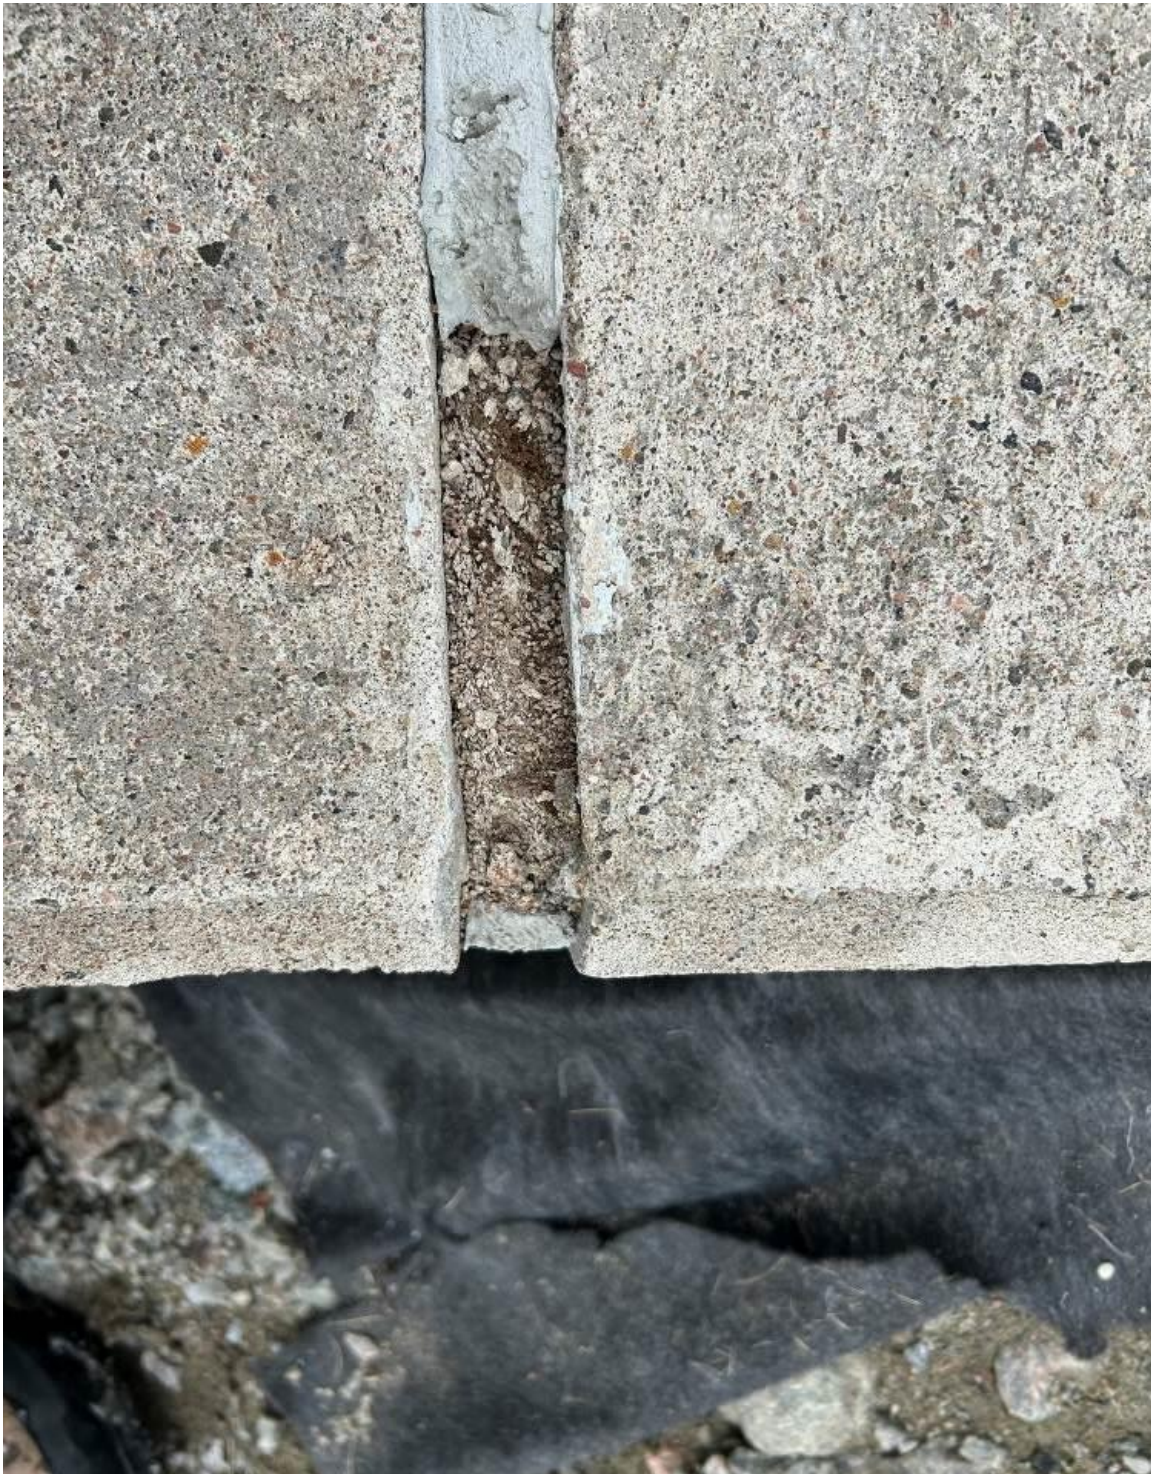
- A small section of the sealant material within the top of the concrete dam is missing at the south end of the dam. This material should be replaced in the immediate future.

Photograph 9 – Deteriorated section of the expansion joint sealant (top of dam).

Sealant Condition – Top of Dam	---	---	Minor sealant damage noted in the expansion joint atop the south end of the concrete dam, see photo. Minor repairs required. No seepage / leakage noted in the visible portion of the joint.	X
Sealant Condition – Up stream face of Dam	---	---	No issues noted.	
Sealant Condition – Downstream face of Dam	---	---	No issues noted.

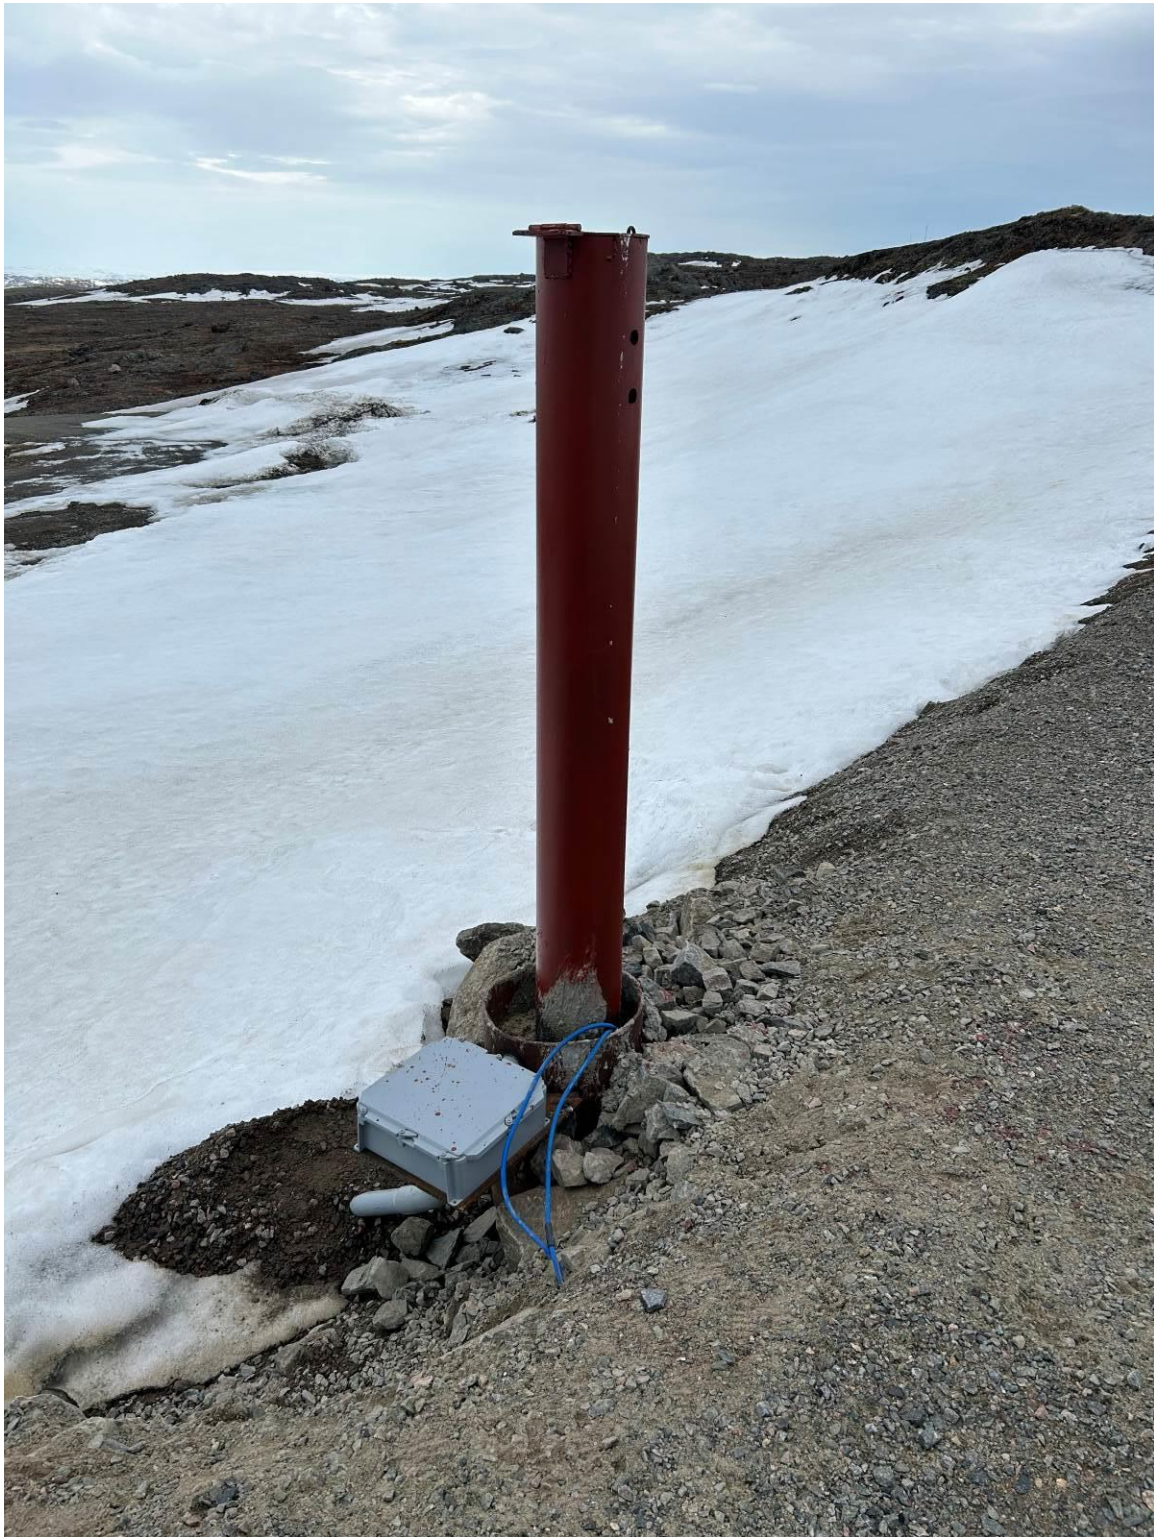
- Installation of five of the ten, temperature data loggers was completed on Thursday June 8, 2023. The data loggers are now operational and recording temperature data at these locations every 30 minutes. Installation of the remaining temperature data loggers will be completed in the immediate future (July 2023), once the snow and ice is gone at the base of the dam.

Photograph 10 – Typical temperature data logger installation.

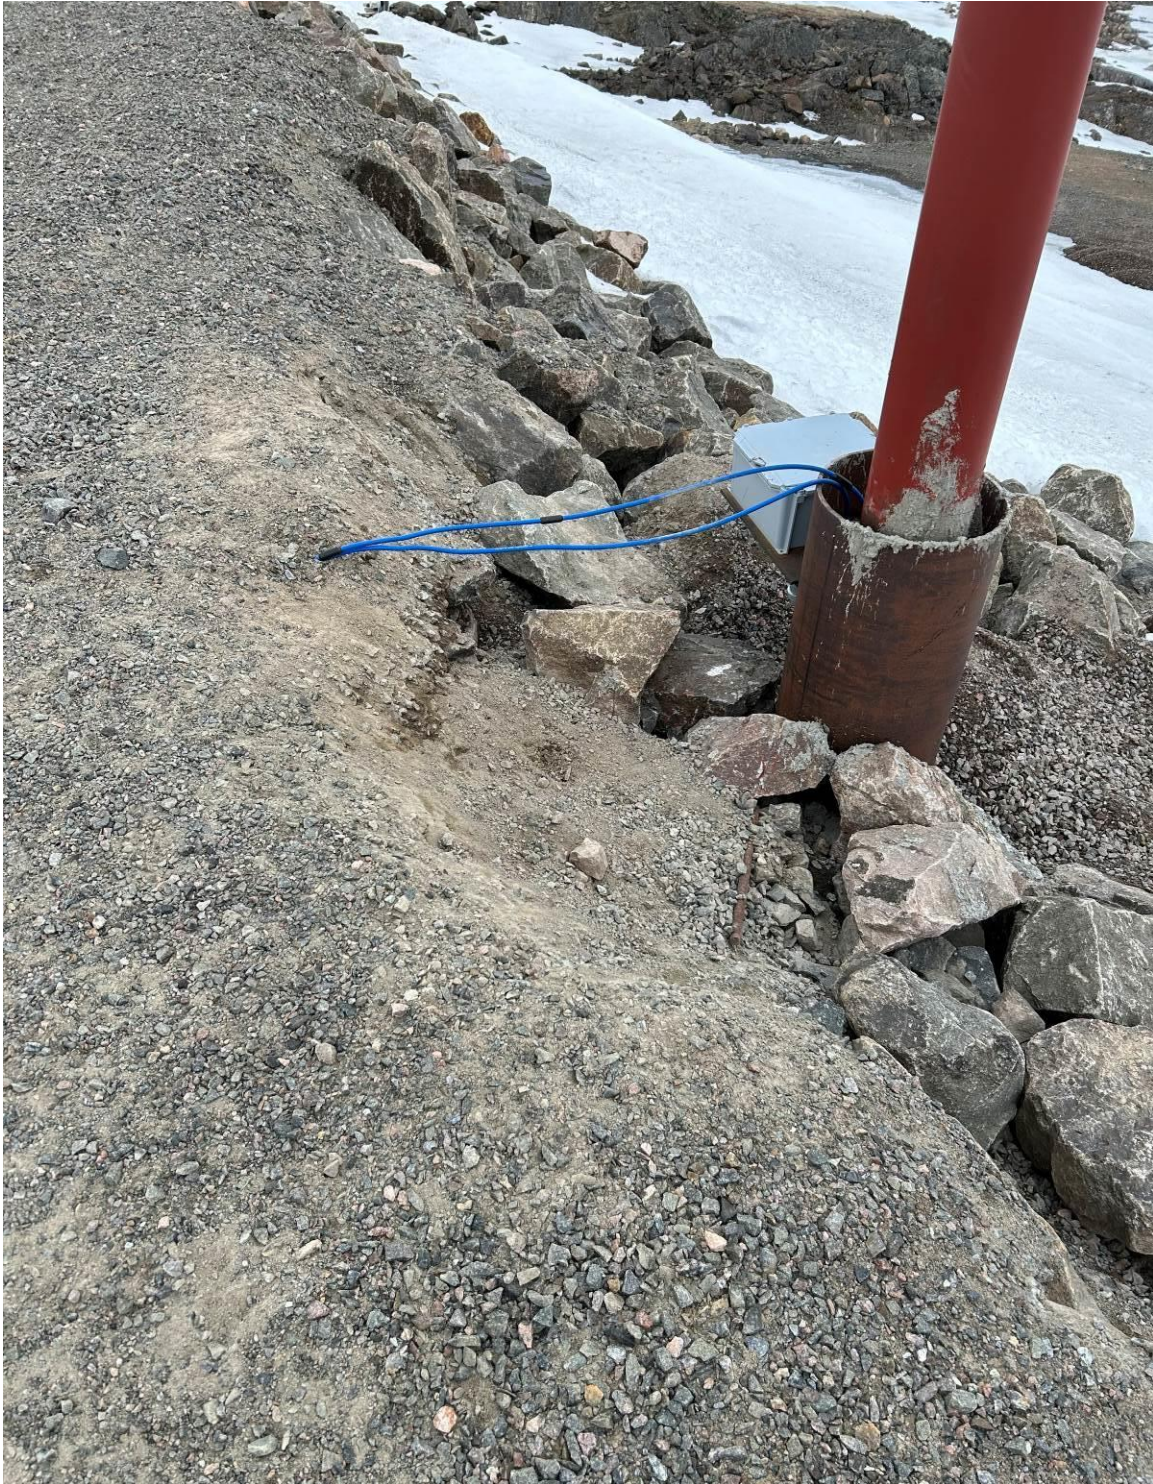
- Portions of the earthen berm have been disturbed at the base of the piles at several locations, the contractor has been directed to correct this item at all affected locations.

Photograph 11 – Typical data logger casing (pile), note a large section of the earthen berm has been moved during the installation of the pile. The contractor has been advised by Concentric to correct this issue at all impacted locations.
