**LAKE GERALDINE DAM
DAM SAFETY INSPECTION 2023 #2
IQUALUIT, NUNAVUT**

PRODUCED FOR: THE CITY OF IQUALUIT
C/O COLLIERS PROJECT LEADERS

PRODUCED BY: CONCENTRIC ASSOCIATES INTERNATIONAL INCORPORATED

DATE: JULY 24TH, 2023

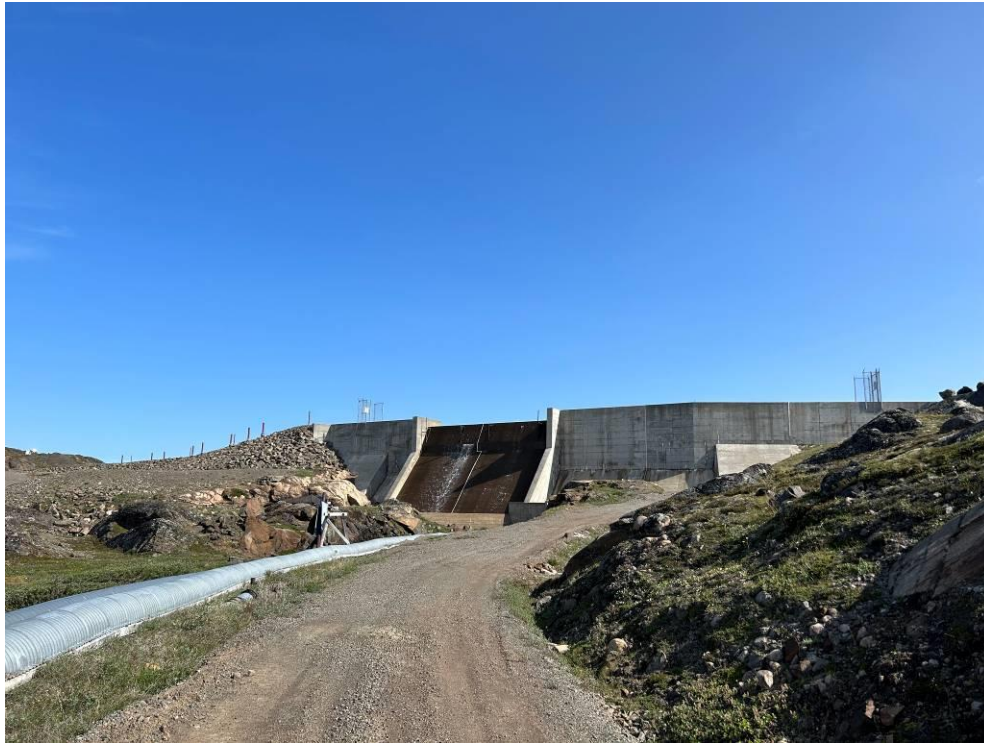
Photograph 1 – Overview of concrete dam structure.

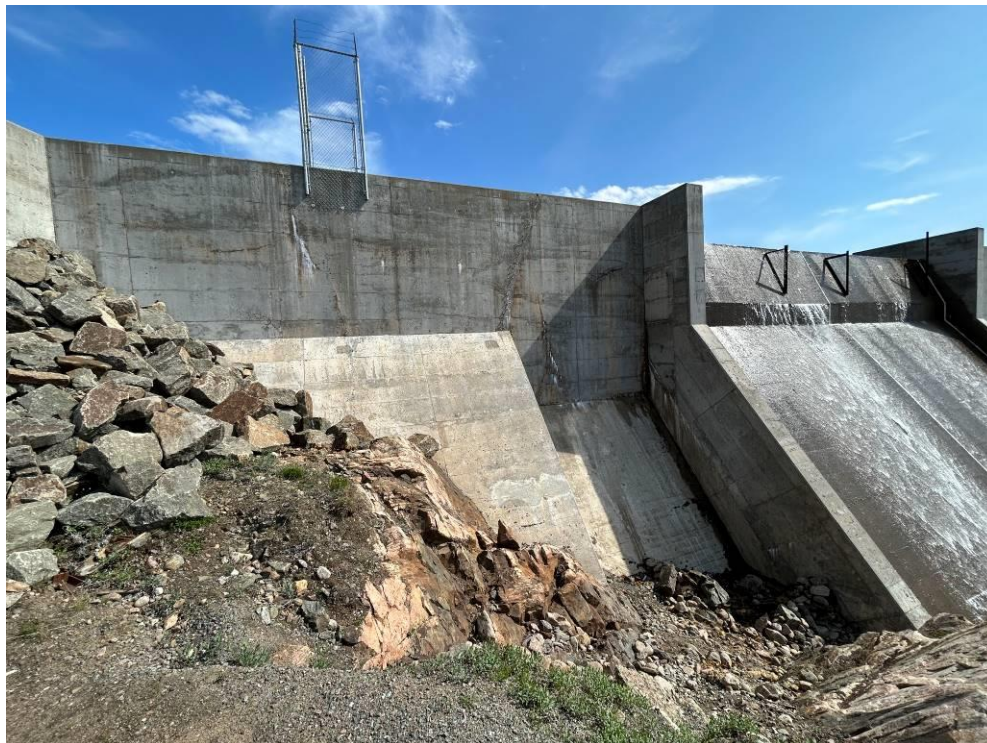
Photograph 2 – Overview of concrete dam structure.

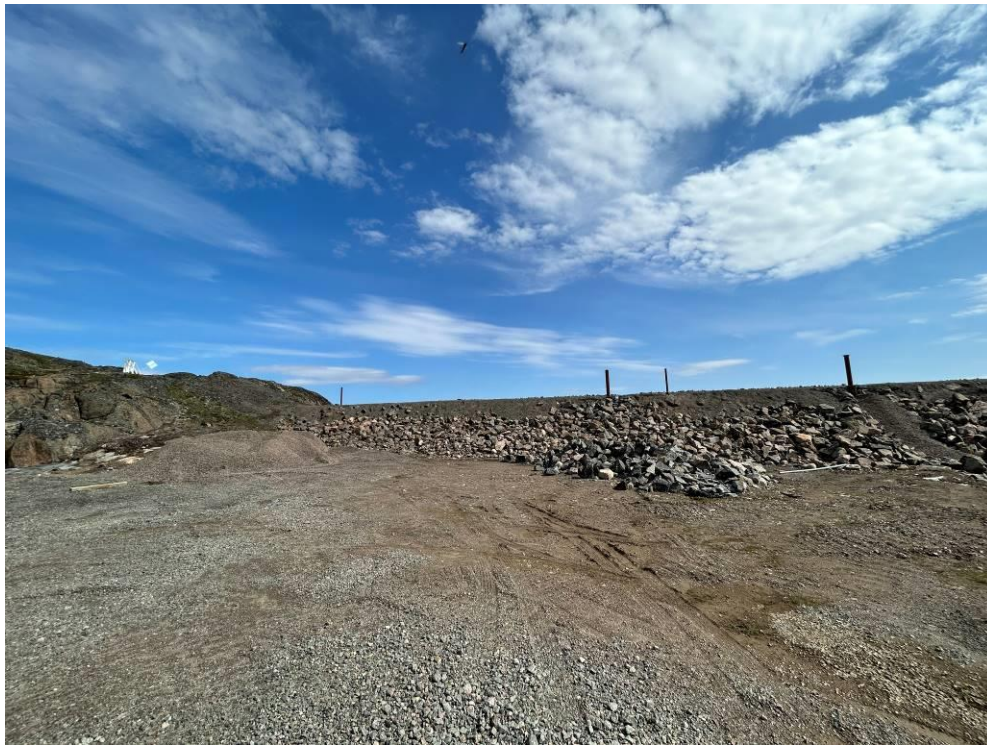
Photograph 3 – Downstream face of the North berm.

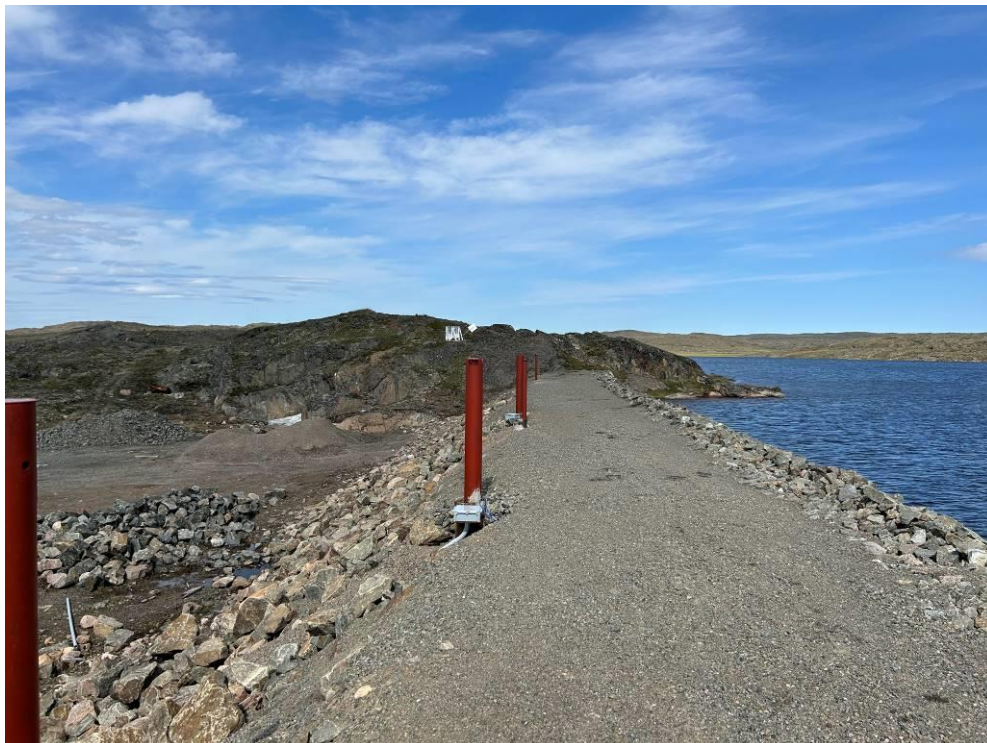
Photograph 4 – Top of the North berm.

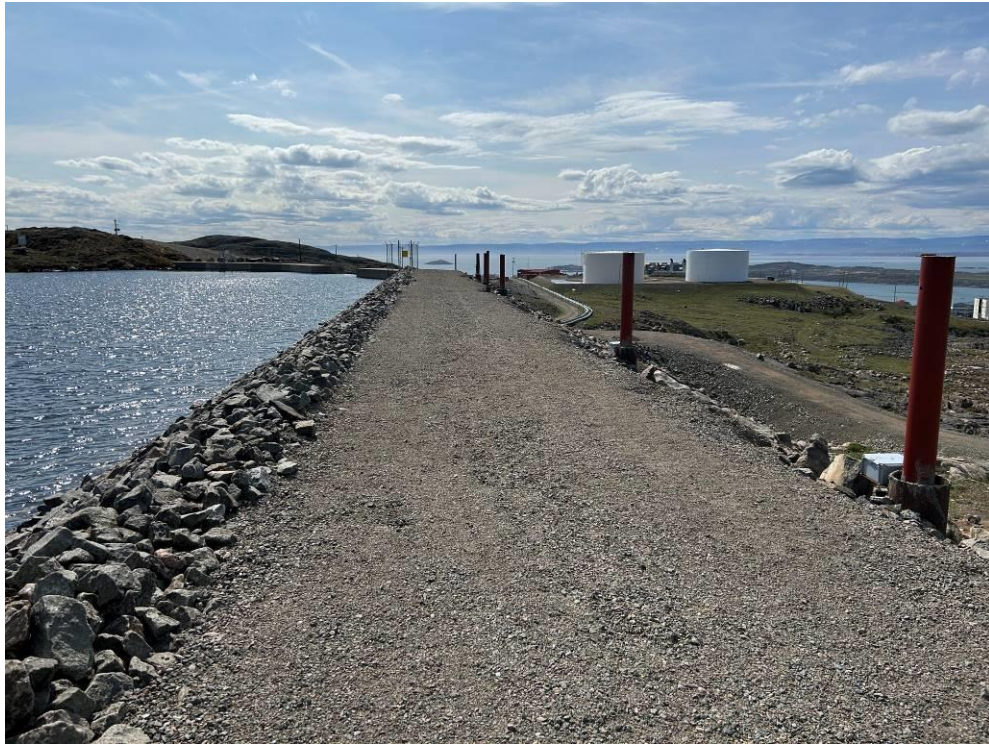
Photograph 5 – Top of Centre berm.

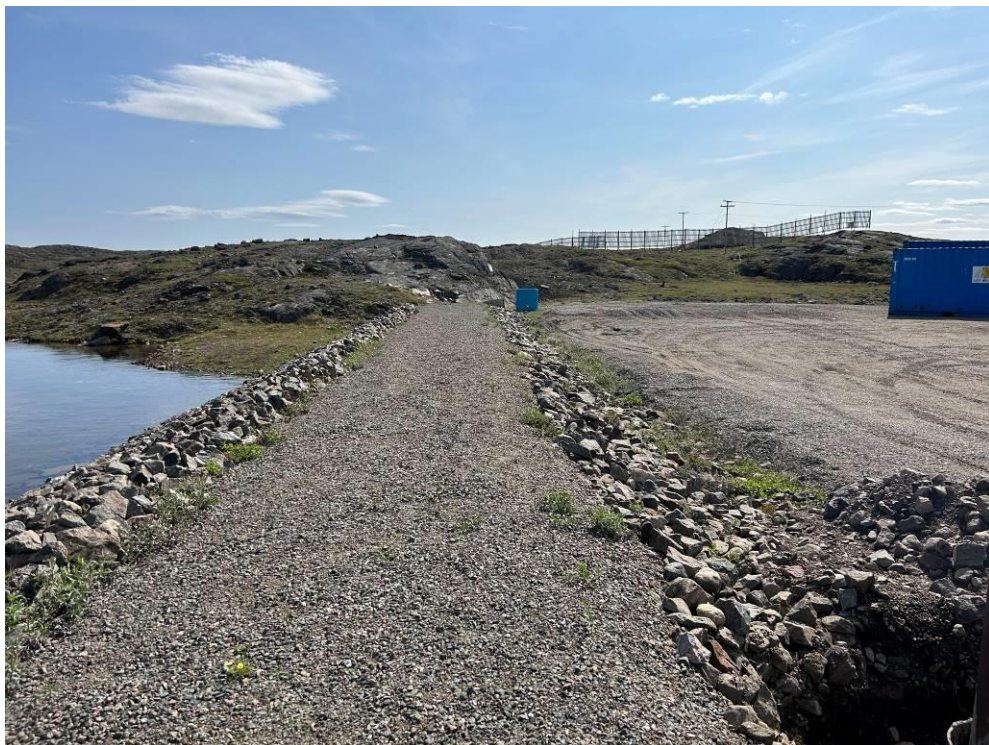
- The concrete barriers on the South access road were in place. The North and South gate were left open, presumably since the previous inspection.
- The power pole that had previously supplied power to the temporary water treatment facility at the South berm has been removed. It does not appear as though the VOC contaminated soil observed at the base of the pole and noted in DSI no. 4, dated September 29, 2022 had been removed from site.

Photograph 6 – South berm, note the electrical pole adjacent to the berm has been removed.

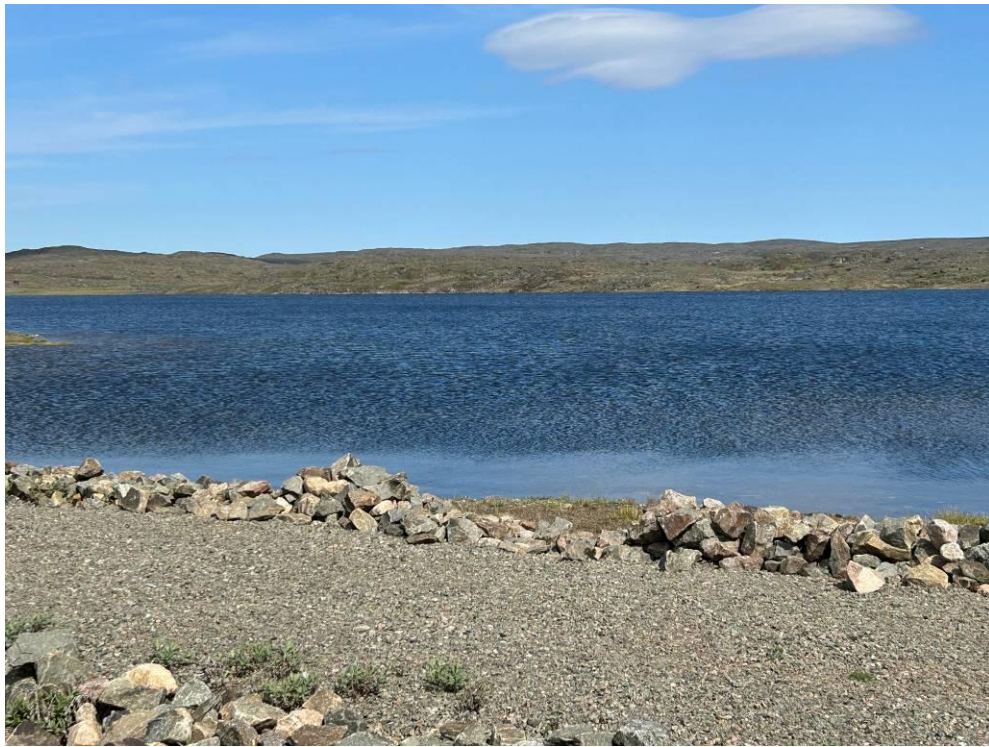
- The rip rap lip at the upstream face of the South Berm has a depression from the GNs mobile water treatment plant. Rip rap should be adjusted to meet the profile of the upstream face of the earthen berm.

Photograph 7 - Depression in rip rap lip on South berm.

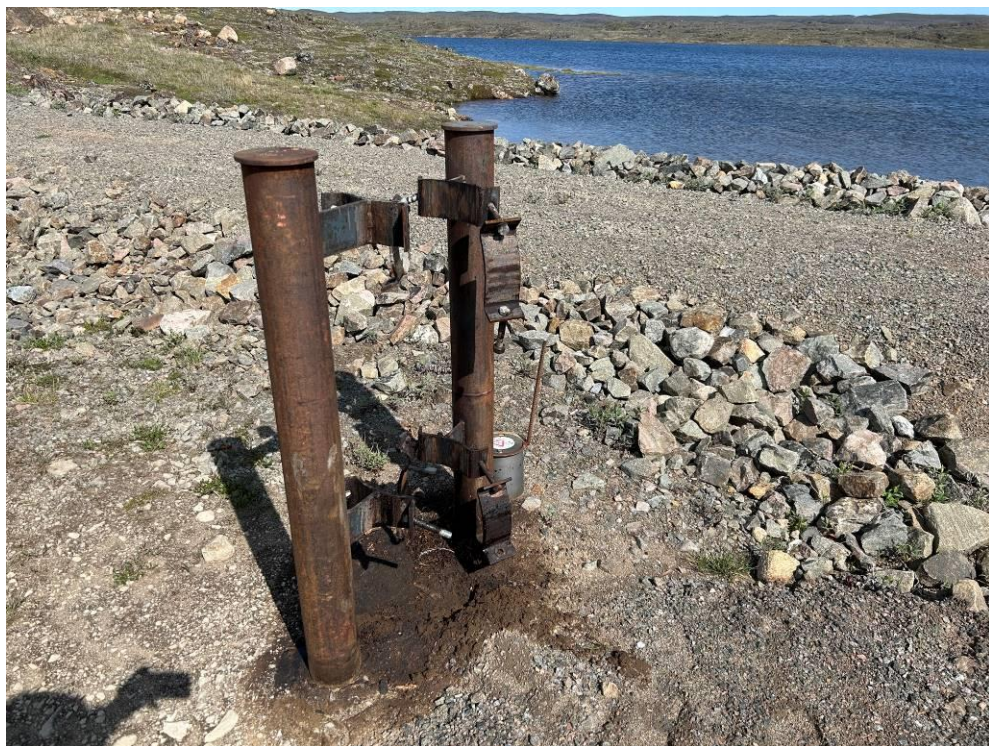
Photograph 8 – Hydro pole removed from pile braces at the downstream face of the South Berm. Note creosote contamination in the soil.

The power pole that had been leaking creosote into the soil near the South berm had been removed, however, the soil that was heavily contaminated with creosote has not yet been remediated.

1. Items deemed to be of an immediate need include:
 - a. Removal of the contaminated soil around the base of the hydro pole adjacent to the south berm.

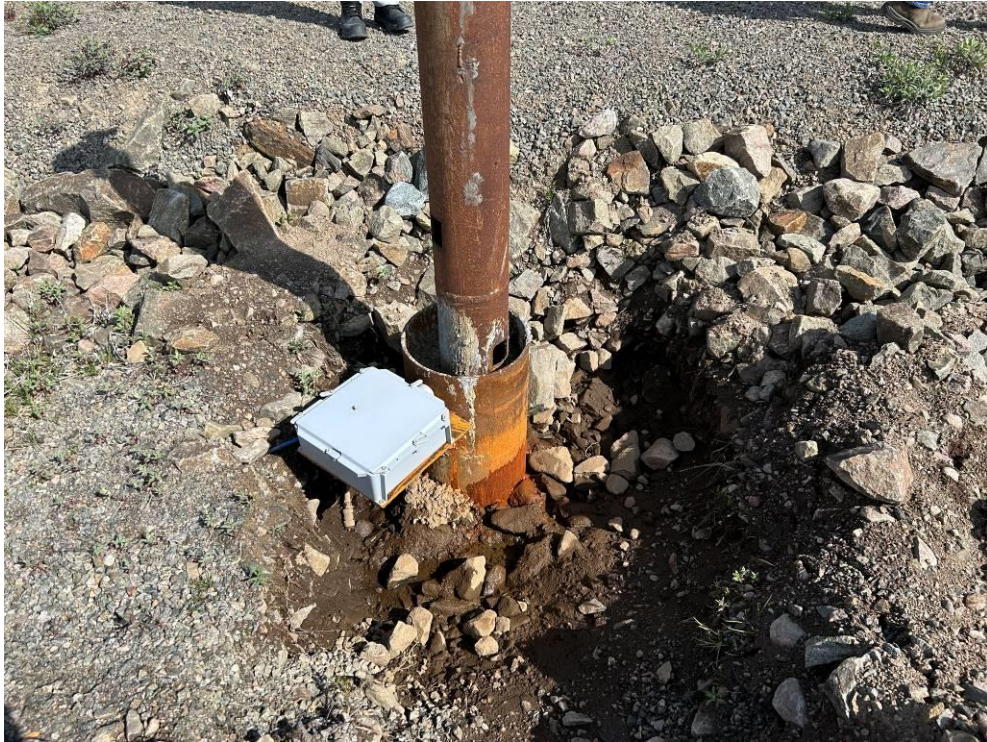
Photograph 9 – Rip Rap disrupted at the downstream face of the South Berm.

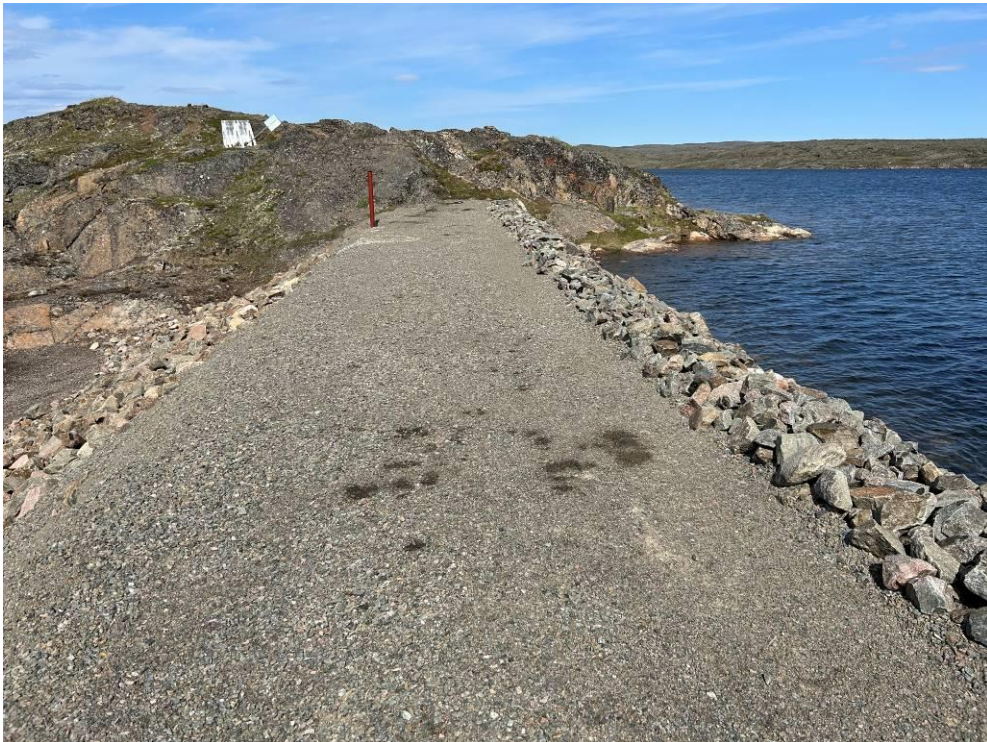
- The hydraulic fluid observed atop the center and north berms in the report dated June 8, 2023, has not yet been removed and replaced. The Contractor has been advised to correct this item by Concentric.

Photograph 10 – Oil residue (hydraulic fluid) atop the center berm from drill rig.

- b. Removal and replacement of the contaminated soil atop the center and north berms. The contractor undertaking the 2022 dam repairs has been directed to complete this work.

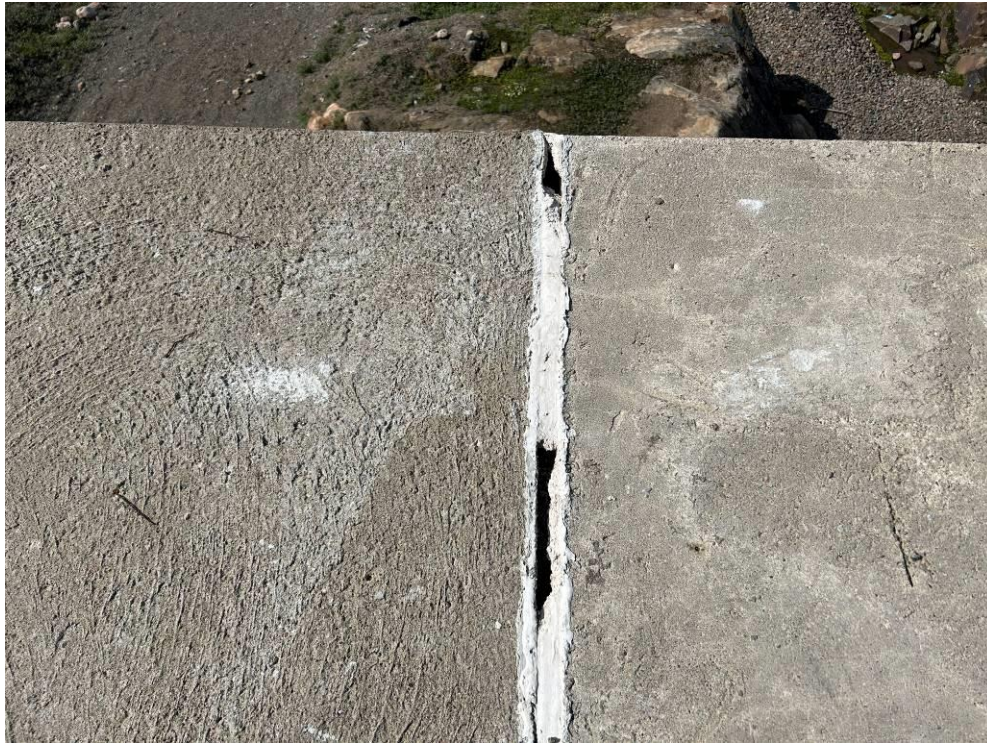
- A small section of the sealant material within the top of the concrete dam is missing at the south end of the dam. This material should be replaced in the immediate future.

Photograph 11 – Deteriorated section of the expansion joint sealant (top of dam).

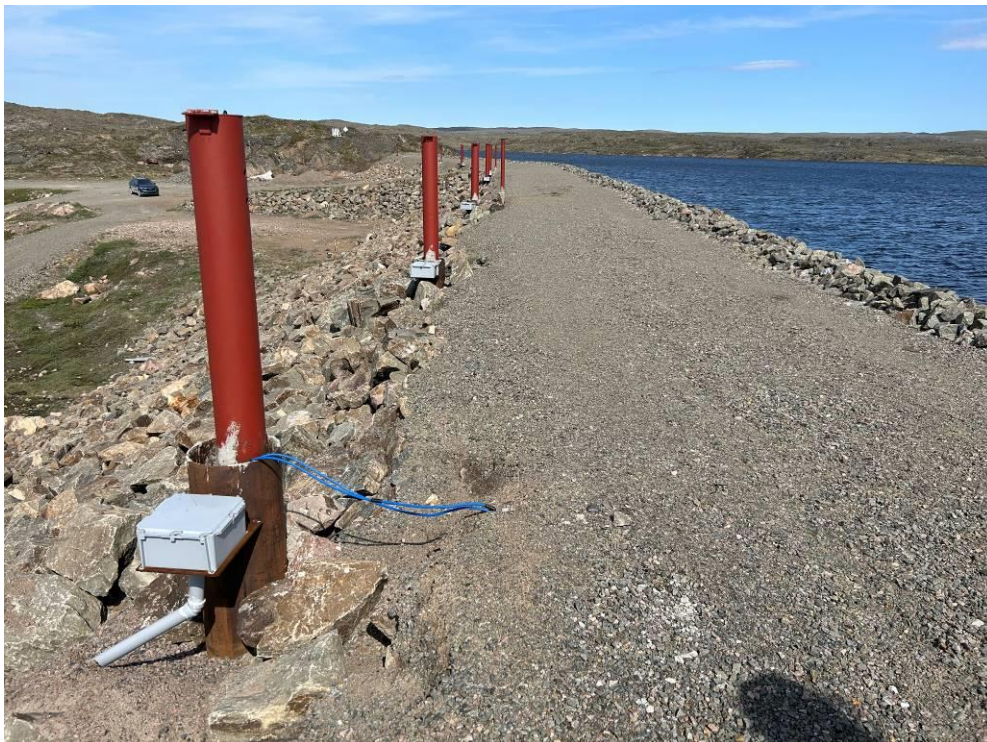
- Installation of five of the ten, temperature data loggers was completed on Thursday June 8, 2023. The data loggers are now operational and recording temperature data at these locations every 30 minutes. Installation of the remaining temperature data loggers will be completed in the immediate future (August 2023).

Photograph 12 – Typical temperature data logger installation.

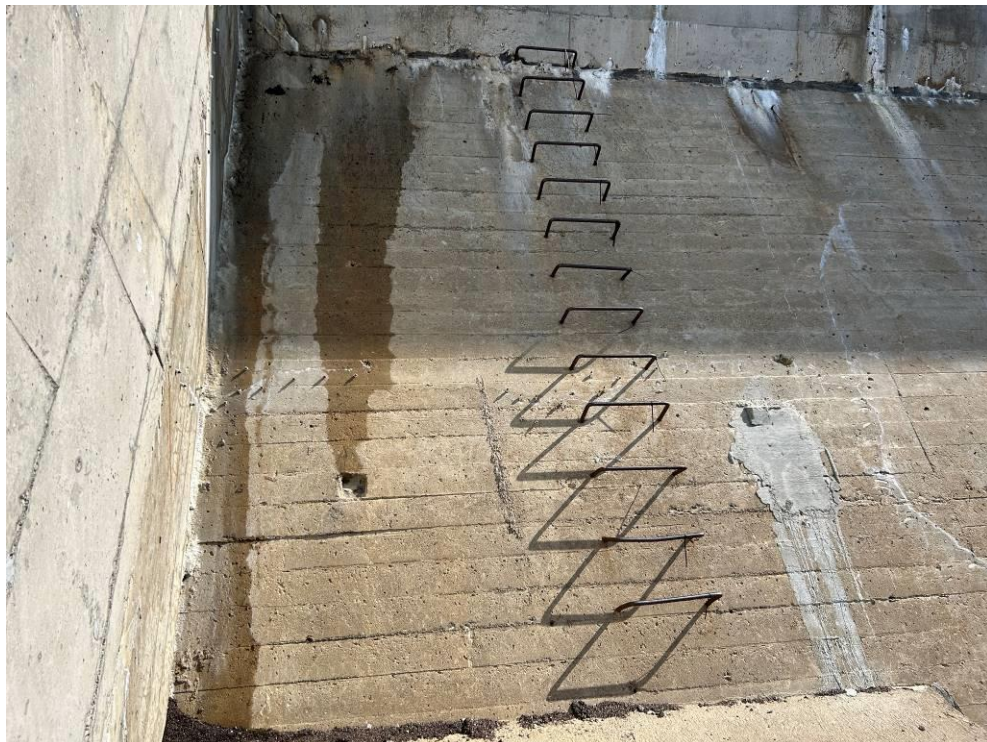
- Seepage / leakage could was observed at the base of the concrete dam at the interface between the bedrock and the concrete dam.
- The rip rap at the base of the concrete dam, within the spillway, needs to be adjusted. The rip rap has been displaced and is no longer covering all portions of the base of the dam. Water was spilling over the spillway at a rate that could cause undermining at the toe of the spillway. The rip rap at the base of the concrete dam needs to be adjusted immediately to prevent further scouring of aggregate from the base of the dam. Miscellaneous materials were observed in the spillway.

Photograph 14 – Seepage adjacent to buttress along Gridline I.

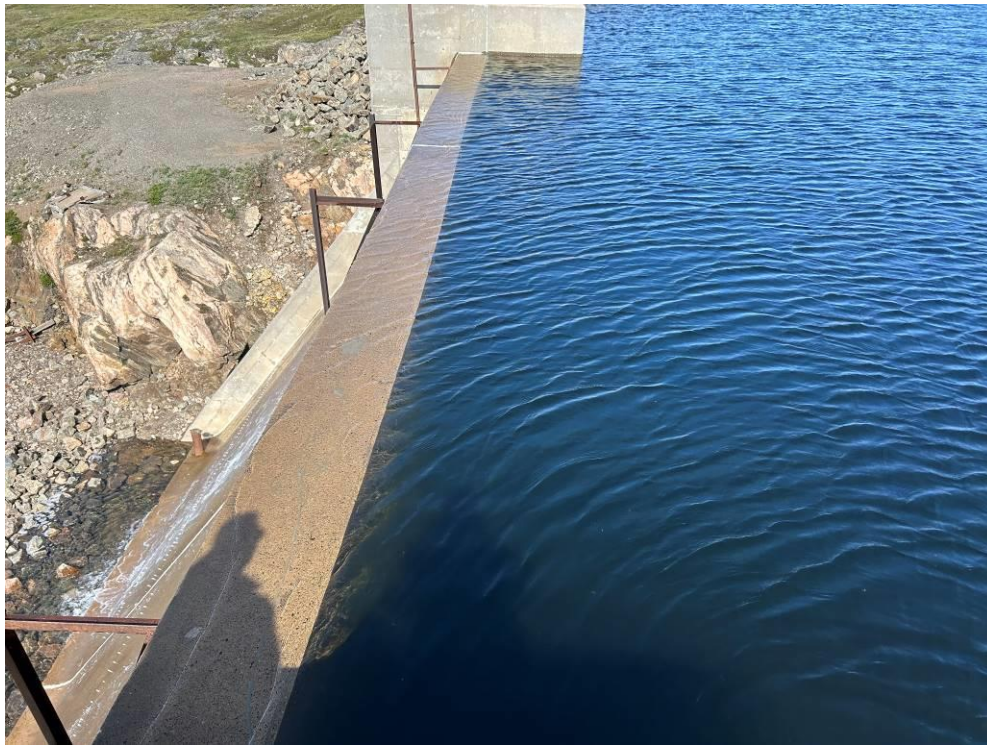
Photograph 15 – Water level spilling over the spillway.

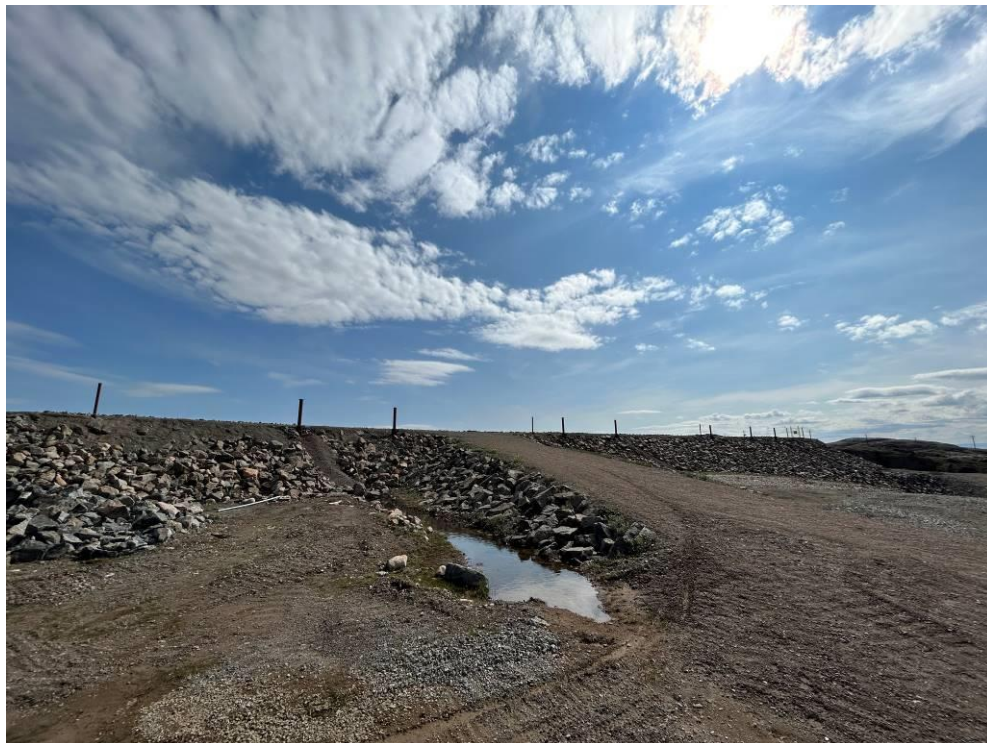
Photograph 16 – Ponding at the North side of the access ramp to the North and Centre berms.

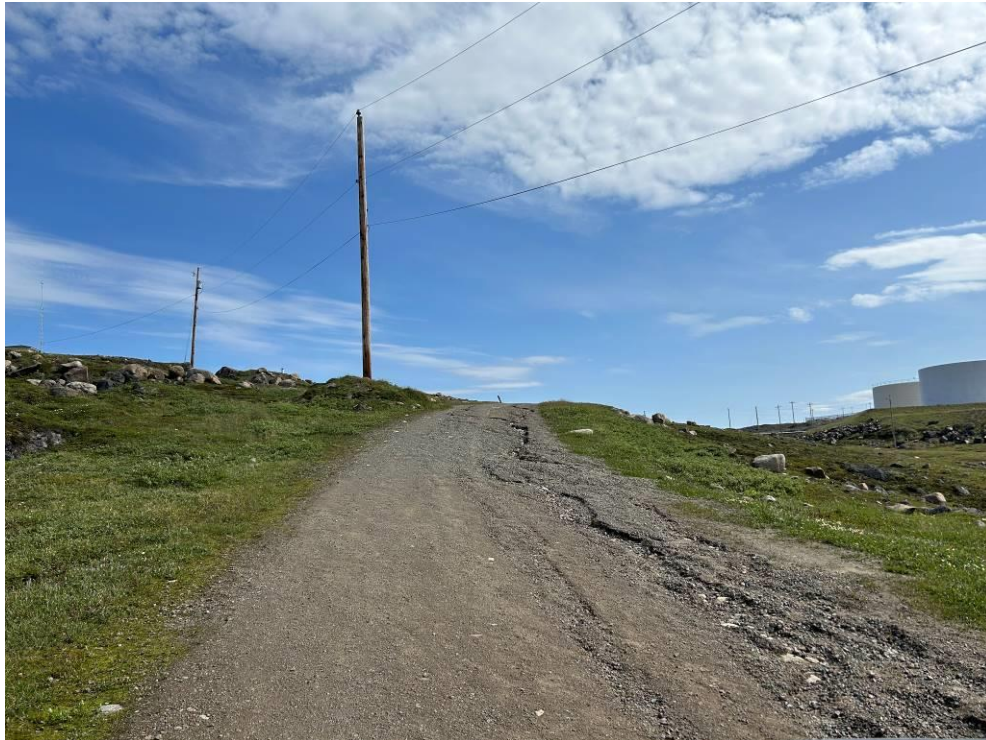
- Erosion of the North access road was noted during our review. Basic grading and maintenance is required along the access road. Periodic repairs to the road from erosion is necessary however, installation of additional culverts would reduce the frequency and severity of repairs required.

Photograph 17 – Erosion on the North access road due to spring melt.

- d. Minor work will be required to repair erosion damage within the north access road, we recommend that the City consider the installation of new steel culverts at the two locations where erosion is most active.

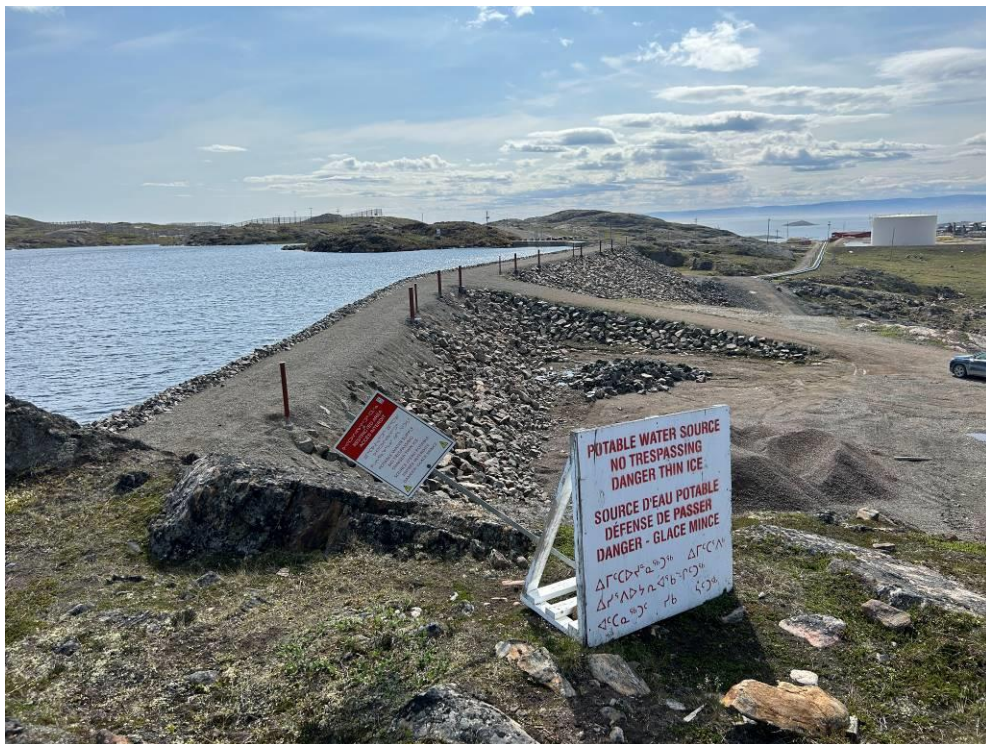
- Signage at the North end of the North berm is falling over.
- With the exception of the above noted, no significant changes, such as sloughing, slides, bulging or displacement, were noted in the earthen berms. No active seepage/leakage was observed within the visible portions of the berms.

Photograph 18 – Signage at the North end of the North berm is falling over.
