**LAKE GERALDINE DAM  
DAM SAFETY INSPECTION 2023 #3  
IQUALUIT, NUNAVUT**

**PRODUCED FOR:** THE CITY OF IQUALUIT  
C/O COLLIERS PROJECT LEADERS

**PRODUCED BY:** CONCENTRIC ASSOCIATES INTERNATIONAL INCORPORATED

**DATE:** AUGUST 24<sup>TH</sup>, 2023

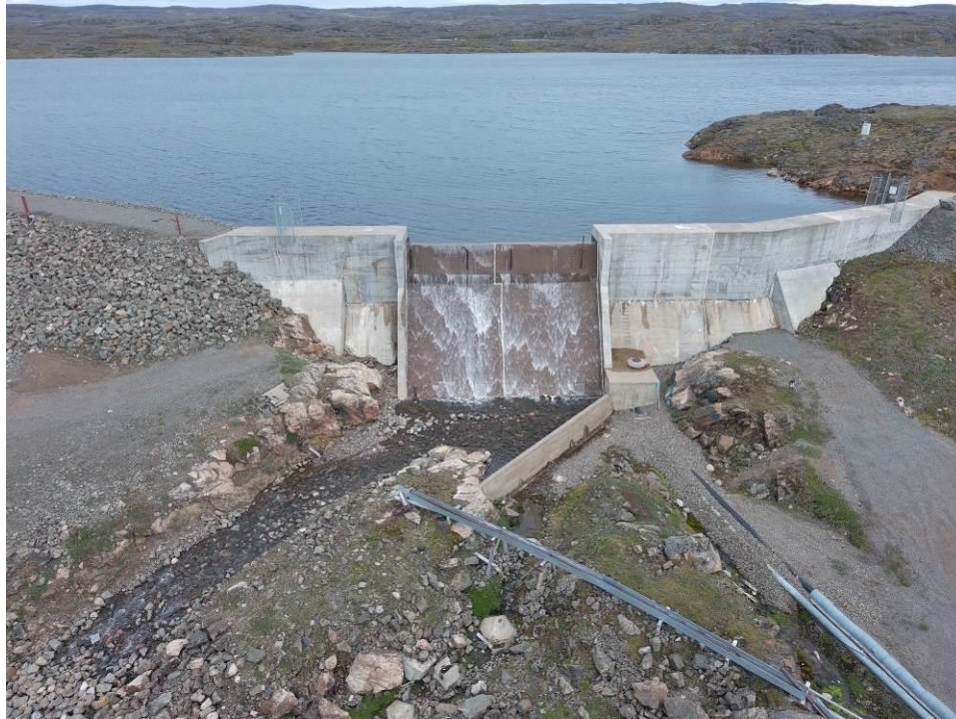
**Photograph 1** – Overview of concrete dam and spillway.

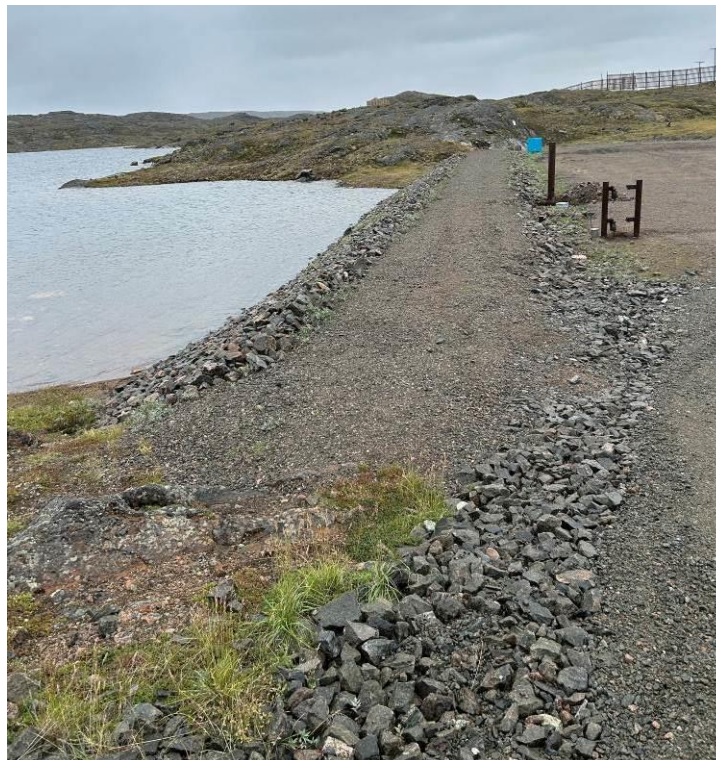
**Photograph 2** – Typical south berm condition at the time of our review.

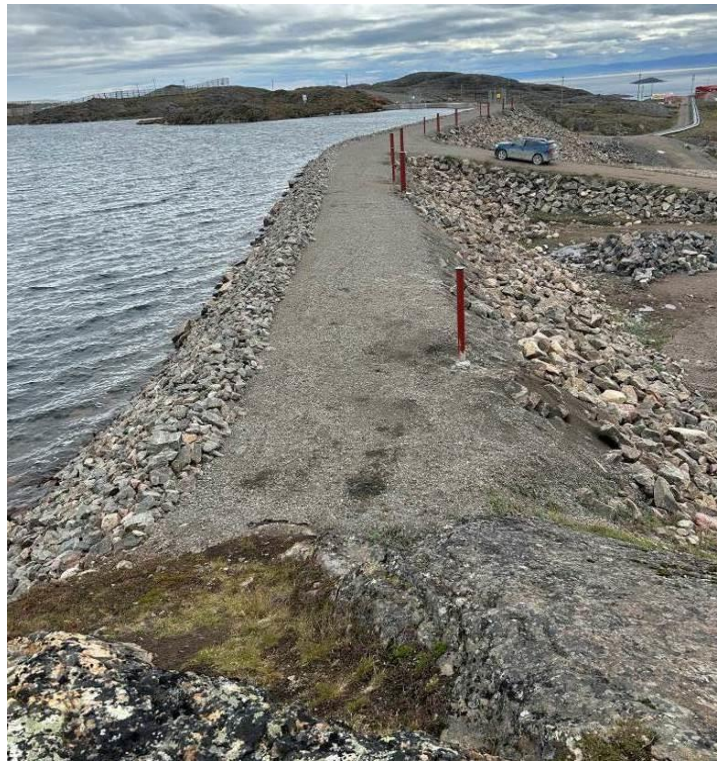
- Several locations across the center and north berm have been contaminated with VOC / oil from the pile installation in the fall of 2021. The Contractor has been directed by Concentric to remove and replace the contaminated material. See Photograph 3 & 7.

**Photograph 3** – Typical north and center berm condition at the time of our review. Note the soil contamination in the foreground atop the berm.

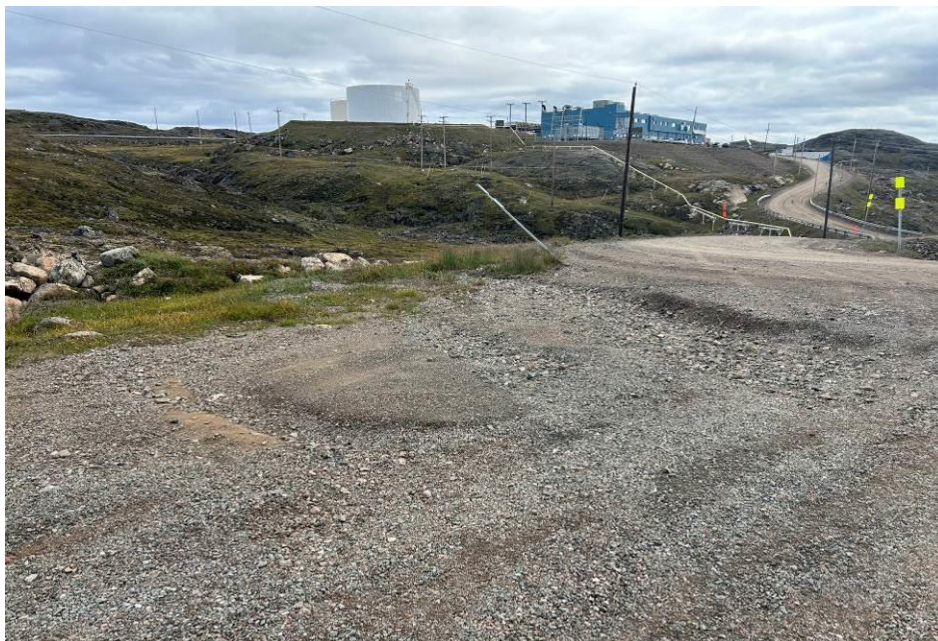
- The north access road has several areas where the sand and gravel roadbed has been eroded away. See Photograph 4.
- The power pole that had previously supplied power to the temporary water treatment facility at the south berm has been removed. However, the VOC contaminated soil at the base of the pole has not been removed from site. See Photograph 5.

**Photograph 4** – erosion of the north access road at the intersection with Takuminaqtuq Avenue.

8. The north and south access roads should be regraded and eroded material replaced in the spring of 2024.
9. Exercising and testing of the valves within the valve chamber is required as part of preventative measures. The condition of the valves within the valve chamber at the base of the dam was previously identified as being in an advanced state of corrosion. To our knowledge no maintenance or testing has been completed on the controls valve in the last 5+ years. There is a significant potential for the valves to fail and not operate correctly when needed in an emergency. A study to address this issue is currently underway.

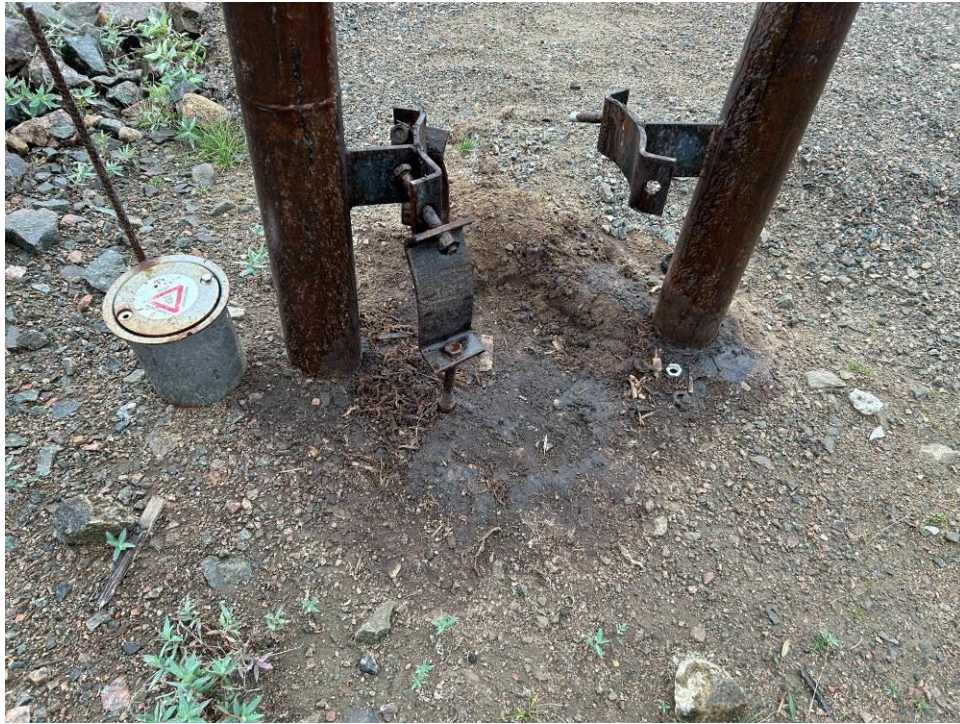
**Photograph 5** – Oil residue on the ground from the hydro pole, that had been previously installed and removed.

1. Items deemed to be of an urgent need include:
  - a. The contaminated soil around the base of the hydro pole adjacent to the south berm should be removed.

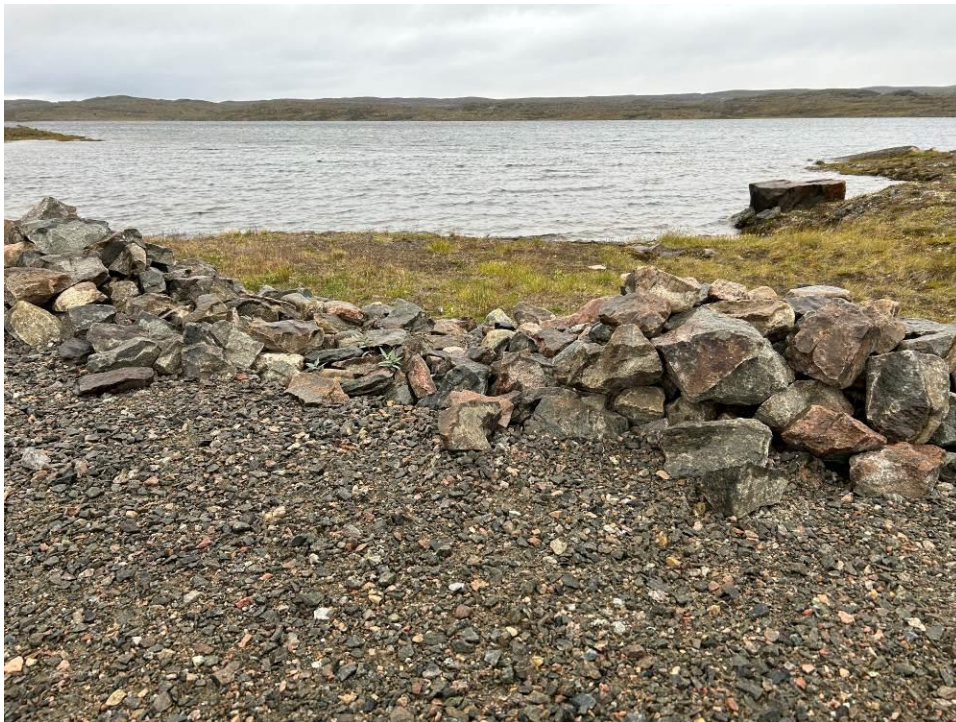
- A depression is present within the rip rap lip on the south berm in line with the GN's mobile water treatment plant units. It appears rip rap may have been displaced to

accommodate intake hoses. This rip-rap material should be corrected. See Photograph 6.

**Photograph 6** – Section of the south berm where the rip-rap material on the upstream face of the dam has been displaced.

12. The rip-rap material in the spillway should be re-distributed to provide cover at the base of the spillway.
13. The displaced rip-rap material at the south end of the south berm should be re-instated.

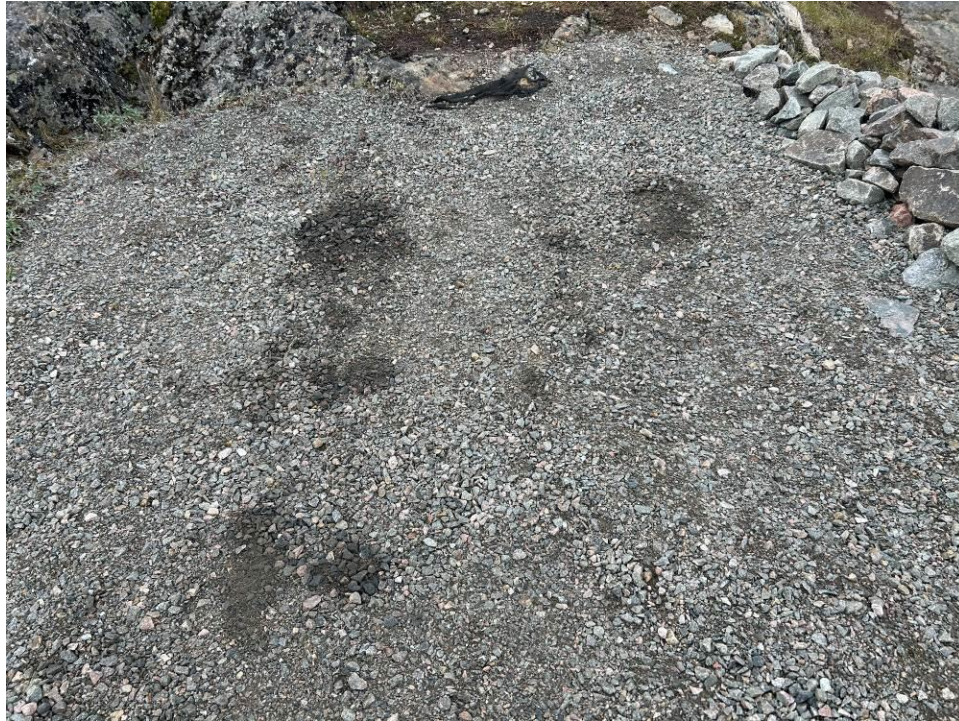
**Photograph 7** – VOC contamination atop the north and center berms. The contractor responsible has been directed to remove and replace the contaminated material.

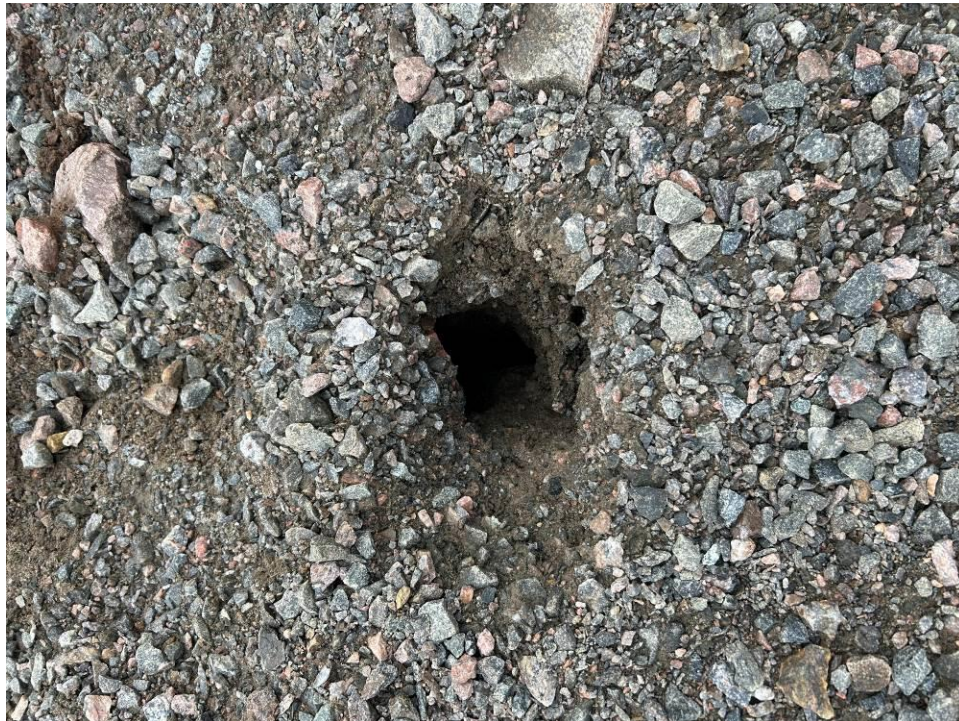
- Two small sink holes were noted on the top of the berm at the down stream face of the center berm. Further investigation is recommended, this work should include excavation of the affected area, visual inspection, and re-instatement of the granular material with compacting of fill material should be done in 12" lifts. We recommend that Concentric be present to oversee this work and provide technical direction should it be necessary. See Photograph 8.

**Photograph 8** – Small sink hole found in the top of the center berm.

- b. The two sink holes observed on the top of the center berm should be excavated and examined to assess the depth of the sink hole after which the excavated area should be refilled and compacted in 12" lifts. We also recommend that Concentric be present to identify the possible cause and record the depth, size and potential impact on the berm.

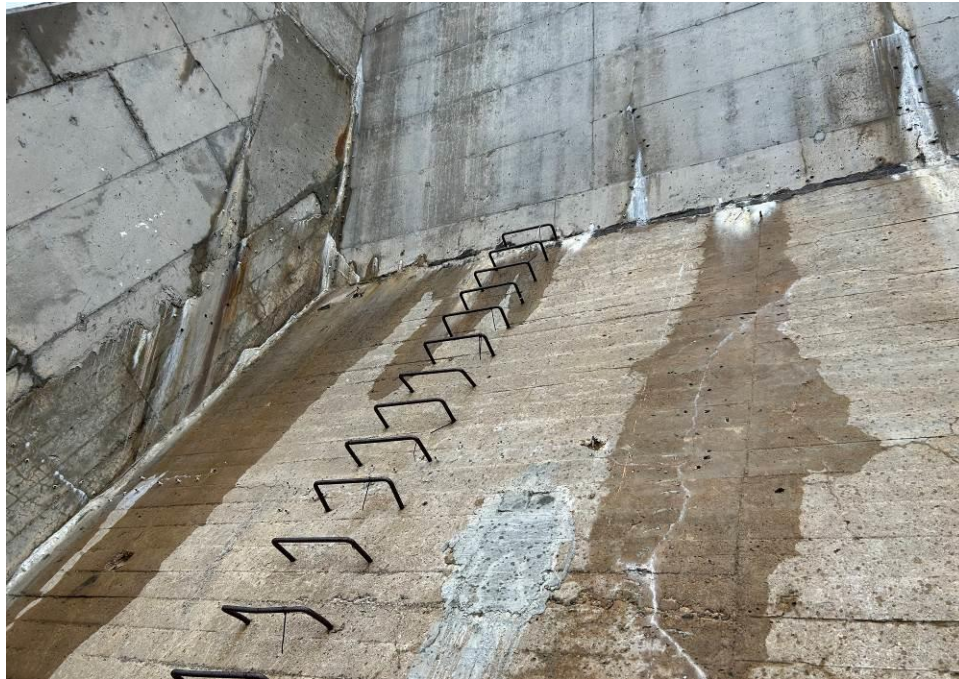
- Leakage was observed at the base of the interface between the bedrock and the concrete dam. Minor leakage at the base of the concrete dam at the interface with the bedrock has been consistent over the last 10+ years. However, during our most recent site review we noted a minor increase in the flow of water at this location. The leakage at this location is believed to be caused by water moving through the fractured bedrock below the dam and seepage of water between the base of the concrete dam and bedrock. We did not observe any changes or displacement of the bedrock at the base of the dam. As such, we do not believe that the underlying bedrock has changed or been disturbed.

**Photograph 9** – Seepage through the concrete dam.

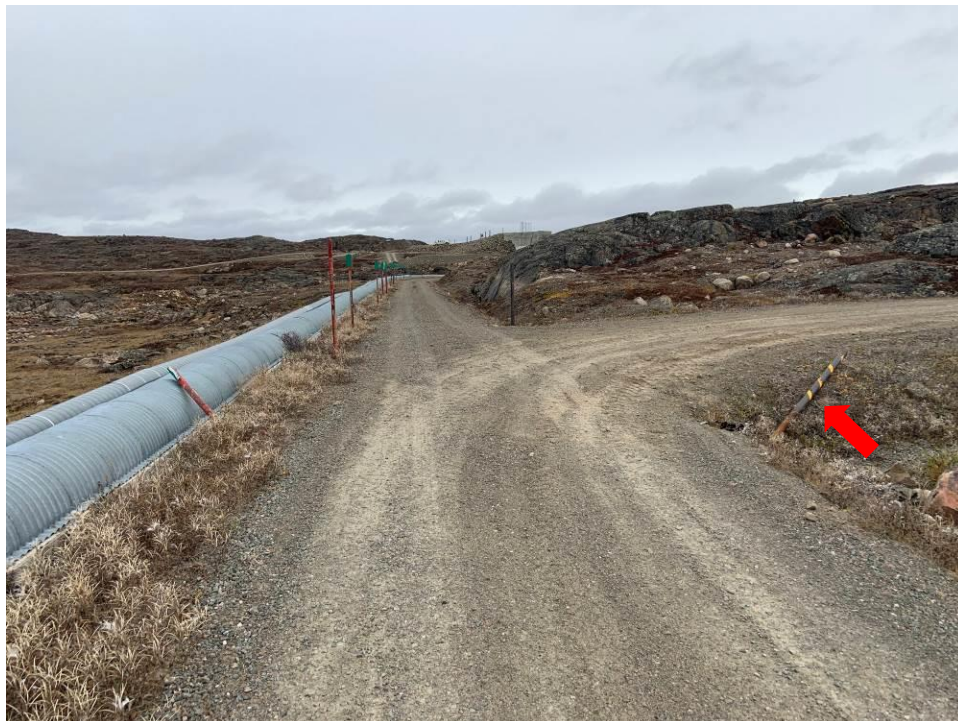
- No change in condition to the metal corner post (used to indicate the edge of the road) identified to have been knocked over by vehicle traffic in the previous reports. See Photograph 10.

**Photograph 10** – Corner marker at the junction of the south access road and the road to the south berm has been knocked over.

4. The protective galvanized metal enclosure installed over the pipeline from the dam to the water treatment plant should be re-instated.
5. The metal posts / markers that were installed along the north side of the south access road should be re-instated.

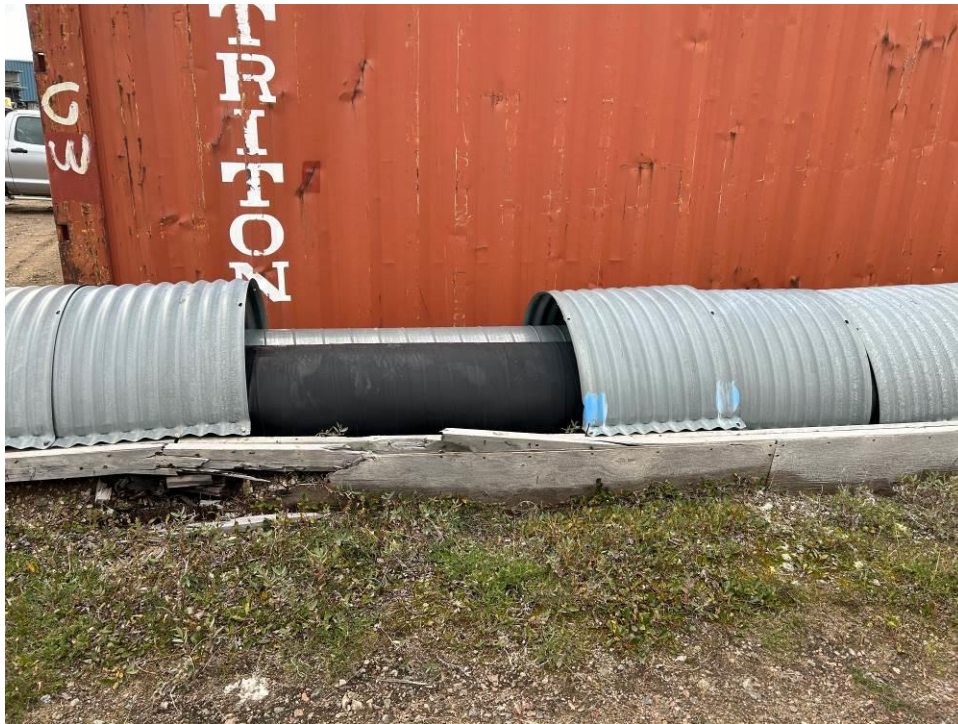
- Portions of the galvanized metal enclosure that covers the pipe that supplies water from the dam to the water treatment plant are still missing. See Photograph 11.

**Photograph 11** – Section of the supply pipe from the dam with the corrugates metal enclosure removed.

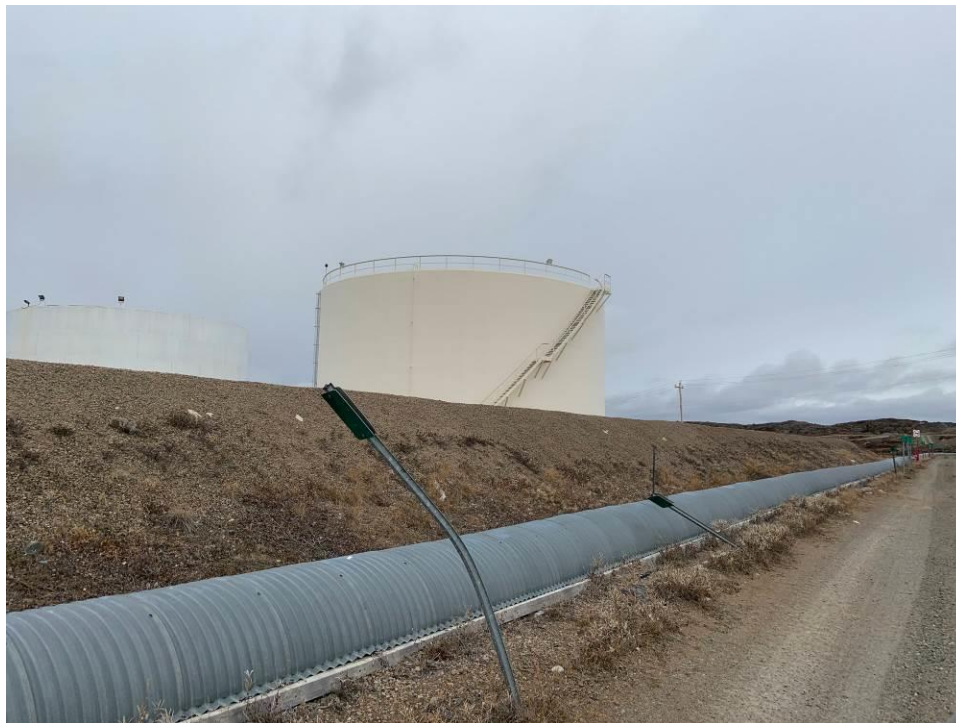
- No change in condition to the blizzard markers installed along the north side of the south access road identified in previous reports. See Photograph 10 & 12.

**Photograph 12** – Blizzard markers knocked over and or missing along the south access road.

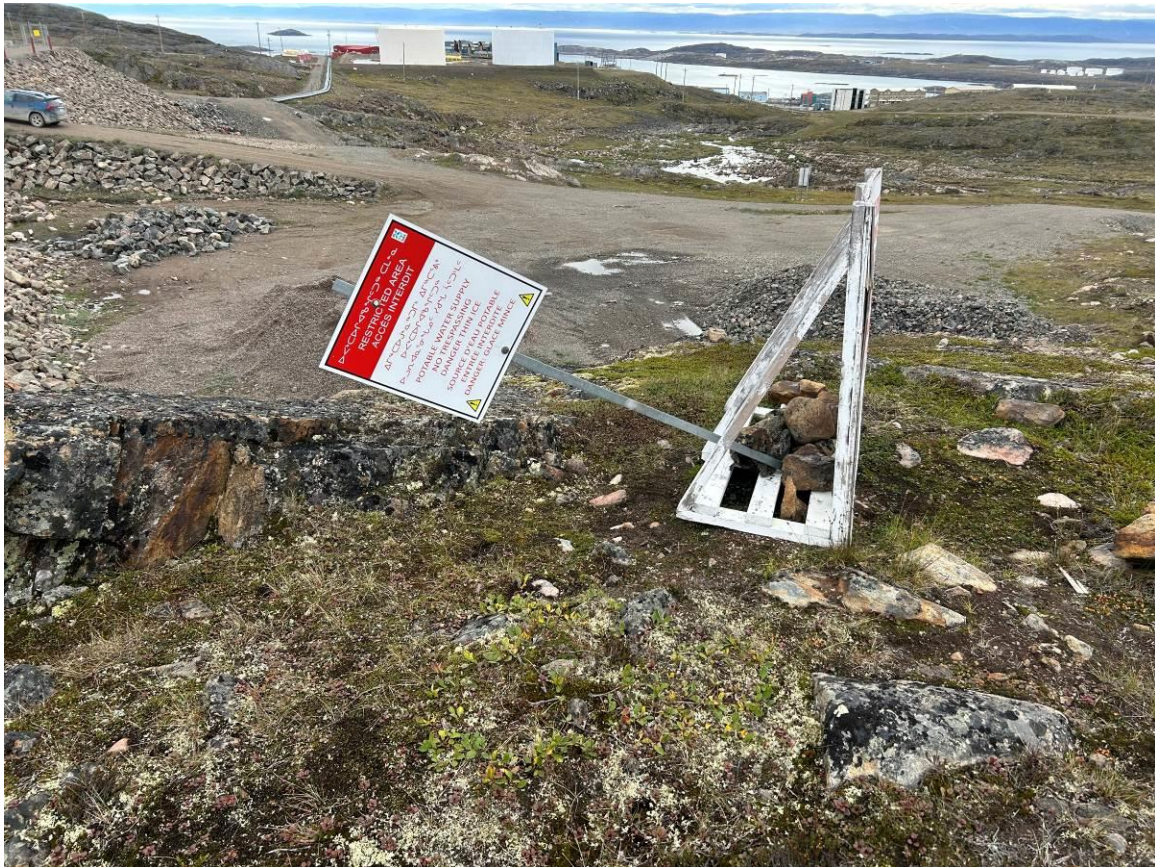
- The warning signage at the north end of the north berm has been installed. Signage is not installed in a suitable manner. See Photograph 13, the contractor has been instructed to re-instate the signage.

**Photograph 13** – Warning signage installed in the wrong location at the South end of the South Berm.
