**LAKE GERALDINE DAM
DAM SAFETY INSPECTION 2023 #4
IQUALUIT, NUNAVUT**

PRODUCED FOR: THE CITY OF IQUALUIT
C/O COLLIERS PROJECT LEADERS

PRODUCED BY: CONCENTRIC ASSOCIATES INTERNATIONAL INCORPORATED

DATE: OCTOBER 4TH, 2023

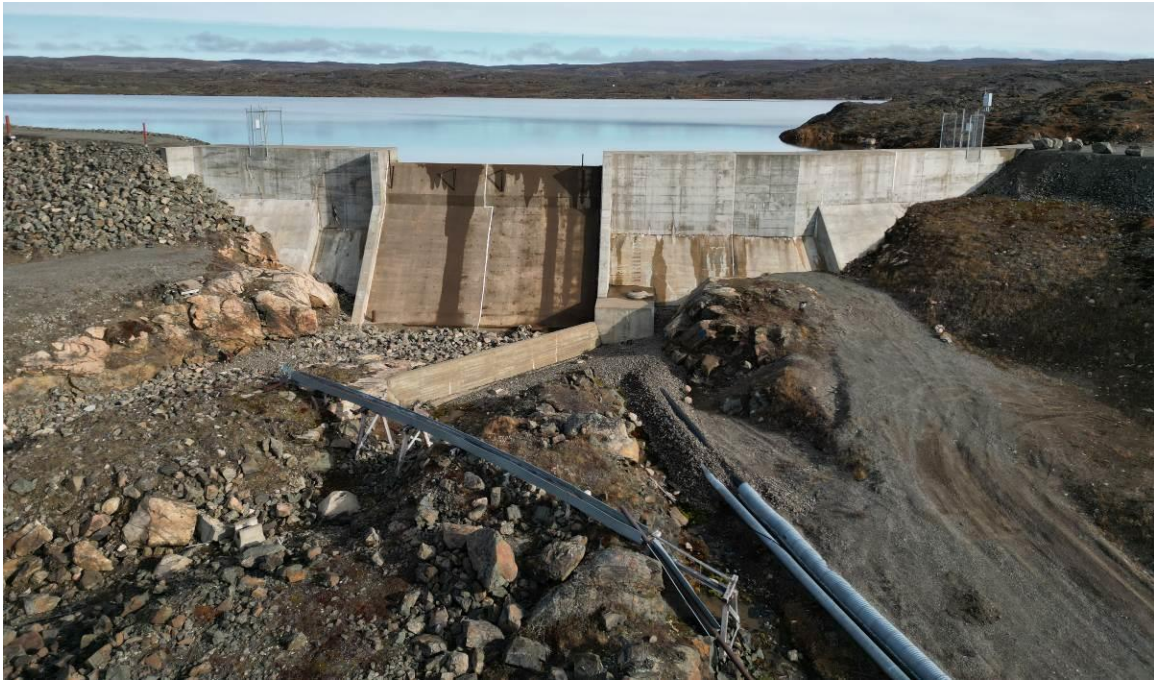
- No significant changes were noted in the general condition of the visible portions of the concrete structures. Seepage at the horizontal cold joint was active at the time of our review, repair of this joint is currently scheduled for summer 2024. See Photograph 1.

Photograph 1 – Overview of concrete dam and spillway.

11. Repair of cracks within the concrete dam, this work is tentatively scheduled for summer 2024.
12. Repair of spalled concrete within the concrete dam, this work is tentatively scheduled for summer 2024.

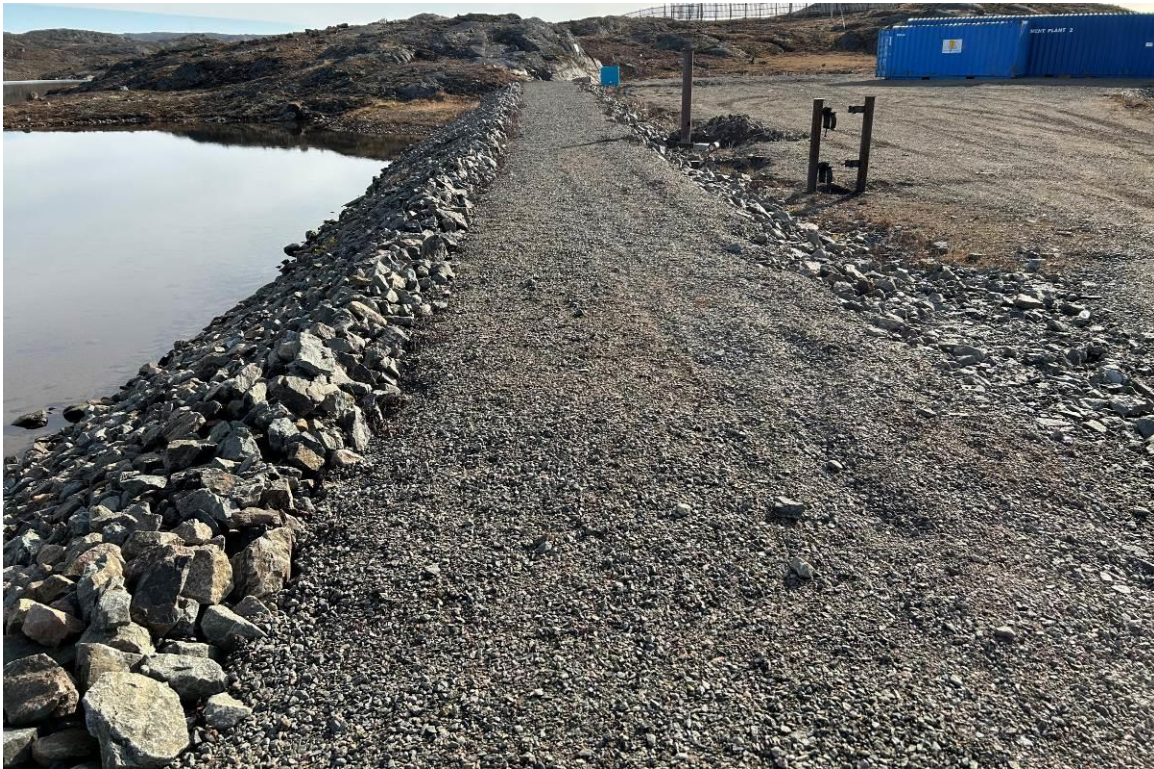
Photograph 2 – Typical south berm condition at the time of our review.

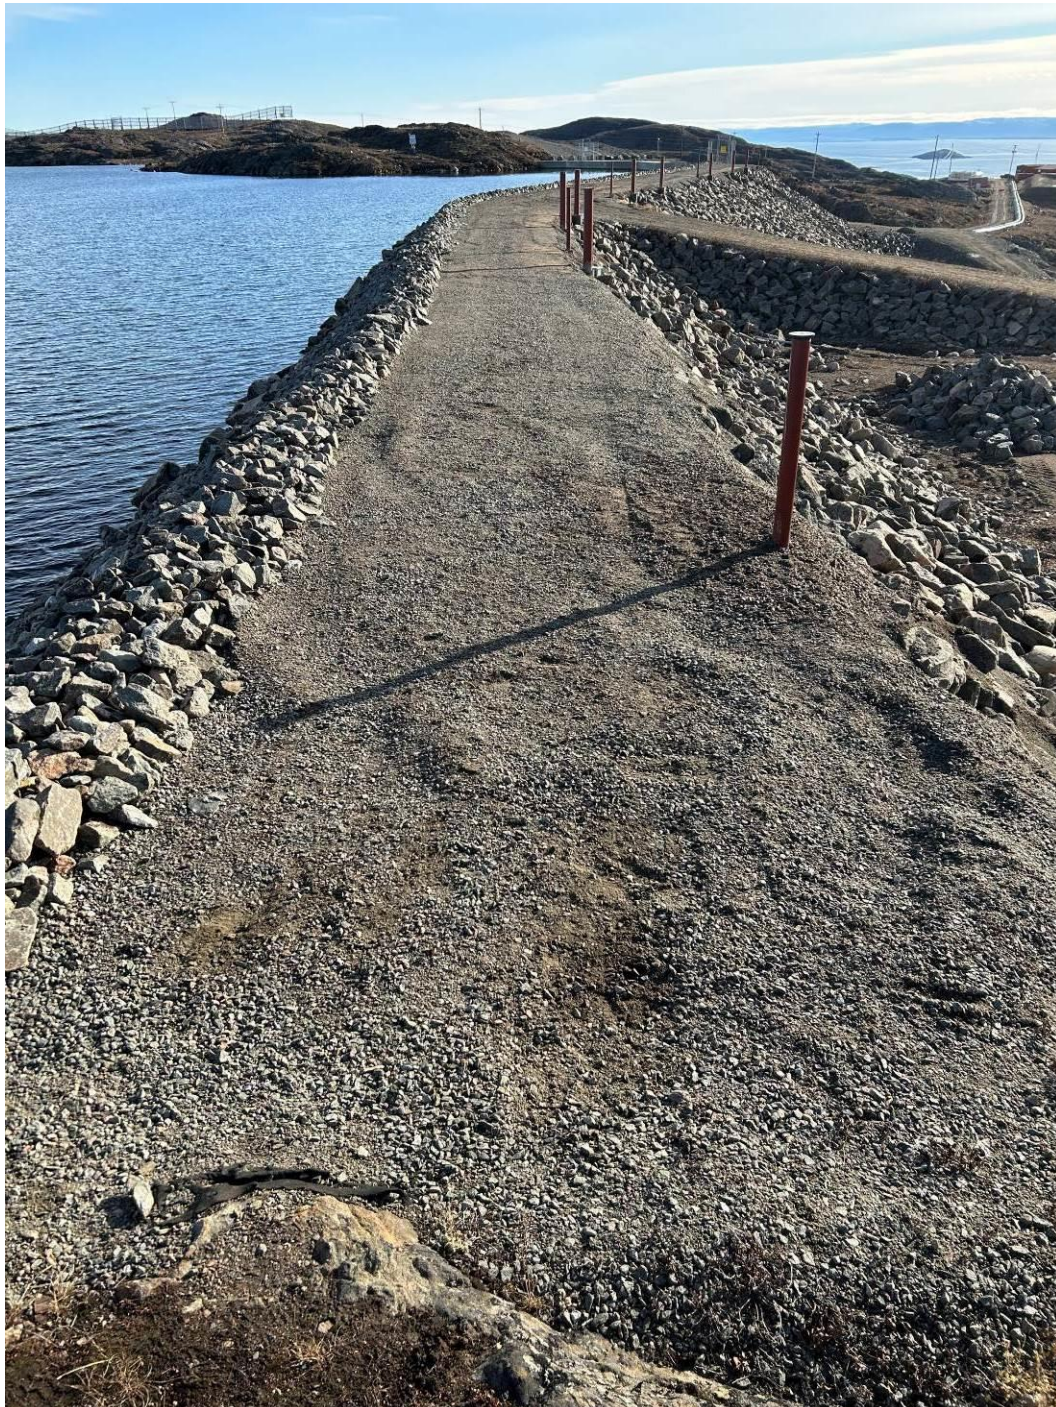
Photograph 3 – Typical north and center berm condition at the time of our review. Note the soil contamination in the foreground atop the berm.

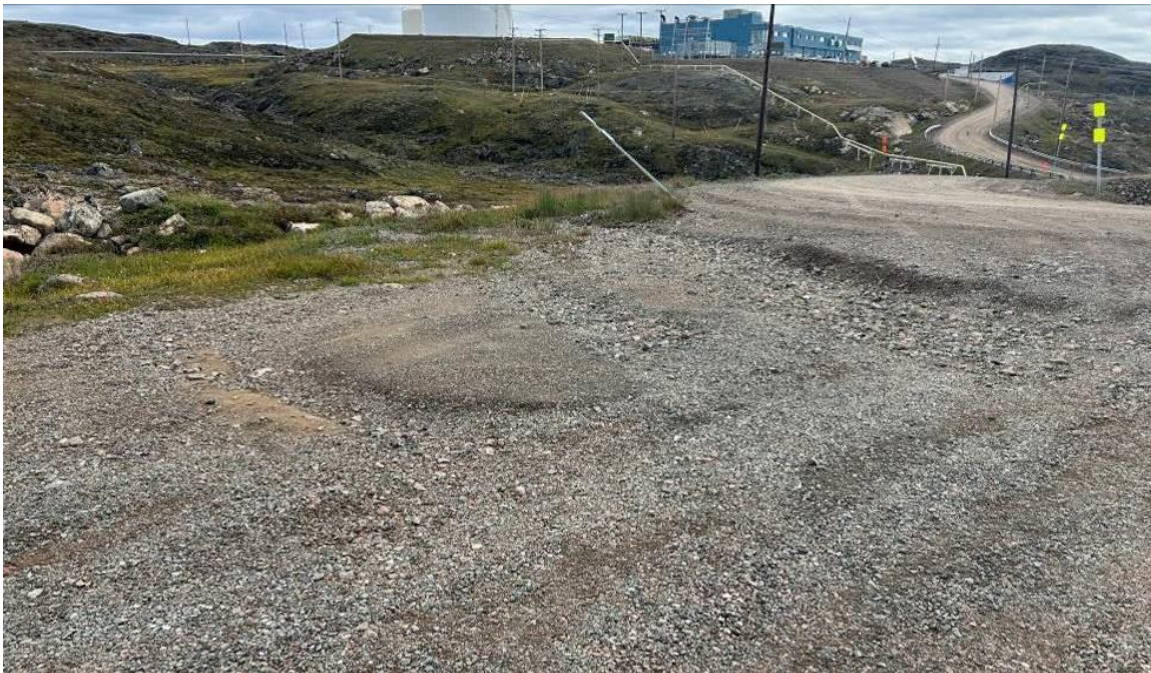
- The north access road has several areas where the sand and gravel roadbed has been eroded away. See Photographs 4 & 5
- The power pole that had previously supplied power to the temporary water treatment facility at the south berm has been removed. However, the VOC contaminated soil at the base of the pole has not been removed from site. See Photograph 6.

Photograph 4 – Erosion of the north access road at the intersection with Takuminaqtuq Avenue.

7. The north and south access roads should be regraded and eroded material replaced in the spring of 2024.
8. Undertake a test opening on the downstream side of the concrete dam and center berm in late January – early February 2024 to ascertain the source of the water that forms large ice sheets within the valley in the winter months.

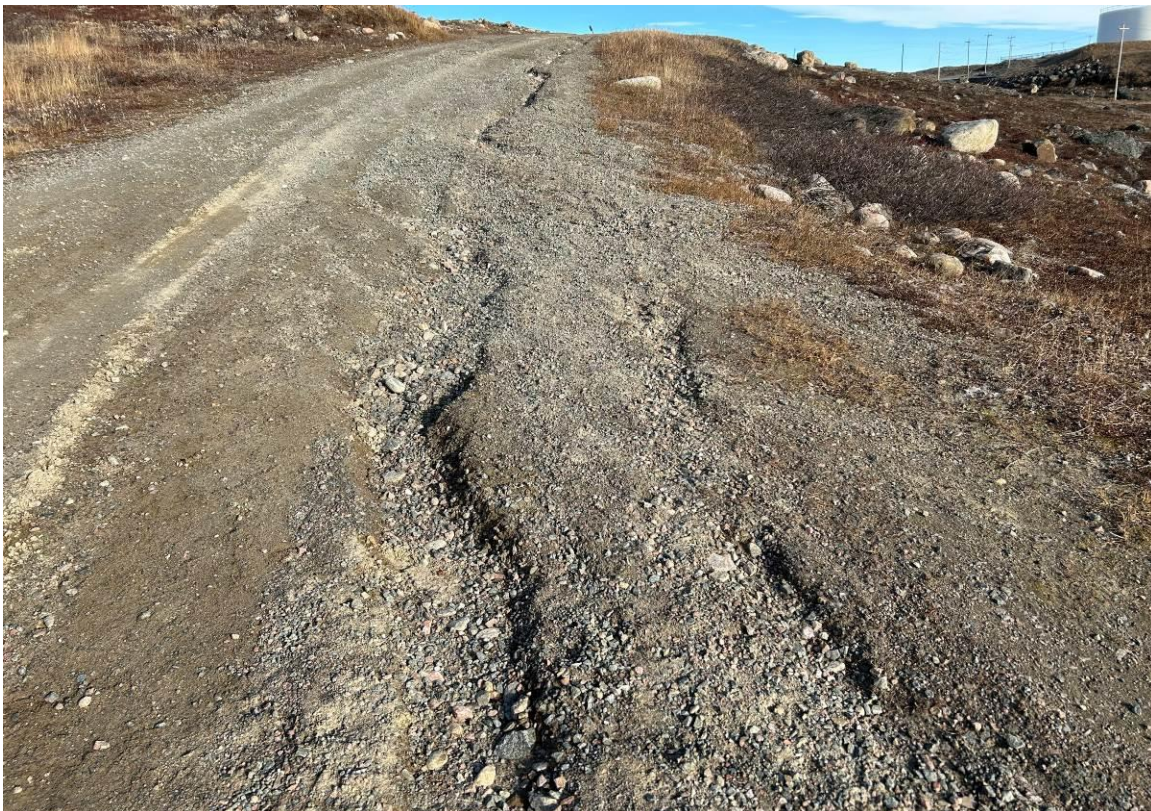
Photograph 5 – Erosion within the north access road.

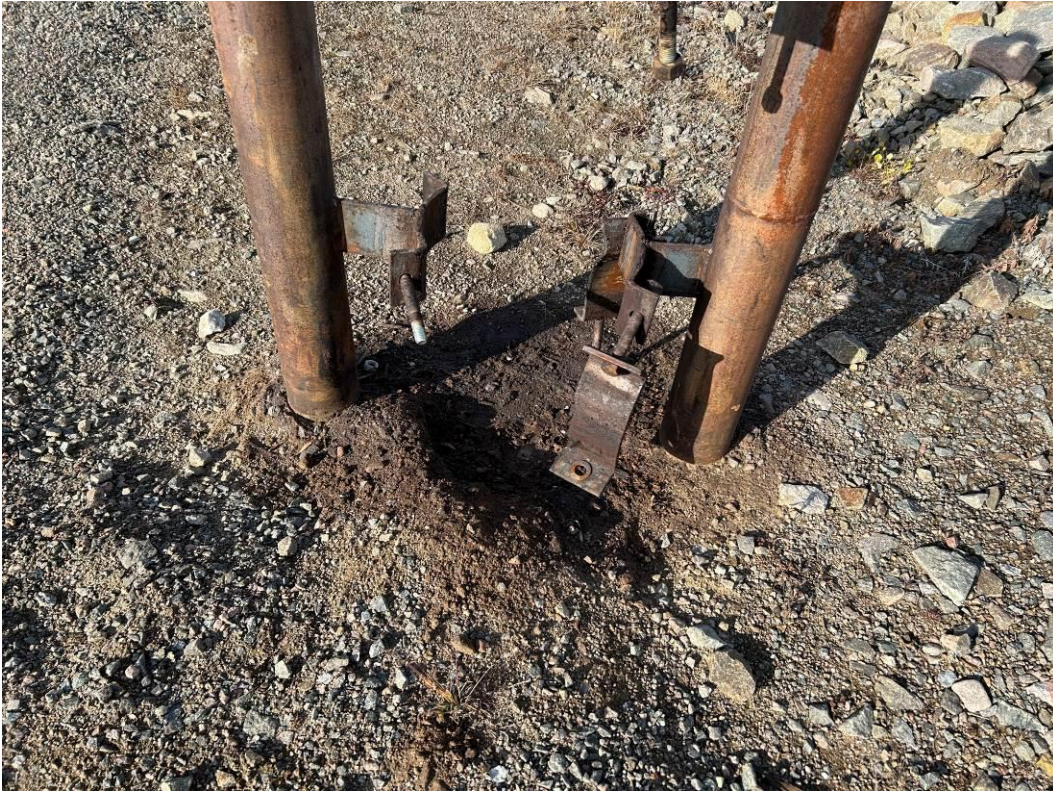
Photograph 6 – Oil residue on the ground from the hydro pole, that had been previously installed and removed.

1. Items deemed to be of an urgent need include:
 - a. The contaminated soil around the base of the hydro pole adjacent to the south berm should be removed.

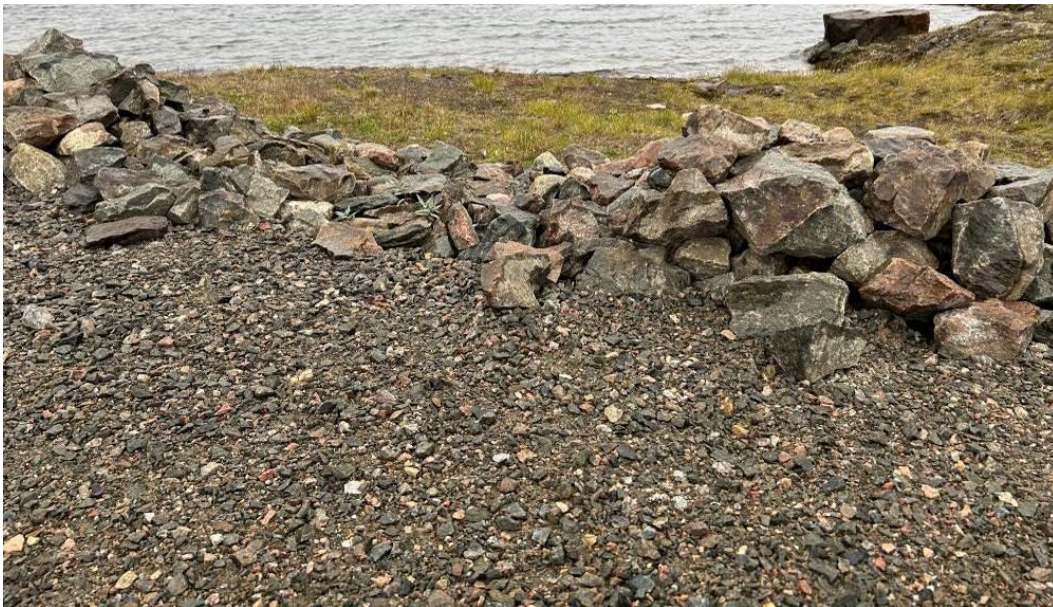
- A depression is present within the crest of the rip rap at the south end, of the south berm (in line with the previously installed mobile water treatment plant). It appears that the rip rap material was displaced to accommodate intake hoses. This rip-rap material should be re-instated. See Photograph 7.

Photograph 7 – Section of the south berm where the rip-rap material on the upstream face of the dam has been displaced.

9. The rip-rap material in the spillway should be re-distributed to provide cover at the base of the spillway.
10. The displaced rip-rap material at the south end of the south berm should be re-instated.

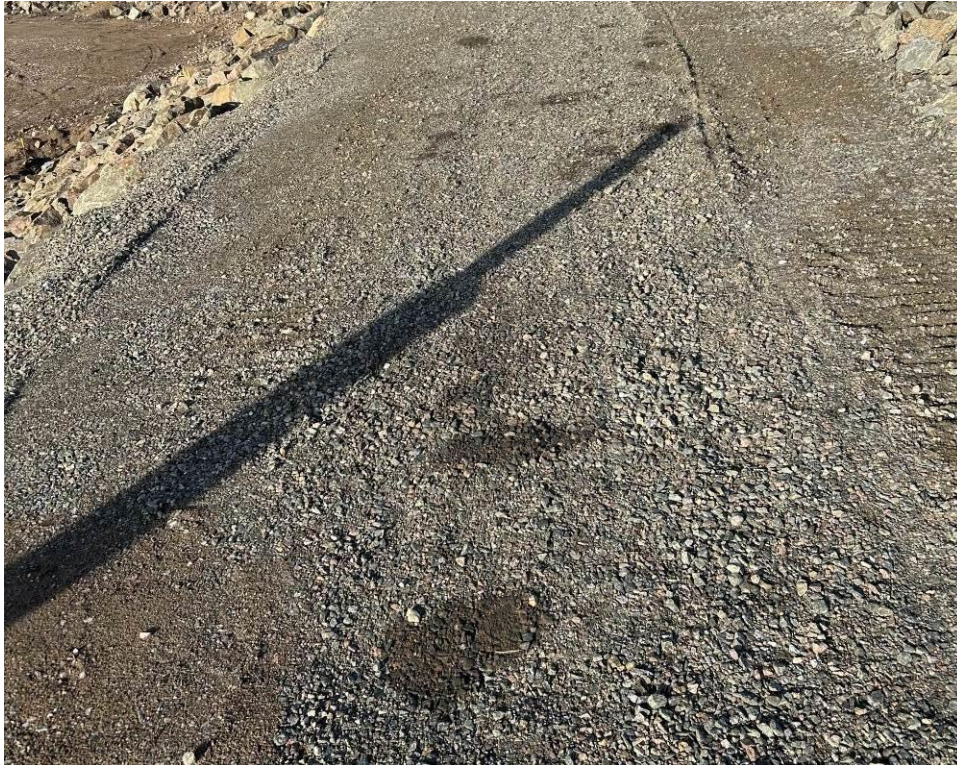
- Several locations across the center and north berm have been contaminated with VOC / oil from the pile installation in the fall of 2021. The Contractor has removed some of this material; however, not all the contaminated material has been taken away. See Photograph 8.

Photograph 8 – VOC contamination atop the center berm. The contractor responsible has been directed to remove and replace the contaminated material.

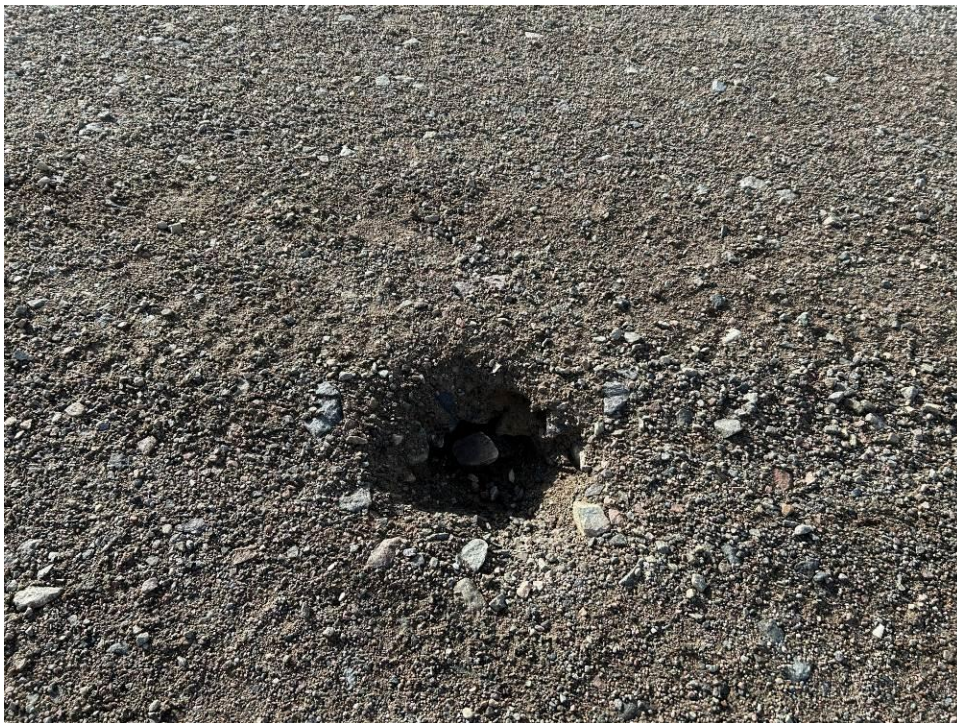
- One small sink hole was noted within the south access road to the south berm. Further investigation is recommended; this work should include excavation of the affected area, visual inspection, and re-instatement of the granular material with

compacting of fill material should be done in 12" lifts. We recommend that Concentric be present to oversee this work and provide technical direction should it be necessary. See Photograph 9.

Photograph 9 – Small sink hole found within the south access road to the south berm.

3. One sink hole was observed within the south access road that leads to the southern berm. The sink hole should be excavated area should be refilled and compacted in 12" lifts. We also recommend the Concentric be present to identify the possible cause and record the depth, size, and potential impact on the berm.

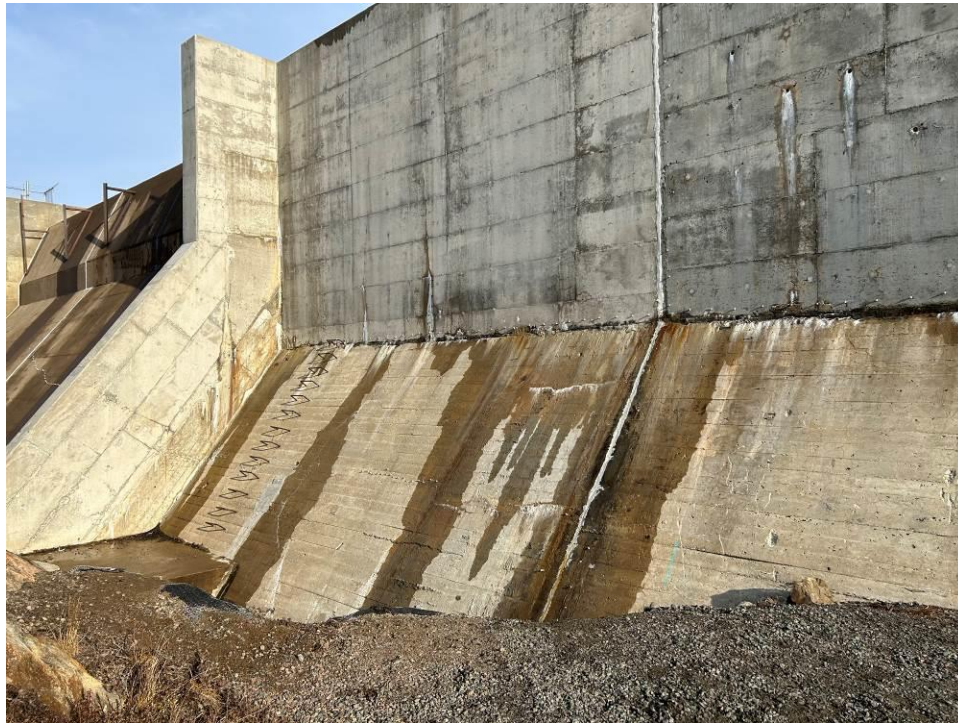
- Minor seepage at the horizontal cold joint in the downstream face of the dam on the south side of the concrete dam was noted during our review. Leakage at this location is typically noted when the water levels in the reservoir are near capacity. See Photograph 10.

Photograph 10 – Seepage through the concrete dam.

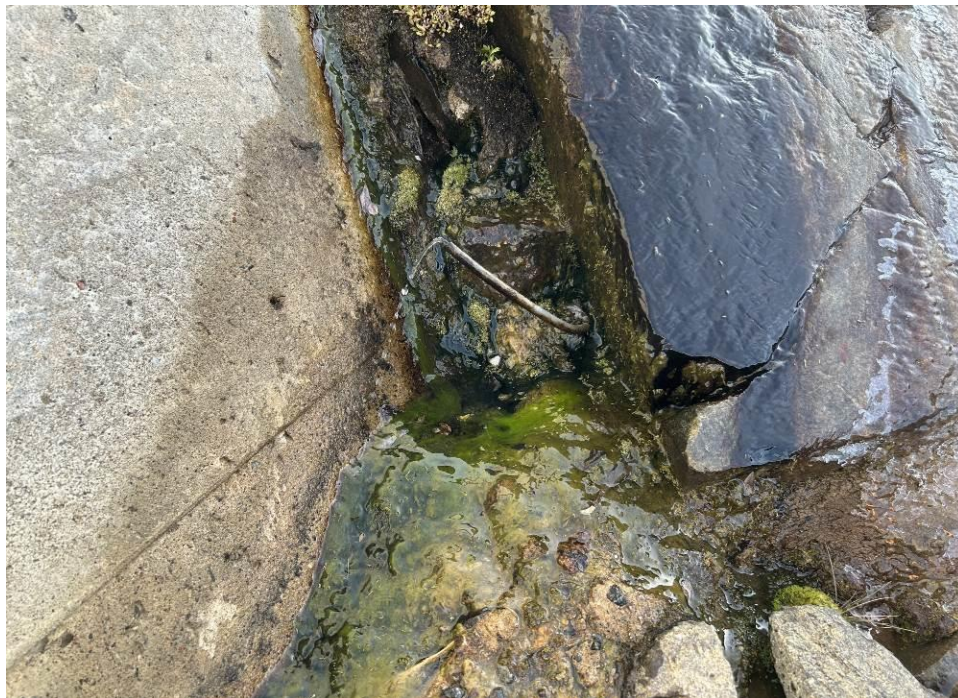
- Leakage was observed at the base of the interface between the bedrock and the concrete dam. Minor leakage at the base of the concrete dam at the interface with the bedrock has been consistent over the last 10+ years. We did not observe any changes or displacement of the bedrock at the base of the dam. As such, we do not believe that the underlying bedrock has changed or been disturbed. See Photograph 11.

Photograph 11 – Seepage at the base of the concrete dam, note the water flow through the drainage tube.

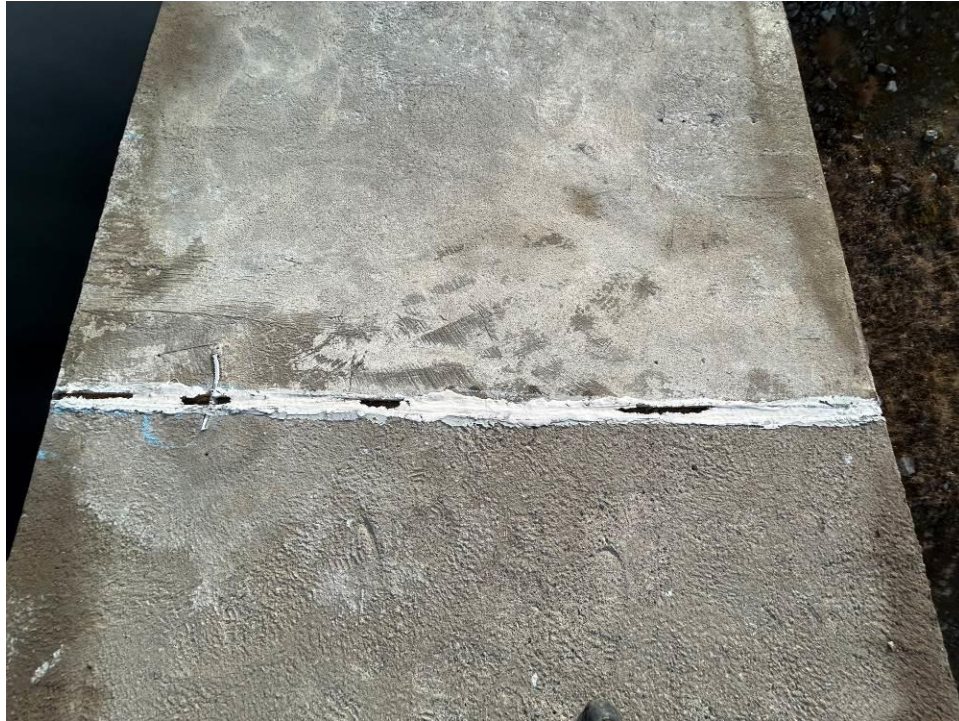
- Sealant within the expansion joints require replacement, this damage appears to be the result of ravens that have picked away at the joint material. See Photograph 12.

Photograph 12 – Deteriorated sealant material at the expansion joint.

2. Damaged and deteriorated sealant material should be replaced in 2024. It may be necessary to install a (removable) sheet metal panel over the horizontal expansion joint to protect it against damage from ravens.

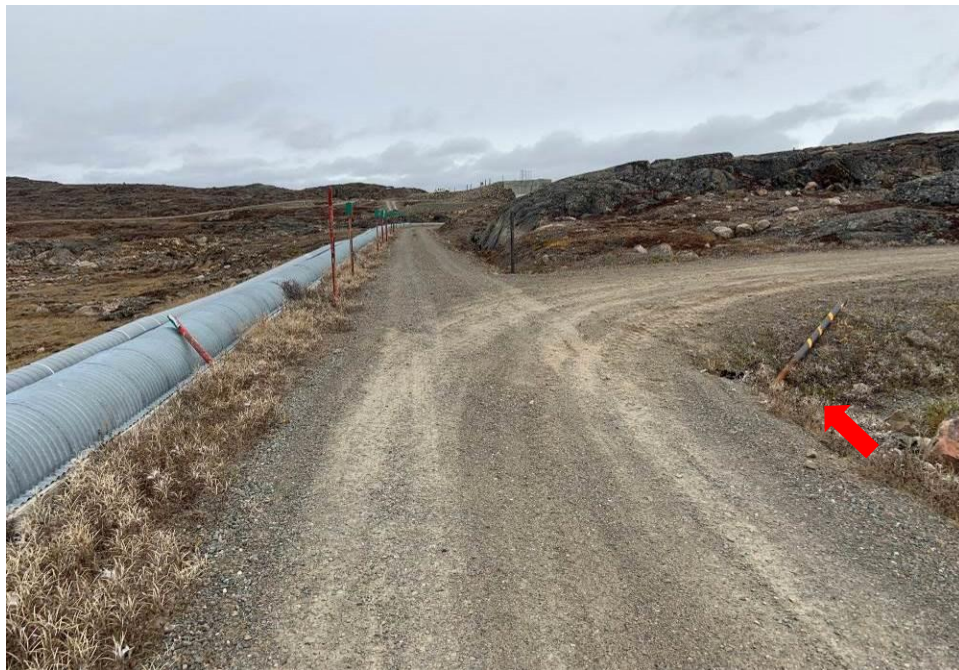
- The metal corner post (used to indicate the edge of the road) knocked over by vehicle traffic on the south access road has not been repaired. See Photograph 13.

Photograph 13 – Corner marker at the junction of the south access road and the road to the south berm has been knocked over.

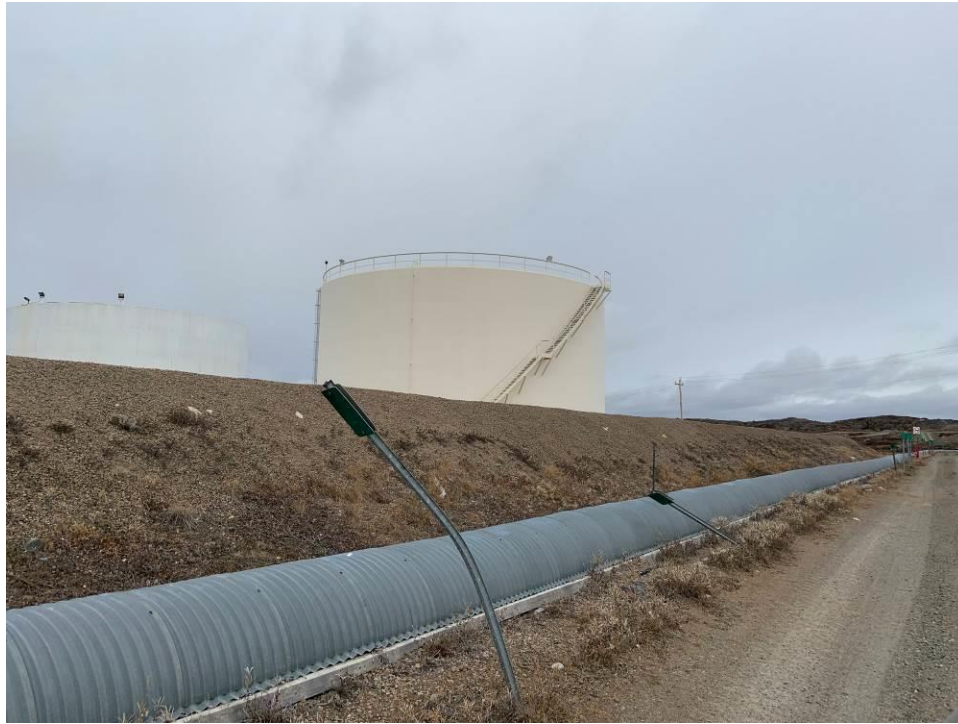
- The blizzard markers installed along the north side of the south access road previously identified in our DSI reports have not been repaired. See Photograph 14.

Photograph 14 – Blizzard markers knocked over and or missing along the south access road.

6. The metal posts / markers that were installed along the north side of the south access road should be re-instated.

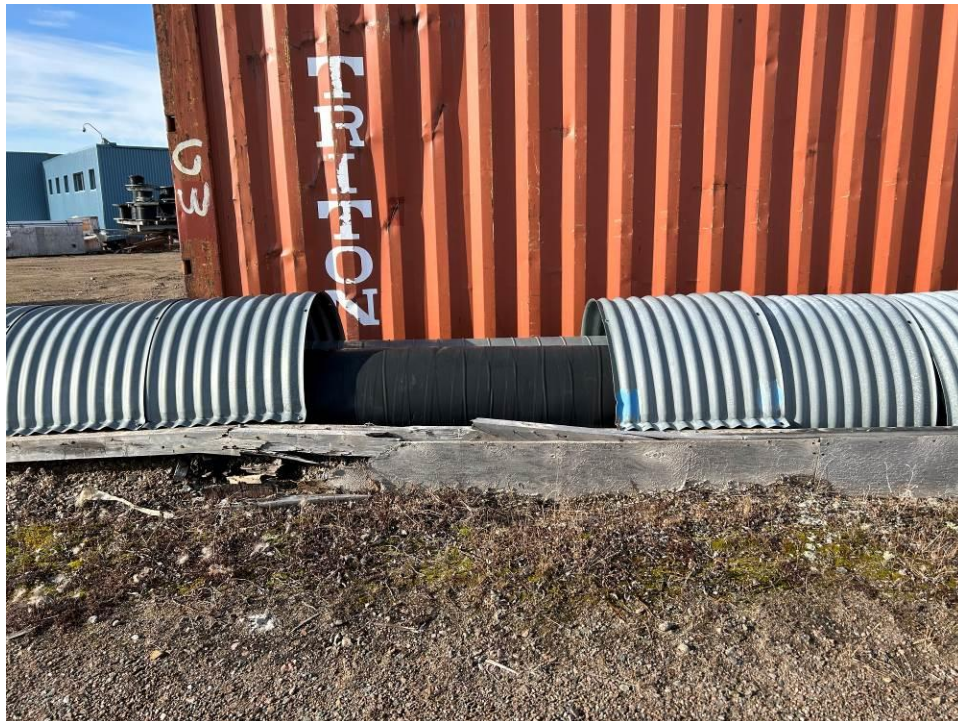
- Portions of the galvanized metal enclosure that covers the pipe that supplies water from the dam to the water treatment plant have not been re-instated. See Photograph 15.

Photograph 15 – Section of the supply pipe from the dam with the corrugates metal enclosure removed.

4. Undertake an underwater survey of the concrete dam and spillway in 2024.
5. The protective galvanized metal enclosure installed over the pipeline from the dam to the water treatment plant should be re-instated.

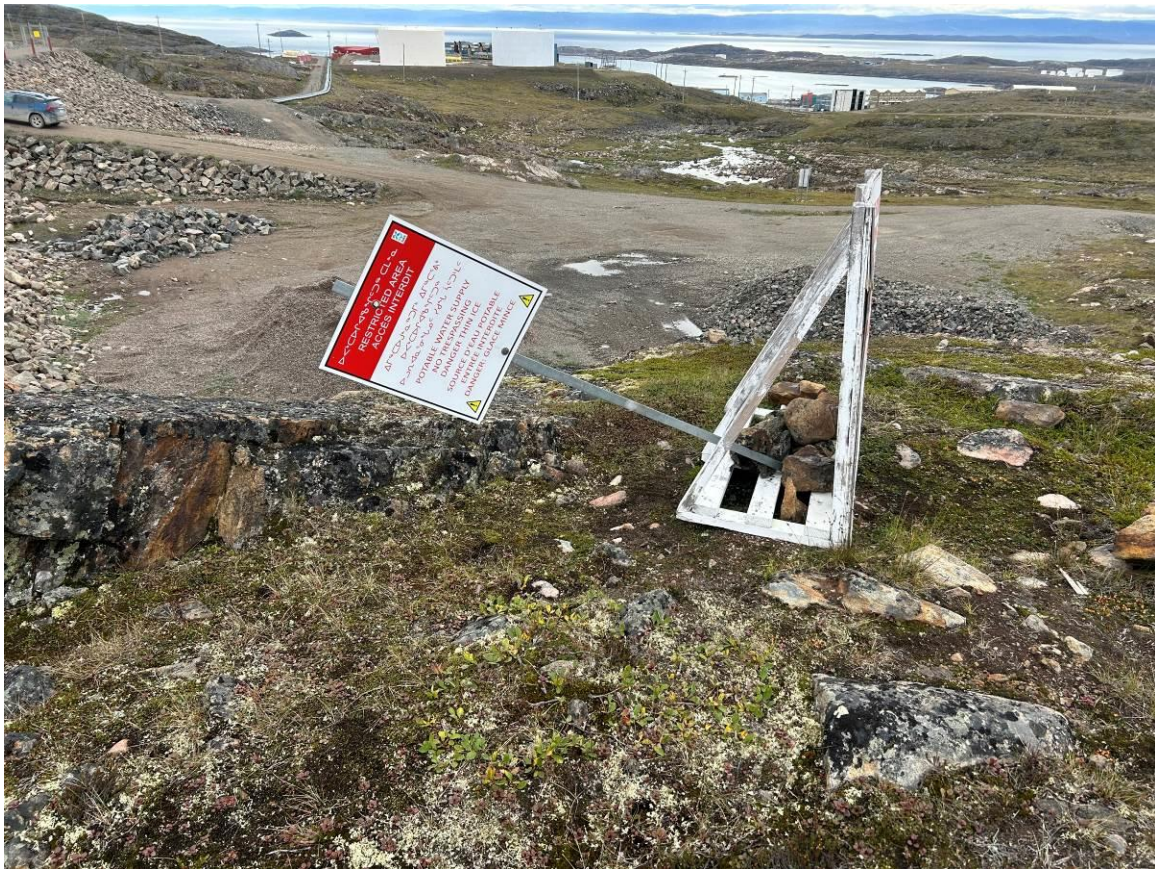
Photograph 16 – Warning signage installed in the wrong location at the South end of the South Berm.
