**CITY OF IQALUIT
DAM SAFETY REVIEW FOR
LAKE GERALDINE DAM**

Trow Consulting Engineers Ltd.

The City Of Iqaluit retained Trow Consulting Engineers Ltd., (Trow), in October 2001, to prepare a Dam Safety Review (DSR) for the Lake Geraldine Dam.

APPENDIX 1
SITE PHOTOGRAPHS
LAKE GERALDINE DAM

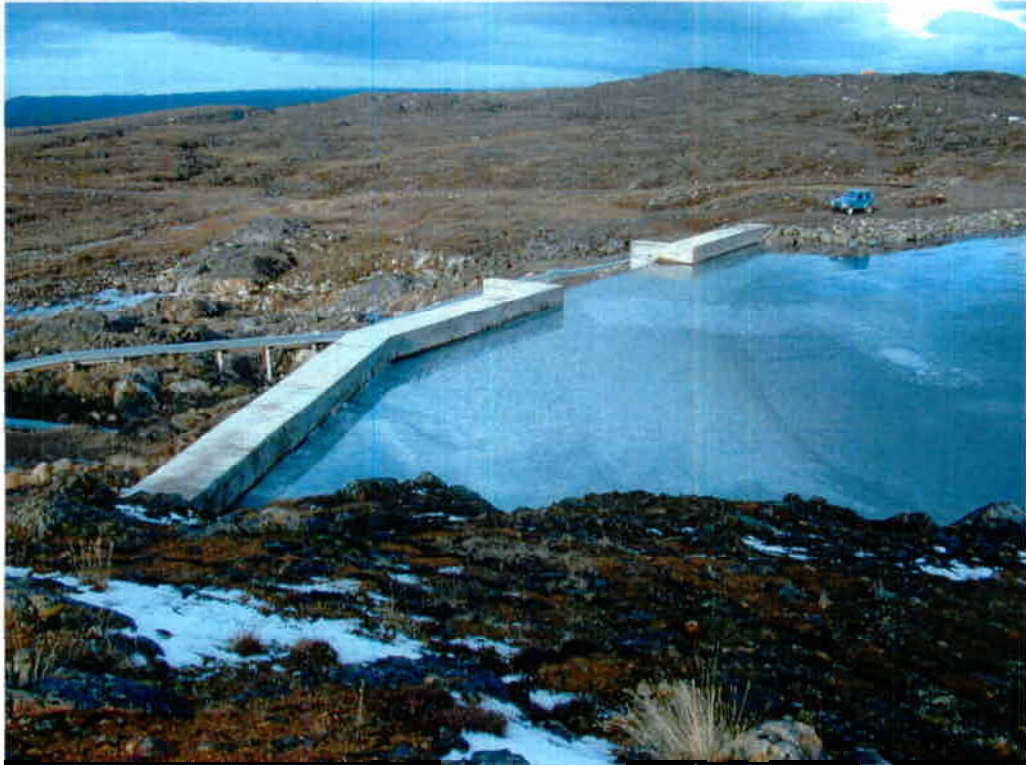
Photograph No. 1 – Lake Geraldine Dam overview, upstream side, looking northwest.

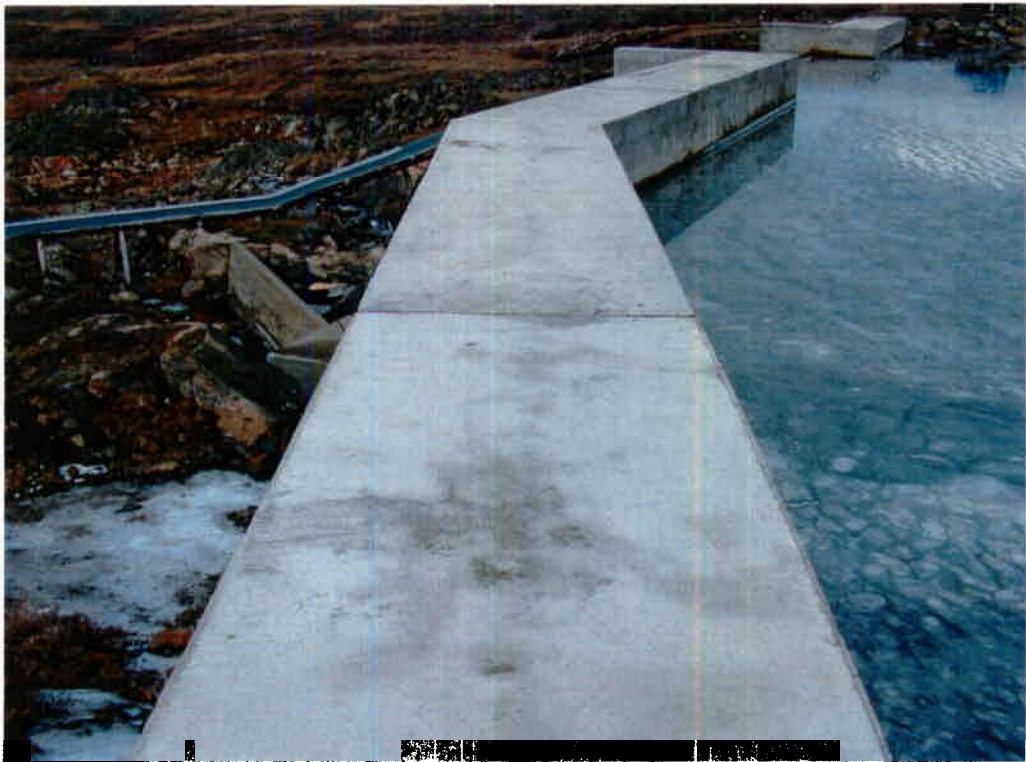
Photograph No. 2 – Top of Gravity Dam, looking northwest.

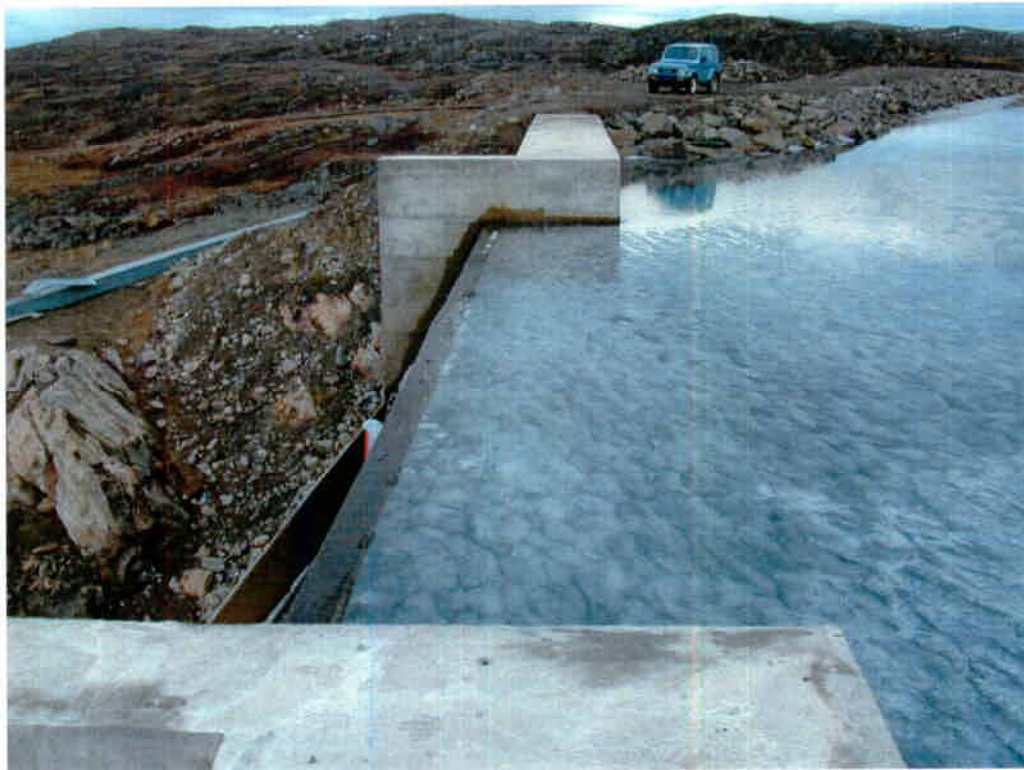
Photograph No. 3 – Spillway section, looking northwest.

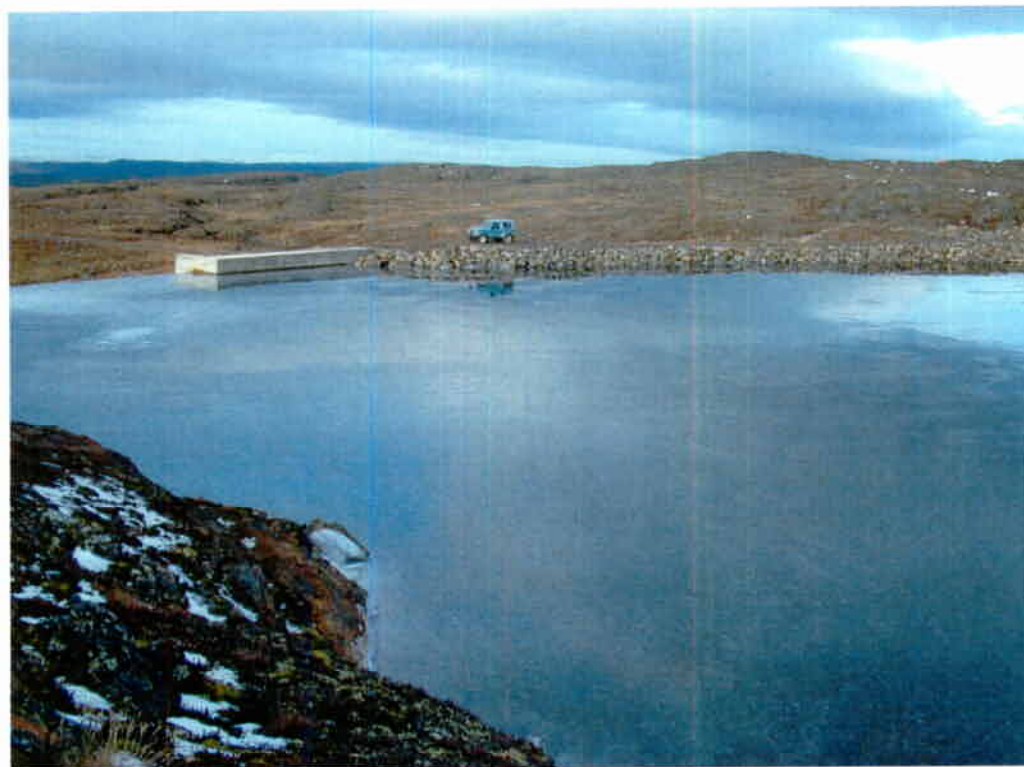
Photograph No. 4 – Lake Geraldine Reservoir, looking northwest to embankment portion of dam. Spillway section is at extreme left.

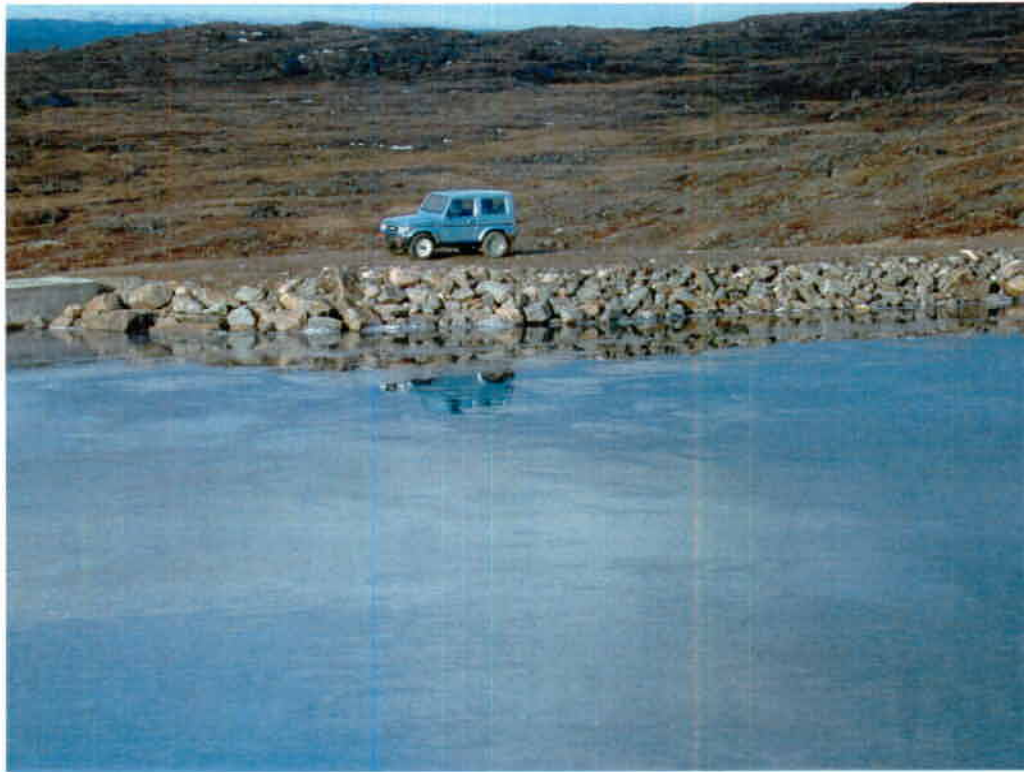
The upstream side of the embankment, with its steep slopes, appears to be potentially unstable. Some slumping of a section of the embankment was observed during the site visit. Factors of safety range from 1.025 to 1.168, which is considerably less than required.

Photograph No. 5 – Close-up of embankment portion at tie-in with Gravity section (at left), upstream face.

3. The embankment portion of the dam does not meet the requirements of Sections 5 and 8 of the DSG. Specifically, factors of safety for dynamic and static stability are significantly lower than required minimums, particularly on the steeper upstream face of the embankment. At this time, it is recommended that provisions be made for the design of repairs, which should be implemented in 2002. Repairs would likely include flattening of upstream slopes.

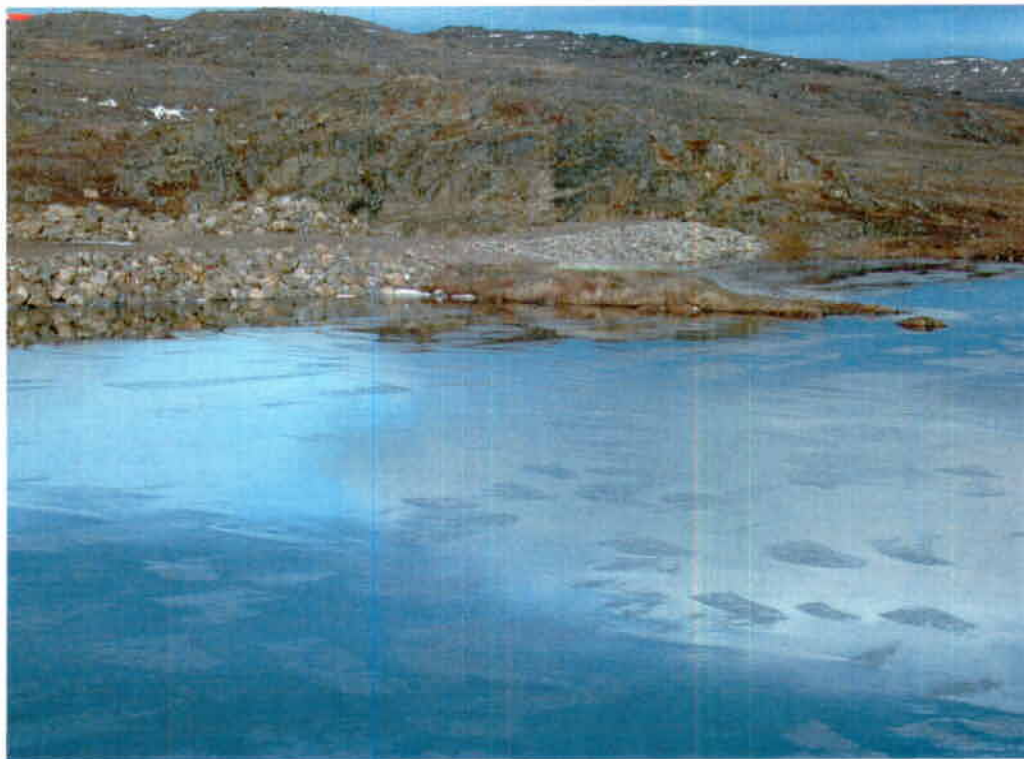
Photograph No. 6 – Close up of embankment portion at north termination, upstream face.

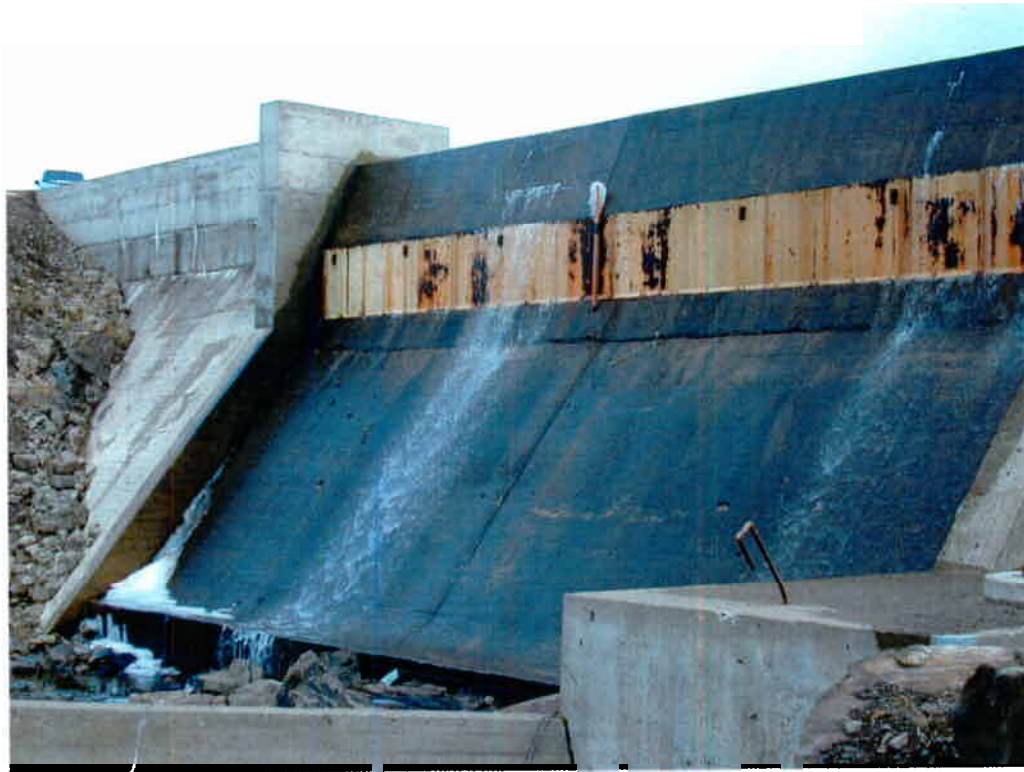
- Several actively seeping cracks were observed. These cracks are generally vertical in orientation and hairline in width, as would be expected for shrinkage (non-structural) cracking. The location and extent of shrinkage cracking has not changed significantly since the 1997 inspection. The recommendation from the 1997 report to chemically grout actively leaking cracks was not carried out.

**Photograph No. 7 – Overview of north end of Gravity elevation and Spillway elevation.
Note leaching cracks on Gravity face.**

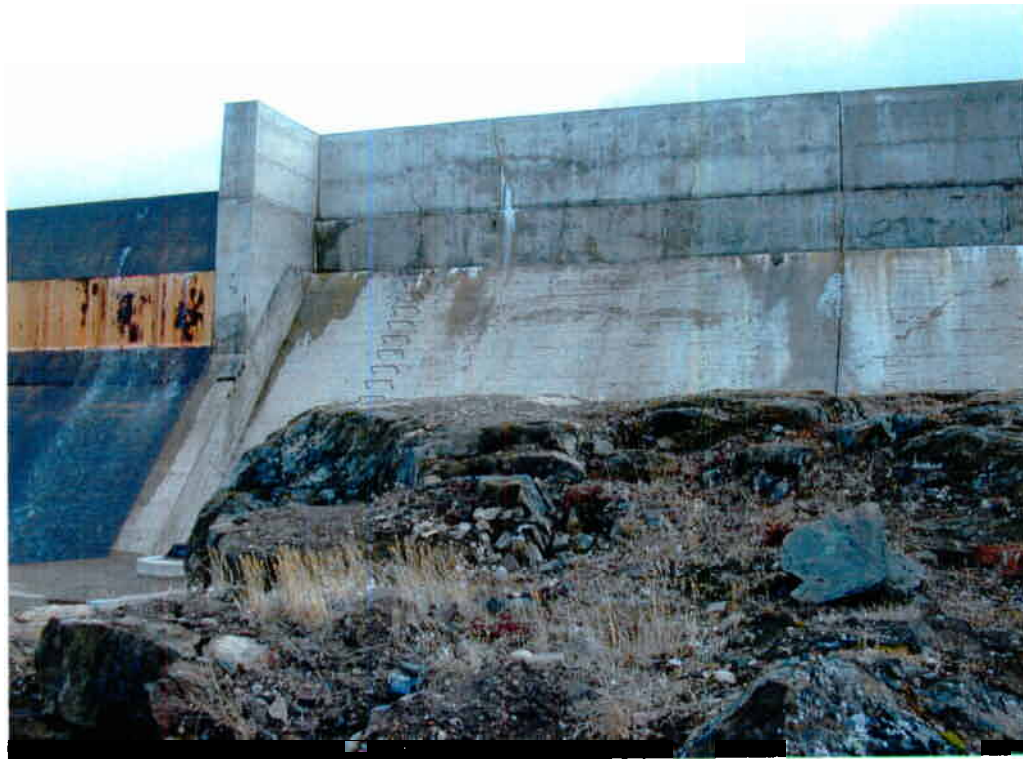
Photograph No. 8 – Overview of southern portion of Spillway section, and south Gravity elevation. Note leaching cracks in Gravity face.

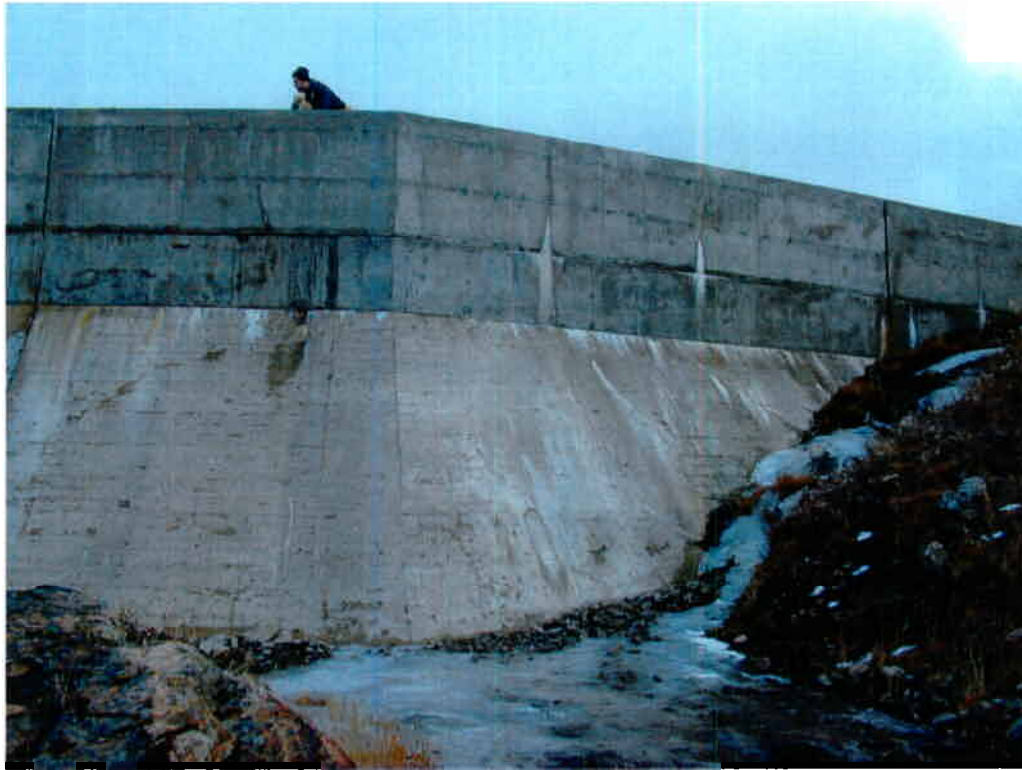
Photograph No. 9 – Overview of south Gravity elevation. Note leaching cracks.

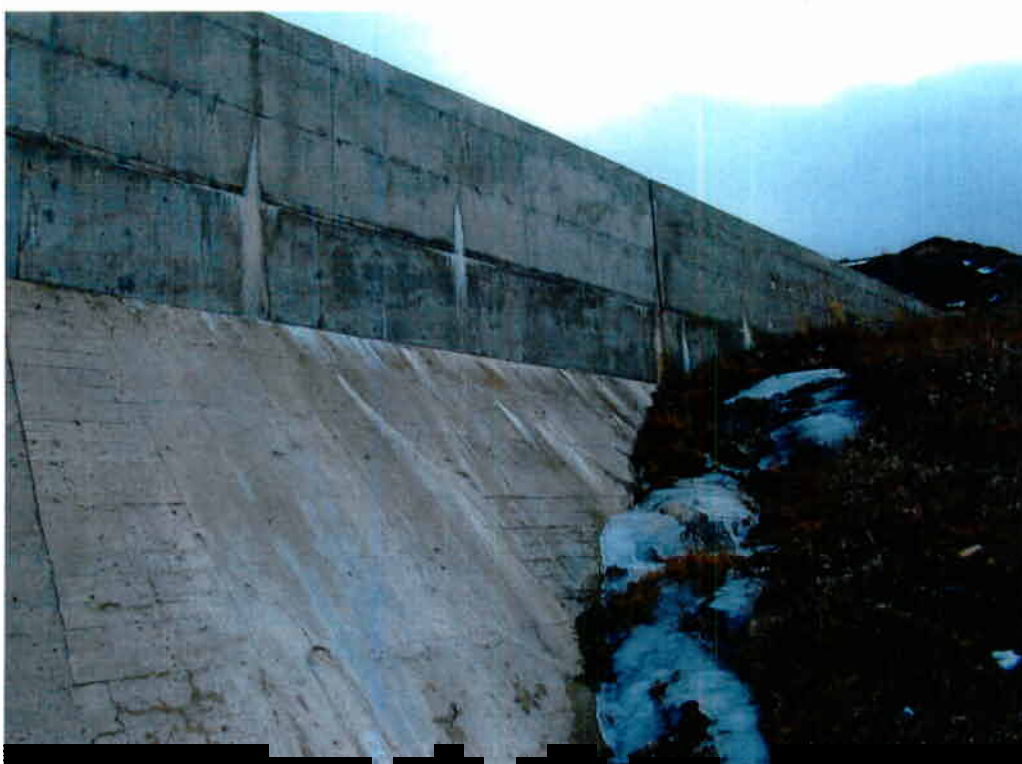
Photograph No. 10 – Southern terminus of Gravity section.

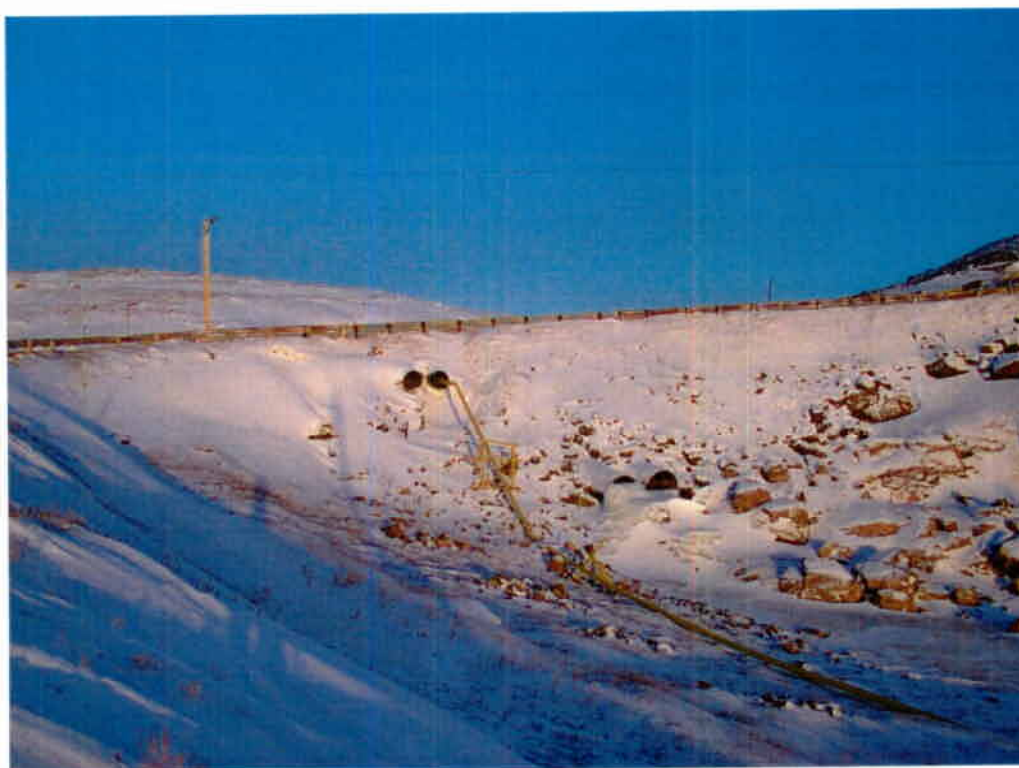
Photograph No. 2 – Looking upstream at Power Station Road Crossing. This crossing would be the first washed out (#1) in the event of a dam breach.

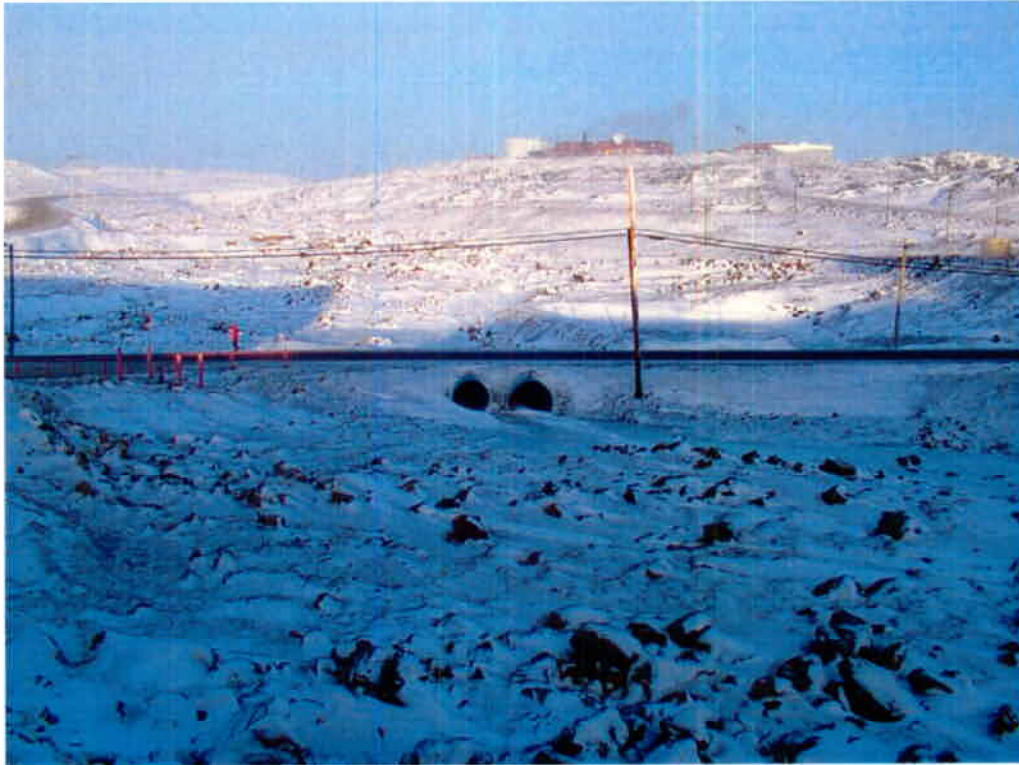
Photograph No. 3 – Looking upstream at Apex Road Crossing, Power Station in background. A second washout (#2) would be expected here.

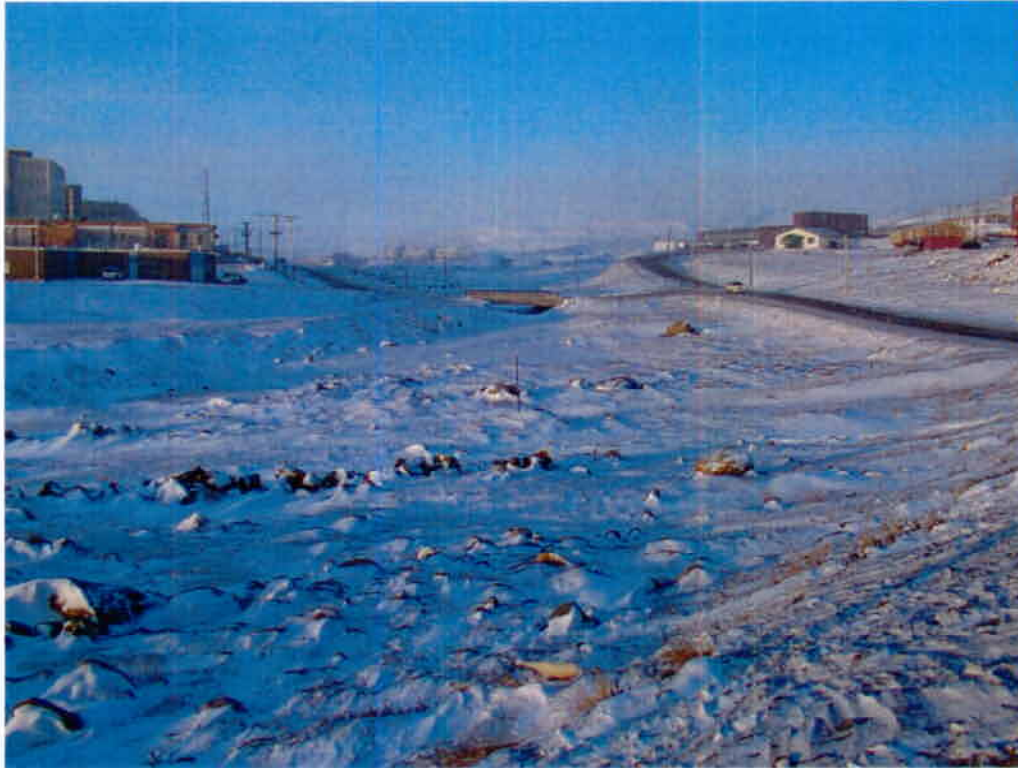
Photograph No. 5 – Further downstream, looking north at bridge to Frobisher Inn. This bridge would likely be lost in the event of a dam breach.

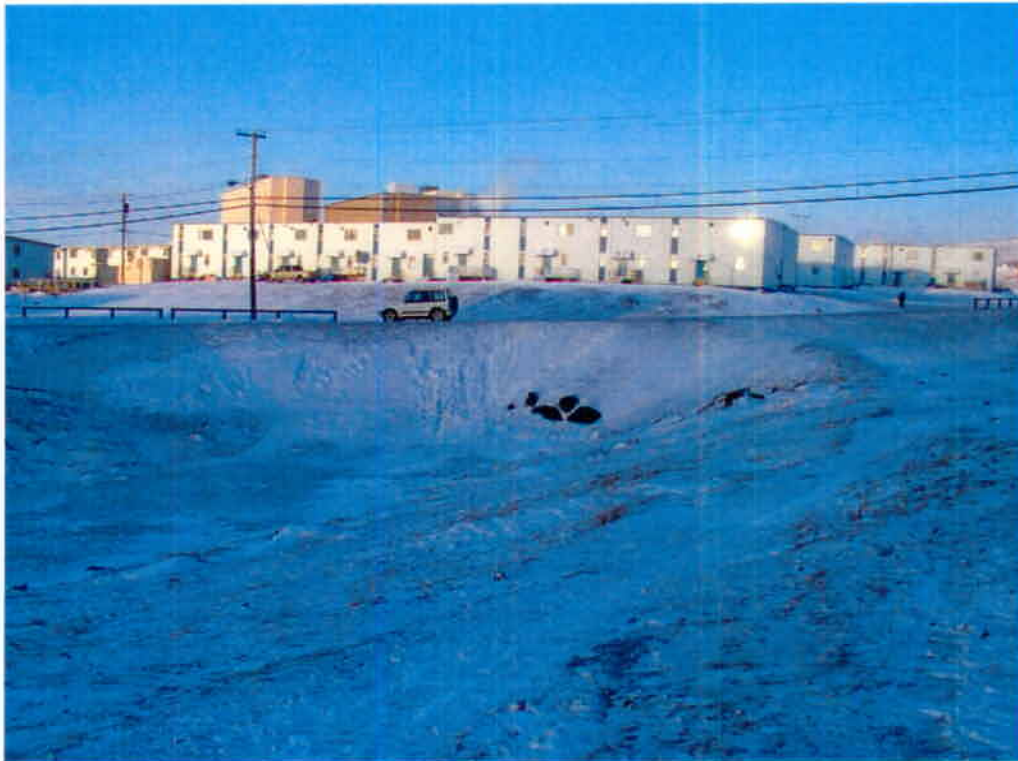
Photograph No. 6 – Looking upstream at UIVVAQ Road Crossing, which would be road washout #3.

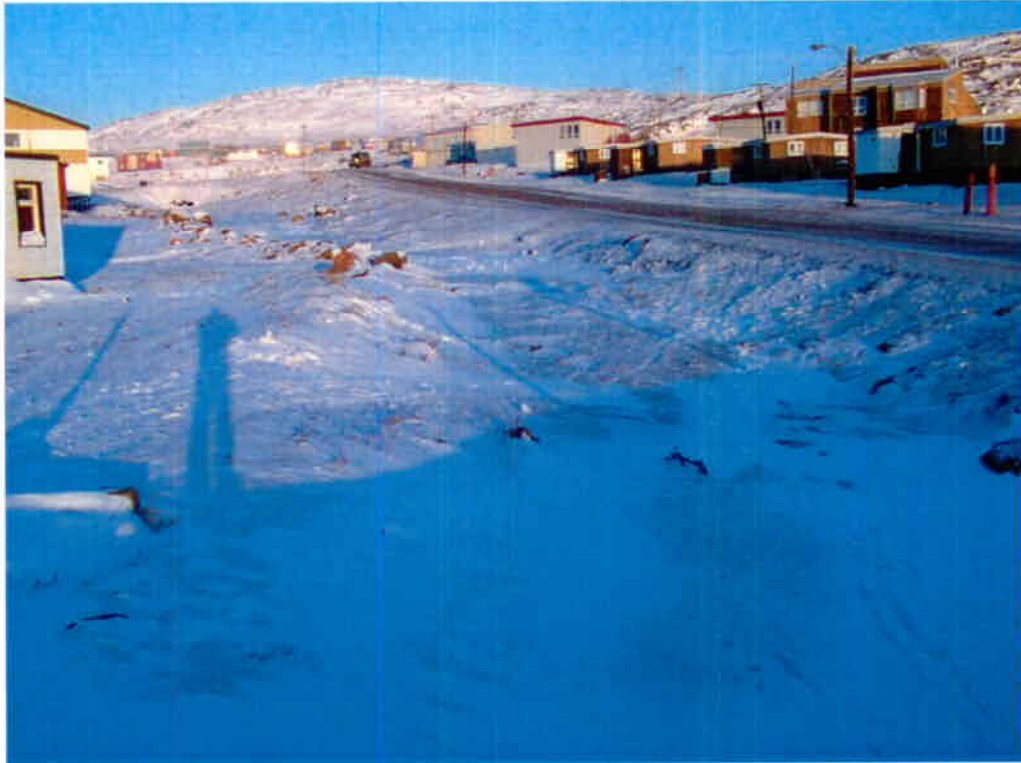
Photograph No. 7 – Further downstream, looking northeast along Nanvq Street. Housing is in the damage path.

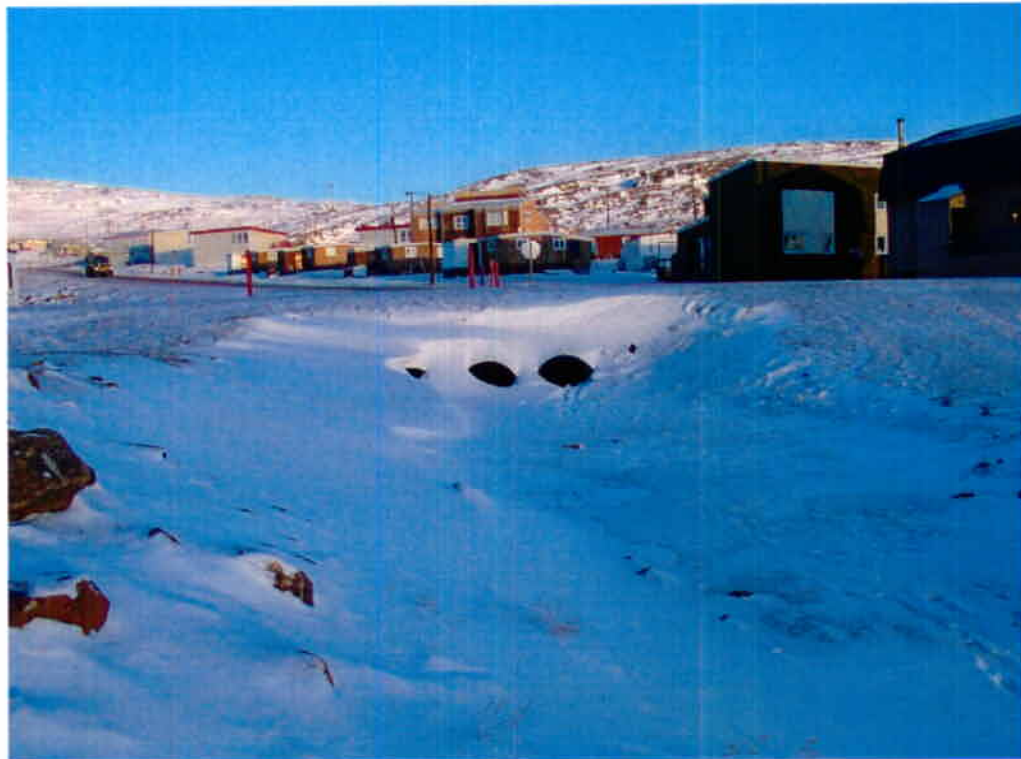
Photograph No. 8 – Moving further downstream to Ikaluit Street Crossing, which would be washout #4.

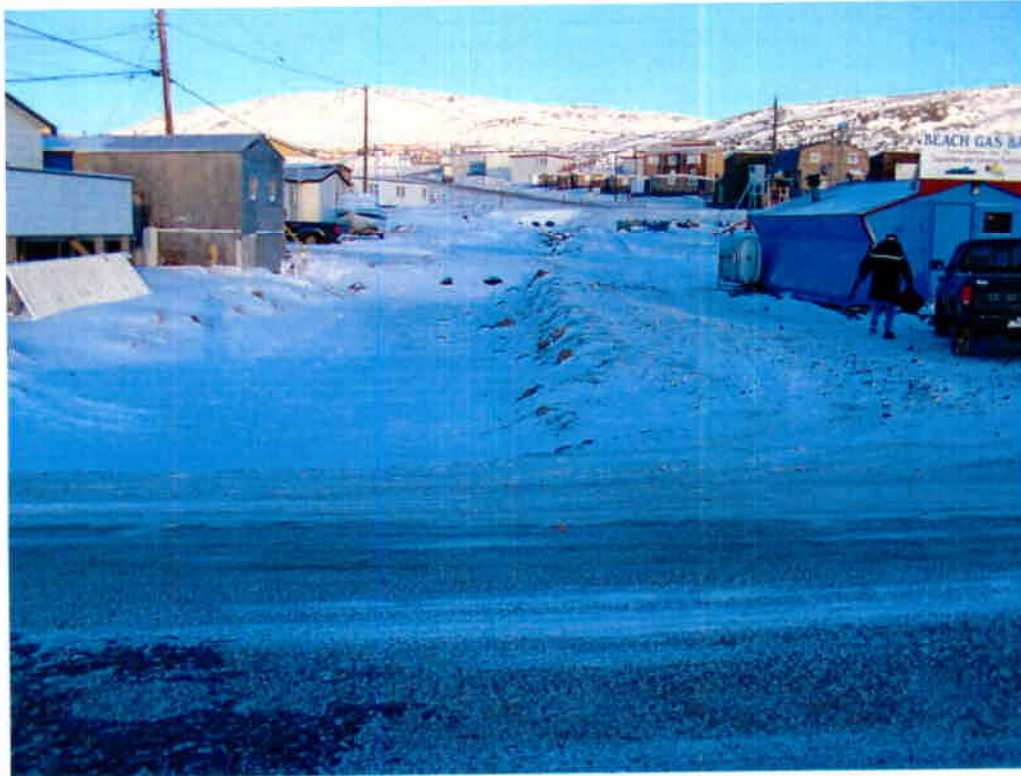
Photograph No. 9 – Moving further downstream to Sinnz Street Crossing, which would be washout #5. All buildings are in damage path.
