City of Iqaluit

Drinking Water Management Program

Development of Drinking Water Program

OTT-00246002-B0

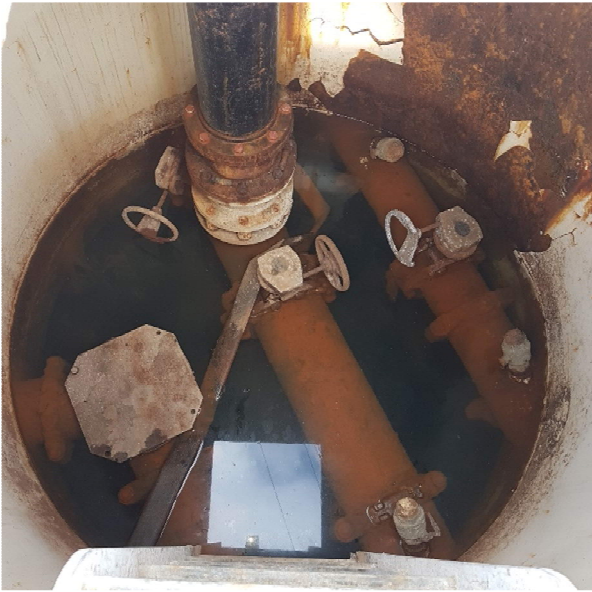
Yes – pump out and inspect
AV 327	<ul style="list-style-type: none"> Incorrect AV numbering on sign, structure is AV 327 not AV 213 Protective coating inside structure failing, probably due to high moisture from standing water.

Yes – install correct sign for structure ID

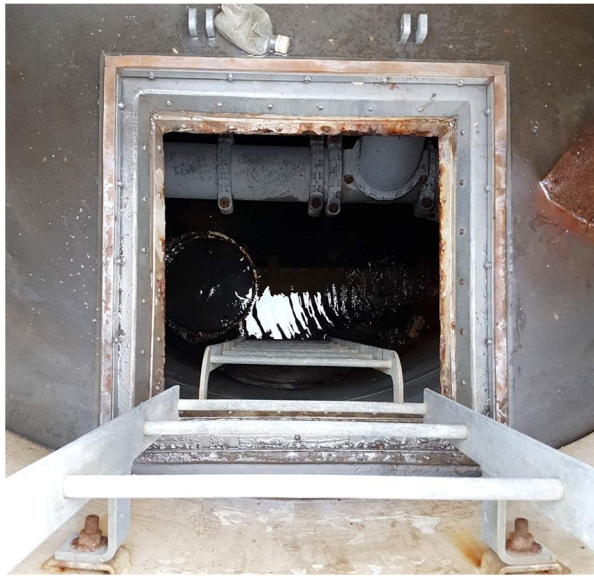
No
AV 500	<ul style="list-style-type: none"> Critical structure for Road to Nowhere Loop, contains key infrastructure. <ul style="list-style-type: none"> Circulation Pumps Check Valve Deep and large structure, utilizes safety landing. Significant water within structure, requires further investigation Sanitary cleanout cover not installed

Yes – Enter structure and determine cause of water. Also investigate condition of pumps and valve configurations.
AV 329	Structure could not be accessed, need to cut lock and investigate		Yes – access and investigate

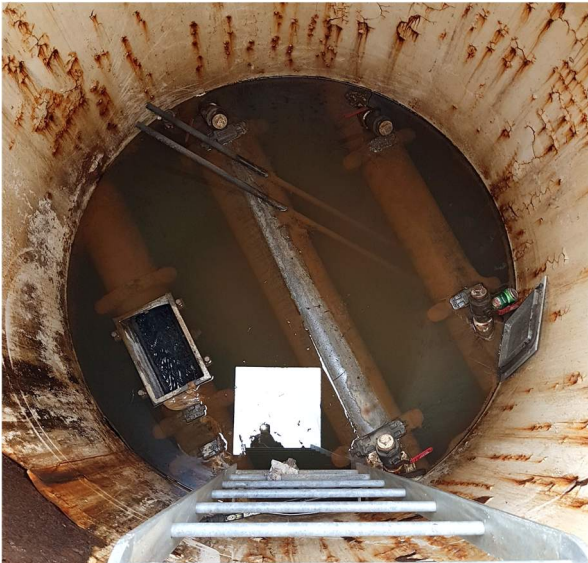
AV 330	<ul style="list-style-type: none">• Sanitary cleanout cover not installed• Protective coating inside structure failing, probably due to high moisture from standing water.• Debris inside structure

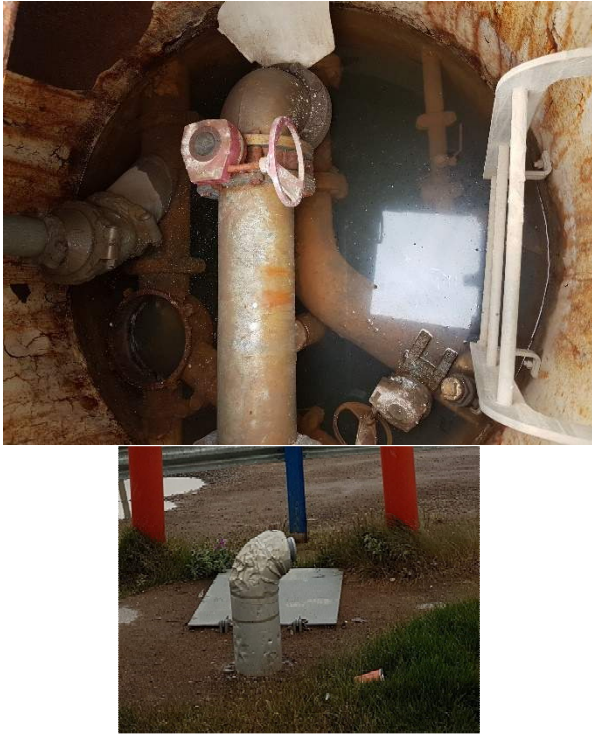
<p>Yes – clean and investigate service return connection inside the vault</p>
<p>AV 335</p>	<ul style="list-style-type: none"> • Above ground sanitary quick connect access <ul style="list-style-type: none"> • Cap missing, and should be locked • Recirculation piping should be abandoned • Protective coating within the structure has failed, probably due to high moisture • Sanitary cleanout cover not installed

<p>Yes – install sanitary quick connect cap</p>

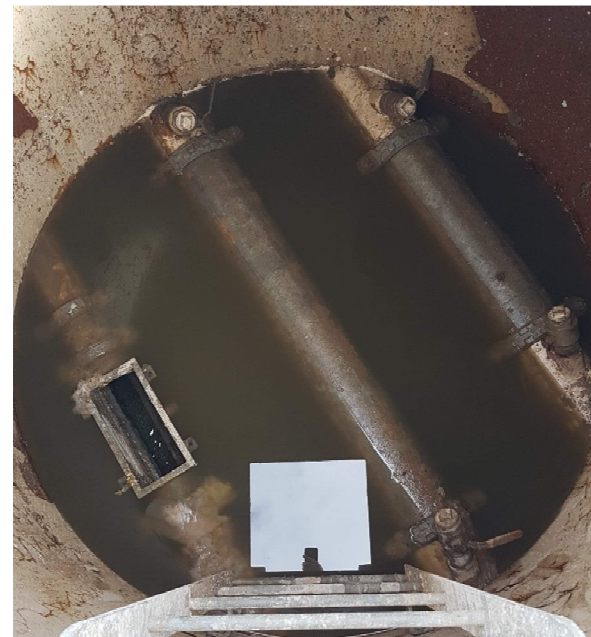
- Structures protective coating has failed, due to high moisture
- Evidence of sewage backups
- Sanitary cleanout cover not installed

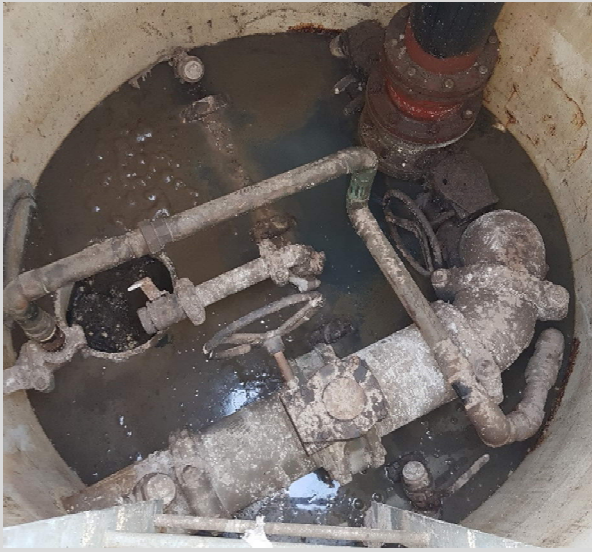
AV 357	<ul style="list-style-type: none"> • School service within vault, old piping shows short circuit as service return was connected to return main. Currently good • Old recirculation piping should be properly blanked, appears to currently only have an old valve • Evidence of sewer backups • Sanitary cleanout not installed

Yes – properly blank old service return piping
AV 358	<ul style="list-style-type: none"> • Active bleed at end of line to help promote circulation • Large service for the arena • Future connections at structure available, if they are used the service configuration will need to be altered to not create short circuit • Protective coating within structure has failed, probably due to high moisture • Evidence of sewer backups • Sanitary cleanout not installed

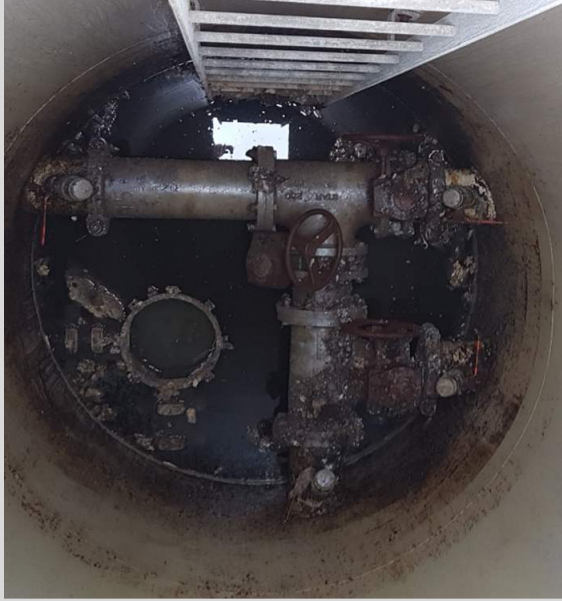
AV 351	Previously reviewed, see above		
AV 351A	Missing, possibly buried		Yes – locate and inspect
AV 352	<ul style="list-style-type: none"> • Two future connections available (right side) • Evidence of sewer backups • Sanitary cleanout not installed

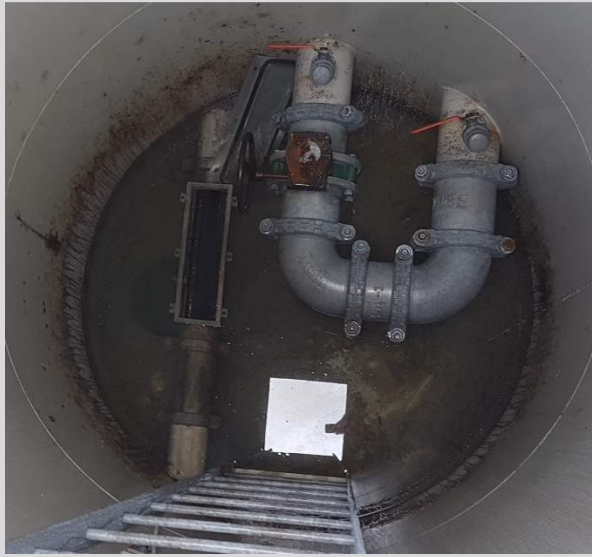
AV 354	<ul style="list-style-type: none"> • Evidence of sewer backups • Sanitary cleanout not installed • No other exceptions noted

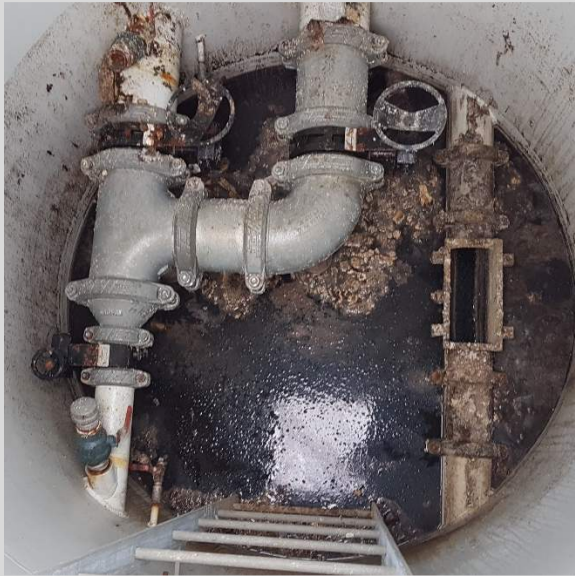
AV 344	<ul style="list-style-type: none">• Valve on 4" piping should be closed, watermain does a 180° turn• Evidence of sewer backups• Sanitary cleanout not installed

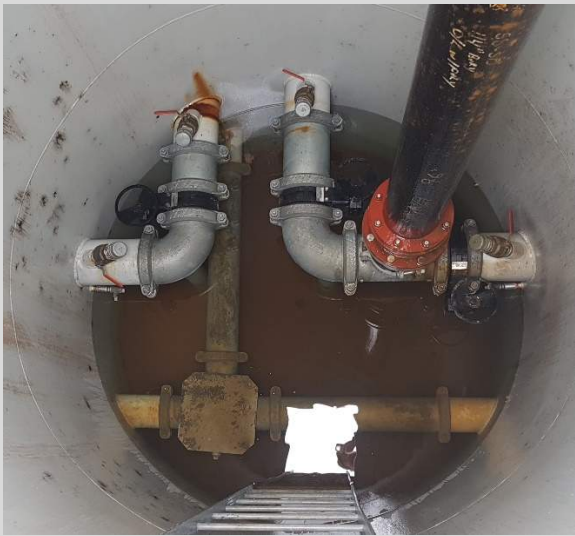
AV 345	Previously reviewed, see above		
AV 346	<ul style="list-style-type: none">• Evidence of minor leak around laterolet• Watermain diverts to service a cul de sac

Yes – repair laterolet

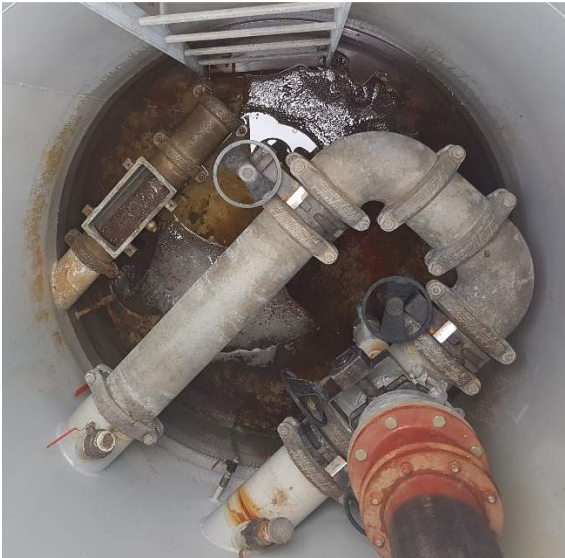
<p>AV 347</p>	<ul style="list-style-type: none"> • Evidence of minor leak around laterolet • Sanitary cleanout cover is not installed

<p>Yes – very minor leak at laterolet</p>
<p>AV 346</p>	<p>Previously reviewed, see above</p>		
<p>AV 348</p>	<ul style="list-style-type: none"> • Evidence of sewer backups • Sanitary cleanout not installed • No other exceptions noted

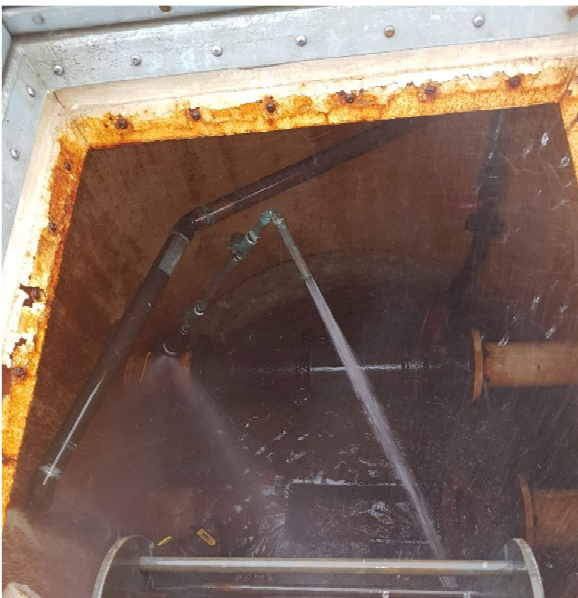
<p>Yes – fix leak. Significant level of effort required to get recirculation system functioning as originally designed</p>
239	<ul style="list-style-type: none"> • Circulation piping still present, but not as per typical piping configuration • Heavy flow at the bleed • Leak on bleed

<p>Yes – fix leak. Significant level of effort required to get recirculation system functioning as originally designed</p>

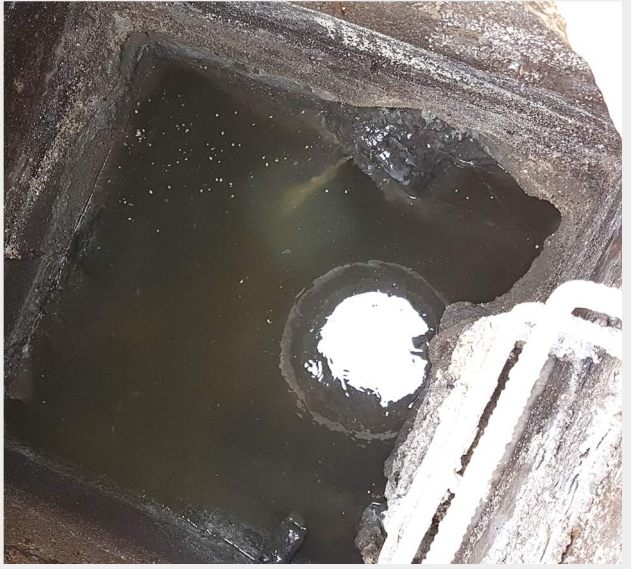
<p>Yes – determine source of water, leak or infiltration</p>
<p>MH 13</p>	<ul style="list-style-type: none"> • Contains valving to control water flow direction • Requires pumping and cleaning as none of the internals visible • Internal condition suggests sewage back-up to substantial depth

<p>Yes – clean and pump out then investigate</p>
<p>Building 222 Reheat Station</p>

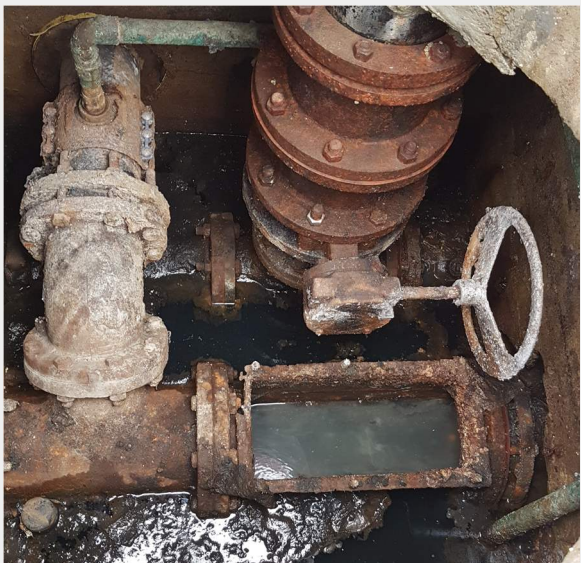
Yes – investigate water piping after cleaning
MH 32A	<ul style="list-style-type: none"> • Requires pumping and cleaning • Clean-out cover missing • Copper piping probably for sump pump that is no longer in service

No

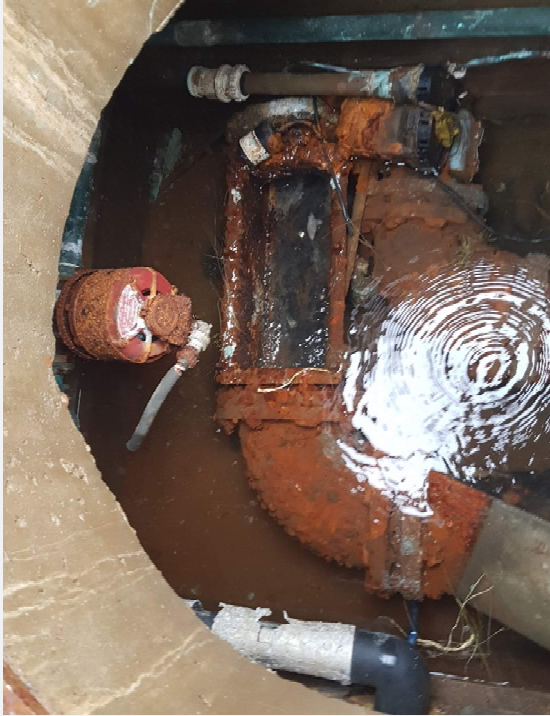
MH 38	<ul style="list-style-type: none"> • Requires pumping • Frame and cover raised using a combination of CSP and concrete collar. • Clean-out cover missing • Appears to contain groundwater

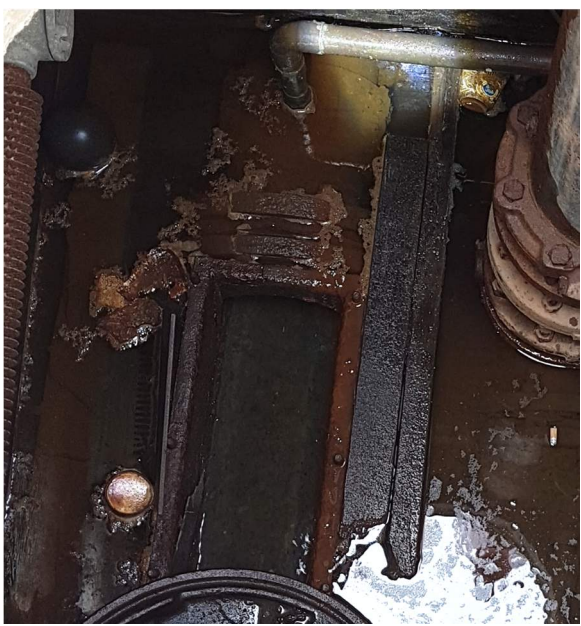
Yes – investigate water source within structure
MH 36	<ul style="list-style-type: none"> • Requires pumping, removal of debris and cleaning • Clean-out cover missing • Sewer appears to have previous backups • Sump pump and heater present but probably not functional

Yes – investigate water source within structure

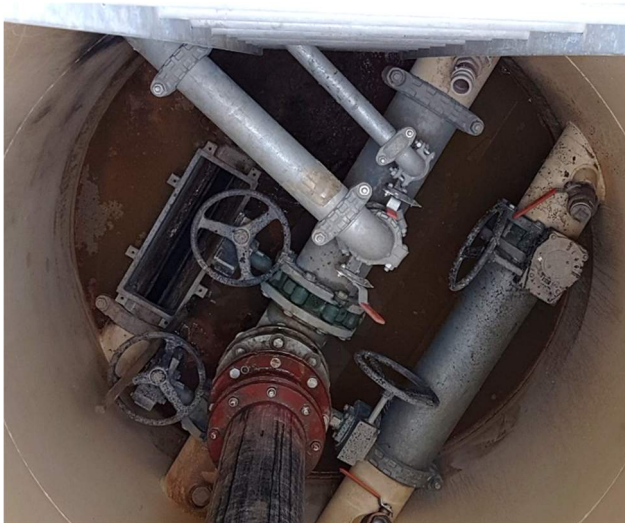
AV 446	<ul style="list-style-type: none"> • Return piping is not in service, this is setup for final configuration • Large service installed properly • Sanitary cleanout not installed • No other exceptions noted

No

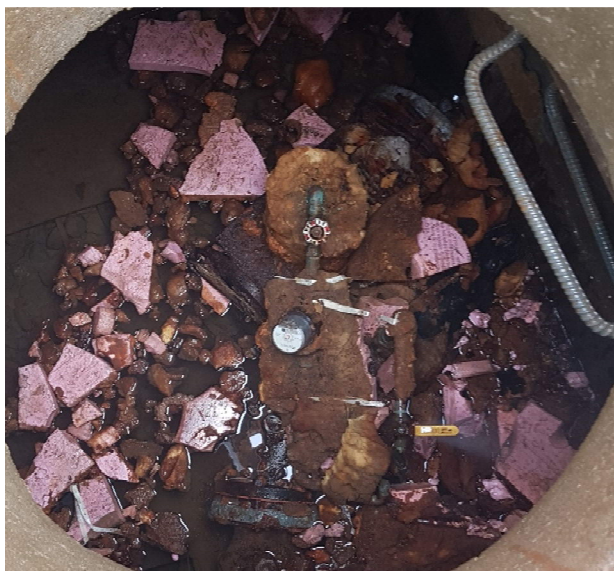
No
MH 55	<ul style="list-style-type: none"> • Leak at the valve on the bleed, valve is closed but not holding • Appears to have a flow meter installed • Debris and water in the structure, clean and re-investigate

Yes – repair leak, clean and pump out remaining structure and investigate
