**Annual Inspection  
Sewage Lagoon, Iqaluit**

Project No. MA15882A  
January 7, 2003

### **Annual Inspection Sewage Lagoon, Iqaluit**

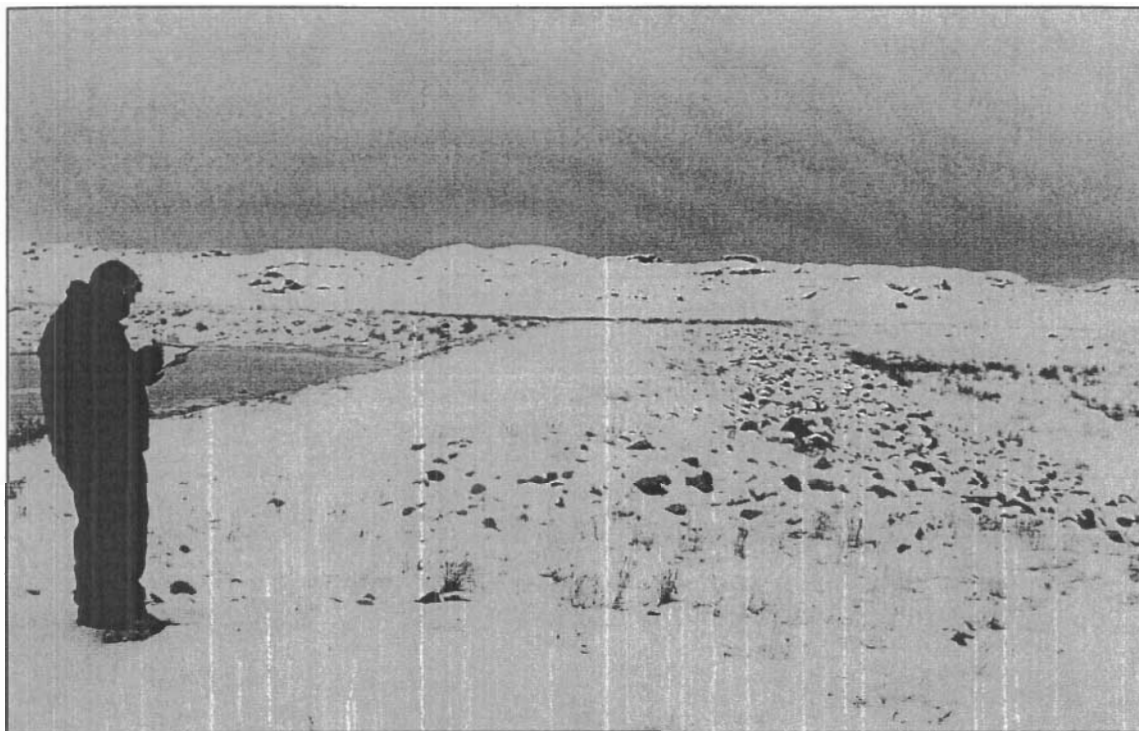
The western perimeter dyke, oriented north-south, is approximately 70 m in length. There is a concrete discharge control structure located along the upstream crest of the dyke, which allows direct discharge via a buried pipe through the dyke from the lagoon to the Inlet. The presence of snow on the dyke slope prevented examination of the slopes for any evidence of erosion or piping. However, at the time of the inspection, there did not appear to be any significant seepage at the toe of the west dyke.

Photo 1 – Showing the West Dyke of the Lagoon

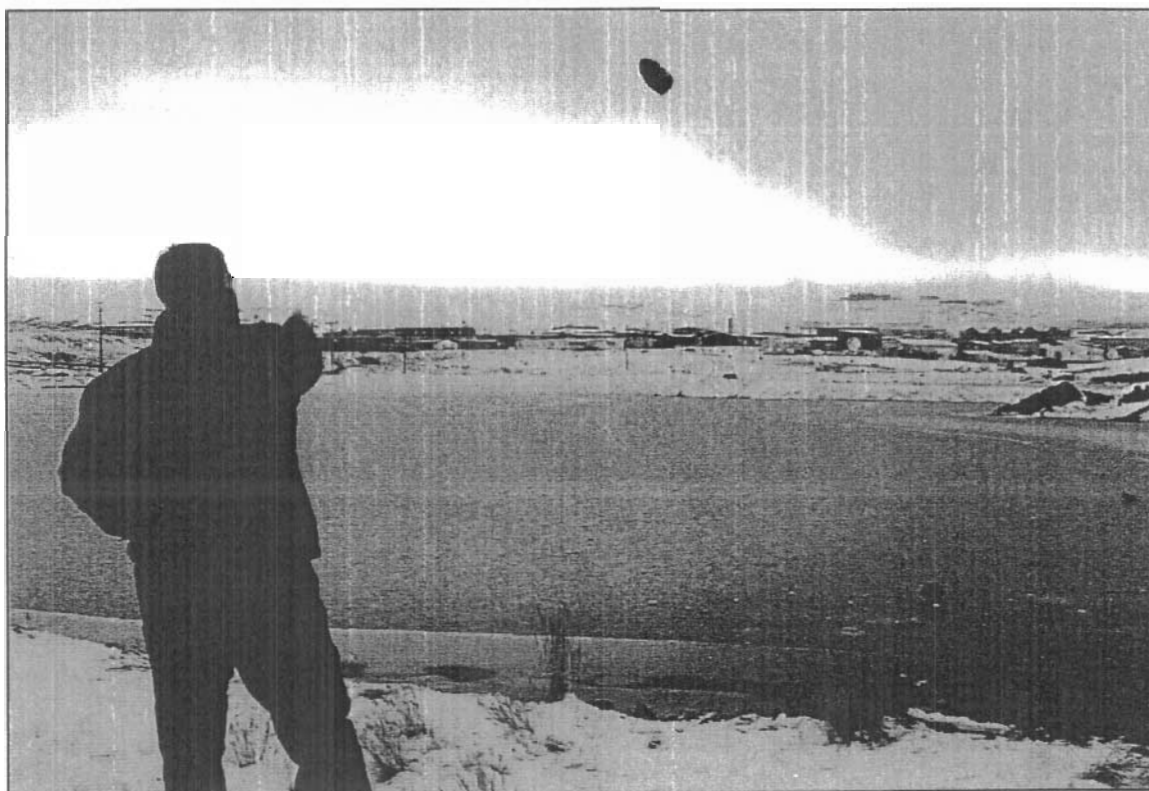
Photo 2 - Showing Frozen Water in the Lagoon (Looking at the East Dyke)

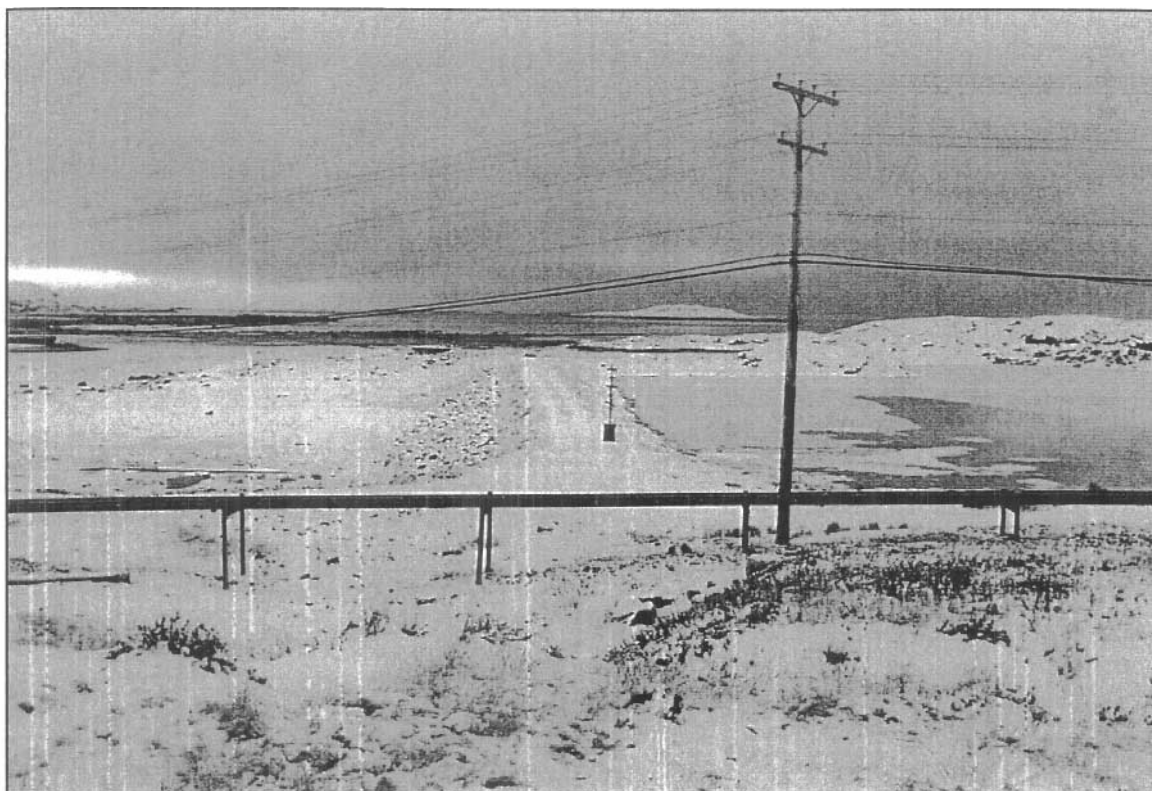
Photo 3 - Looking at The East Dyke of the Sewage Lagoon

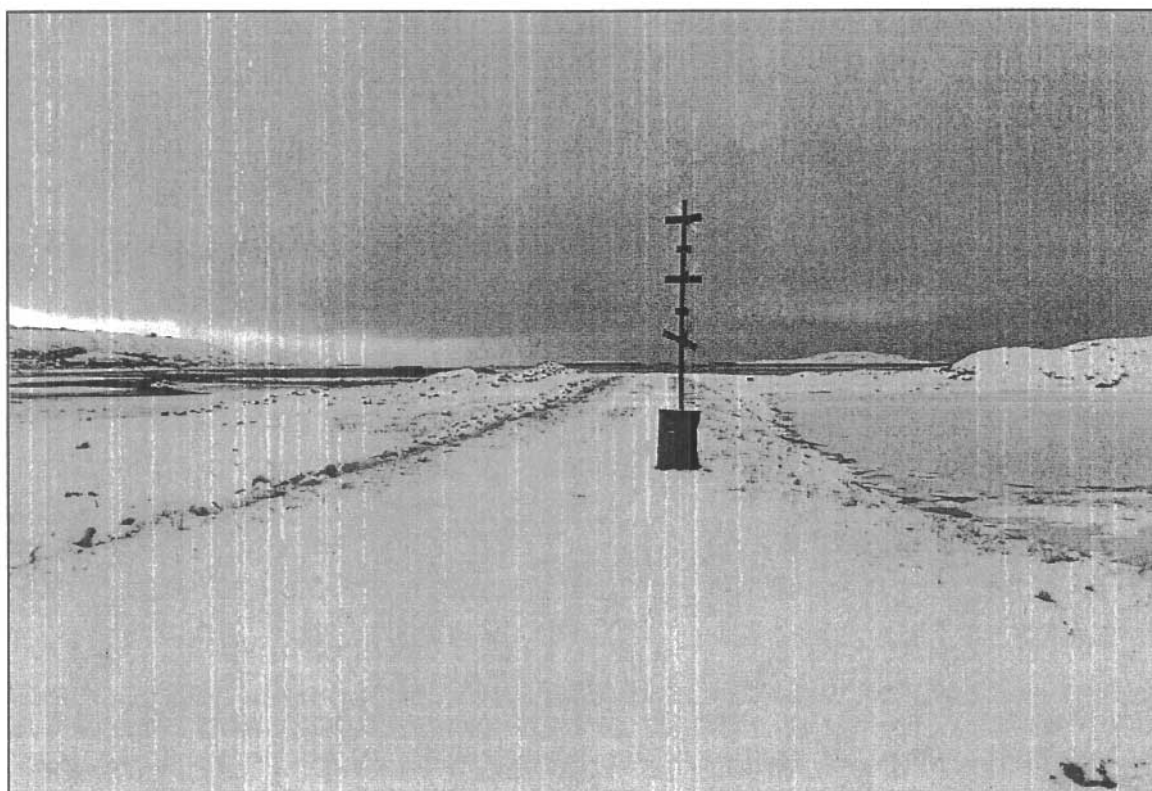
Photo 4 - Close Look at The East Dyke of the Sewage Lagoon

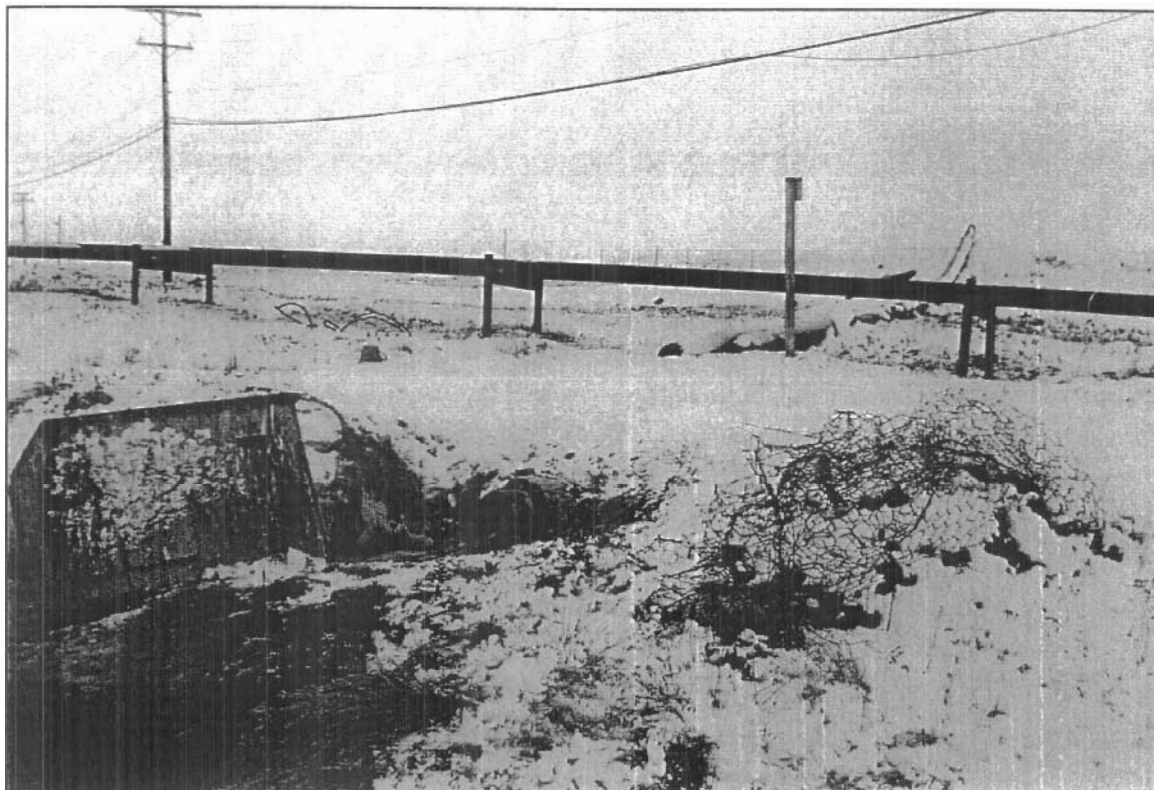
Photo 5 - Discharge Pipe in the Sewage Lagoon (South Side of Lagoon)

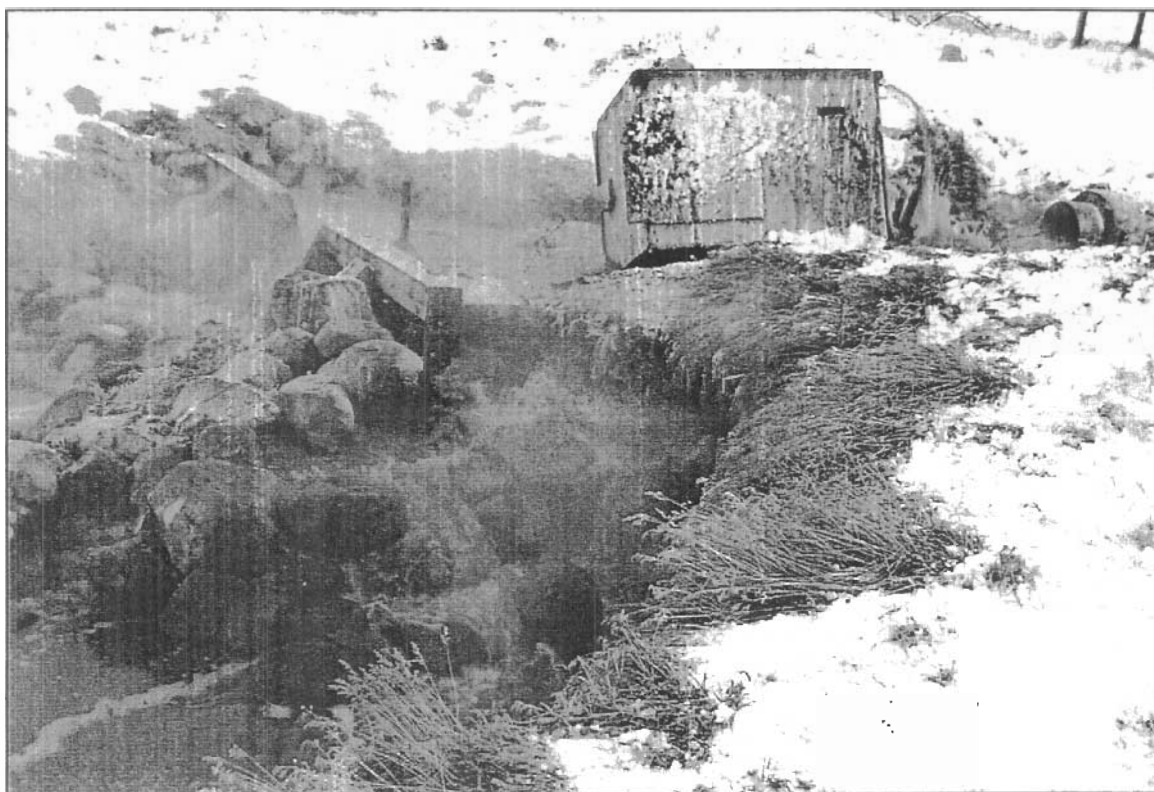
Photo 6 - Close Up of Discharge Pipe Into Lagoon

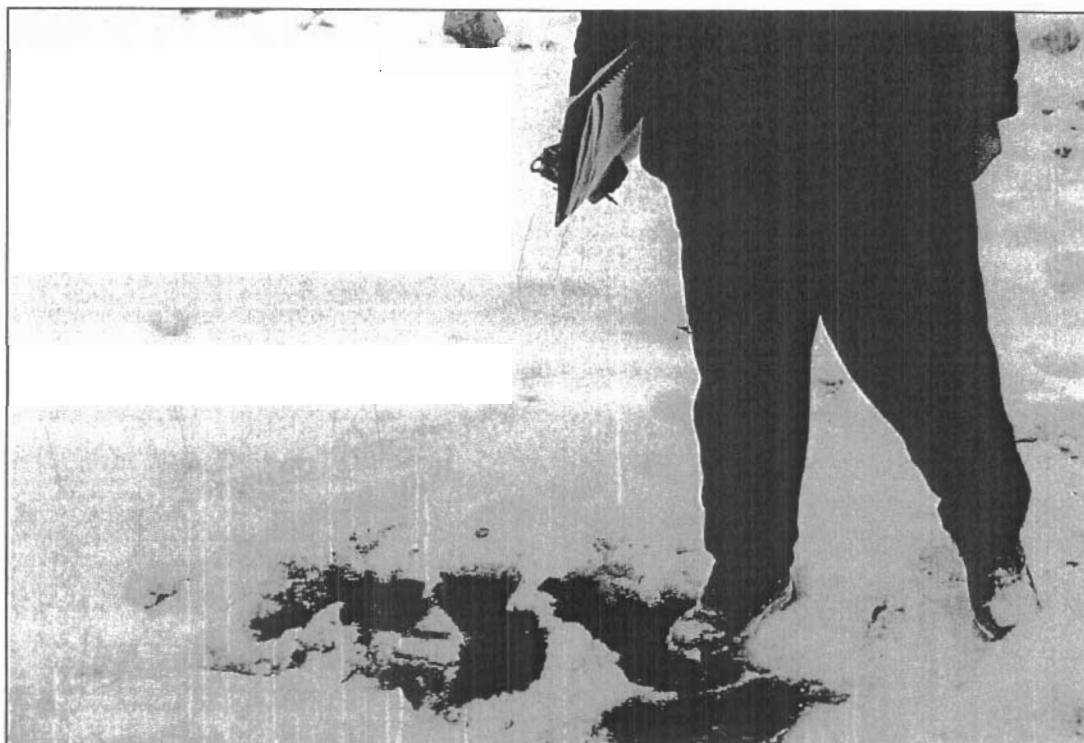
There was obvious discolored brown sewage effluent ponded at the deeper section along the downstream toe of the eastern dyke, across a horizontal distance of at least 25 m. This indicates that some seepage takes place through the dyke similar to that observed during the inspection of 2001. The volume of water was difficult to estimate because it was frozen along the toe. Therefore, it was difficult to determine if the condition of the dyke had worsened since the 2001 inspection. Also, it was not possible to determine if there was erosion along the upstream face of the dam or piping conditions along the toe of the dam due to frozen water surface and snow on the dyke slopes.

Photo 7 – Showing Discolored Water at the Downstream of the East Dyke

In the interim, it is recommended that an inspection of the lagoon site should be undertaken following the spring run-off, i.e. during the period between late June and mid July 2003 when snow and ice have melted so that a more detailed evaluation of the lagoon slopes will be possible. Items that will be addressed include but will not be limited to, evidence of toe erosion and piping conditions, effect of rapid drawdown of spring runoff and tidal changes on dykes slopes, etc..

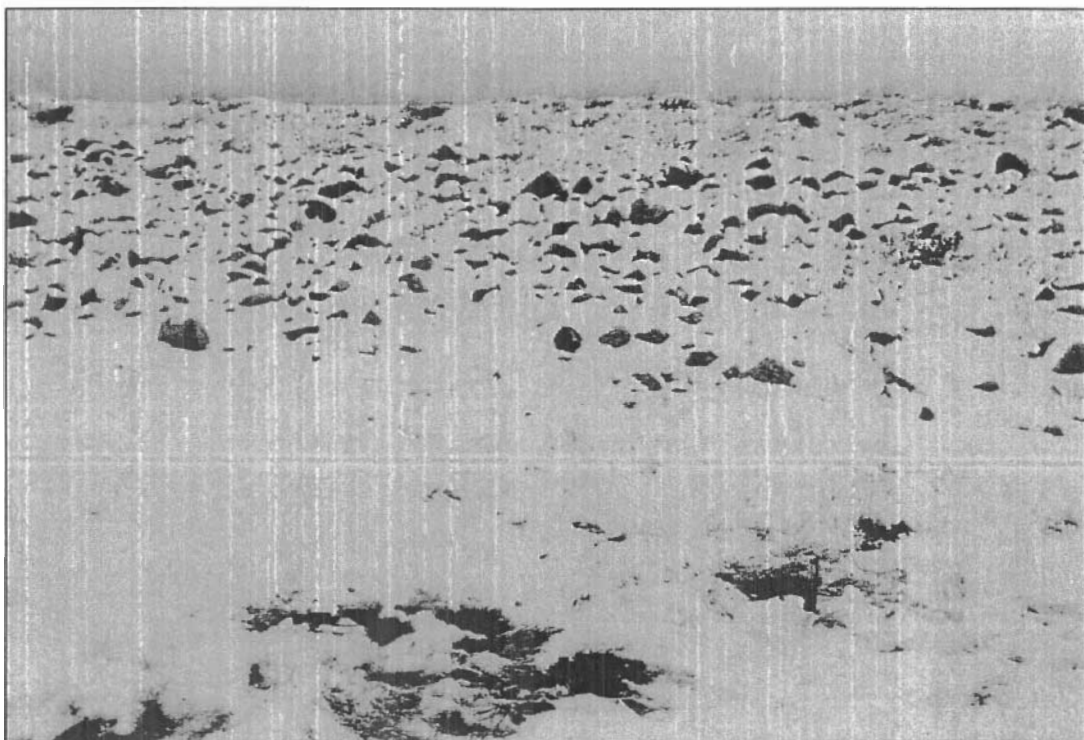
Photo 8 –Showing Saturated Organic Soil at the Downstream Side of the East Dyke

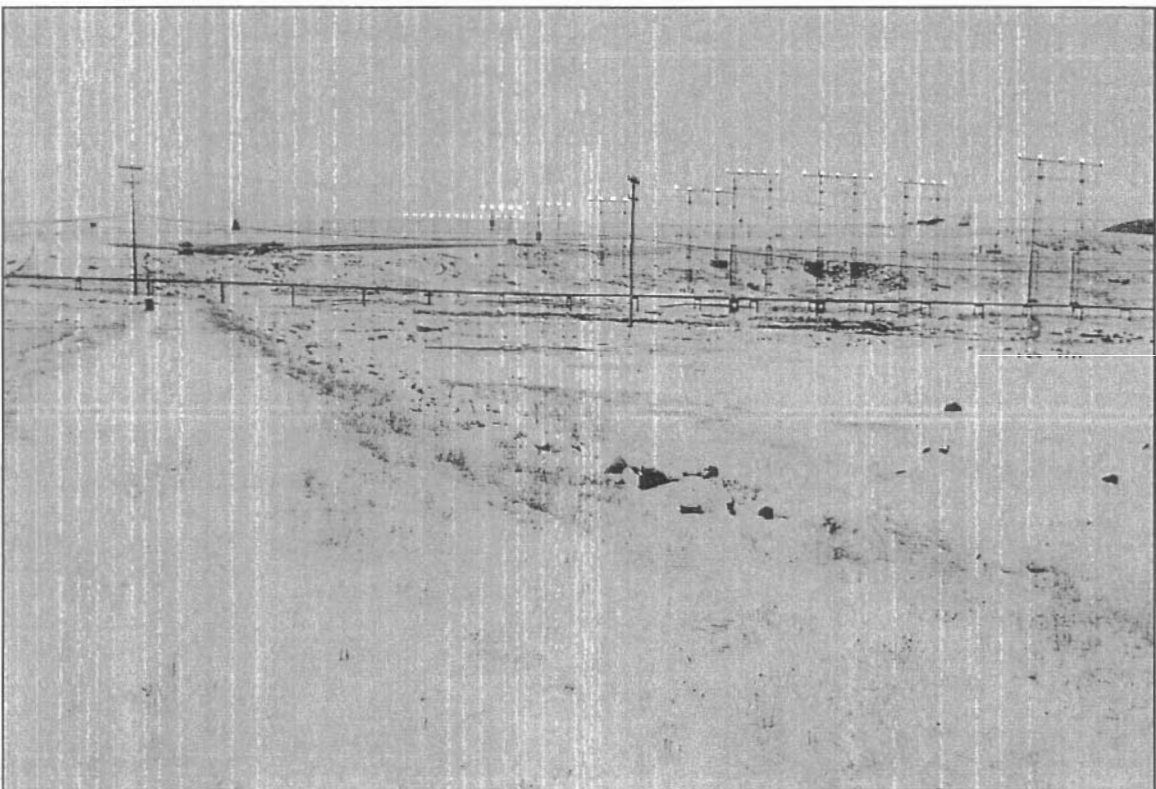
Photo 10 – Looking South at the East Dyke of Lagoon

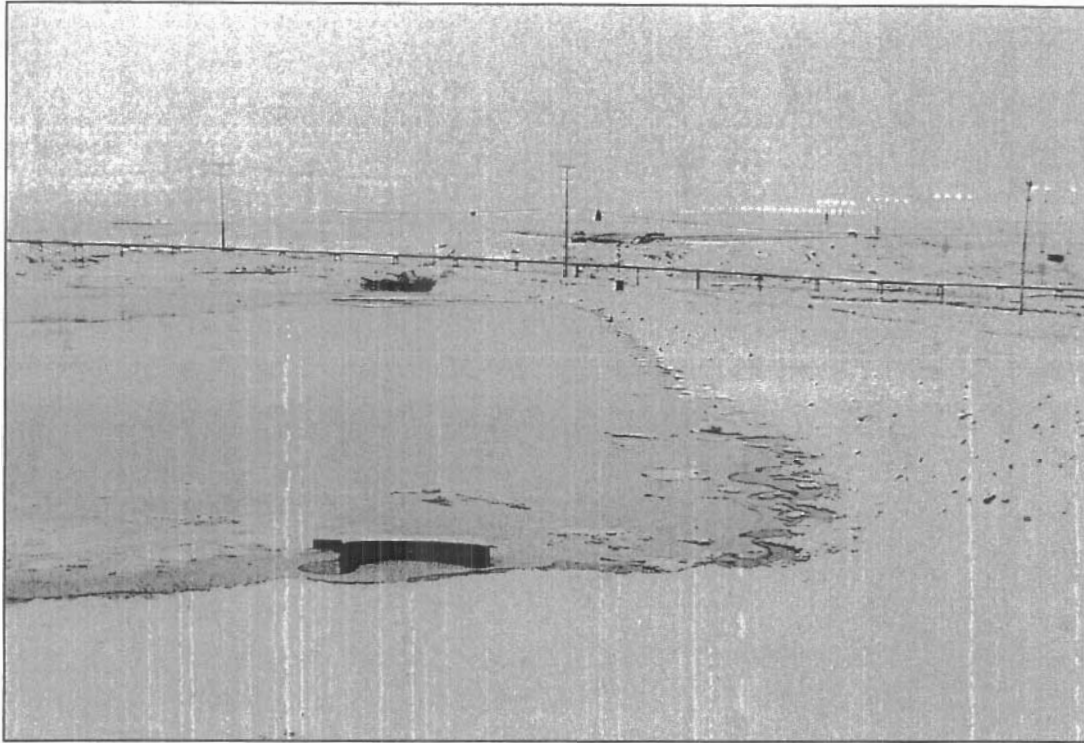
Photo 11 – General View of the Sewage Lagoon

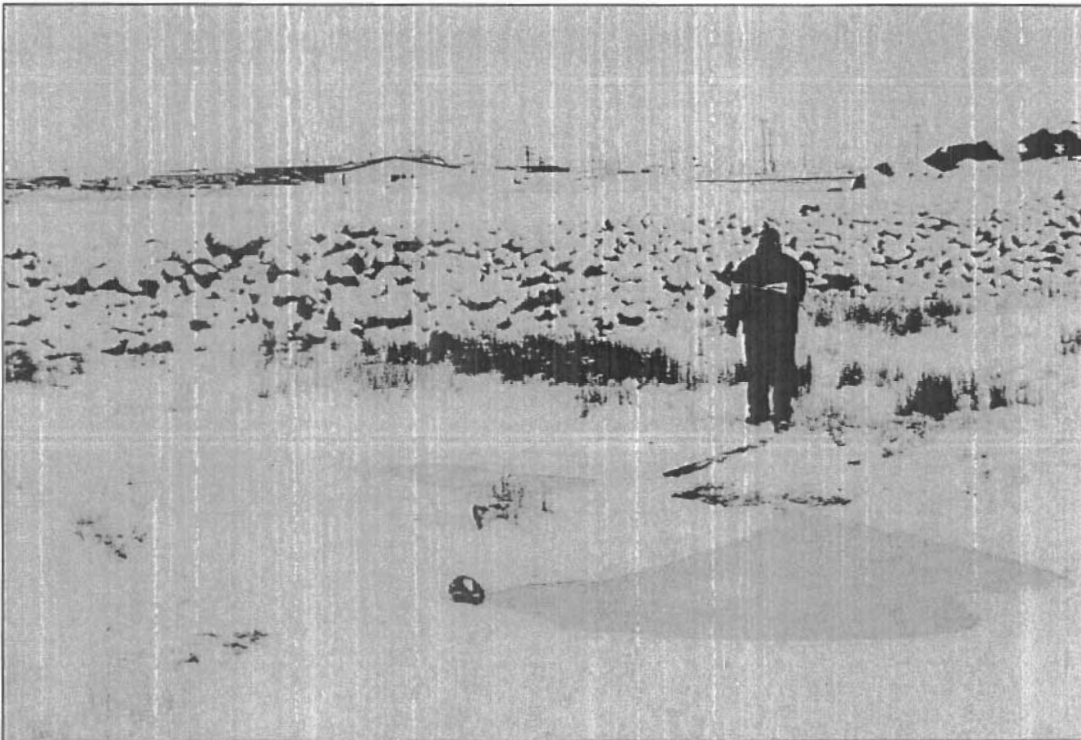
The shorter southeastern dyke, located between the small bedrock island and the larger bedrock island forming the southern boundary of the lagoon, is oriented NE-SW, and is approximately 30 m in length, with a maximum height of approximately 2.0 m to 2.3 m, as measured from the downstream toe. There was some frozen water ponded below the southeastern dyke, but it was not discolored. This indicates that either some seepage takes place through the dyke or accumulation of the surface runoff is a continuing phenomenon. However, it was not possible to establish if piping takes place close to the toe of the dyke due to presence of snow and ice.

Photo 12 –Downstream at the Southeast Dyke of the Lagoon
