**FINAL REPORT
CITY OF IQALUIT
DAM SAFETY REVIEW FOR
SEWAGE LAGOON**

Project No: MU15152B/S08768G
October 4, 2002

Site Photographs Town of Iqaluit Sewage Lagoon

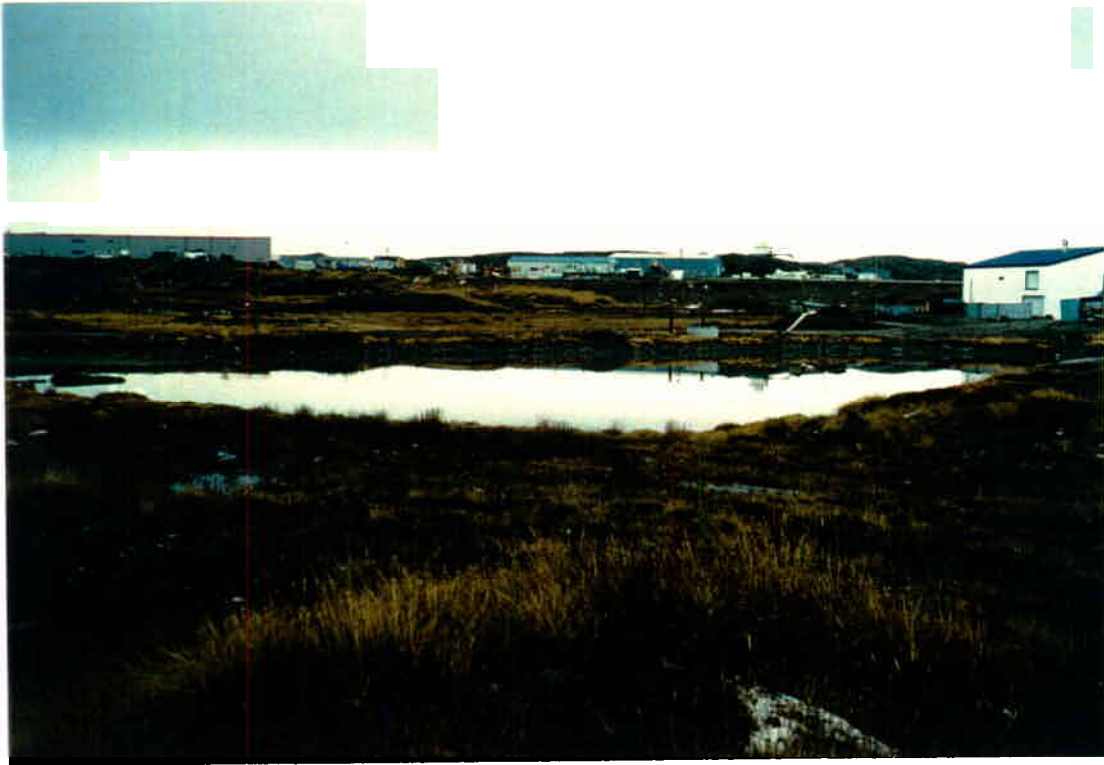
Photo 1 - View of Town of Iqaluit Sewage Lagoon taken from north end of East Dyke looking west across the lagoon towards the West Dyke.

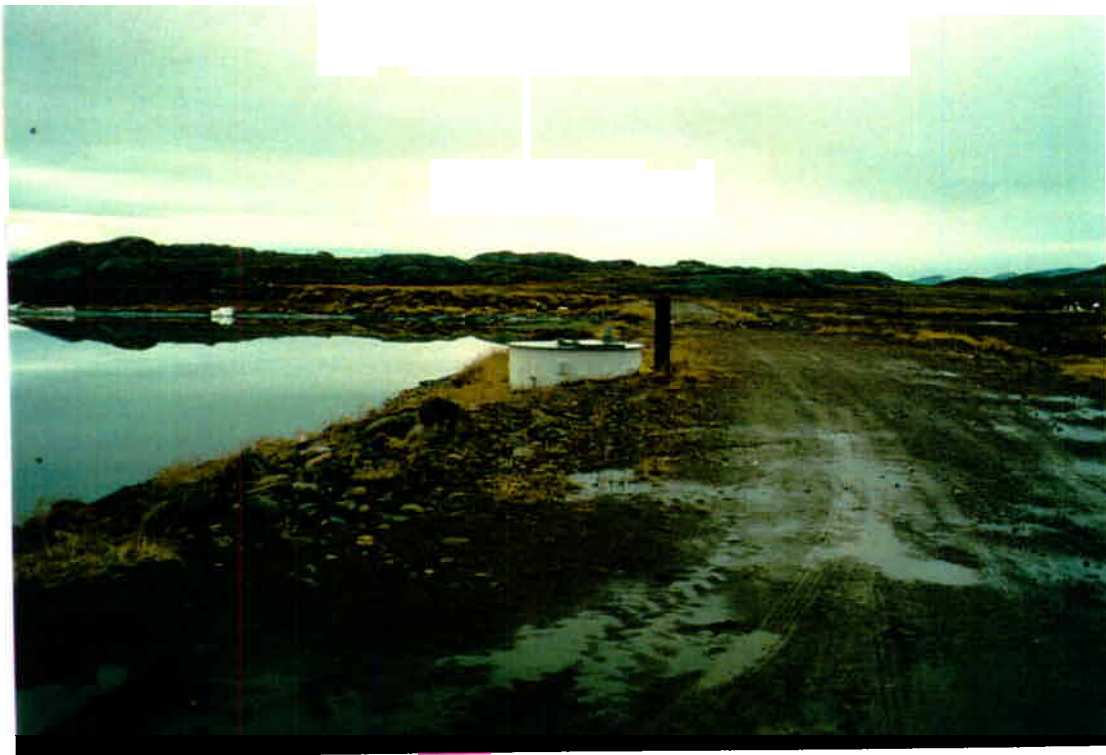
Photo 2 View taken from north end of West Dyke looking south along upstream face and crest of West Dyke. The Discharge Control Structure for the lagoon is in the foreground

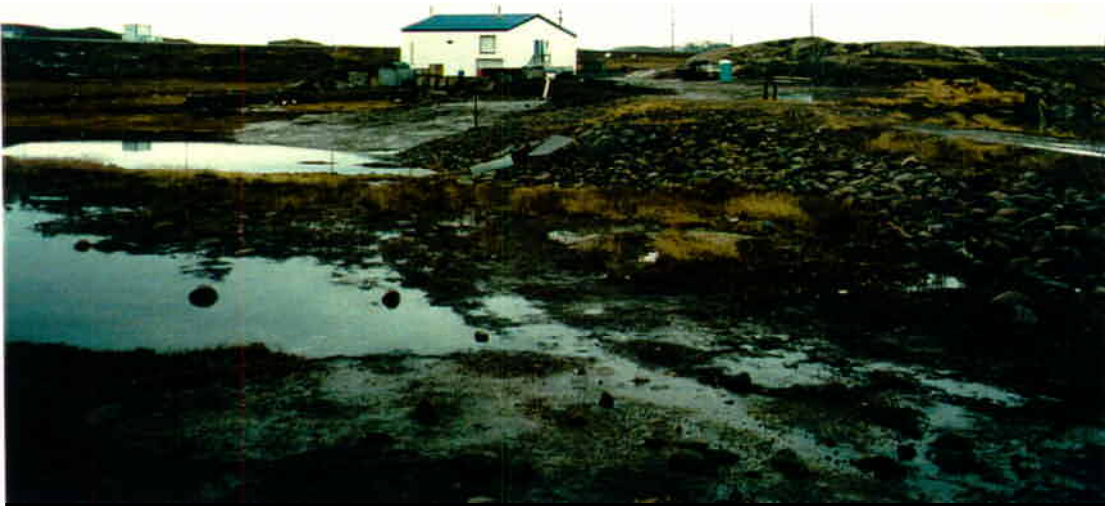
Photo 3 View looking north at downstream (ocean) side of West Dyke.

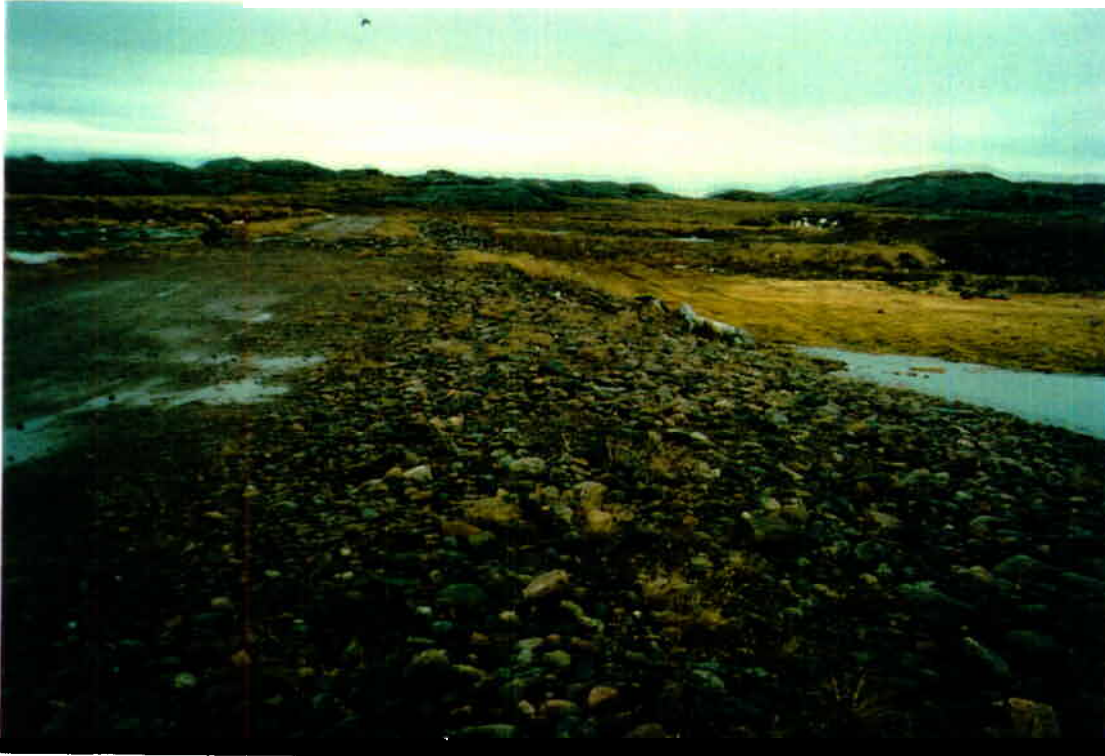
Photo 4 View looking south along crest and downstream face of West Dyke.

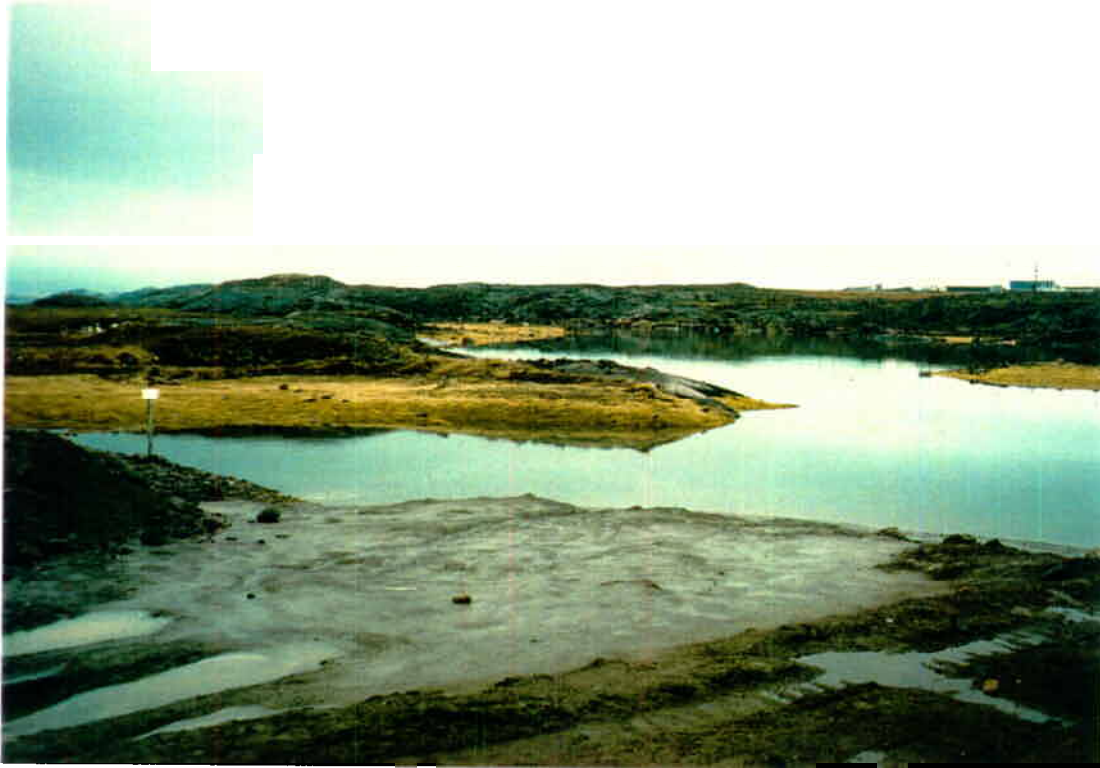
The western dyke has reportedly been breached several times in the early 1980's and again in June 1991 and December 1991. The failures appear to have occurred as a result of either overtopping due to high pond levels occurring during the spring runoff period, the occurrence of very high tide conditions, which eroded the toe, and possibly from high-level seepage and resulting instability. The repair work has typically involved rebuilding the western dyke to its original design as a "leaky" dam. Recommendations to provide an impervious liner, which would remove some of the inherent risks associated with a leaky dam, have apparently not been implemented by the City.

Photo 5 View taken from north end of West Dyke showing area that appears to have been previously breached and was infilled with local silty sand & gravel fill. The fill material appears to be saturated.

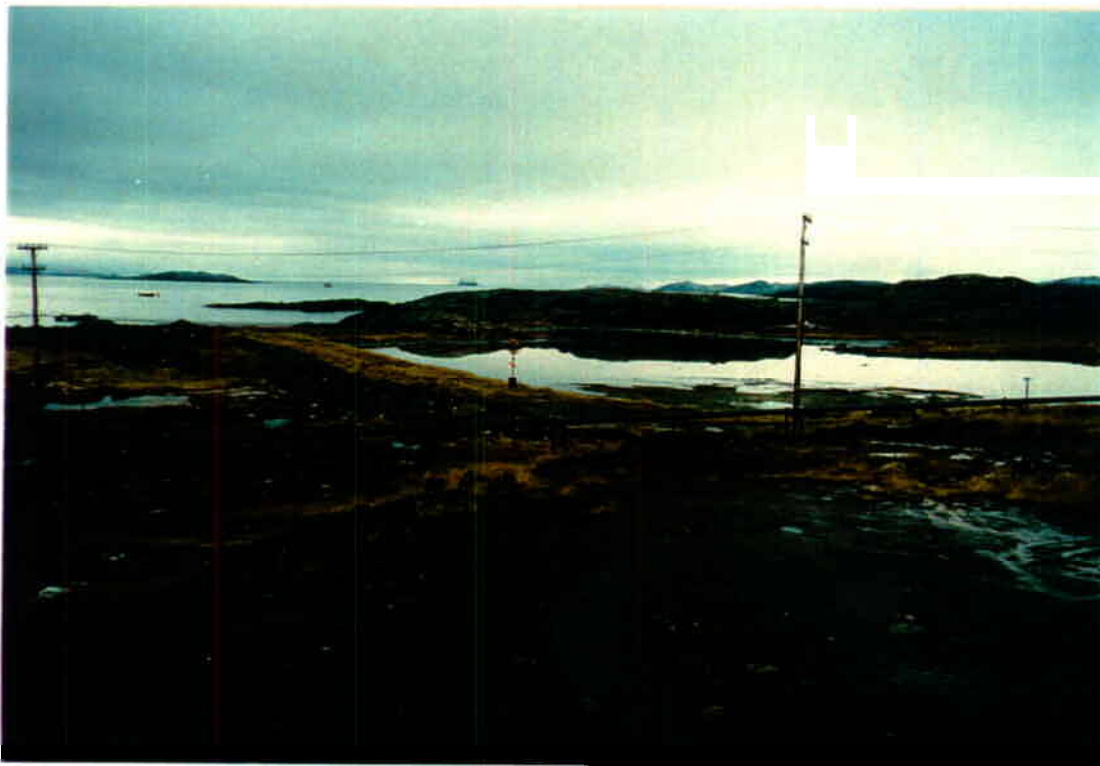
Photo 6 View looking south-southwest at lagoon. The East Dyke is on the LHS of the lagoon.

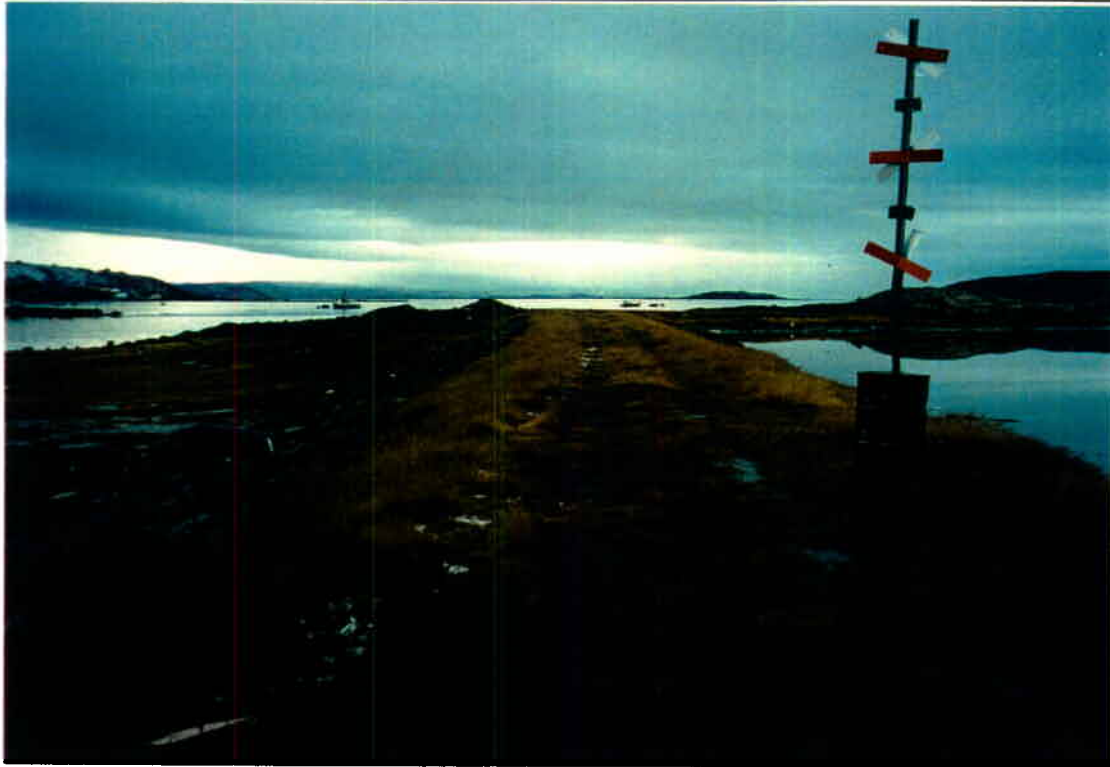
Photo 7 View from north end of East Dyke looking south along crest and downstream slope of East Dyke.

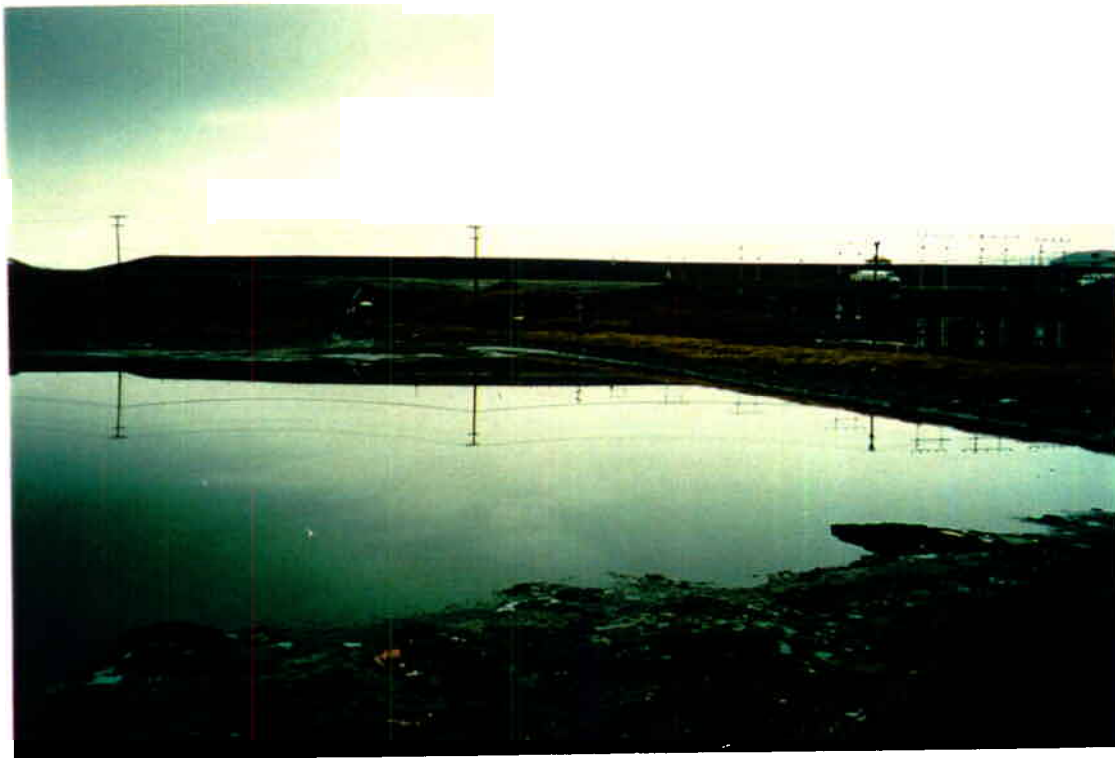
Photo 8 View looking north along upstream face of East Dyke. Sewage outfall is located adjacent to the north end of the East Dyke.

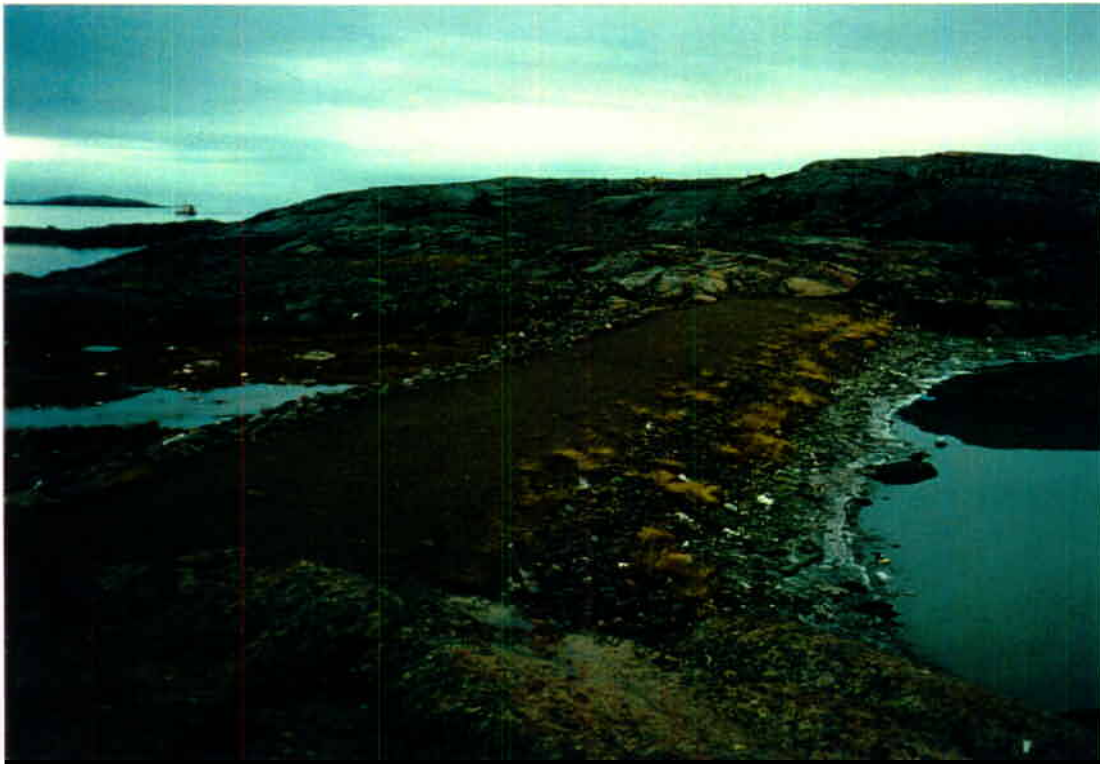
Photo 9 View looking southwest at crest and upstream face of the smaller Southeast Dyke.

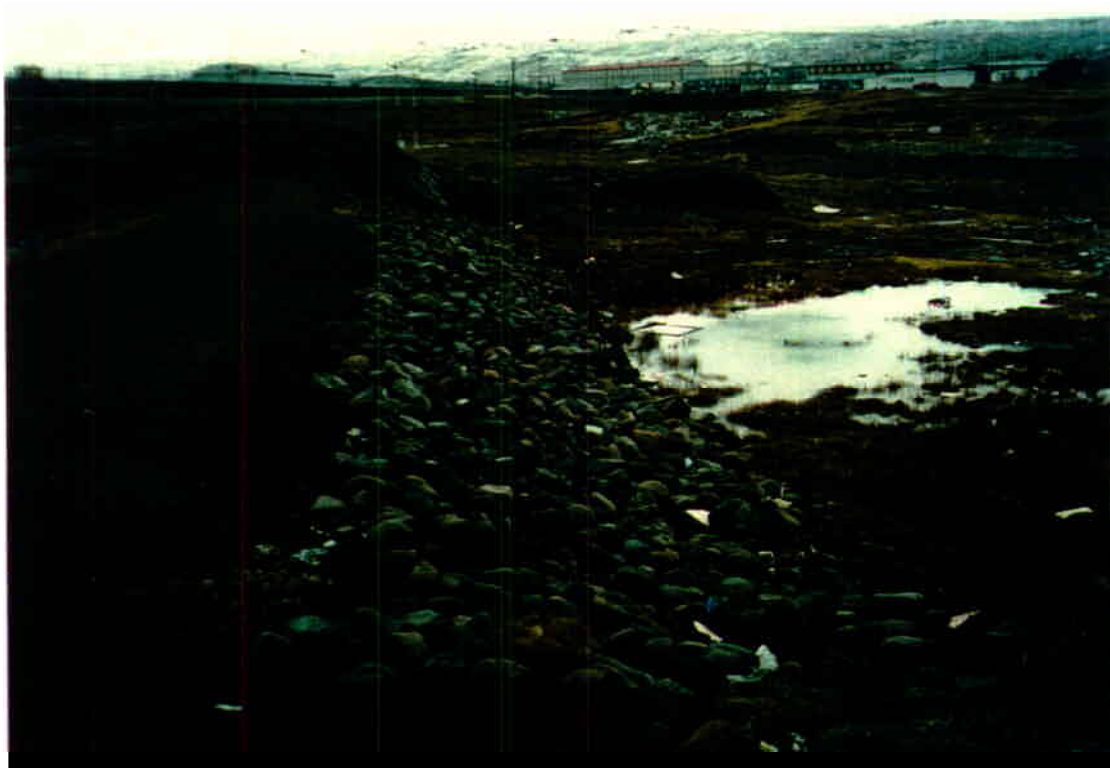
Photo 10 View looking northeast at downstream slope of Southeast Dyke. Some seepage ponding is evident along the toe.

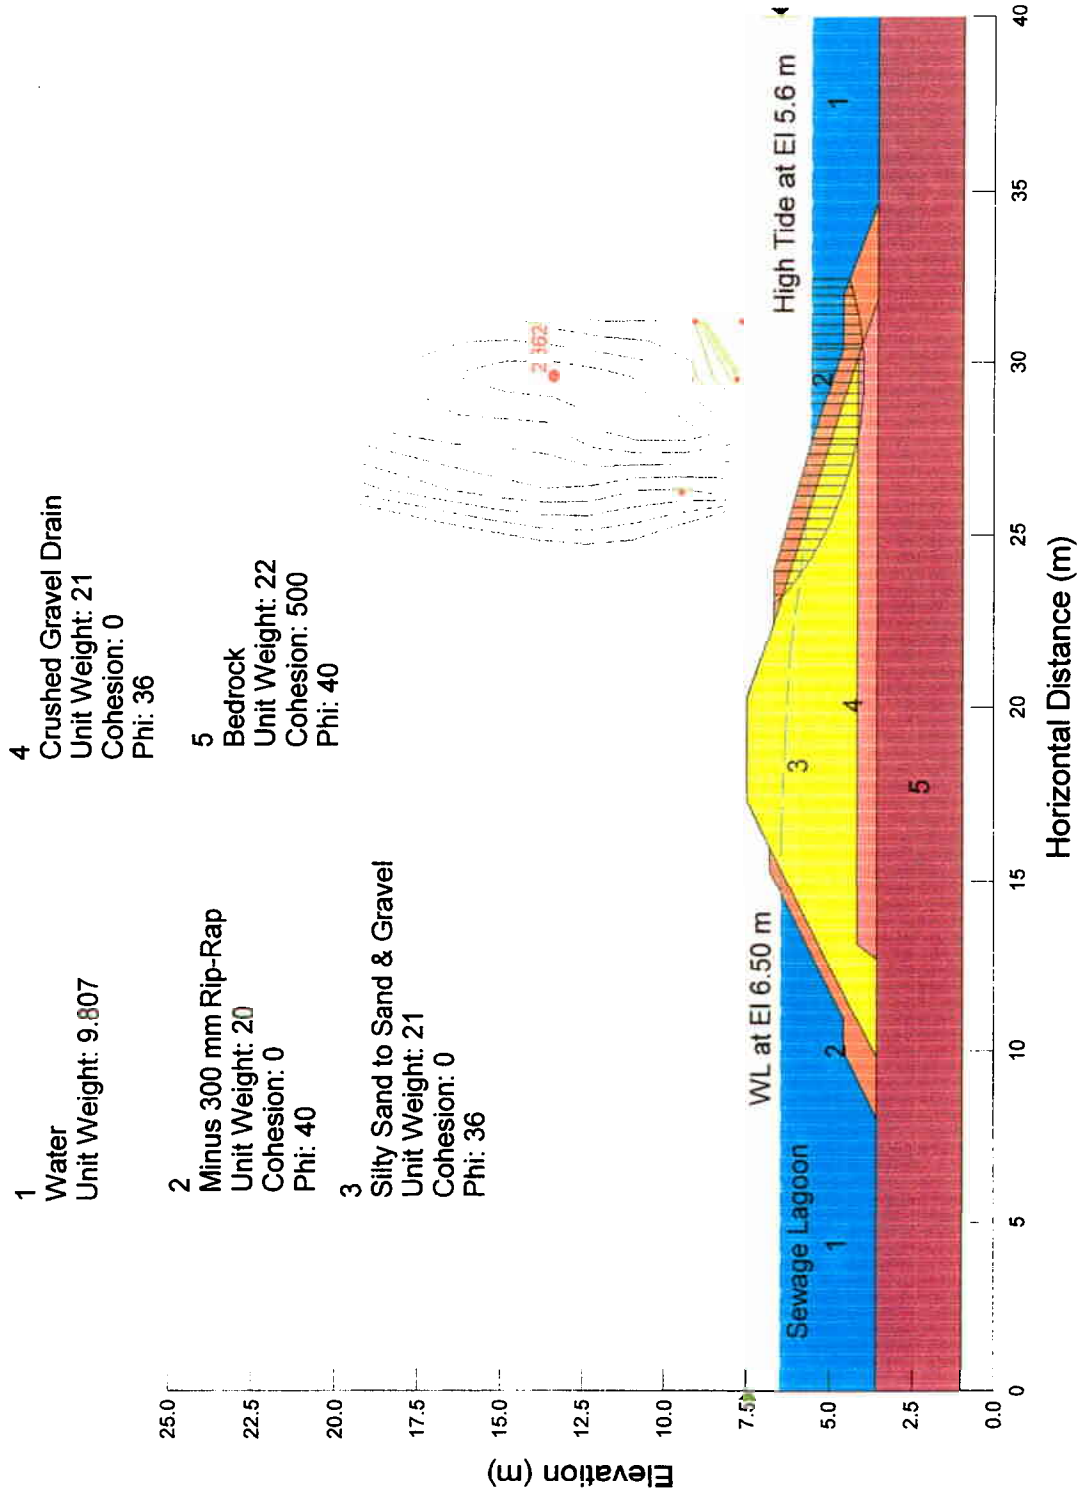
Iqaluit Sewage Lagoon
Review of Dyke Slope Stability
File Name: IQS-1.slp
Fig 3-1 High Tide Conditions

The stability of the section of the west dyke, as sketched by Hardy, was analysed under various static loading conditions, under both normal and flood level conditions. The Dam Safety Guidelines require a minimum factor of safety of 1.5 for the downstream slope for steady state seepage conditions with a maximum storage pool. The stability analyses indicate acceptable factors of safety, assuming the dyke is unfrozen, and standard soil strength parameters are applicable. With a maximum upstream water level, the dam has a computed factor of safety of 2.16 against a total failure, which would cause a major breach in the dam.

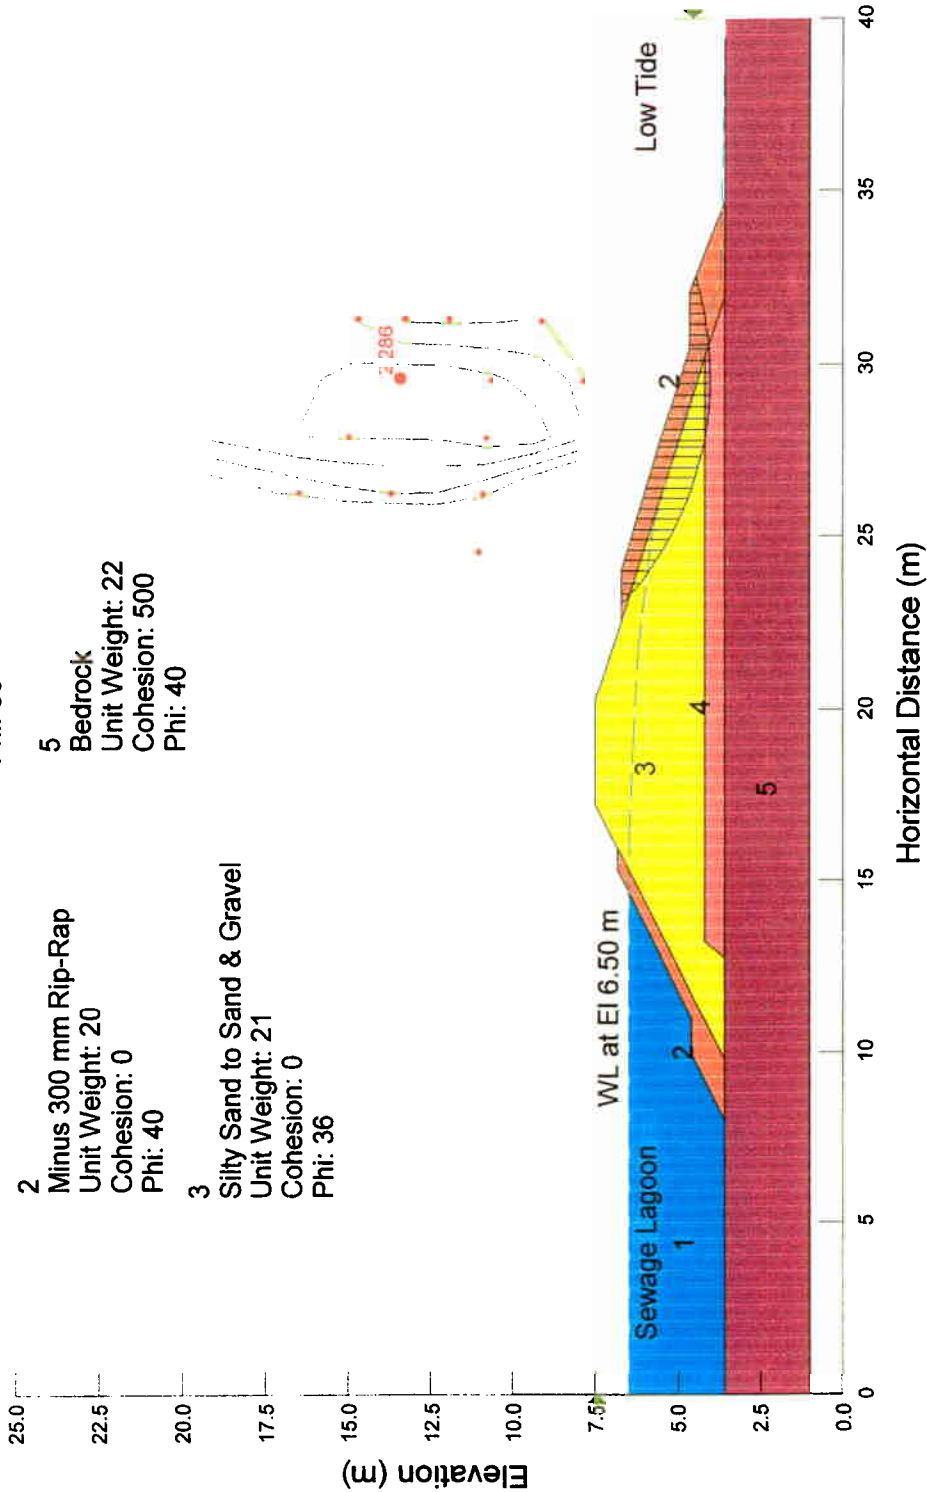
Iqaluit Sewage Lagoon
Review of Dyke Slope Stability
File Name: IQS-2-Low Tide.slp
Fig 3-2

Analysis with High Phreatic Level & Low Tide

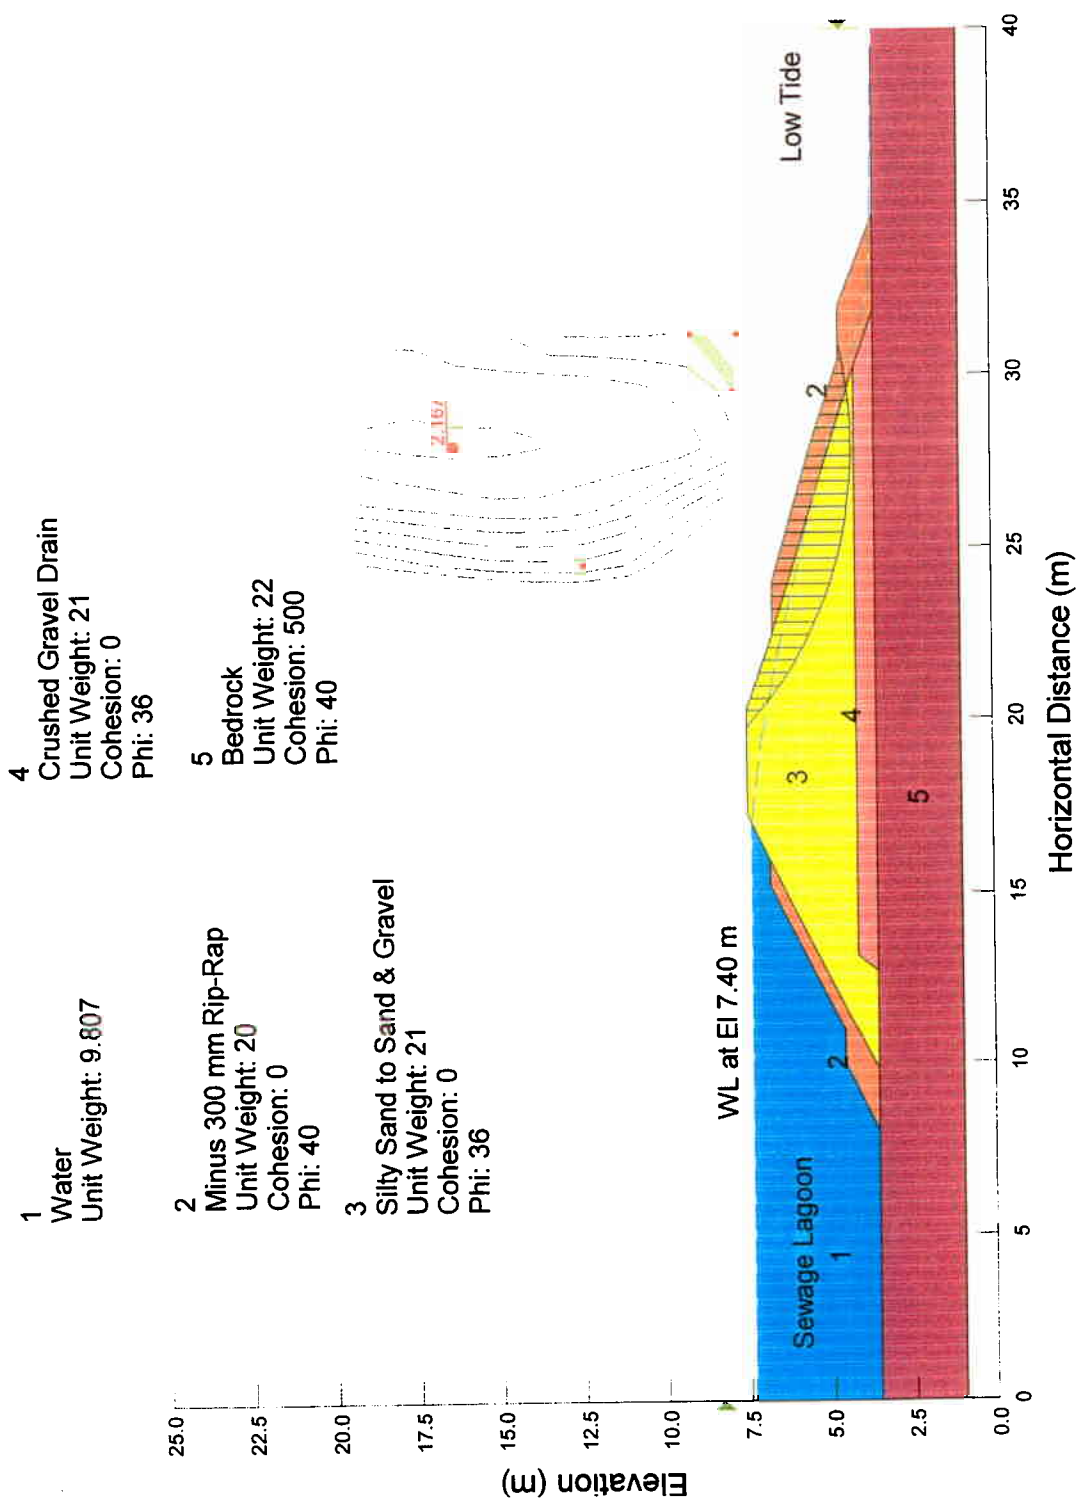
Iqaluit Sewage Lagoon
Review of Dyke Slope Stability
File Name: IQS-3- Flood Level - Low Tide.slp
Fig 3-3

Analysis with High Phreatic Level & Low Tide

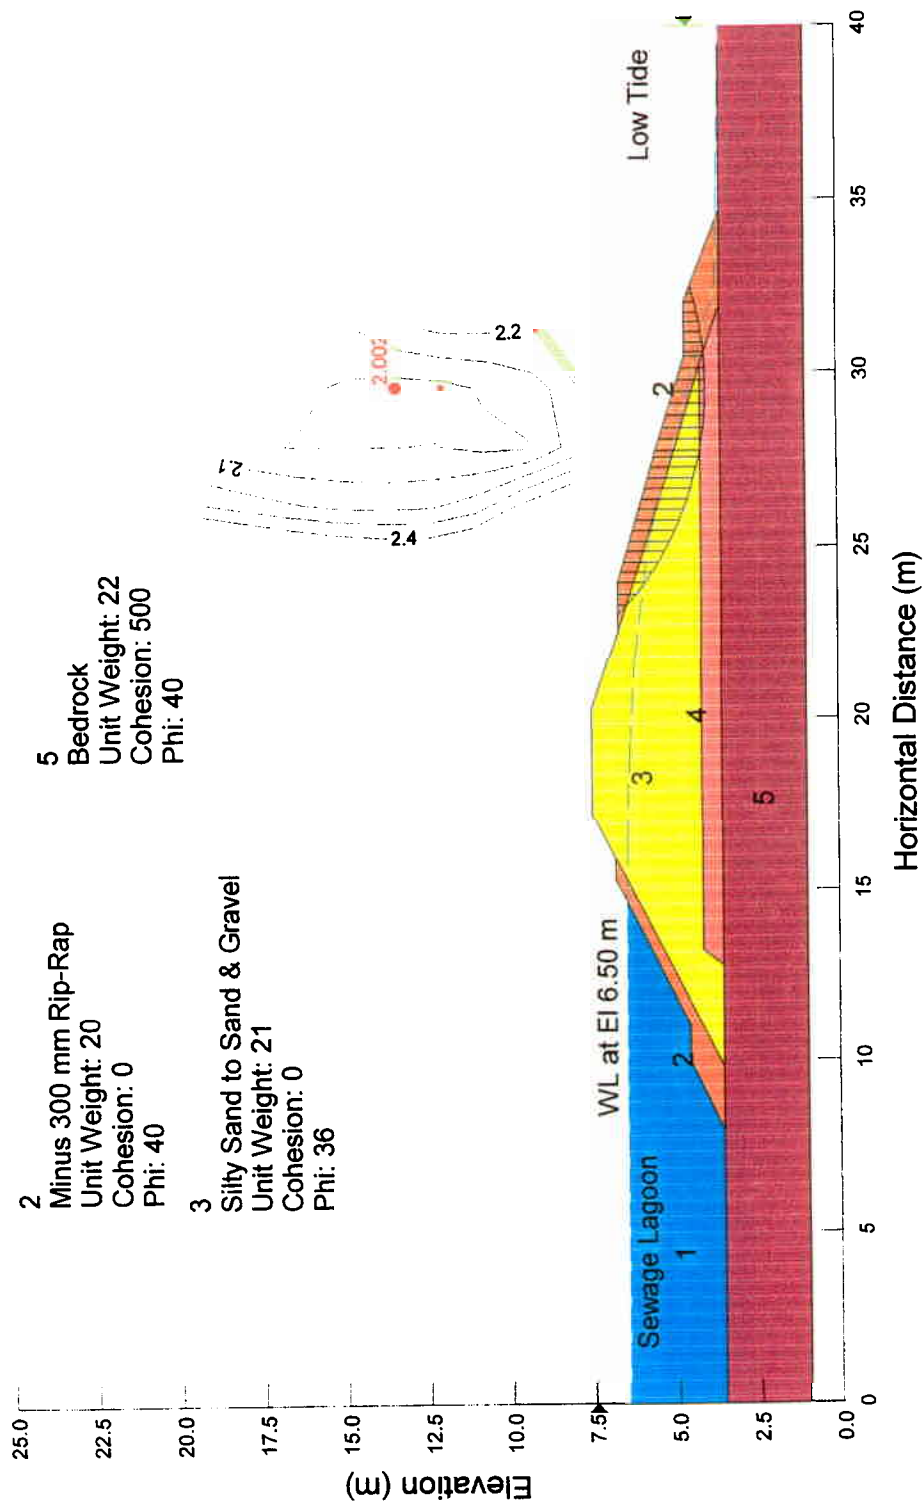
Iqaluit Sewage Lagoon
 Review of Dyke Slope Stability
 File Name: IQS-4-Low Tide-Seismic.slp
 Fig 3-4

Pseudostatic stability analyses indicate acceptable factors of safety for the dykes under the design seismic conditions, assuming a horizontal and vertical acceleration of 0.04g (i.e. a factor of safety of 2.00 was obtained). As well, the potential for liquefaction of the foundation material is considered remote, especially if the dam is founded on bedrock or the foundation soils are frozen.

Analysis with High Phreatic Level & Low Tide
 Seismic Loading = 0.04 g

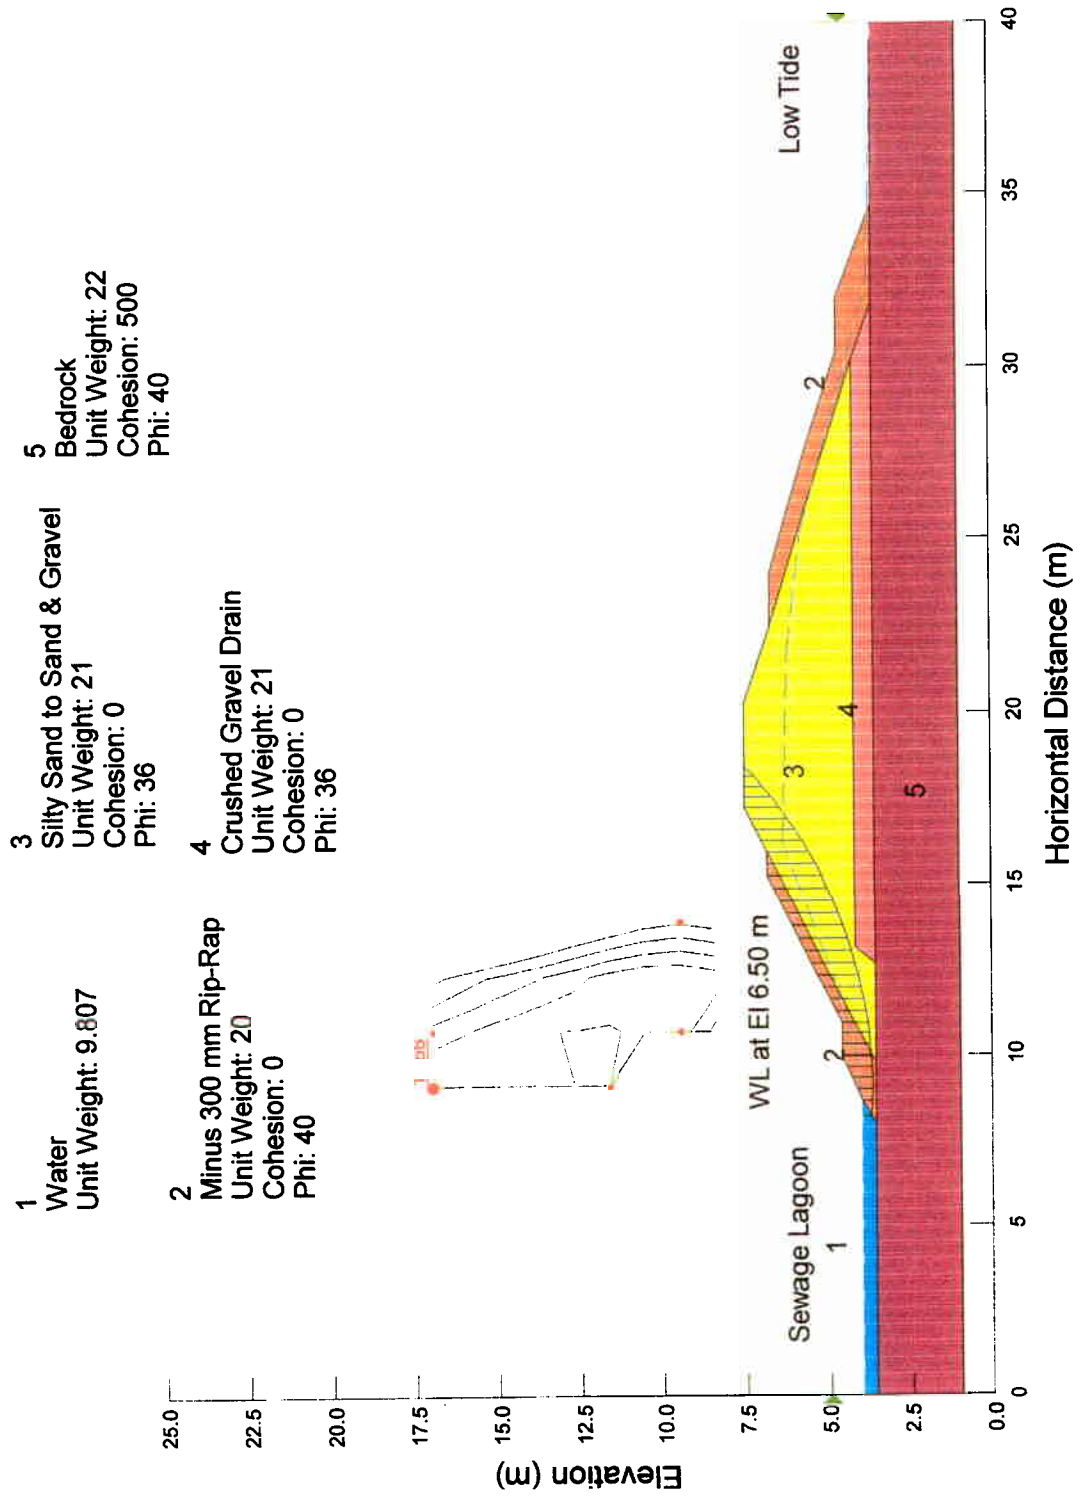
Fig 3-5 Rapid Drawdown Condition
on Upstream Slope

For the full or rapid drawdown condition, a minimum factor of safety of 1.2 to 1.3 is required for the upstream slopes. Our analyses indicate a factor of safety of 1.46 for this case.

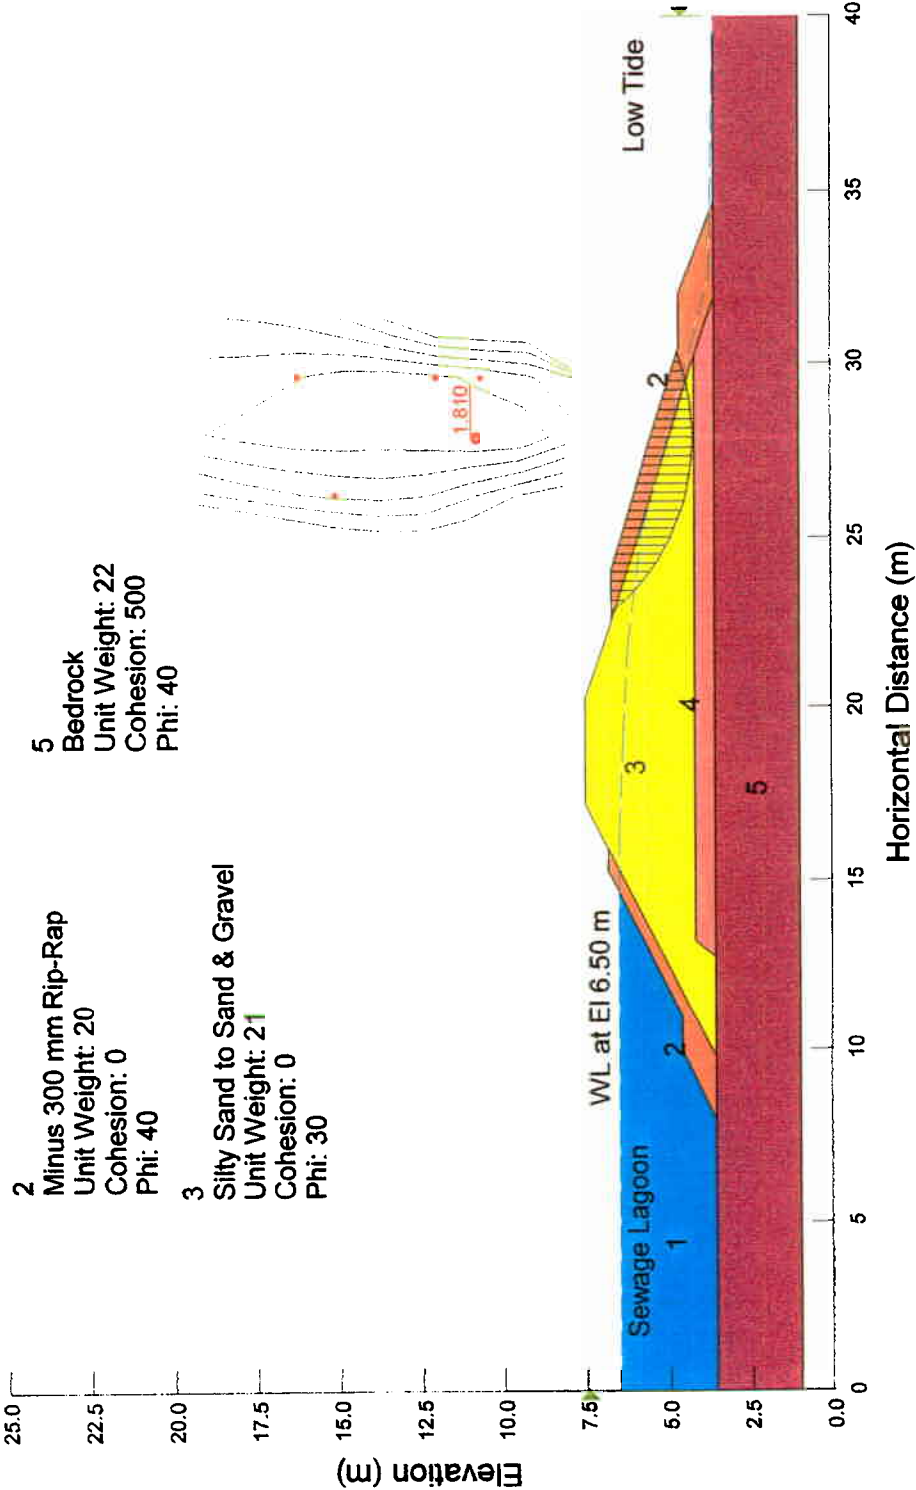
Iqaluit Sewage Lagoon
Review of Dyke Slope Stability
File Name: IQS-6-Weakened Soil.slp
Fig 3-6

Analysis with High Phreatic Level & Low Tide, Weakened Soil

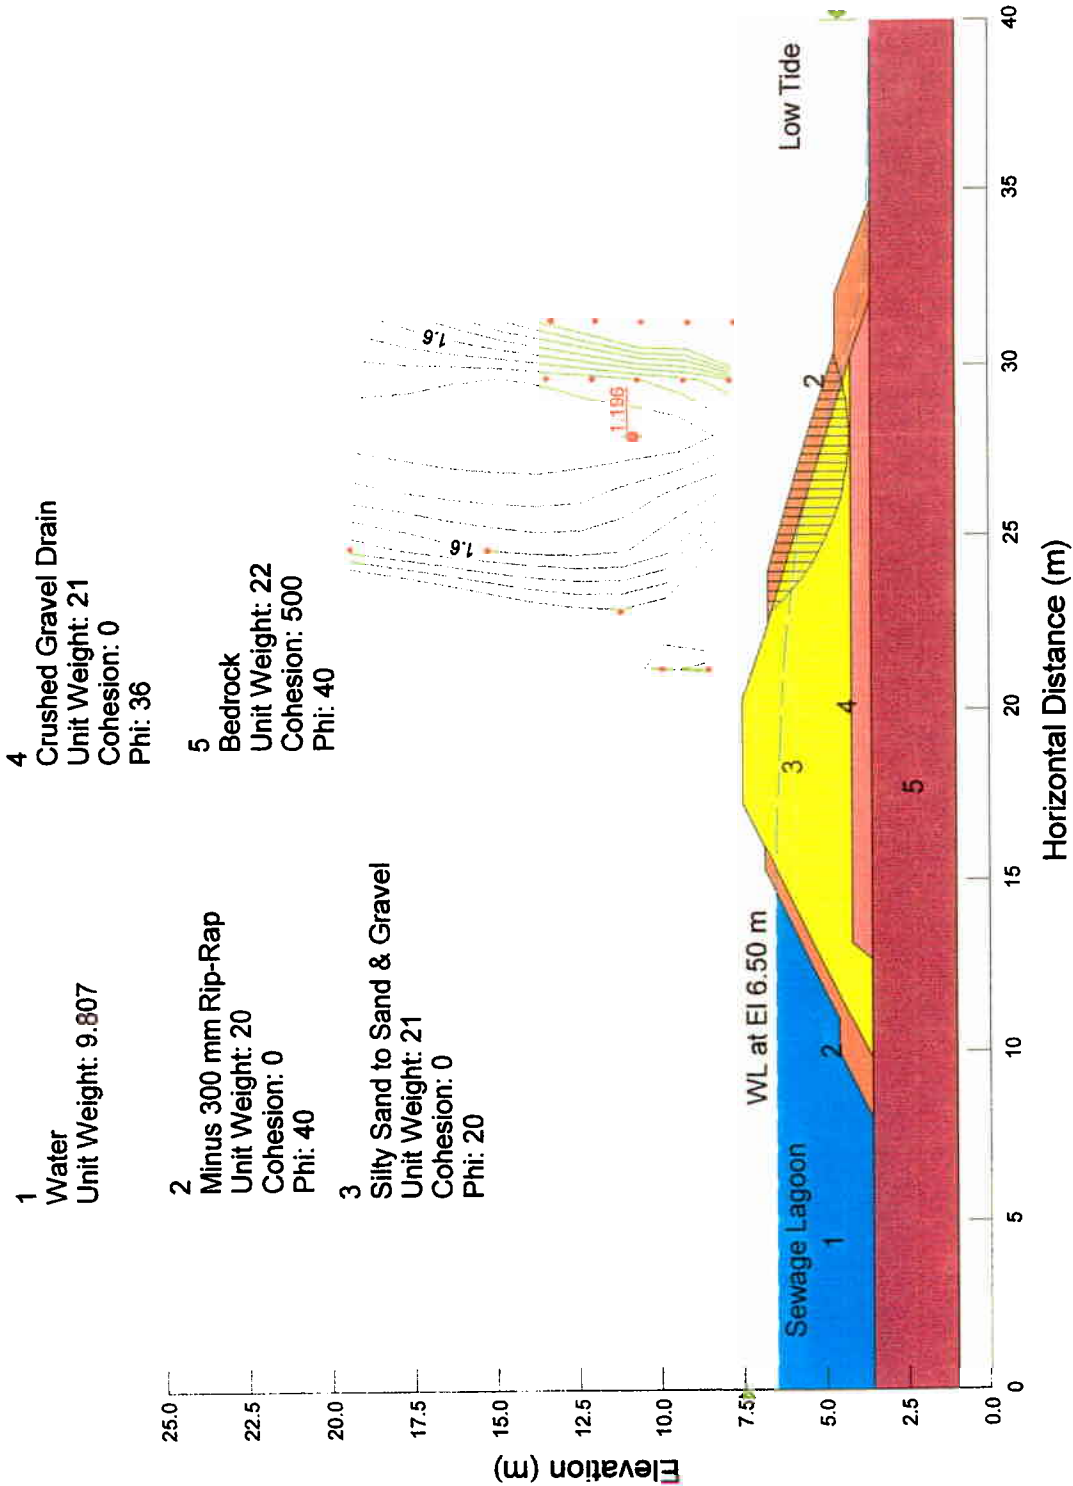
Iqaluit Sewage Lagoon
Review of Dyke Slope Stability
File Name: IQS-7-Weakened Soil-phi=24.slp
Fig 3-7

Analysis with High Phreatic Level & Low Tide, Weakened Soil Due to Thawing
