**IQALUIT SEWAGE LAGOON INVESTIGATION  
FINAL REPORT**

**FSC PROJECT NO. 97-1970  
February 5, 1998**

**RE: - Iqaluit Sewage Lagoon Investigation**  
**Final Report**

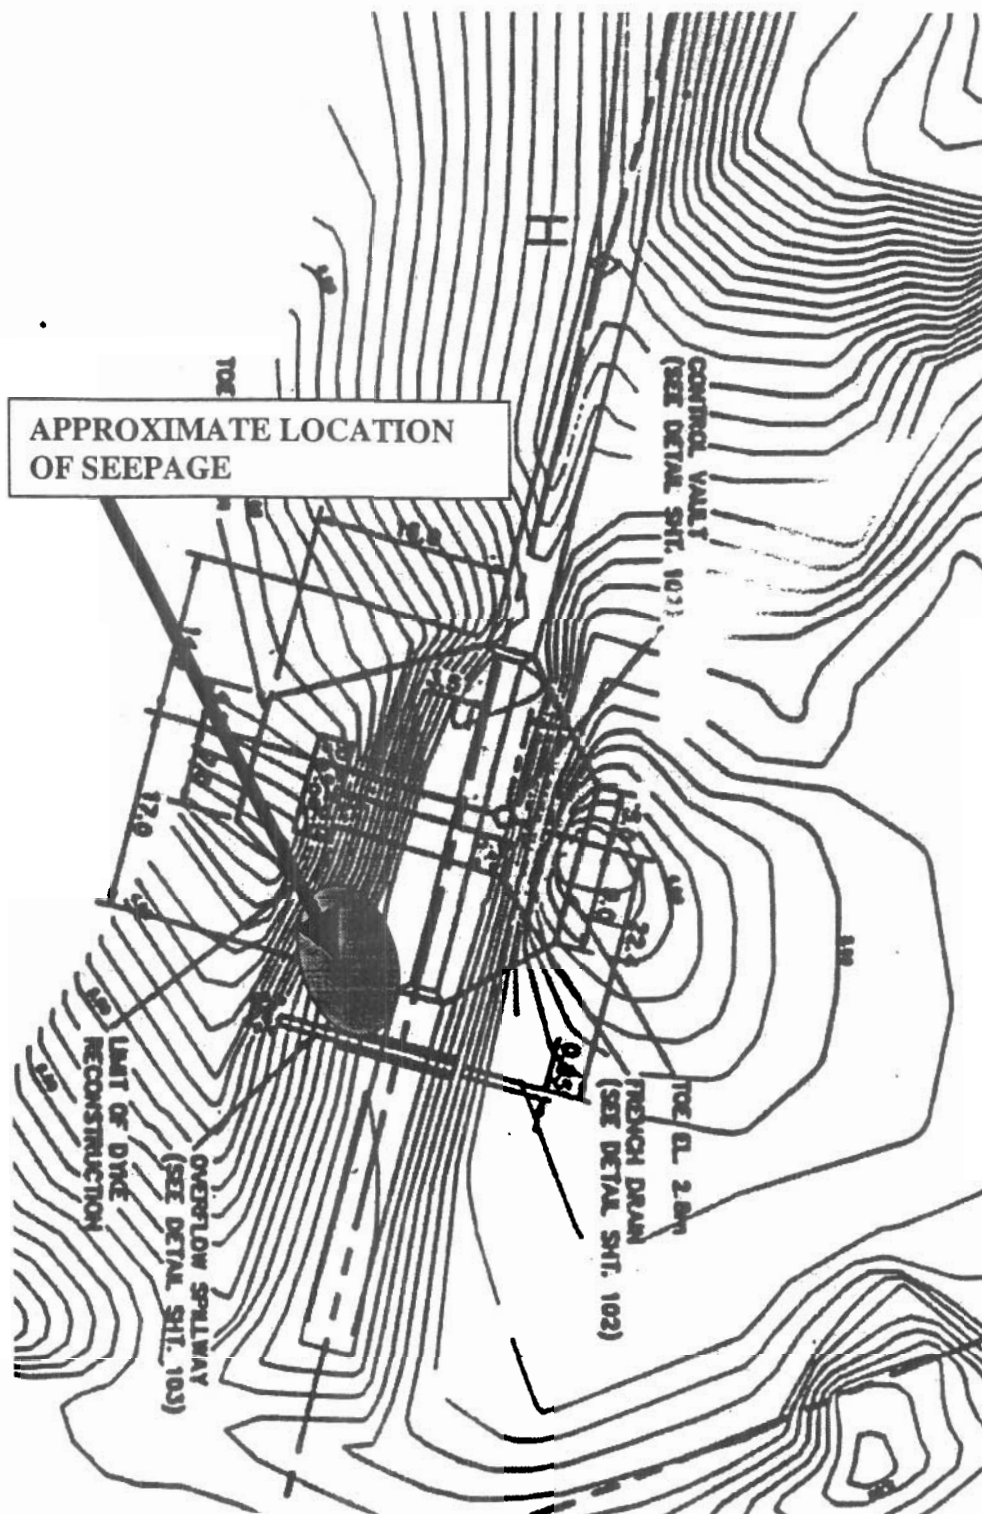
FIG. 1

On January 8, 1998 FSC was able to complete a chain survey of the west dyke to determine the approximate location of the seep. Shown on Figure 1, the seep is located on the downstream face, between 7 and 17 metres in a southerly direction from the outfall pipe, near the edge of the section that was repaired in September - October of 1991.

As may also be seen by Figure 1, the seep location is apparently located above the un-repaired portion of the dyke, i.e. not in UMA's repair area.

During the survey it was noted that the ice associated with the seepage was clear with a green colour. Neither the rock toe drain, nor the french drain, could be observed because of the accumulation of significant quantities of ice and snow. It is unknown if the seep continues to grow or if it has stopped as a result of lowering the level of the lagoon. It appears now that the level of the ice associated with the seep is above the current level of the lagoon.

- 7.1 Option 3 should be implemented. The following monitoring should be undertaken:
  - 7.1.1 The site should continue to be monitored frequently. The frequency of monitoring should increase if problems develop. Some estimation of the amount of ice should be made routinely to determine if the seep continues; and
