**Lake Geraldine Dam  
Iqaluit, Nunavut  
Dam Safety Inspection**

*October 29, 2009*

*REPORT*

**Produced For:**  
THE CITY OF IQALUIT

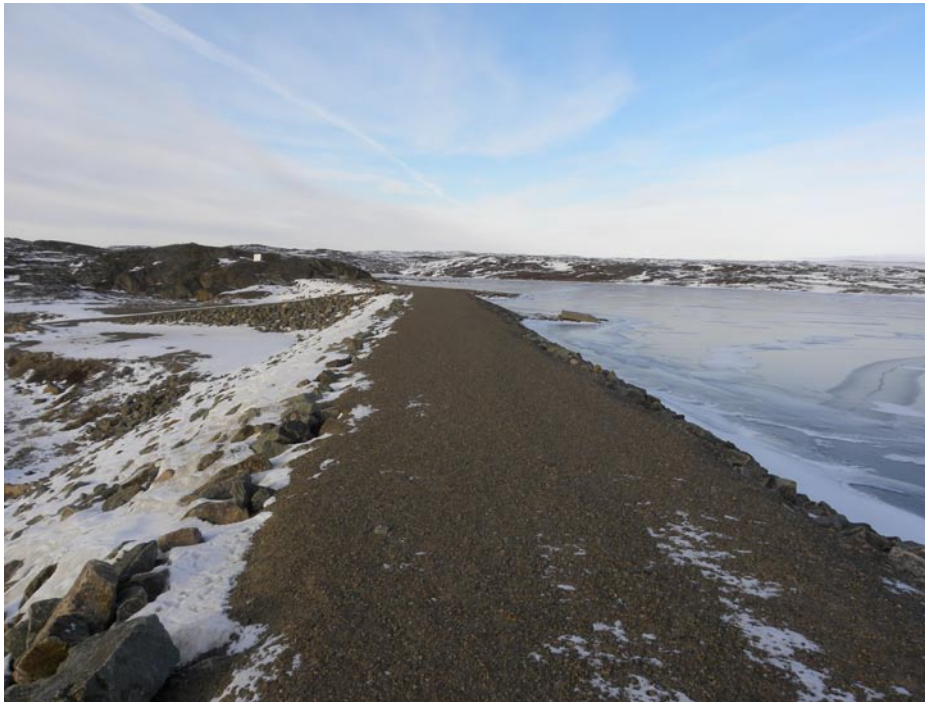
Photograph 1  
Overview of North berm.

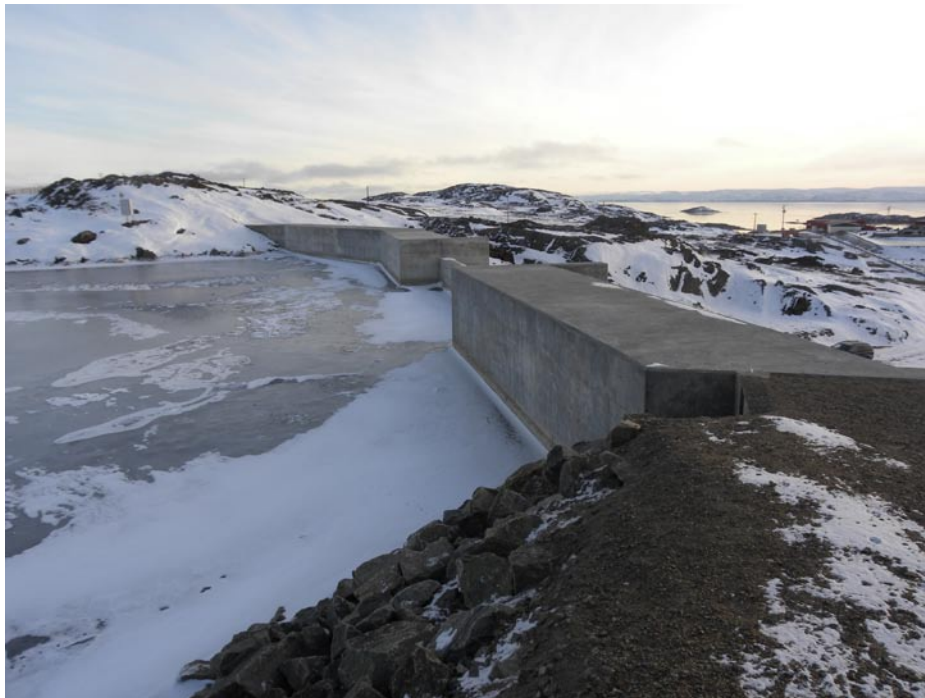
Photograph 2  
Overview of upstream face of concrete structure.

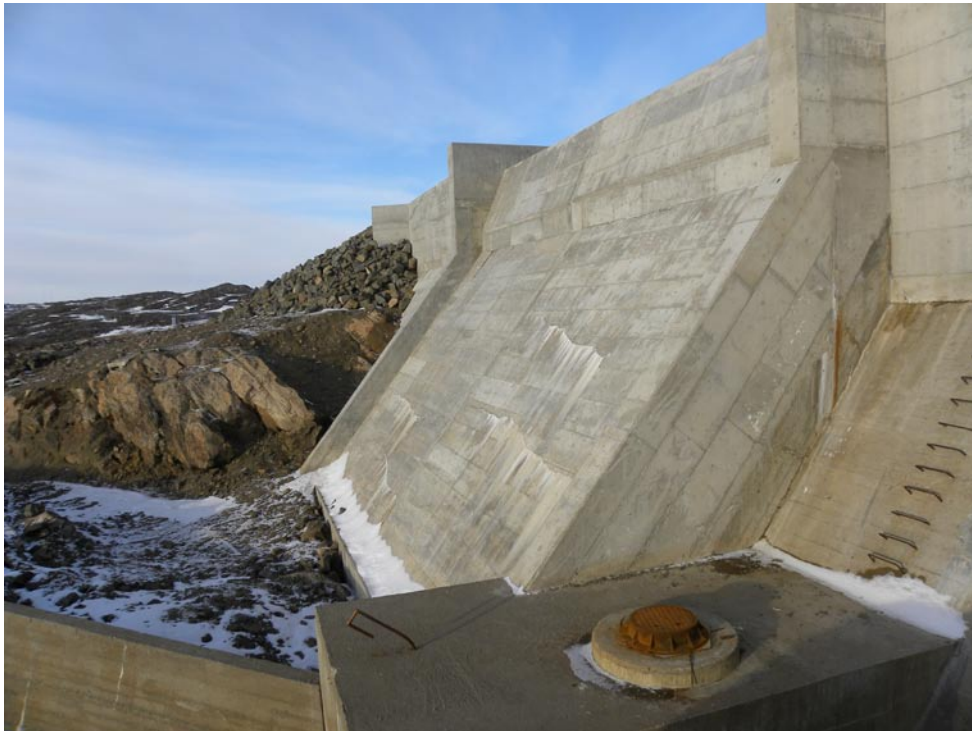
Photograph 3  
Overview of spillway section, downstream face.

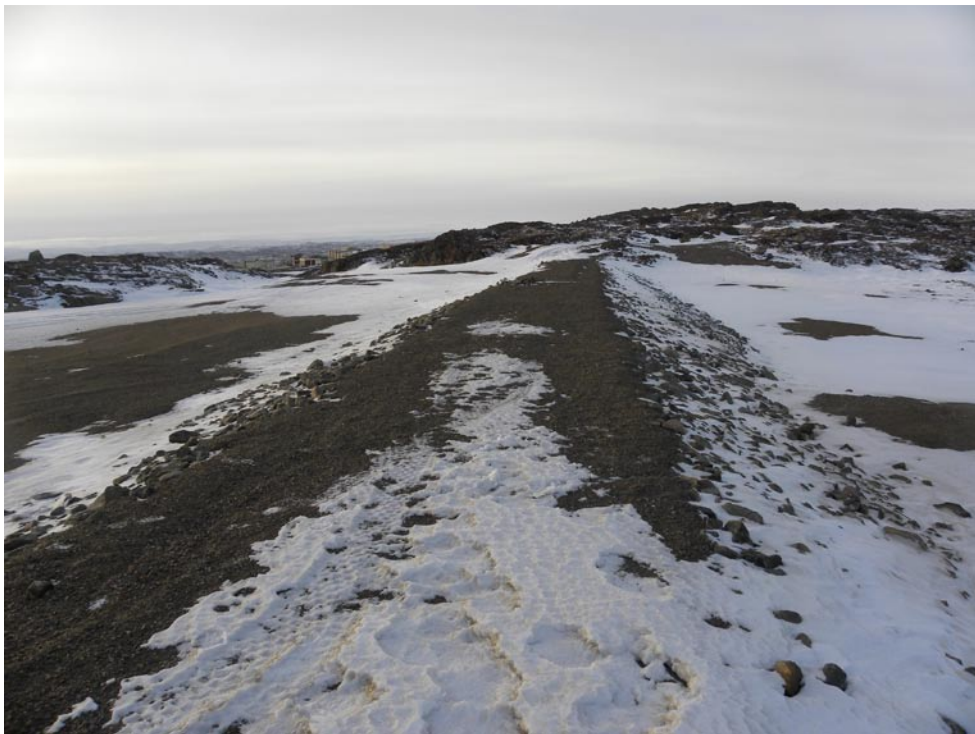
Photograph 4  
Overview of South berm.

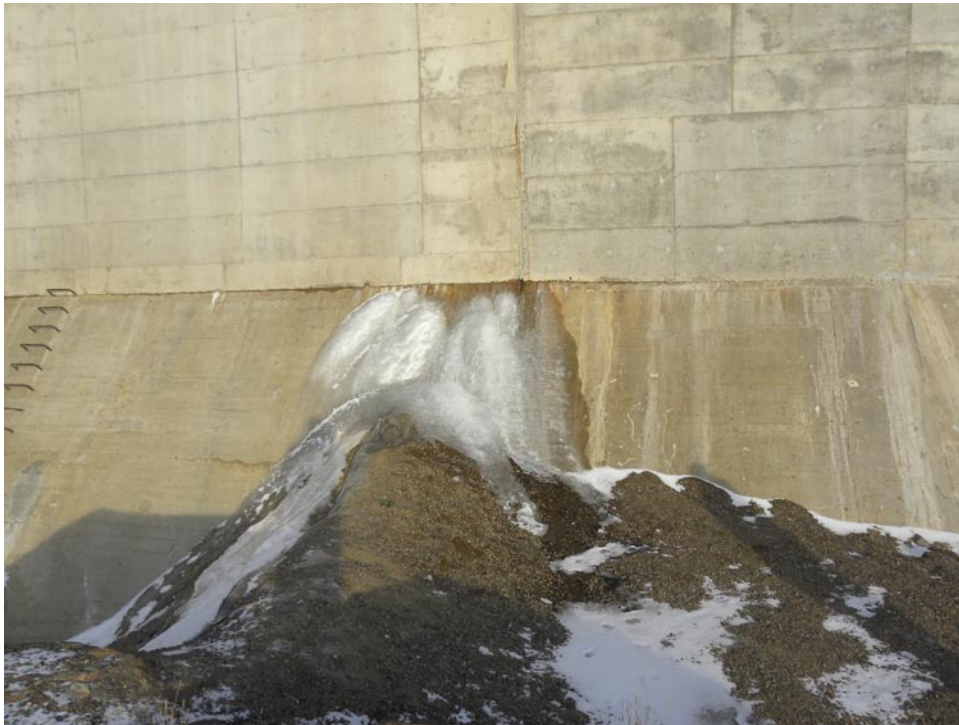
- The concrete portions of the dam structure are in general unchanged from that observed for the 2006 DSI.
- The berm structures are in general unchanged from that observed for the 2006 DSI.
- A significant leak has developed in the concrete dam structure south of the spillway section.
- Upwelling along the south concrete wing wall appears to have increased moderately since originally identified in 1997.

Photograph 5  
New leak South of spillway section.

1. A grouting program should be designed for implementation in 2010 to address the observed leakage. The grouting program should include injection of the vertical and transverse joints in the vicinity of the above grade leak in the concrete section south of the spillway.

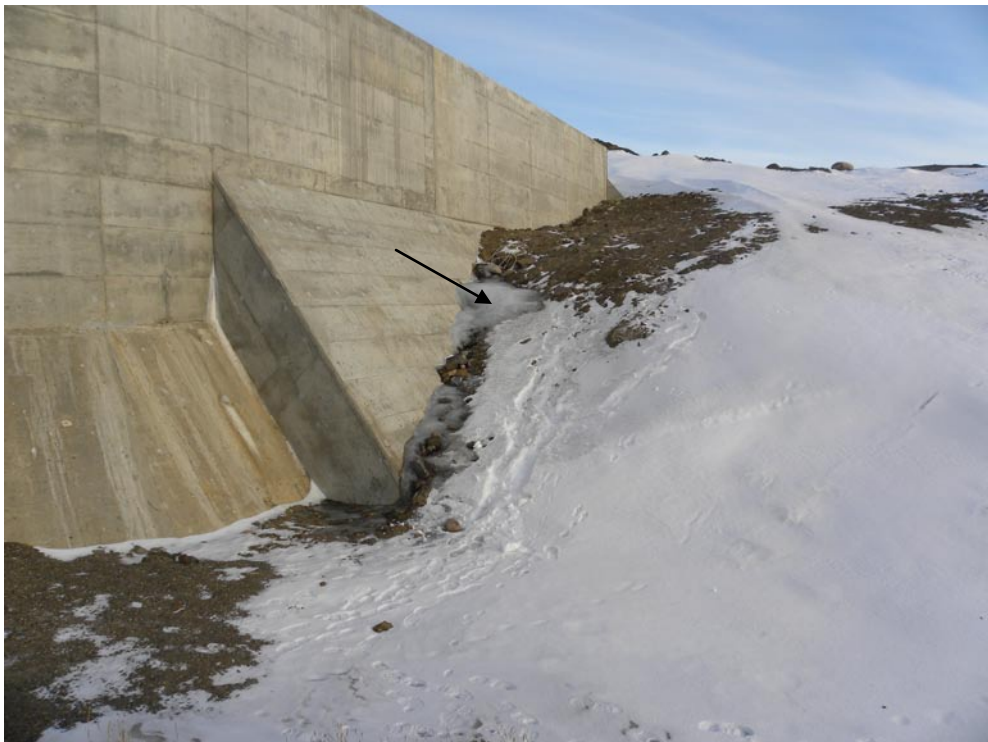
Photograph 6  
Upwelling area previously identified in 1997.

A grouting program should also target the upwelling source. It is possible that the underwater survey (recommended below) will assist in assessing the source and developing a repair strategy.
