**City of Iqaluit Sewage Lagoon
Iqaluit, Nunavut
Dam Safety Inspection**

October 29, 2009

Produced By:
CONCENTRIC ASSOCIATES INTERNATIONAL INCORPORATED

Concentric Project Reference Number:
09-2930

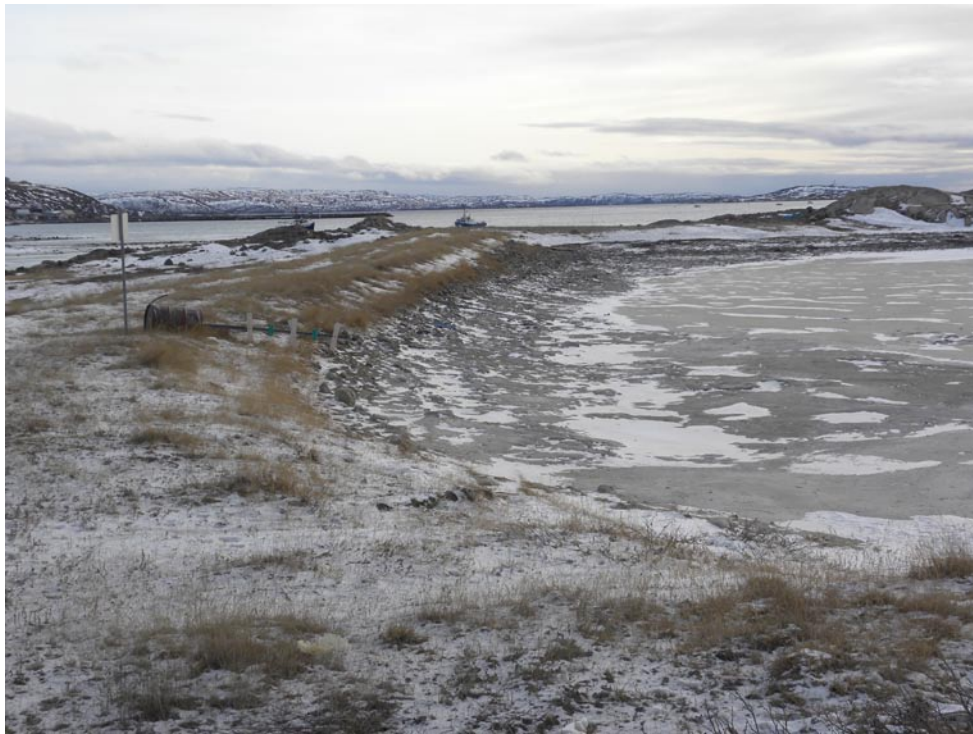
Photograph 3
East Berm, North segment; no change since 2006

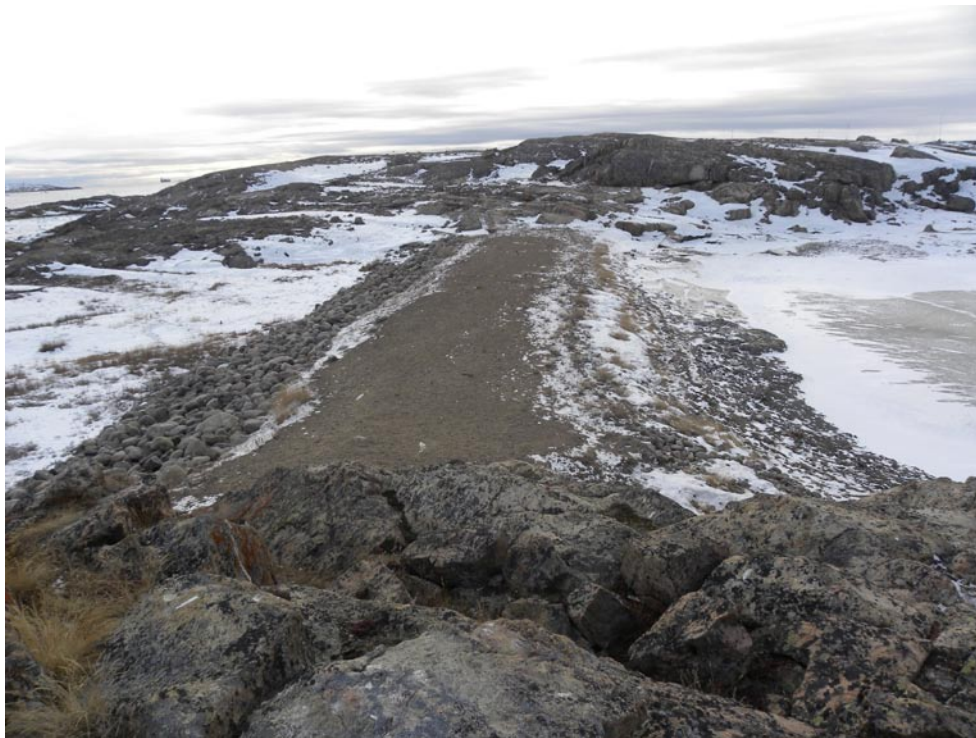
Photograph 4
East Berm, South segment; no change since 2006

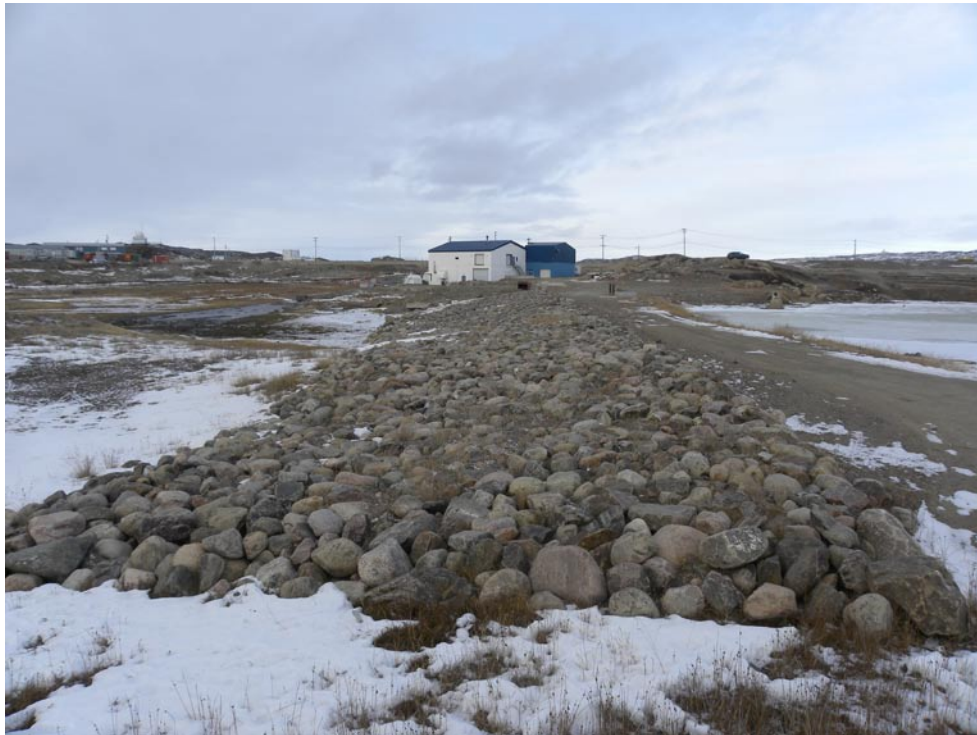
Photograph 5
West Berm, no change since 2006

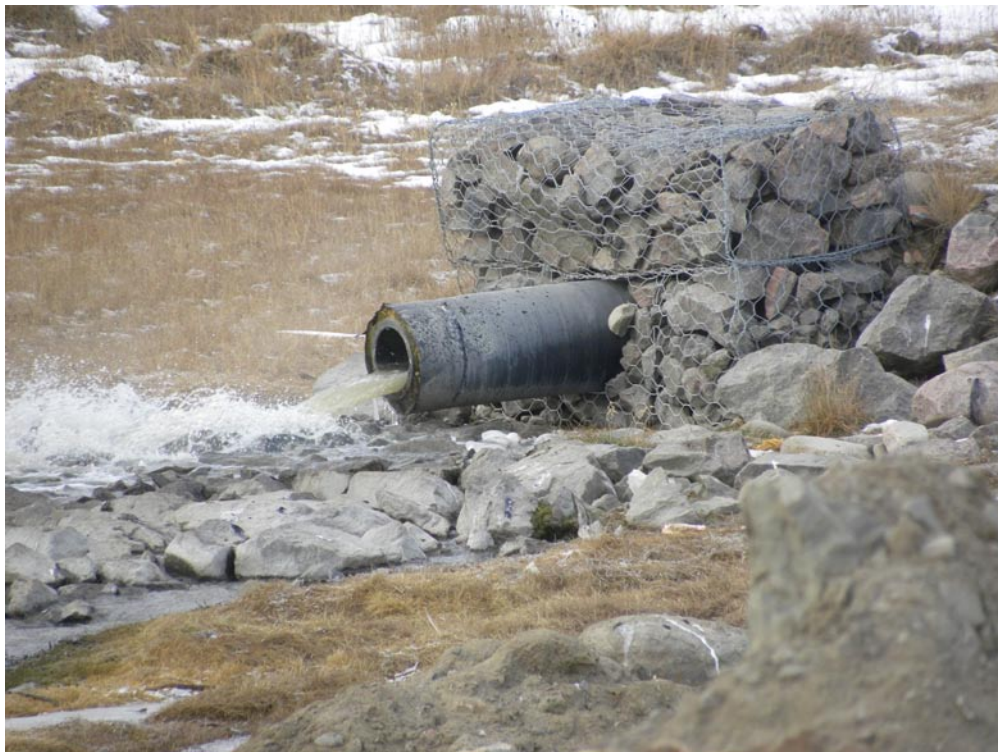
Photograph 6
Discharge from Sewage Treatment Plant
