**City of Iqaluit Sewage Lagoon
Permanent Record File
Iqaluit, Nunavut**

PRODUCED FOR:
City of Iqaluit

CONCENTRIC ASSOCIATES INTERNATIONAL INCORPORATED

May, 2012

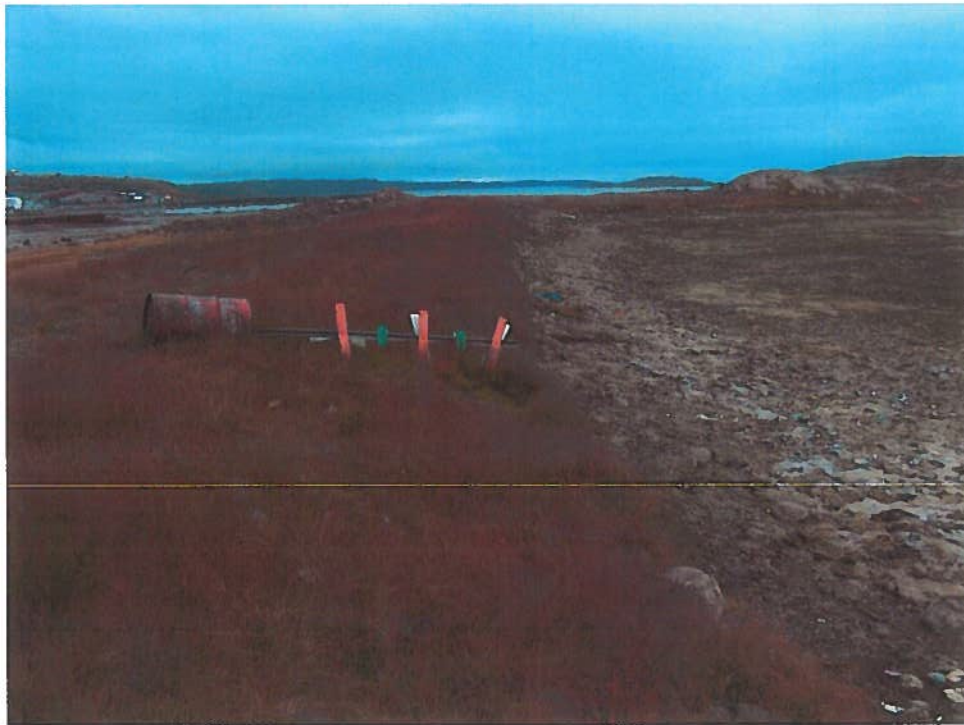
Photograph 1
Overview, East Berm; note sludge buildup visible now that lagoon is inactive.

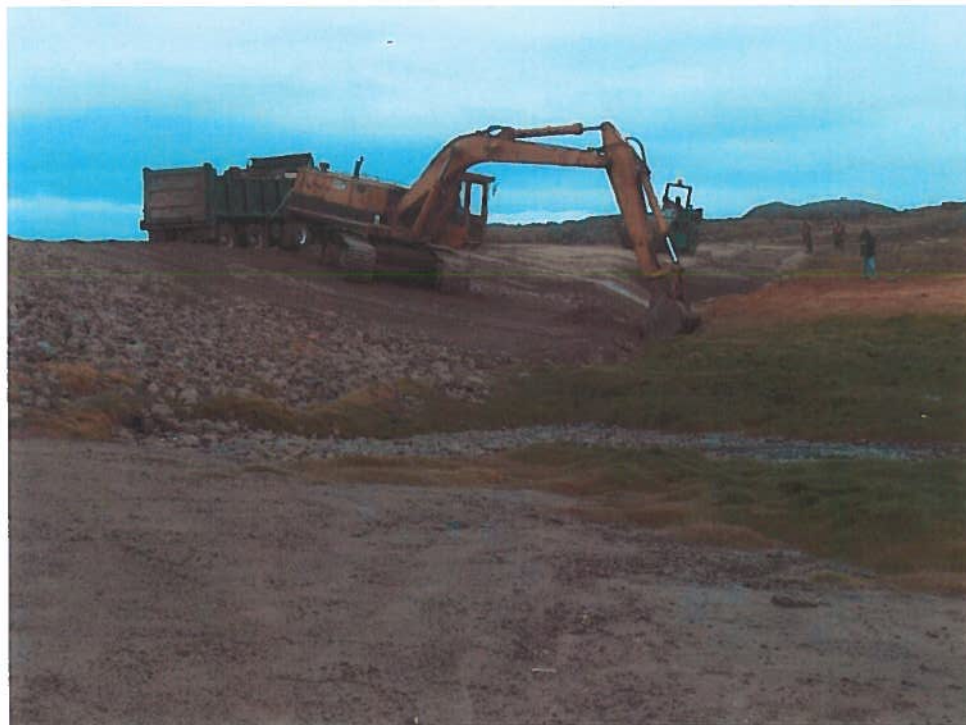
Photograph 2
Overview, West Berm; looking south during 2006 repairs

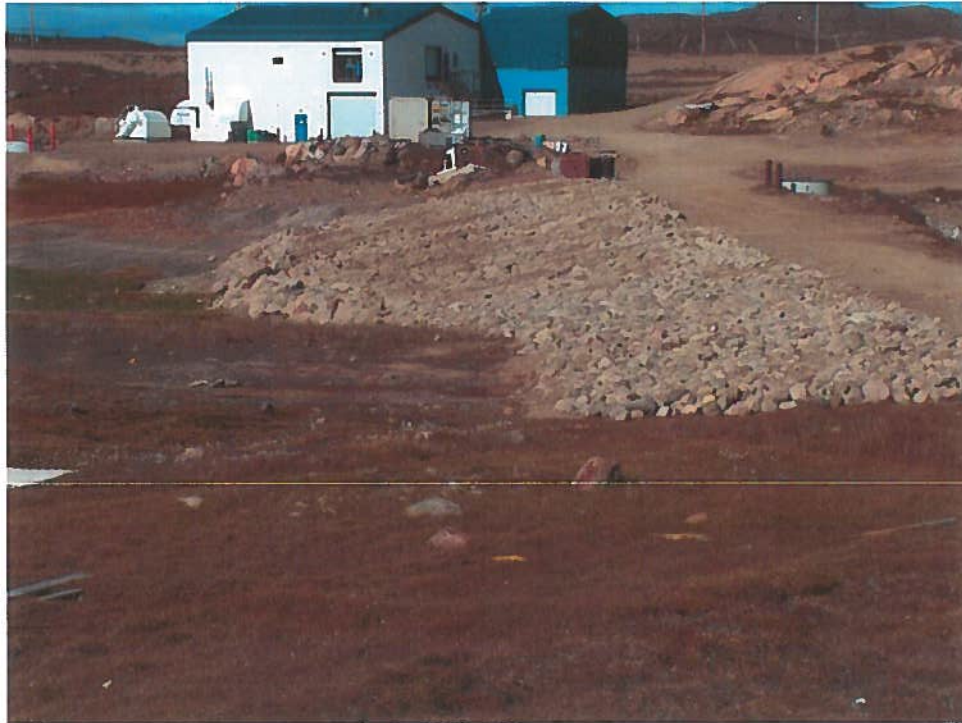
Photograph 3
Overview, West Berm, completed 2006 repairs, looking north

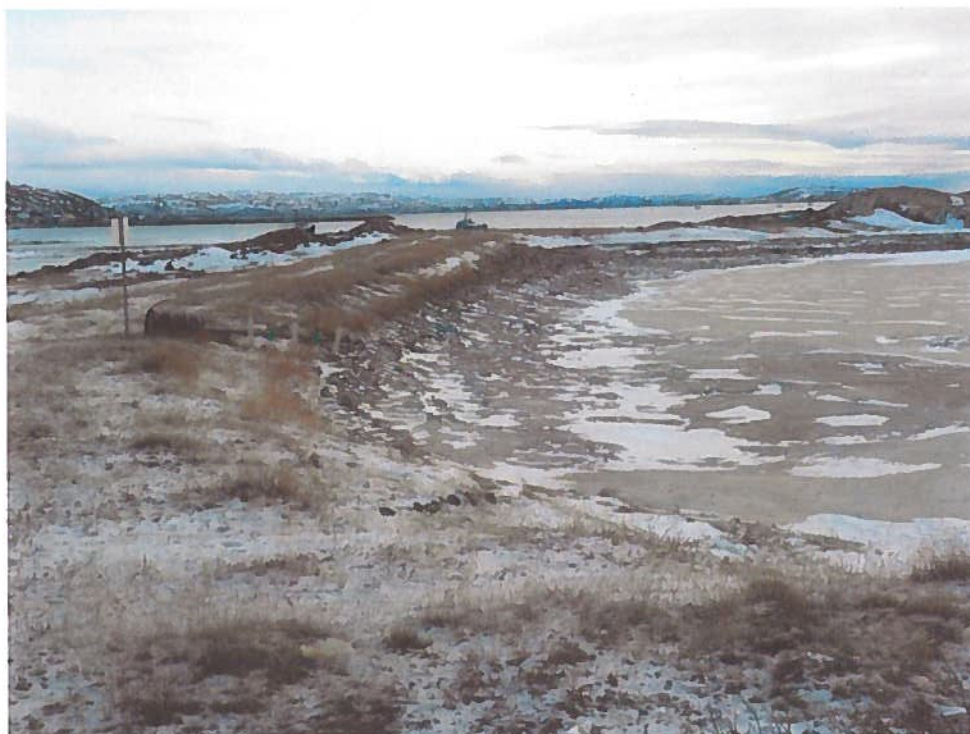
Photograph 3
East Berm, North segment; no change since 2006

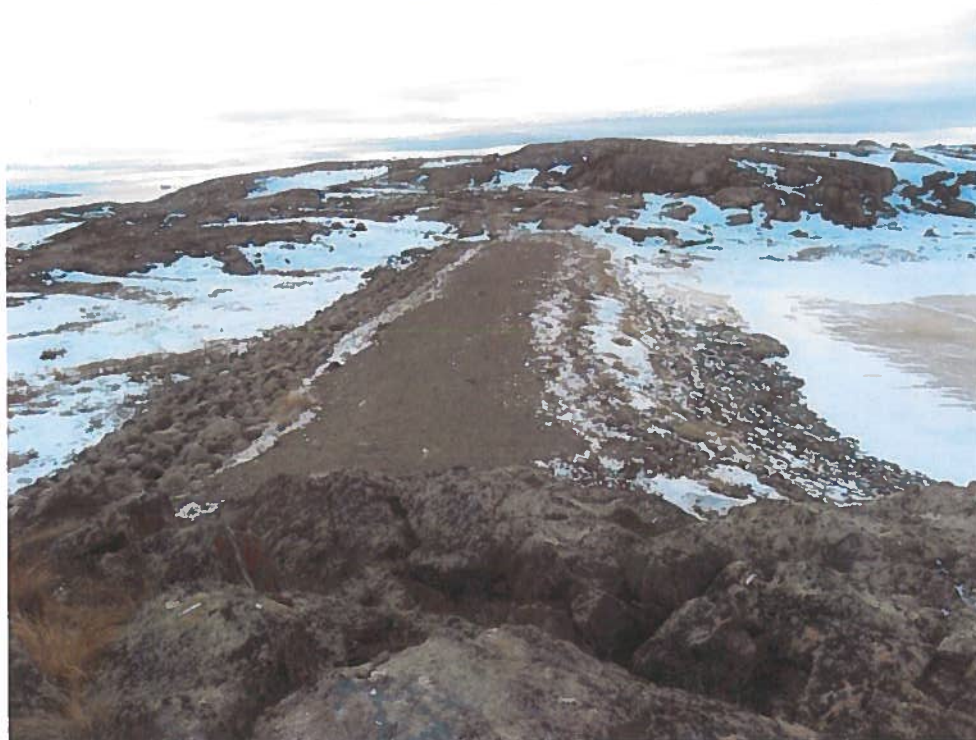
Photograph 4
East Berm, South segment; no change since 2006

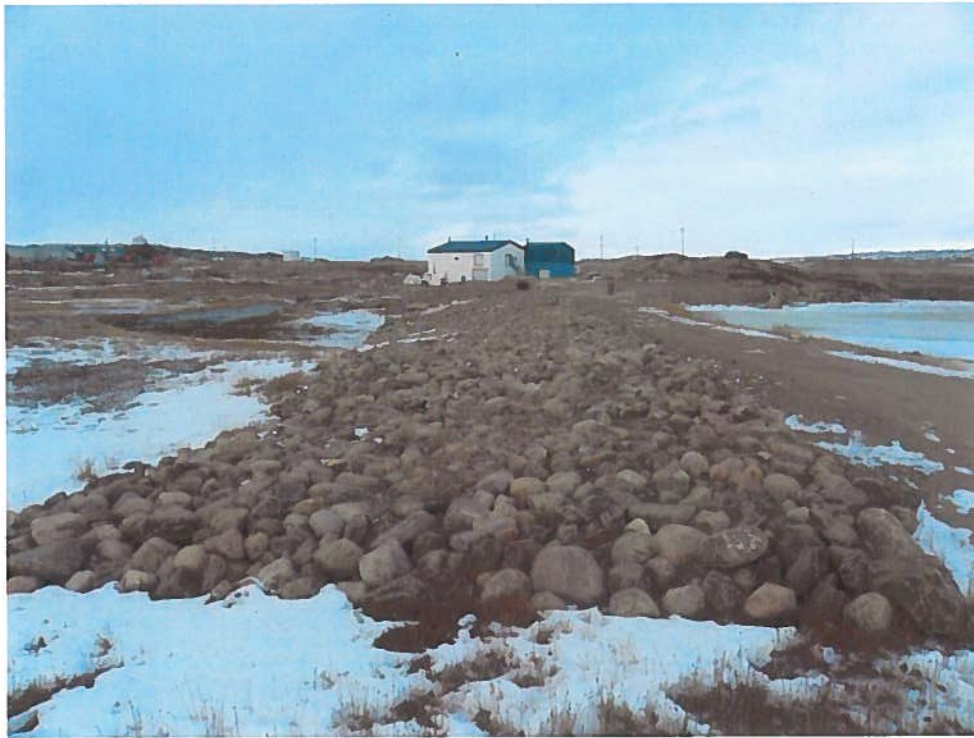
Photograph 5
West Berm, no change since 2006

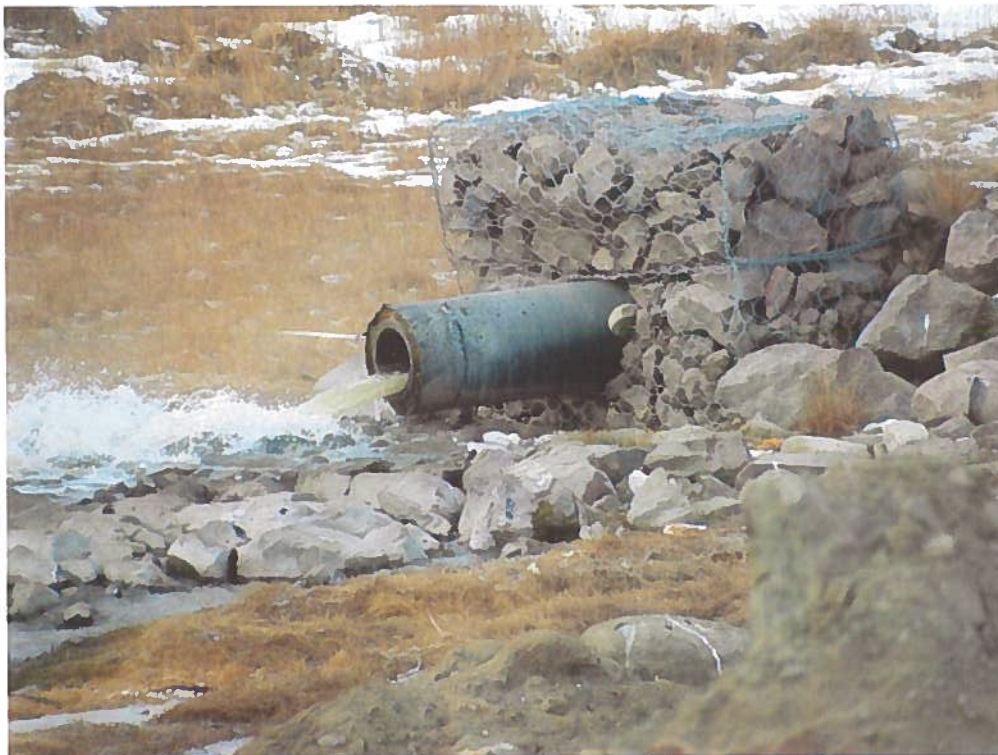
Photograph 6
Discharge from Sewage Treatment Plant

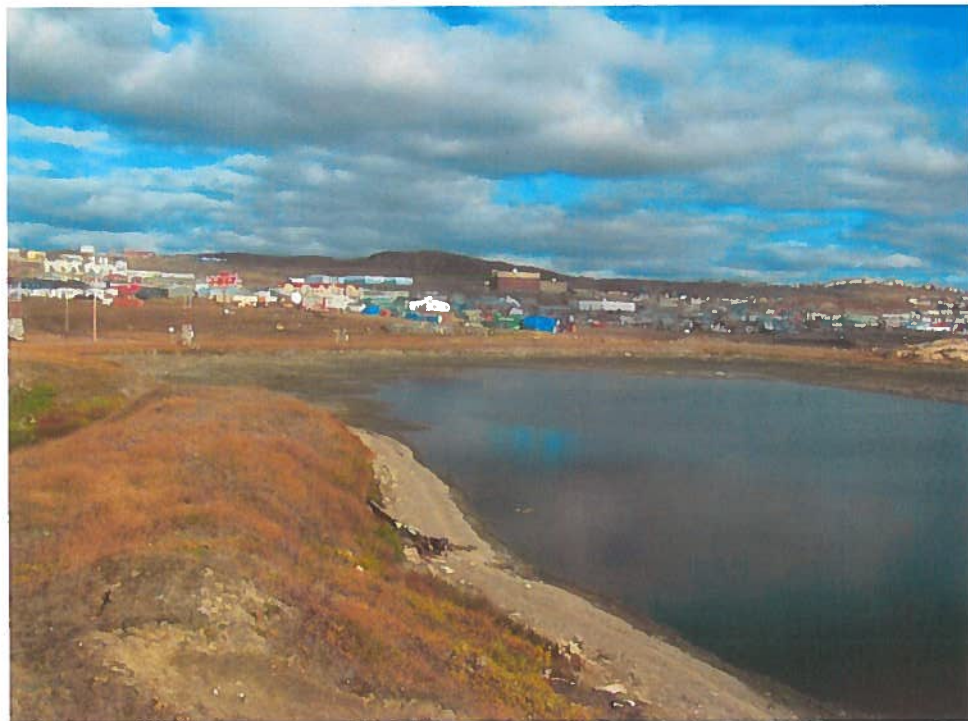
Photograph 2
Overview looking East; note lagoon level and sludge accumulation.

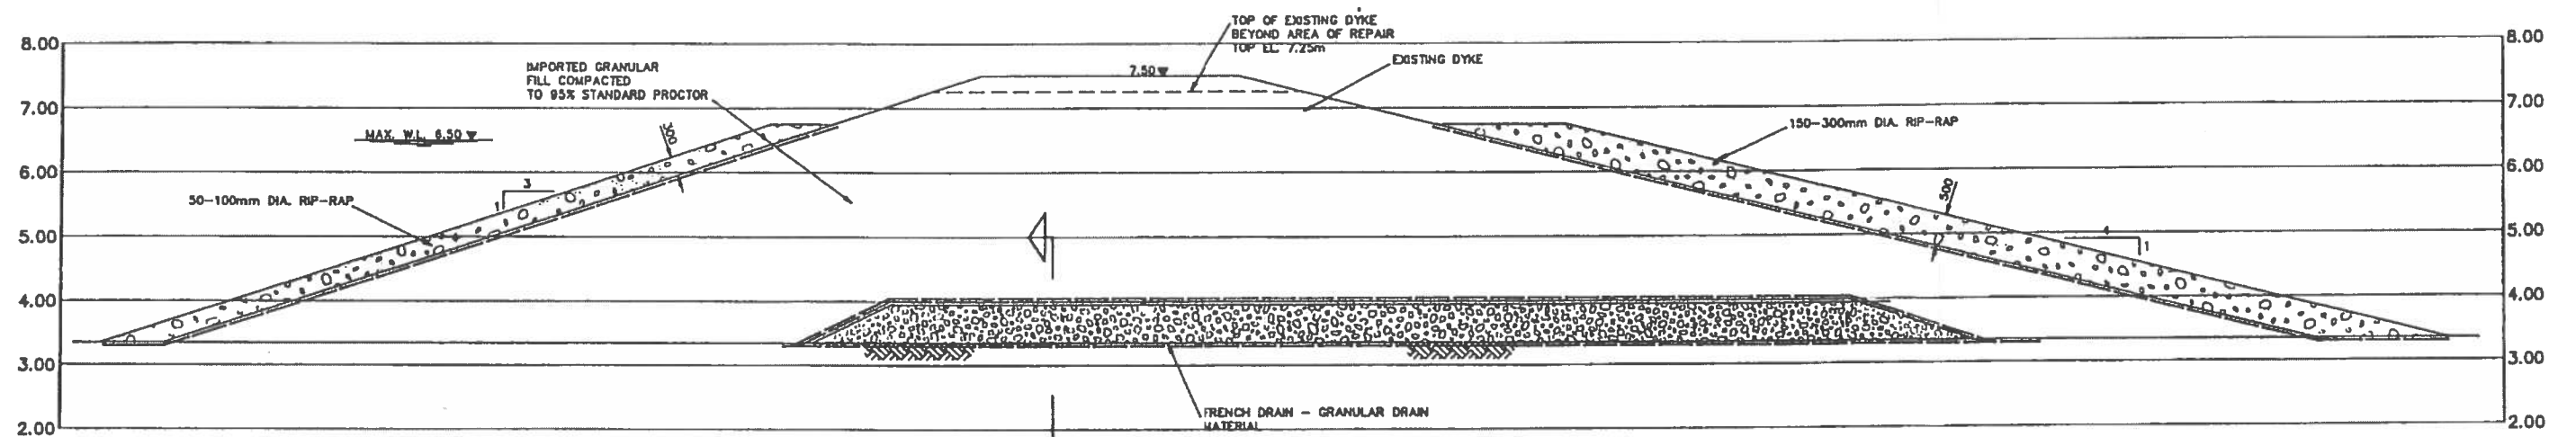
FRENCH DRAIN (MINIMAL FUNCTION WITH SUBSTITUTED MATERIAL)

NOTE: IMPORTED GRANULAR FILL CLASS D2 NOT UTILIZED ABOVE ELEVATION OF FRENCH DRAIN. MATERIAL WITH LARGER FINES COMPONENT SUBSTITUTED BY TOWN OF IQALUIT. DESIGN SLOPES OF 4:1 (EXTERIOR) AND 3:1 (INTERIOR) ACCOMMODATE THIS MATERIAL.
