Map V-2: Upper Base

2. Results of Previous Studies

3. Current Sampling Program

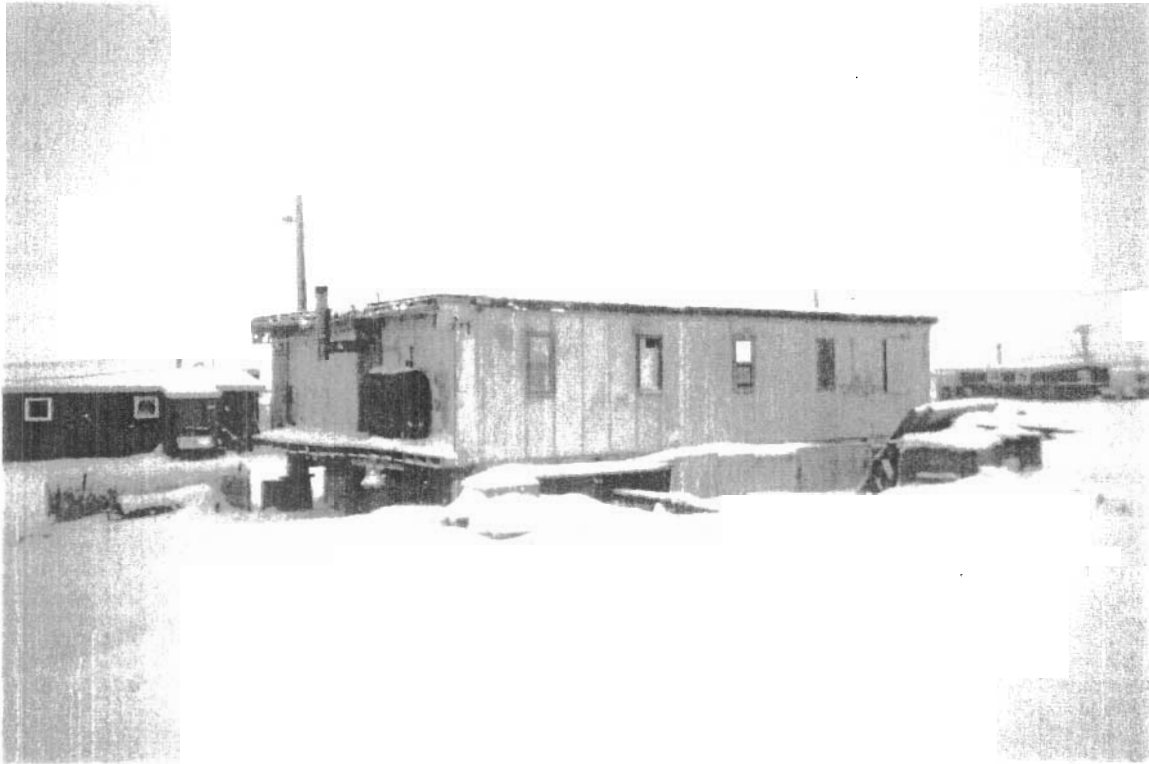
Photograph V-5: This residence is an example of the items scavenged from the Upper Base.

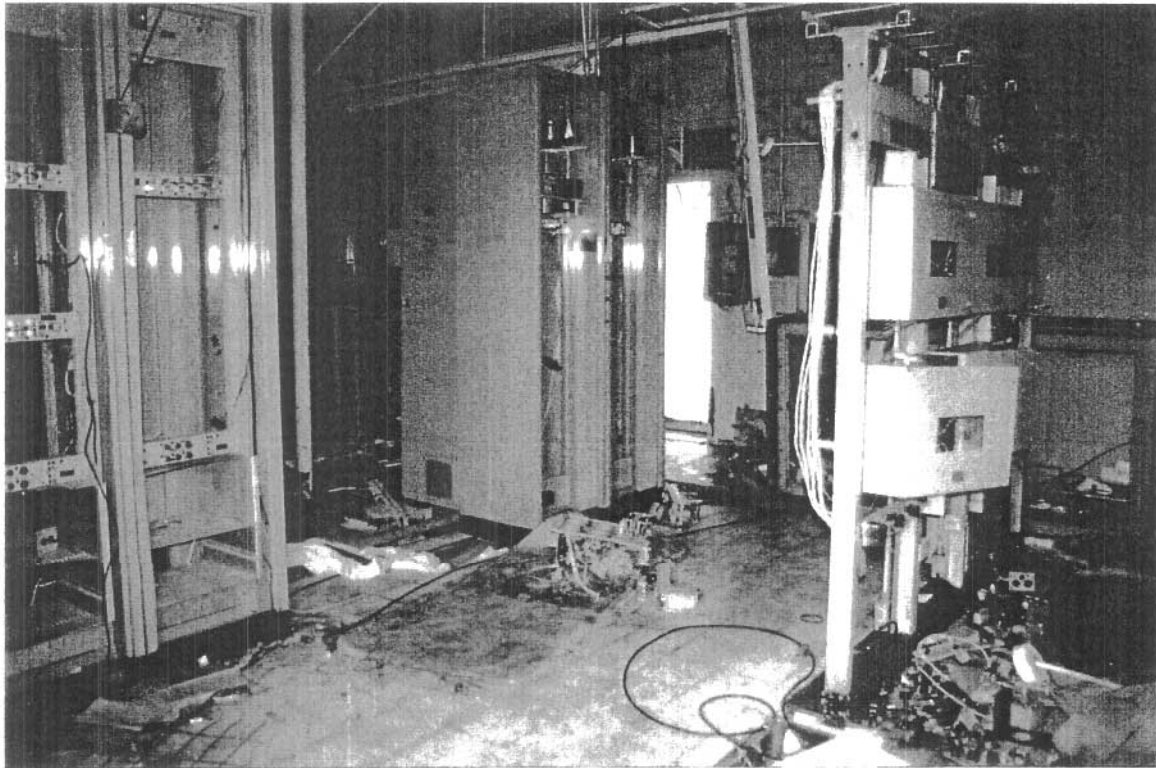
Photograph V-6: The easternmost room of Pole Vault Building 222 where electrical equipment containing capacitors was observed.

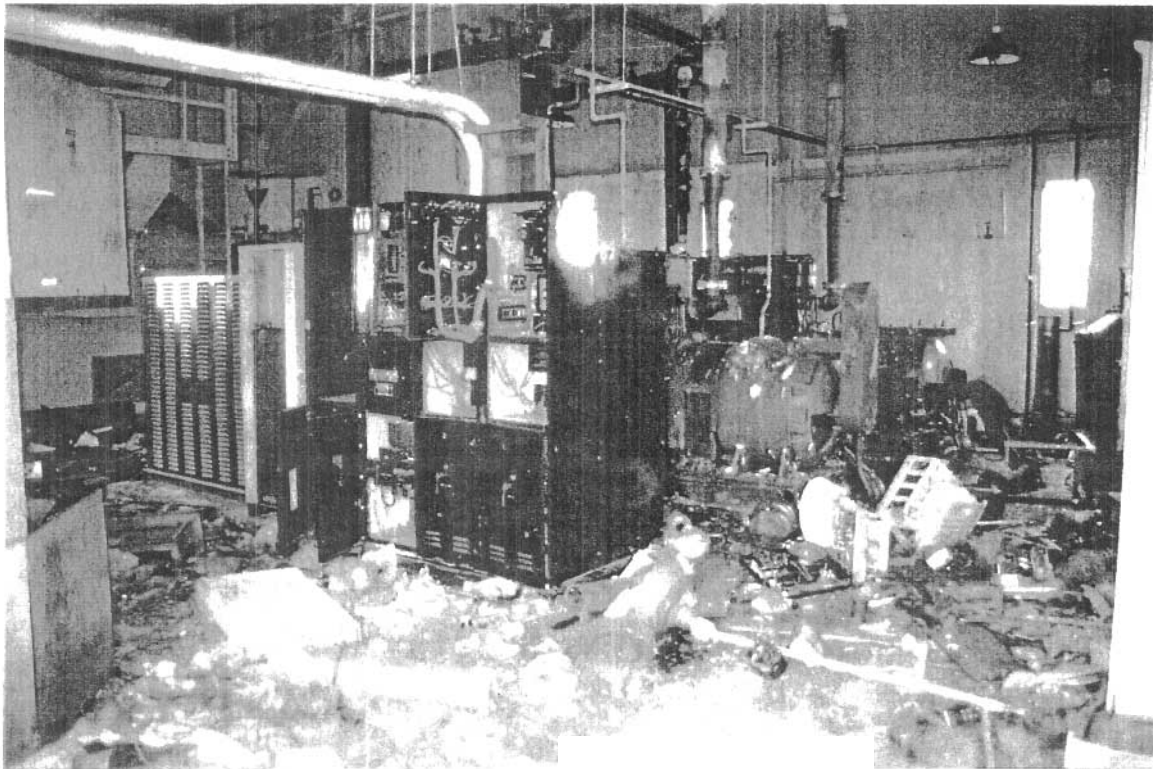
Photograph V-7: View of the westernmost room of Pole Vault Building 222, where transformers and capacitors were found.

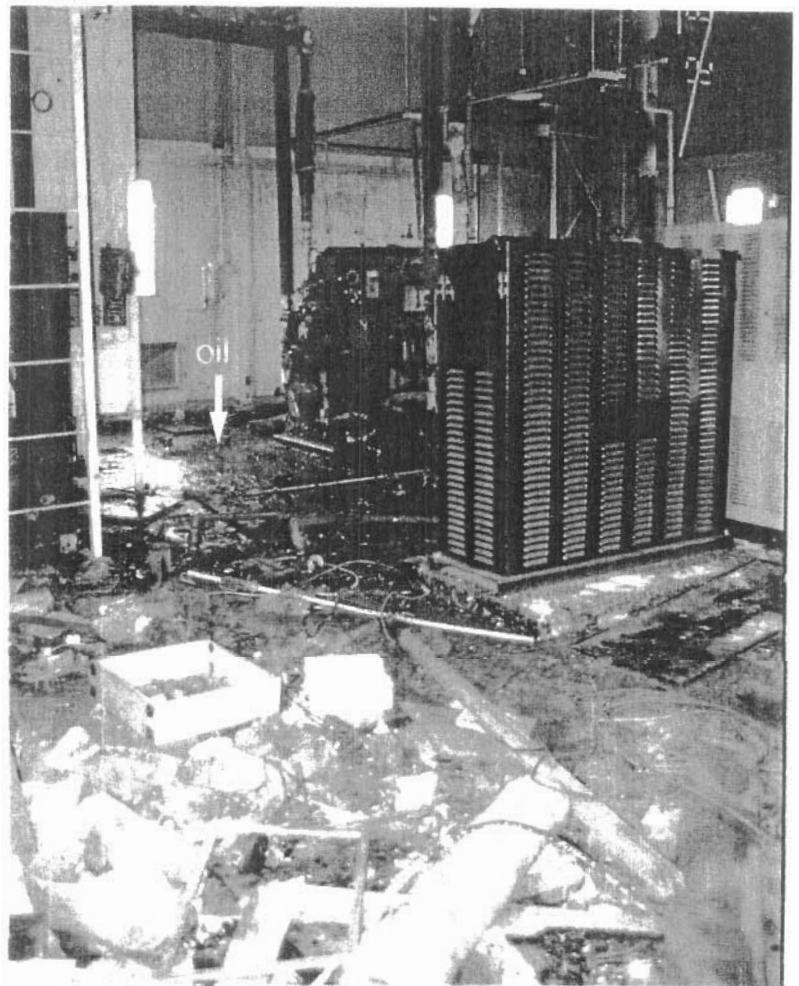
An inspection was made of the interior of Building PV222 and nine swabs of the wall were taken to determine levels of surface contamination. A sample of pipe insulation was collected for asbestos analysis. The Pole Vault building had been heavily vandalized - floors were scattered with paper, insulation and electrical equipment (Photograph V-6). Throughout the building, walls were riddled with bullet holes. Many capacitors had not been removed from electrical units in the easternmost room of the building, and transformers and capacitors were observed on the floor of both rooms (Photograph V-7). An oily residue covered much of the floor of the westernmost room of PV222 (Photograph V-8). A sample of floor debris was collected for PCB analysis.

Photograph V-8: The floor of the westernmost room in Pole Vault Building 222, littered with debris and covered with an oily coating.

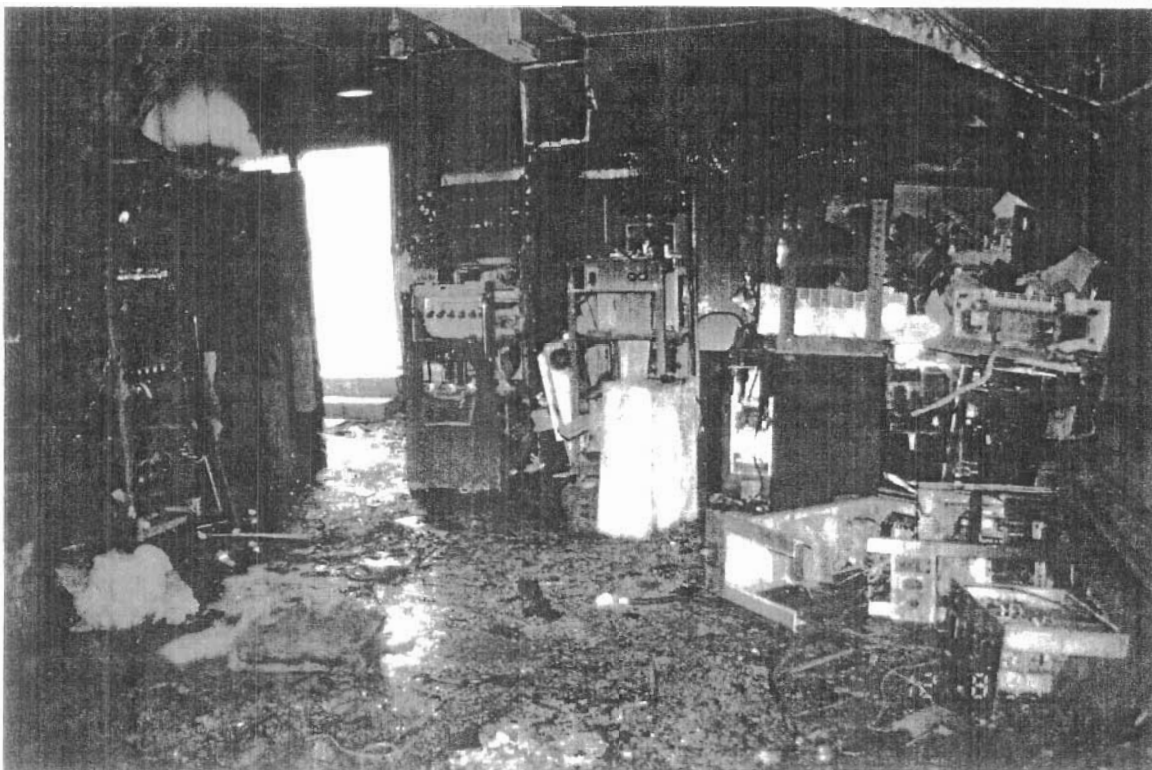
of the building is blackened due to the fire which occurred there, likely at some time during its operation (Photograph V-9). Dismantled electrical equipment is strewn about the room.

Photograph V-9: The burnt interior of Communications Building S-28 where the remains of electrical equipment were found.

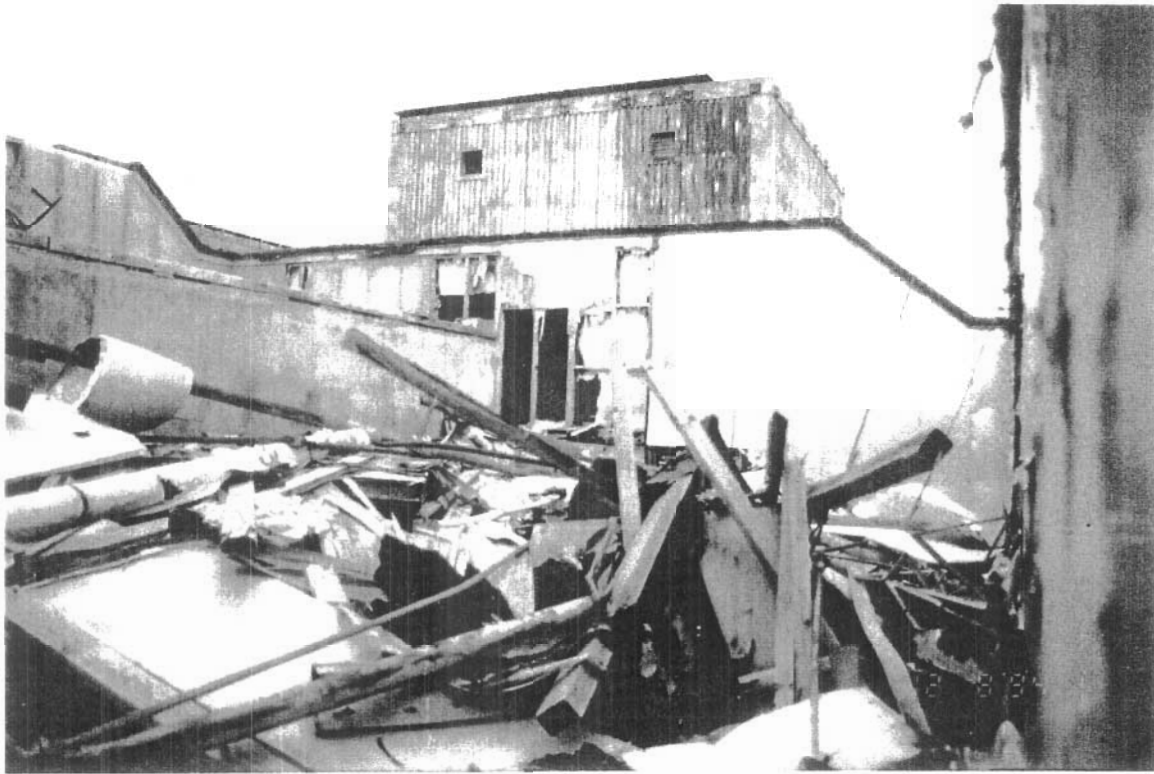
Photograph V-10: Building remains scattered around the Main Site.

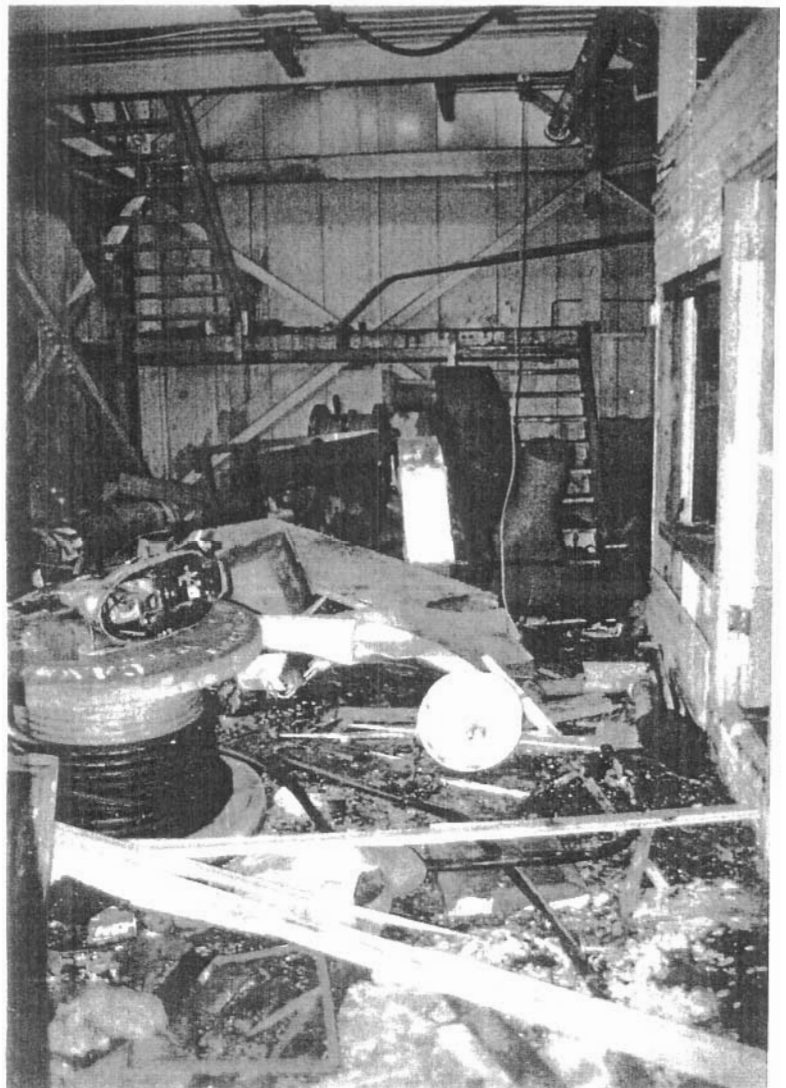
The approach to sampling at the Main Site was based on the types of activity that may have occurred in specific areas (e.g., disposal of waste liquid out doors or down drains, use of hazardous materials in the power plant) and on visible evidence of potential contamination (e.g., staining of soil). Drainage from areas of potential contamination was also sampled. A total of 39 soil samples, including two field duplicates, were collected at the Main Site (Map V-7), which was littered with debris and the remains of partially removed buildings (Photograph V-10). As noted above, buildings have been removed and used for storage or, in at least one case, as a residence. The interiors of the buildings were similarly scattered with materials as a result of scavenging and vandalism (Photograph V-11). Six wall swabs were collected inside one of the towers.

Photograph V-11: The interiors of a typical building at the Main Site, littered with debris and equipment.
