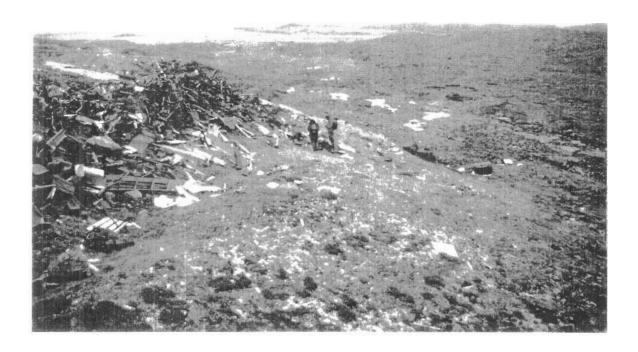
Photograph V-12: View of the northwest toe of the Upper Base Landfill.

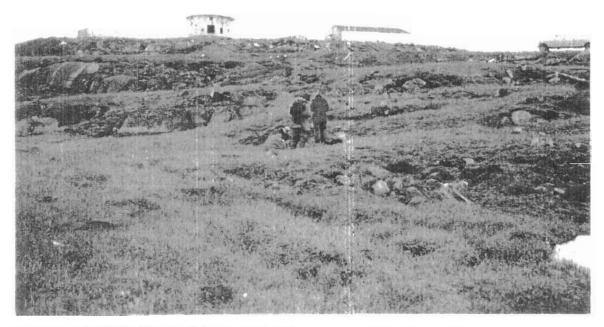
Photograph V-13: The lushly vegetated lower area of the Upper Base Outfall.

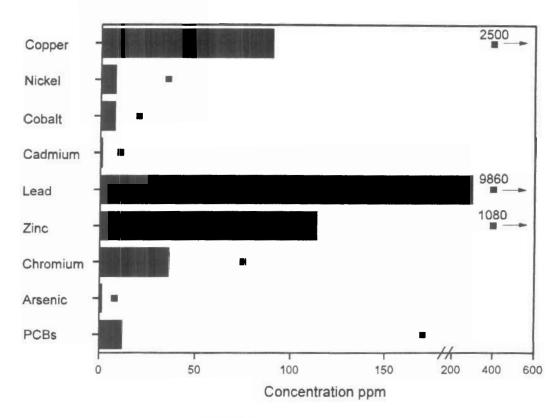
Figure V-3: Mean and Maximum Concentrations of Inorganic Elements and PCBs in Building PV222 Soil

Thirty-six of the 45 soil samples collected around Pole Vault Building 222 were analyzed for inorganic contaminants. Mean concentrations of lead were elevated above DCC Tier I (Figure V-3).

Mean concentrations of all other analytes were below the DCC, and the mean concentrations of nickel, cobalt, cadmium, and chromium in soils from around Building PV222 were comparable to the means for background soils. Maximum concentrations, however, of copper (2500 ppm), cadmium (10.4 ppm), lead (9860 ppm) and zinc (1080 ppm) were significantly elevated above DCC Tier II. Three soil samples contained at least one of these elements at concentrations exceeding the criteria. Sample G5902, collected on the edge of a small drainage catchment, 22 m from the northeast corner of Building

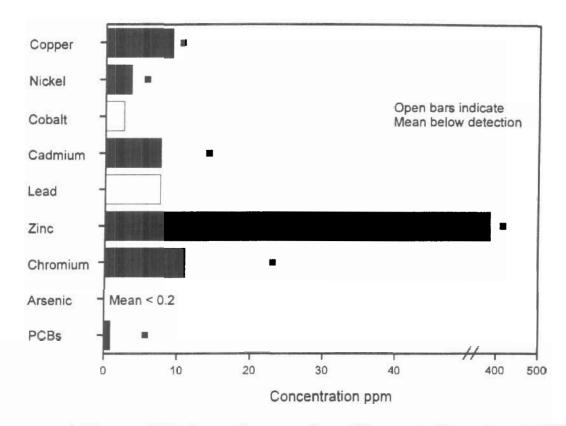
Figure V-4: Mean and Maximum Concentrations of Inorganic Elements and PCBs in Building PV222 Vegetation

Three of the 26 plant samples collected in the vicinity of Building PV222 were analyzed for inorganic elements. Two of the analyzed samples were root and shoot subsamples from the same location. Mean concentrations of all inorganic analytes, except cadmium, were not significantly elevated above the mean calculated for background plants. The mean concentration of cadmium in plants collected from around Building PV222 (7.6 ppm, Figure V-4) was seven times the mean concentration calculated for background plants (1.1 ppm, Figure V-2). Levels of cadmium in vegetation collected near Building PV222 were elevated above the mean concentration in background plants in all three analyzed plant samples. G5908P (Salix arctica) contained concentrations of cadmium 13 times greater than the mean background plant level; the soil sample (G5908) collected in the same location contained cadmium in excess of the DCC. Concentrations of cadmium in the root (4.8 ppm) and shoot (3.8 ppm) tissues of G5902P (Salix arctophila) were 4.4 and 3.5 times, respectively the mean for whole background plants. Cadmium concentrations in these plants were higher than concentrations in soil from the same location (2.5 ppm).

Twenty-one of the 25 plant samples collected near Building PV222 were analyzed for PCBs. Mean (0.9 ppm) and maximum (5.6 ppm) concentrations of PCBs in plants collected in this area were 1525 and 9500 times the mean and maximum concentrations in background plants (Figure V-4). The lowest PCB concentration (0.0054 ppm) in a plant sample collected in the vicinity of Building PV222 was nine times the mean background plant concentration. G5920P (Salix arctica) contained an especially high concentration of PCBs (5.6 ppm) which exceeded even the DCC Tier II criteria for soils. The average concentration of PCBs in soils at the same location (7.7 ppm) also exceeded the Tier II level.
