Map V-15: Samples Exceeding the Cleanup Criteria, North 40 Dump

## **D. Dump Site #1: Sylvia Grinnell Park Dump**

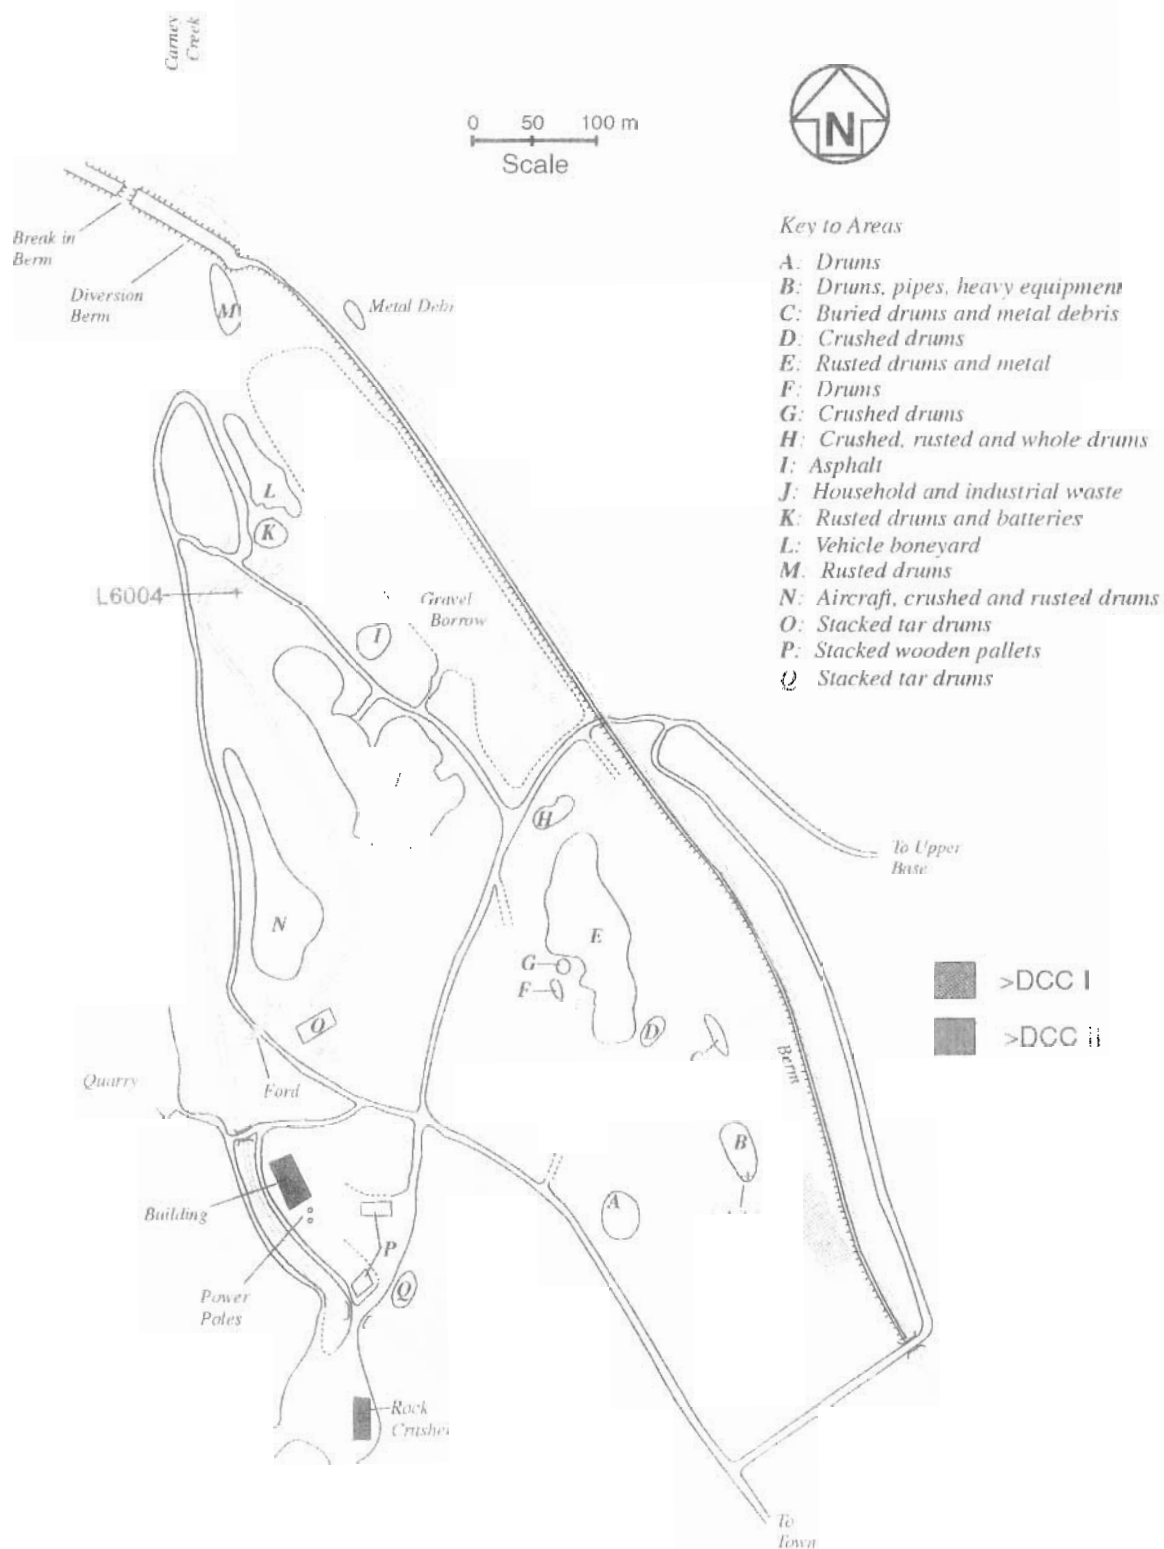
**Only two soil samples collected in the North 40 Dump contained inorganic elements at concentrations exceeding the DCC. The concentration of copper in L6004 exceeded Tier II, and the lead concentration in the stained soil sampled at L6030 exceeded Tier I.**

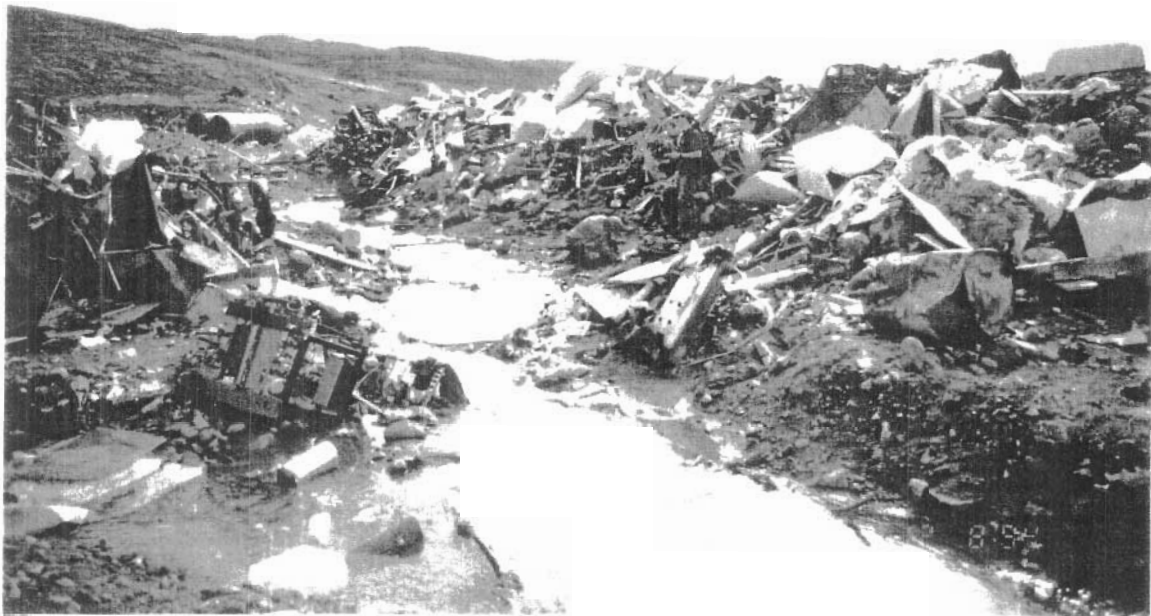
Photograph V-29: Soil sample L6004 contained elevated levels of copper.

In accordance with the DLCU Protocol, soils exceeding DCC Tier II level must be removed from contact with the Arctic ecosystem. Therefore soils in the vicinity of sample location L6004 containing copper at concentrations in excess of Tier II require excavation and shipment off-site. The stained soil in Area B which contains lead at concentrations in excess of DCC Tier I should be excavated and placed in a properly engineered landfill with sufficient fill placed over it to effectively seal the contaminants into the permafrost layer (see Implementation, Chapter II). Heavily oiled soils such as those present in the southeastern end of the North 40 have the potential to be incorporated into sands being extracted for fill material; these soils should therefore be treated in a manner similar to Tier I soils and removed to an engineered landfill. Materials within the dump require sorting into hazardous and non-hazardous components. All hazardous materials should be shipped South for disposal. Non-hazardous wastes can be further divided into metal and non-metal categories. Scrap metal could be shredded and then, if economically feasible,

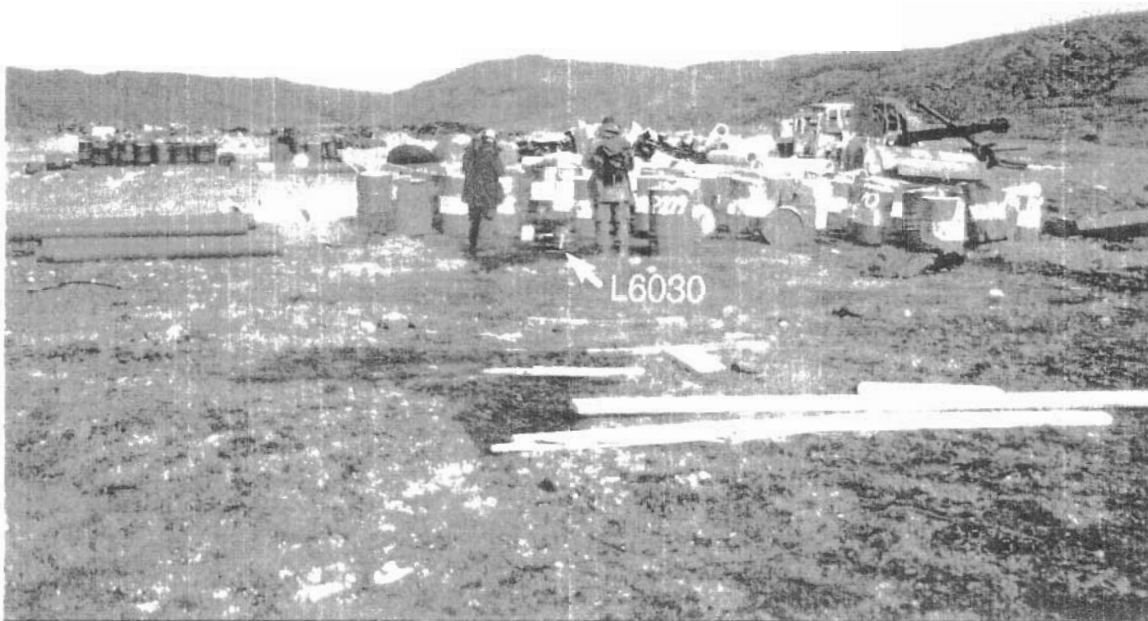
Lead (249 ppm) was found at concentrations exceeding DCC Tier I level in sample L6030, collected in a light stain emanating from a barrel in Area B of the eastern half of the site (Photograph V-30).

Photograph V-30: Soil sample L6030, collected in a stain amongst the barrels in Area B, contained elevated levels of lead.

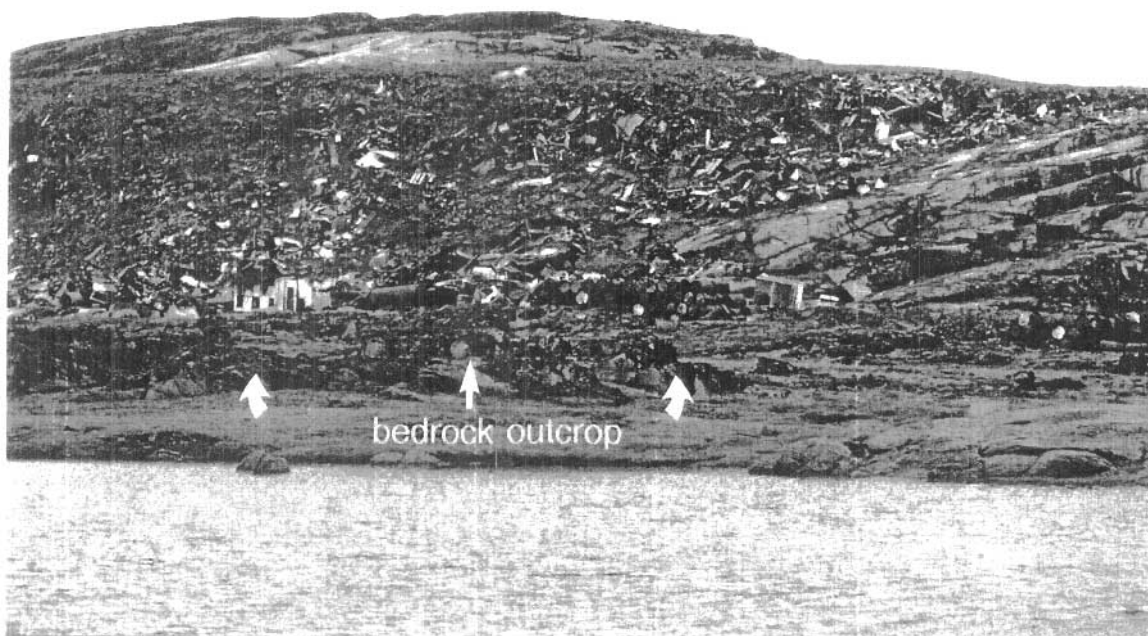
The main area of the dump covers approximately 1 hectare on a steep slope approximately 150 m above the river (Photograph V-31). Waste in this portion of the site is not readily visible from the top of the slope. Vegetation is extensive on top of the slope and consists primarily of early successional grass species. The slope itself is made up of pockets of waste surrounded by granular material. Debris on the slope is composed principally of metals and wood. It was estimated that more than 60% of the slope face is covered with fill. Vegetative cover in filled areas is extensive and also consists primarily of early successional grass species. The west end of the slope is characterized by a steep cliff overlooking a pond. During the current sampling program, field workers observed some barrels in the pond.

Photograph V-31: Dump Site #1 as viewed from the south bank of the Sylvia Grinnell River. Note the bedrock outcrop running parallel to the dump face.

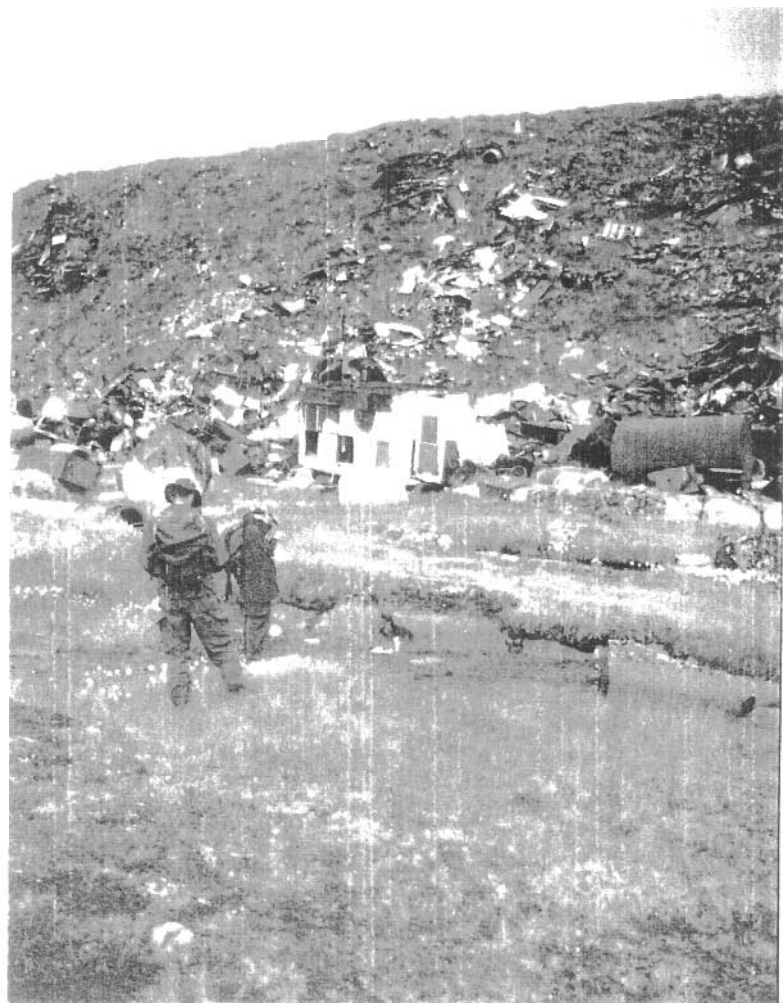
Other areas within Dump Site #1 include the toe of the main slope into which a considerable amount of large metal waste has fallen (Photograph V-32), and four barrel piles located on a flat area just beyond the toe (Photograph V-33). Some staining is present around the barrel piles. The substrate at the base of the slope consists of a thin sandy soil layer over bedrock and supports a thin covering of vegetation. A border of

Photograph V-32: View of the toe of Dump Site #1, showing the accumulated debris at the base of the slope

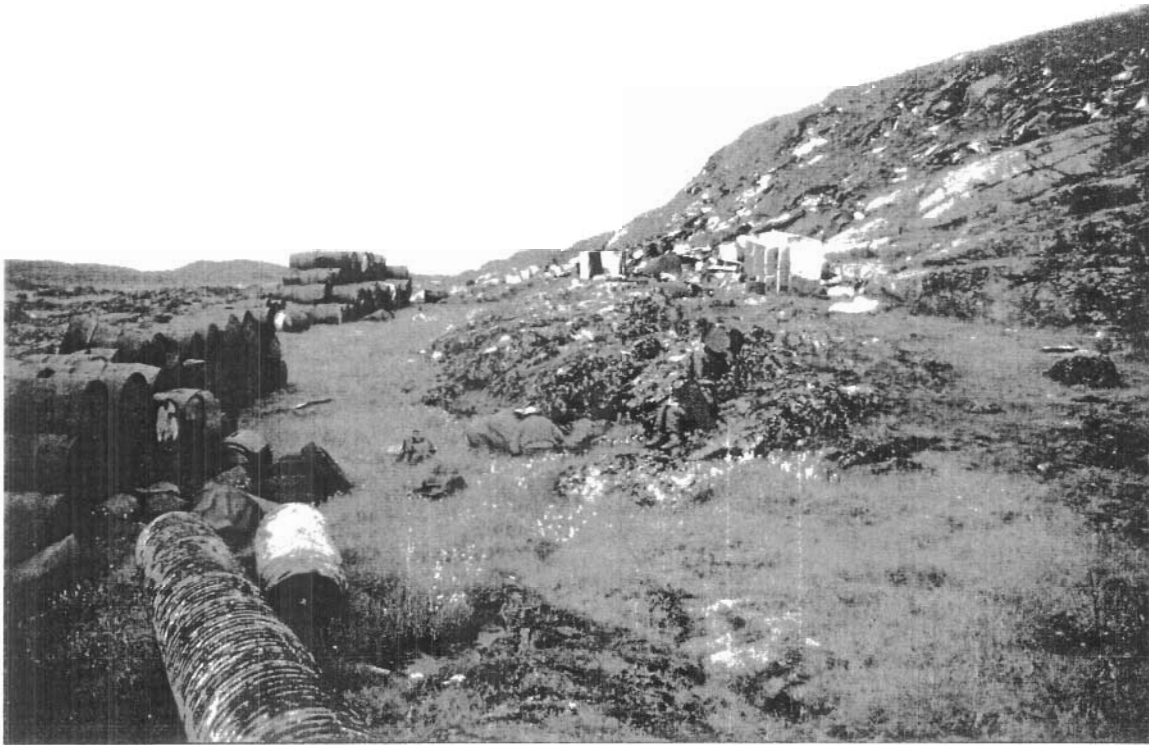
**Photograph V-33: View to the west from within Dump Site #1. Note the steep angle of the slope and the piles of barrels stacked along the toe of the dump.**

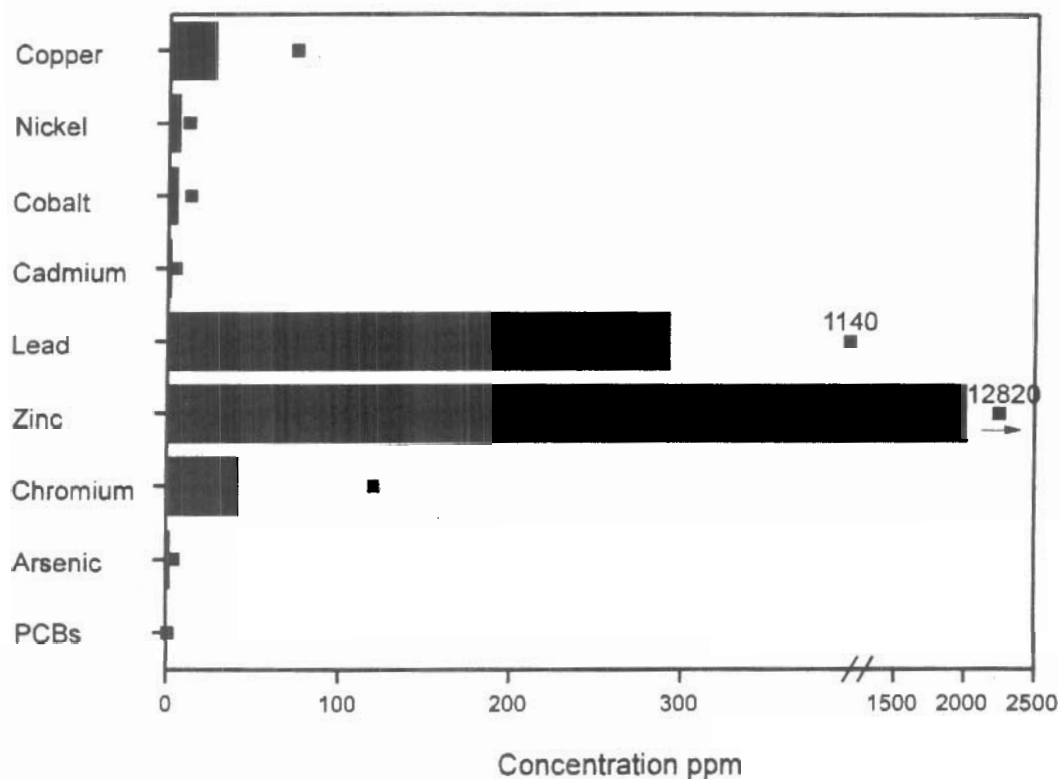
Seven of the eight soil samples collected at Dump Site #1 were analyzed for inorganic elements. The mean concentration of lead (293 ppm) and zinc (2020 ppm) in soils from this site exceeded the DCC (see Figure V-11). Mean and maxima for all other analytes were below the DCC.

**Figure V-11: Mean and Maximum Inorganic Element and PCB Concentrations in Soils Collected at Dump Site #1.**
