Map V-17: Samples Exceeding the Cleanup Criteria, Dump Site #1

## **E. Dump Site #2: Summer Camp Dump**

## **F. Dump Site #3: Site of the New Municipal Landfill**

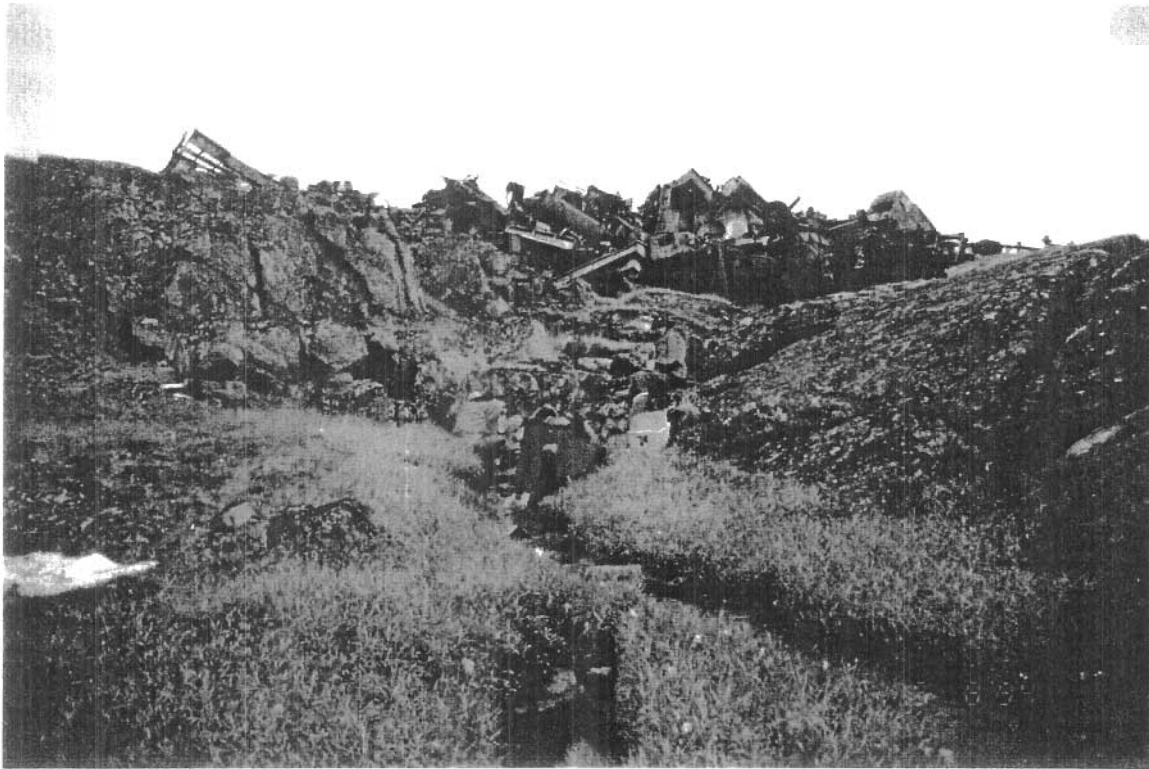
Although PCBs were present in soils below the vehicle pile, no PCBs were detected in water sample WF6006 collected at the same location.

fallen below that level. It is likely that the removal of electrical equipment in 1986 also removed the sources of the PCBs and hence PCB levels have dropped. The concentrations of PCBs (0.71 ppm) detected in soils downstream from the vehicle pile suggest that the currently inaccessible soil under the vehicle pile needs to be assessed for PCBs. **Following the removal of the vehicles as outlined below, soil from this area should be collected and analyzed for PCBs.**

**Photograph V-34:** Sample L6055 was collected from the drainage channel running through the vehicle pile and contained elevated levels of lead and PCBs.

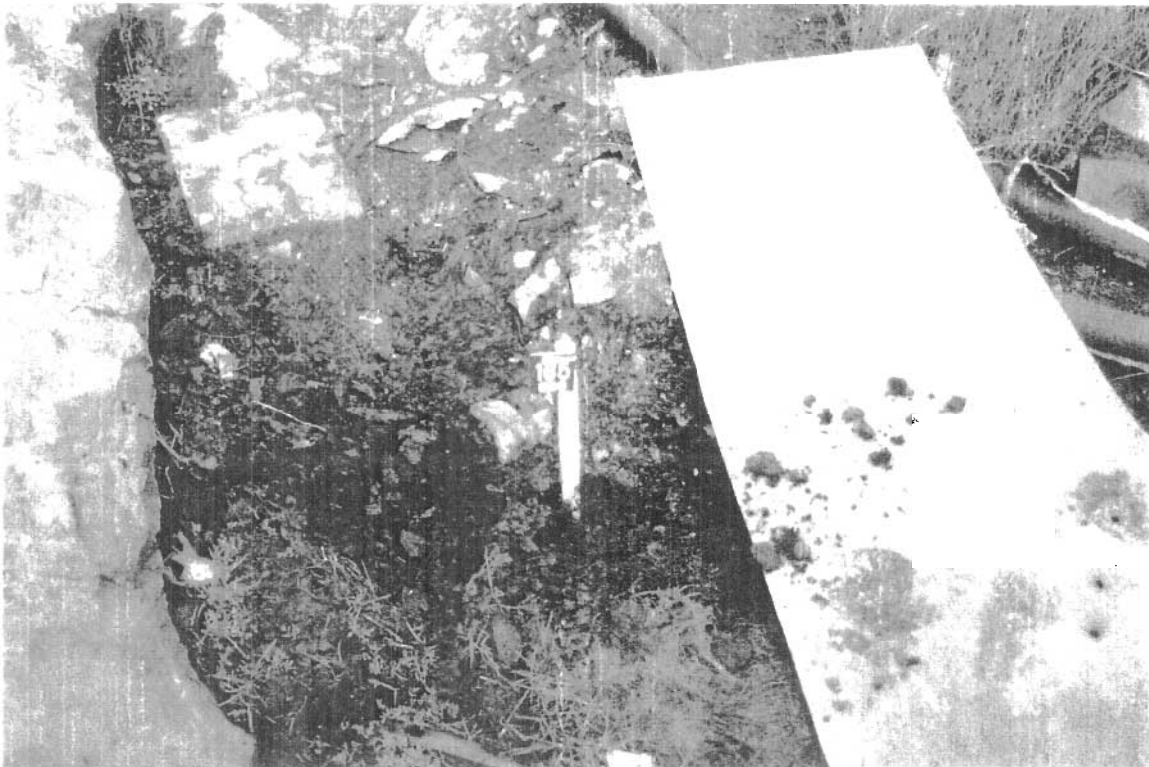
**Photograph V-35:** Sample L6057 was collected from the small stained area and contained elevated levels of lead and zinc.

The results suggest that the area at the base of the dump is contaminated with metals from the debris present there. Soils around the areas where samples L6057 and L6058 were collected should be excavated and removed from contact with the Arctic ecosystem as outlined for Tier II soils in the DLCU Protocol. Soils near the L6055 and L6056 sampling locations, in which lead concentrations exceeded DCC Tier I, should be excavated and placed in an engineered landfill in accordance with the DLCU Protocol. The concentration of PCBs in sample L6055, though significantly elevated above background, does not warrant soil remediation under the DCC. Nevertheless, the area represented by this sample will be excavated because of the high levels of lead found in the same sample. It is suggested that after removal of the DCC II soils, any soil remaining between the base of the main area of the dump and the first boulder outcrop (see Haertling 1988) should be removed along with the Tier I soils because it contains some inorganic contamination at levels significantly elevated above background. The area to be excavated is defined by the base of the landfill slope and the first of a series of parallel bedrock outcrops.

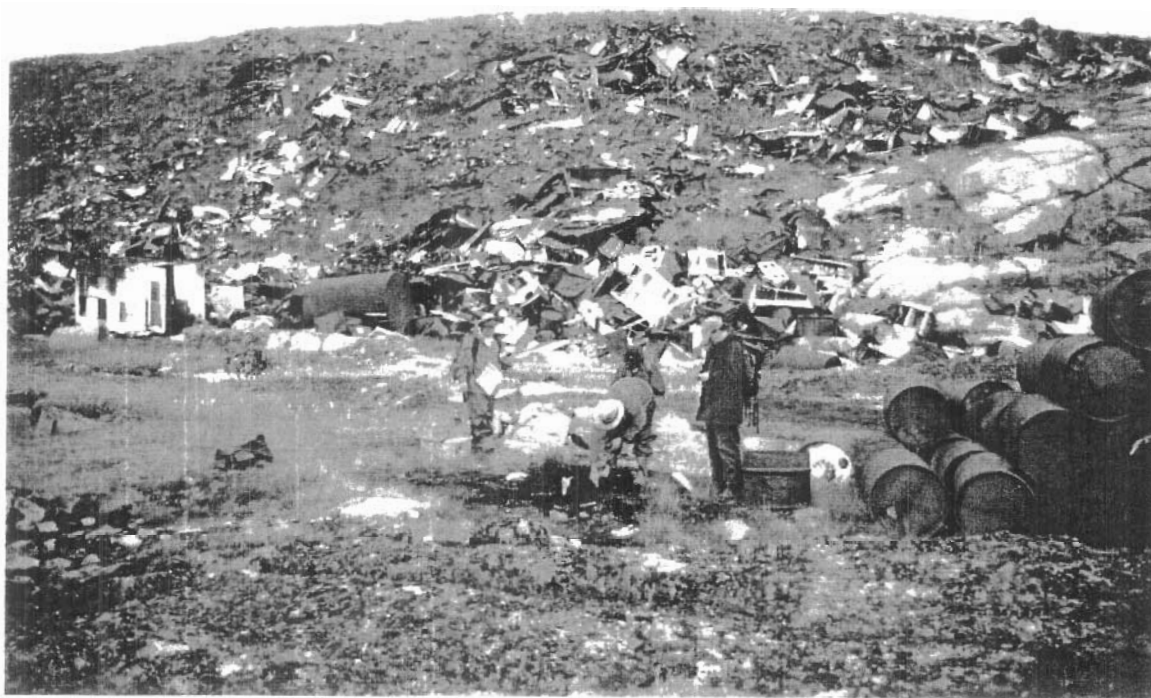
Photograph V-36: Sample L6058, collected from the black stain, contained elevated levels of zinc.

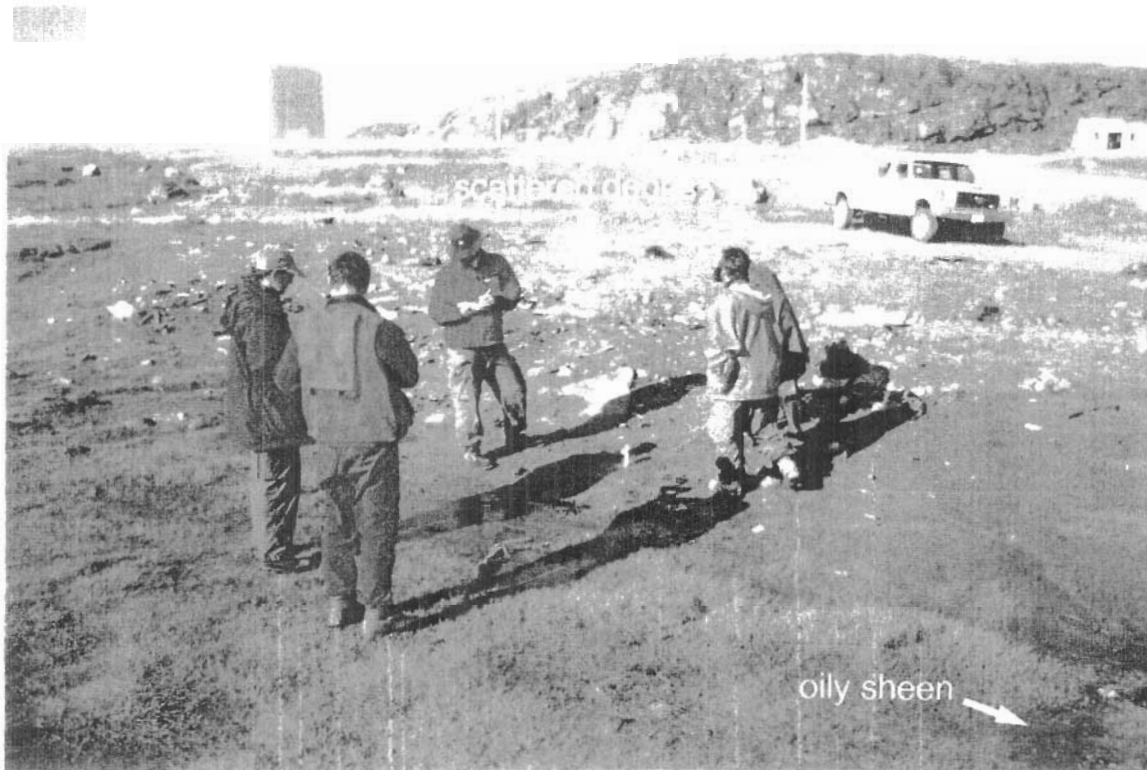
**Photograph V-37:** The area littered with debris in Dump Site #2. Note that water in the vicinity has an oily sheen on its surface.

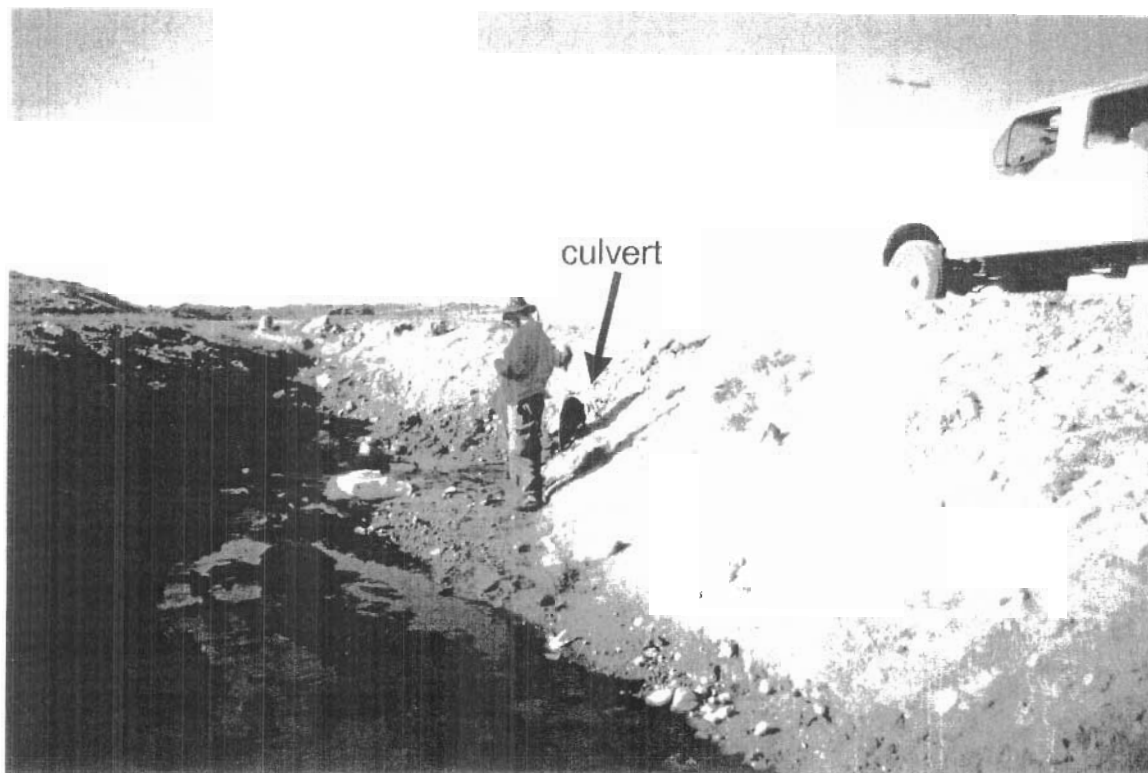
A portion of the area occupied by wastes is situated within the limit of high tide. Erosion of the area by tidal action may have caused the debris at the south end of the site to become exposed. Additional erosion may be occurring as a result of water flowing over the area from a large drainage ditch on the eastern side of the site.

The large drainage ditch on the east side of the site making its way through the area and into a small embayment of Frobisher Bay is the only major drainage path through the site. This ditch currently receives runoff from Dump Site #3 to which it is connected by a road culvert.

Photograph V-38: View to the north of the large drainage ditch on the east side of Dump Site #2.

Erosion of the areas where wastes are buried does pose a risk, however, as exposed wastes could be transported into the ocean by tidal action should it continue. The practice of burning materials before burial while the site was active indicates that a significant portion of the buried materials may be ash which is considered hazardous under the DLCU Protocol. Permitting any hazardous materials to enter fish bearing waters constitutes a potential violation of the Fisheries Act (Section 36). Any debris present on top of the substrate should therefore be removed, and erosion reduced with the addition of an appropriate amount of fill over the area most affected by the drainage channel which runs through the site. Exposed materials not readily removed from the substrate should be left undisturbed to avoid decreasing the stability of the filled areas. Rerouting the drainage channel under the access road by installing a culvert, as suggested by UMA (1994), is a possible further measure for the reduction of erosion.
