2. Results of Previous Studies

3. Current Sampling Program

5. Cleanup Recommendations

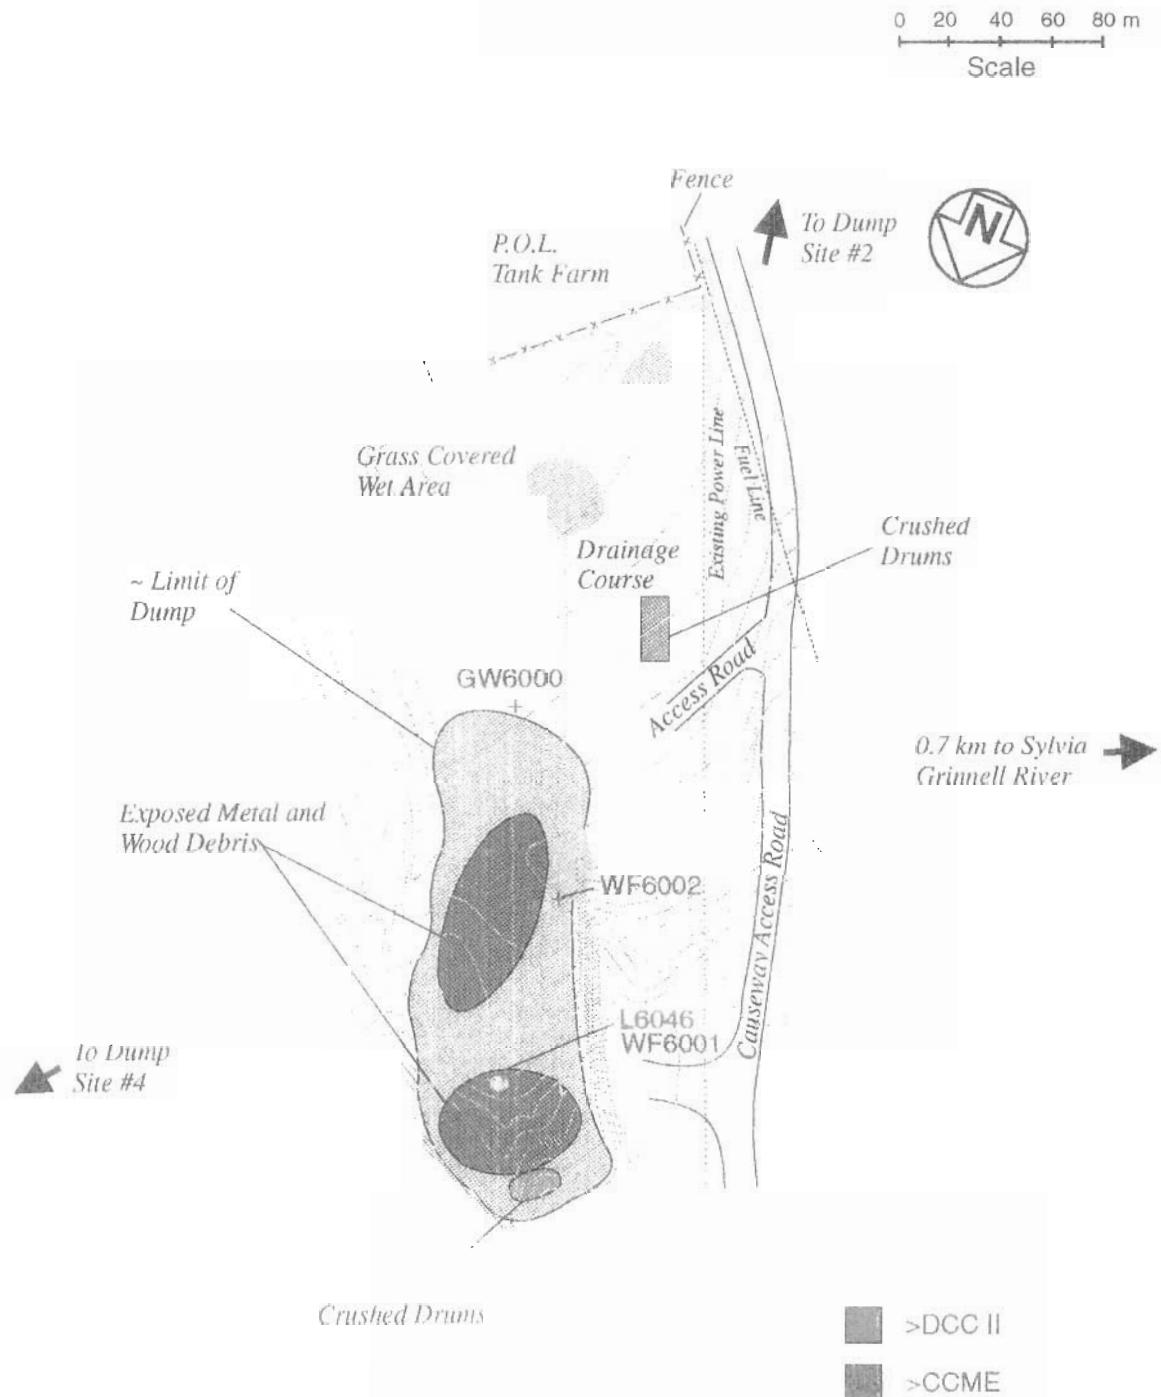
Map V-22: Samples Exceeding the Cleanup Criteria, Dump Site #3

The analytical results for this and all other sites can be found in Chapter V of the Appendices. One soil sample and three water samples contained inorganic elements or PCBs in excess of the DCC (Map V-22).

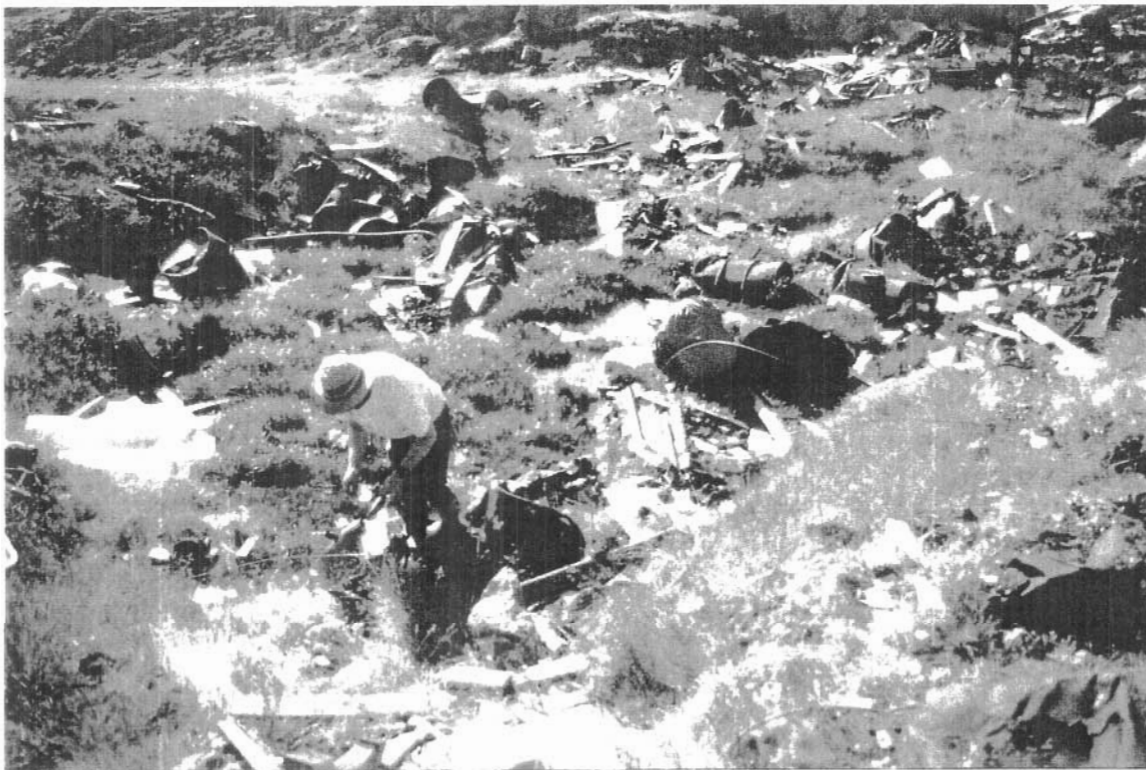
Contaminants at concentrations exceeding the DCC were found in only one sample, L6046, collected from the bottom of a small drainage catchment on the south side of the northernmost debris pile (Photograph V-40).

All three water samples were analyzed for inorganic elements. Zinc was detected in two of the samples. WF6001, a sample of standing water collected from a drainage catchment on the south side of the northernmost debris pile, contained levels of zinc (0.14 ppm) which were 4.6 times greater than the CCME FAL Remediation criterion (0.03 ppm). Zinc concentrations in the soil sample collected from the bottom of the same drainage catchment (L6046) were significantly higher than the DCC Tier II for that element (see above). Zinc was also detected in the water sample collected on the west side of the southernmost debris pile (WF6002) but did not exceed any criteria for zinc in water. The ground water sample (GW6000) collected from UMA (1991) borehole #13 situated at the south end of the southernmost debris pile contained levels of copper (0.012 ppm) which exceeded the CCME FAL Remediation criterion (maximum 0.004 ppm) for that element (Photograph V-41).

Cadmium, lead and zinc are leaching from Dump Site #3, as evidenced in soil from the bottom of a drainage catchment at the north end of the site. Elevated concentrations of zinc were present in water collected from the same drainage catchment and from a borehole which suggests that the migration of inorganic contaminants may be occurring within the site. Vegetation in Dump Site #3 did not contain elevated concentrations of inorganic elements, indicating that impact has been minimal.

Photograph V-40: L6046 and WF6001 containing elevated levels of zinc, phenol and PAHs and zinc, respectively, were collected in this drainage catchment.

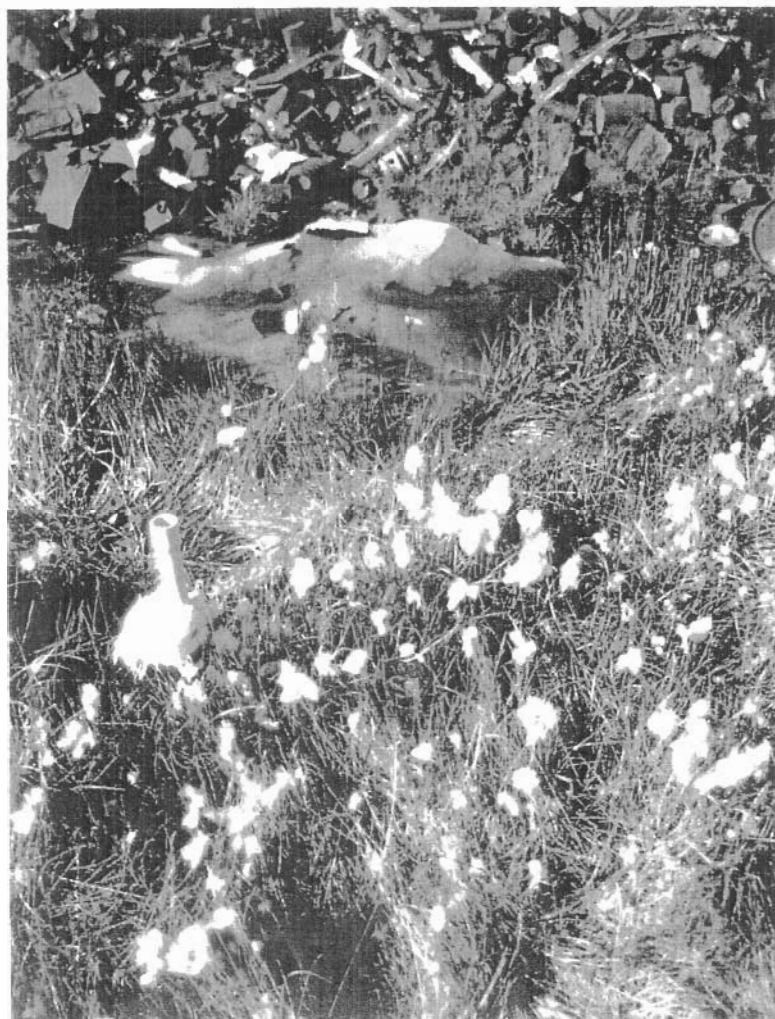
Photograph V-41: Ground water sample GW6000 was collected from UMA borehole pipe #13, pictured here, and contained elevated concentrations of copper

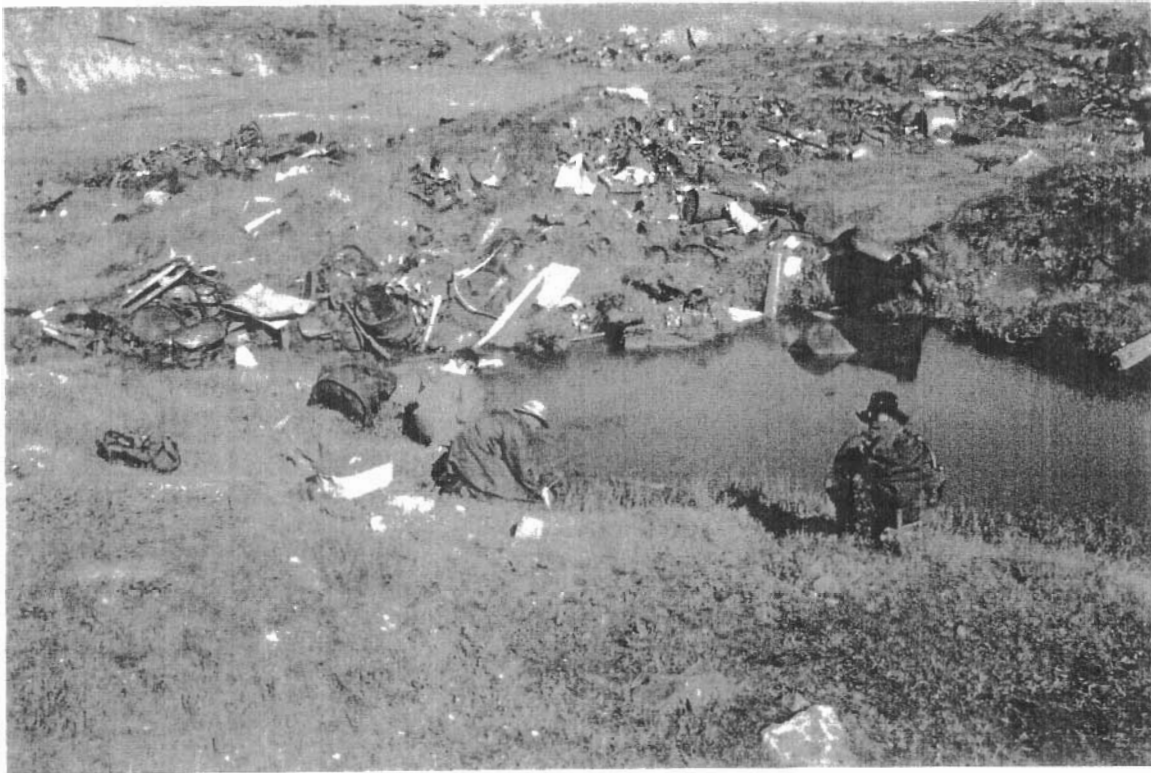
Two of the three water samples collected were analyzed for PCBs. Water collected from the pool on the west side of the southernmost debris pile (WF6002) contained levels of PCBs (0.0086 ppb) 8.6 times greater than the CCME FAL Remediation Criteria (0.001 ppb, Photograph V-42). Water from this pool drained south to a flat marshy area dominated by sedges, and then into the ditch next to the causeway access road. Ultimately the water from this area enters Frobisher Bay via Dump Site #2. The levels of PCBs in water collected from UMA (1991) borehole #13 (GW6000) were below the limit of detection.

Soils in Dump Site #3 contain concentrations of PCBs elevated above background levels, but not in excess of the DCC. The presence of PCBs in a water sample from the site suggests that these contaminants may be transported off-site and towards the marine environment. Vegetation in Dump Site #3 was unaffected by elevated concentrations of PCBs in soils.

Photograph V-42: Water sample WF6002, collected from the drainage catchment pictured here, contained elevated levels of PCBs.
