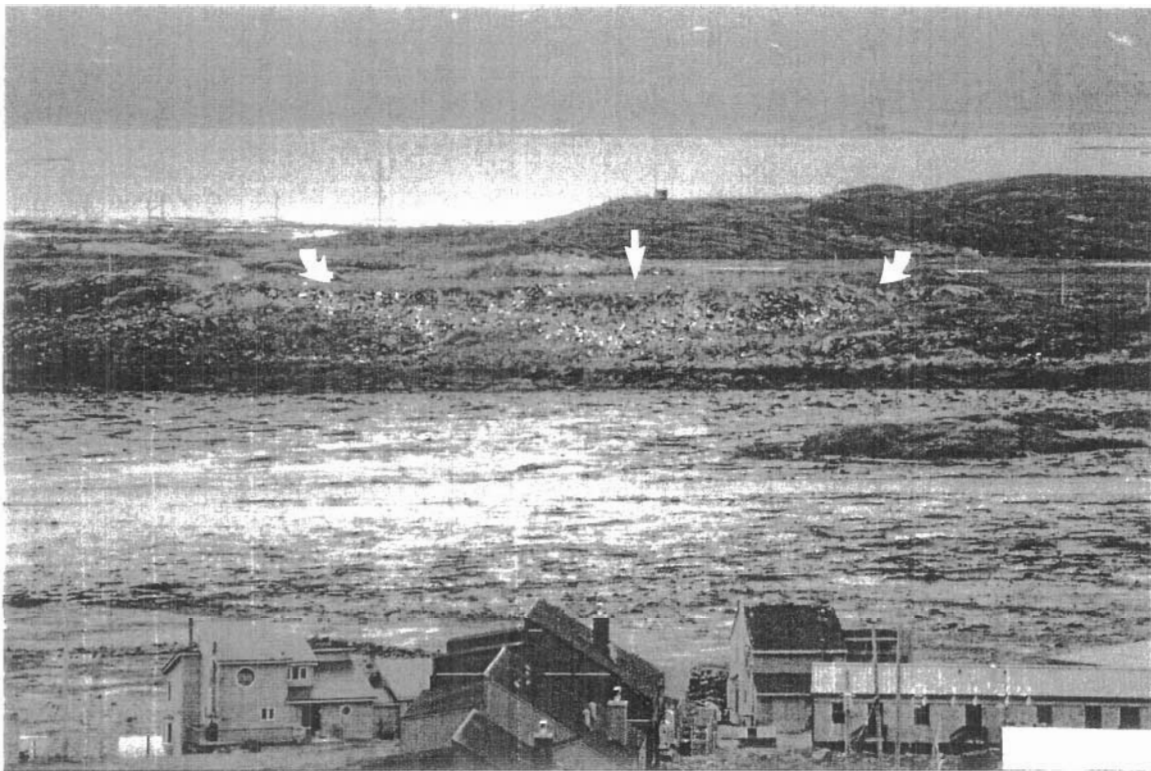
Photograph V-43: Dump Site #4 overlooking the foreshore flats of Koojesse Inlet as seen from the town of Iqaluit.

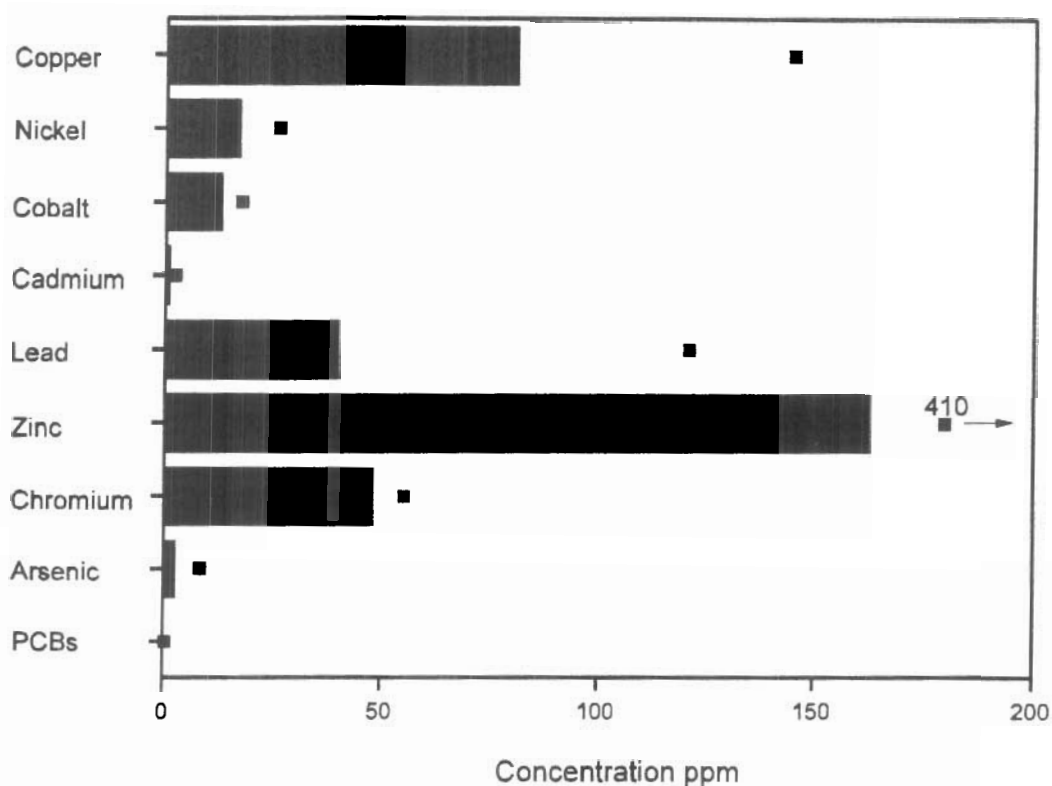
Figure V-14: Mean and Maximum Inorganic Element and PCB Concentrations in Soils Collected at Dump Site #4.

Four of the six soil samples collected at Dump Site #4, including one field duplicate, were analyzed for inorganic elements. Mean concentrations of all elements investigated were well below the DCC, although the maximum concentration of copper exceeded the DCC Tier II value (Figure V-14).

Five of the six soil samples collected, including one field duplicate, were analyzed for PCBs. Mean PCB concentrations in soils (0.094 ppm) from the dump were 94 times greater than those in background soil samples (0.001 ppm, Figure V-14). None of the soil samples contained PCBs at concentrations which exceeded the DCC, but the concentration (0.34 ppm) detected in one sample (L6040) was significantly elevated with respect to background. This sample was collected in a well-defined drainage path approximately two-thirds of the way down the slope, in the eastern half of the dump (Photograph V-45). Of the three plant samples collected none were analyzed for PCBs because of the low levels of PCBs found in the corresponding soils.

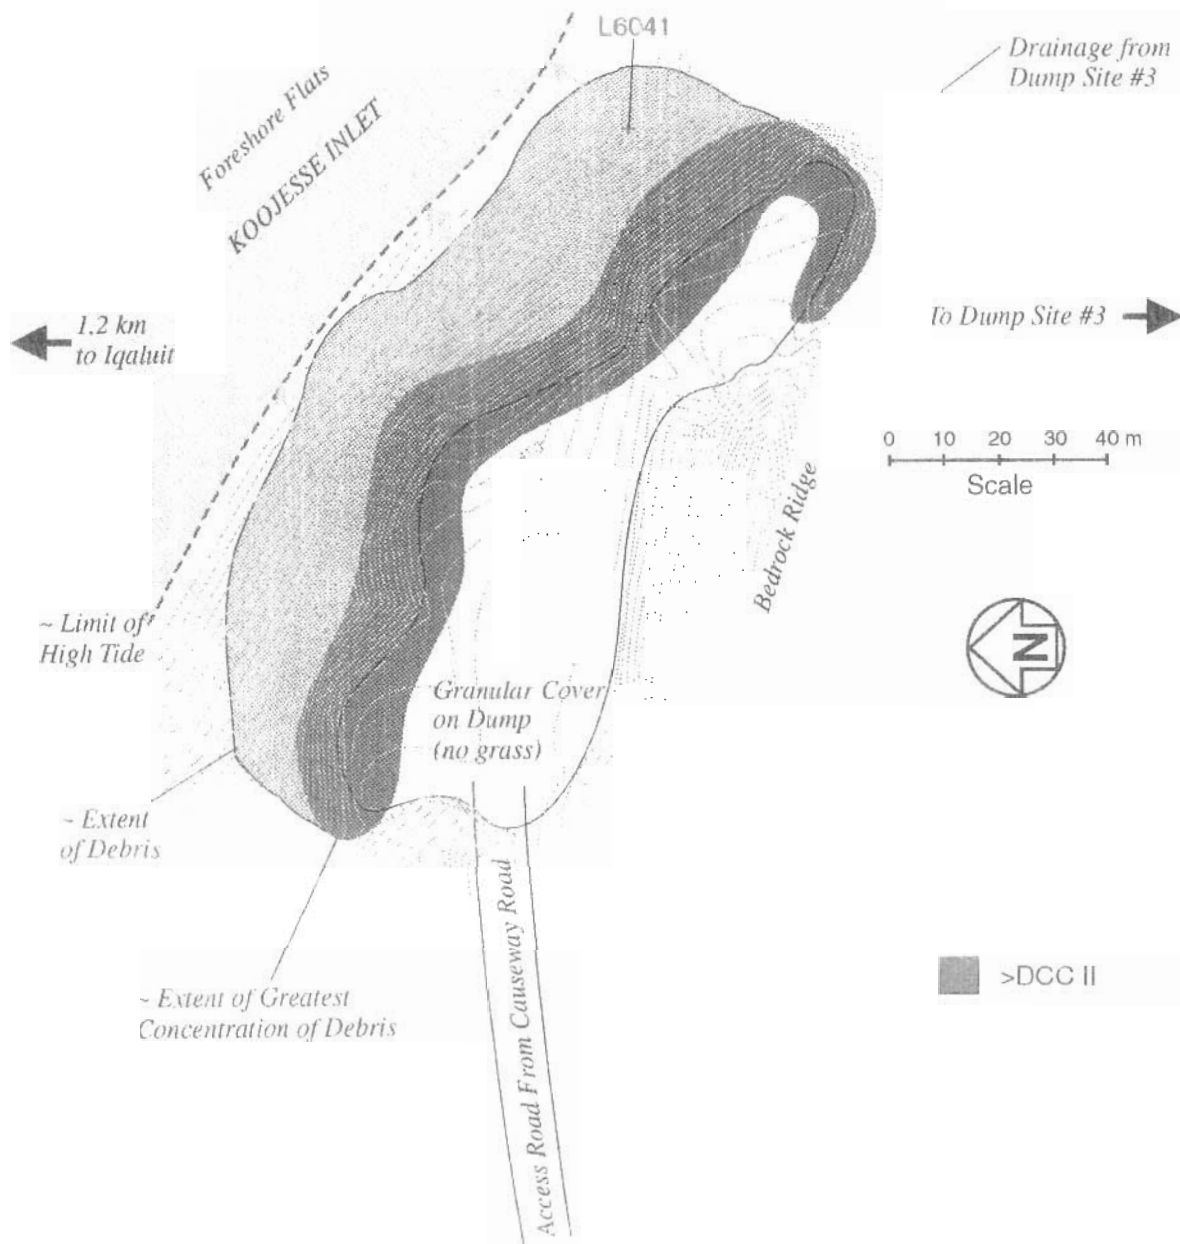
Map V-24: Sample Exceeding the Cleanup Criteria, Dump Site #4

The analytical results for samples from this and all other sites can be found in Chapter V of the Appendices. One sample collected in the municipal dump (Dump Site #4) contained inorganic elements in excess of the DCC (Map V-24).

Sample L6041 collected in a drainage path below and east of the area of concentrated debris contained copper (145 ppm) in excess of the DCC Tier II level (Photograph V-44). This element is typically present in municipal waste materials. Levels of zinc in the same sample (410 ppm) approached the DCC Tier II level for that element (500 ppm).

Hazardous and non-hazardous loose debris should be removed from the site. Hazardous materials should be shipped south for disposal; however, non-hazardous materials should be buried in the engineered landfill proposed for construction at the North 40 (see Implementation section, Chapter II). Metallic debris could be shredded and shipped South for recycling.

Control of leachate production within the dump requires implementation of the following measures: pulling back the top accumulated debris from the edge of the slope and depositing it as far to the south as possible within the area currently occupied by the dump; capping it with sufficient clean fill to promote permafrost infiltration of the waste-containing layer; and diverting drainage, which could potentially infiltrate the waste, away from the slope. Further mediation of leachate production within the dump could be accomplished by the placement of a synthetic membrane or amended soils over the regraded area. Revegetation of the area should be encouraged by reseeding with endemic early successional species, as outlined for Dump Site #1.

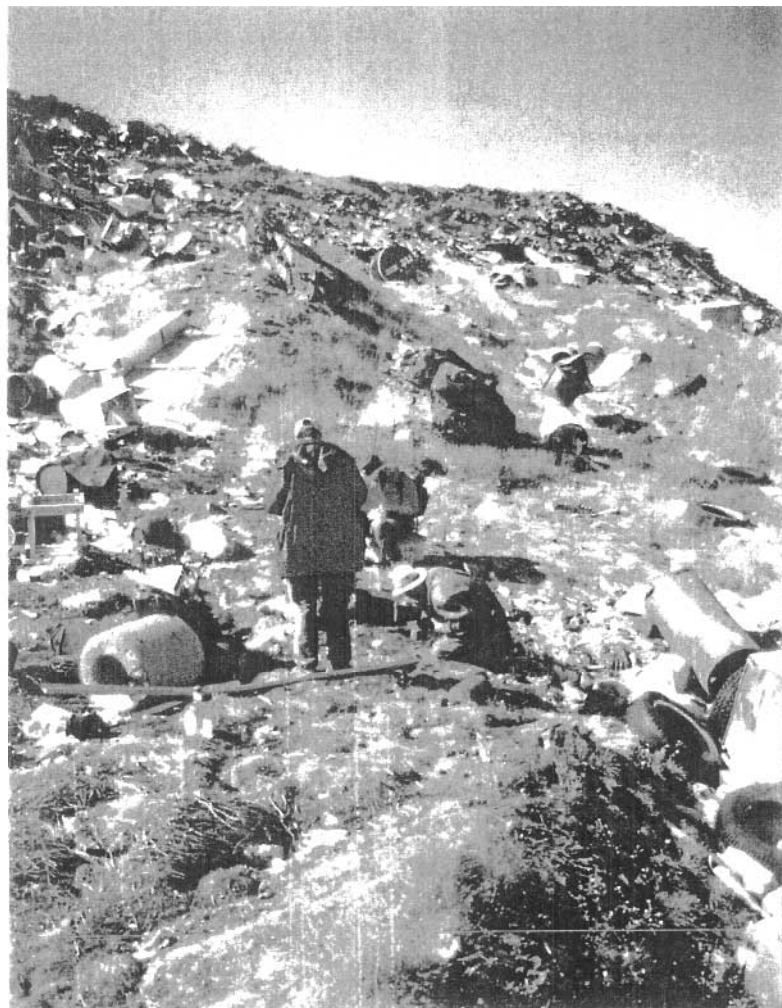
Photograph V-44: Soil Sample L6041 collected in drainage off the east side of Dump Site #4 contained elevated levels of copper.

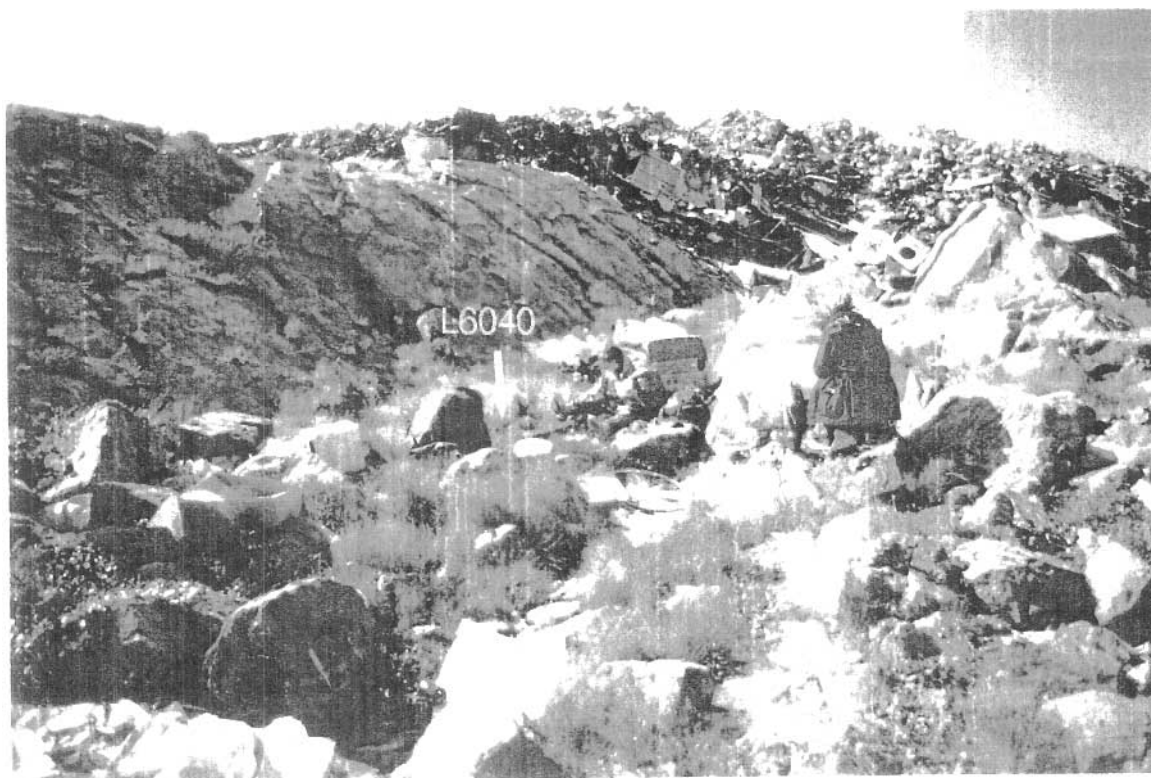
Photograph V-45: Soil Sample L6040 collected in a well-defined drainage path in the eastern half of Dump Site #4 contained pesticides and elevated levels of PCBs.

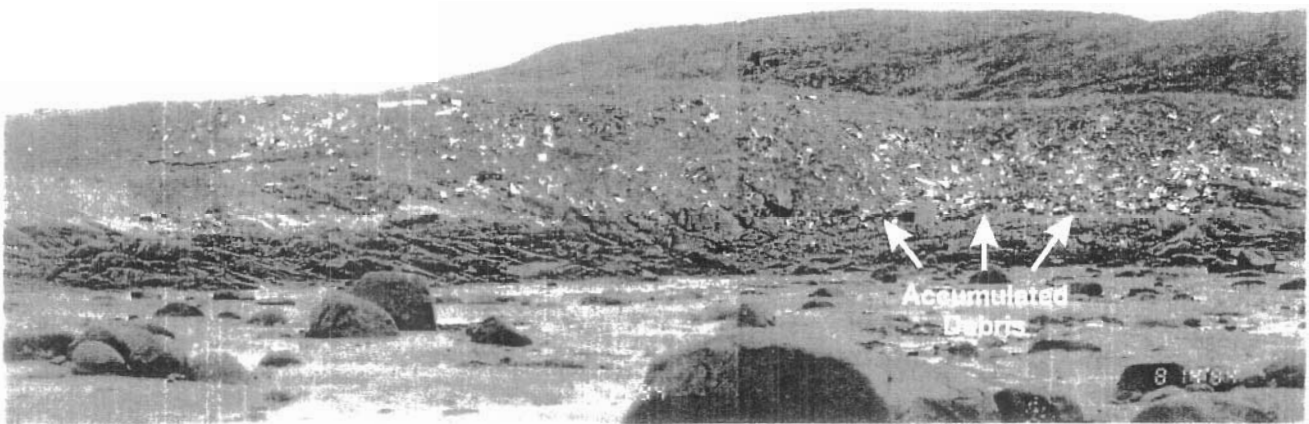
Photograph V-46: View of the face of Dump Site #5, showing a large accumulation of bulk wastes at the toe of the dump.

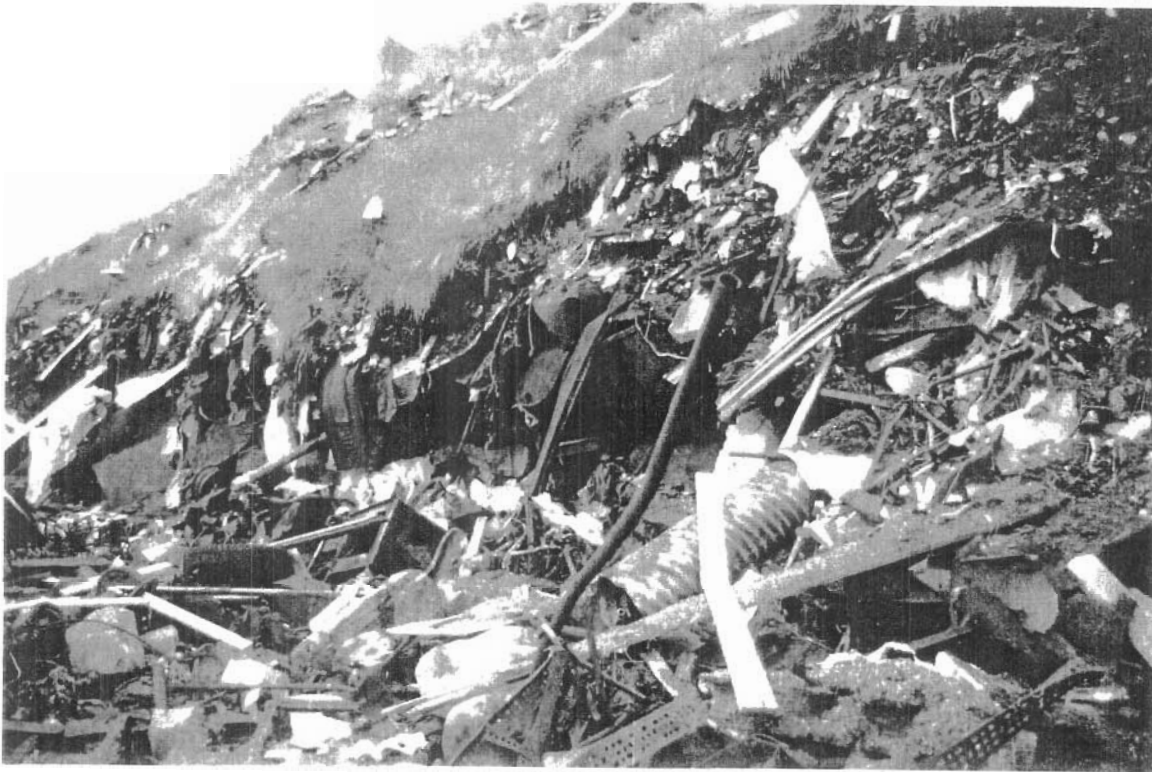
Photograph V-47: Extensive erosion of the toe of Dump Site #5 by tidal action and ice scouring.

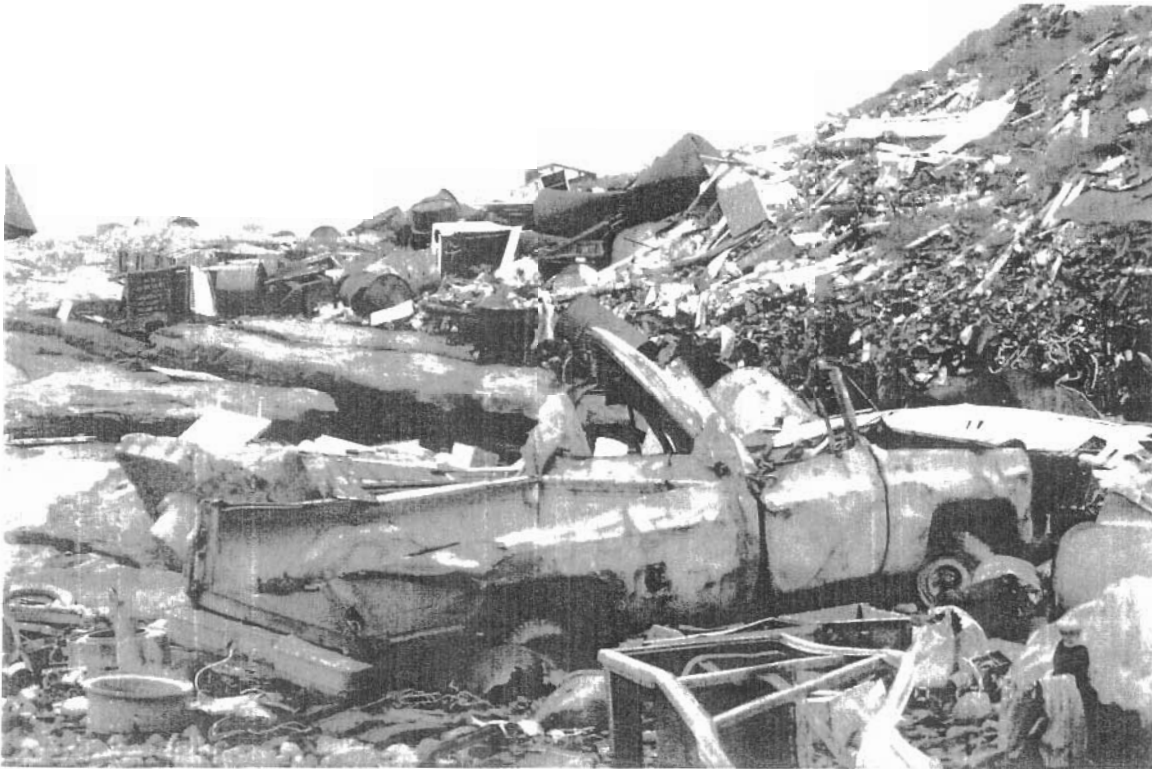
Photograph V-48: Metallic wastes, including a vehicle body, within the limit of high tide.

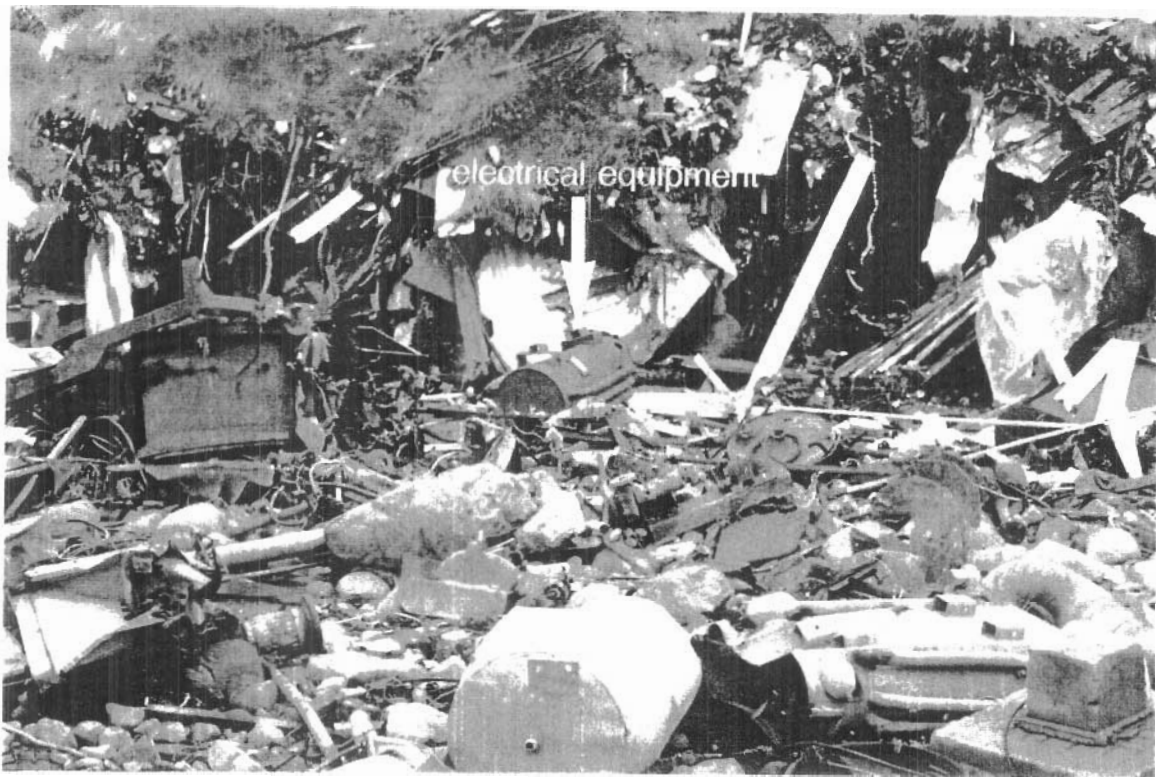
Photograph V-49: Electrical equipment previously buried within the slope, deposited on the beach at the east end of the dump.

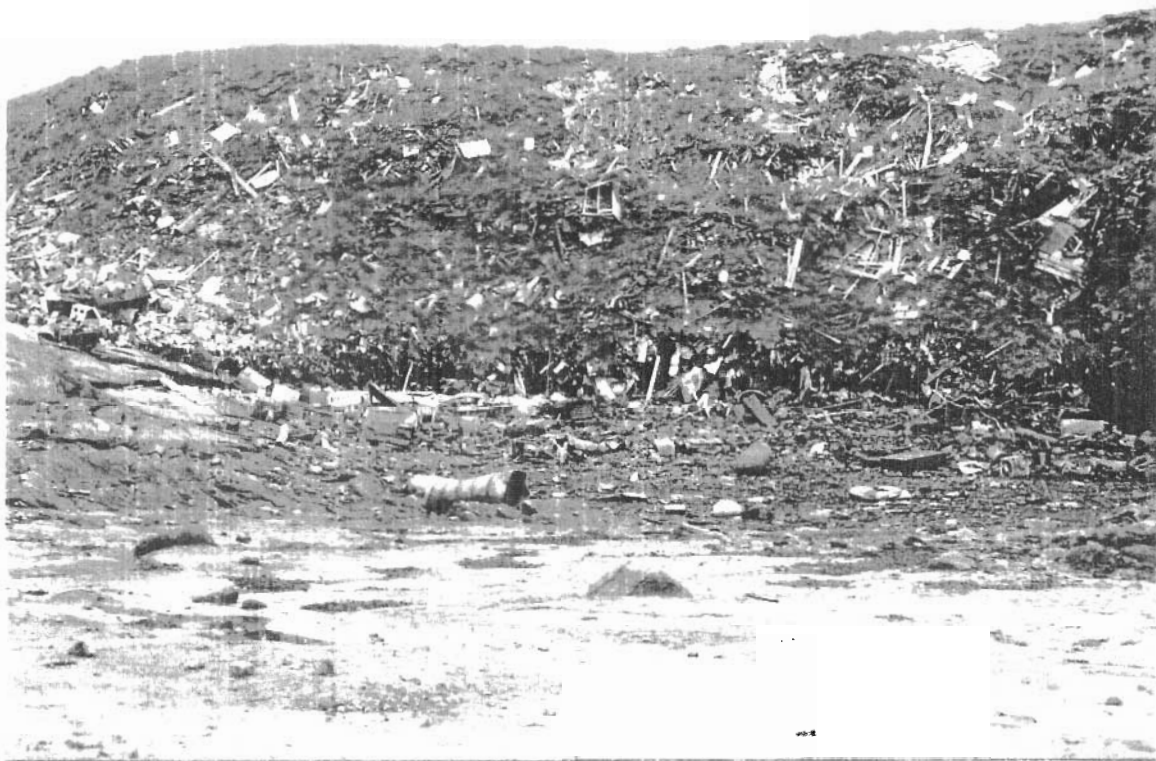
The dump covers an area of approximately two hectares and is bounded by bedrock to the east and northeast. A gravel deposit is located southwest of the site and the tidal flats border it to the south. The top of the dump constitutes about half the total dump area and slopes gently towards the face of the dump. It is well covered with granular material and there is little visible evidence of waste. The face of the dump is approximately 240 m long and is nearly vertical at its eastern end (Photograph V-46). Large pockets of combustible and non-combustible waste, surrounded by grass-covered fill, are present in the face of the slope. Fifty to 75 percent of the slope face consists of exposed waste materials (UMA 1994). The toe of the dump has undergone extensive erosion due to tidal action and ice scouring, and is littered with material eroded from the face of the dump (Photograph V-47). At the time of the ESG field investigation, these materials appeared to comprise both military era and municipal wastes and included vehicle bodies, tires, many barrels, domestic water heaters, and construction material consisting of wood, metal culverts, rebar, and aluminum siding (Photograph V-48). Electrical equipment was found lying on the beach at the eastern toe of the dump (Photograph V-49). The tidal flats immediately south of the dump are extensively littered (Photograph V-50).

Photograph V-50: The intertidal zone south of the dump, littered with a great deal of debris.
