Memorandum

Project Name: Hamlet of Pangnirtung

Subject: Pangnirtung Water Reservoir – Berm Repairs

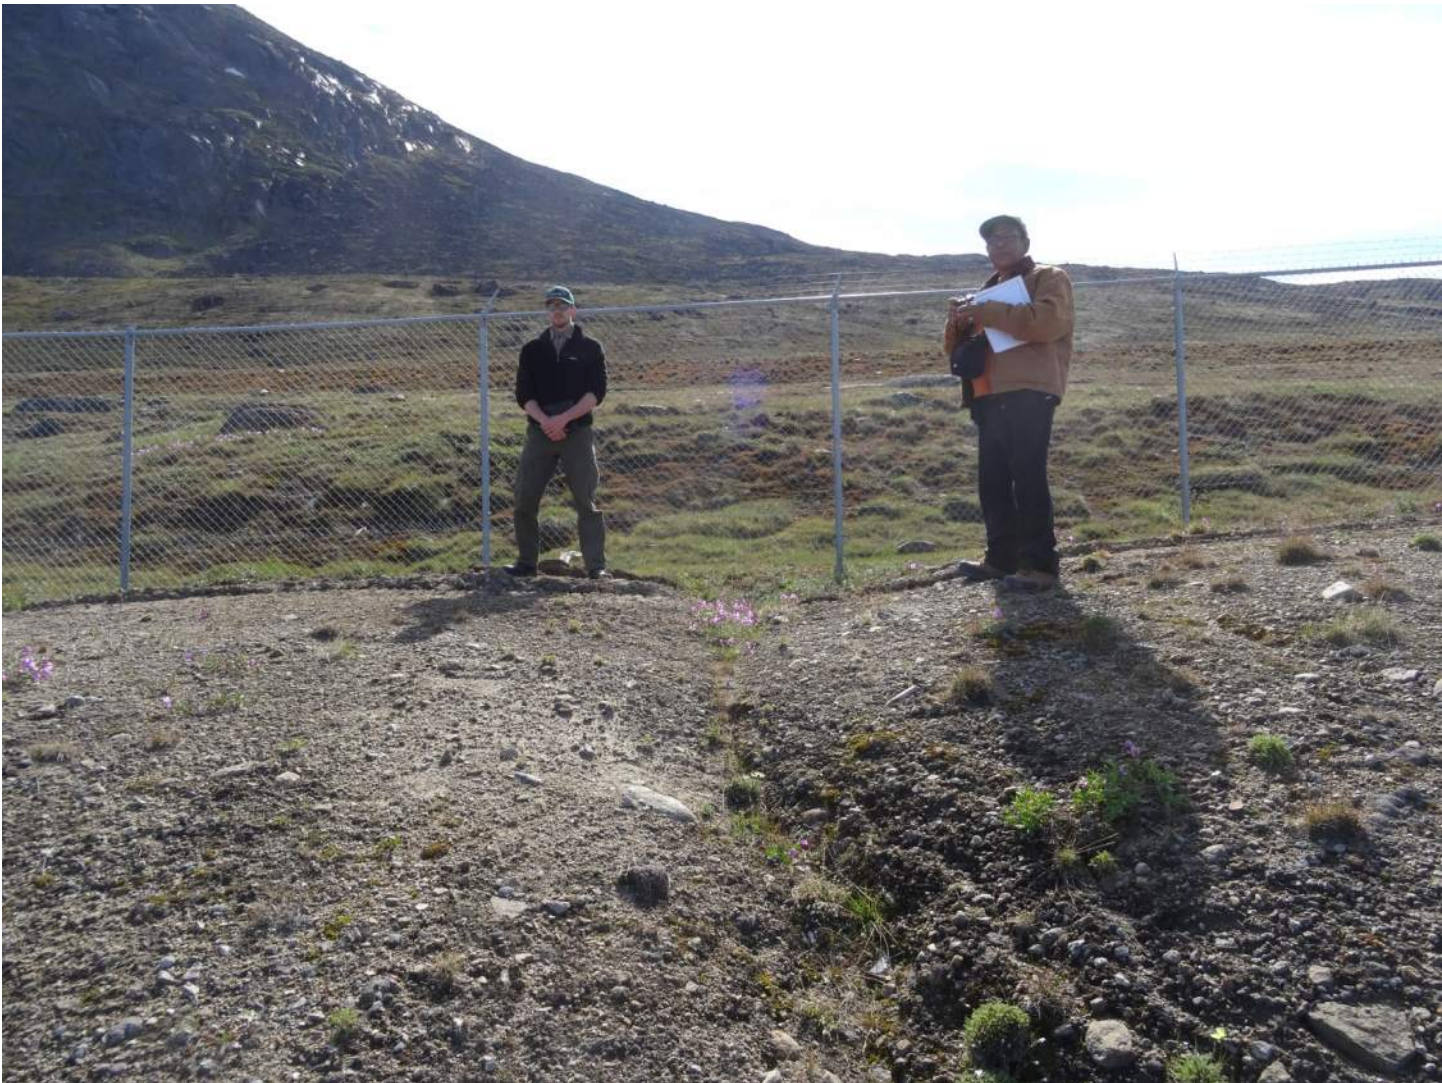
- Water is being withdrawn from the Duval River as approved in the Water License by a diesel pump located near the riverbed.
- In 2015, the Hamlet of Pangnirtung withdrew approximately a total of 51,217m³ of water and is withdrawing water at approximately the same rate in 2016.
- The berm wall around the reservoir has a depression near the northeast corner. This was likely caused from upstream surface water run-off. The depression is likely allowing surface water from the surrounding environment to flow into the reservoir during heavy rainfall events only. This should be addressed to maintain the designed integrity of the structure. See Figure A.

Figure A: Photo of the erosion caused by surface water near the northeast corner of the water reservoir.

6. The areas of erosion (Drawing C100) along the exterior slope of the reservoir's northern berm were observed to have been regraded/repared.
7. The drainage ditch/swale along the new truck turn (Drawing C200) around was being used during the site inspection for truck fill building pump and treatment tests.

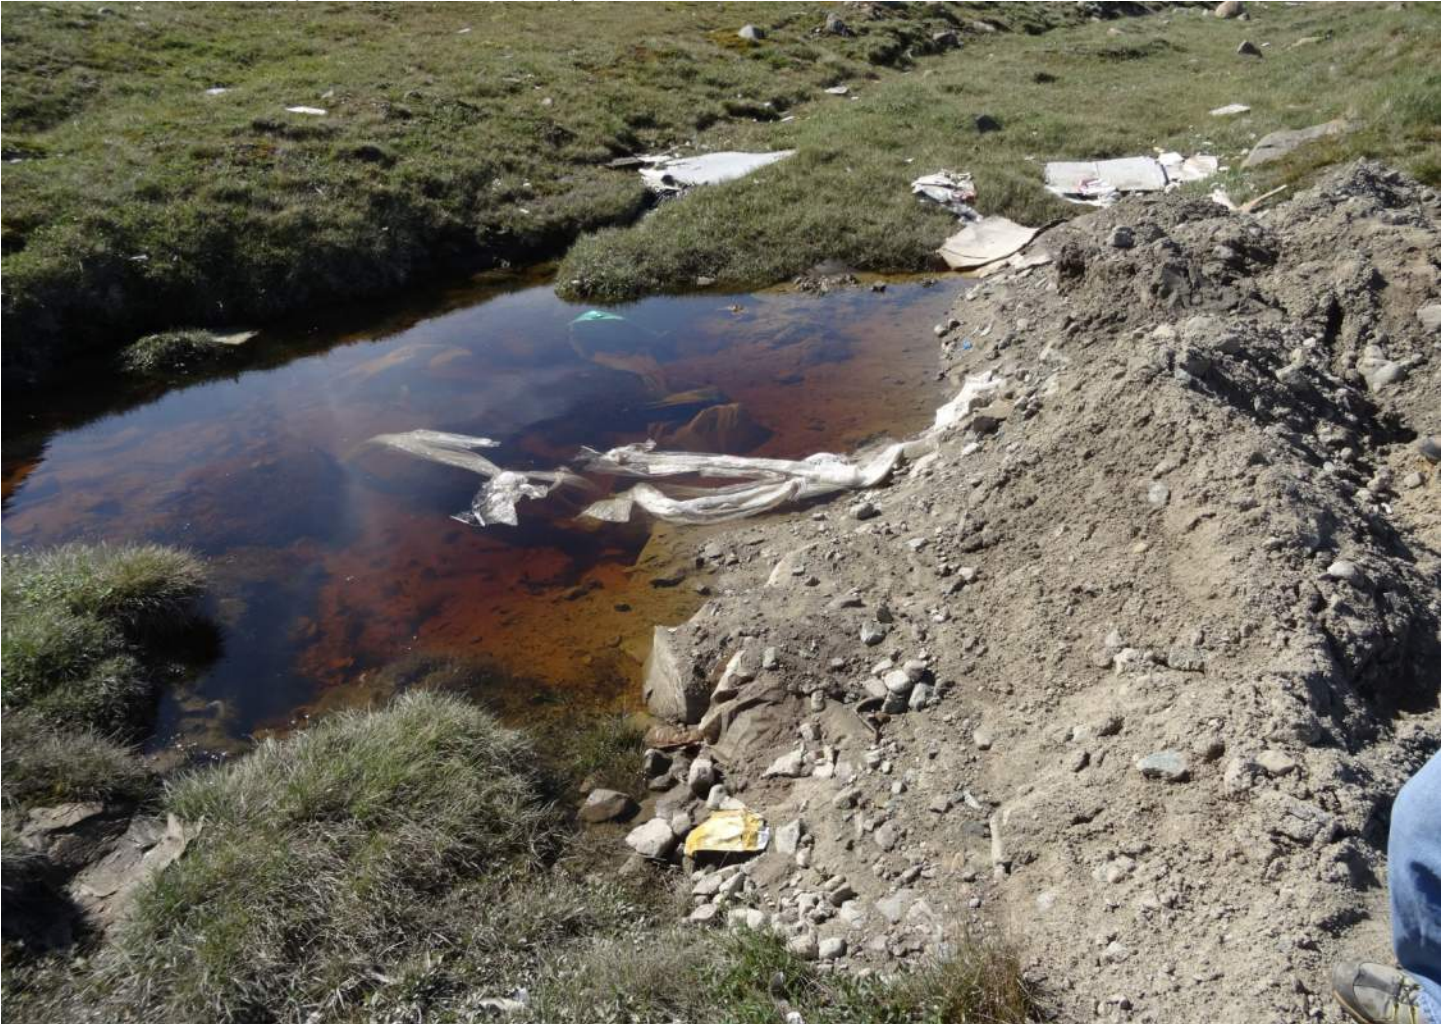
9. Due to changing drainage patterns coming off of the mountains behind the metal disposal area, the berm walls surrounding this facility has been breached in previous years which led to water flowing through the facility in three separate locations.

10. The Hamlet has since addressed this issue by filling the breached sections of the berm with hardened cement and soil to divert the surface water around the metal storage area. However, water is accumulating behind these sections and the water is slowing exfiltrating into the Metal Storage Area. See *Figure B*.

11. INAC has concern related to this structure because of its inability to properly divert water around the metal storage area causing small amounts of leachate to enter the surface water.

Figure B: One of three locations where water has built up behind the berms surrounding the metal storage area.

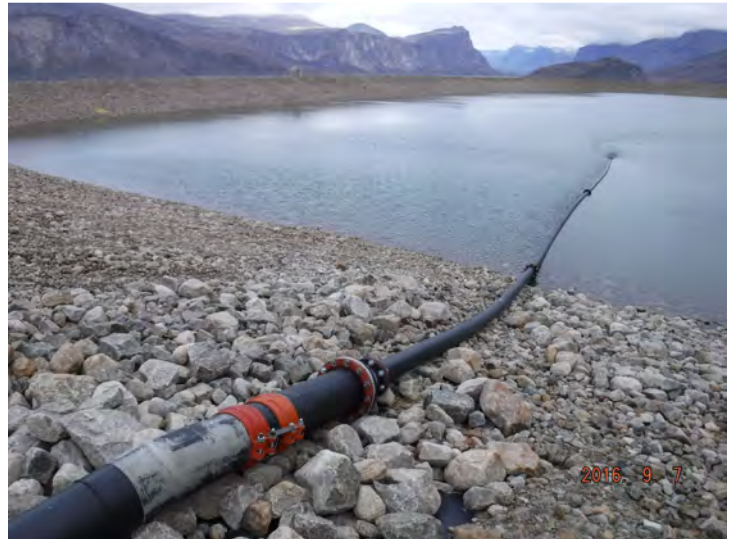
5. The water reservoir was being actively filled with water from the Duval River during the inspection. Rip-rap was not placed along the interior slopes of the reservoir as directed previously by ARKTIS in 2015. The area along the western slope of the water reservoir in the vicinity of the filler pipeline/overflow pipe that experienced erosion was observed to have been repaired with rip-rap.

Western interior slope adjacent to filler pipe repaired with rip-rap

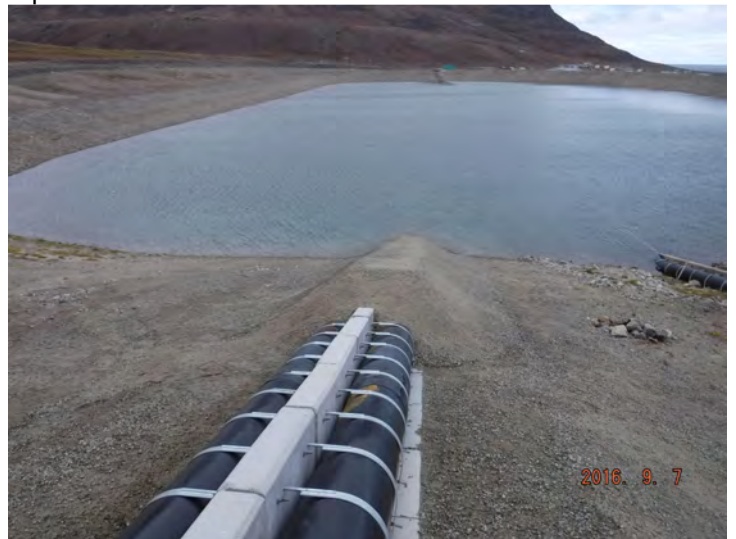
8. The fill material under and above the new intake pipes (Drawing C200) appears to be in excellent condition.
9. The earthworks/grading in the vicinity of the exterior stairs (Drawing C200) to the new building was not completed. Kudlik noted during the inspection that the existing truck fill station was being actively used by the Hamlet, and further grading (adding fill) adjacent to the stairs would prevent filling of water trucks at the old truck fill station. The grading/fill activities should be completed in coordination with the change of operation from the old to the new truck fill stations.

View of granular cover over intake pipes looking towards west into the reservoir

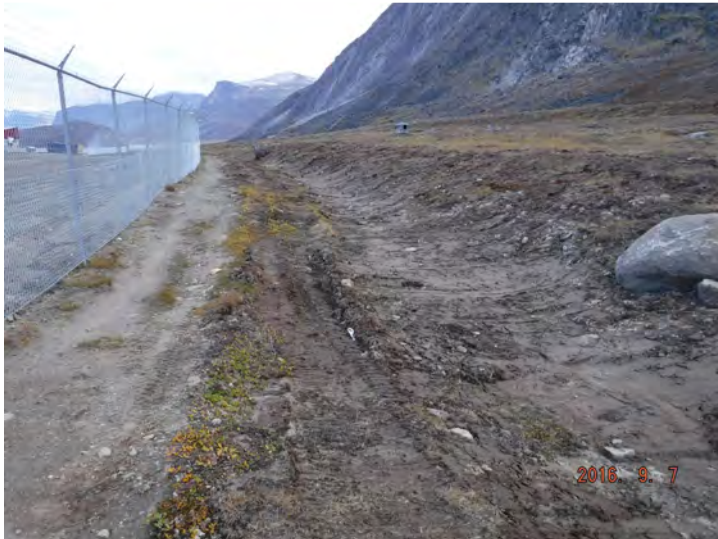
4. The secondary diversion ditch (Drawing C100) was observed to have been cleaned out by means of mechanical excavator. The secondary drainage ditch was noted to be sloped to promote water drainage around the reservoir, both towards the east and west. A low spot located approximately towards the centre of the reservoir was noted during the inspection, which may cause runoff waters from entering the reservoir area. ARKTIS notified Kudlik of this deficiency. Kudlik noted that they will deepen the secondary cutoff ditch in that area to promote drainage around the reservoir.

View of secondary diversion ditch, showing area that will need to be regraded by Kudlik. Kudlik to submit photograph once completed. View looking towards east.

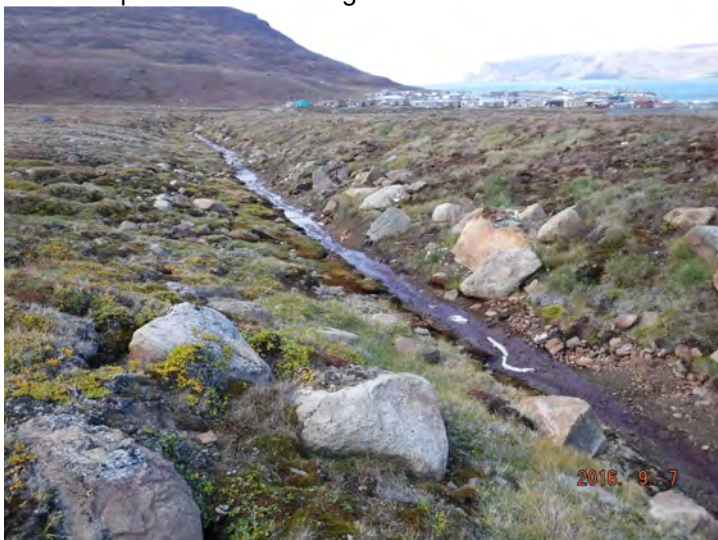
3. The primary diversion ditch (Drawing C100) was observed to be actively receiving seepage/runoff water and diverting it towards the west, as noted on the drawings.

View of primary diversion ditch looking towards west showing flow of water towards the west.

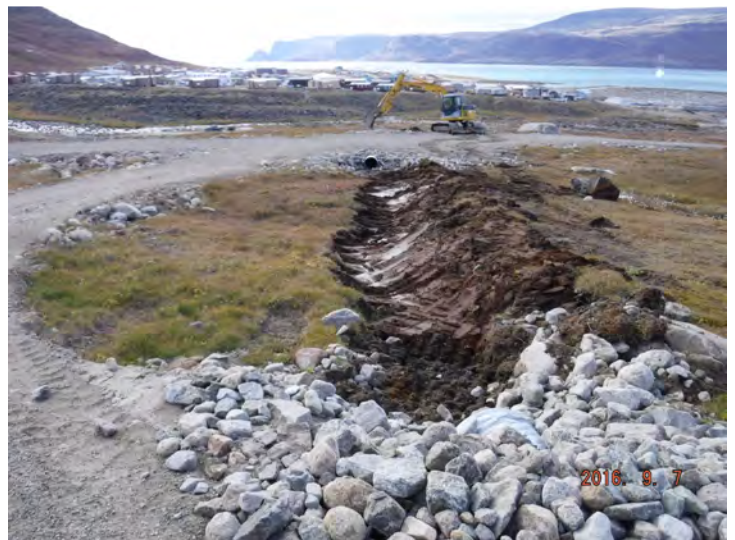
2. The overflow ditch (Drawing C100) was not observed to be constructed. ARKTIS brought this to the attention of Kudlik during the inspection as a deficiency; Kudlik promptly rectified this deficiency and constructed the overflow ditch on September 07, 2016 by means of mechanical excavator and was witnessed by ARKTIS.

View of overflow ditch being excavated by Kudlik during site inspection. View looking towards northwest.

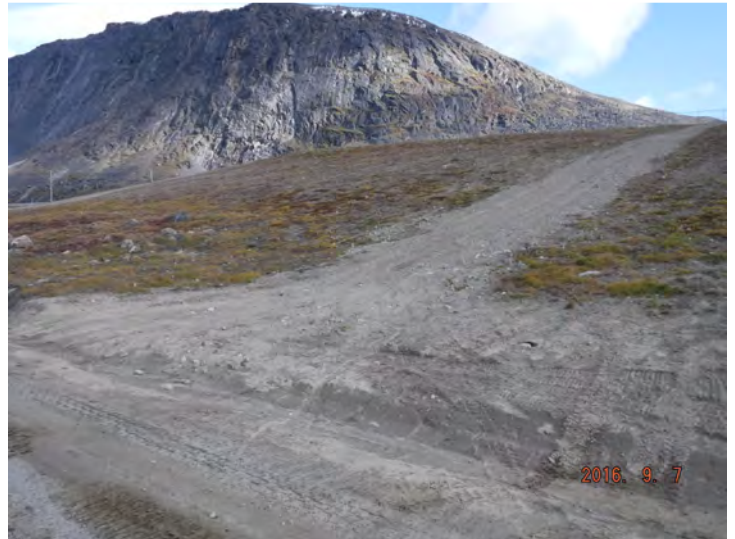
View of reservoir's northern berm exterior where erosion has been regraded/repared. View looking towards southeast.

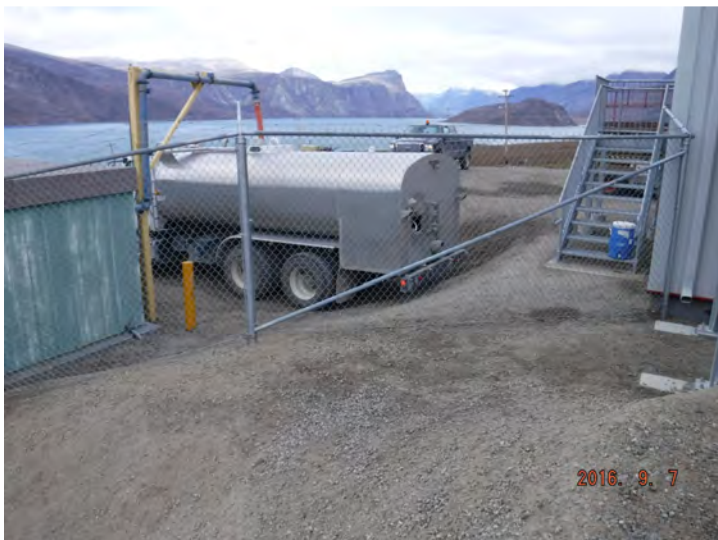
View of area adjacent to new truck fill station stairs that are being encroached on by trucks using old truck fill station. Fill to extend approximately 1 m from the stairs towards the rear of the truck in the photograph.

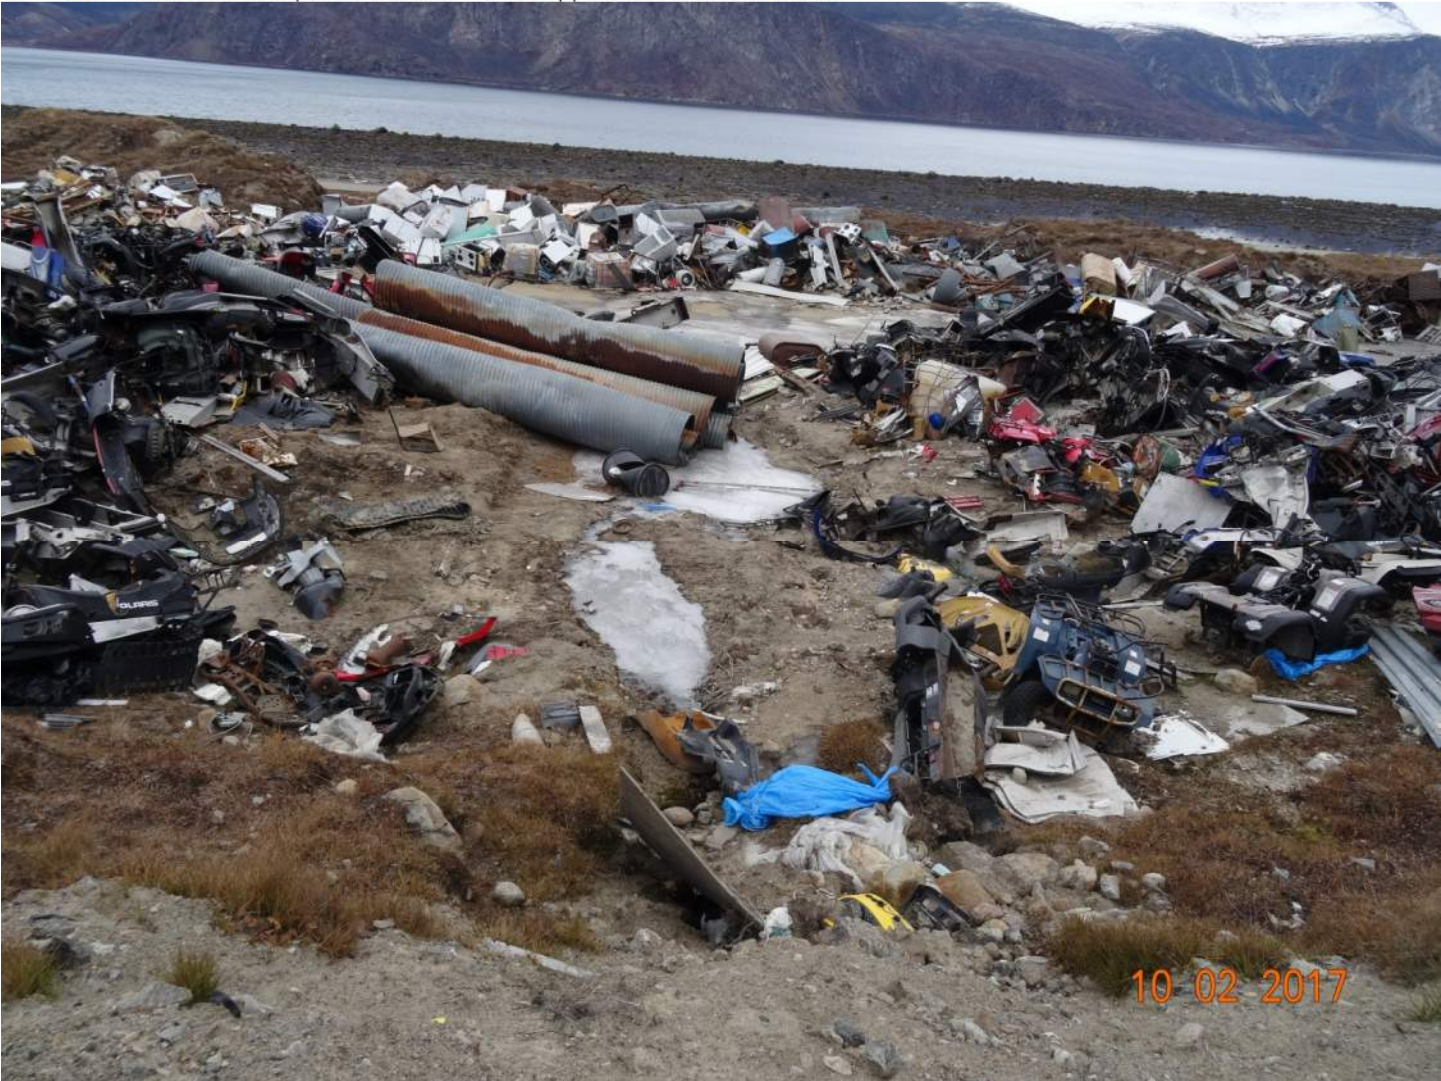
- 10. The community is segregating and storing metals, vehicles, batteries, and electronic waste within the Metal Storage Area.
- 11. This location has issues with changing drainage patterns coming off of the mountains behind the metal disposal area, the non-engineered berm walls surrounding this facility had been breached in the past which led to water flowing through the facility in three separate locations.

- 12. The Hamlet has attempted to fix the breached sections of the berm with hardened cement and soil. However, water is accumulating behind low-lying sections and is slowing infiltrating the Metal Storage Area. See *Figure 2*.

- 13. INAC has expressed concern related to this structure in past reports because of its inability to properly divert water around the metal storage area.

Figure 2: Water infiltration of the metal storage area.
