August 23, 2000 Water Licence Inspection - Report

MUNICIPAL WATER USE INSPECTION FORM

Date: 2000/08/23 Licensee Rep. (Name/Title): Tim Dialla / Foreman
Licensee: Hamlet of Pangnirtung Licence No.: N5L4-1447

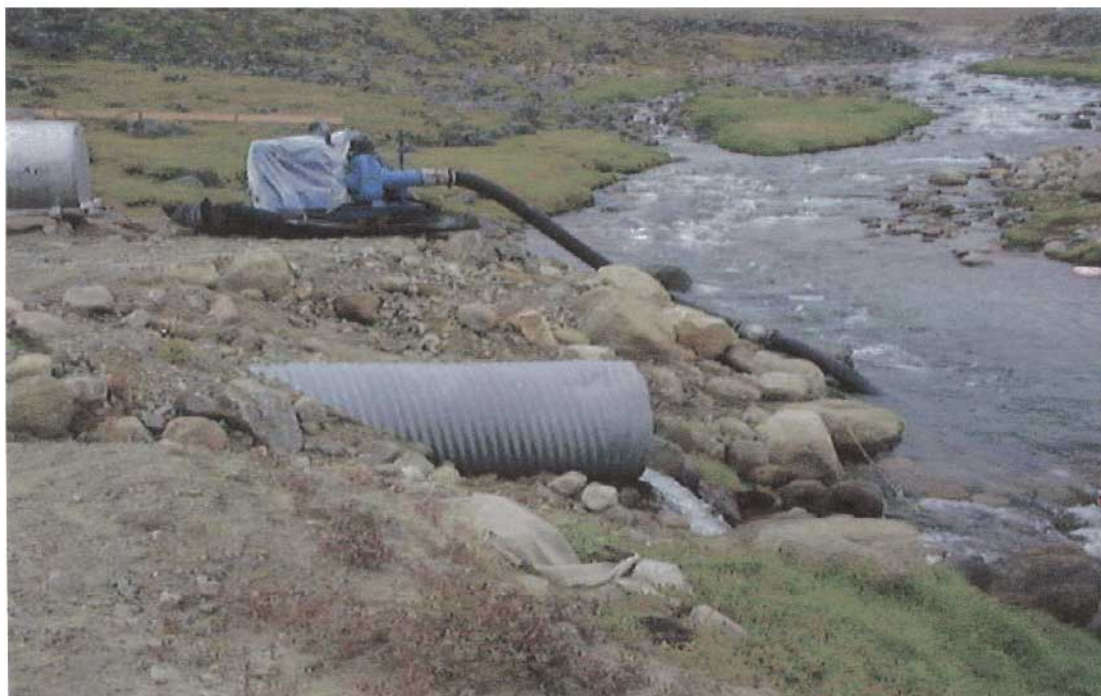
- **Water supply:** Concern was raised over the proximity of new housing developments to the water intake facility (figure 1), and their potential negative impact on the quality of the Hamlet's water supply. Accordingly, the Inspector will collect a raw water sample during the next field season. In any case, the Licensee may wish to take a proactive approach by considering the feasibility of an eventual upstream relocation of the water intake. Further, especially due to the noted increase in winter water consumption, the Hamlet ought to ensure that sufficient chemicals are in stock to allow for the refill of the reservoir prior to fall freeze-up.

Comments: Concerns raised over the proximity of new housing developments to the intake facility. Water use averages 120 m³/day. Reservoir is fenced, truckfill station is well-kept. Awaiting fluoride on upcoming sealift to begin refilling the reservoir. Chlorination in use.

figure 1. Water intake facility, Duval river; 2000/08/23.

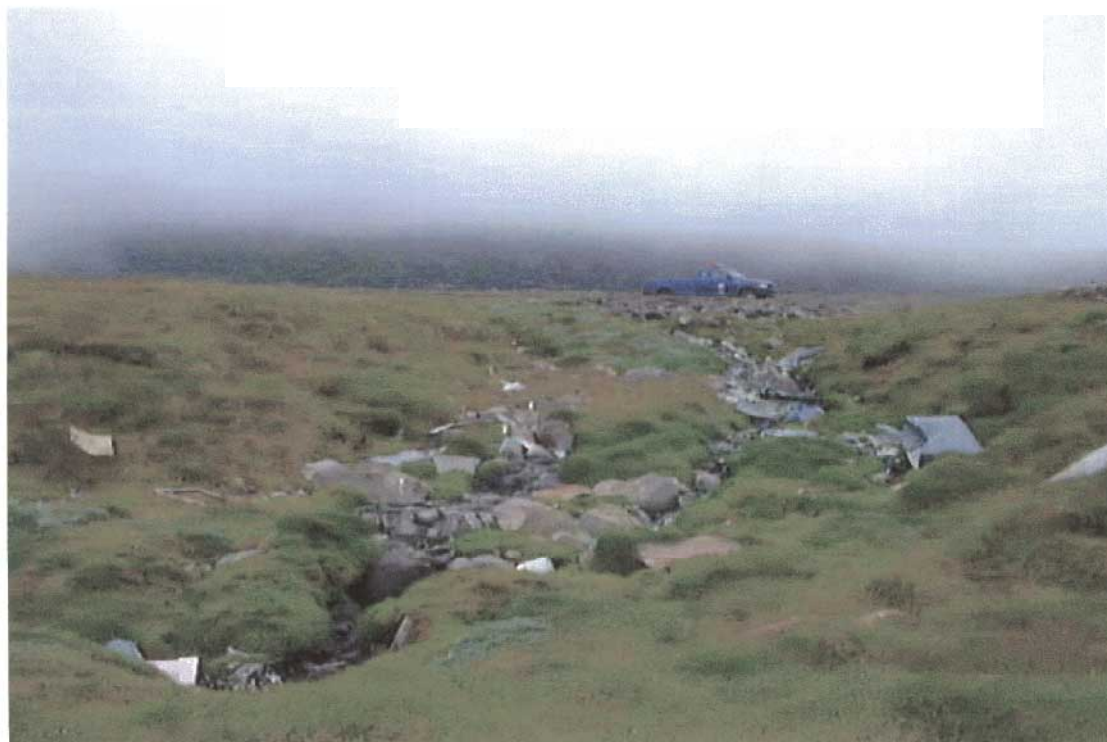
- **Sewage waste disposal:** Significant slumping was observed in the sewage discharge area, thus lessening the efficiency of the already negligible treatment provided by the facility. Indeed, the attached analytical results reveal that essentially untreated sewage effluent is discharged from the sewage disposal area (figure 2). In fact, while the ammonia level exceeds guidelines for the protection of both freshwater and marine life, the sampled concentrations of all regulated parameters violate the effluent quality standards set under the current Water licence (Part C, Item 4). Moreover, the Microtox sample, which constitutes a reliable indicator of the biological toxicity attributed to an associated discharge, indicates extreme toxicity: half of light-producing bacteria were inhibited by a sample concentration of 2.4%, whereas 45% and over is considered non-toxic.

figure 2. Path of discharge from the sewage disposal site; 2000/08/23.

Consequently, by copy of this letter to Community Government and Transportation (CG&T), the Inspector underlines the dire need of an effective and viable sewage treatment/disposal facility for the Hamlet.

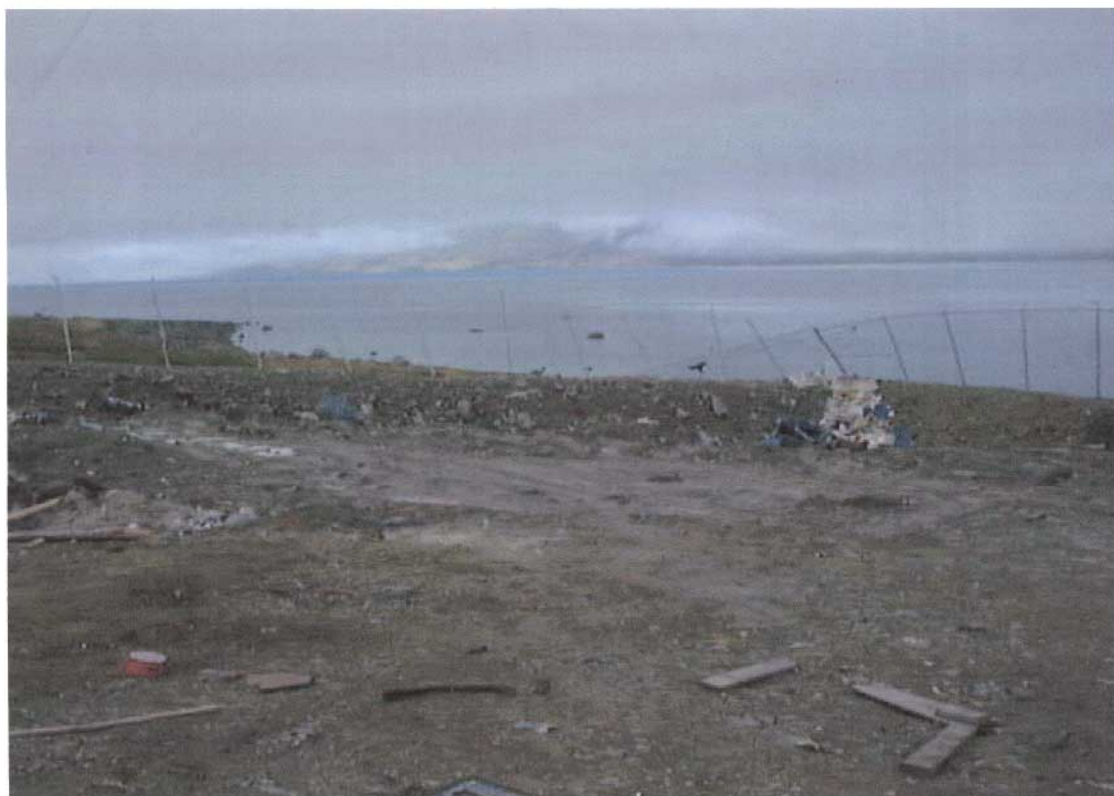
- **Solid waste disposal:** Owing to prevailing windy conditions, the perimeter fence has been partly dismantled (figure 3). As a result, a fair quantity of windblown material was noticed beyond the compound. In this regards, the Licensee has already contacted CG&T on the proposed installation of stouter fence poles and wiring. Also, leachate has pooled in the old fish plant disposal area (figure 4), and is seeping out through the downslope berm (figure 5). As the highest tides now reportedly lick the toe of the dump, this area should be monitored for signs of slumping and instability. The attached analytical results relating to the dump leachate sample indicate elevated levels of suspended solids, ammonia, and numerous metals. In addition, a Microtox sample once again attributes a significant toxicity to the discharge: 22.9% versus the 45% non-toxic threshold. This being said, the Licensee pointed out to the Inspector that without formal transferral/ownership documents from the Government of Nunavut, the Licensee could not rightly be assigned responsibility over the status and upkeep of the solid waste disposal facility.

figure 3. Partially dismantled fence, solid waste disposal facility; 2000/08/23.

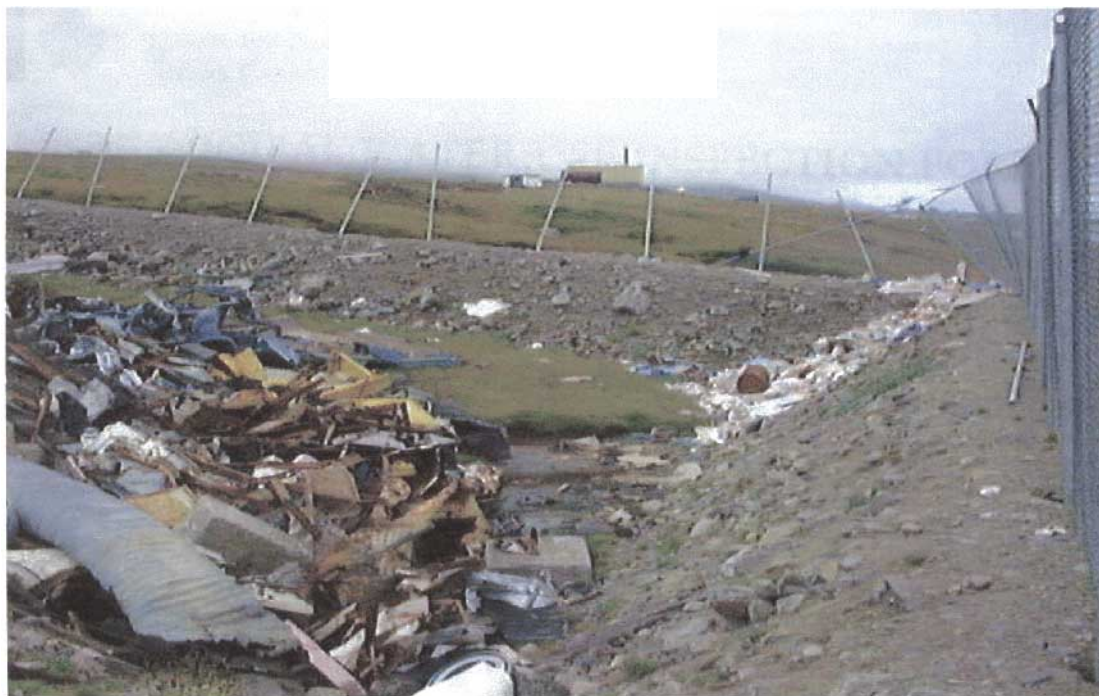
figure 4. Old fish plant disposal area, solid waste disposal facility; 2000/08/23.

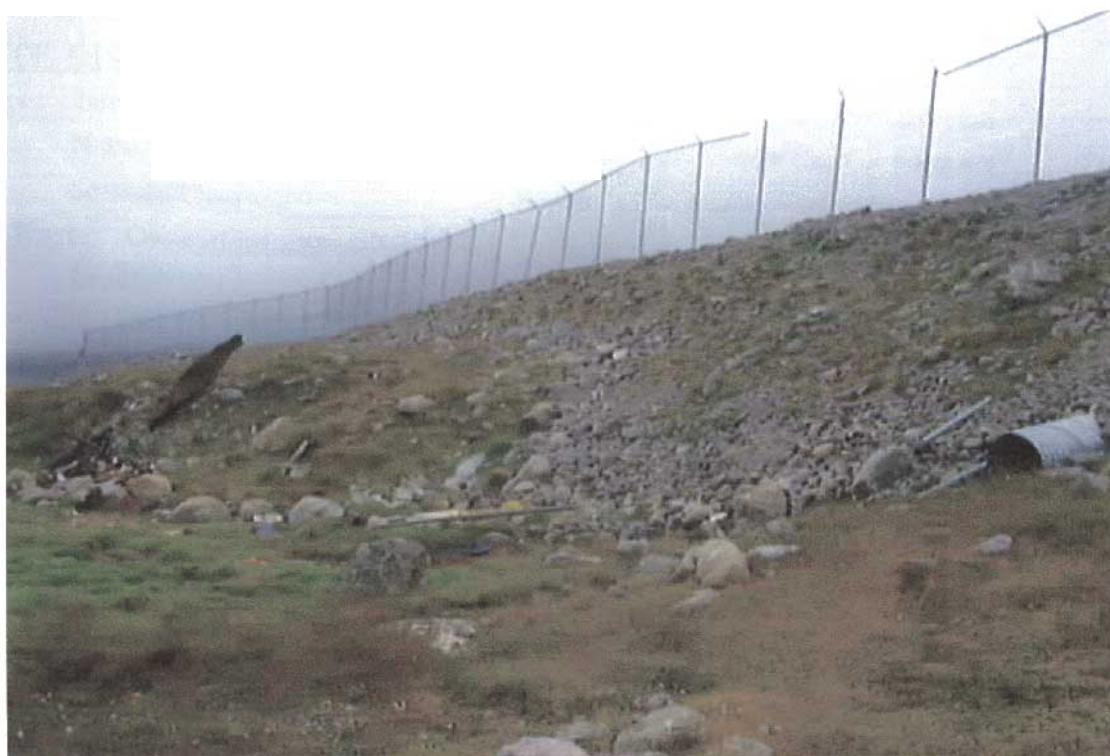
figure 5. Leachate from the solid waste disposal facility; 2000/08/23.

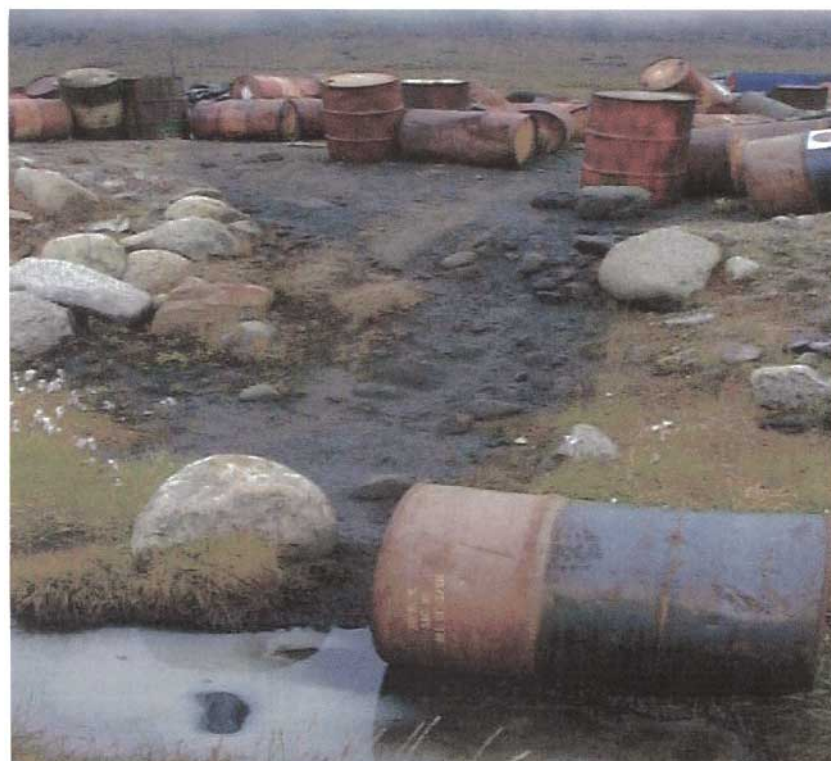
In parallel, the management of waste oil poses definite concerns. The storage area currently consists of a collection of drums, many of which are battered and leaking. Significant ground staining is also noticeable in the area, as oily runoff migrates downslope from the storage site (figure 6). In light of this, the Inspector requests that the Licensee file a spill report, thereby formally acknowledging the release from the waste oil storage area as an unauthorized discharge of waste. Further, the ground along the runoff path from the storage area is to be considered as hydrocarbon-contaminated soil, and consequently disposed of ensuring that waste does not migrate into waters. At the time of the inspection however, the Licensee mentioned that the Department of Sustainable Development had already been contacted on the matter, and that practical recommendations were pending.

figure 6. Waste oil storage site; 2000/08/23.
