**RE: July 30, 2002 Municipal Water Use Inspection - Report**

## MUNICIPAL WATER USE INSPECTION REPORT

Licensee: Hamlet of Pangnirtung

Licence No.: NWB3-PAN0207 (NEW)

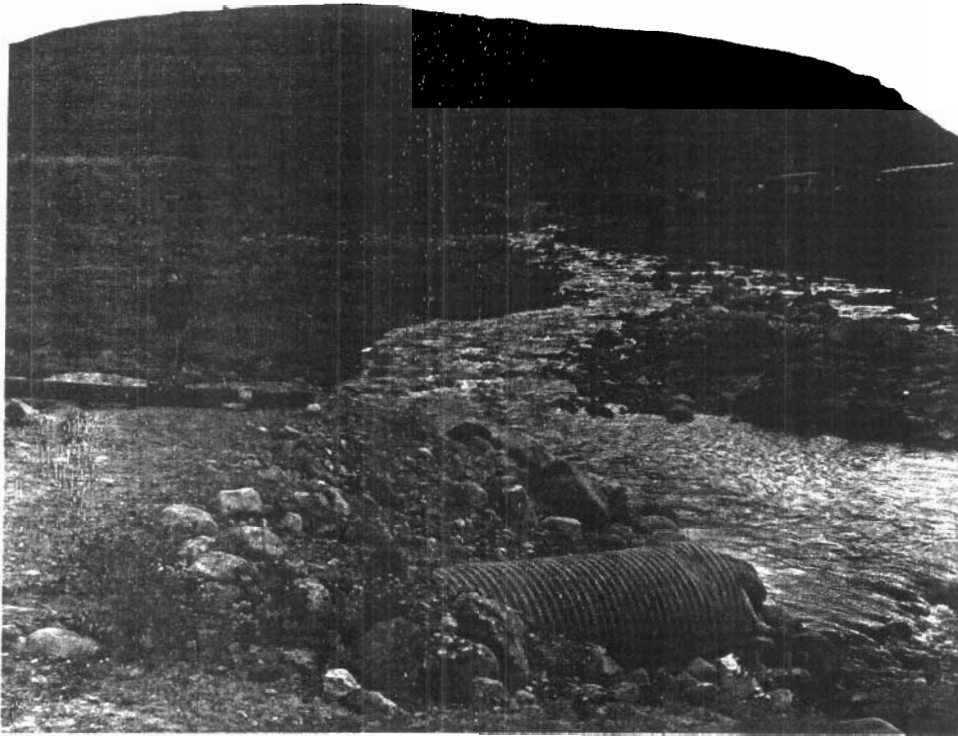
- ☐ **Water Supply:** During the time of inspection it was noted that the depth of Duval River was quite low (Photo 1). Recharging the reservoir from such a shallow water supply could cause infiltration of silt to the water reservoir. The Water Intake Facility and water reservoir appeared to be well maintained facilities (Photo 2 & 3). Attached analysis of water samples taken at (PAN-1) the water reservoir indicate that Nitrate + Nitrite (<0.008 mg/L vs 3.2 mg/L) and Colour (10 TCU vs 15 TCU) are within *Guidelines for Canadian Drinking Water Quality*. Enclosed analysis indicate that a pH of ( 6.44 vs 6.5-8.5) is in excess of the *Guidelines for Canadian Drinking Water Quality* Maximum Acceptable Concentration.

Photo # 1 Water supply River; intake pipe for reservoir.

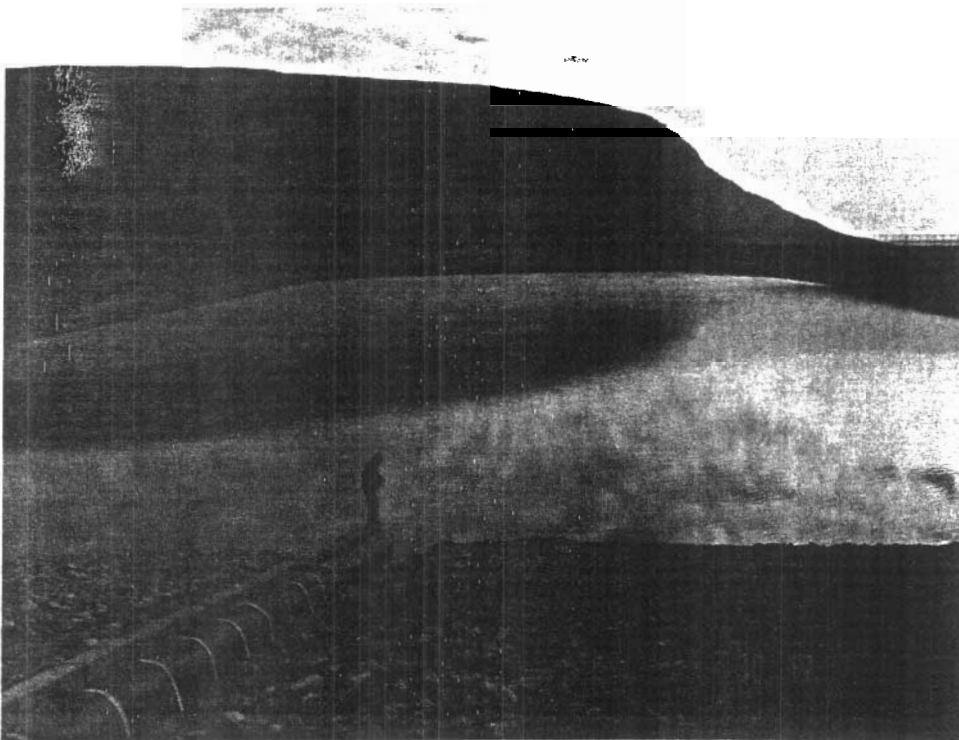
Photo # 2 Water reservoir fully fenced; location of potable water sample.

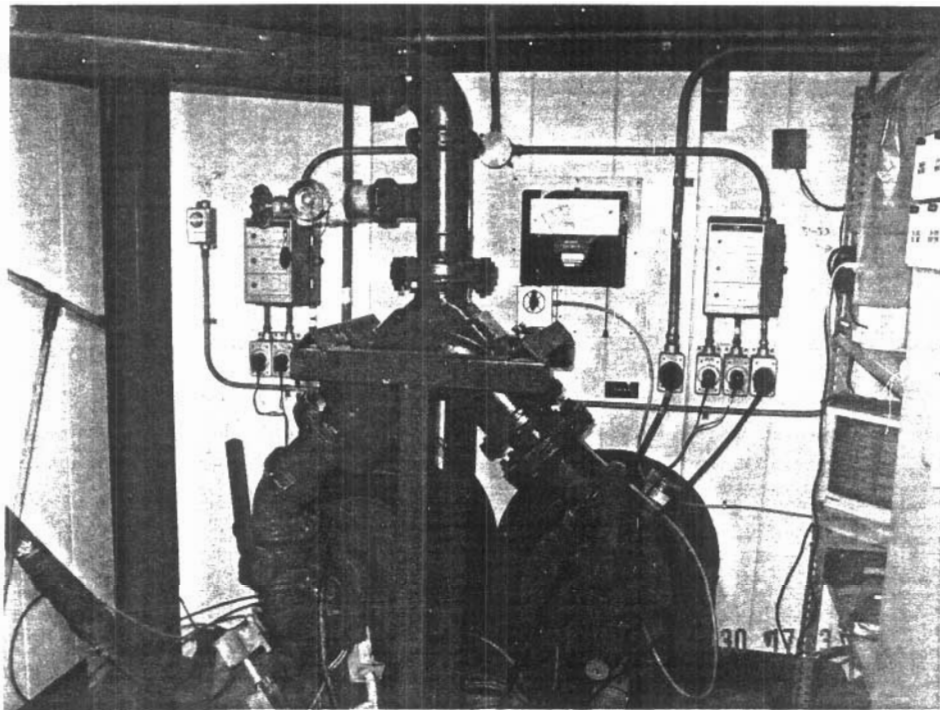
Photo # 3 Inside Water Intake Facility submersible pump lines.

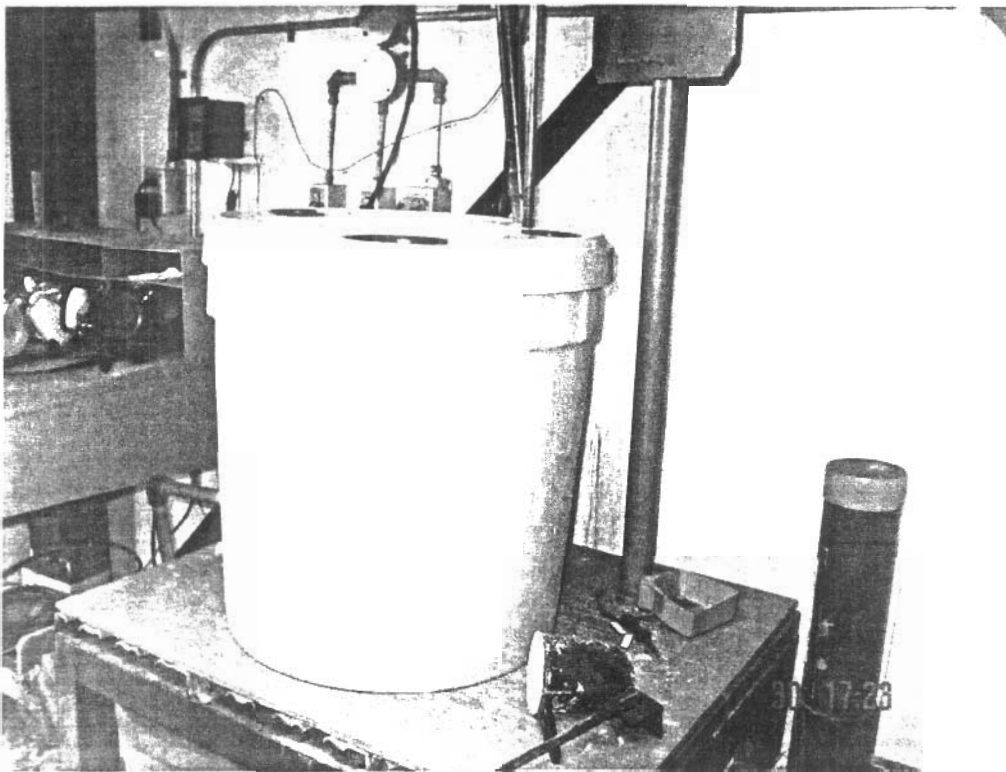
Photo # 4 Chlorination system in Water Intake Facility located at water reservoir.

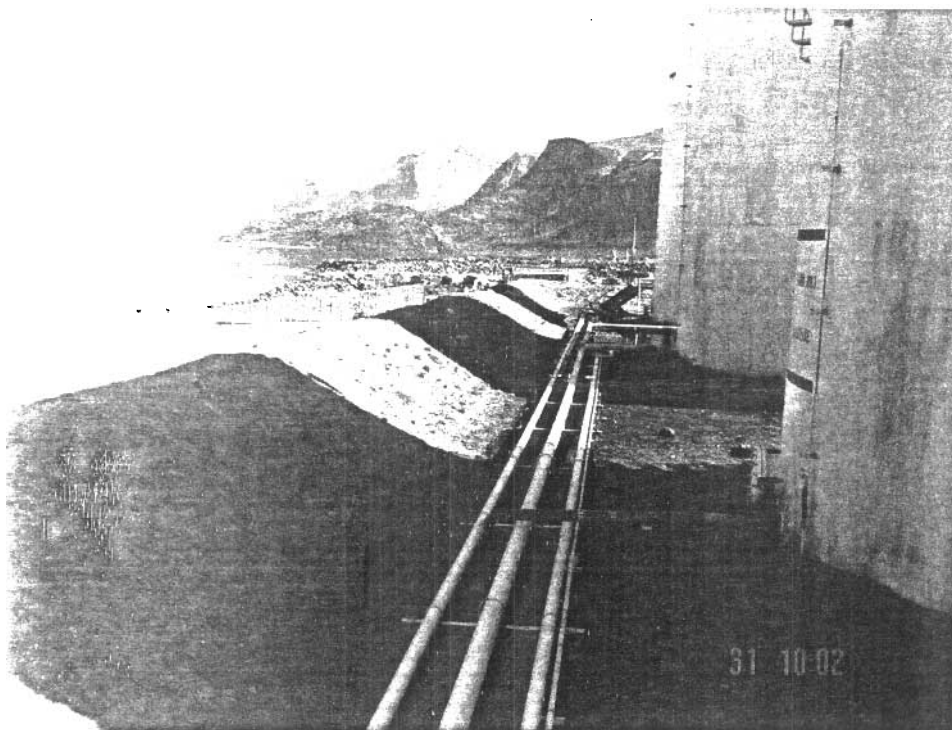
- ☐ **Fuel Storage:** The Tank Farm berm appeared to be in good repair (Photo 5). There was no obvious signs of fuel or oil spillage within the bermed area. There was some water within the berm area but no concerns were raised. Of concern was the fact that several unmanned drainage hoses were left unattended at the Tank Farm (Photo 6), they should be removed.

Photo # 5 Tank farm berms appear in good repair.

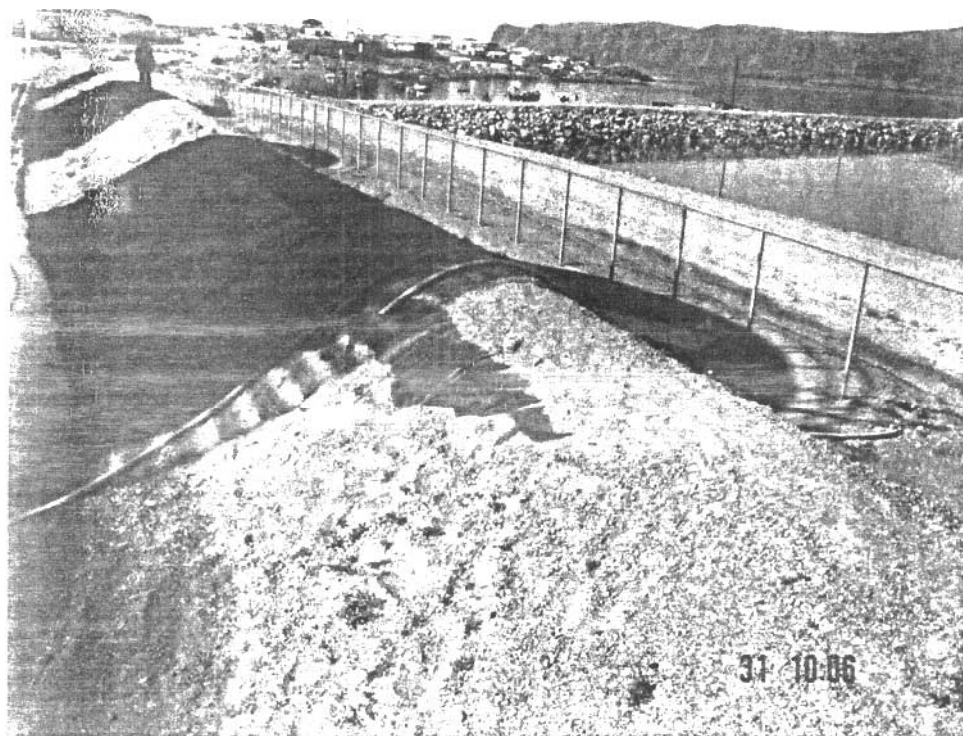
Photo # 6 Drainage hose left unattended at tank farm.

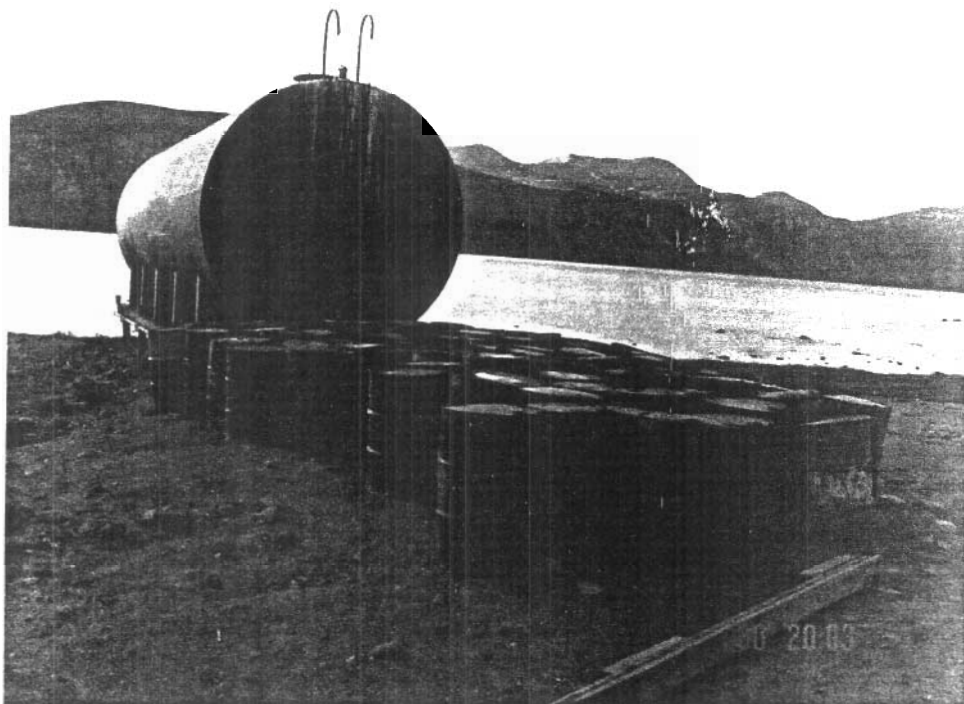
- ☐ **Solid Waste Disposal Facility:** Waste batteries and waste oil are stored in separate locations removed from the Solid Waste Disposal Facility (Photo 7 & 8). As previously noted, the fence at the Solid Waste Disposal Facility is only partly intact (Photo 14). There is considerable wind blown debris in the vicinity of the Solid Waste Disposal Facility (Photo 10). The WRO noted that there was considerable waste associated with the processing of fish at the dump (Photo 12). It was noted that waste seepage was emitting from 3 culverts that had been placed along the west side of the dump draining to the ocean (Photo 9). The Water Resources Officer suggested that measures be undertaken to stop seepage from the Solid Waste Disposal Facility. Enclosed laboratory analysis of (PAN-2) seepage from the dump indicate Total Suspended Solids (870 mg/L vs 120 mg/L), Biological Oxygen Demand (1070 mg/L vs 100 mg/L) and Total Ammonia (379 mg/L vs 2.2 mg/L) exceed the *Municipal Wastewater Effluent Quality Guidelines*.

Photo # 7 Waste oil stored by proposed sewage treatment building, about 70 drums stored there.

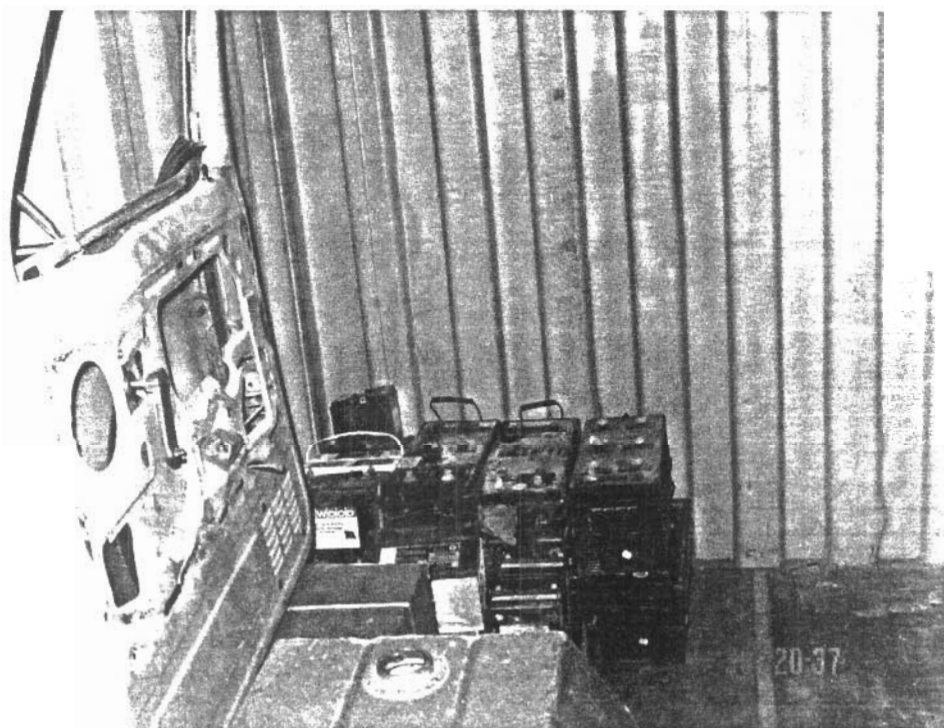
Photo # 8 Waste batteries that have been segregated from Solid Waste Disposal Facility in sea-lift container by power plant.

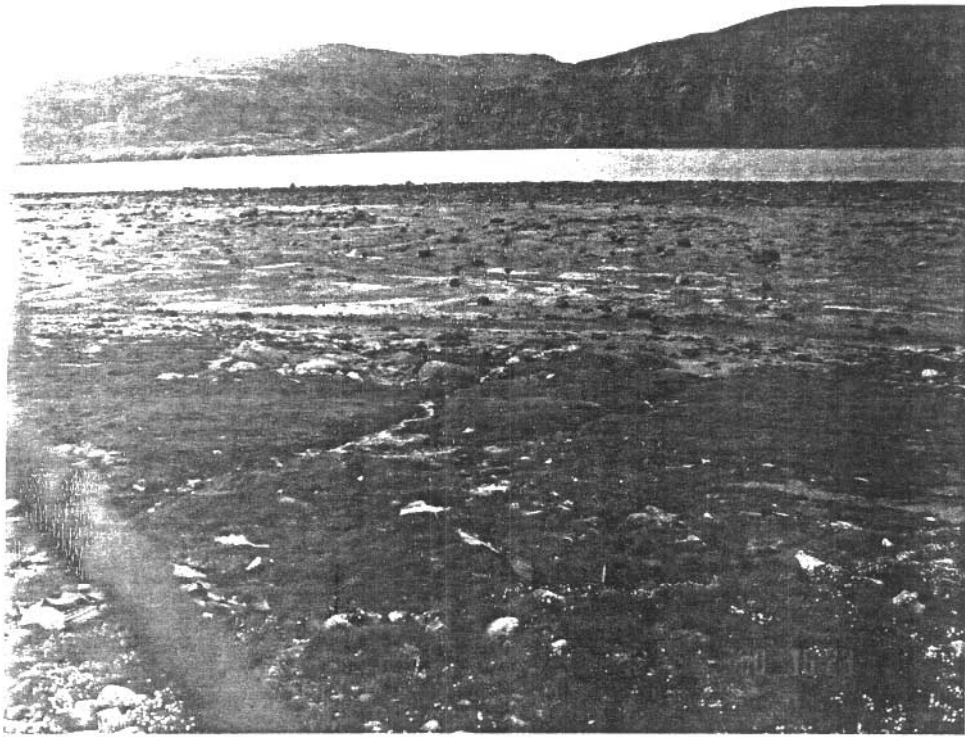
**Comments:** The present Sewage Disposal Facility does very little in the way of treating sewage prior to discharge into the ocean. The Solid Waste Disposal Facility similarly has problems with seepage due to 3 culverts presently placed through the berm at the west side of the dump. The perimeter fence at the dump requires maintenance.

Photo # 9 Seepage from solid waste disposal facility.

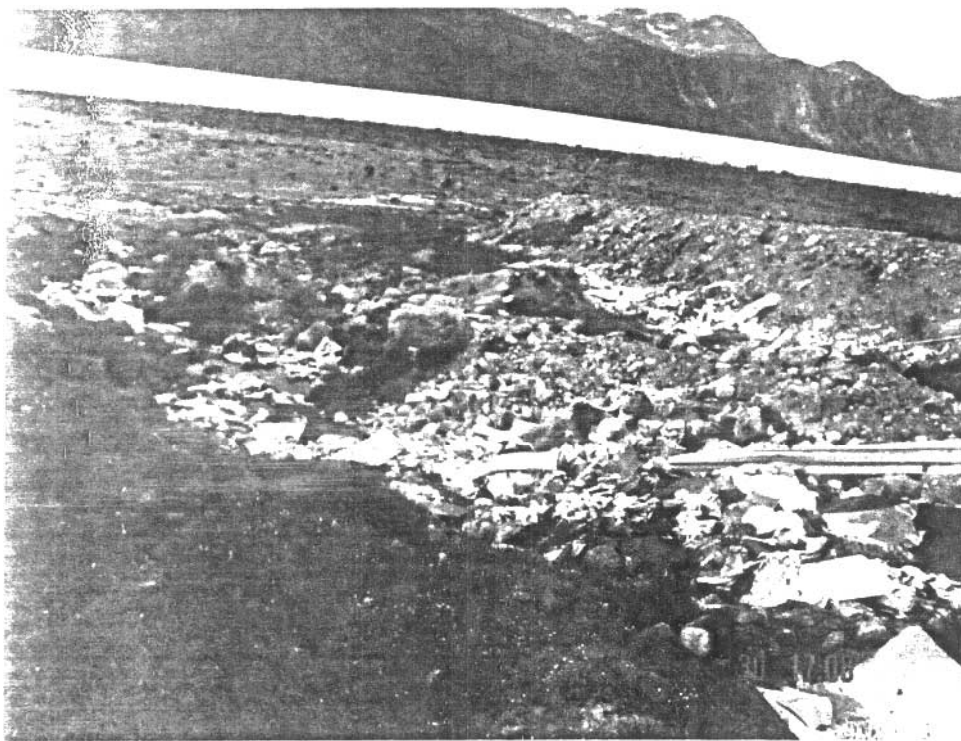
Photo # 10 Creek alongside municipal Solid Waste Disposal Facility showing windblown refuse .

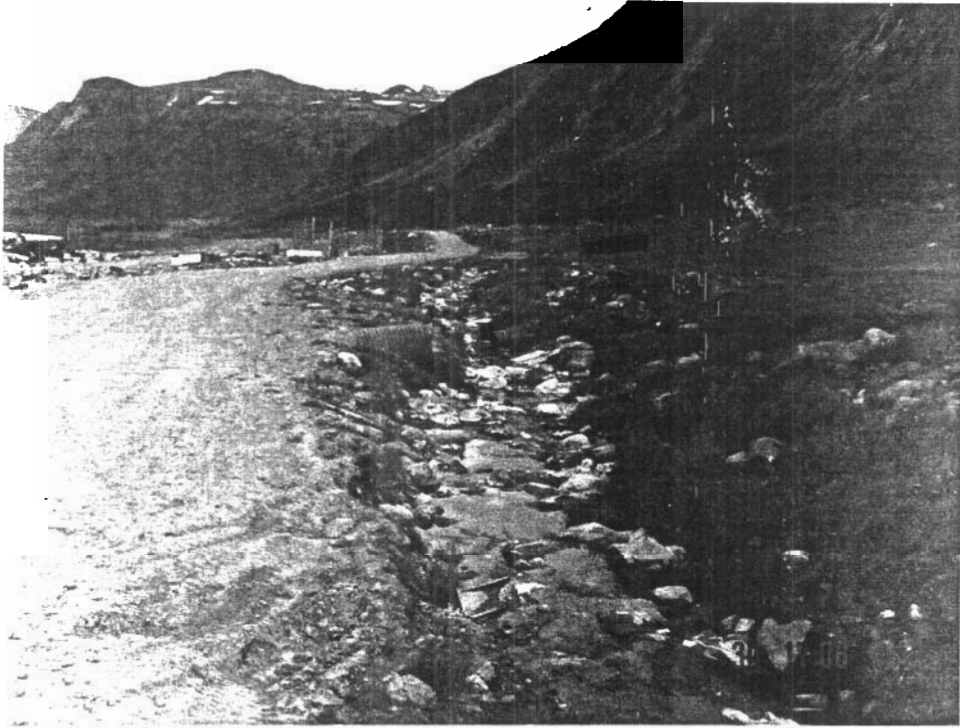
Photo # 11 Ditch across the road from solid waste disposal ground; windblown refuge shown in ditch.

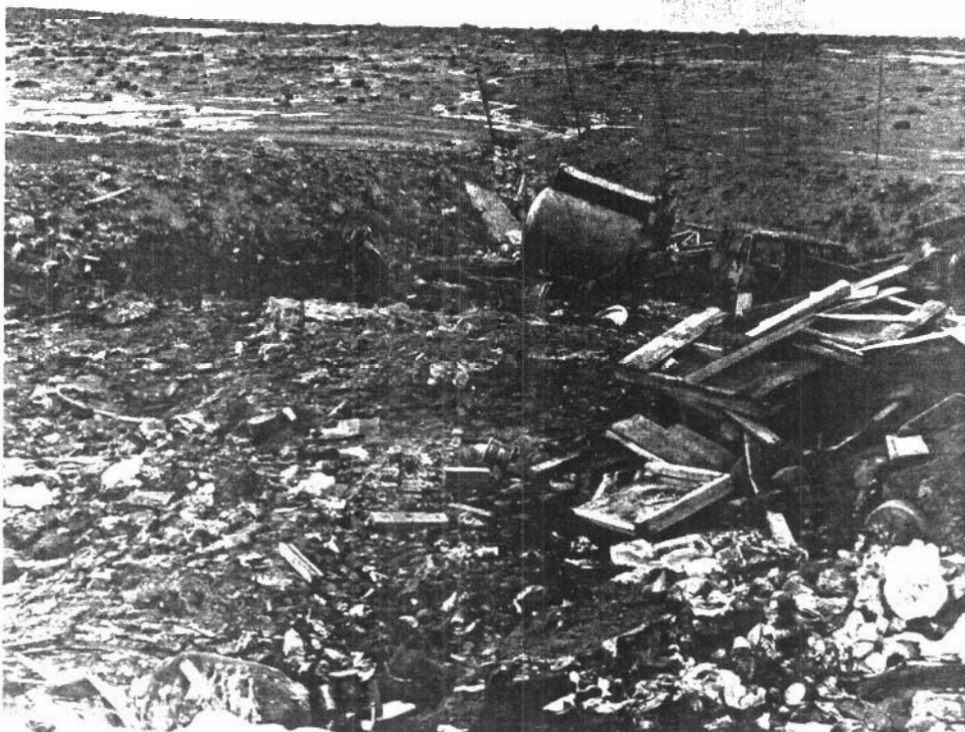
Photo # 12 Tipping face of Solid Waste Disposal Facility; waste from fish processing plant shown in left of photo

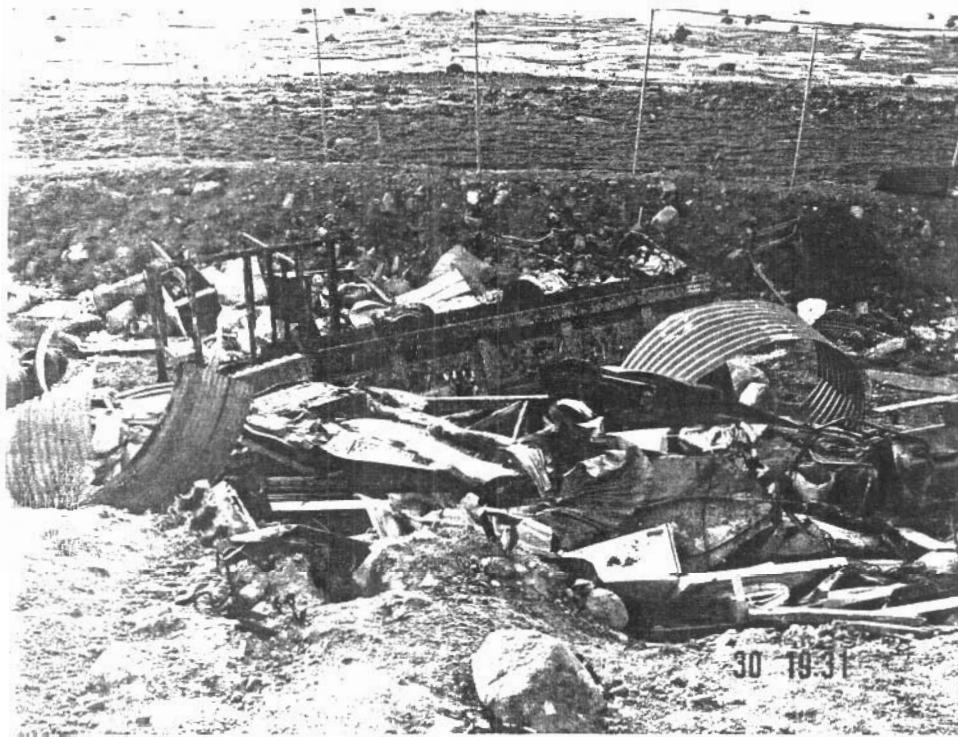
Photo # 13 Large metal waste section of Solid Waste Disposal Facility.

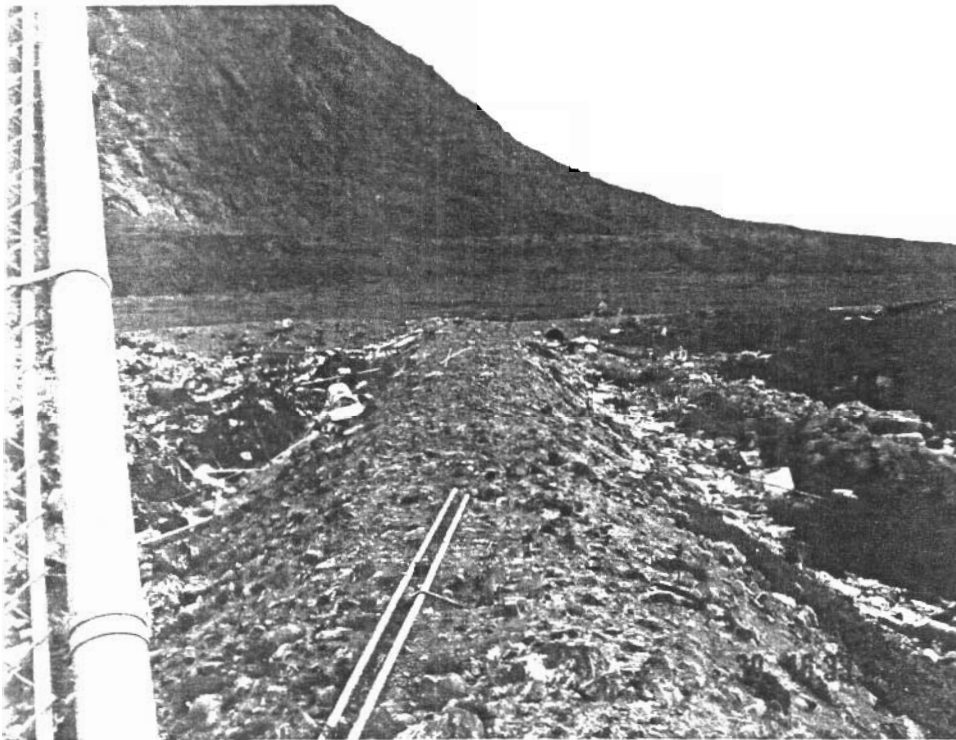
Photo # 14 Solid Waste Disposal Facility berm shown; separating creek from landfill. Fence has been damaged and is no longer in place along berm. Considerable garbage has been windblown into creek.

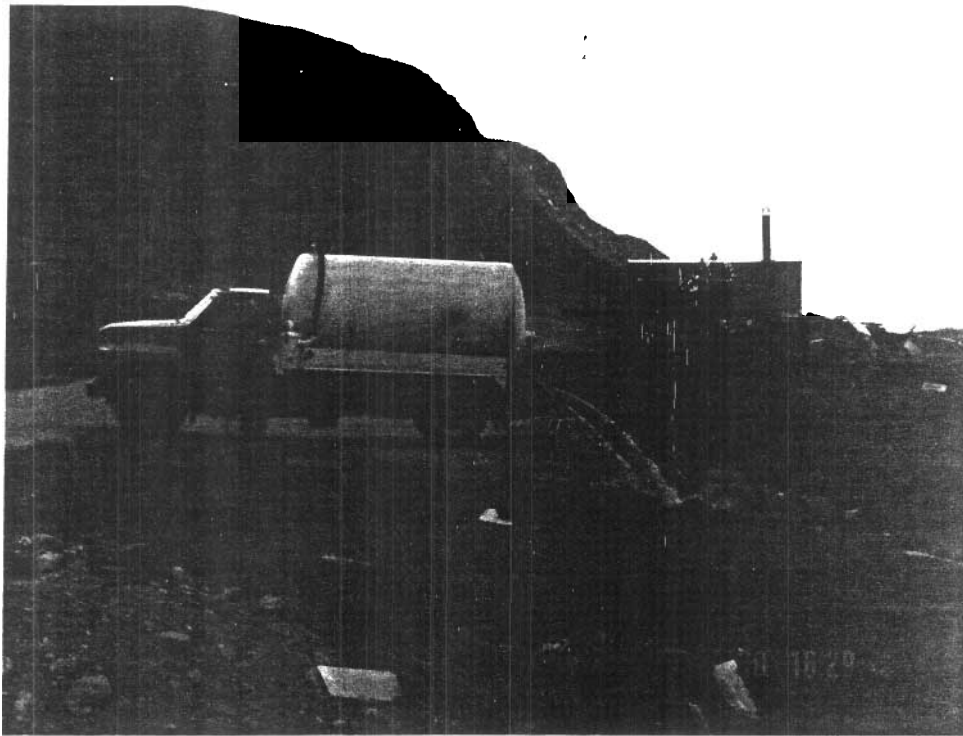
- ☐ **Sewage Disposal:** The Sewage Lagoon is all but non functioning. Trucks discharge sewage onto a area of large aggregate material (Photo 15). The sewage then drains down a refuge laden trench to the ocean (Photo 16). Little if any treatment is accomplished prior to the sewage effluent entering the ocean. The Water Resources Officer gave suggested that measures be undertaken to place a retention berm at the discharge of the Sewage Lagoon. Enclosed

Photo # 15 Sewage truck discharged at Sewage Lagoon discharge structure.

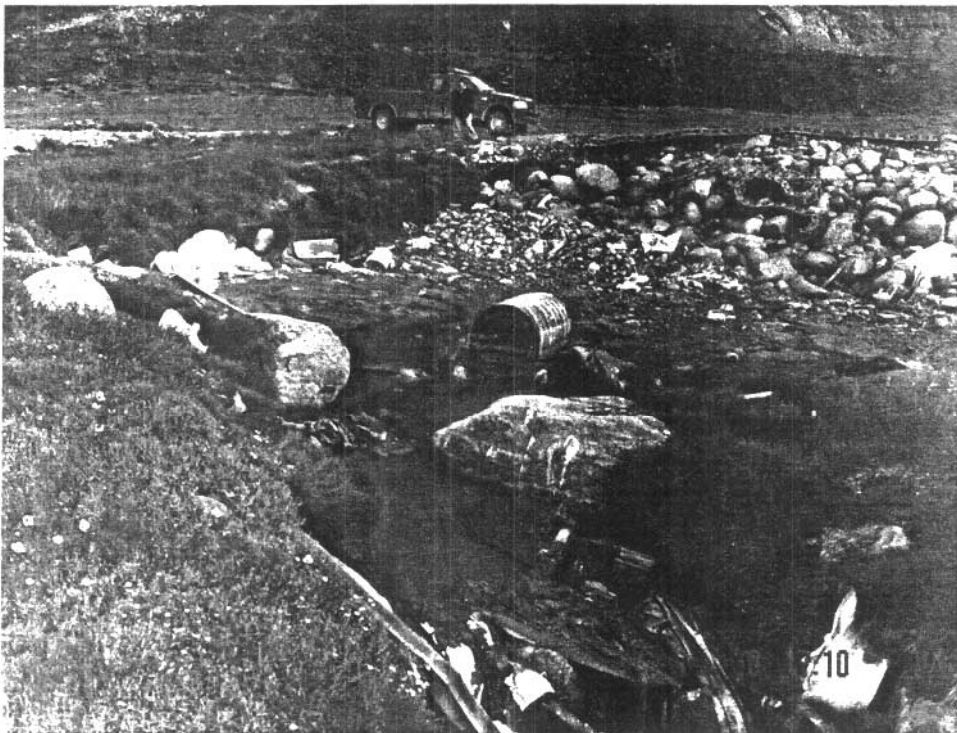
analysis of (PAN-3) Sewage Lagoon effluent indicate that Biological Oxygen Demand (431 mg/L vs 100 mg/L), Total Suspended Solids (384 vs 120 mg/L) and Total Ammonia (151 mg/L vs 2.2 mg/L) all exceed *Municipal Wastewater Effluent Quality Guidelines*.

Photo # 16 Sewage lagoon; shown minuets after discharge from sewage truck. Note that little if any retention of sewage is accomplished at lagoon
