WATER LICENCE INSPECTION FORM

Licensee		Licensee Representative	
Hamlet of Pangnirtung		John Hussy	
Licence No. / Expiry		Representative's Title	
3BM-PAN1417		Senior Administrative Officer	
Land / Other Authorizations		Land / Other Authorizations	
Date of Inspection		Inspector	
July 27, 2016		Justin Hack	
Activities Inspected			
<input type="checkbox"/> Camp	<input type="checkbox"/> Drilling	<input type="checkbox"/> Mining	<input type="checkbox"/> Construction
<input type="checkbox"/> Roads/Hauling	<input type="checkbox"/> Other: Water Discharge	<input type="checkbox"/> Reclamation	<input checked="" type="checkbox"/> Fuel Storage
<input checked="" type="checkbox"/> Other: Municipal

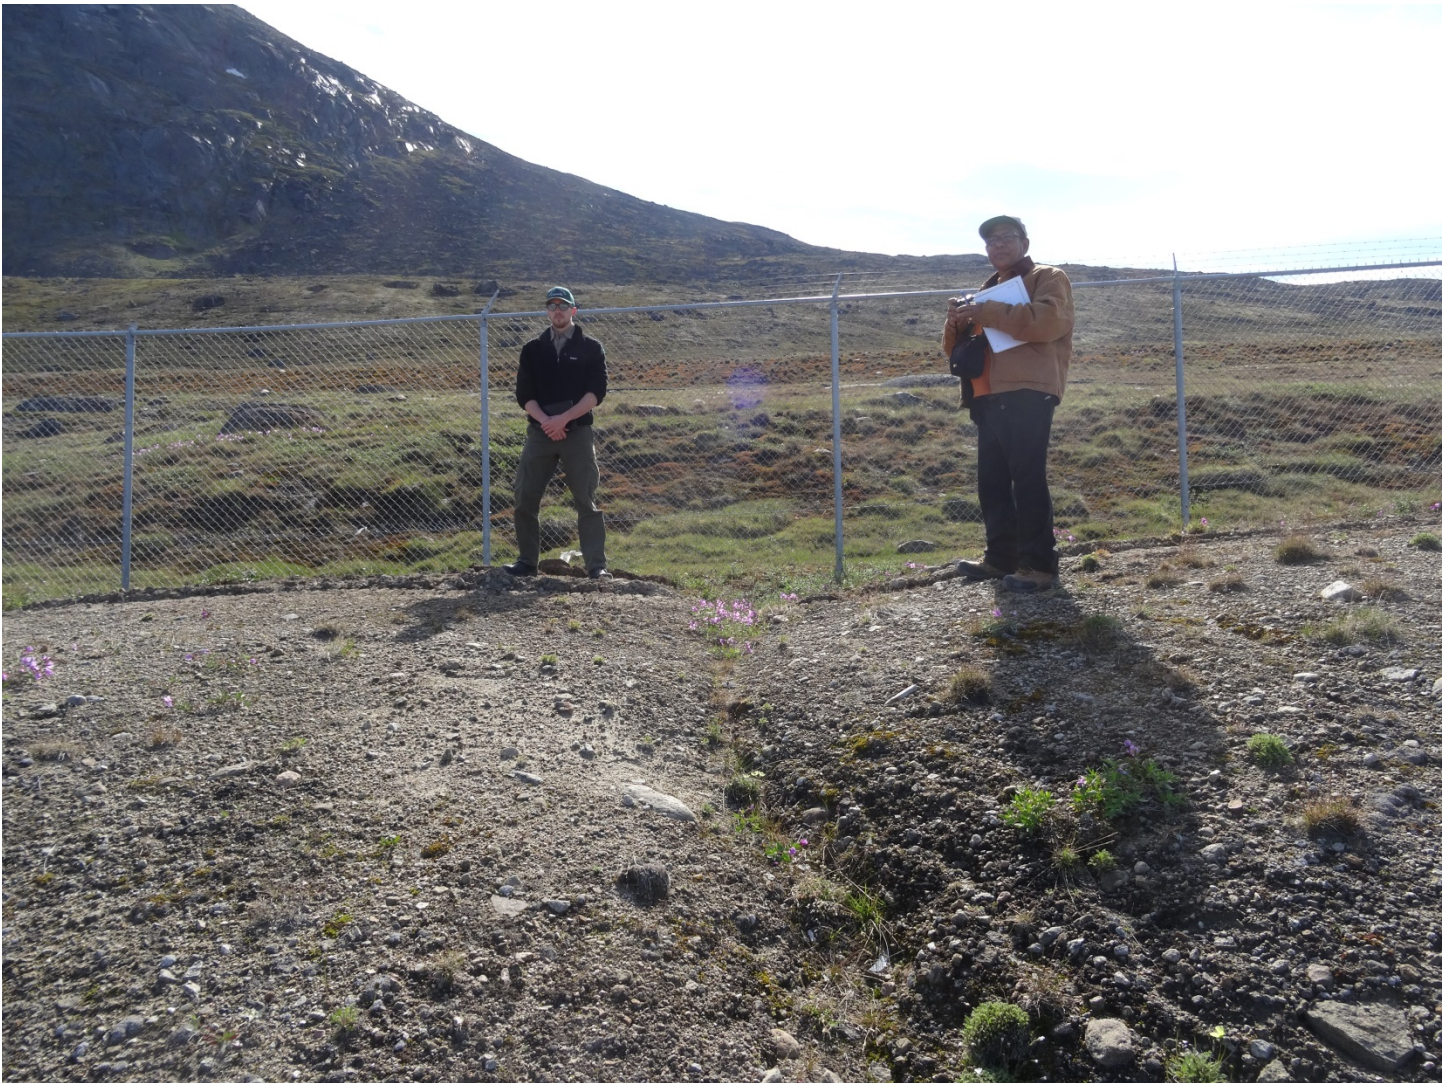
Figure A: Photo of the erosion caused by surface water near the northeast corner of the water reservoir.

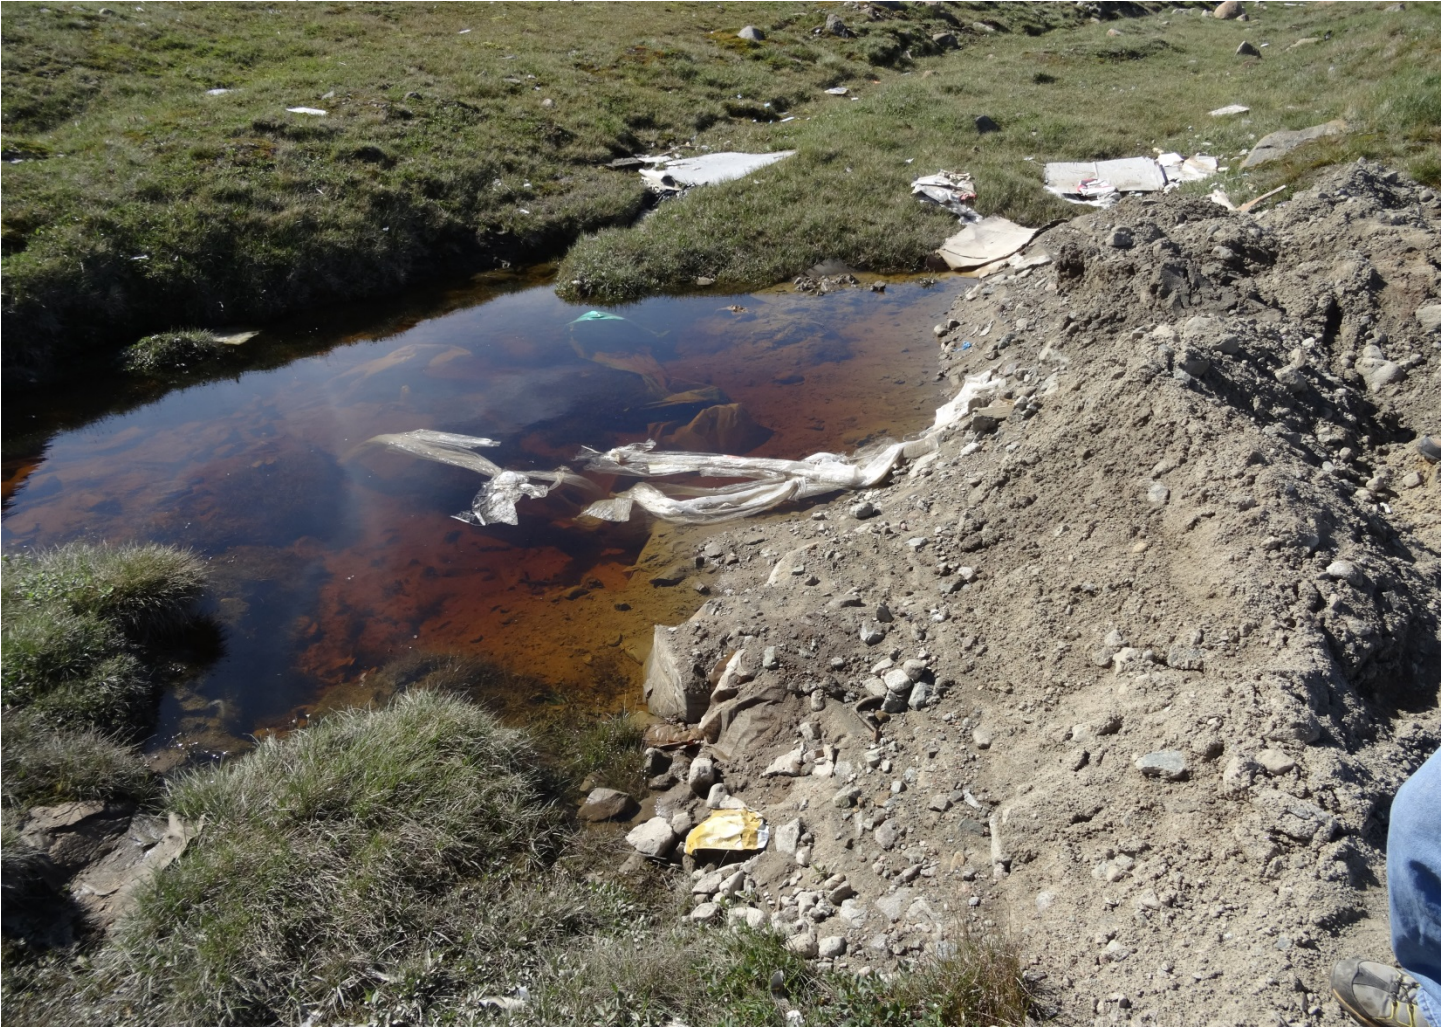
8. The community is segregating and storing metals, vehicles, batteries, and electronic waste within the Metal Storage Area. Small amounts of leachate appear to be entering a small amount of surface water at this facility before it drains into the ocean.

9. Due to changing drainage patterns coming off of the mountains behind the metal disposal area, the berm walls surrounding this facility has been breached in previous years which led to water flowing through the facility in three separate locations.

10. The Hamlet has since addressed this issue by filling the breached sections of the berm with hardened cement and soil to divert the surface water around the metal storage area. However, water is accumulating behind these sections and the water is slowing exfiltrating into the Metal Storage Area. See *Figure B*.

11. INAC has concern related to this structure because of its inability to properly divert water around the metal storage area causing small amounts of leachate to enter the surface water.

Figure B: One of three locations where water has built up behind the berms surrounding the metal storage area.
