WATER LICENCE INSPECTION FORM

Licensee		Licensee Representative	
Hamlet of Pangnirtung		Bhabesh Roy, P.Eng.	
Licence No. / Expiry		Representative's Title	
3BM-PAN1417		Regional Municipal Engineer	
Land / Other Authorizations		Land / Other Authorizations	
Date of Inspection		Inspector	
October 2, 2017		Jonathan Mesher	
Activities Inspected			
<input type="checkbox"/> Camp	<input type="checkbox"/> Drilling	<input type="checkbox"/> Mining	<input type="checkbox"/> Construction
<input type="checkbox"/> Roads/Hauling	<input type="checkbox"/> Other: Water Discharge	<input type="checkbox"/> Reclamation	<input checked="" type="checkbox"/> Fuel Storage
<input checked="" type="checkbox"/> Other: Municipal

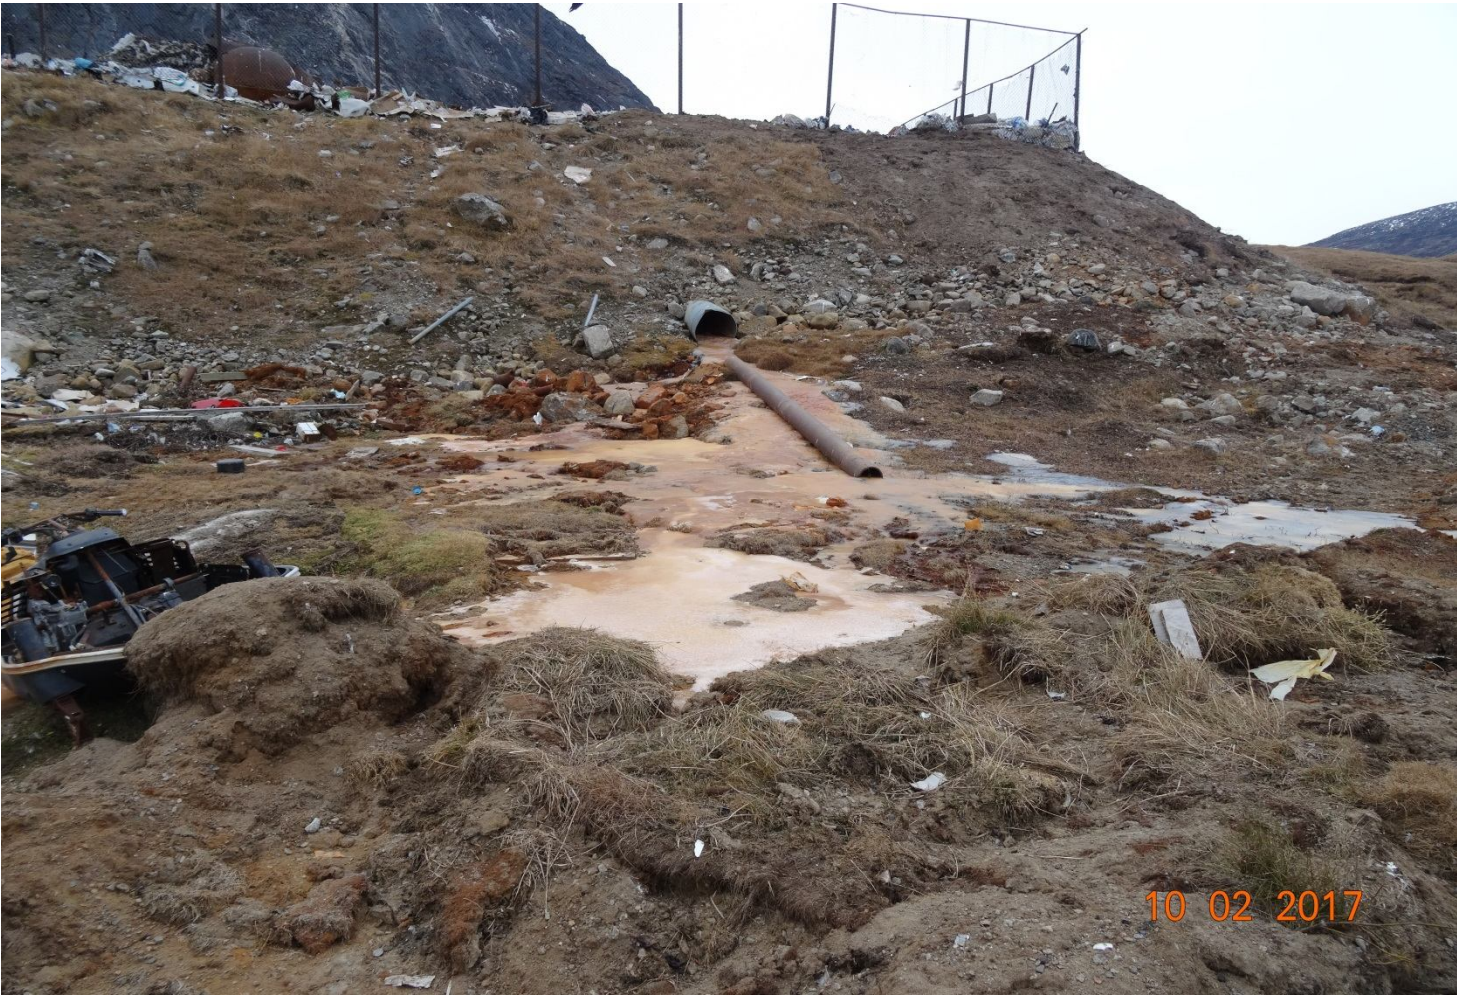
Figure 1: PAN-5 monitoring location.

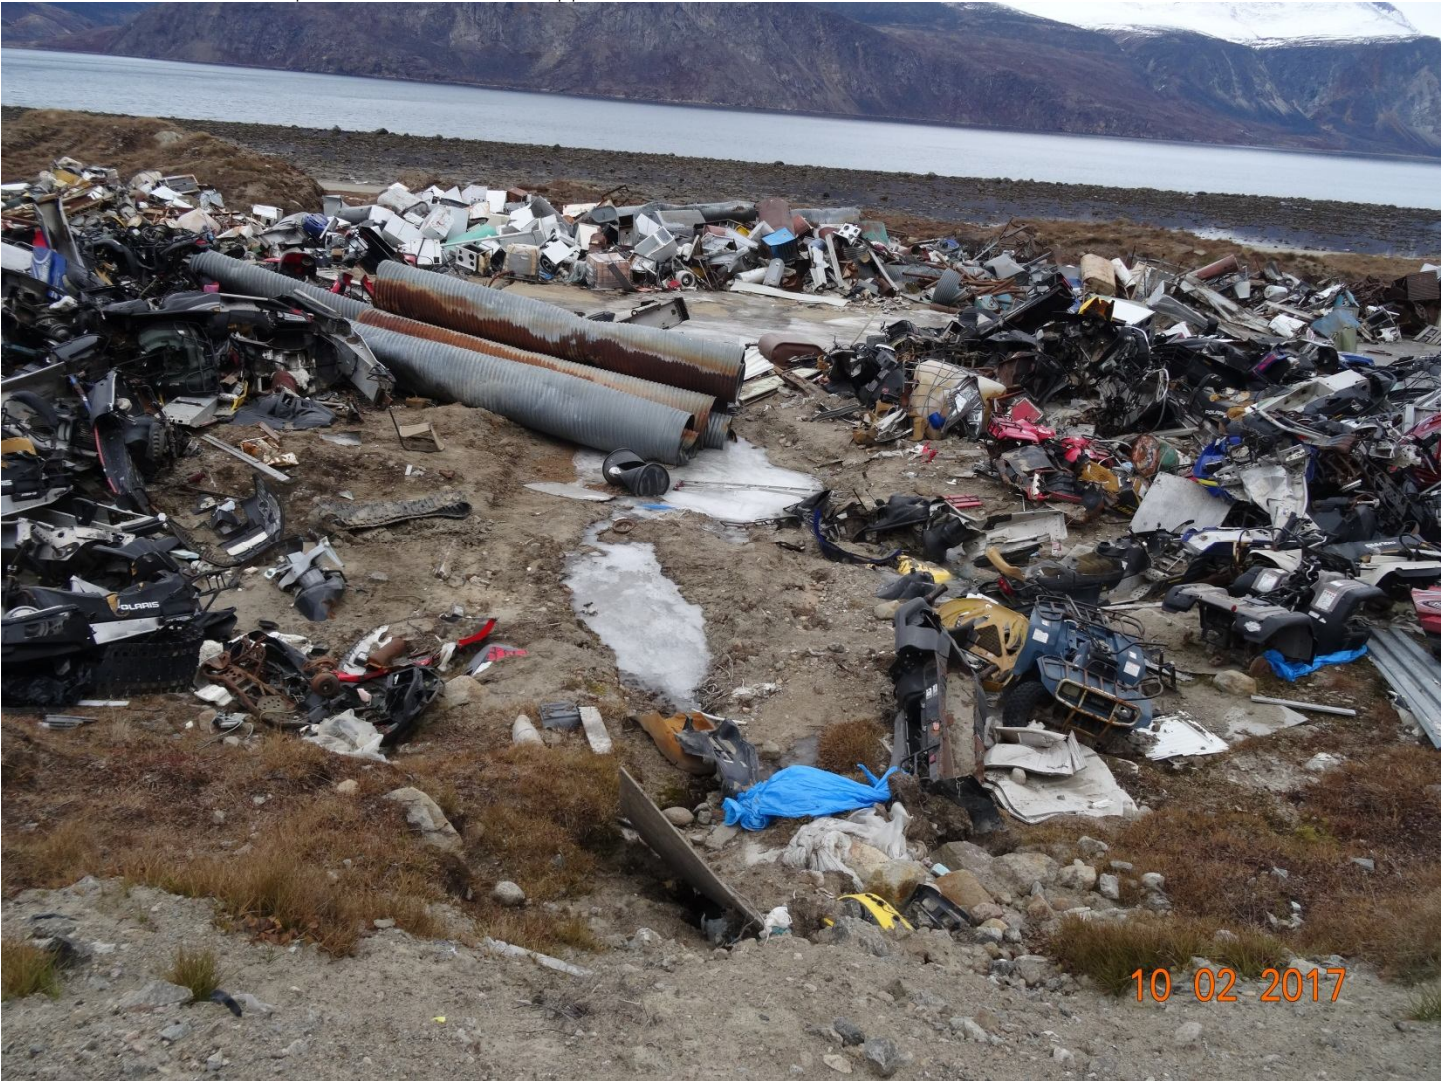
- 10. The community is segregating and storing metals, vehicles, batteries, and electronic waste within the Metal Storage Area.
- 11. This location has issues with changing drainage patterns coming off of the mountains behind the metal disposal area, the non-engineered berm walls surrounding this facility had been breached in the past which led to water flowing through the facility in three separate locations.

- 12. The Hamlet has attempted to fix the breached sections of the berm with hardened cement and soil. However, water is accumulating behind low-lying sections and is slowing infiltrating the Metal Storage Area. See *Figure 2*.

- 13. INAC has expressed concern related to this structure in past reports because of its inability to properly divert water around the metal storage area.

Figure 2: Water infiltration of the metal storage area.

- 14. The space required for the metal storage remains an issue for Pangnirtung, Practical short-term solutions do not appear feasible. The community along with the Government of Nunavut is currently working towards a new waste management facility.
