WATER LICENCE INSPECTION FORM

Licensee	Licensee Representative
Hamlet of Pangnirtung	Bhabesh Roy
Licence No. / Expiry	Representative's Title
3AM-PAN1828 expiry May 3, 2028	Municipal Engineer
Land / Other Authorizations	Land / Other Authorizations
Date of Inspection	Inspector
August 23, 2018	Joseph Monteith
Activities Inspected	
<input type="checkbox"/> Camp	<input type="checkbox"/> Drilling
<input type="checkbox"/> Roads/Hauling	<input type="checkbox"/> Mining
	<input checked="" type="checkbox"/> Other: Potable Water Source, Waste Water Treatment, and Solid Wastes
	<input type="checkbox"/> Construction
	<input type="checkbox"/> Reclamation
	<input type="checkbox"/> Fuel Storage
	<input type="checkbox"/> Other:

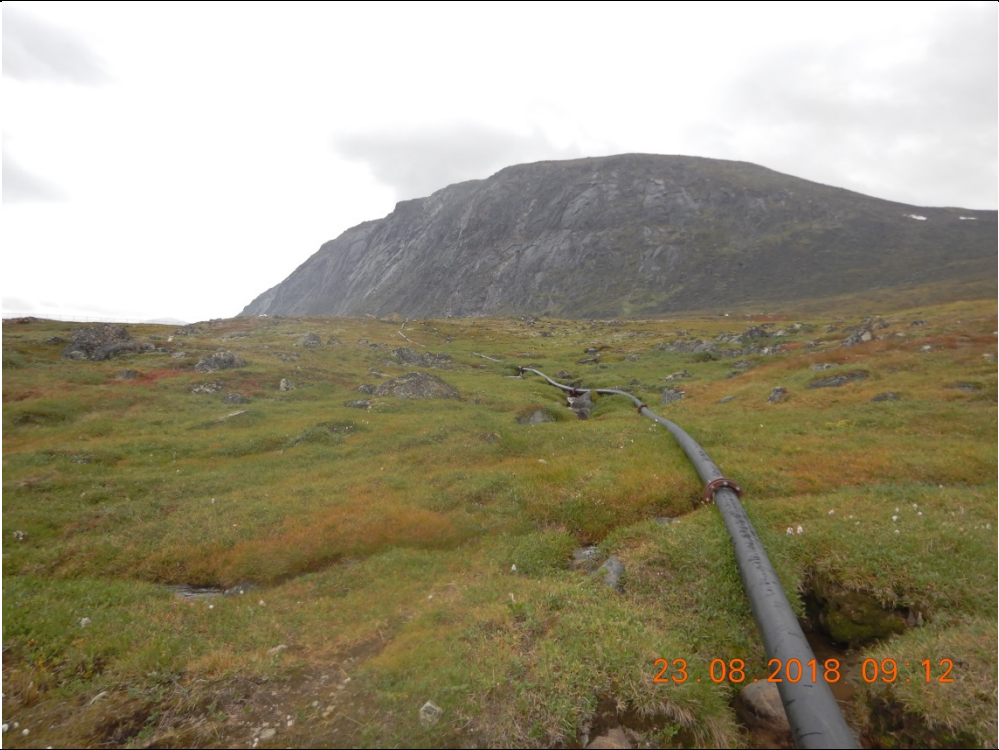
Photo 2

1. Water is extracted from the Duval River using a water pump and mobile generator (See photo 1).
2. The water transferred by pipes from Duval River to the Water Storage Reservoir (See photo 2).
3. No fish mesh screen on extraction pipe at Duval River.
4. No Water Meter at Duval River

Description: Insulated pipe on top of the land scape. No signs of leaks

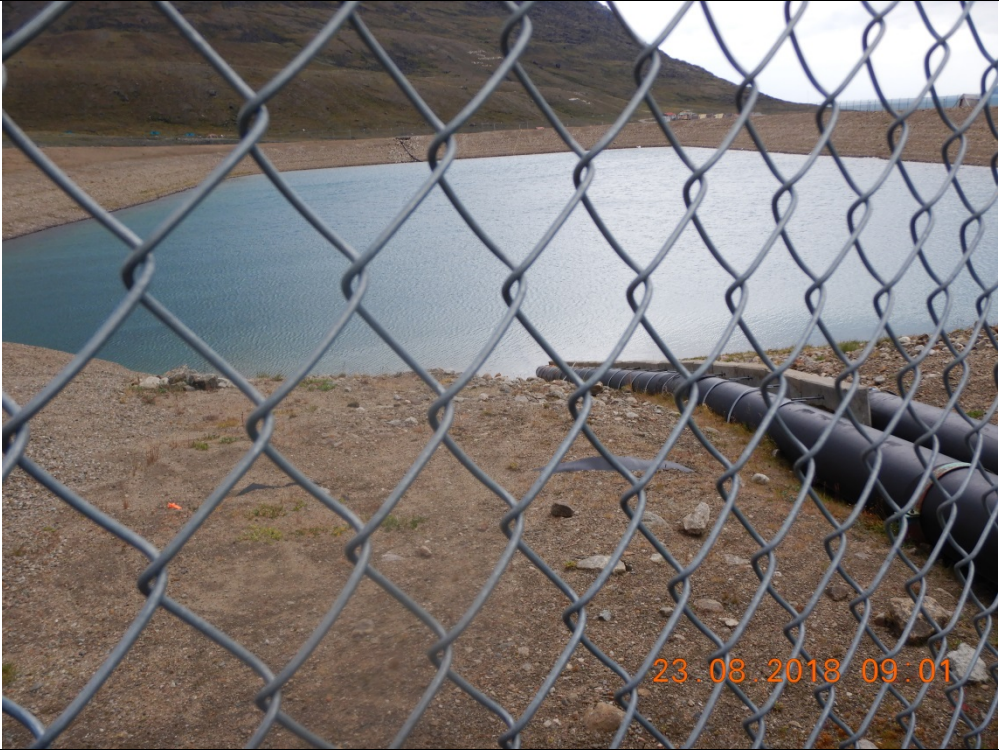
Photo 3

5. The Water from Duval River is deposited into a reservoir next to the Water Treatment Facility (See Photo 3).
6. Water is delivered from the Water Treatment Plant by truck to the public (See photo 4).

9. Records show between the months of January and July 2018, the Hamlet of Pangnirtung delivered a total of 28,529m³ of water (See photo 8).
10. The Water Storage Reservoir capacity is 12,000m³ in the summer, and taking in considerations for the 1.8 metres of ice 71,000m³ in winter. The walls looked to be in good shape, with no signs of erosion or slumping (See photo 3). Past inspection reports documented seepage of water into the reservoir from the east, but the installation of the walls above the fence line on the East up slope have appear to corrected that issue.

Description: Water Reservoir capacity is 12,000m³ in the summer, and taking in considerations for the 1.8 metres of ice 71,000m³ in winter. Past inspection reports have documented water seeping into the reservoir from the East.

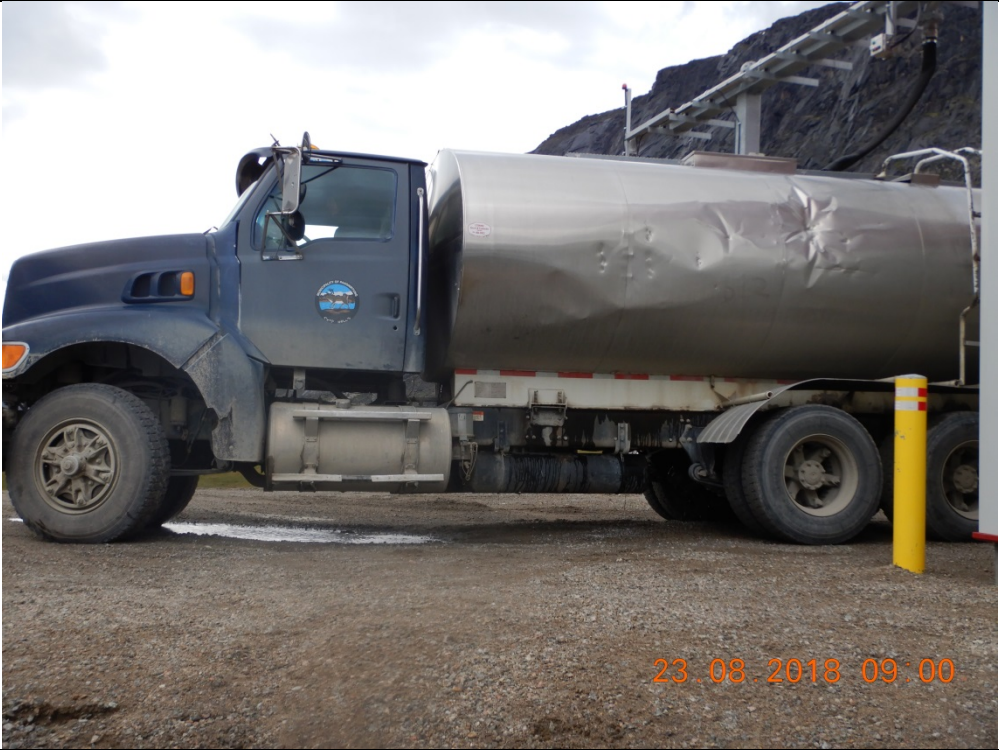
Photo 4

Description: Water Truck being recharged at Water Treatment Facility

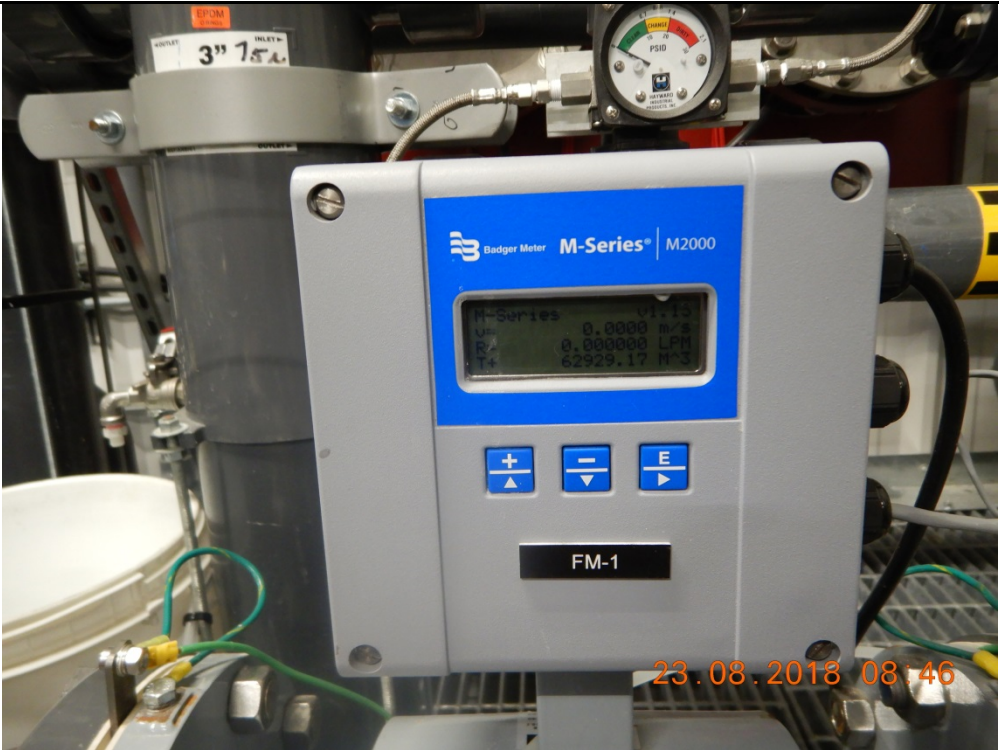
Photo 5

7. Water Meter reading read 62,929m³ (See photo 5).
8. Water Usage Records were up to date and provided at the Waste Water Treatment Facility (See photo 6). Water Technician log sheet, Water Flow Meter Readings shows 62,929m³ before being filtered and 64,433 m³ after being filtered (See photo 7).

Description: Water Meter before filtration reads 62929.17m³

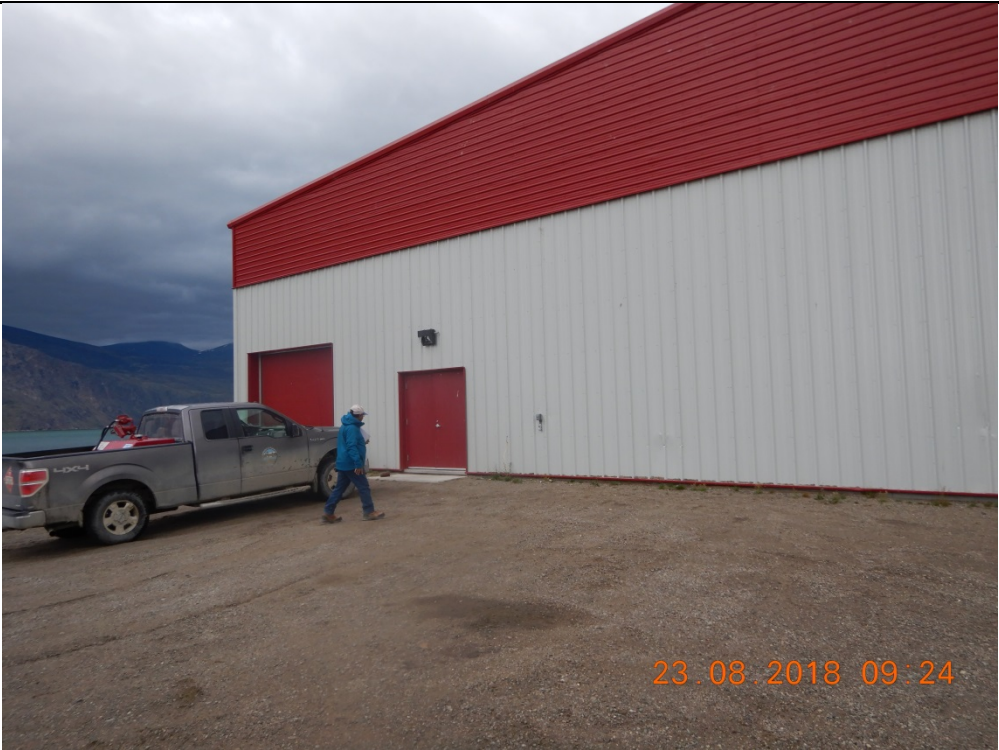
Photo Log #1
Photo 9

12. The Waste Water Treatment Facility located 146 metres from the high water mark of the ocean.
13. Liquid treated waste is discharged towards the ocean from a pipe that extends out 19 metres out of the Waste Water Treatment Facility (See photo 10).

Description: Waste Water Treatment Facility

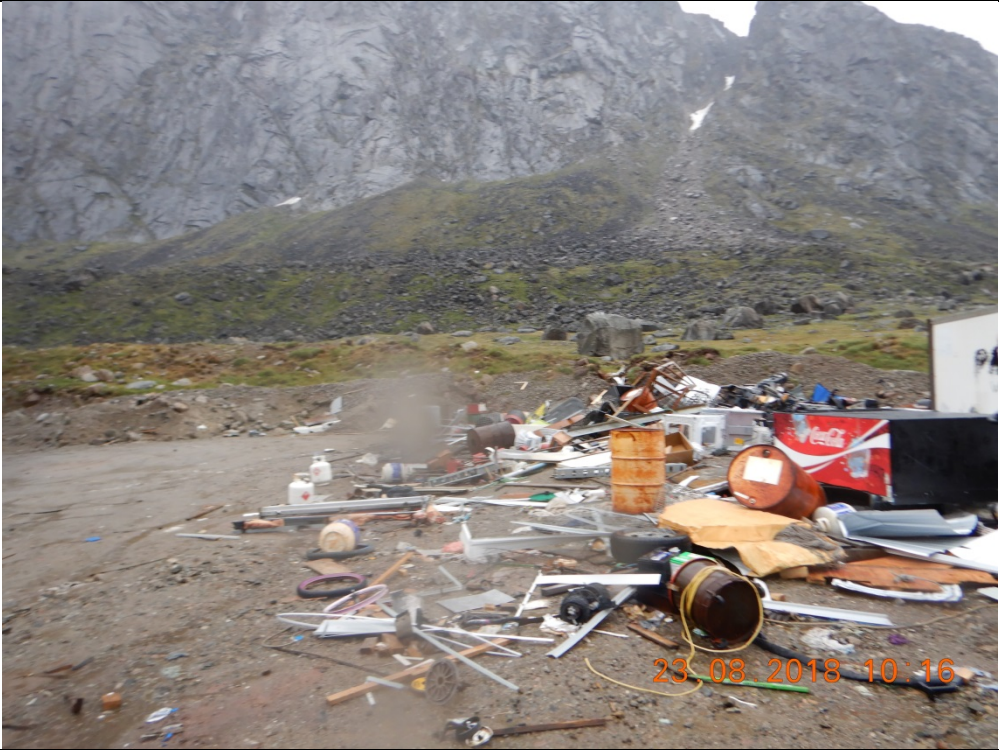
Photo 14

16. Hazardous Waste was found throughout the Bulk Metals section such as waste oil drums, and batteries. (See photo 14).
17. The Bulk Metals section is merged with the Hazardous Waste section (See photo 15).

Description: Hazardous Waste in the Bulk Metals section. Waste Oil Drums, can propane tanks can be seen littered around the entrance fringes of the Bulk Metals section. Embankment appears to be working diverting water into the Solid Waste Facility.

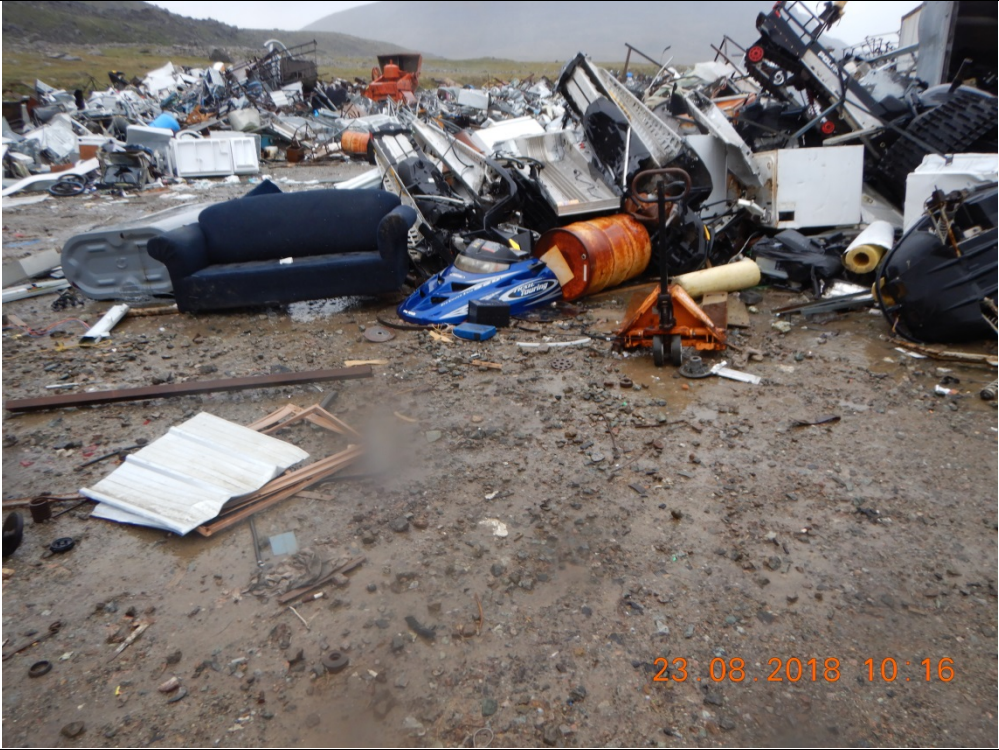
Photo 15

Description: The Bulk Metal Debris in front of Hazardous Waste Sea Can. Sea can door is on the top right of photo.

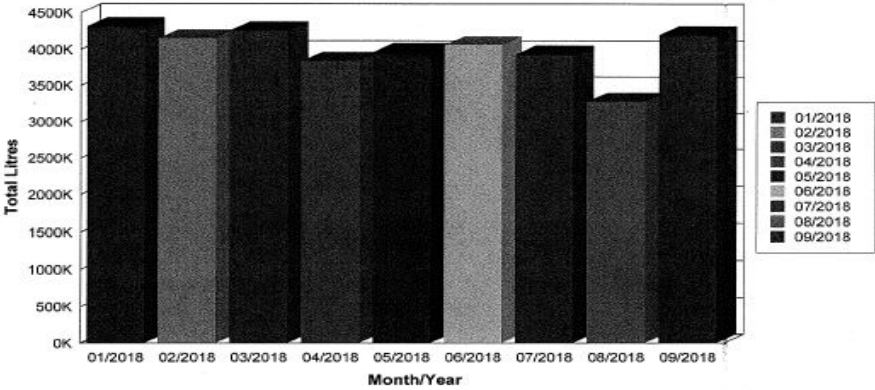
Photo 20

11. On October 25, 2018 William Toonoo, Municipal Technician, Government of Nunavut, Community Government, and Services, emailed WRO Monteith a copy of the "Delivery Summary by Month and Year" for the months of January to September 2018 showing 36,004.735 m³ delivered to date. That doesn't account for the amount of water within the Water Reservoir, the Water Treatment Facility, and for uses such as Suppression (See photo 22).

Description: Delivery Summary By Month and Year total delivered equals 36,004.723 m³ doesn't account for the amount of water in the reservoir, the water treatment plant, and for activities such as dust suppression.

- Articulate the calculation for use of water, as the “Delivery Summary by Month and Year, doesn’t take into account the amount of water in the Water Storage Reservoir, the Water Treatment Facility, and for such uses as dust suppression;
- Dig a trench downslope of the hazardous waste deposit (see photo 17, 18, and 19), to control the migration of hazardous waste and install a monitoring station at that site, and sample for Oil and Grease, and hydrocarbons.
- Prioritize the segregation of the Hazardous Waste Section from the Solid Waste Facility;
- Remove drums from the Hazardous Waste site, and deposit them in an area where the leaks and spills doesn’t mix with water;
- Install a water meter at Duval River as requested in previous inspection reports to get an accurate result of withdrawal from the site.
