Water Licence Inspection Report

Authorization	Representative
Municipality of Pangnirtung	Mary Ann Mike
Authorization No. / Expiry	Representative's Title
3BM-PAN1828	Acting Senior Administrative Officer
Activities Inspected	
<input type="checkbox"/> Camp, Commercial <input type="checkbox"/> Drilling <input type="checkbox"/> Mining <input type="checkbox"/> Construction <input type="checkbox"/> Reclamation <input type="checkbox"/> Fuel Storage <input type="checkbox"/> Roads/Hauling <input type="checkbox"/> Winter Hauling <input type="checkbox"/> Camp, Private <input checked="" type="checkbox"/> Municipality

On July 21, 2025, I, Sean Noble-Nowdluk, along with Joseph Monteith, Inspectors with Crown-Indigenous Relations and Northern Affairs Canada (CIRNAC) completed an Inspection of the site named above for the purpose of verifying compliance with the terms and conditions of which this water license was issued upon.

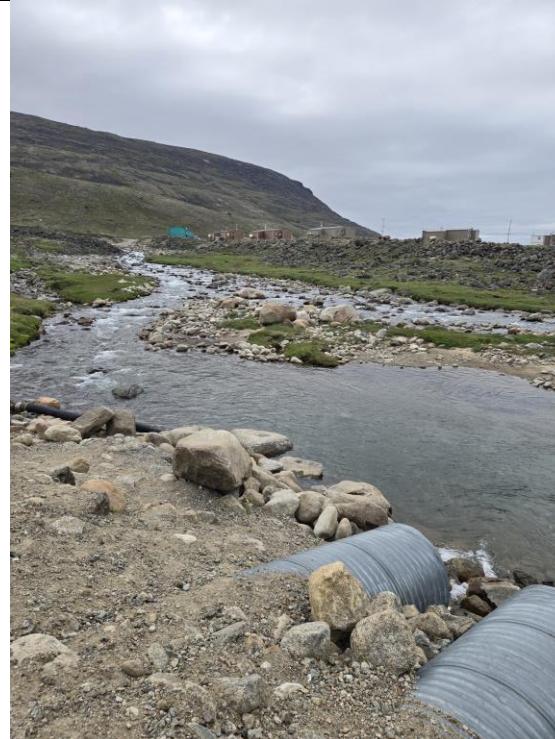
Photo No. 1

Duval River, Pangnirtungs main water source. Water is pumped from the Duval River up to the water reservoir via pipeline.

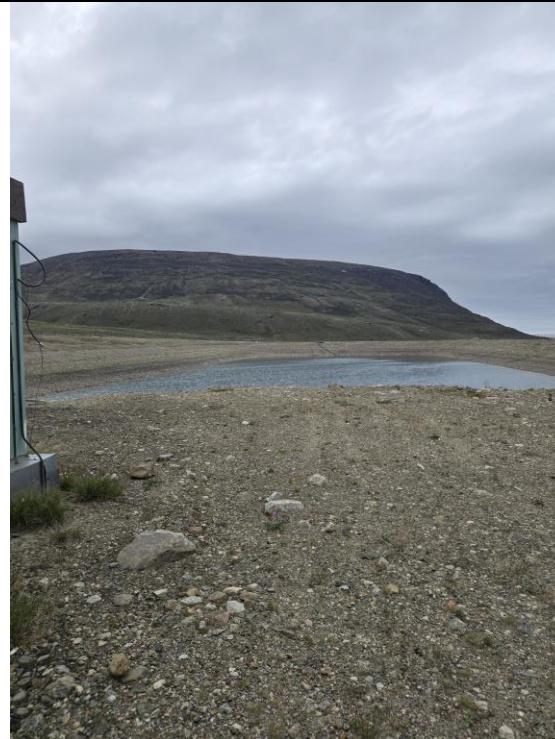
Photo No. 2

Photo of Pangnirtungs water reservoir.

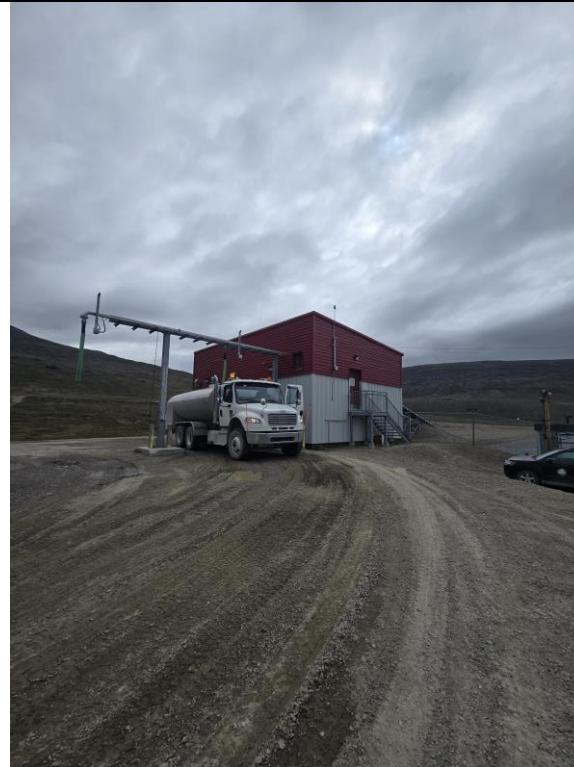
Photo No. 3

Water delivery operations in Pangnirtung. Water is treated at the treatment plant prior to being trucked to houses.

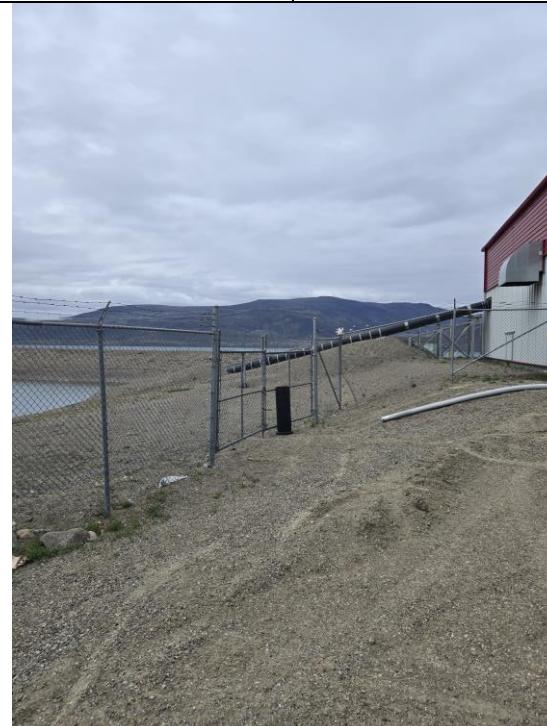
Photo No. 4

View of the treatment plants water pick-up line from the reservoir.

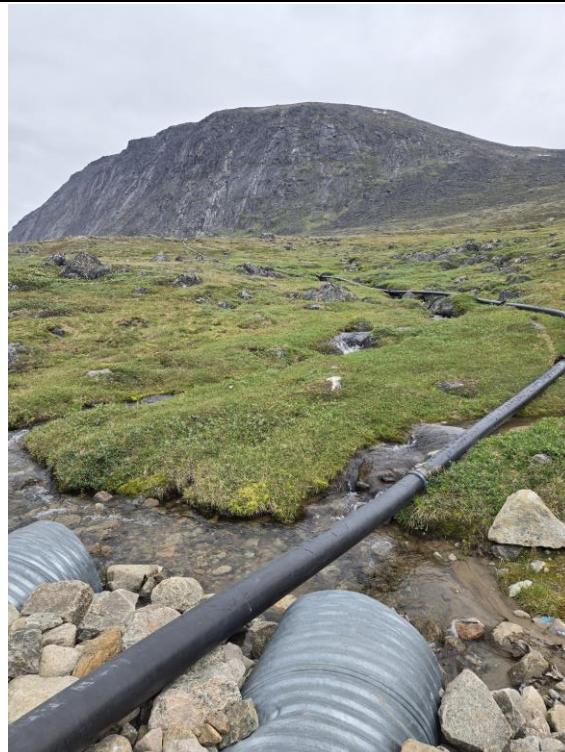
Photo No. 5

Photo showing pipe that is used to transfer water from Duval River up to the water reservoir.

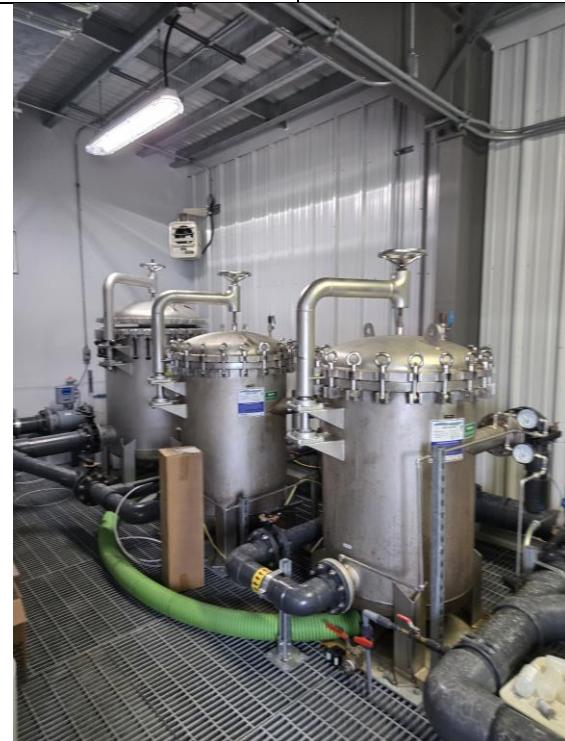
Photo No. 6

Part of the water filtration system inside the water treatment plant.

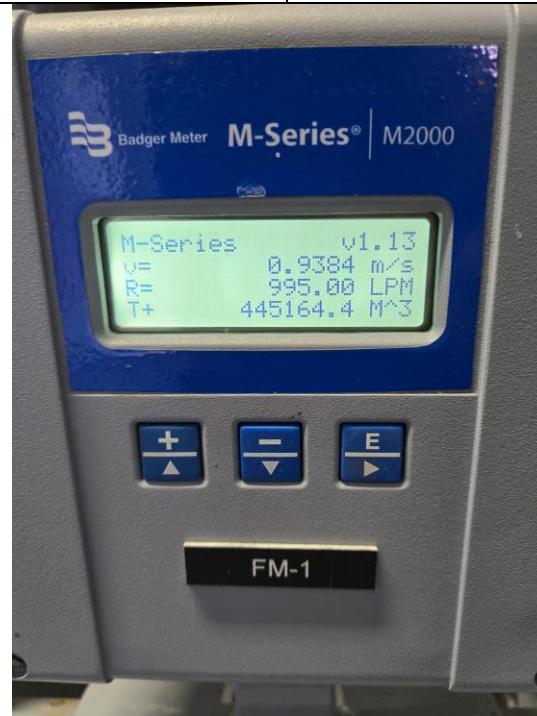
Photo No. 7

Digital monitoring of water intake located within the water treatment plant.

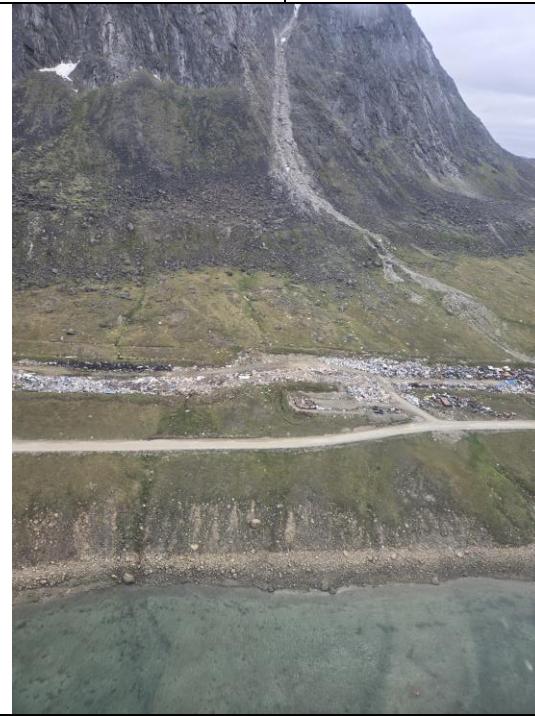
Photo No. 8

Aerial photo of Pangnirtungs Solid Waste Disposal Facility with bulk metals and bulk woods.

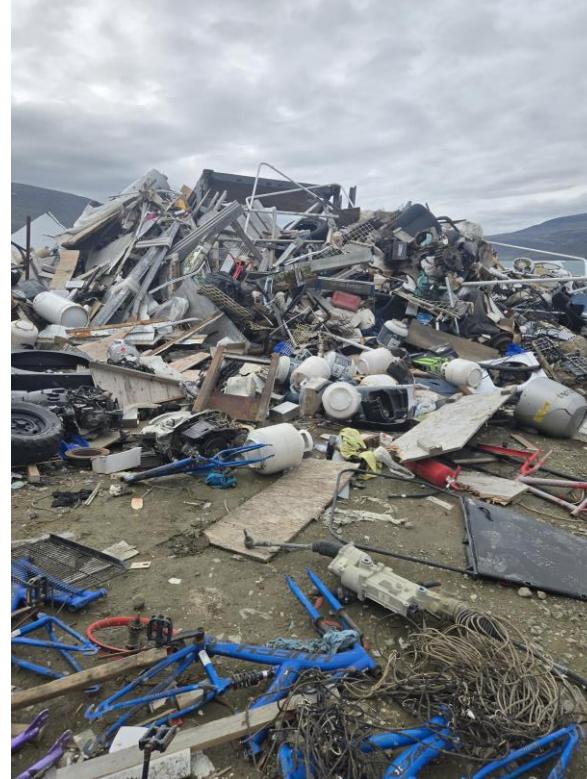
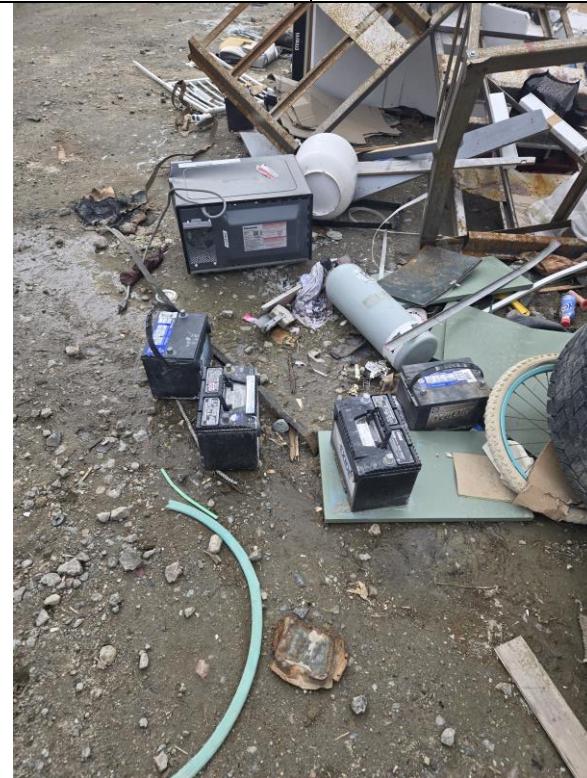
1. Sections of the fencing at the Solid Waste Facility were damaged and missing, allowing garbage to escape from the facility.
2. Hazardous Waste were found in the Solid Waste Facility, Burn Cap, and Waste Metal Facility.
3. Waste was observed outside of the Solid Waste Facility and was gathering in the culvert that leads to the ocean.
4. Hazardous Waste in the Hazardous Waste Facility was observed outside any form of secondary containment.

Different types of hazardous waste were found in the Solid Waste Disposal Facilities. These include propane tanks, batteries, paint cans, etc.

1. Wind-blown debris must be collected around the fencing and set in the appropriate waste facilities.
2. Damaged fencing at the Solid Waste Facility/Burn Cap must be repaired or replaced.
3. Hazardous Waste must be stored in a designated Hazardous Waste Facility.
4. Waste/garbage must be removed from the culverts to allow water to flow through the designated path.
5. Hazardous Waste must be placed within secondary containment or in a lined berm.

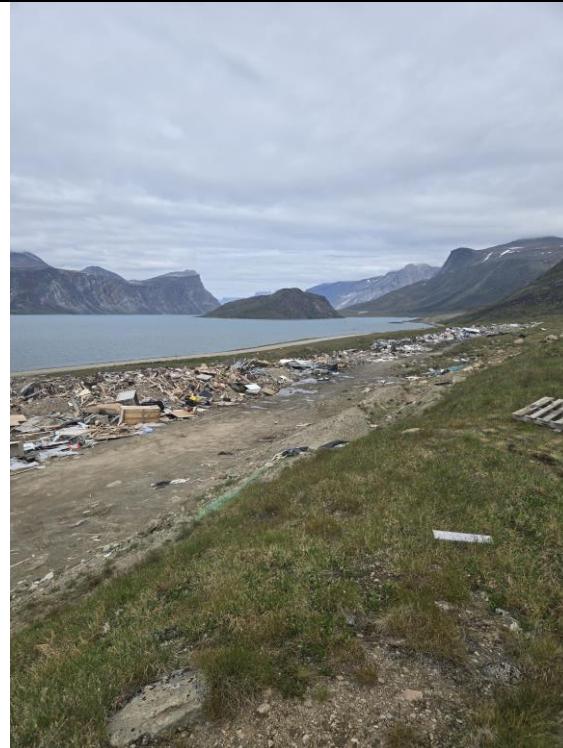
Photo No. 11

Photo of Solid Waste Disposal Facility facing North.

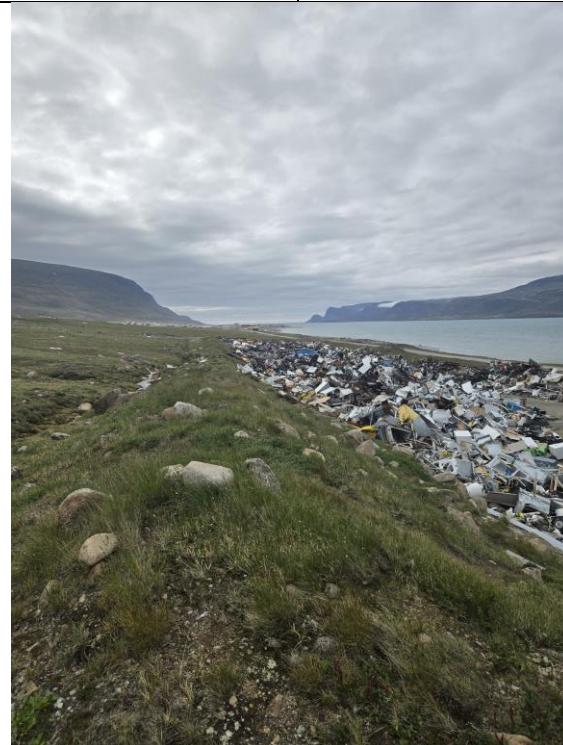
Photo No. 12

Photo of Solid Waste Disposal Facility facing South.

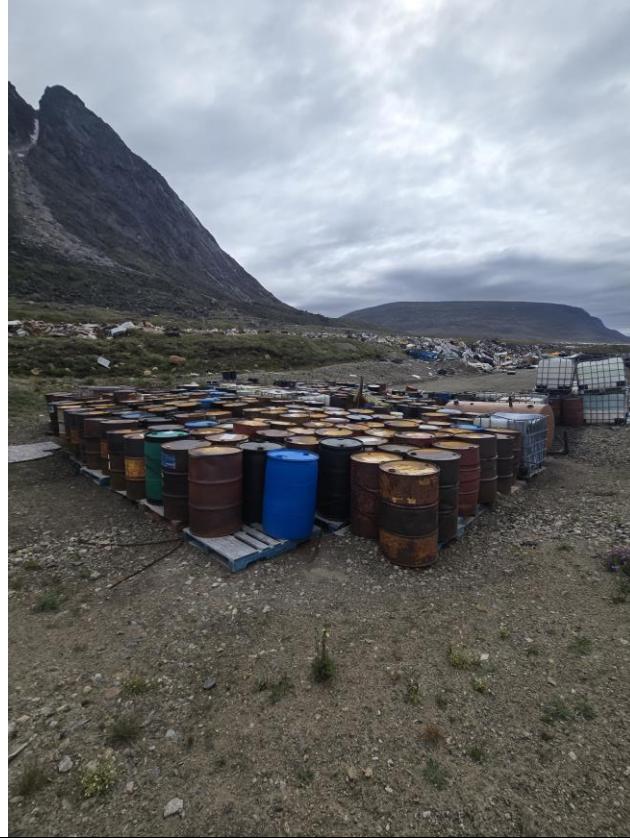
Photo No. 13

Pangnirtung Hazardous Waste Storage Facility.

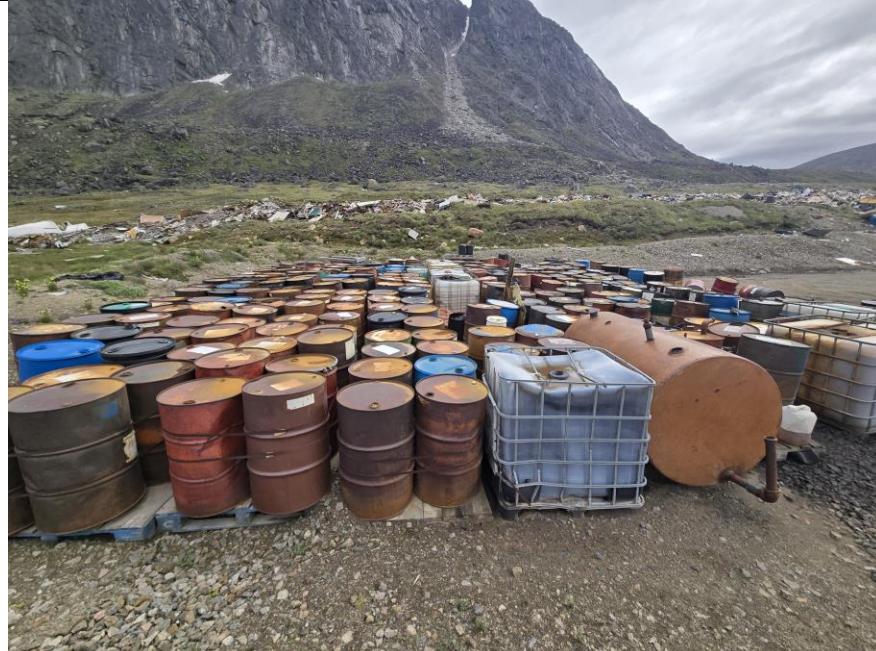
Photo No. 14

Photo of the contents observed at the Hazardous Waste Storage Facility.

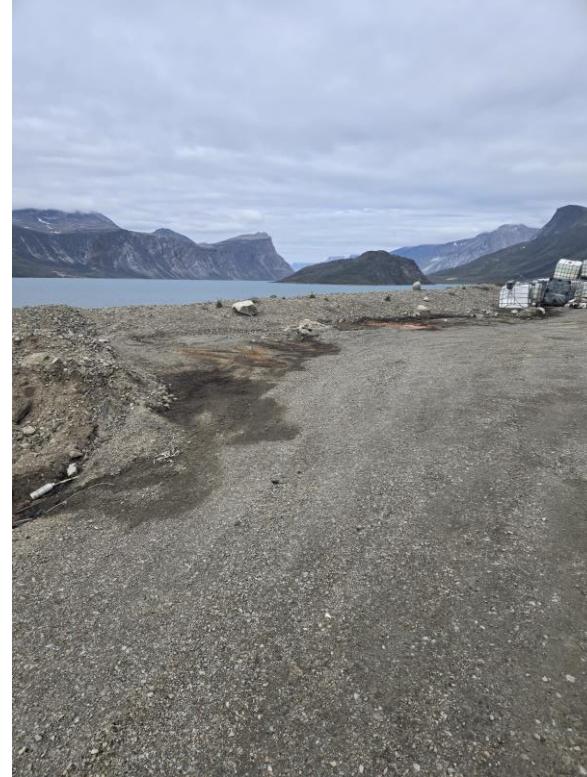
Photo No. 15

Ground staining was observed exiting the Hazardous Waste Disposal Facility.

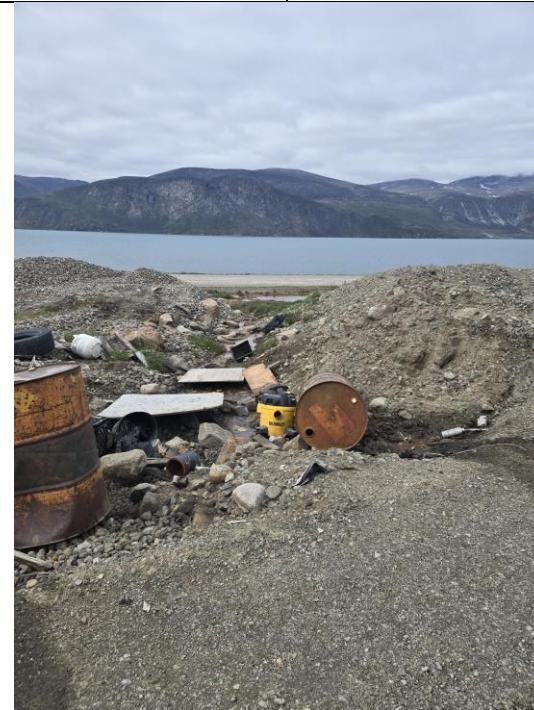
Photo No. 16

Photo of the ditch that exits the Hazardous Waste Storage Facility.

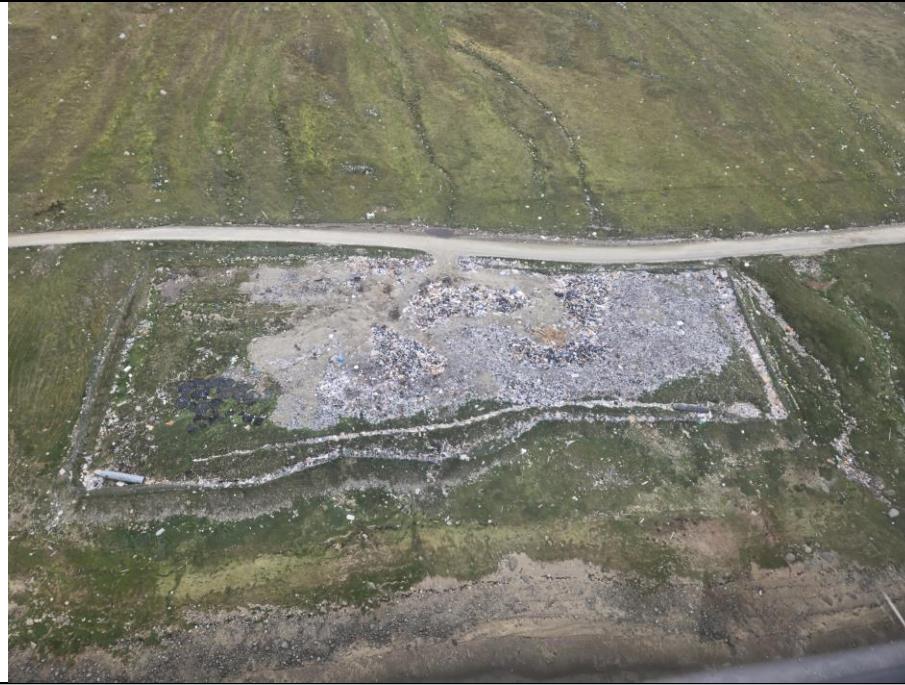
Photo No. 17

Aerial photo of the Solid Waste Disposal Facility with the burn and cap.

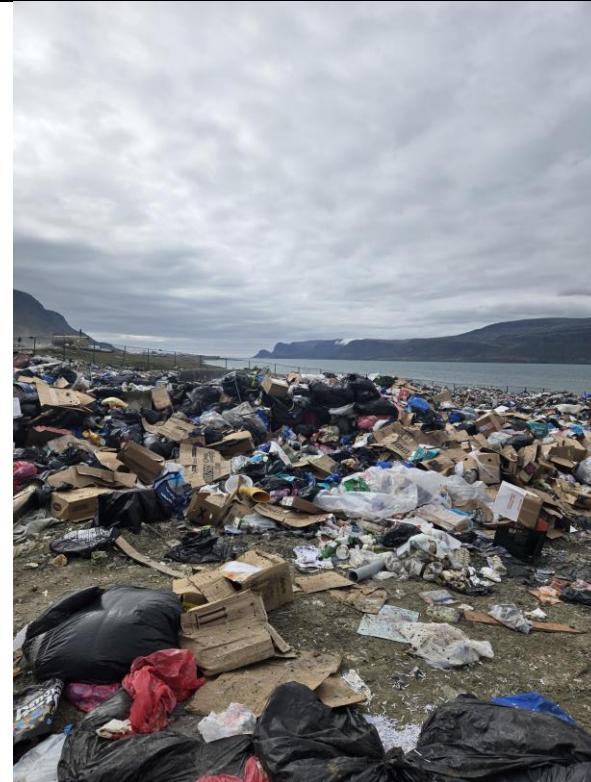
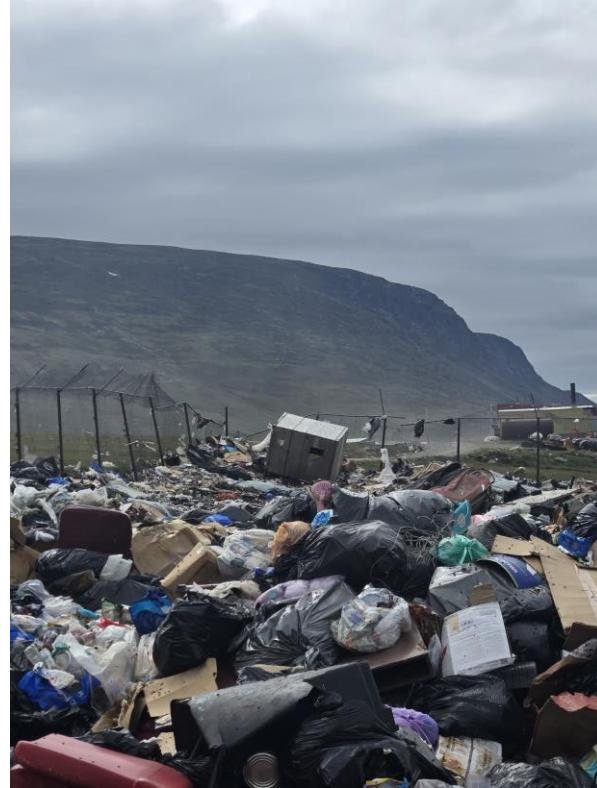
Photo of miscellaneous waste found inside the Solid Waste Disposal Facility.

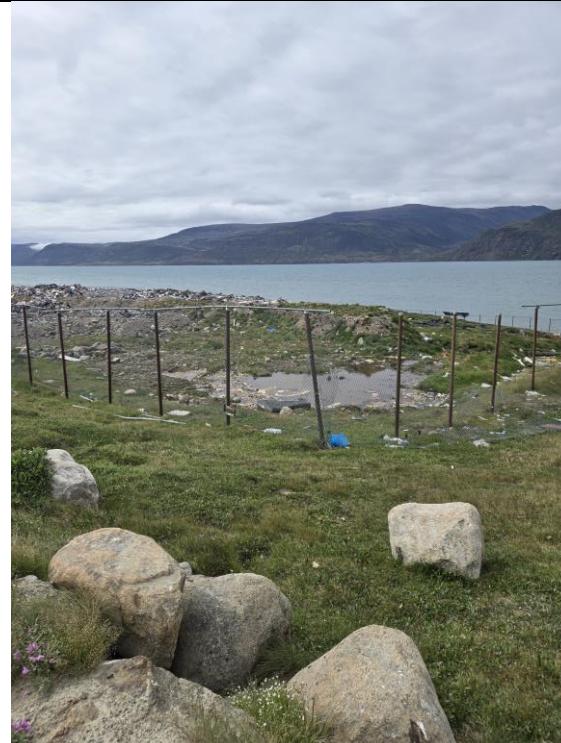
Photo No. 20

Sections of the fencing surrounding the facility has been damaged and is allowing wind-blown debris to escape the facility.

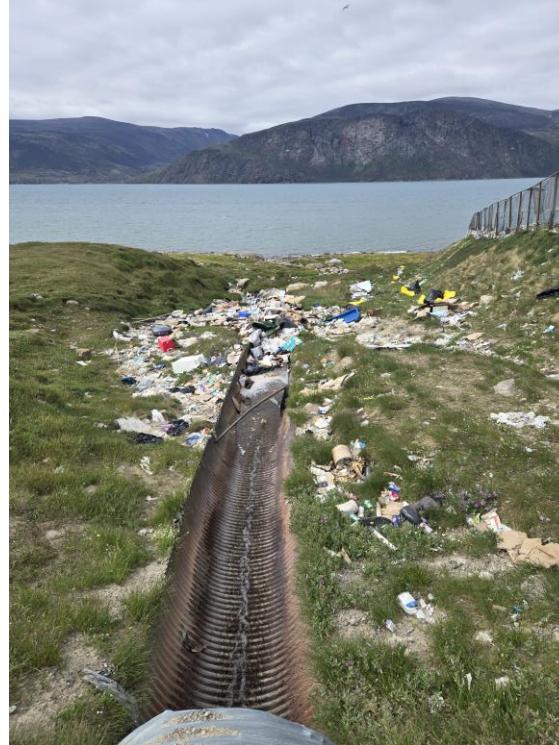
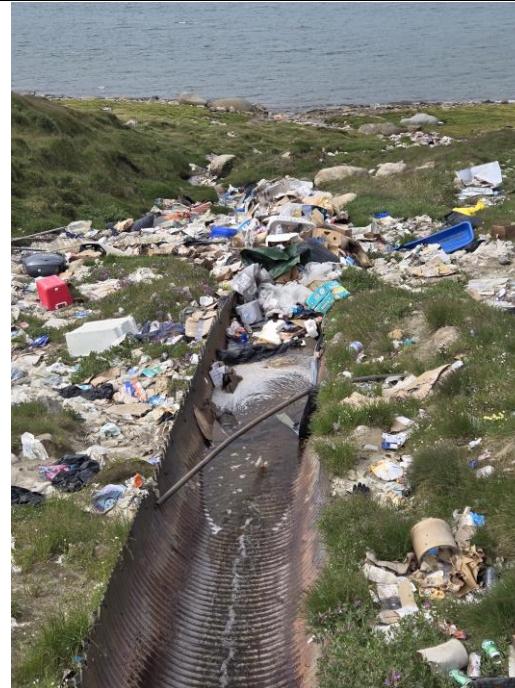
Photo showing garbage that has entered the culvert system outside the disposal facility.

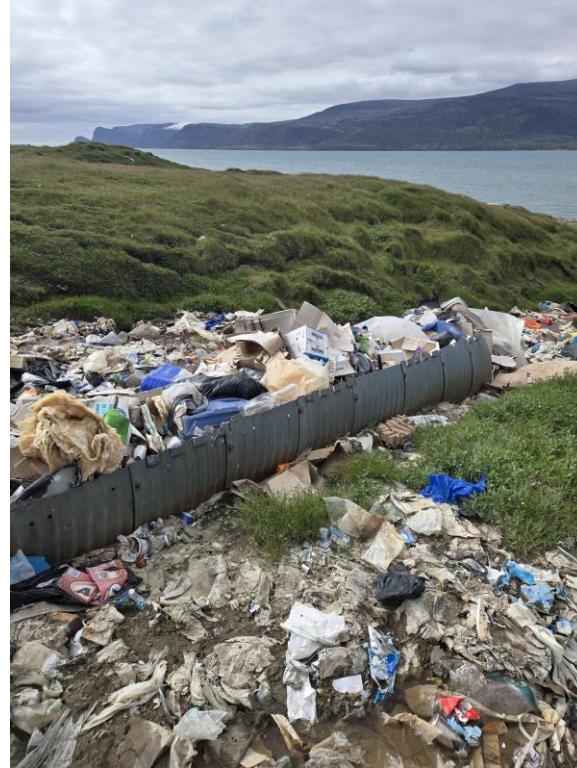
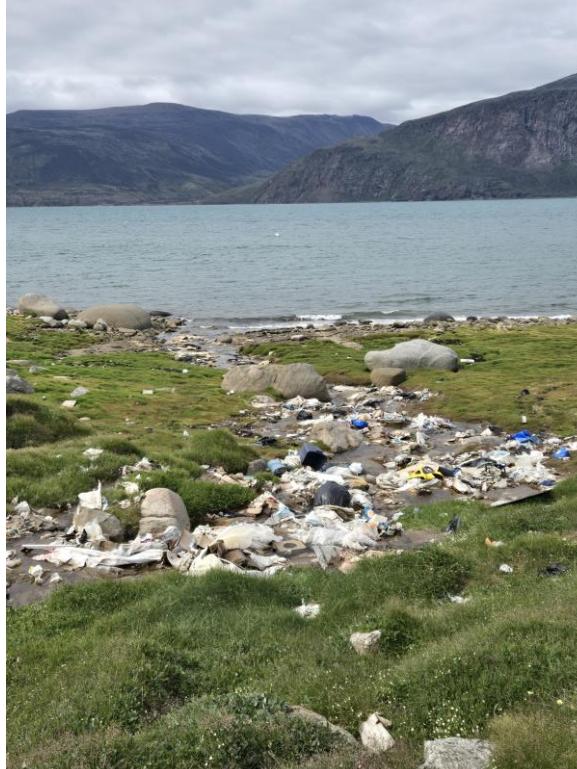
Garbage has begun to back up in the culvert. Garbage was seen following the stream towards the ocean.

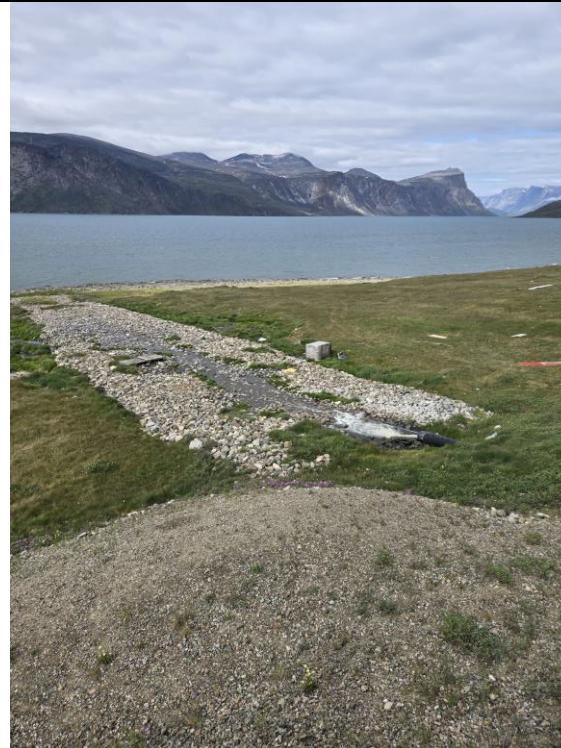
Photo No. 25

Photo of Pangnirtungs treated sewage being discharged down the spillway.

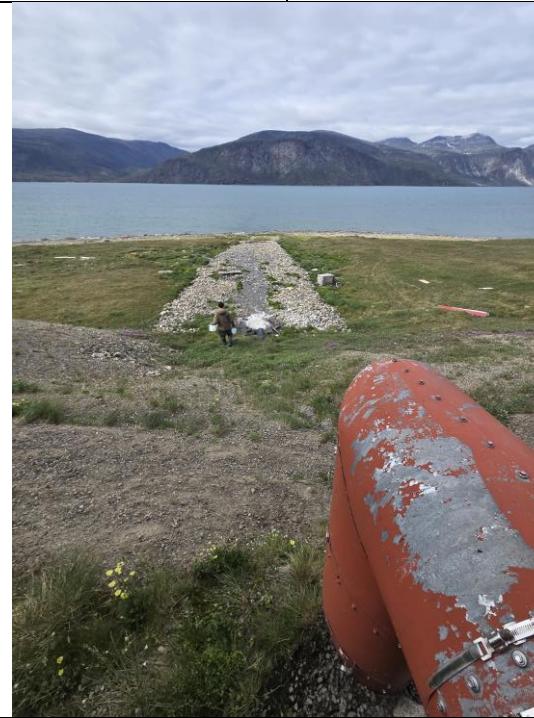
Photo No. 26

Photo of the exit pipe at the Sewage Treatment Facility. Raw sewage is treated and then discharged from the facility through this pipe.

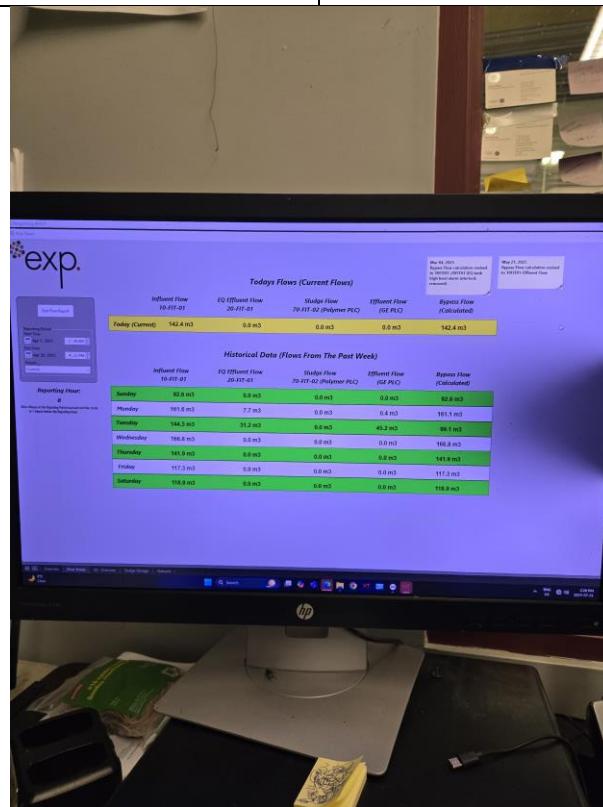
Photo No. 27

Monitoring program at the Sewage Treatment Facility. Data is recorded digitally and with paper copies.
