WATER LICENCE INSPECTION FORM

| Hamlet of Pangnirtung | Bhabesh Roy |
| 3AM-PAN1828 expiry May 3, 2028 | Municipal Engineer |
| October 7, 2021 | Joseph Monteith |

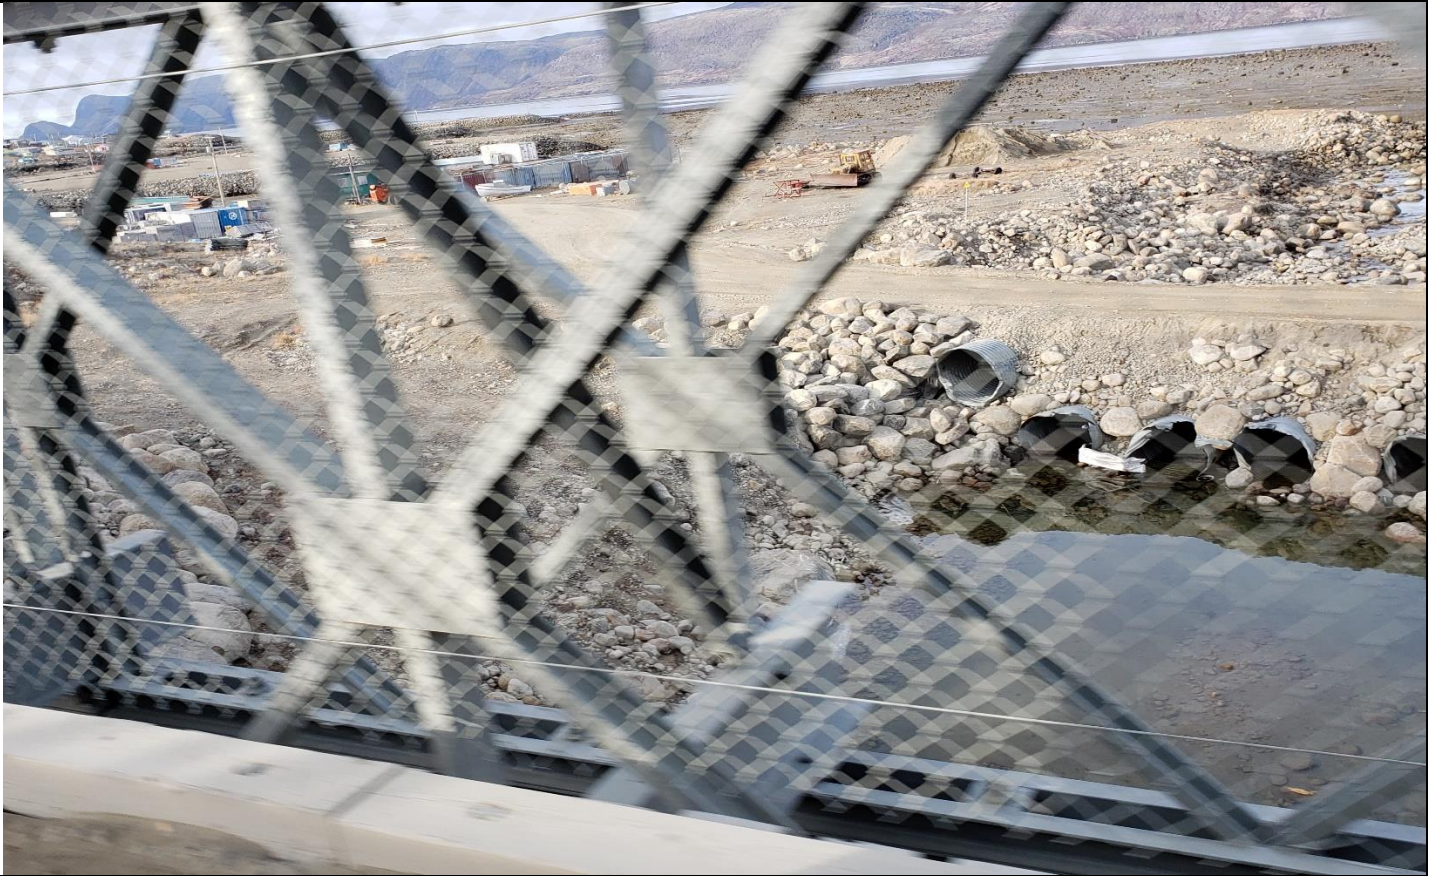
| Photo Log #1 | Location |
|---|---|
| Description: Culvert Bridge as observed from the Duval River Bridge. The culverts appear to be working as intended, but cobble stone mean to maintain structural integrity of road appears to have fallen to the entrances of the culverts. | |

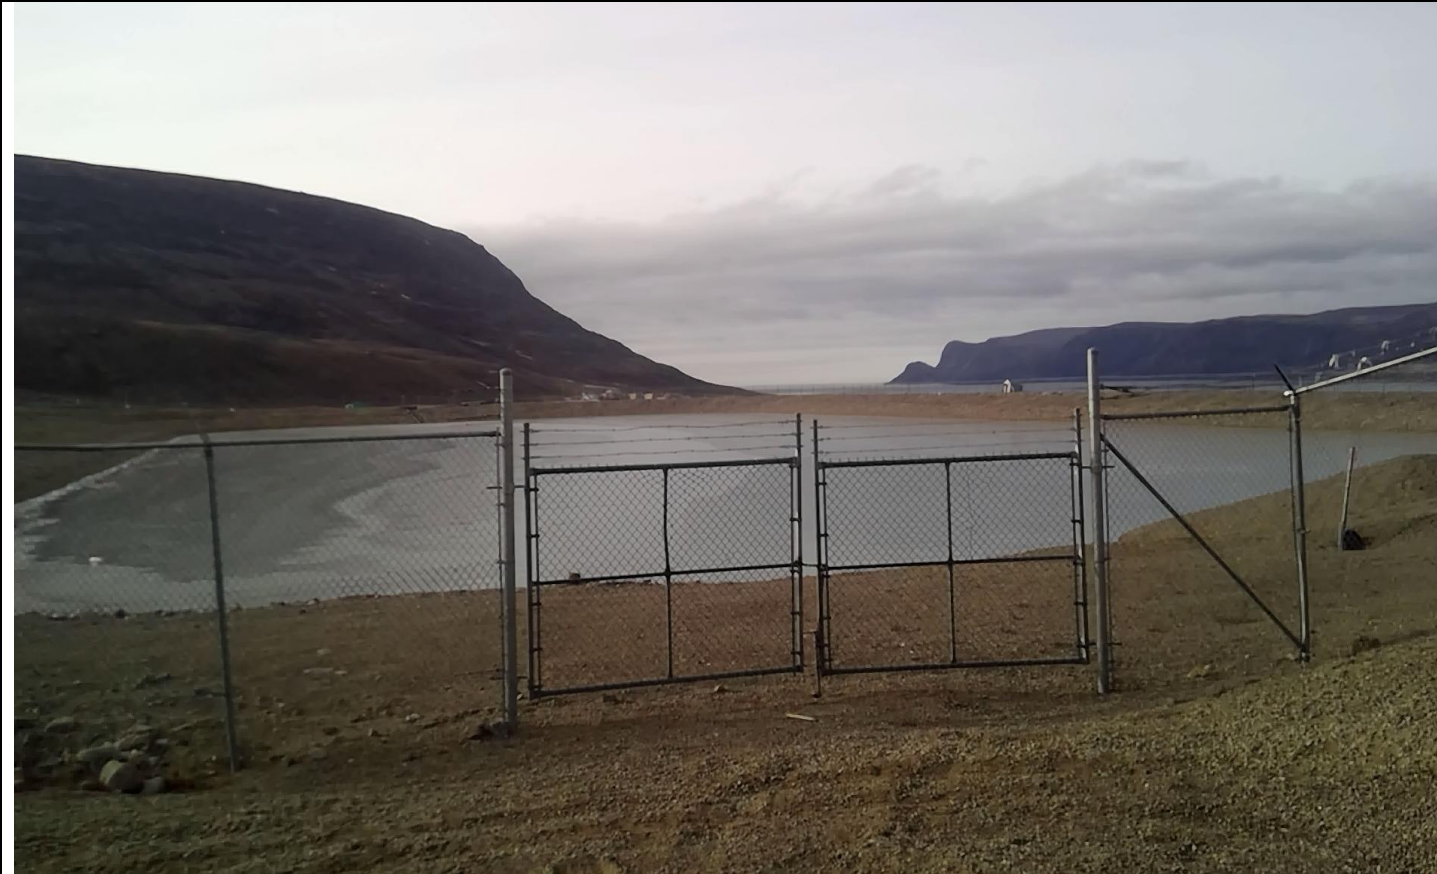
| Photo Log #1 | Location |
|---|---|
| Photo 3 | Pangnirtung |

Description: Water Reservoir capacity is 12,000m³ in the summer, and taking in considerations for the 1.8 metres of ice 71,000m³ in winter.

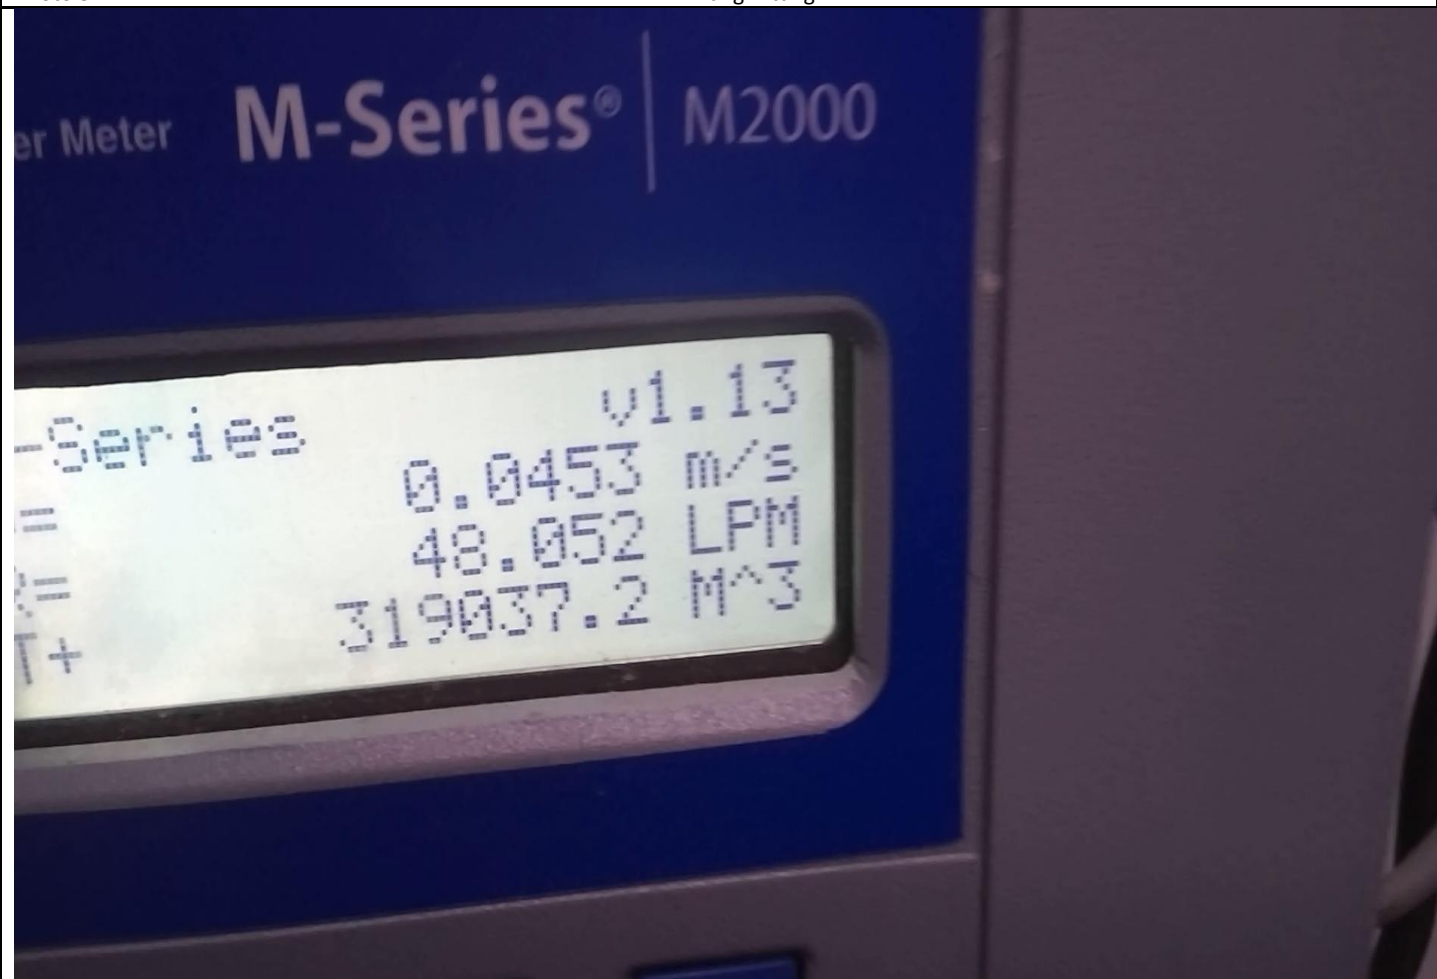
Photo 4

4. Water is delivered from the Water Treatment Plant by truck to the public.
5. Water Meter after reads 319037.2m³ (photo 4).
6. Water Technician log sheet were up to date and provided at the Waste Water Treatment Facility. First reading is 235260m³ and the second reading is 235532m³ (photo 5).
7. The Water Storage Reservoir capacity is 12,000m³ in the summer, and taking in considerations for the 1.8 metres of ice 71,000m³ in winter. It was reported that there was a leak in the west wall facing the community coming from a monitoring station, and culvert.

Description: Water Meter after reads 319037.2m³

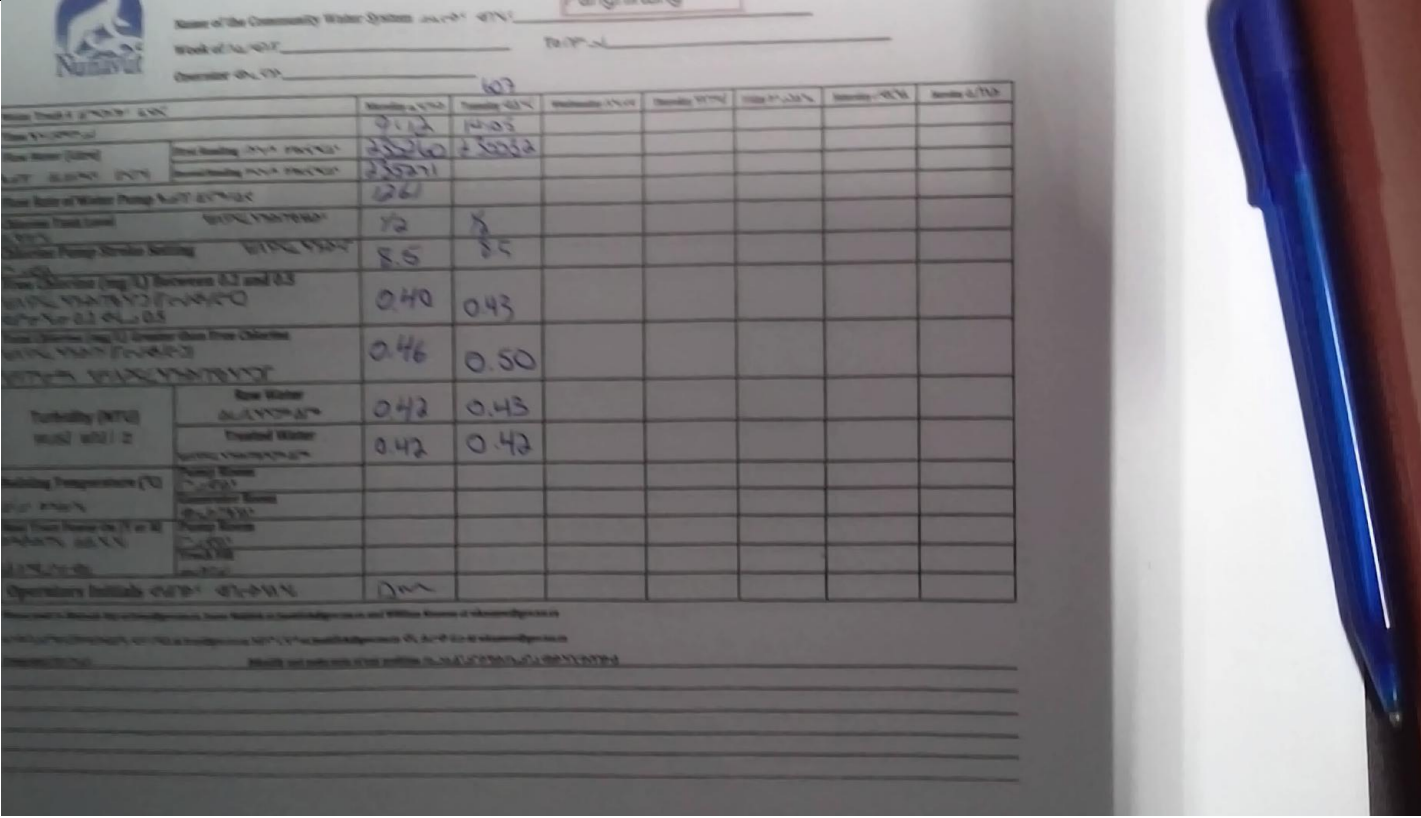
Photo 5

Description: Log Book in Water Treatment Facility. Readings appear to be in chronological order, but the dates haven't been filled in, so no date to ascertain the uniformity in recording. First reading is 235260m³ and the second reading is 235532m³

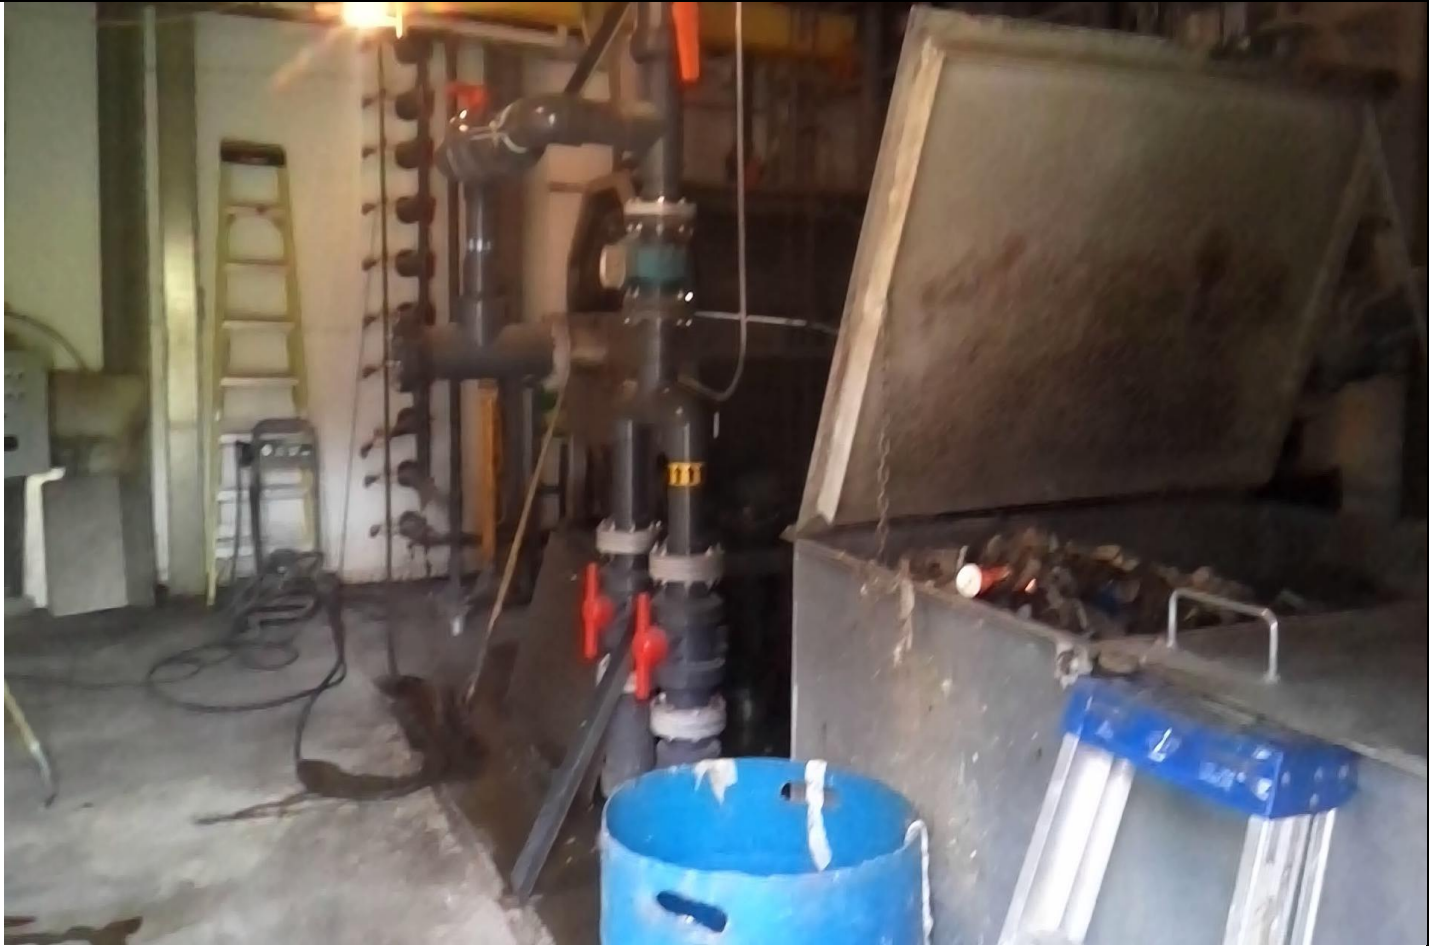
Photo 7

Description: Inside the receiving station of the Waste Water Treatment Facility on the right side of the road. Drainage basin on the side of the road. No issues with water entering facility. Waste from facility could migrate to this drainage basin. A truck had just deposited waste into the facility.

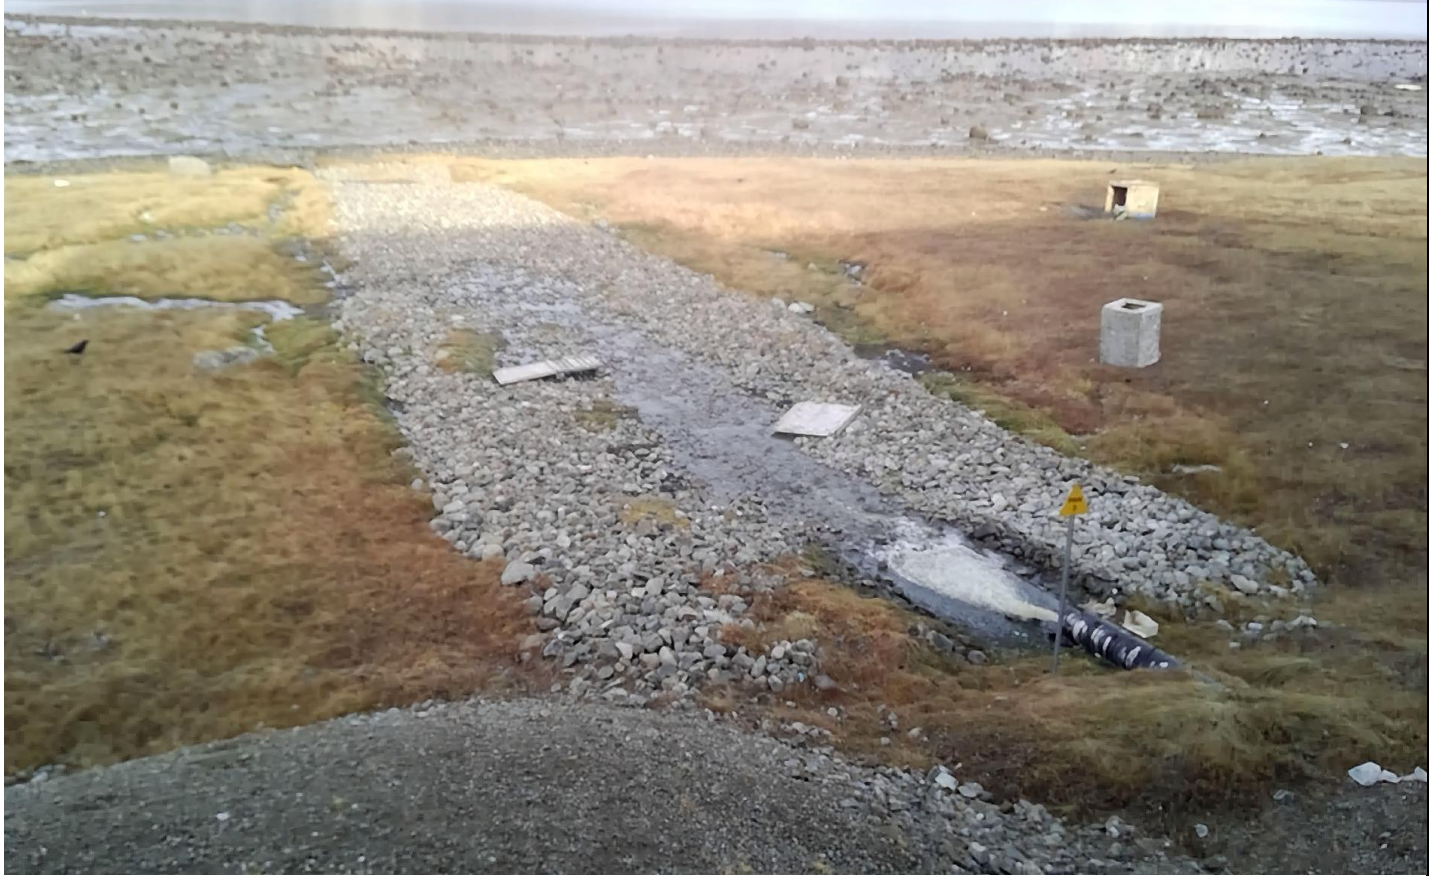
Photo 8

9. Liquid waste is discharged from the WWTP towards the ocean from a pipe that extends out 19 metres out (See photo 8). At the time of the inspection the WWTP was discharging waste directly to the receiving environment, it may be because the facility was decommissioned due to a mechanical issue within the facility.

Description: Spill from within the facility. Spill drains into a sump pit in the receiving side of the waste water facility. At the time of the inspection, it was unknown if the facility was operating as intended as there was no operator, and it appears that a truck that discharged into the facility, had triggered this decant. It is unknown whether the facility was doing any treatment.

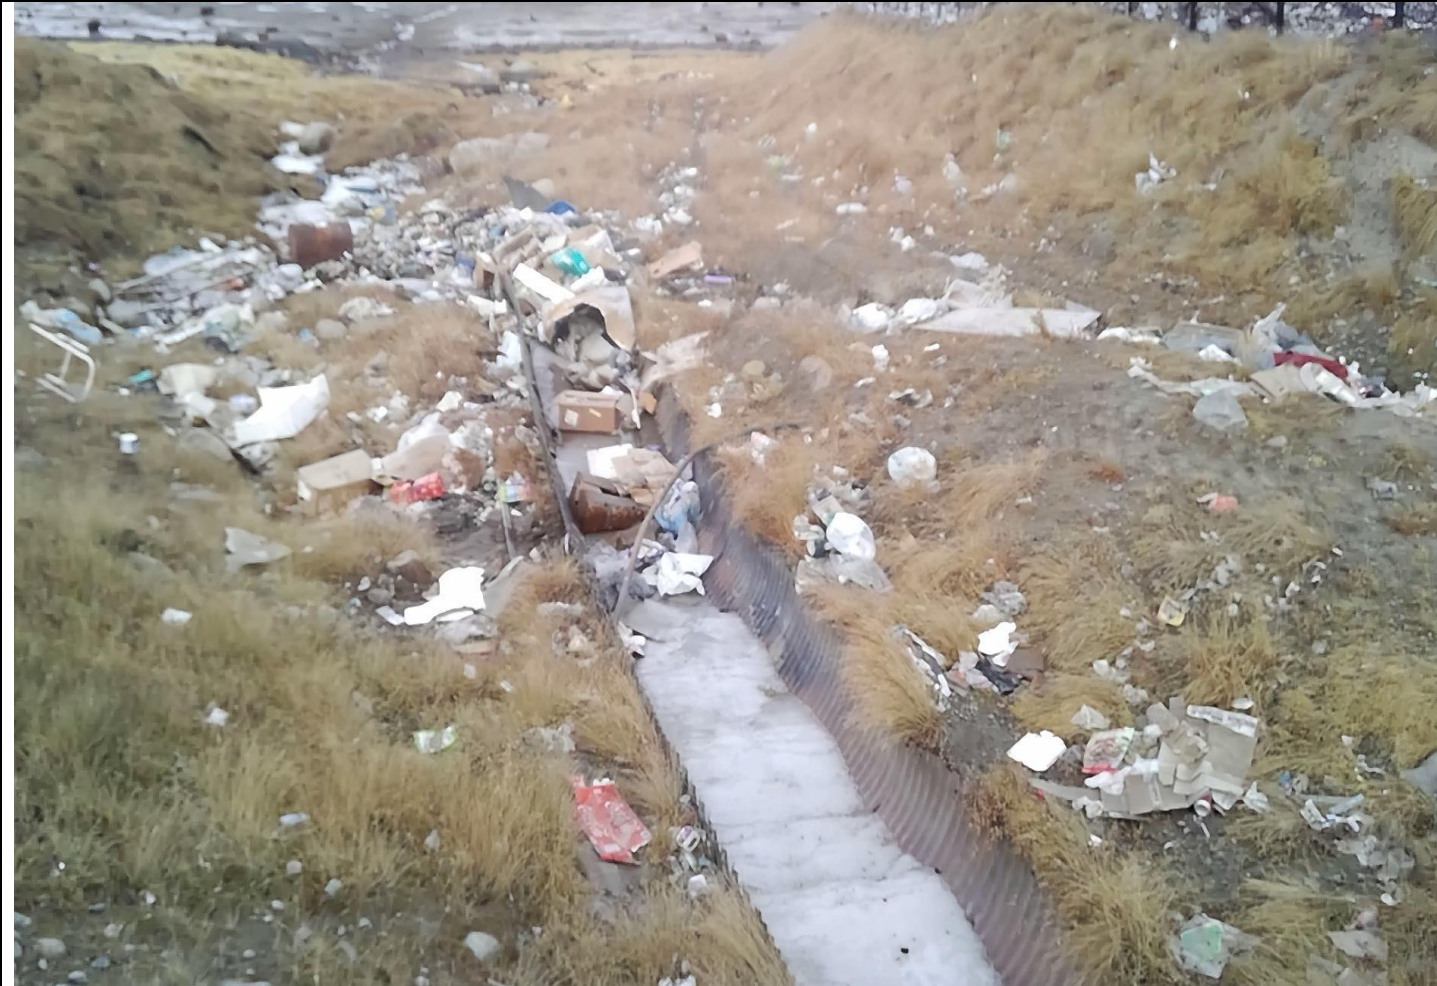
Photo 9

10. The burn and cap is fenced, and also has two drainage culverts at the base of the landfill. A drainage basing on East side of the burn and cap has large amounts of wind blown debris and bulk wood deposits (photo 9).

Description: Burning is conducted on the left, and the storage of the solid waste from the Waste Water Treatment Plant is on the right. Windblown garbage litters the drainage ditches on the sides of the Burn and Cap waste disposal facility. The beach side was cleaned up, the drainage ditch wasn't cleaned up.

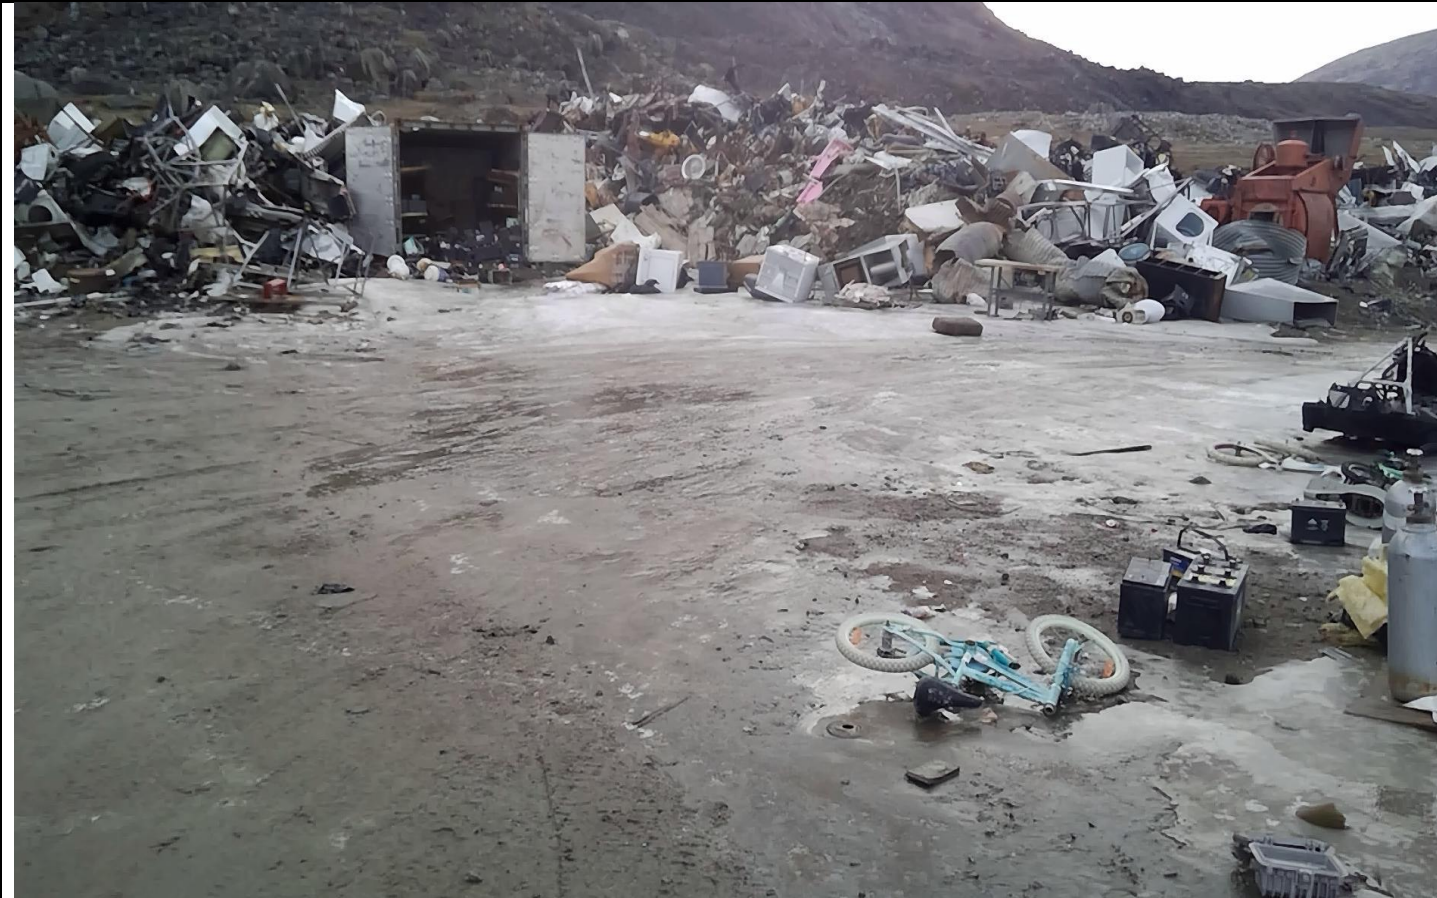
Photo 10

11. The bulk metals area contains such waste as vehicles, white waste, snowmobiles, and all-terrain vehicles, various sized storage tanks. It was observed that the containment walls meant to divert water and waste from entering and exiting this facility has retained water, and possibly mixed with waste. (photo 9, 10, and 18).

Description: Bulk Metals section. East Corner of the Bulk Metals Facility. The wall to divert water from entering the facility has washed away. The washed away wall, allows water to move through one of three hazardous waste facilities, and makes it haz

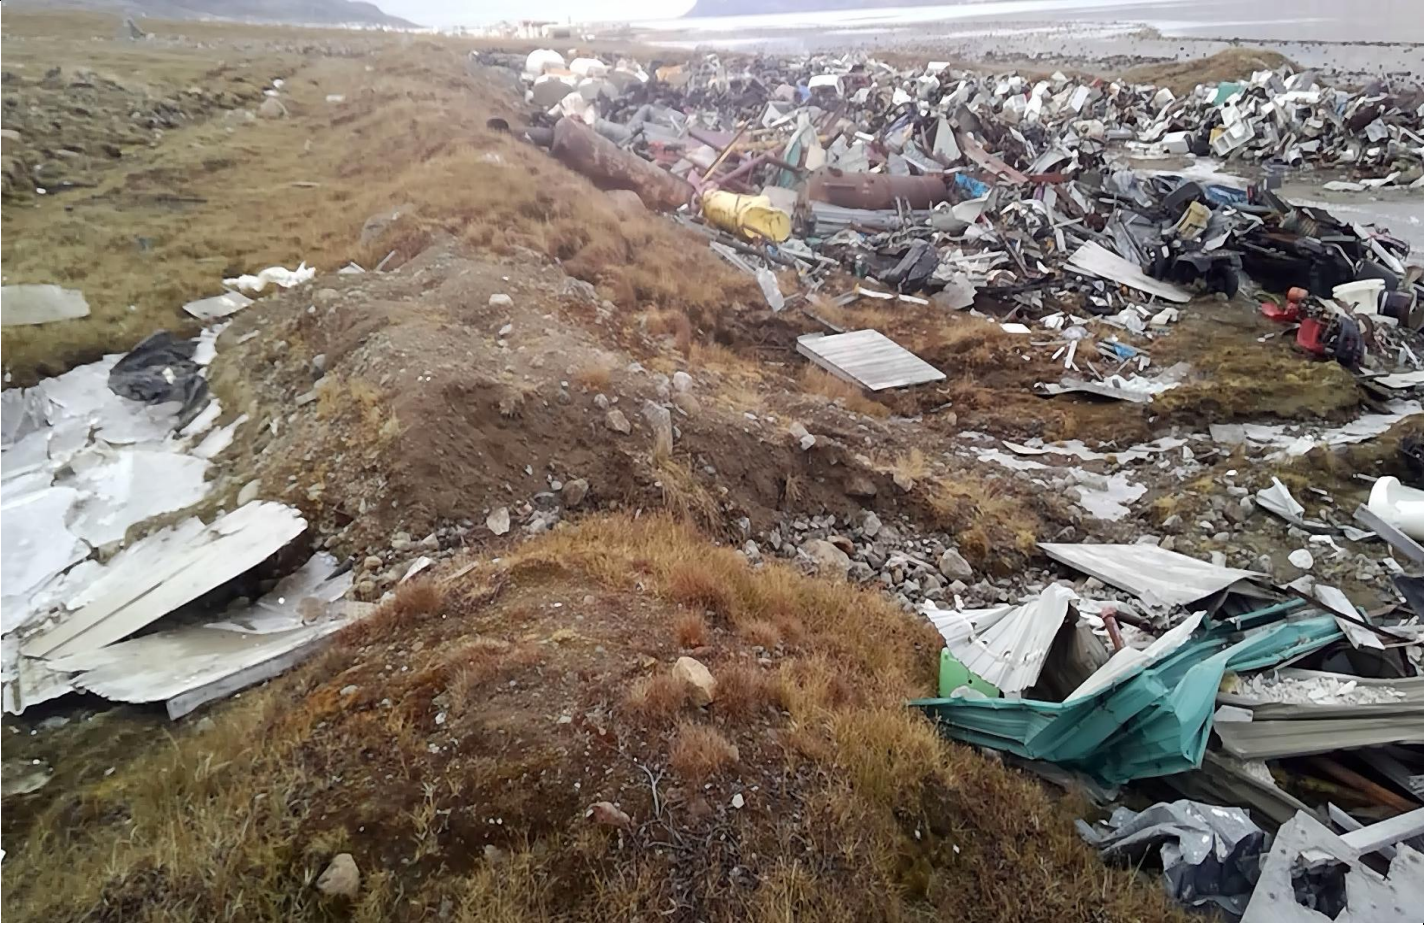
Photo 11

14. Hazardous Waste section contains a full sea can mostly of electronics, paint cans and batteries. Accessing the sea can proved unsafe due to the amount of abandoned snowmobiles, and other bulk metal in front of the sea can entrance. Walls of sea can are compromised, and cannot hold any leaks. The bulk metal and the hazardous waste does not have any fencing as required by Part E: Item 6. (Photo 9 &11).

Description: Hazardous Waste in the Bulk Metals section. . A couple of parts of the walls on the East side of the Bulk Metal, and Treated Wood appear to have washed out. These washed out walls need to be repaired to ensure that no water is entering the facility, and taking waste with it as it exits the facility.

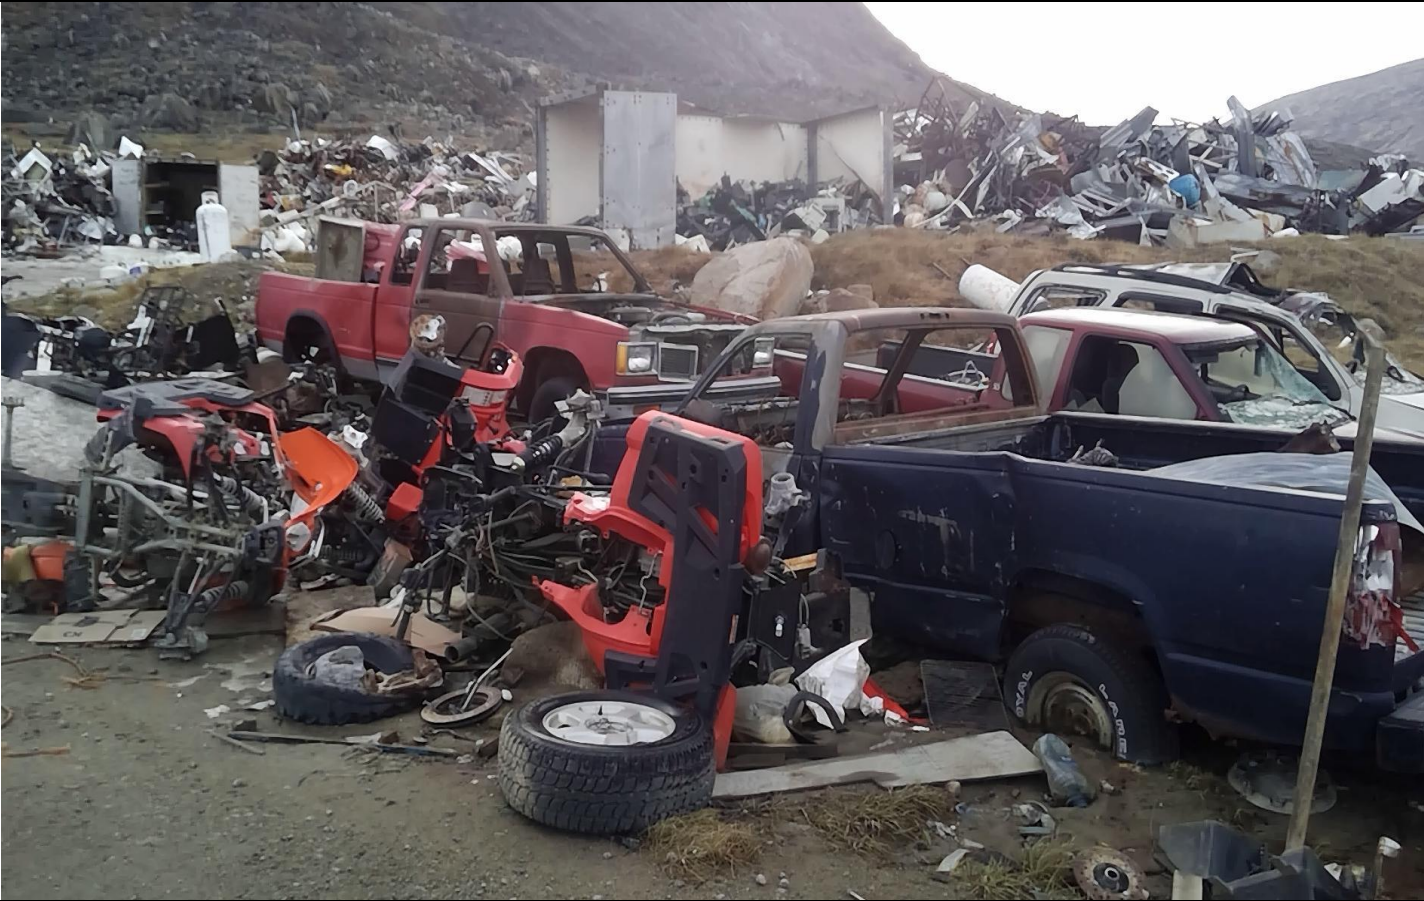
Description: The Bulk Metal Debris in front of Hazardous Waste Sea Can. Sea can is damaged; the wall observed in 2019 to be pushed out. New deposits of bulk metal along the entrance of the bulk metals and hazardous waste facilities.

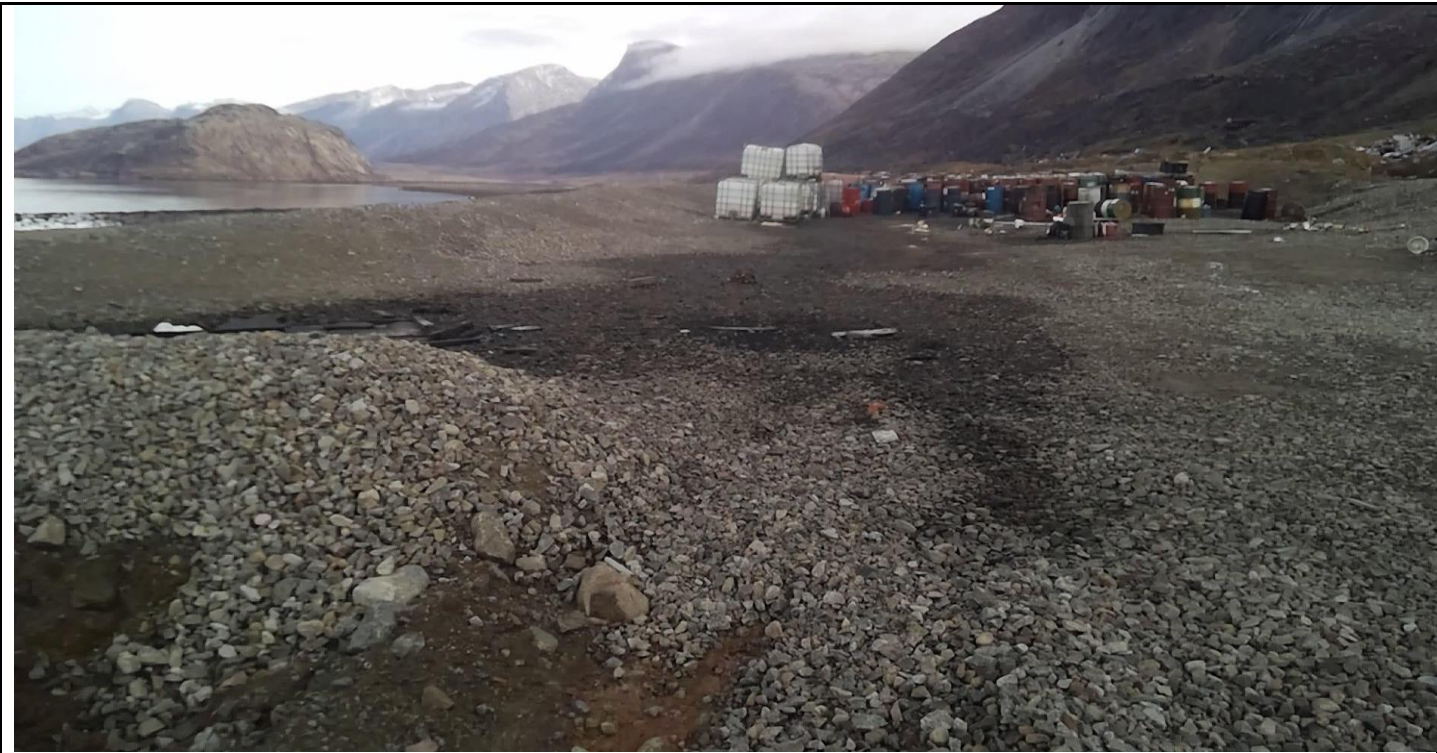
15. A separate and standalone Hazardous Waste non-engineered berm was constructed to address Spill Report 2019-244 (photos 12, 13, & 14). A submission of a Spill Report was requested due to the abundance of leaks, and spills that have damaged the surrounding vegetation and the amount of hazardous waste blowing away from the site (photo). The Spill Report was submitted on June 17, 2019. And issued Spill Report number 2019-244. This spill report won't be closed off till the spills has been cleaned up, and a report to confirm that the spill has been cleaned up. It was observed that large spills did occur in the newly built non engineered berm for hazardous waste and still has gone un reported (photo 14, & 15). The spill observed appeared to be migrating towards the entrance to the non engineered hazardous waste berm (photo 15).

Description: The drums from Spill Report 2019-244, placed into a non-engineered secondary containment. New spill migrating towards the opening of the non-engineered berm for hazardous waste. A spill report should be generated for this spill, and mitigate the migration of it.

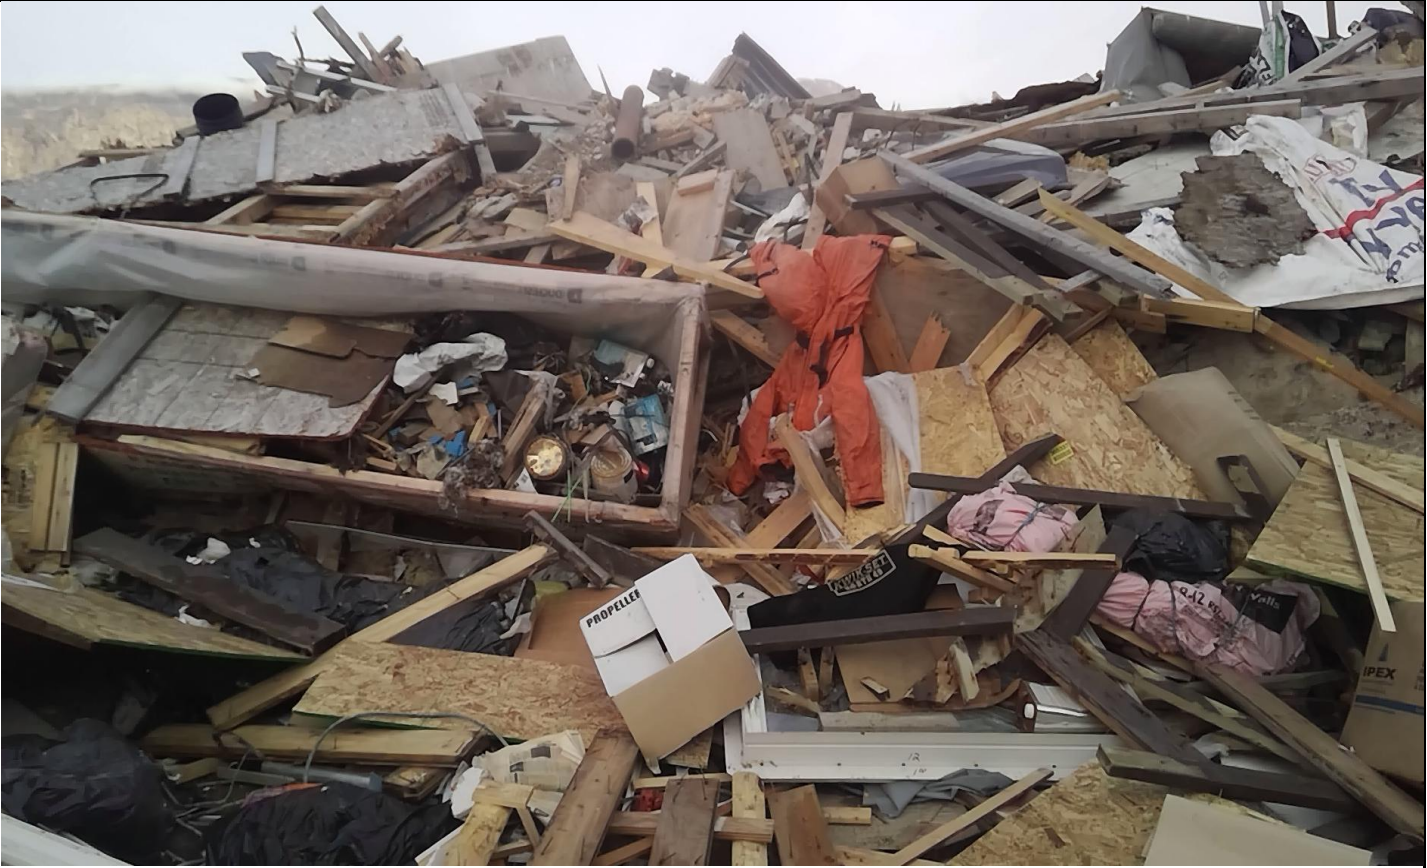
12. Hazardous Waste was found throughout the Bulk woods section such as paint cans, and batteries(photo 16).
13. The Bulk Metals section is merged with the Hazardous Waste section (photo 9).

Description: Bulk Woods section, Signs of hazardous waste mixed with bulk woods.

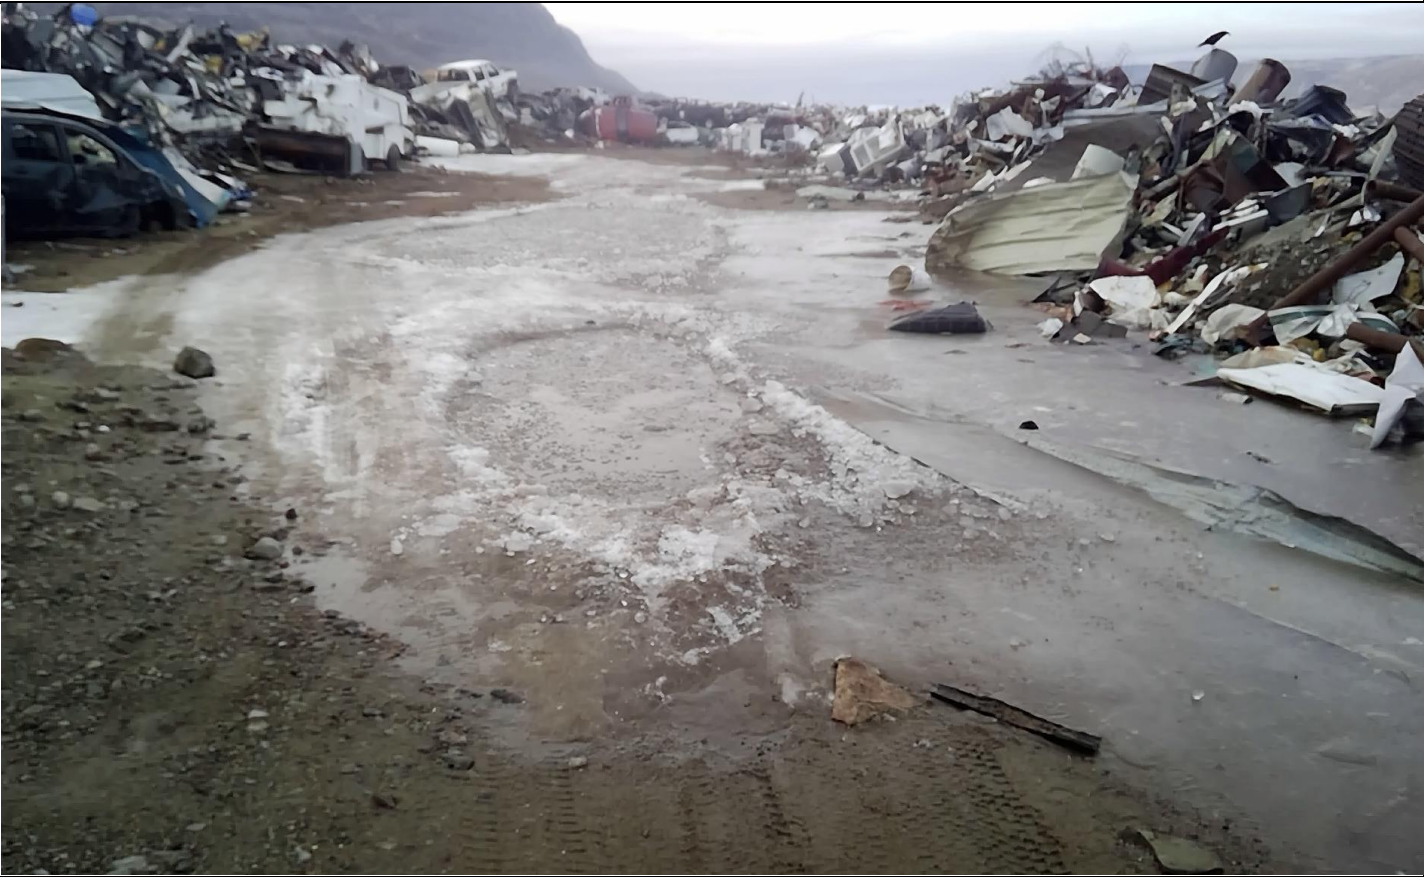
Description: Buildup of surface water within the Bulk Metals section of the Solid Waste Facility.
