WATER LICENCE INSPECTION FORM

Licensee	Licensee Representative
Hamlet of Pangnirtung	Gord Marinic
Licence No. / Expiry	Representative's Title
3AM-PAN1828	Municipal Engineer
Land / Other Authorizations	Land / Other Authorizations
1BW-DUV2025	
Date of Inspection	Inspector
June 22, 2022	Joseph Monteith
Activities Inspected	
<div><input type="checkbox"/> Camp<input type="checkbox"/> Drilling<input type="checkbox"/> Mining<input type="checkbox"/> Construction<input type="checkbox"/> Reclamation<input type="checkbox"/> Fuel Storage</div> <div><input type="checkbox"/> Fuel Storage<input type="checkbox"/> Other:<input type="checkbox"/> Other: Water Use &amp; Waste Disposal</div>

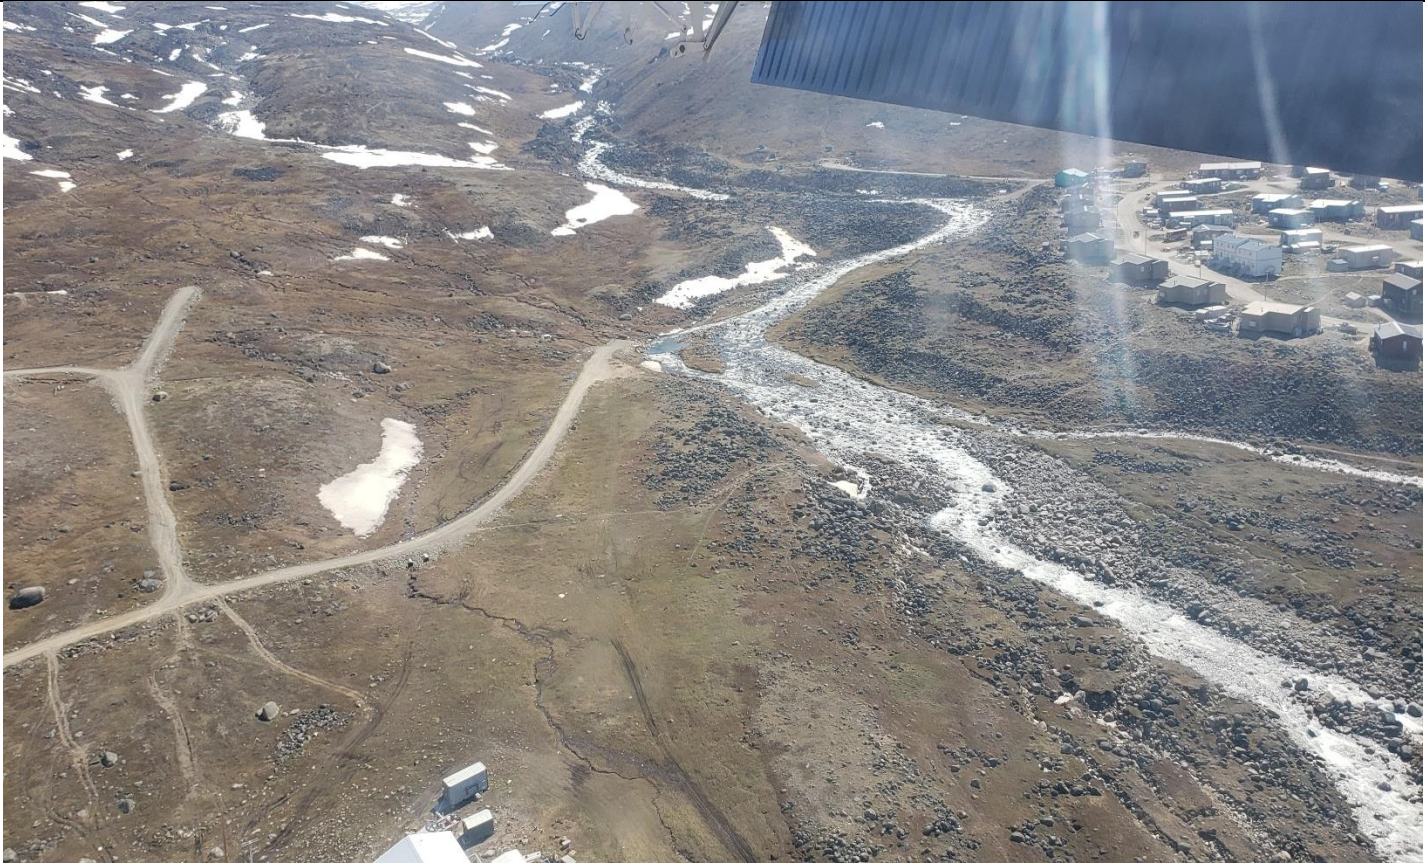
Photo 3

3. The Water from Duval River is deposited into a reservoir next to the Water Treatment Facility (photo 3).
4. Water is delivered from the Water Treatment Plant by truck to the public.
5. Water Meter after reads 275587.9m<sup>3</sup> (photo 4).
6. Water Technician log sheet were up to date and provided at the Waste Water Treatment Facility. First reading is 235260m<sup>3</sup> and the second reading is 235532m<sup>3</sup> (photo 5).
7. The Water Storage Reservoir capacity is 12,000m<sup>3</sup> in the summer, and taking in considerations for the 1.8 metres of ice 71,000m<sup>3</sup> in winter. It was reported that there was a leak in the west wall facing the community coming from a monitoring station, and culvert.

**Description:** Water Reservoir capacity is 12,000m³ in the summer, and taking in considerations for the 1.8 metres of ice 71,000m³ in winter.

- Provide an action plan to clean up the site of Spill Report 2019-244;
- Find the reason why there is water leaks coming from the water reservoir and repair;
- Repair the walls to the Bulk Metals, and Bulk Woods on the Eastern Wall, so that surface water may not enter the facility;
- Submit spill report for the spills in the newly built non engineered berm for hazardous waste;
- Erect a fence surrounding the Metal and Hazardous Waste Storage Area as per Part E: Item 8;
- Submit a spill report for the dump fire at the Bulk Wood and Hazardous Waste sections of the Solid Waste Facility.

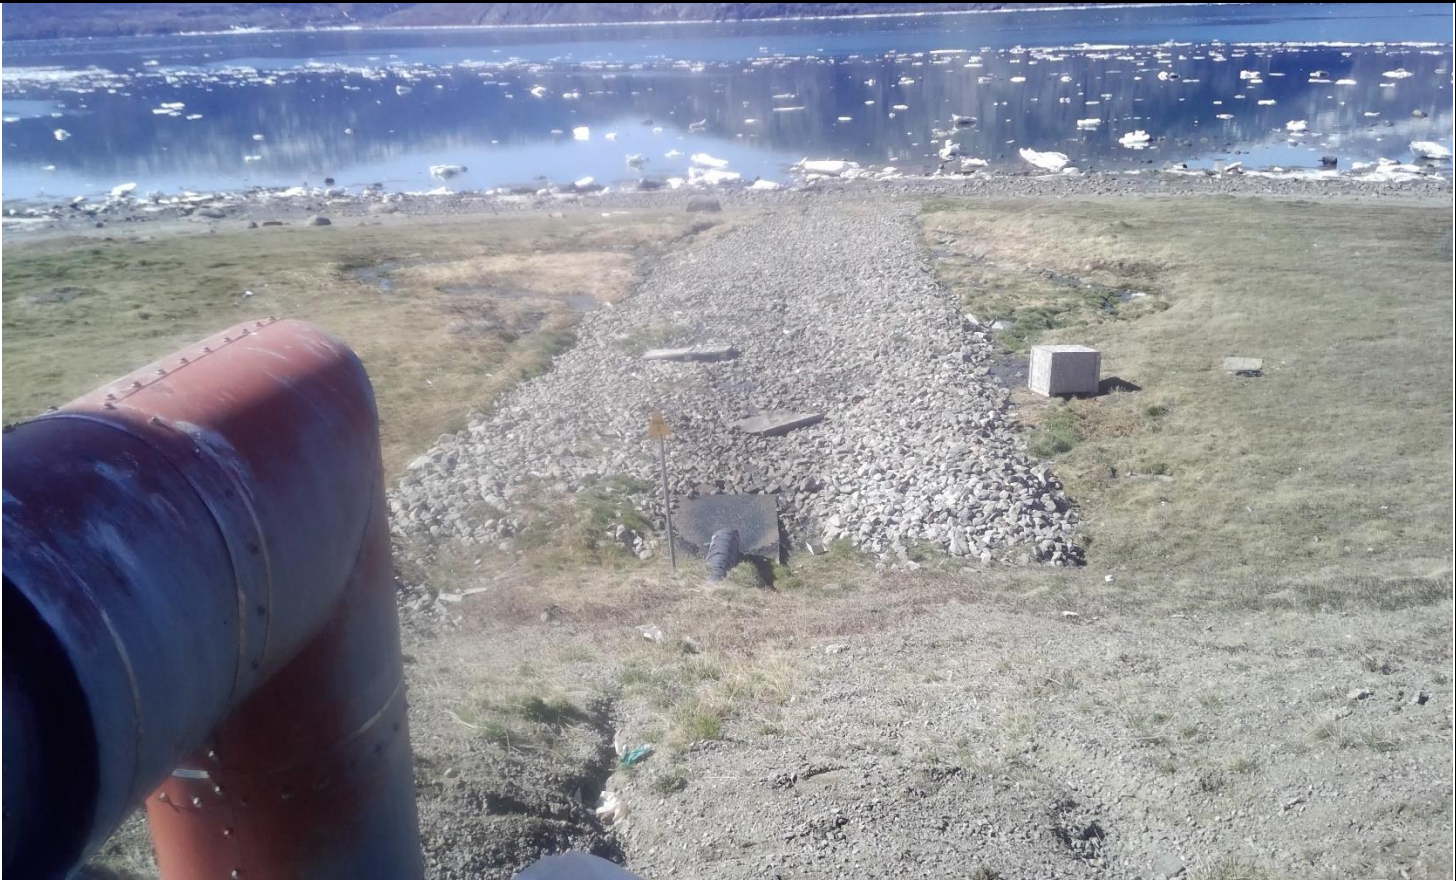
Photo 9

12. The burn and cap is fenced, and also has two drainage culverts at the base of the landfill. A drainage basing on East side of the burn and cap has large amounts of wind blown debris and bulk wood deposits (photo 9).

Description: The drainage ditch next to the fenced in burn and cap facility. Littered with domestic wind blown debris.

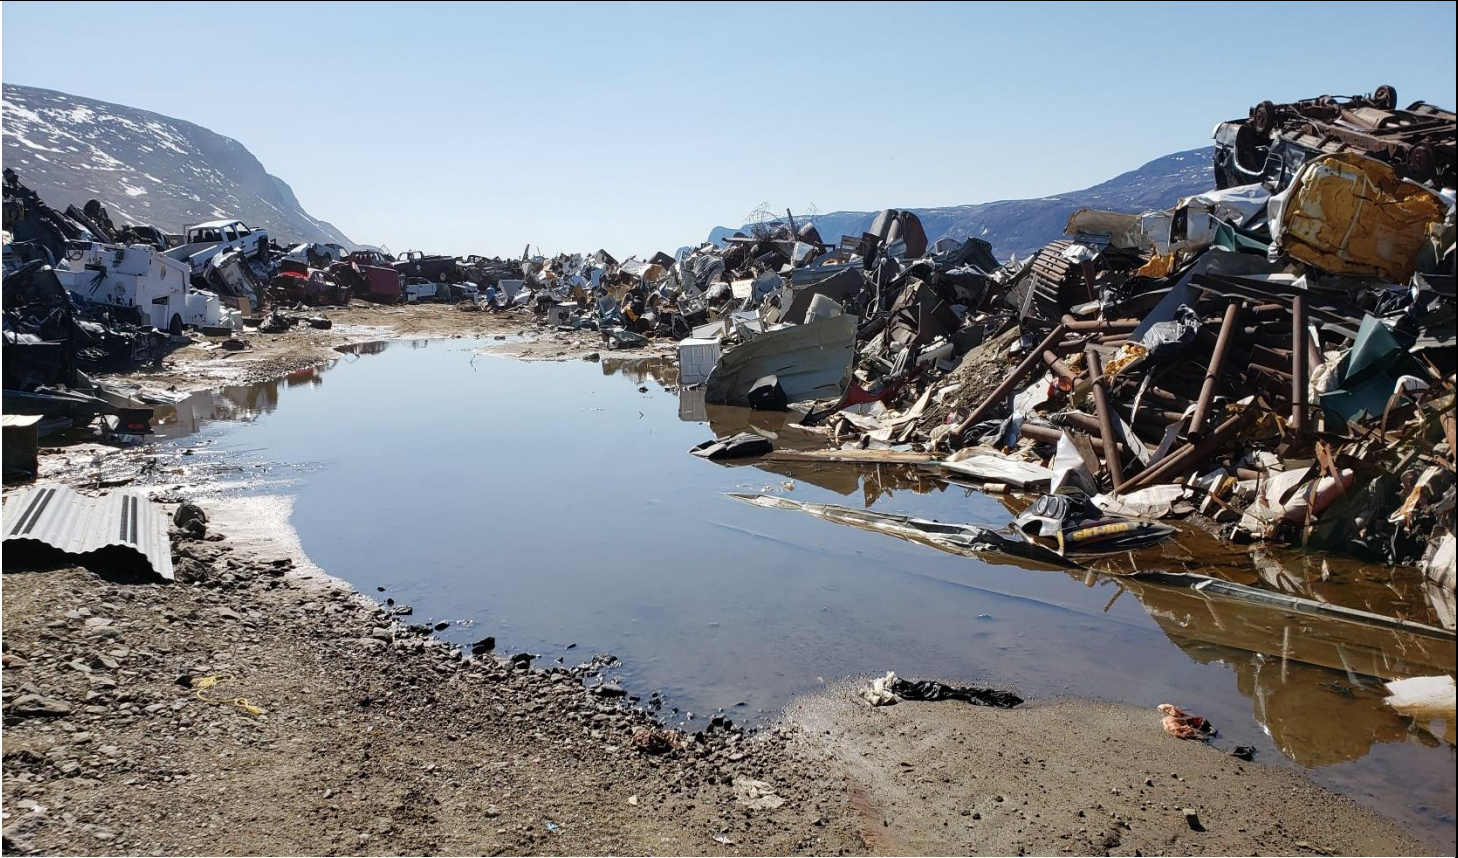
Photo Log #1	Location
Photo 10	Pangnirtung

13. The bulk metals area contains such waste as vehicles, white waste, snowmobiles, and all-terrain vehicles, various sized storage tanks. It was observed that the containment walls meant to divert water and waste from entering and exiting this facility has retained surface water. (photo 10 & 11).

Description: Bulk Metals section. East Corner of the Bulk Metals Facility. The wall to divert water from entering the facility has washed away. The washed away wall, allows surface water to move through one of three hazardous waste facilities.

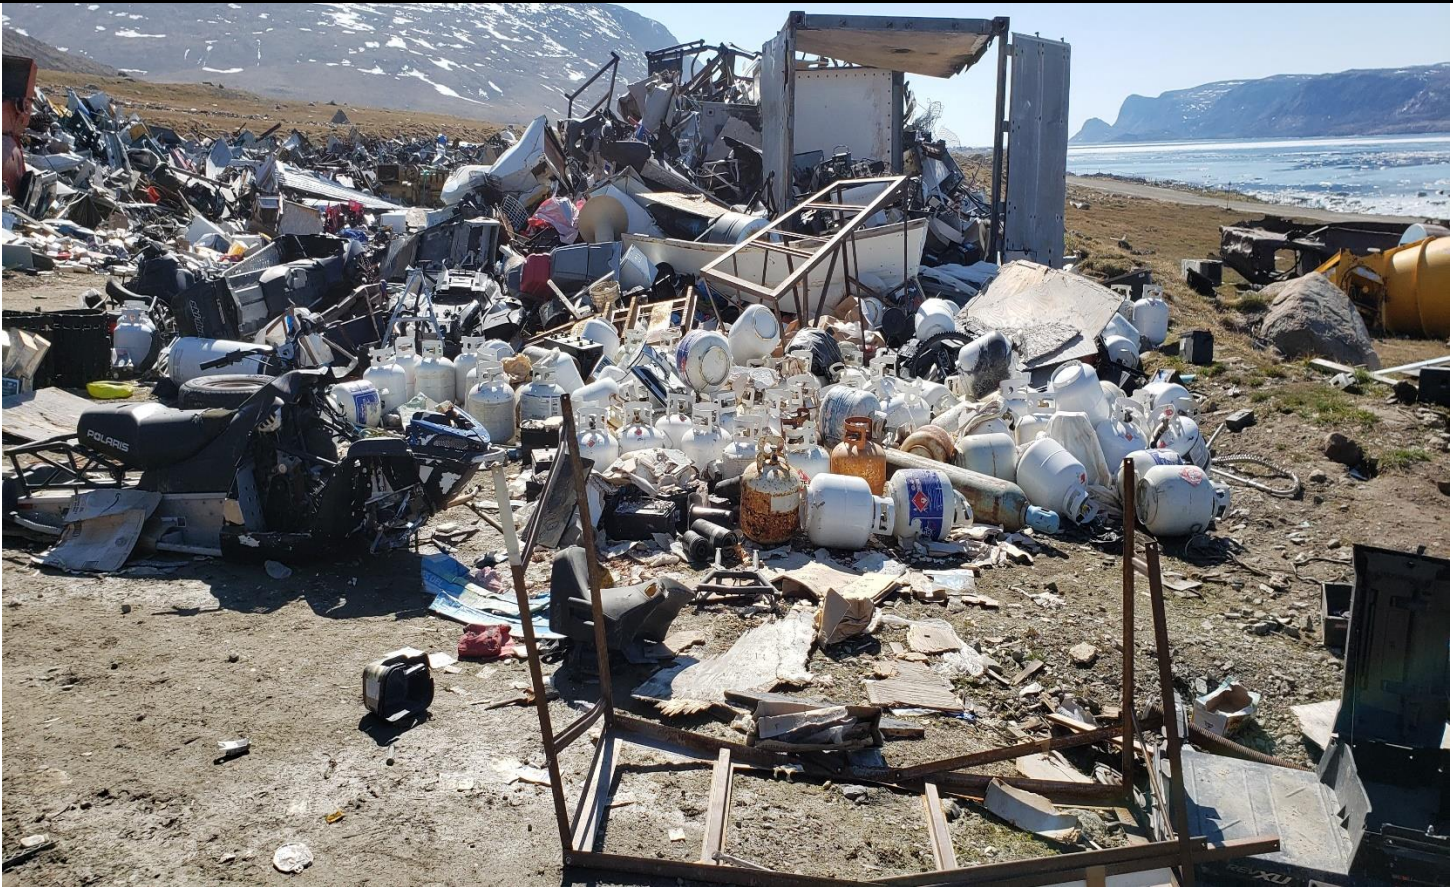
Photo 13

**Description:** Site of Spill Report 2019-244. All the sources of the spills were removed and placed into a non-engineered berm on the opposite side of the road, and at the entrance to the Bulk Metals facility. The spills that leaked out of the drums hasn't been cleaned up, and the spill report will remain open till it has been cleaned up. A report should be generated as per the license to provide a status update, and plans to clean up the spill.

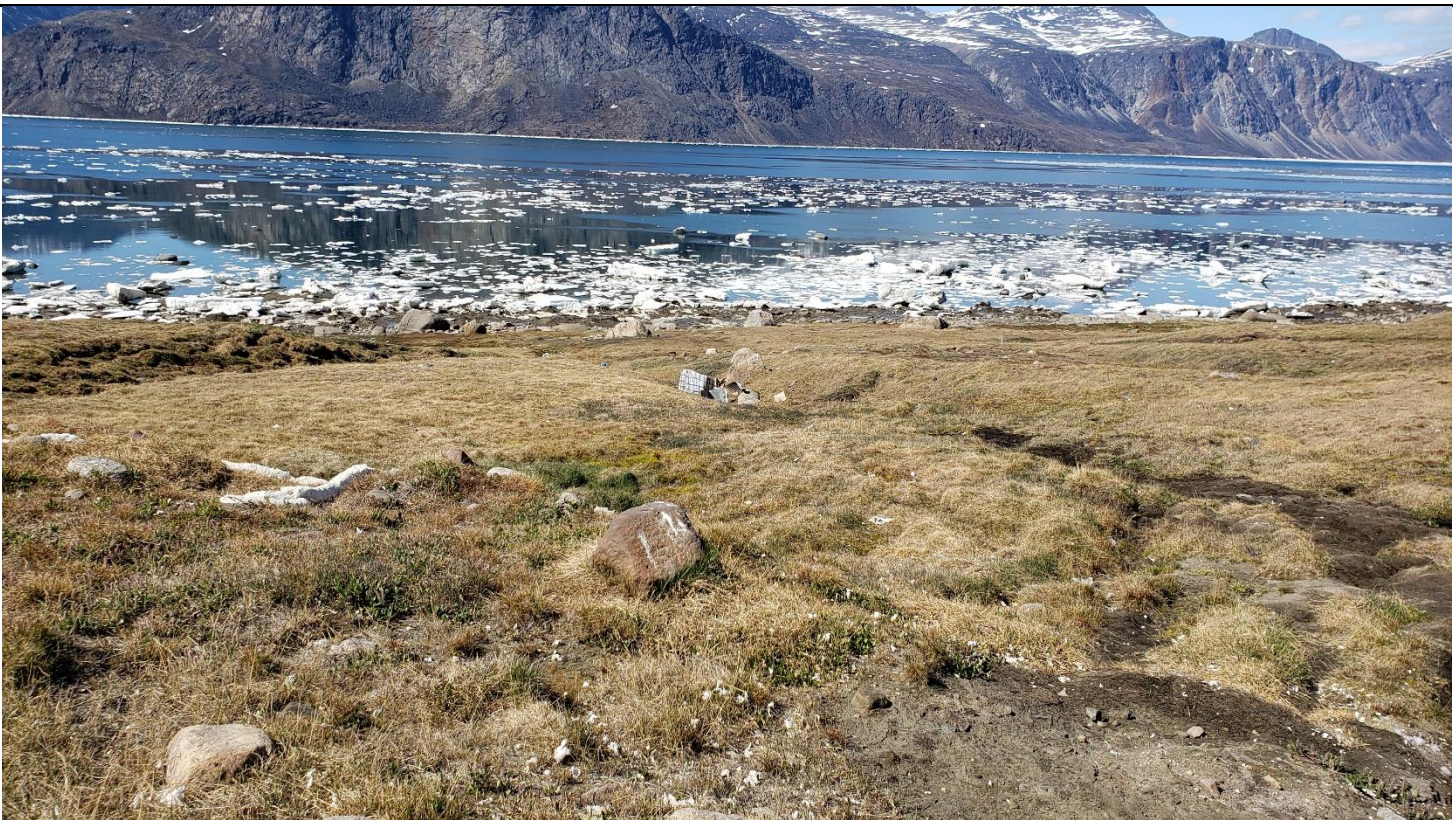
Photo 14

18. A separate and standalone Hazardous Waste non-engineered berm was constructed to address Spill Report 2019-244 (photos 14, 15, & 16). A submission of a Spill Report was requested due to the abundance of leaks, and spills that have damaged the surrounding vegetation and the amount of hazardous waste blowing away from the site (photo 13 &14). The Spill Report was submitted on June 17, 2019. And issued Spill Report number 2019-244. This spill report won't be closed off till the spills has been cleaned up, and a report to confirm that the spill has been cleaned up. It was observed that large spills did occur in the newly built non engineered berm for hazardous waste and still has gone un reported (photo 15). The spill observed appeared to be migrating towards the entrance to the non engineered hazardous waste berm (photo 16).

Description: Although the source of contamination has stopped, there is still clean up required of the historic spills.

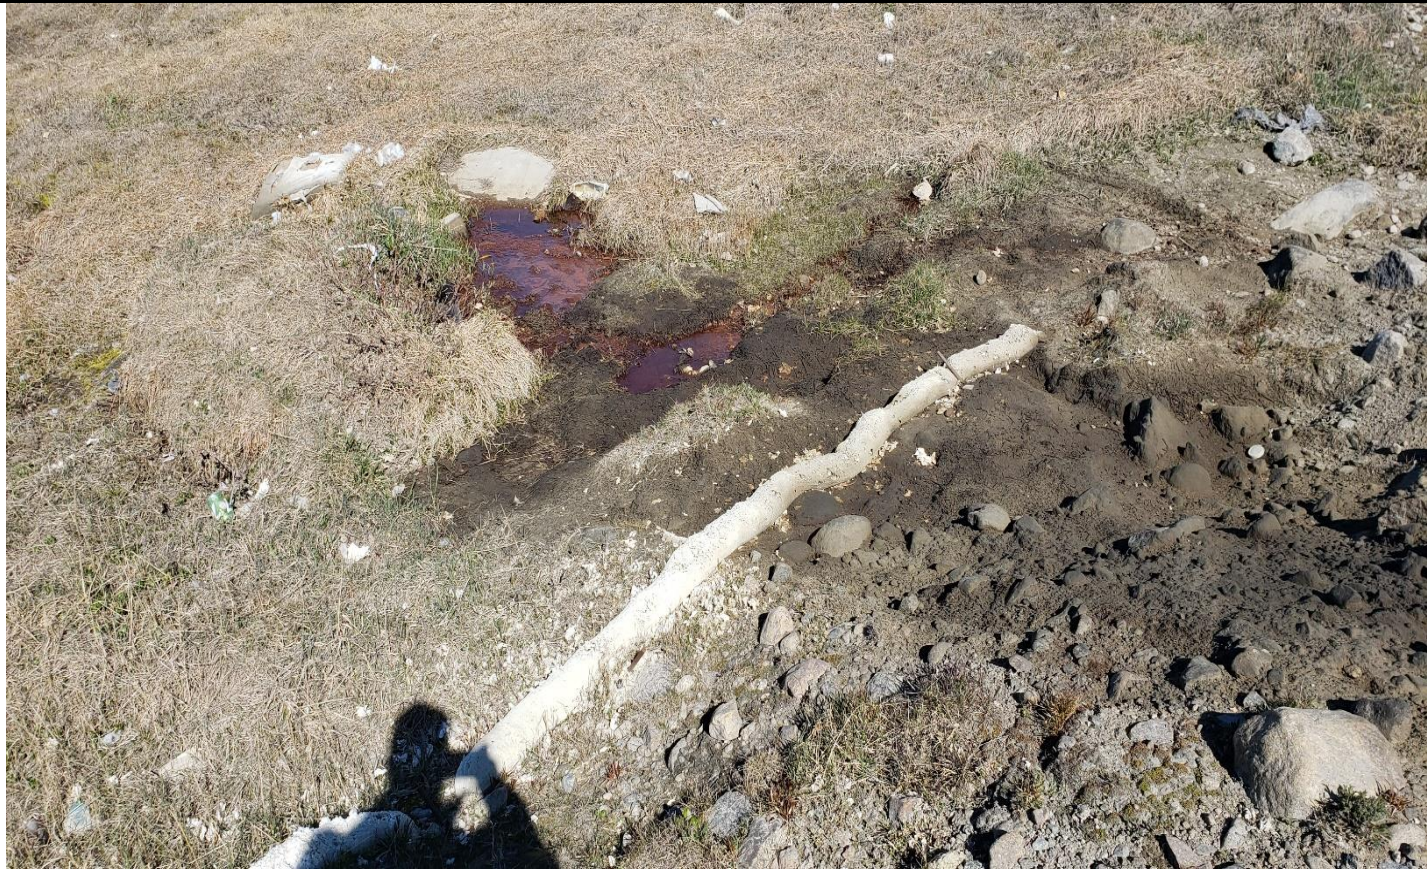
Photo 15

Description: The drums from Spill Report 2019-244, placed into a non-engineered secondary containment. New spill migrating towards the opening of the non-engineered berm for hazardous waste. A spill report should be generated for this spill, and mitigate the migration of it. To date no spill reports have been submitted for the spills in the hazardous waste facility.

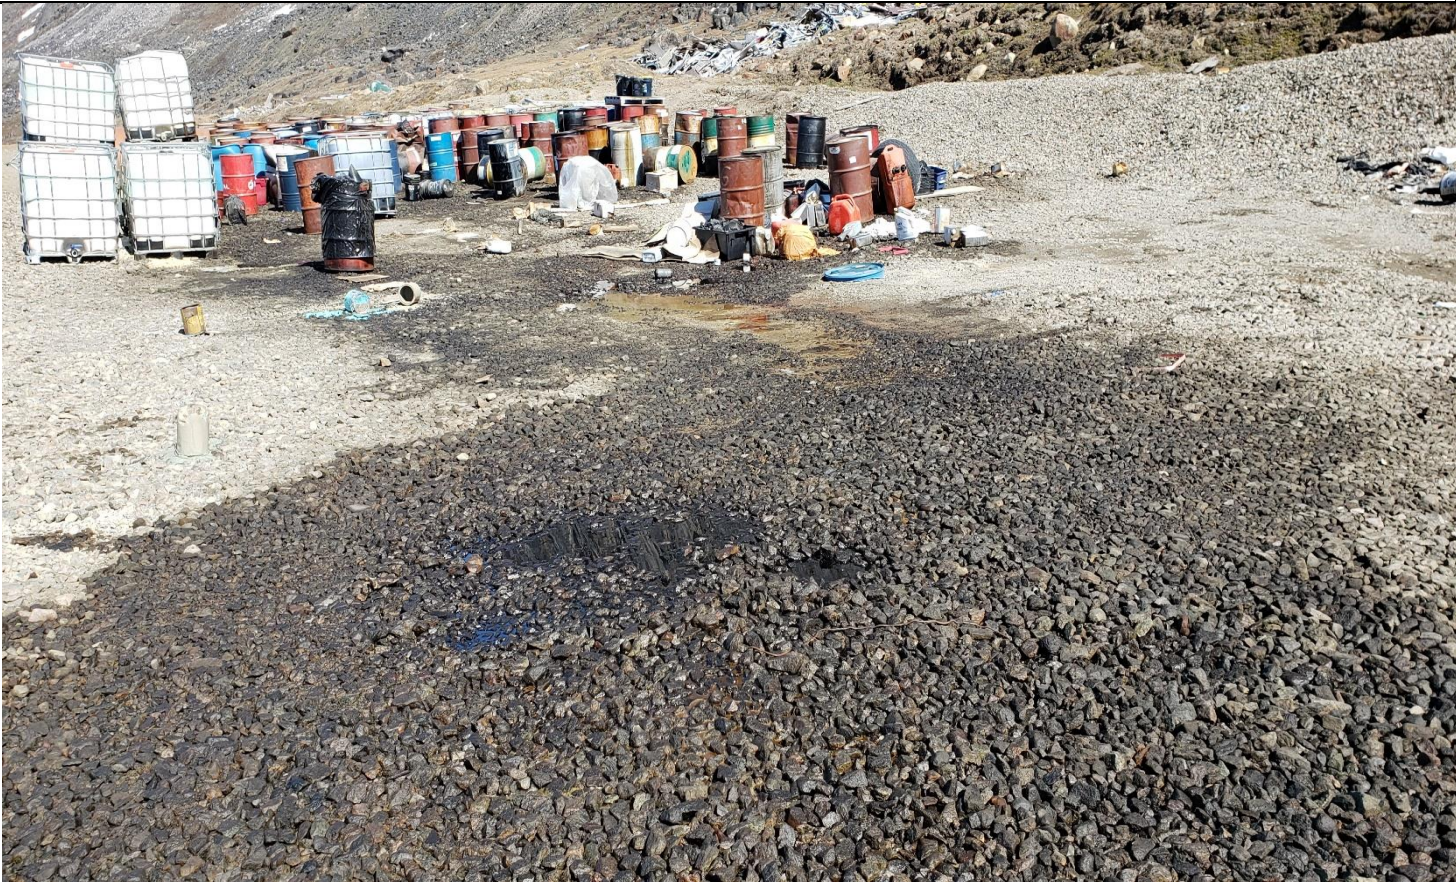
Photo 16

Description: subsurface water drainage exposed and migrating out of non-engineered berm used to house the hazardous waste. A drum is situated in the drainage ditch, and new spill can be observed migrating towards the drainage ditch.

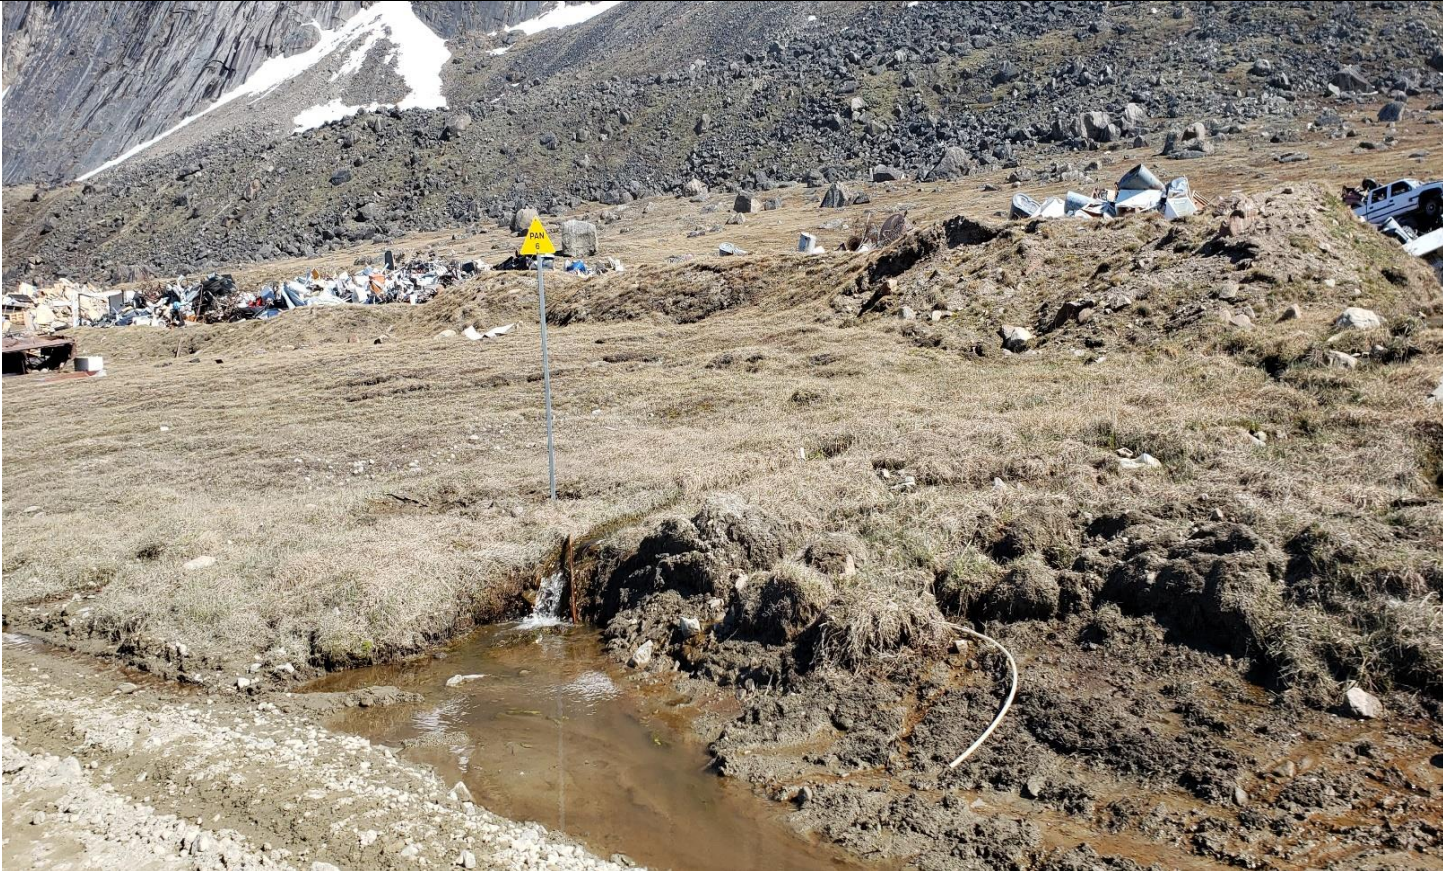
Photo 19

19. Spill Report 2022-119 A heave in the foundation of the WWTP has caused damage to the headworks piping, which rendered the bypass function of the WWTP inoperable. The hamlet deposited its sewage directly to the receiving environment and logged the discharge volumes. On October 26, 2022, Gord Marinic emailed WRO Monteith a copy of the "Pangnirtung Wastewater Treatment Plant Repair Report", and the "Pangnirtung Emergency Sewage Discharge Volume Estimate April 5-May 27 2022". A total of 9434 m<sup>3</sup> was discharged to the receiving environment. The discharge location was greater than 31 metres from the high

Description: A total of 9434m³ of sewage was deposited to the receiving environment between April 5, 2022, and May 27, 2022. Deposits are a result of spill report 2022-119.
