**ANNUAL REPORT
FOR THE MUNICIPALITY OF PANGNIRTUNG, 2022**

YEAR BEING REPORTED: 2022

The following information is compiled pursuant to the requirements of Part A, Item 1 of Water Licence # 3AM-PAN1828 issued to the Municipality of Pangnirtung.

WATER LICENCE INSPECTION FORM

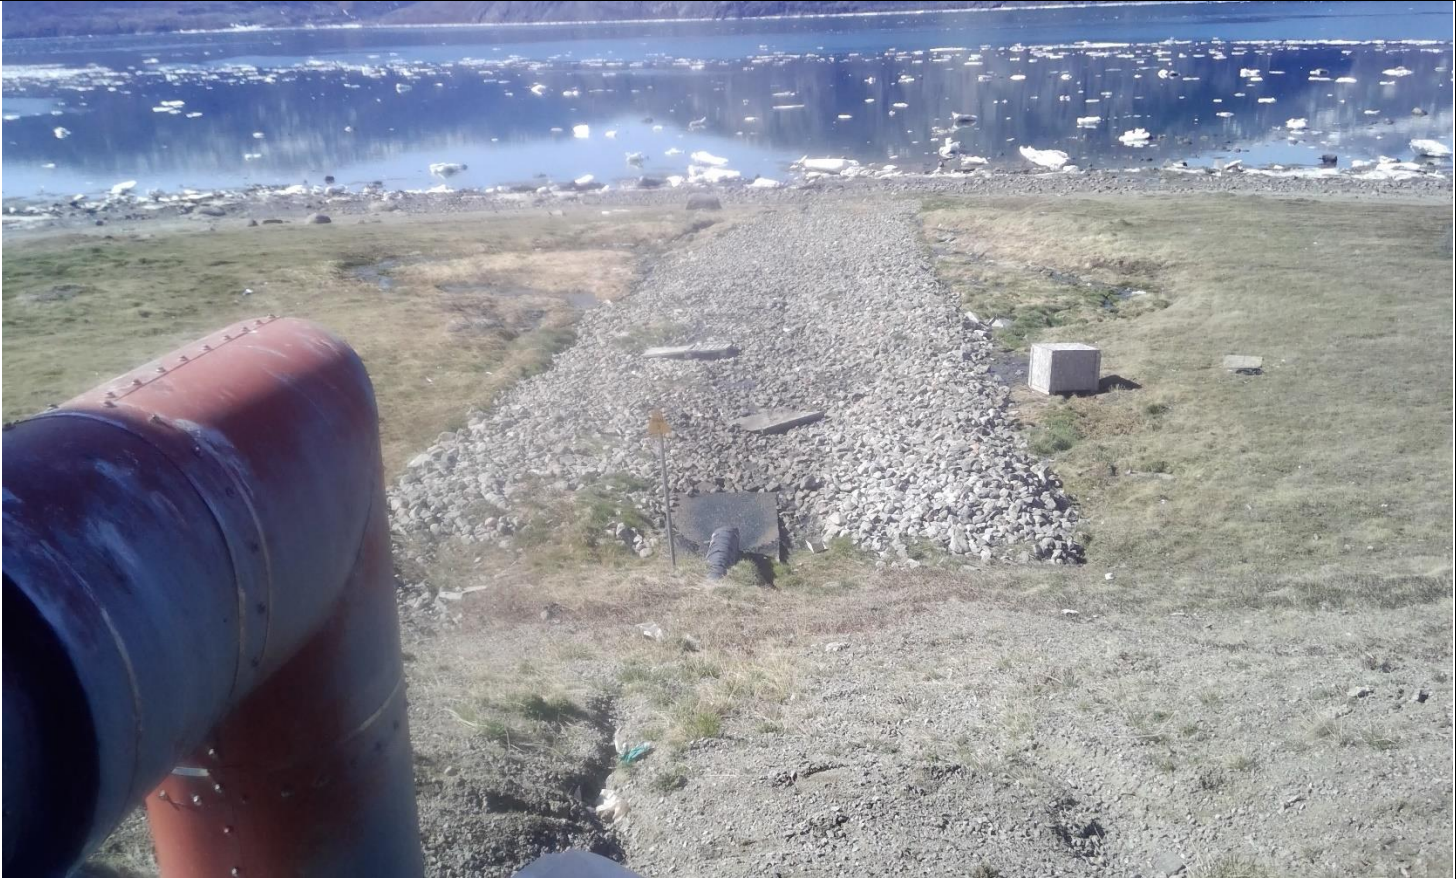
Photo 8

10. Liquid waste is discharged from the WWTP towards the ocean from a pipe that extends out 19 metres out (See photo 8).
11. Due to decommissioning all waste water was deposited GPS Coordinate N66.15617°, W65.67116° (decimal degrees). On October 26, 2022, Gord Marinic emailed WRO Monteith a copy of the "Pangnirtung Wastewater Treatment Plant Repair Report", and the "Pangnirtung Emergency Sewage Discharge Volume Estimate April 5-May 27 2022". A total of 9434 m³ was discharged to the receiving environment(photo 19). All details of the occurrence that lead to the deposits are in observation # 19.

Description: Discharge Location. Greater than 31 metres from the high water mark. Monitoring station observed.

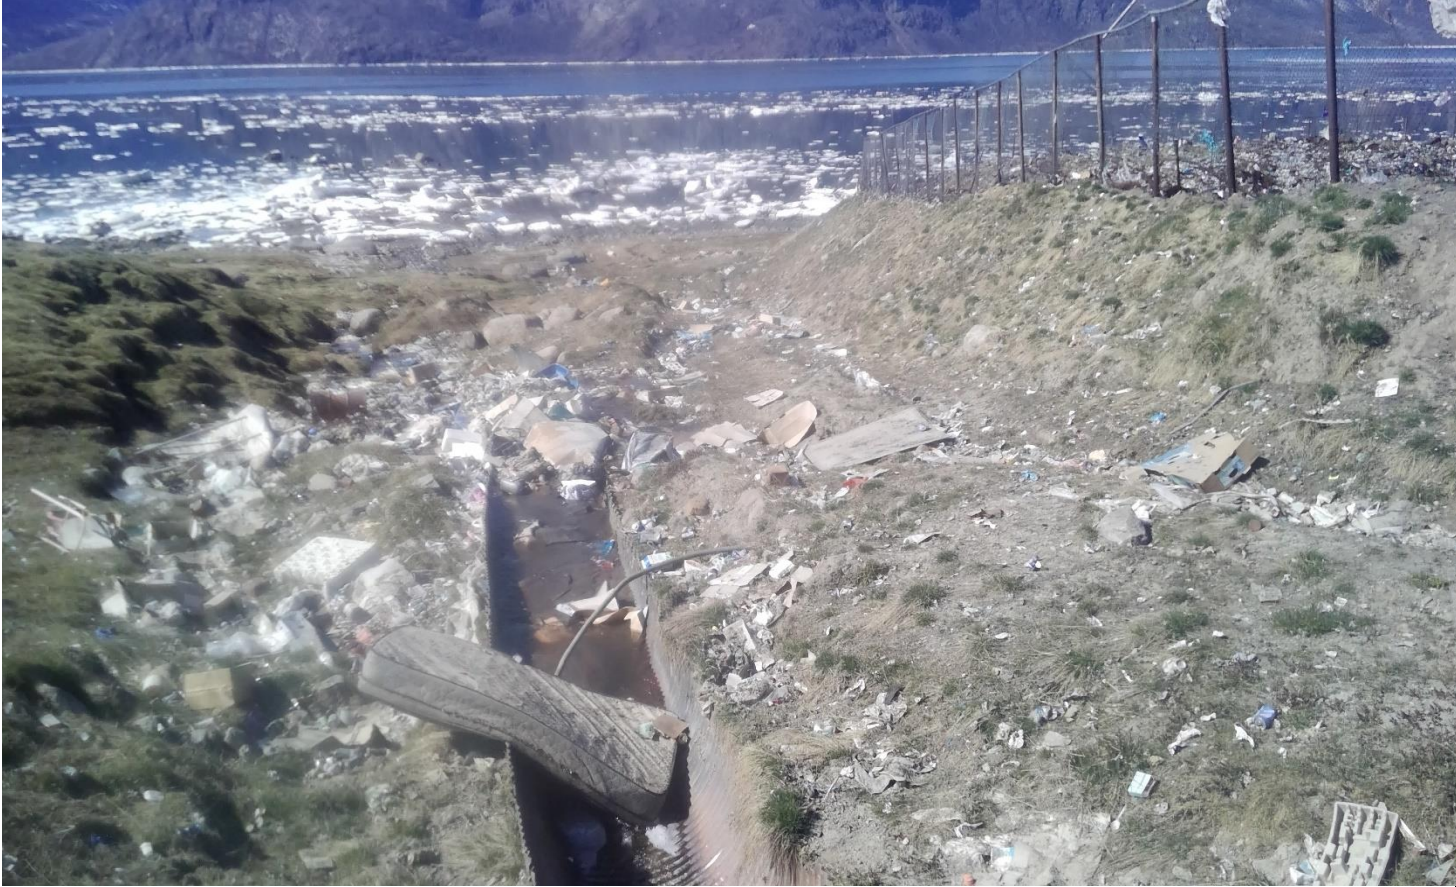
Photo 9

12. The burn and cap is fenced, and also has two drainage culverts at the base of the landfill. A drainage basing on East side of the burn and cap has large amounts of wind blown debris and bulk wood deposits (photo 9).

Description: The drainage ditch next to the fenced in burn and cap facility. Littered with domestic wind blown debris.

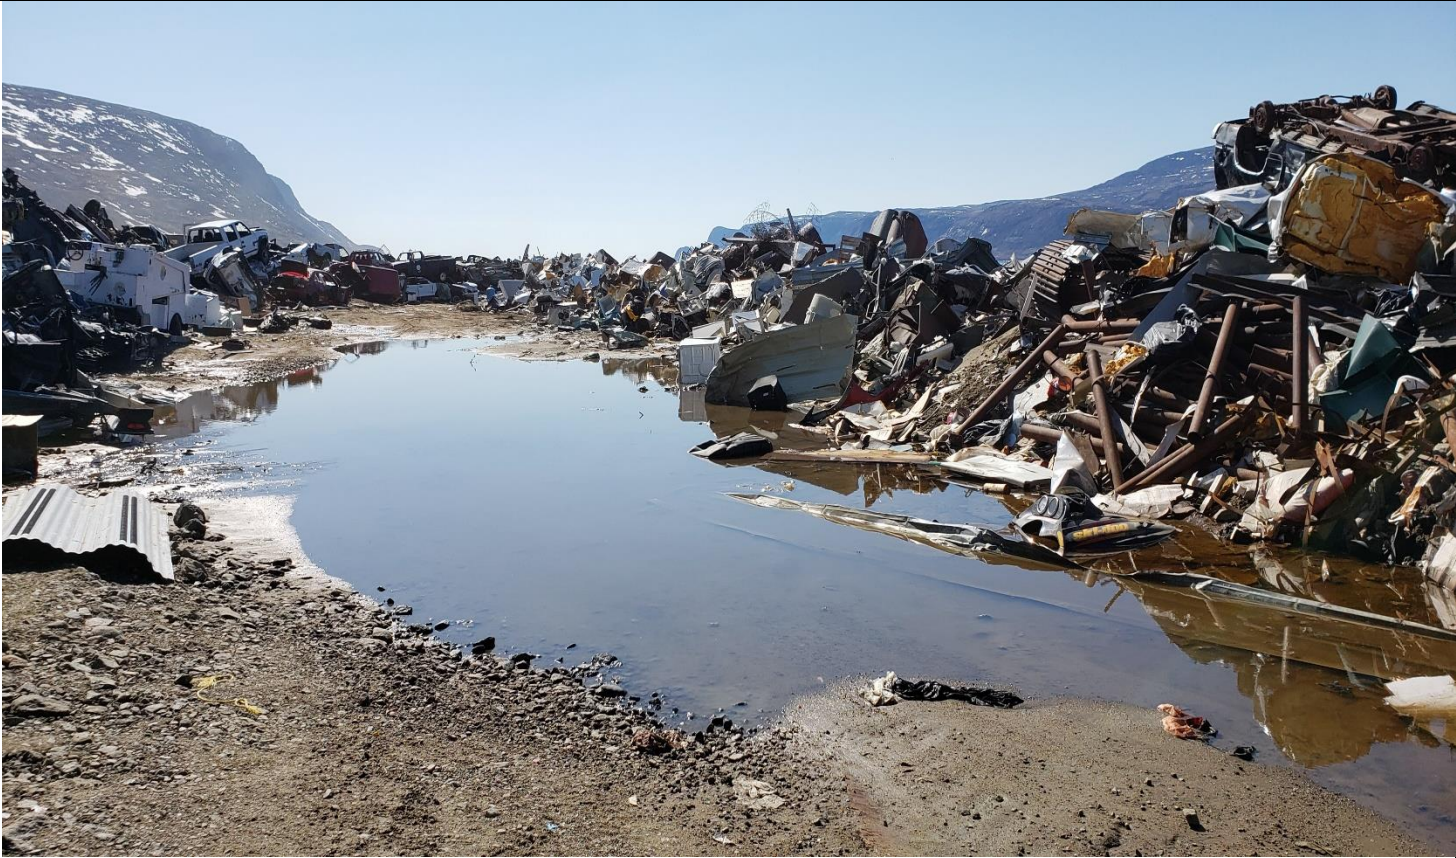
Photo 10

13. The bulk metals area contains such waste as vehicles, white waste, snowmobiles, and all-terrain vehicles, various sized storage tanks. It was observed that the containment walls meant to divert water and waste from entering and exiting this facility has retained surface water. (photo 10 & 11).

Description: Bulk Metals section. East Corner of the Bulk Metals Facility. The wall to divert water from entering the facility has washed away. The washed away wall, allows surface water to move through one of three hazardous waste facilities.

- Provide an action plan to clean up the site of Spill Report 2019-244;
- Find the reason why there is water leaks coming from the water reservoir and repair;
- Repair the walls to the Bulk Metals, and Bulk Woods on the Eastern Wall, so that surface water may not enter the facility;
- Submit spill report for the spills in the newly built non engineered berm for hazardous waste;
- Erect a fence surrounding the Metal and Hazardous Waste Storage Area as per Part E: Item 8;
- Submit a spill report for the dump fire at the Bulk Wood and Hazardous Waste sections of the Solid Waste Facility.

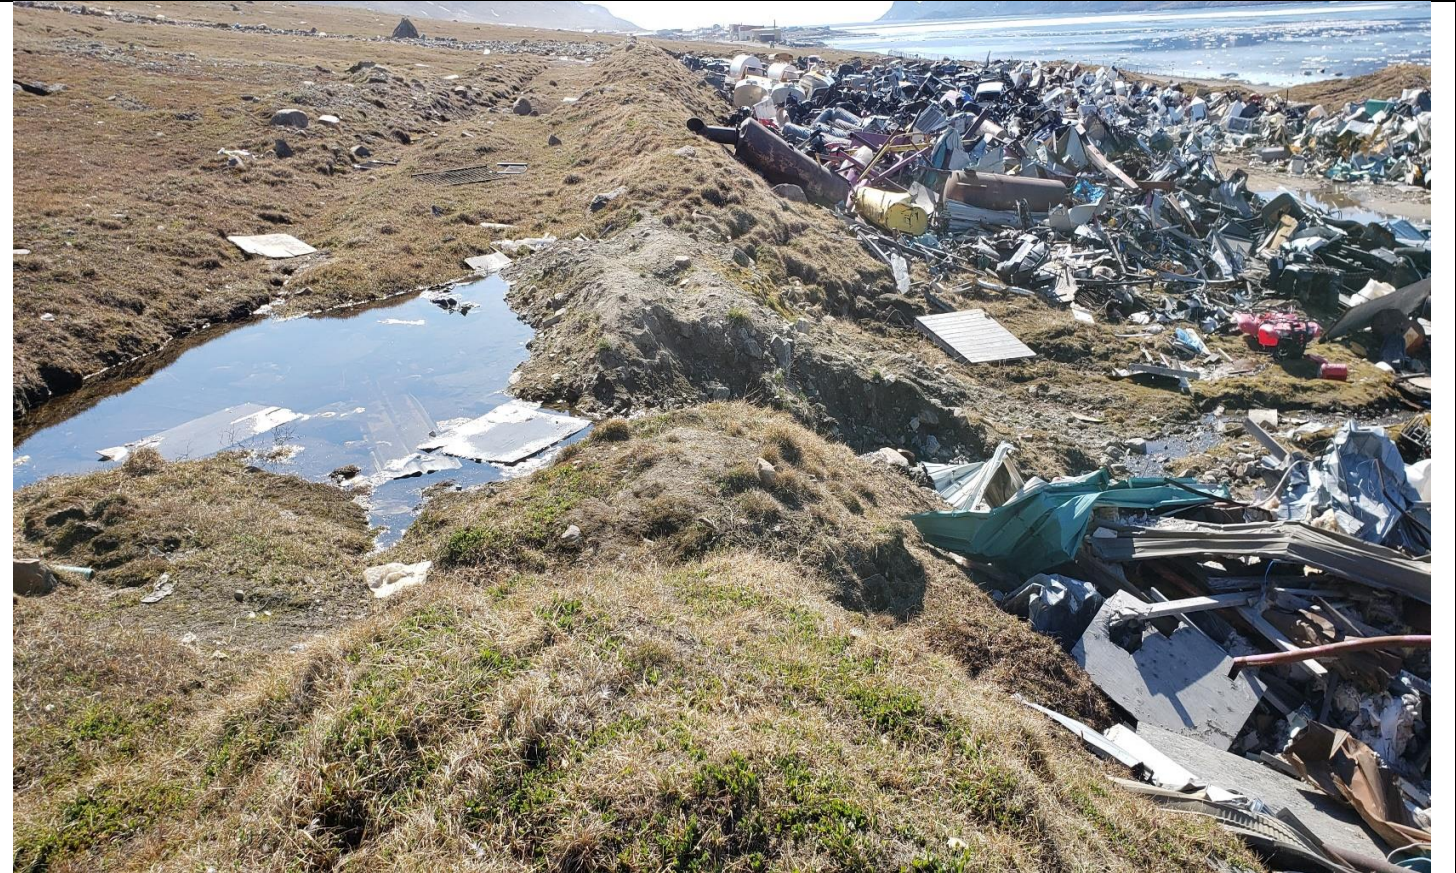
Photo 11

Description: Hazardous Waste in the Bulk Metals section. A couple of parts of the walls on the East side of the Bulk Metal appear to have washed out. These washed out walls need to be repaired to ensure that no water is entering the facility, and taking waste with it as it exits the facility.

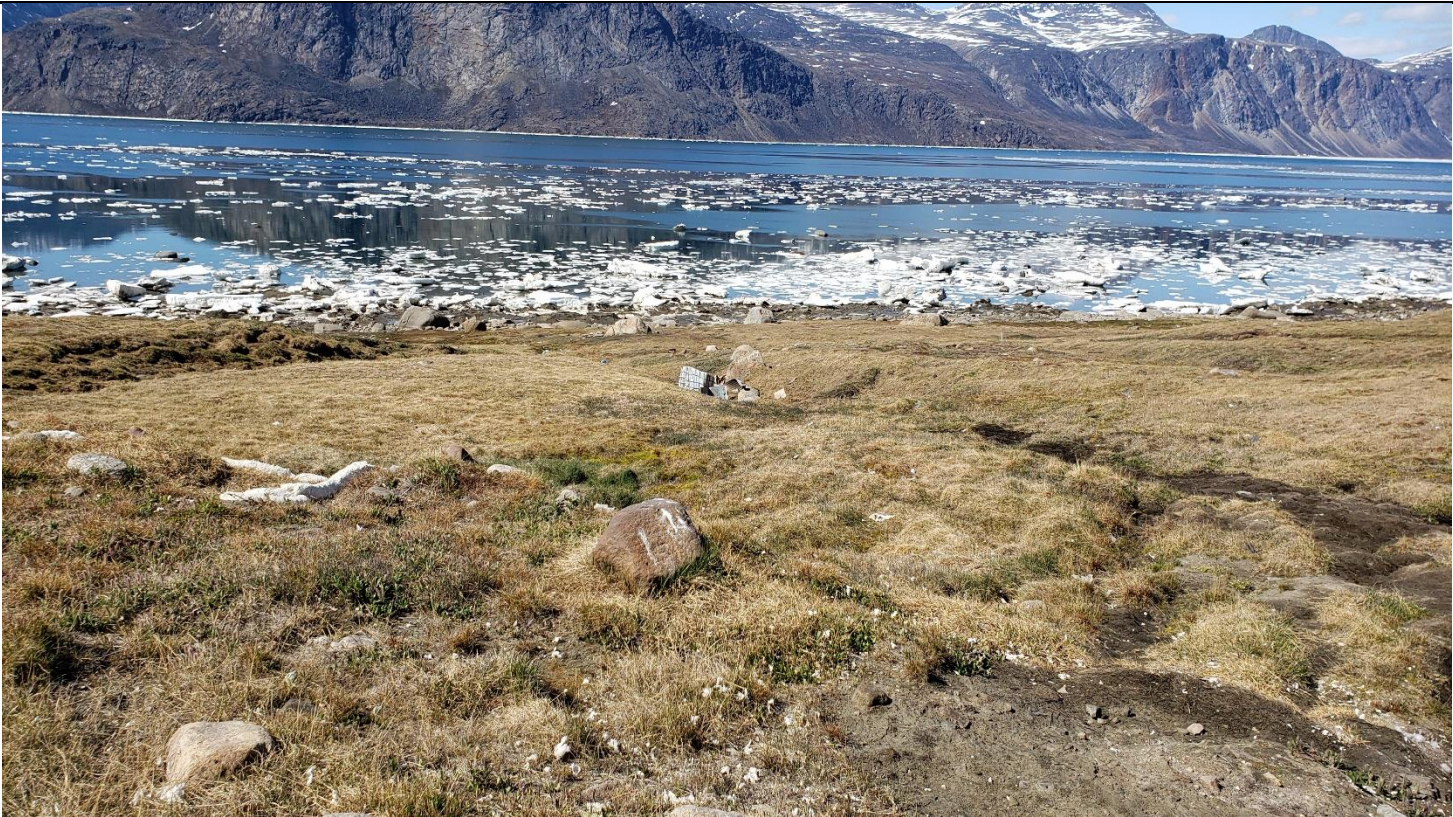
Photo 13

Description: Site of Spill Report 2019-244. All the sources of the spills were removed and placed into a non-engineered berm on the opposite side of the road, and at the entrance to the Bulk Metals facility. The spills that leaked out of the drums hasn't been cleaned up, and the spill report will remain open till it has been cleaned up. A report should be generated as per the license to provide a status update, and plans to clean up the spill.

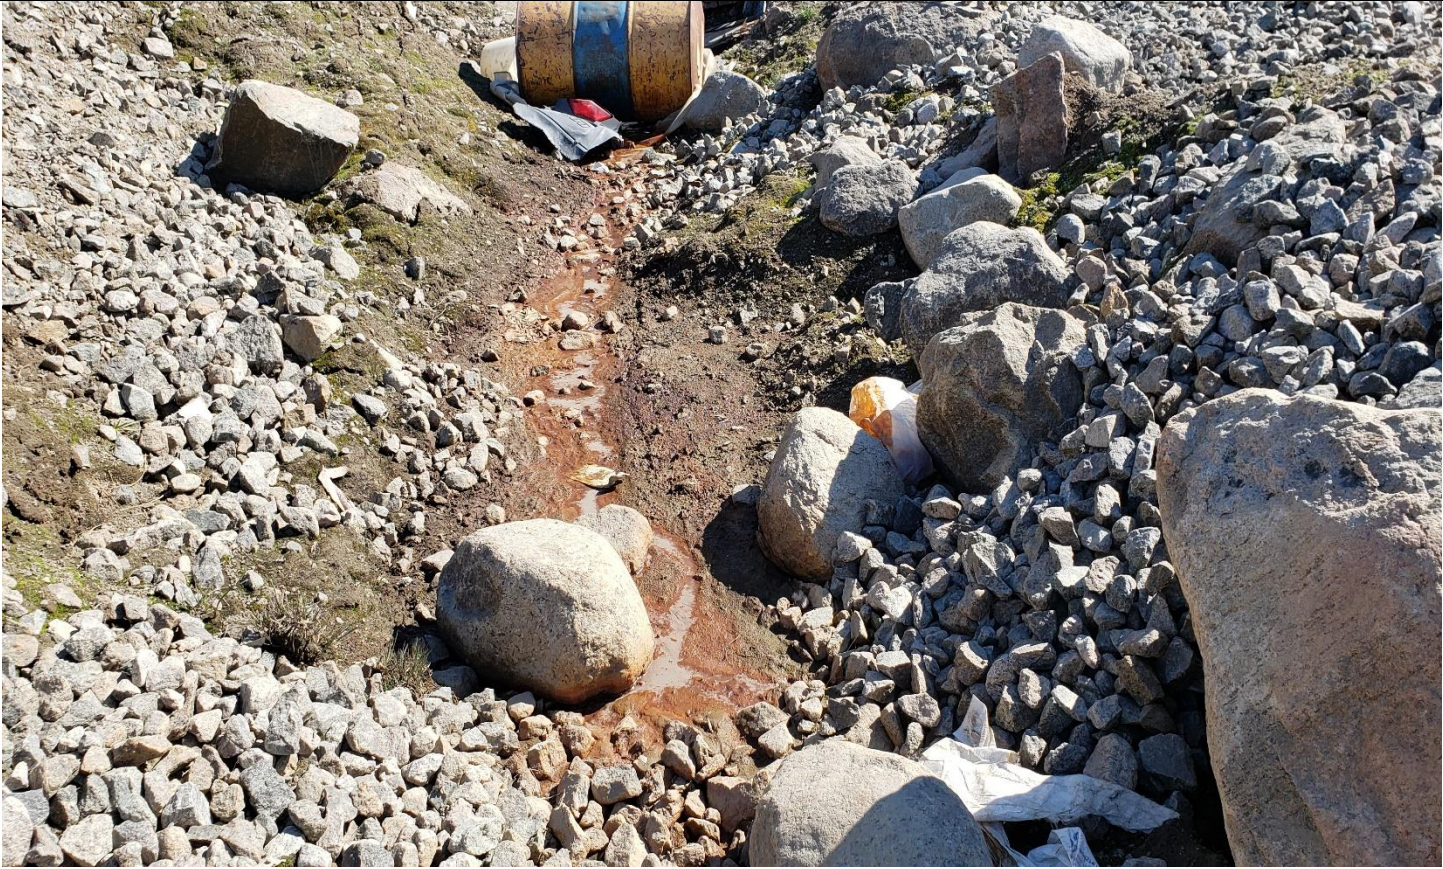
Photo 16

18. A separate and standalone Hazardous Waste non-engineered berm was constructed to address Spill Report 2019-244 (photos 14, 15, & 16). A submission of a Spill Report was requested due to the abundance of leaks, and spills that have damaged the surrounding vegetation and the amount of hazardous waste blowing away from the site (photo 13 &14). The Spill Report was submitted on June 17, 2019. And issued Spill Report number 2019-244. This spill report won't be closed off till the spills has been cleaned up, and a report to confirm that the spill has been cleaned up. It was observed that large spills did occur in the newly built non engineered berm for hazardous waste and still has gone un reported (photo 15). The spill observed appeared to be migrating towards the entrance to the non engineered hazardous waste berm (photo 16).

Description: subsurface water drainage exposed and migrating out of non-engineered berm used to house the hazardous waste. A drum is situated in the drainage ditch, and new spill can be observed migrating towards the drainage ditch.

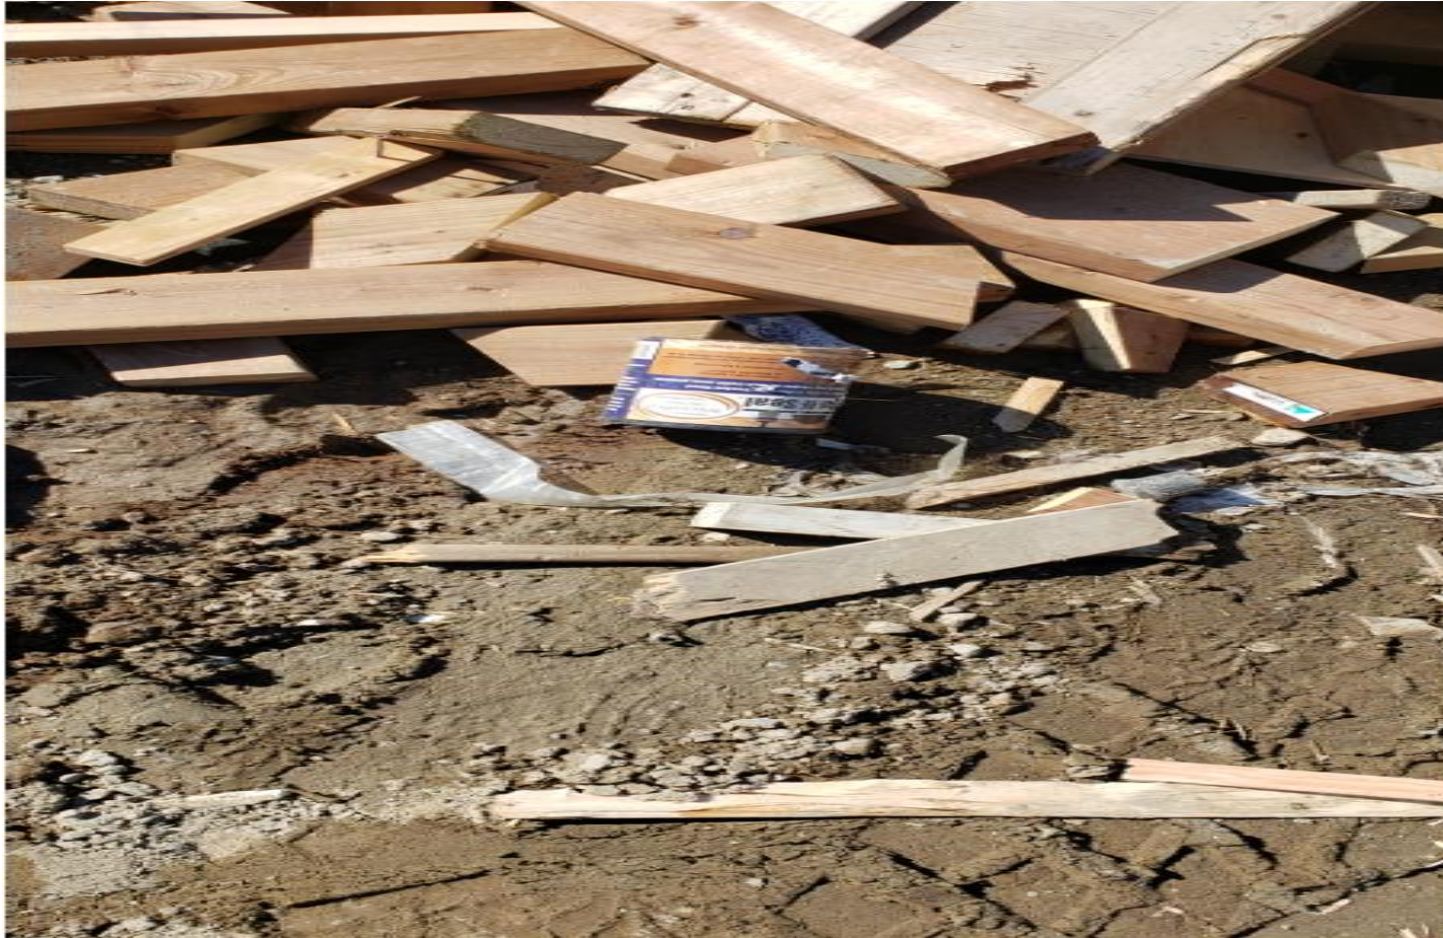
Photo 17

14. Hazardous Waste was found throughout the Bulk woods section such as paint cans, and batteries. A dump fire was reported on December 2, 2022 in Nunatsiaq News, it was reported that the dump fire was extinguished on December 5, 2022. A spill report has not yet been submitted to the NT/NU Spills Data base (photo 17).

Description: Bulk Woods section, hazardous waste mixed with bulk woods.
