Project Title: Pangnirtung WWTF

Project No.: FRE-00232735-A5

Aftercare Service – Site Visit #16 (SUMMARY REPORT)

Site Visit: Sept 19-28, 2023

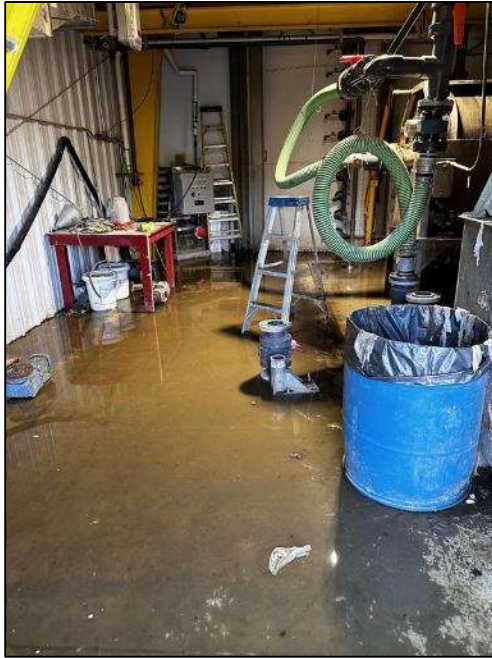
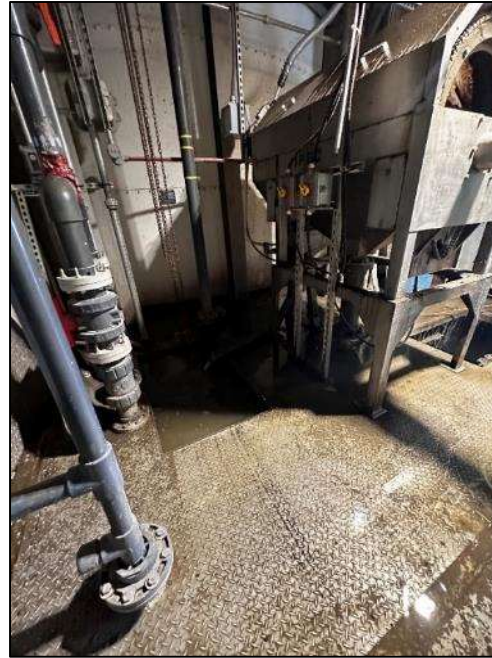
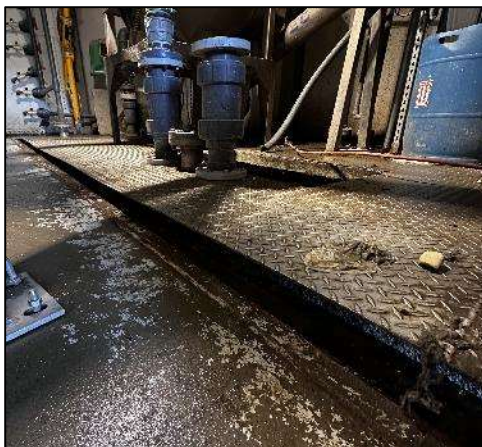
- The operators have noted significant issues at the headworks of the plant. During the site visit, EXP witnessed numerous occasions where the raw sewage and screened sewage sumps were overfilled. Typically, these events would occur during peak hours (first thing morning, after coffee break, after lunch break) when sewage trucks were at the WWTP emptying their loads. On one occasion, overflow sewage entered the annular space around the sumps causing the steel plate to heave 3-4".

- Plant operators noted that they typically bypass a majority of the flows from the raw sewage sumps directly to the EQ tanks (>80%) and stated that only one raw sewage pump and one screened pump have been operational over the past year.
- During the site visit, it is apparent that the screened sewage pumps are not discharging flows at their expected rates. This is causing the sumps to back up and overflow

Figure 1: Headworks Overflowing
Figure 2: Screened Sump Overflowing
Figure 3: Screen Plate Heaving

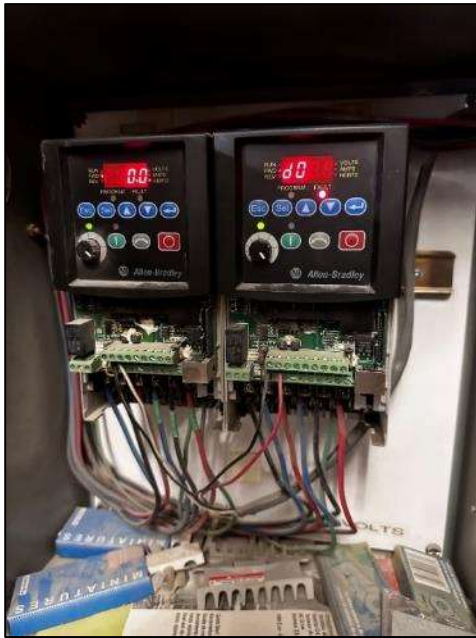
- A fault was observed with the Allen-Bradley drive (Pump #2)

Figure 4: Screen Pump Allen Bradley Drive Fault

- **Immediately hire a contractor to replace the length of the PVC pipe and fittings from the discharge end of the isolation valves to the 90° bend toward the EQ tank including clearing all connections of potential blockages – this is a critical connection for the plant and in its current condition, it is vulnerable to further damage**
 - **There are no spare parts onsite and the contractor would be required to bring up the PVC pipe fittings and spare parts to complete this work**
- **Contractor to fix the drive fault (Allen Bradley) and confirm programming for the screened sewage Pump #2 (lag pump)**

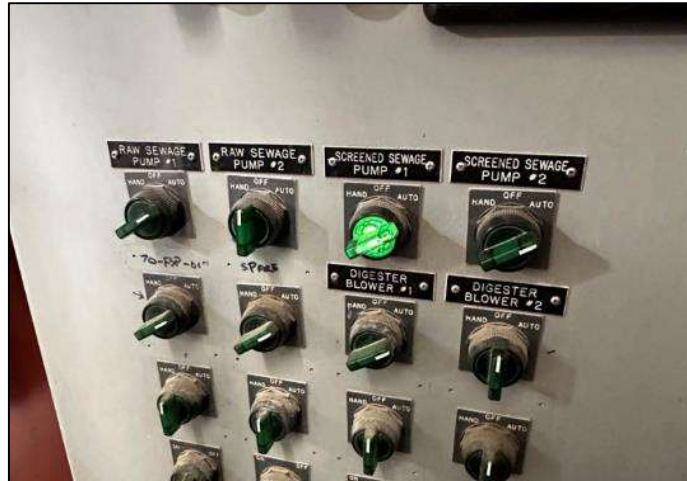
Figure 5: Screen Pump Electrical Box

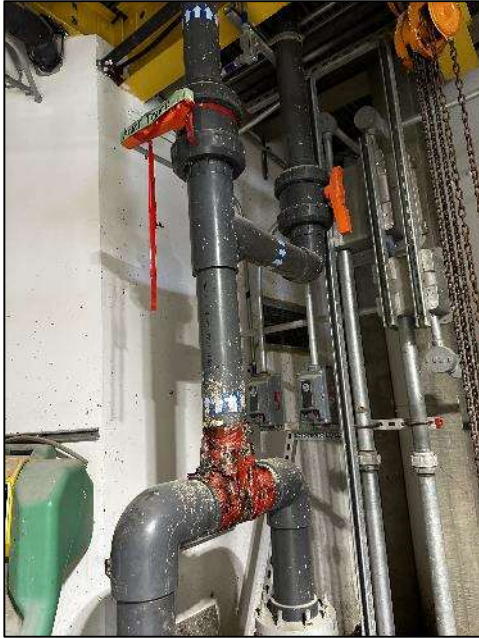
- The screened pump discharge piping (4" PVC tee) is cracked and taped together.
 - During the site visit, with help from the operators, we attempted to open up the valving below the tee to inspect and clean the check valves. However, the connections were tight. Attempts to open the connections applied significant stresses to the existing PVC piping and would potentially lead to a bigger failure. EXP directed the plant staff to stop as this discharge piping is a critical connection that cannot fail.

- There were no replacement fittings onsite to try to repair the piping
 - Based on the 2023 sealift order list, there are no replacement fittings (4" PVC tees, unions, valves, elbows, etc.) due to arrive this year.

Figure 6: Cracked 4" PVC Screened Pump Discharge Tee

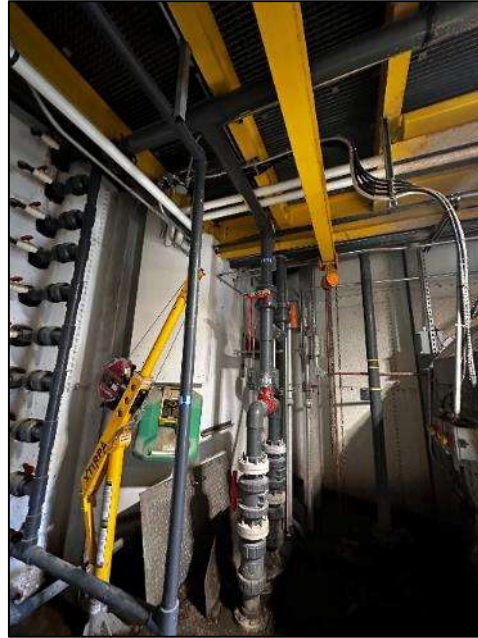
Figure 7: Screened Pump Discharge Piping

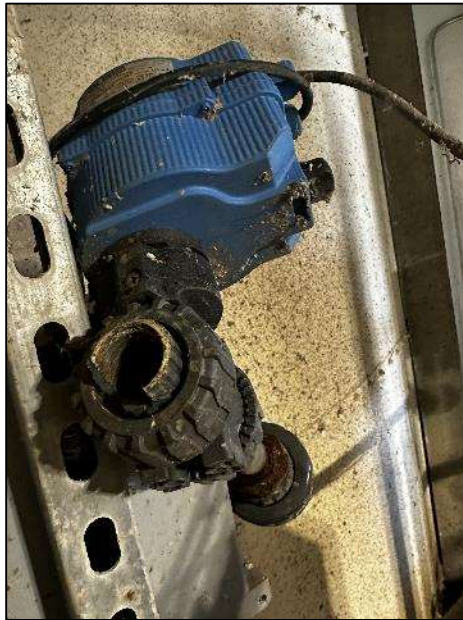
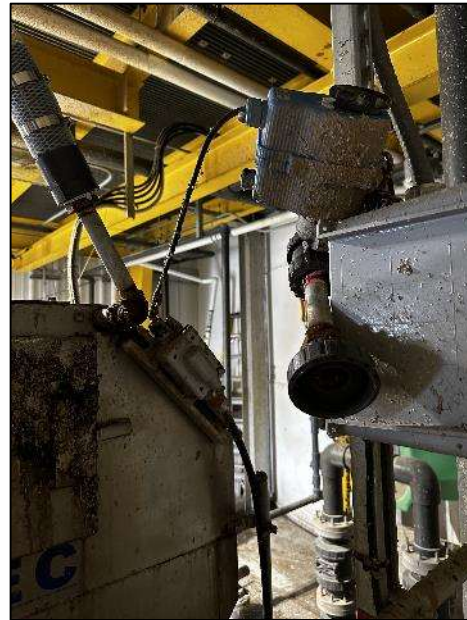
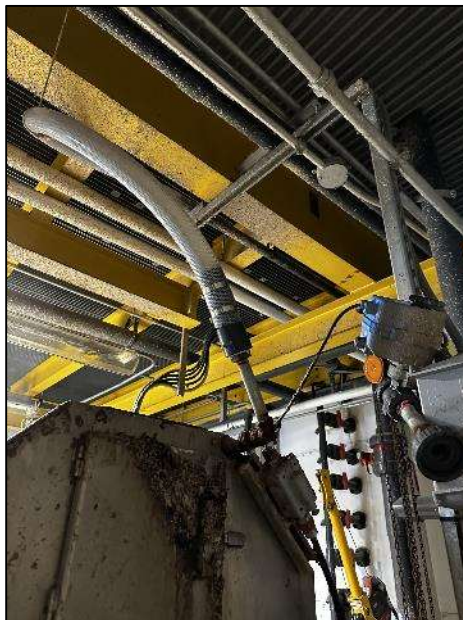
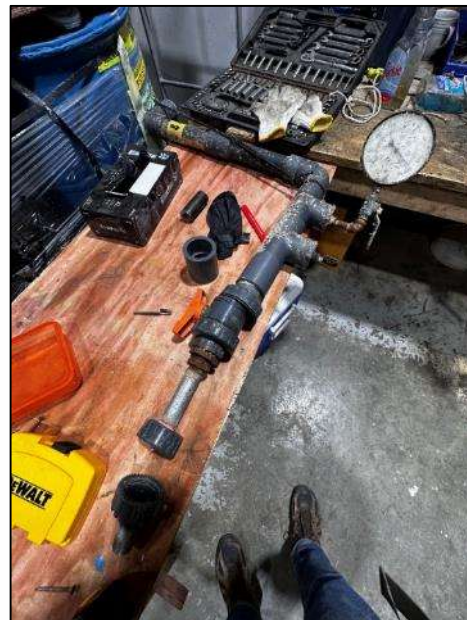
- The fine drum screen is functioning properly, but the spray wash bar is not operational, due to a cracked ball valve. The operators are required to routinely clean the drum screen manually with a pressure washer.

- Fittings for the 81-V-09 Ball Valve are cracked and there are no replacement valves onsite.
 - The existing actuator (VALBIA - VB015-HT) does not appear to be actuating (open or close). However, it was not confirmed if this was due to a minor electrical issue or if the component requires replacement

Figure 8: Cracked Solenoid Valve for Drum Screen Wash

Figure 9: Cracked Solenoid Valve for Drum Screen Wash

- **hire a contractor to repair the spray wash system. Contractor to provide and bring replacement parts:**
 - **new ball valve 1"**
 - **new actuator (VALBIA – VB015-HT)**
 - **PVC fittings (1", 1 ½" and 2") to repair connection to non-potable water system**

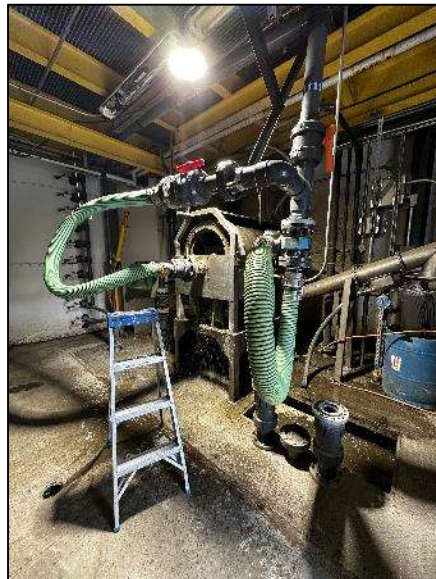
Figure 14: Existing Raw Sewage Pump/Sump

- Hire a contractor to install a connection to the second raw sewage pump (add 4" tee and flexible hose connection) including confirming the pump programming to run in a lead/lag configuration.**

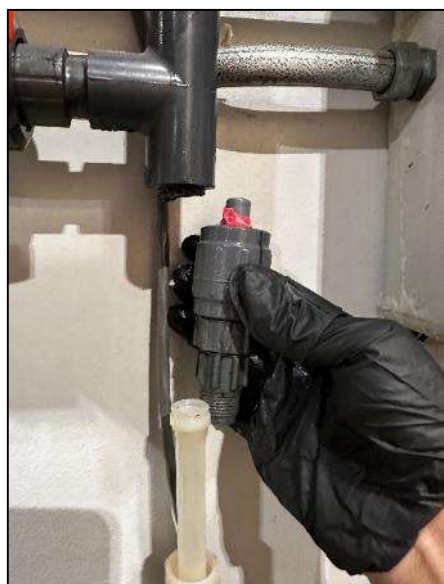
- Operators had noted that the defoamer system was not operational for over 6 months. They noted only one occasion where they needed to dose defoamer agent directly into bioreactor
- During the site visit, the defoamer pump, piping, and valves (pressure and suction) were taken apart, inspected and cleared of any blockages. BPV and PRV pressure setpoints were checked and confirmed at 45 and 60 psi, respectively
- It was observed that there is a crack on the discharge size of the pump on the union/tee fitting (injection quill) which does not allow the defoamer to be delivered to the RAS line.
- There are no spare parts available at the plant. In general, there is limited supply for all the 1/2" sizing.
- As we could not repair the system onsite, the defoamer pump has been turned off

Figure 15: Defoamer Injection Quill and Cracked Piping

- ***Hire a contractor to replace the ½" piping from tee to pump discharge including the required Prominent injection quill component.***

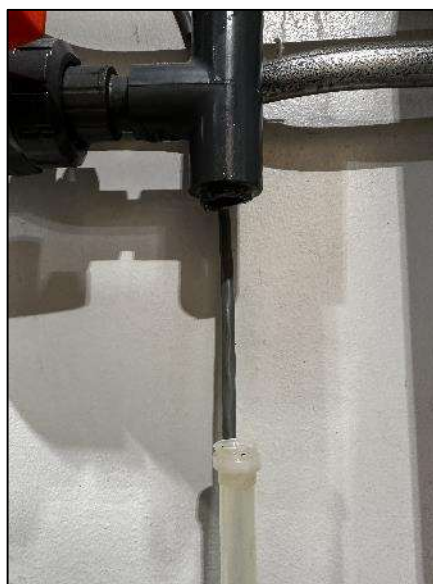
Figure 16: Defoamer Cracked PVC Piping

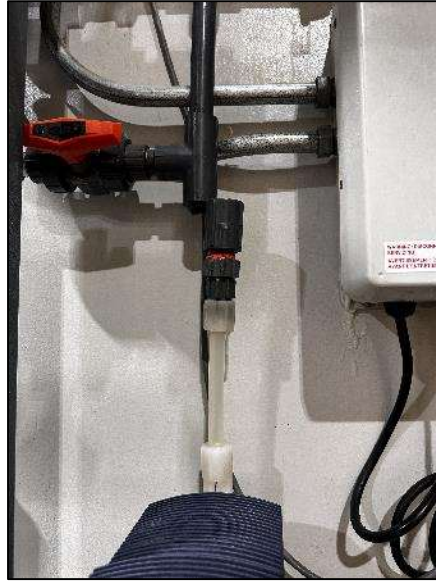
Figure 17: Defoamer ½" PVC Replacement from Pump Discharge to Tee

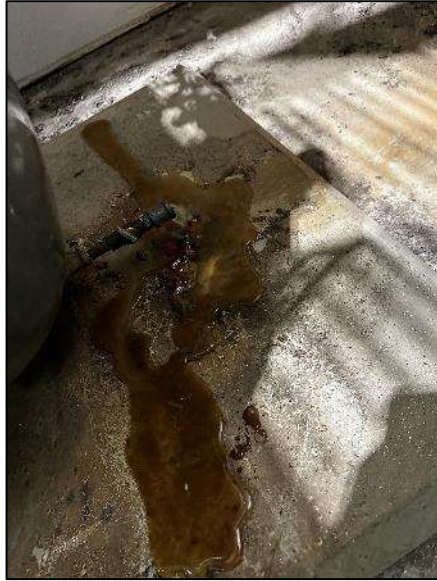
- According to plant staff, no maintenance has ever been done on the compressor and compressed air system
- The automatic drain valve that was previously installed does not appear to be expelling moisture due to the 1/8" ID tubing being clogged with rust particles. The blockage was cleared, and new manual drain valves were installed on the drain line and on the filter air dryer inlet. The operators were instructed to manually drain the tank daily to confirm the auto drain is working.

Figure 18: Water Drained from Compressor

- **Hire a contractor to service the air dryer, compressor and compressed air system (drain air lines). It is also recommended to replace the existing auto drain with one controlled by an electronic timer.**

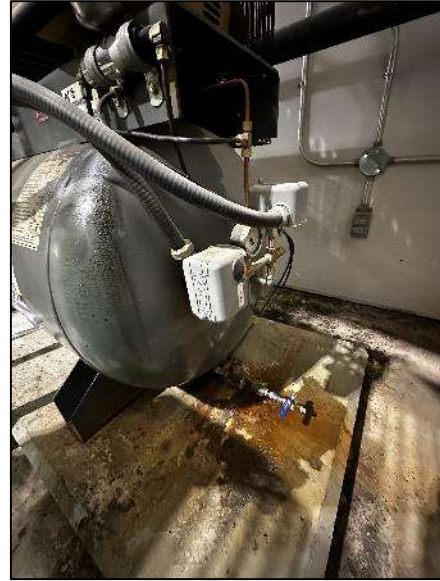
Figure 19: 1/4" Valve installed on compressor

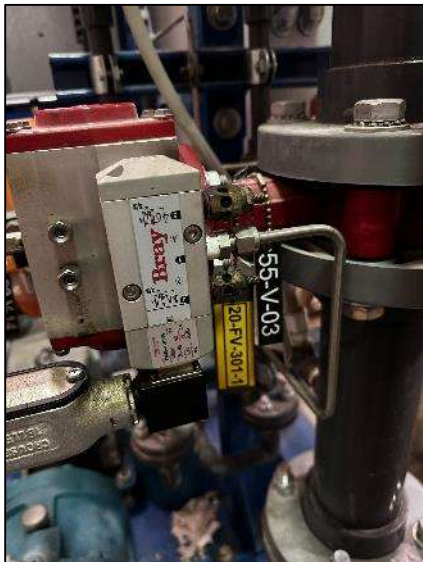
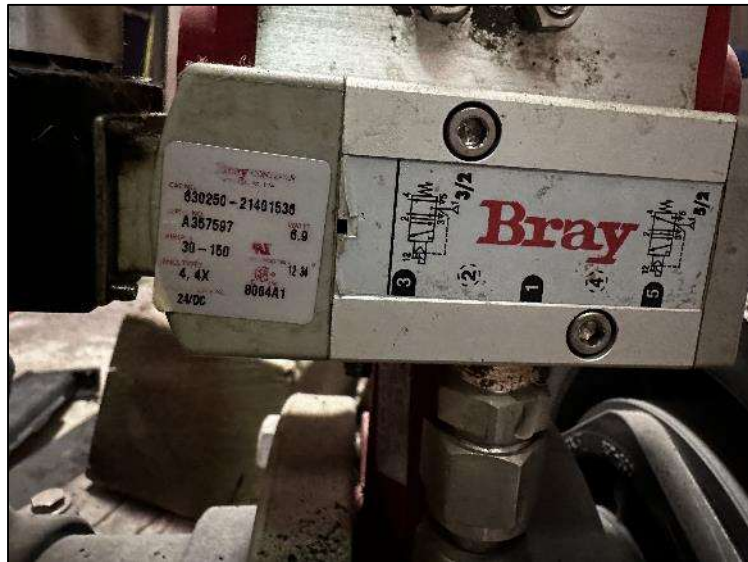
Figure 21: 55-V-03 Valve
Figure 22: 55-V-03 Valve

- Permeate Backpulse Valves (55-V-03 and 55-V-04)
 - The permeate/Backpulse outlet valves (55-V-03) and (55-V-04) appear to be always open. This is typically not an issue as there is typically flow either forward (permeate) or backward (backpulse) through this section. However, for maintenance purposes, these valves should have the ability to close to isolate the sections

- Hire a contractor to service the air dryer, compressor, compressed air system (drain air lines).
- Replace the position sensor on 60-V-20 and 60-V-21
- After the air issues are resolved, replace any valve actuators that are still not functioning properly.
 - The contractor should bring up the valves/actuators/switches to complete this work
- We also recommend that additional spare parts (valves/actuators/switches) be ordered for the next sealift.

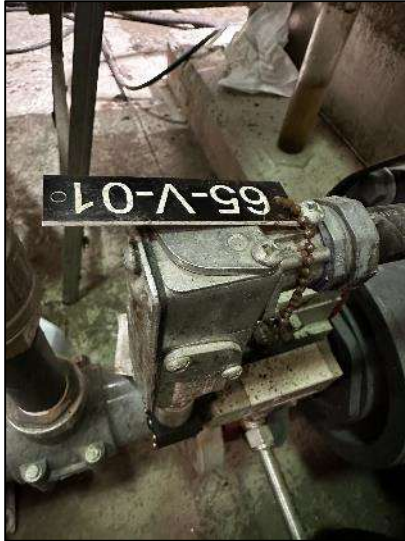
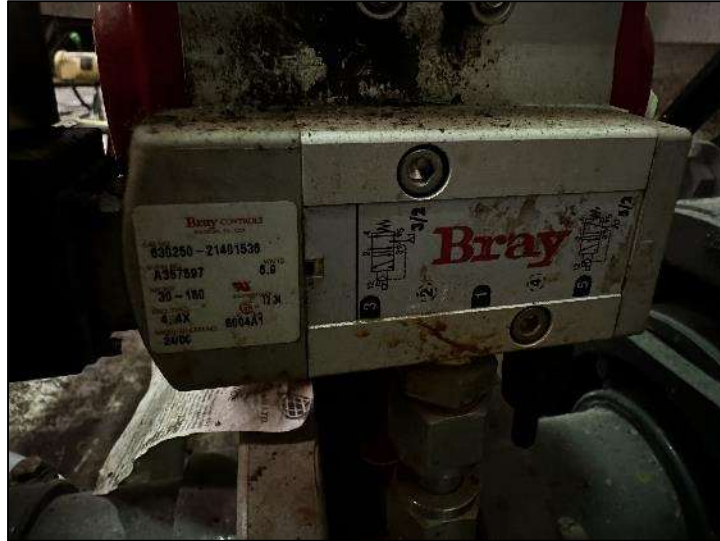
Figure 23: Valve 65-V-01

- WAS/RAS Solenoid Outlet Valve (65-V-01 and 65-V-02)
 - The WAS/RAS solenoid outlet valve (Bray 630250) on Train #1 (65-V-01) does not close (in both auto/manual modes) and is always open
 - Valve on Train #2 (65-V-02) was noted by plant staff to be non-functioning but appears to be working when observed during the site visit

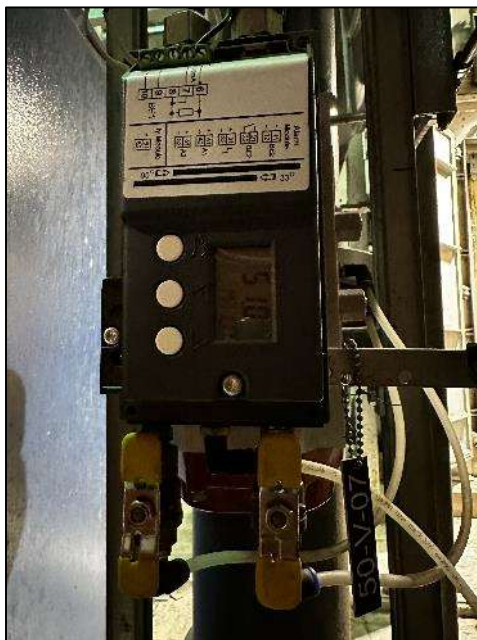
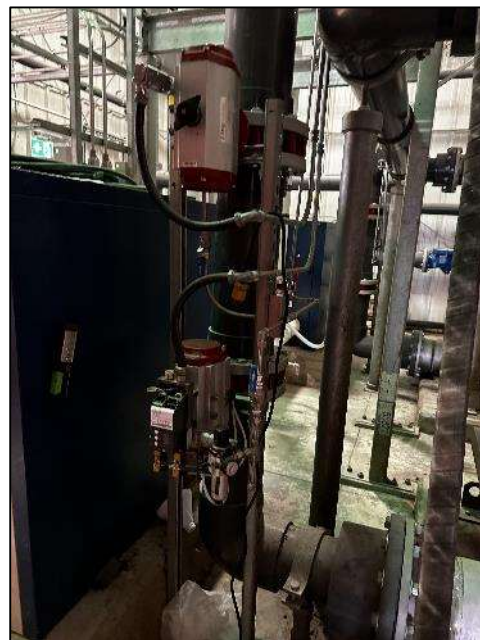
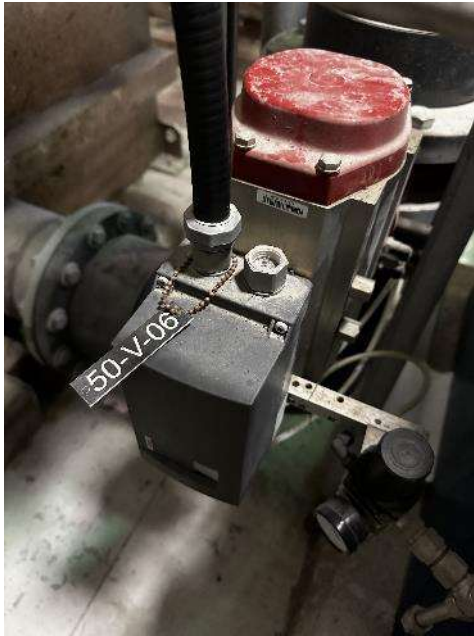
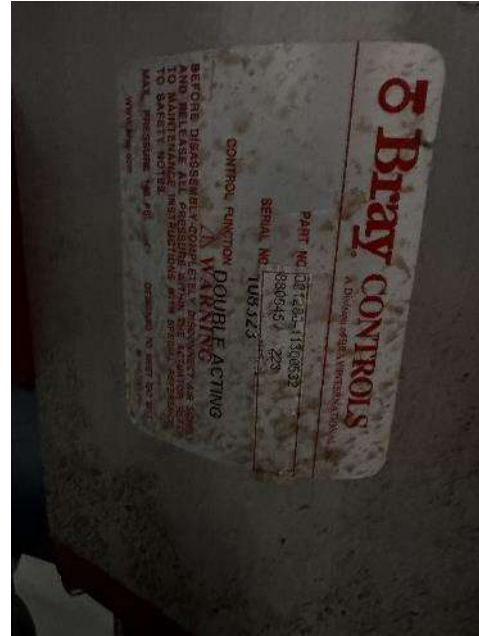
Figure 25: Valves 50-V-06 and 50-V-07

- Membrane Flow Control Inlet (50-V-06 and 50-V-07)
 - 50-V-06 and 50-V-07 (Train 1 and 2 membrane flow control inlet valves) do not open/close automatically.
 - Both these valves are run in manual. At the beginning of the day, at the start of production, operators will bleed line and set valve at ~25-50% open to manually control the flow through the MBR
 - This issue was noted in previous inspections. The plant changed one of the actuators on 50-V-07 themselves but the valves are still malfunctioning.

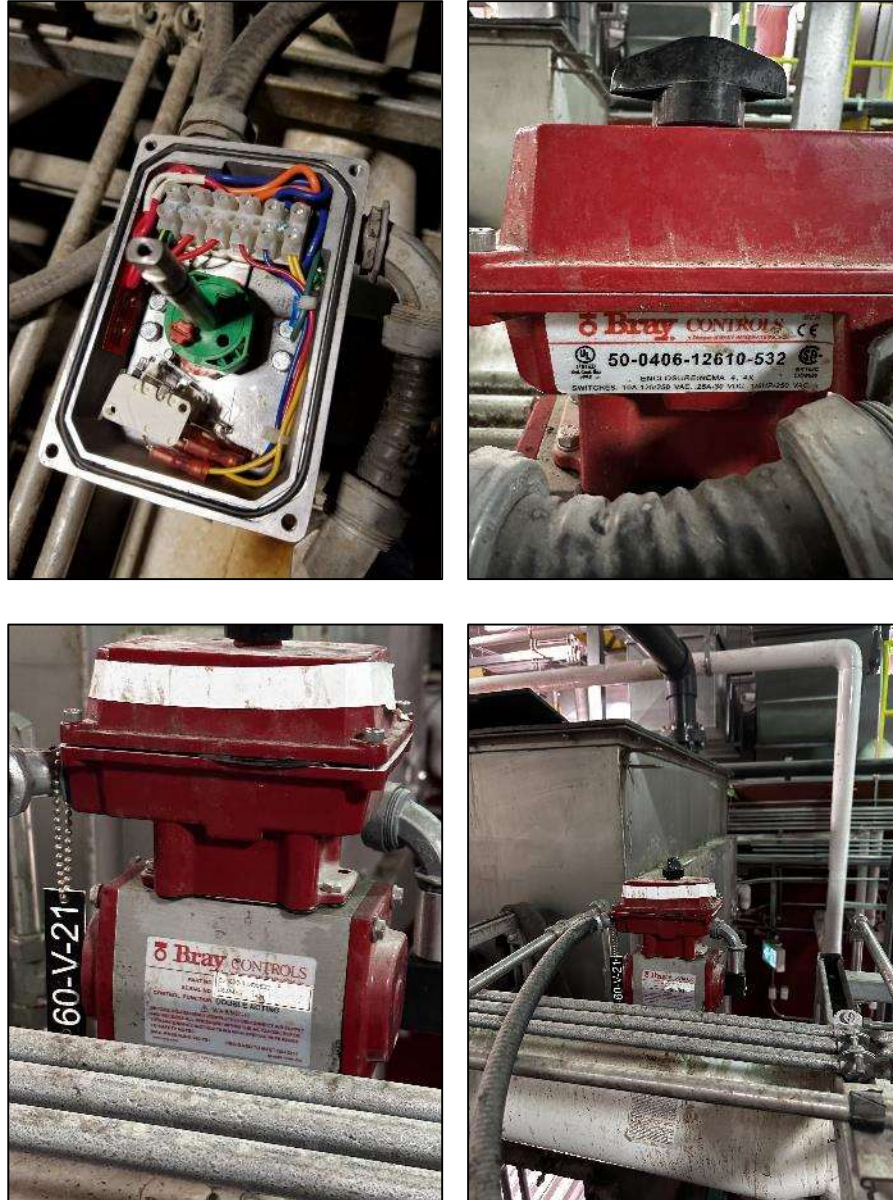
Figure 29: Valves 60-V-20 and 60-V-21

- Membrane Air Inlet Valves (60-V-20 and 60-V-21)
 - The noted issues with the automatic valves (air dryer/compressed air system) are affecting the actuation of the air blower valve and shutting down the trains every time a maintenance clean is initiated (automatic or manual)
 - Train #1 and #2 – aborted Maintenance clean alarm– fault at air blower valve 60-V-20/21
 - Train #1 – The position sensor for the train 1 cyclic air valve (60-V-20) was not reading open. The roller for the switch had fallen out. It was reinstalled with a temporary fix.
 - Train #2 – the solenoid valve/sensor was sticking as well. The valve was opened and it appeared that the o-ring was leaking and rusting the spring. The spring was lubed with Molykote.
 - There are no spares onsite.

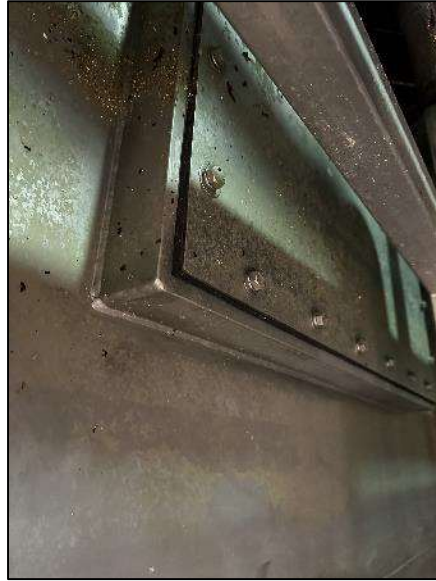
- Sept 22 – cassettes disassembled
 - Inside washed down further and sludge removed and cleaned from inlet and outlet valves
 - Overflow weir (Tank #1) backing plate and gasket appears to be in good shape – no visible signs of damage

Figure 33: Tank 1 - Overflow Weir

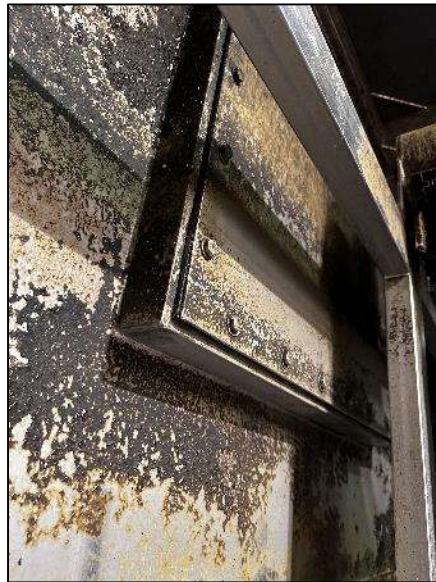
- Dropped to = 1852mm (9:00am – Sept 26)
- Sept 26
 - Tank #2 drained and old membranes/cassettes pulled out and disposed
- Sept 27
 - Tank further washed and cleaned to prepare tank for new membrane installation
 - Steel frames lifted
 - diffuser installation completed
- Sept 28
 - Overflow weir (Tank #2) backing plate and gasket appears to be in good shape – no visible signs of damage
 - Bolts were tightened on outflow weir

Figure 34: Tank 2 Overflow Weir

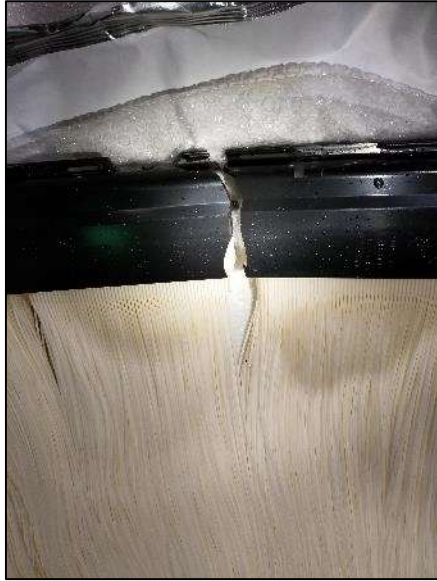
- One crate had been damaged during transportation resulting in one module breaking, and another had its foil packaging punctured potentially exposing the fibers to heat and/or dryness

Figure 35: Damaged Module

- **Replacing the blank with a new module at the earliest convenience. The potentially exposed module can be replaced at that time, or can be replaced once it starts to show reduced performance.**
- **Re-calibrating on the next visit when fresh calibration solution is available.**

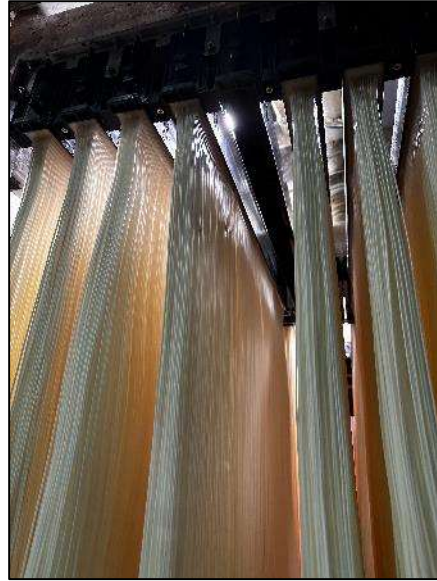
- Assembly of cassettes
- Installed new membranes
- Tank was filled with clean water overnight
- A blank was installed on cassette 2 of train 2, in place of the broken module. The module with the potential exposure was installed on cassette 1 of train 2. While it did not behave abnormally during the bubble test, it's longevity may be affected by the exposure.
 - A damage claim has been submitted by Veolia to the courier service

Figure 36: Blank Module Installation in Train #2

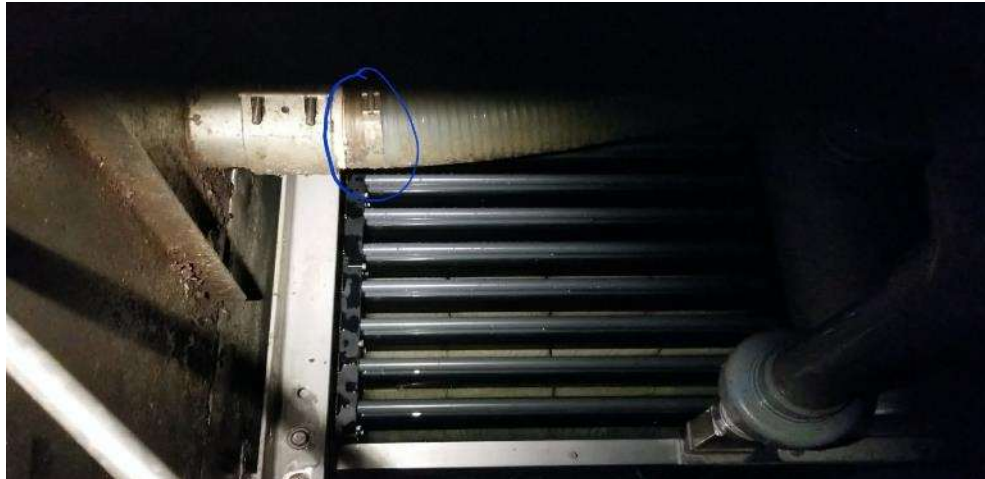
Figure 37: Train #1 Leak in Air Hose Connection

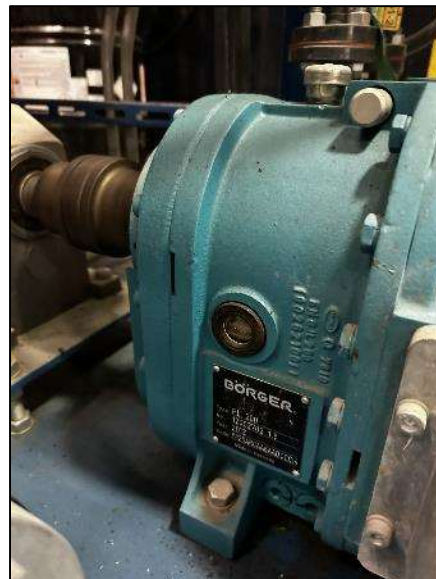
- Both permeate pumps requires an oil change and there appears that some water has entered the pump (apparent through the viewfinder)

Figure 38: Permeate Pump Oil Change

EXP recommends that a contractor be hired to service the permeate pumps. It is noted that the plant has a set of new spare pumps (delivered Feb 2021)

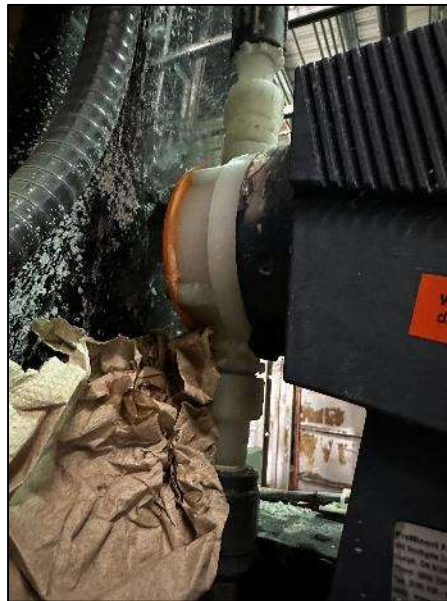
- Maintenance cleans were tested on both trains. Maintenance cleans are now operational, however the dosing pump is old and has an intermittent leak behind the pump diaphragm (leakage hole)

Figure 39: Sodium Hypo Pump Leak behind Pump Diaphragm

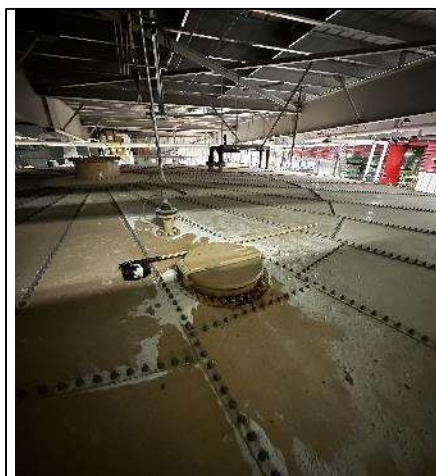
- Plant has been manually dumping soda ash directly into bioreactor. Currently, they use the forklift to lift a couple buckets of soda ash up to the top of the bioreactor tank and then climb up the ladder and dump the soda ash directly through the anoxic hatch
- Operators noted that manual mixing tank that was provided over by the sludge storage tank is no longer in use
 - Outlet valve to connect the hose would constantly get plugged and/or not mix properly (especially in the winter)
 - The outlet valve is located at the bottom of the tank (lifted on pallets) and would accumulate solids
 - The new soda ash pumping system should ensure that the suction pipe is elevated from the bottom of the tank

Figure 41: Soda Ash on top of Bioreactor Tank

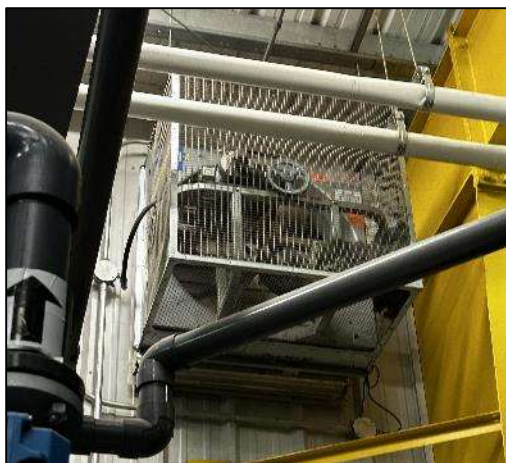
- The air louver (near the roof by the membranes and EQ tank) does not open – the motor belt is loose and needs to be replaced.

Figure 42: Air Louver System

- **Hire a contractor to repair the motor belt**

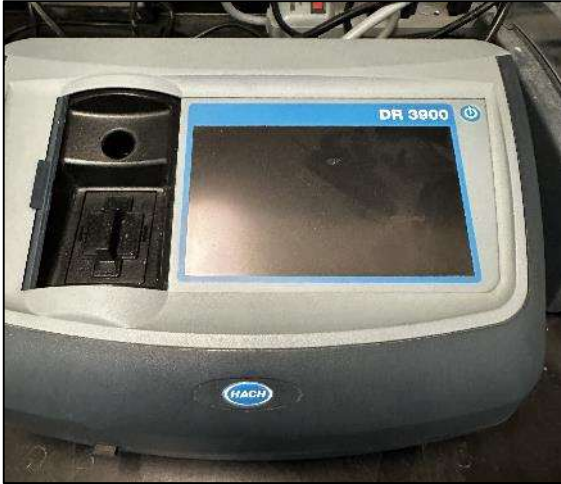
- The HACH DR3900 spectrometer machine is not turning on at all. Charger appears to be getting power but machine won't power on. It appears that the screen is broken.
- Small compressor to filter TSS samples is broken

Figure 43: HACH DR3900 Broken Screen

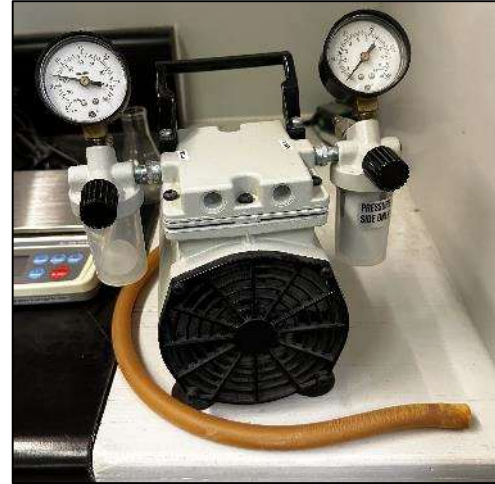
Figure 44: Broken lab compressor machine

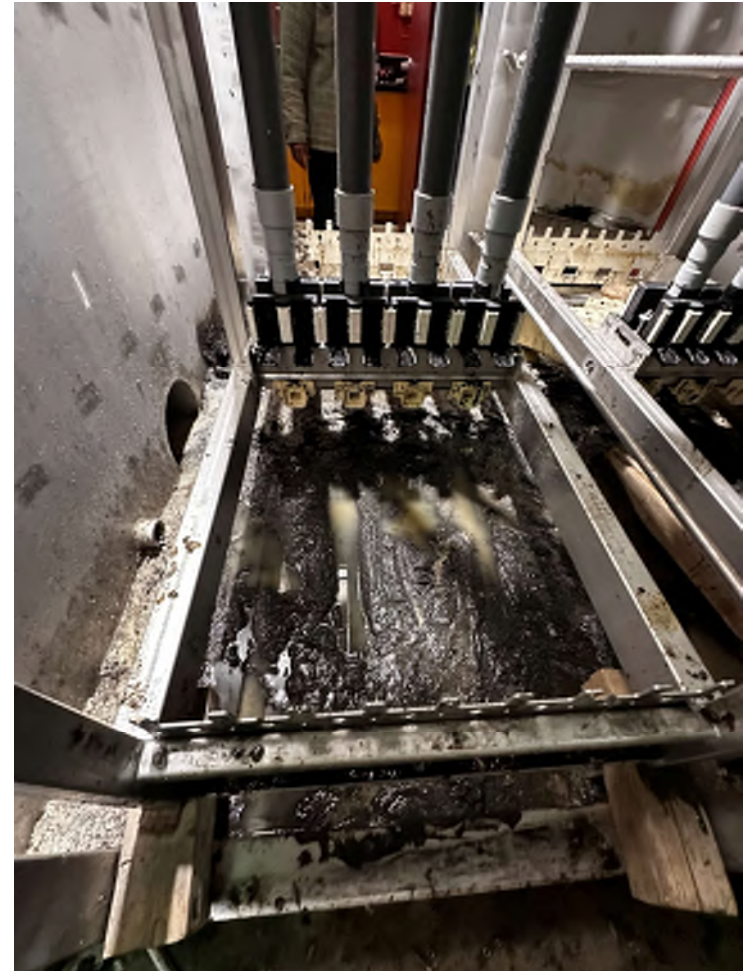
Membrane Tank Sludge Accumulation (0)
