Project Name: Hamlet of Pangnirtung –
Drainage Survey

Project #: FRE-00253815-A0
/File No: 60.2

Subject: Pangnirtung Drainage Plan Topographic Survey

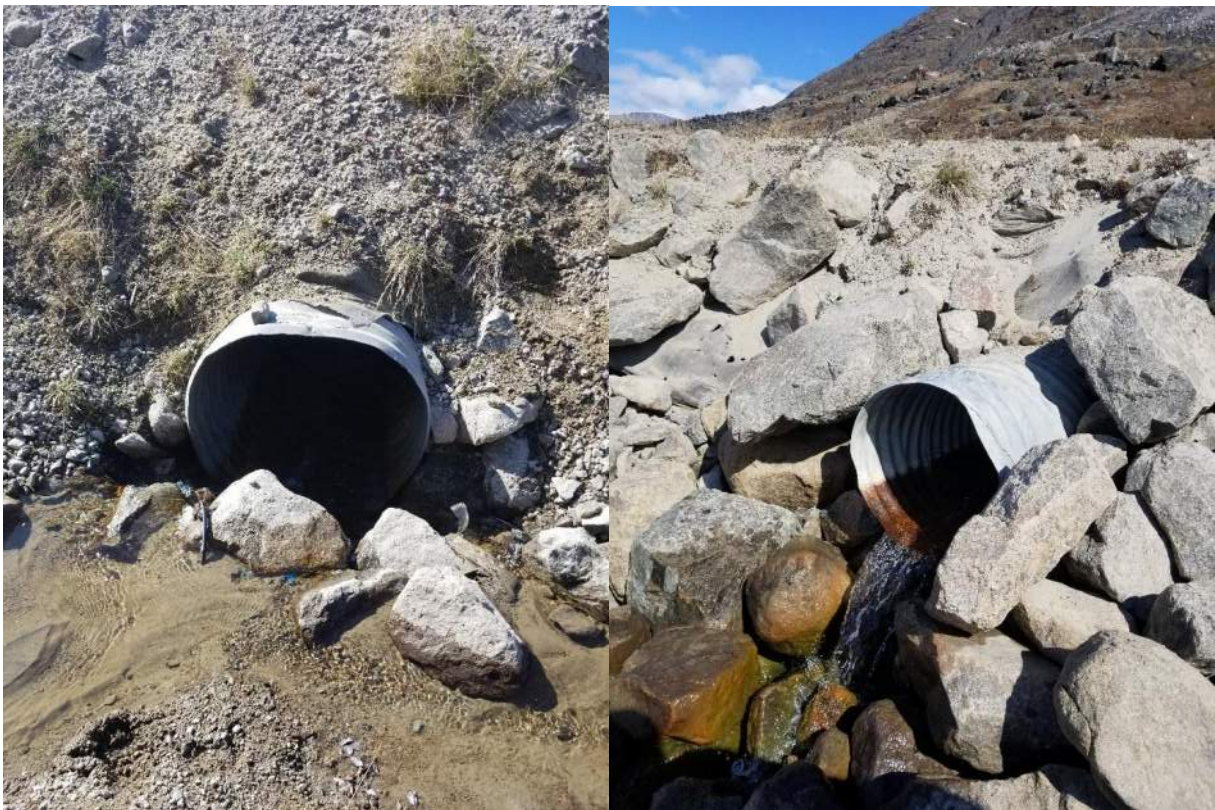
Culvert ID: 1

Culvert ID	Diameter (mm)	Type	Condition Assessment
1	600	Corrugated Steel	Good condition.
2	450	Corrugated Steel	Good condition.
3	900	Corrugated Steel	Sagged midway under road. Both ends damaged.
4	900	Corrugated Steel	Sagged midway under road. Contains debris and silt build up. Outlet end 50% plugged with silt.
5	900	Corrugated Steel	Minor sag midway under road. Debris build up on inlet end. Silt and stone buildup of approximately 15% of culvert. Damaged at outlet end.
6	1200	Corrugated Steel	Minor sag at inlet end (approx. 3 meters). Garbage all throughout culvert. Half pipe extension at outlet end, full of garbage from dump (see photo). Culvert has less than recommended cover depth.
7	600	Corrugated Steel	Silt build up 50% at inlet. Plugged at outlet.
8	600	Corrugated Steel	Runs from within the dump. Contains various debris. Could not examine inlet side. Major sag midway under dump fence.
9	600	Corrugated Steel	Runs from within the dump. Plugged with garbage and silt. Could not examine inlet side.
