Leak Repair Program Resolute Bay October 2010

Prepared For:
Department of Community and Government Services
Government of Nunavut

Project No: OTT00020430A
Report date: October, 2010

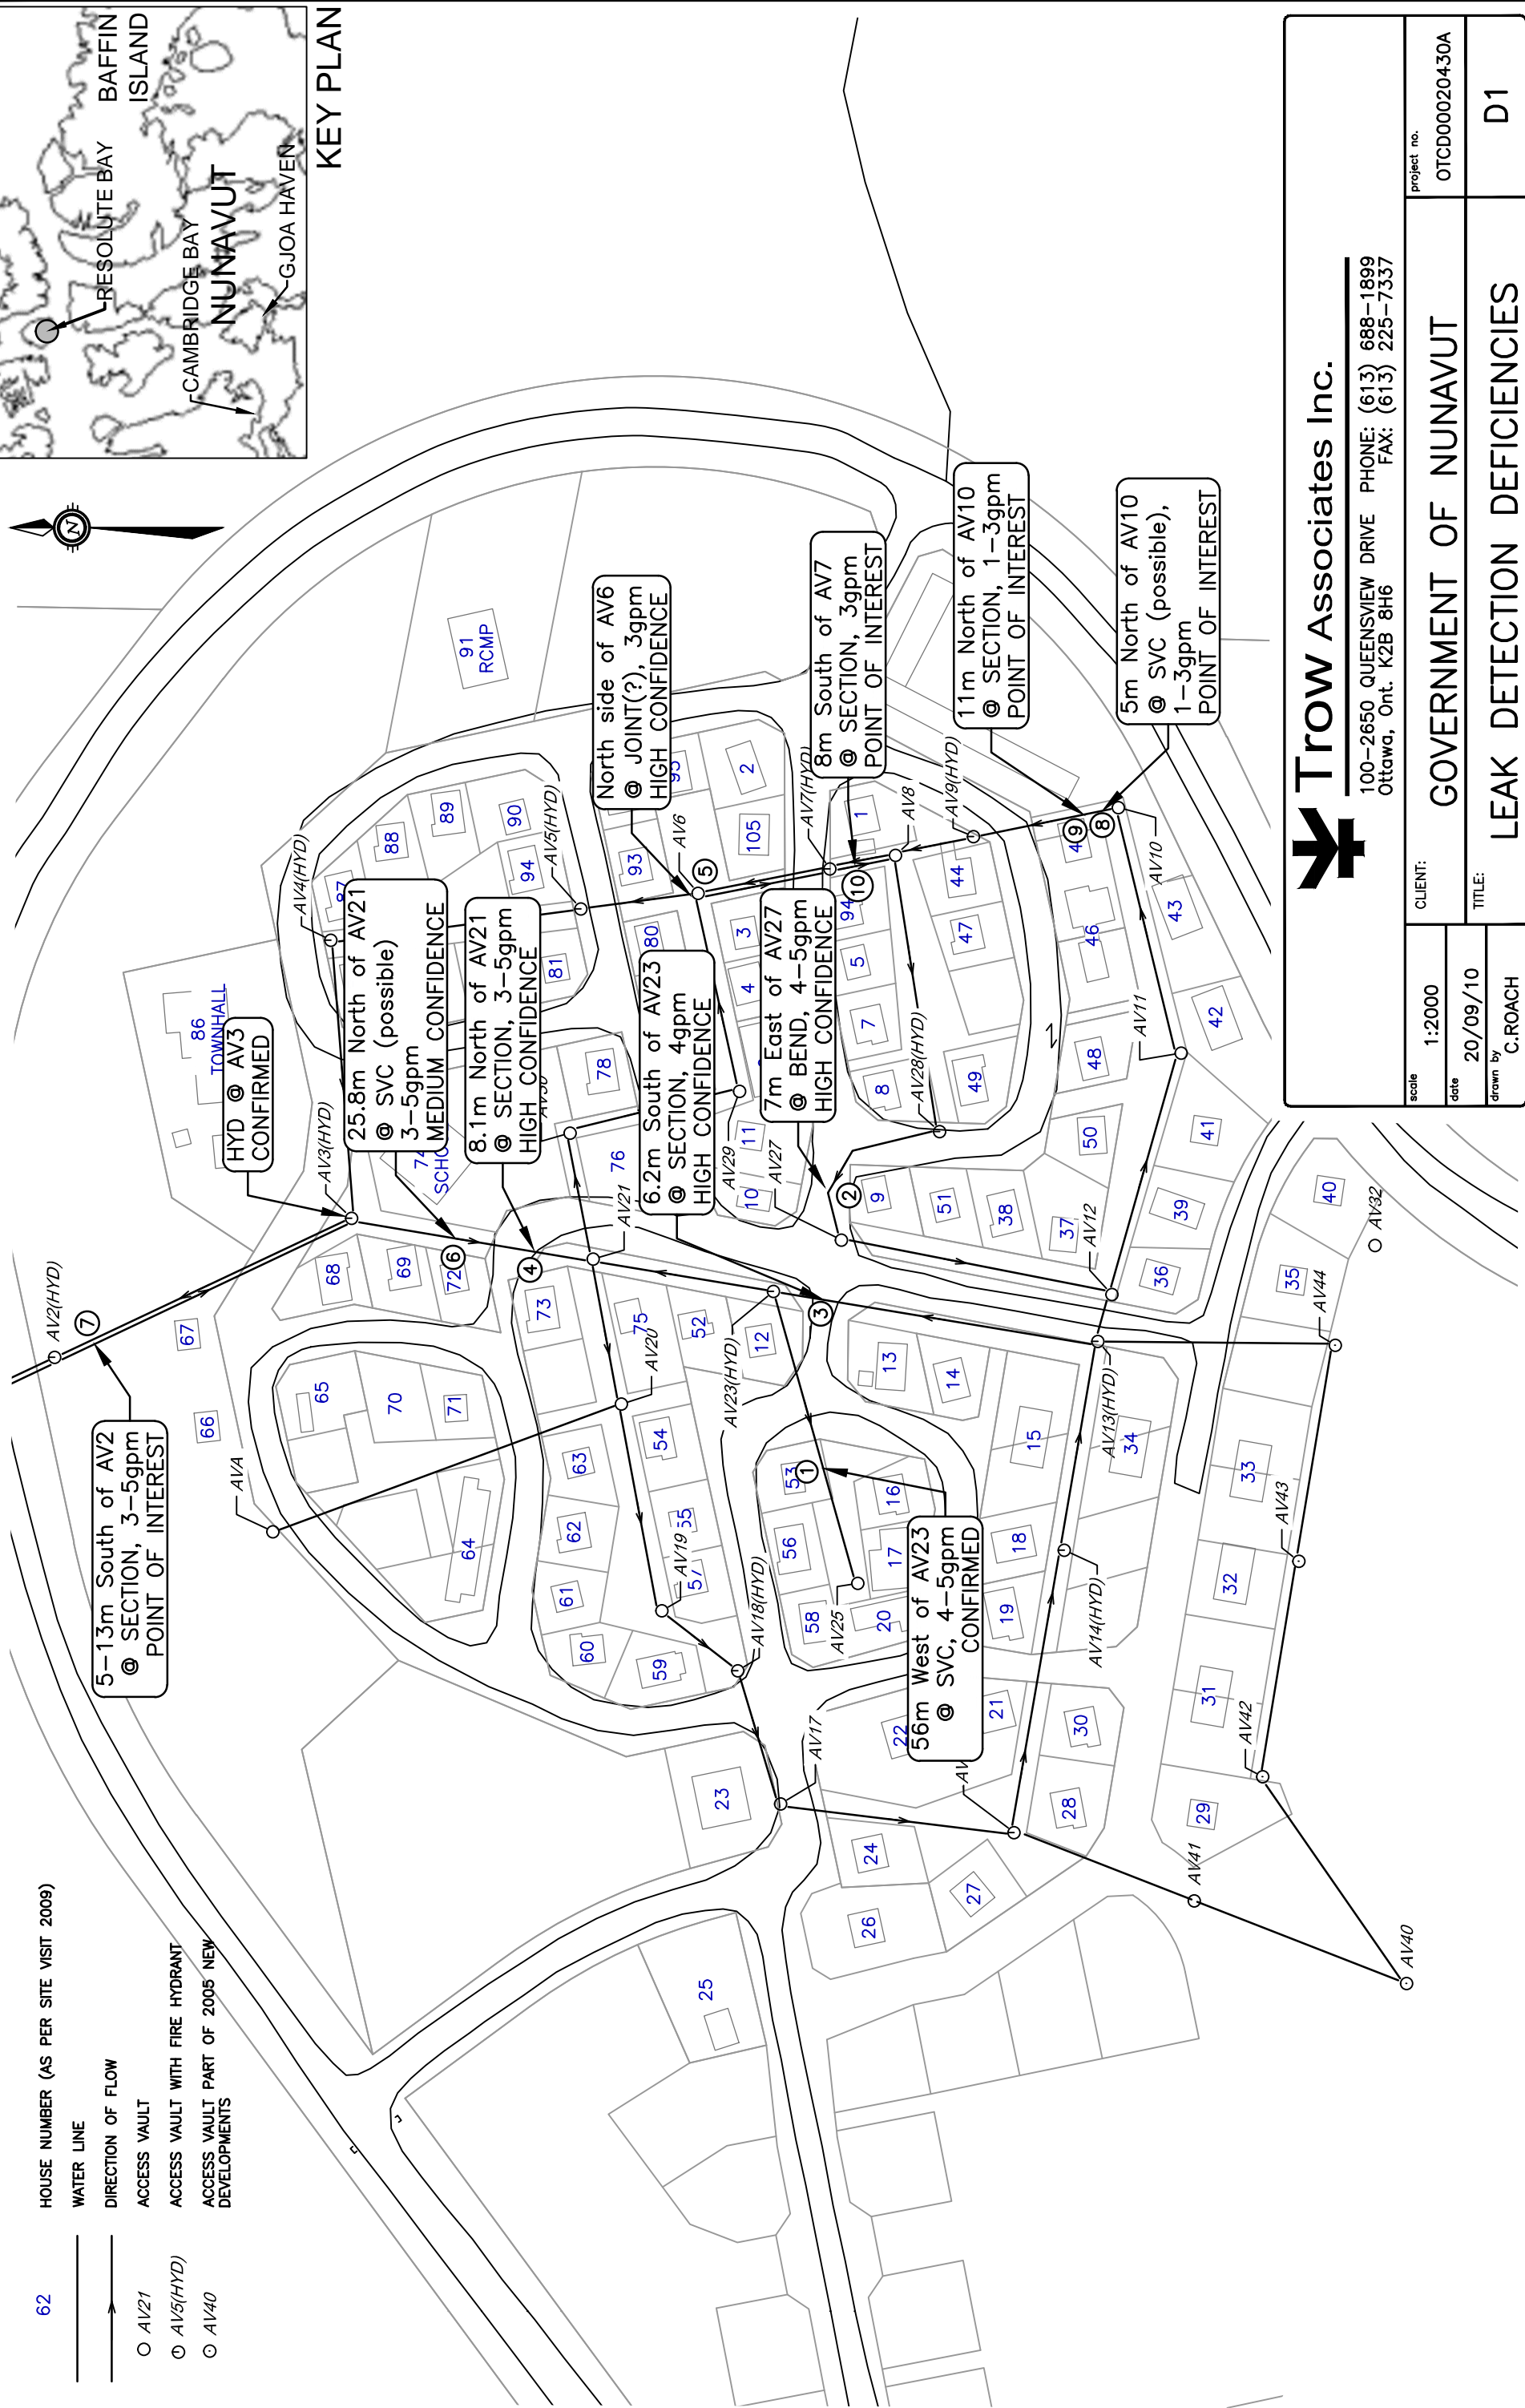
scale 1:2000		CLIENT: GOVERNMENT OF NUNAVUT	project no. OTCD00020430A
date 20/09/10			
drawn by C.ROACH		TITLE: LEAK DETECTION DEFICIENCIES	D1

5-13m South of AV2
@ SECTION, 3-5gpm
POINT OF INTEREST

HYD @ AV3
CONFIRMED

25.8m North of AV21
@ SVC (possible)
3-5gpm
MEDIUM CONFIDENCE

8.1m North of AV21
@ SECTION, 3-5gpm
HIGH CONFIDENCE

6.2m South of AV23
@ SECTION, 4gpm
HIGH CONFIDENCE

7m East of AV27
@ BEND, 4-5gpm
HIGH CONFIDENCE

56m West of AV23
@ SVC, 4-5gpm
CONFIRMED

North side of AV6
@ JOINT(?), 3gpm
HIGH CONFIDENCE

8m South of AV7
@ SECTION, 3gpm
POINT OF INTEREST

11m North of AV10
@ SECTION, 1-3gpm
POINT OF INTEREST

5m North of AV10
@ SVC (possible),
1-3gpm
POINT OF INTEREST

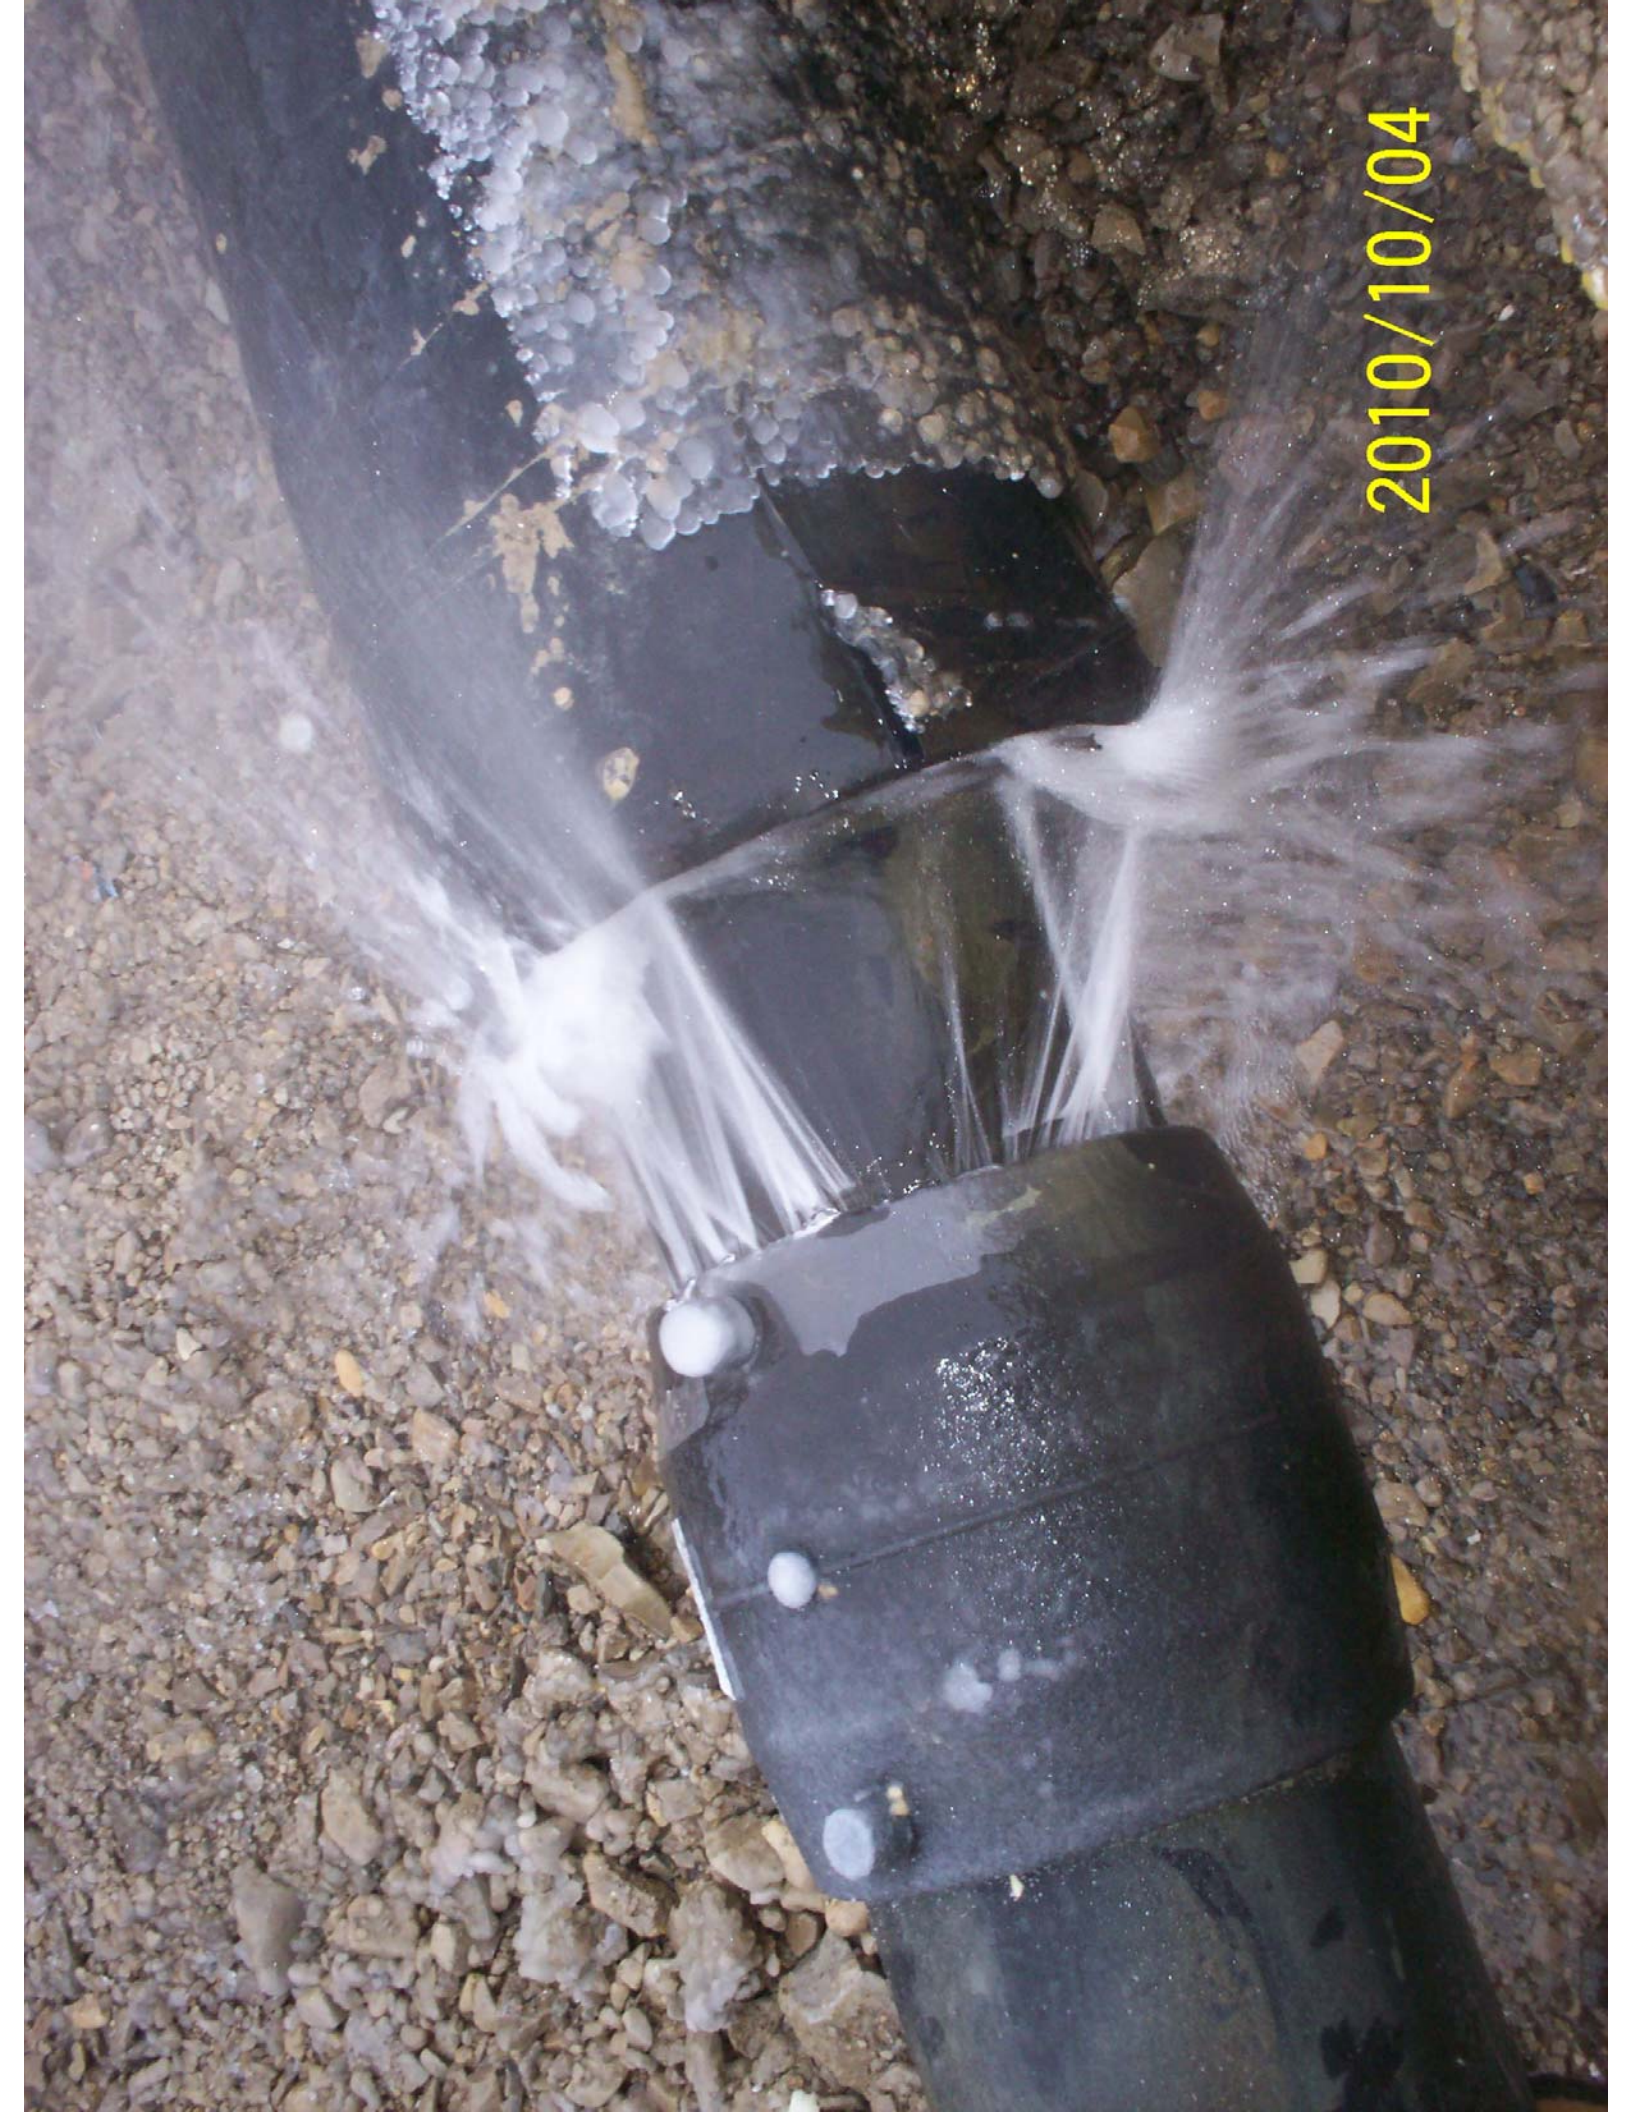
2010/10/04

Of the ten potential leaks identified in the Echologics report, three leaks were found and repaired. They included one leaking service connection (location 1) and two leaking electrofusion couples (locations 5 and 9). Photographs of the leaking couples are included in Appendix C. Although it is difficult to accurately quantify the size of the leaks that were found, they can all be classified as significant. In particular the two leaking electrofusion couples were contributing significantly to the amount of unaccounted water usage. It is believed that although the number of leaks repaired was less than anticipated, the overall reduction in water loss was equivalent to the amount anticipated in the original leak repair program.

- 7:00 a.m. prepared for electrofusion at locations nos. 5 and 9.
- Kudlik continued to excavator location no. 5.
- Generator and fusion machine were needed all day for the repair.
- Water was shut down 9:00 a.m. by isolating half of the town (East Loop).
- 11:00 a.m. system is fully drained.
- The main valve feeding the hamlet water system was eventually shut off because the isolation loop valves leaked.
- Chlorine test 0.64 ppm.
- 2:15 p.m. location no. 5 was repaired with a 1.0m long section of HD Polyethylene pipe electrofused at both ends to the existing system.
- 2:30 p.m. location no. 9 was repaired with a 1.0m long section of HD Polyethylene pipe electrofused at both ends to the existing system.
- 4:30 p.m. water system was opened.
- 6:00 p.m. backfilling the 2 locations complete.
- Material used: 4 Electrofusion Parts, Foam, Shrink Wrap 4 sheets max.

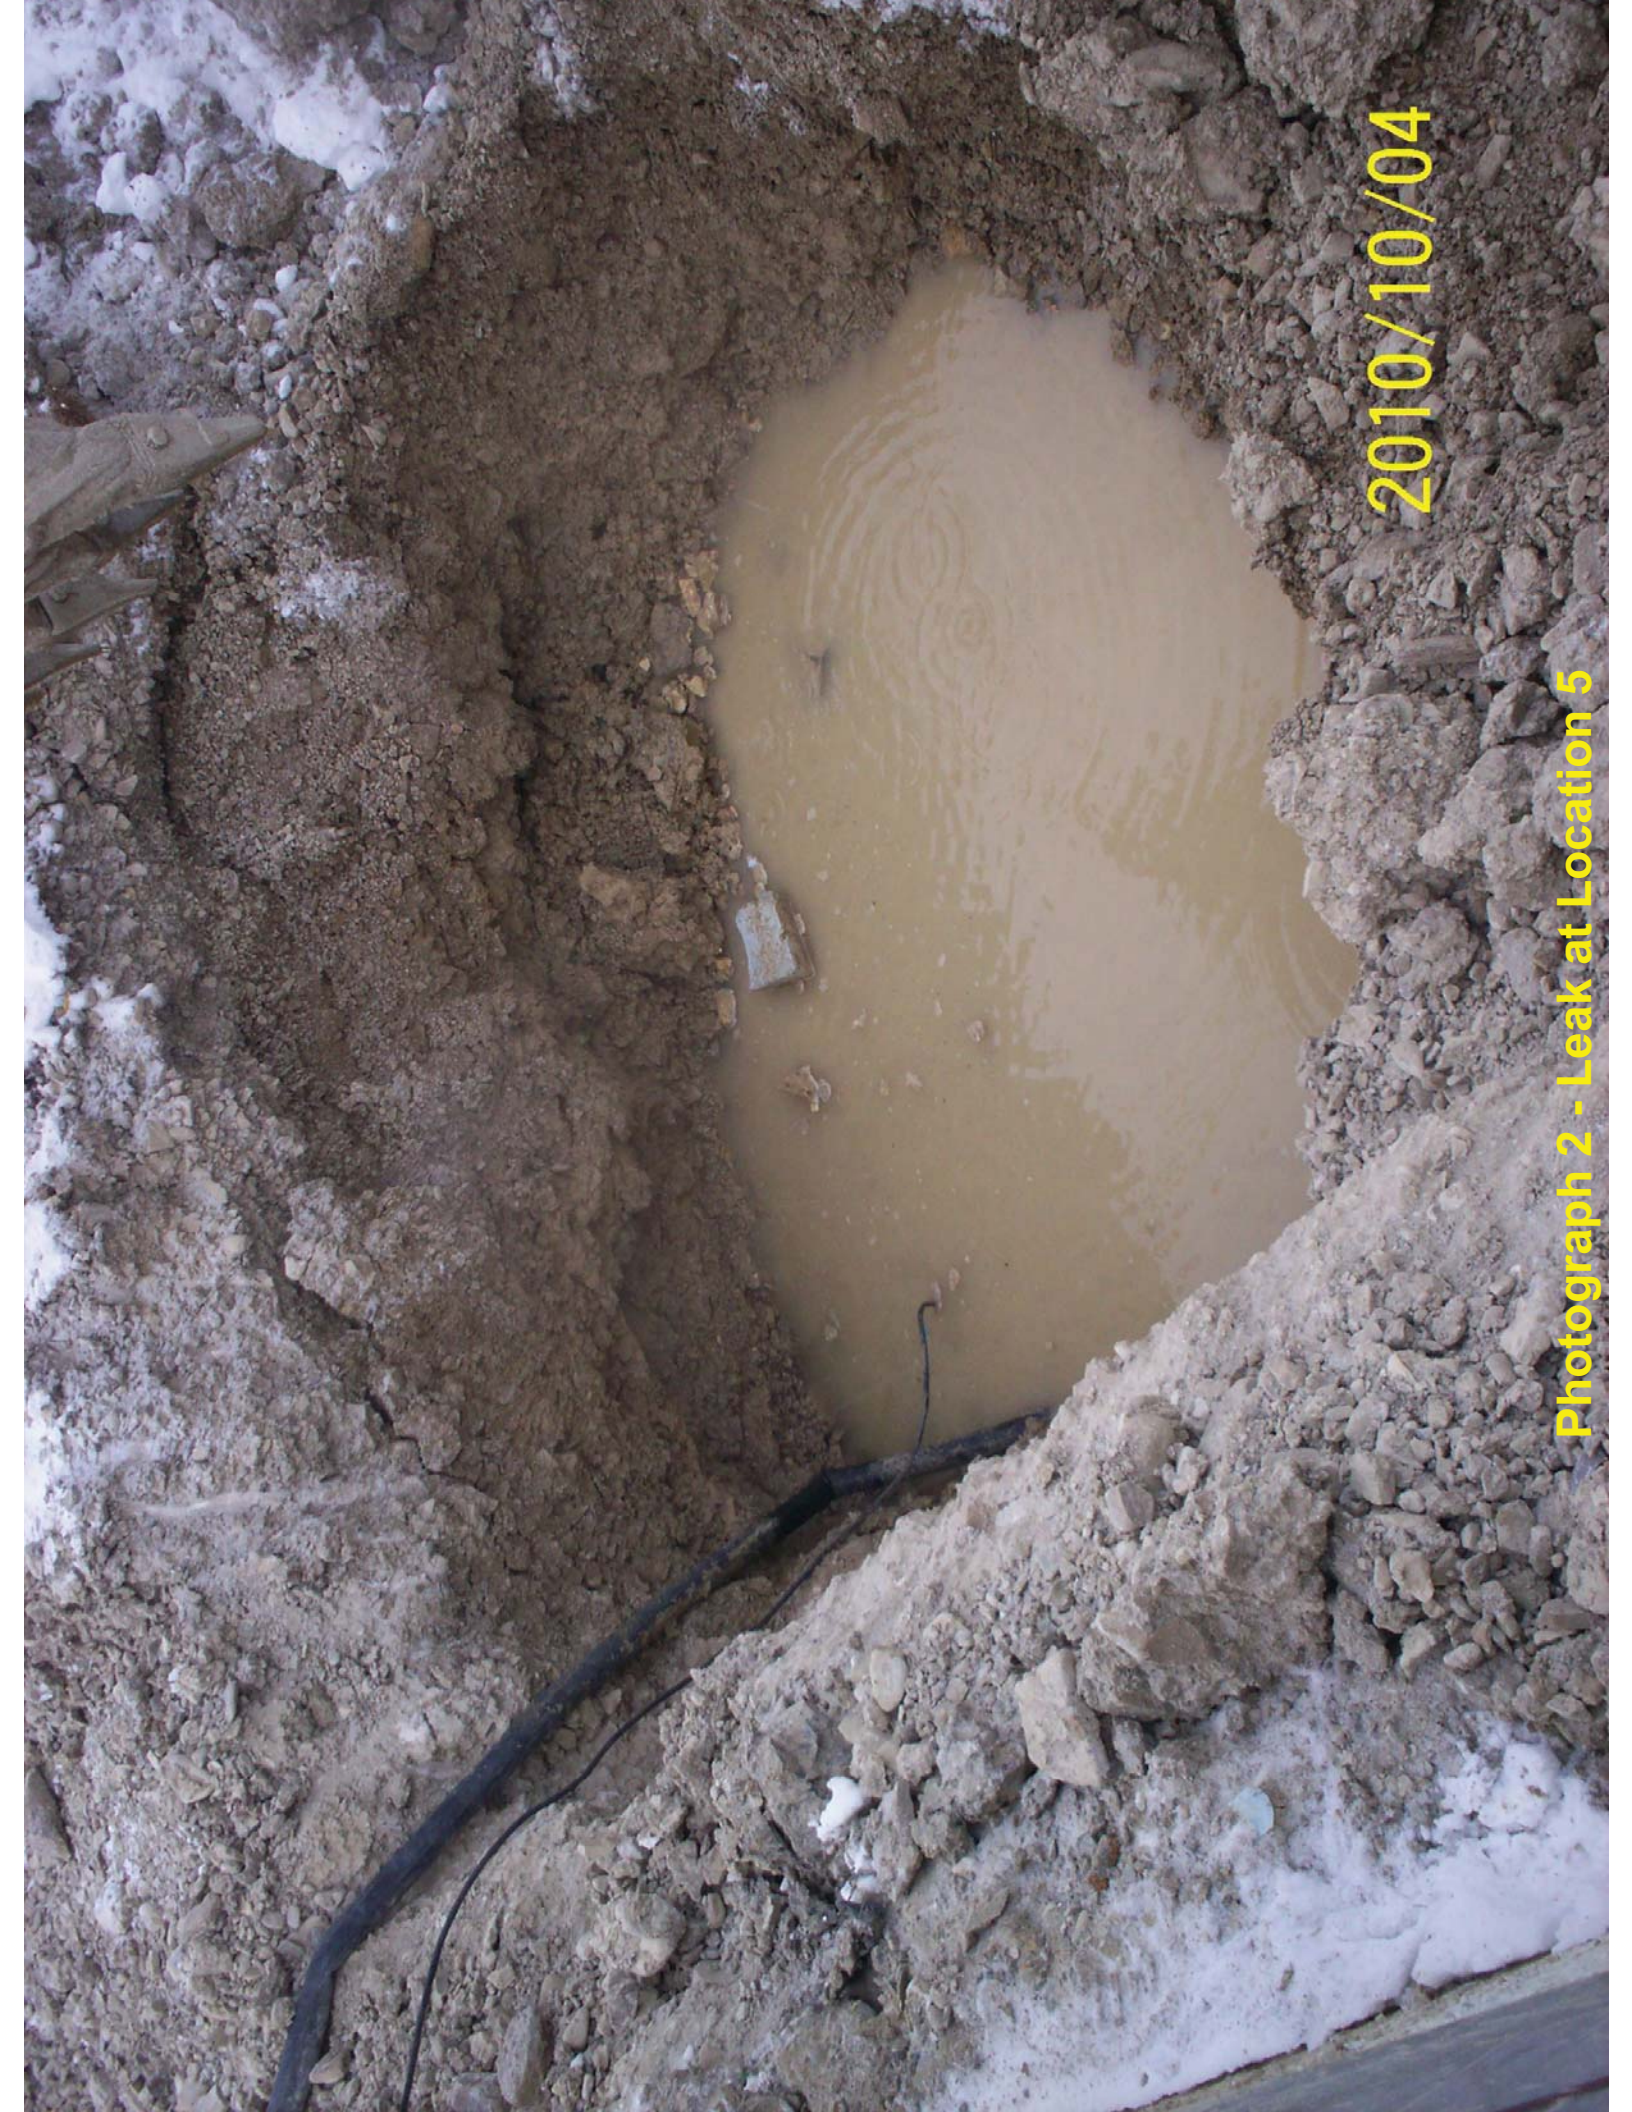
- Kudlik exposed the leak and found a second electrofusion connection leaking.
- 4:30 p.m. a chlorine residual test was completed, result 0.38 ppm.
- 5:00 p.m. moved to location no. 10 and started excavating.
- 5:00 p.m. Loader is brought to support a hydro pole near the hole.
- 6:00 p.m. Finished work for the day.

Photograph 2 - Leak at Location 5
